PRELIMINARY GEOTECHNICAL INVESTIGATION

11-13 Percy Street, Auburn NSW

Fabcot Pty Ltd – July 2019

Report reference: 1901031GTRpt01FinalV01_10Jul19

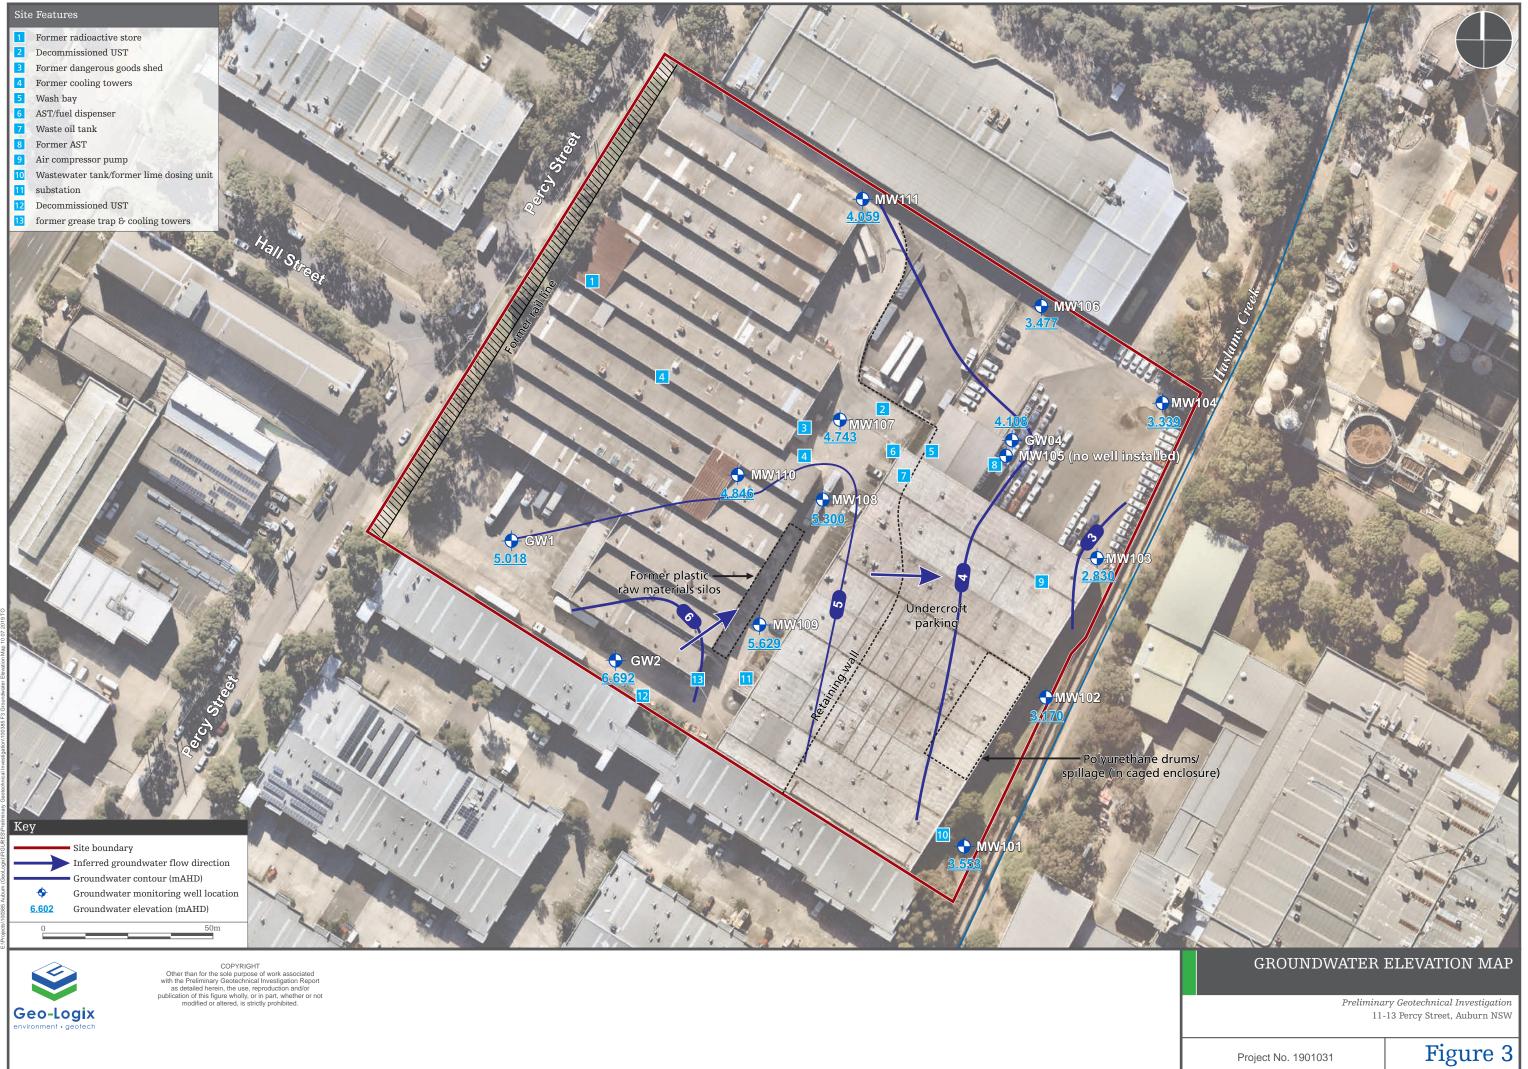
Figure 2

Figure 1: Site Location MapFigure 2: Sample Location MapFigure 3: Groundwater Elevation Map

The location of each boring and test pit was estimated using measurements from existing features (Figure 2). A copy of the boring logs and SPT results are provided in Attachment B.

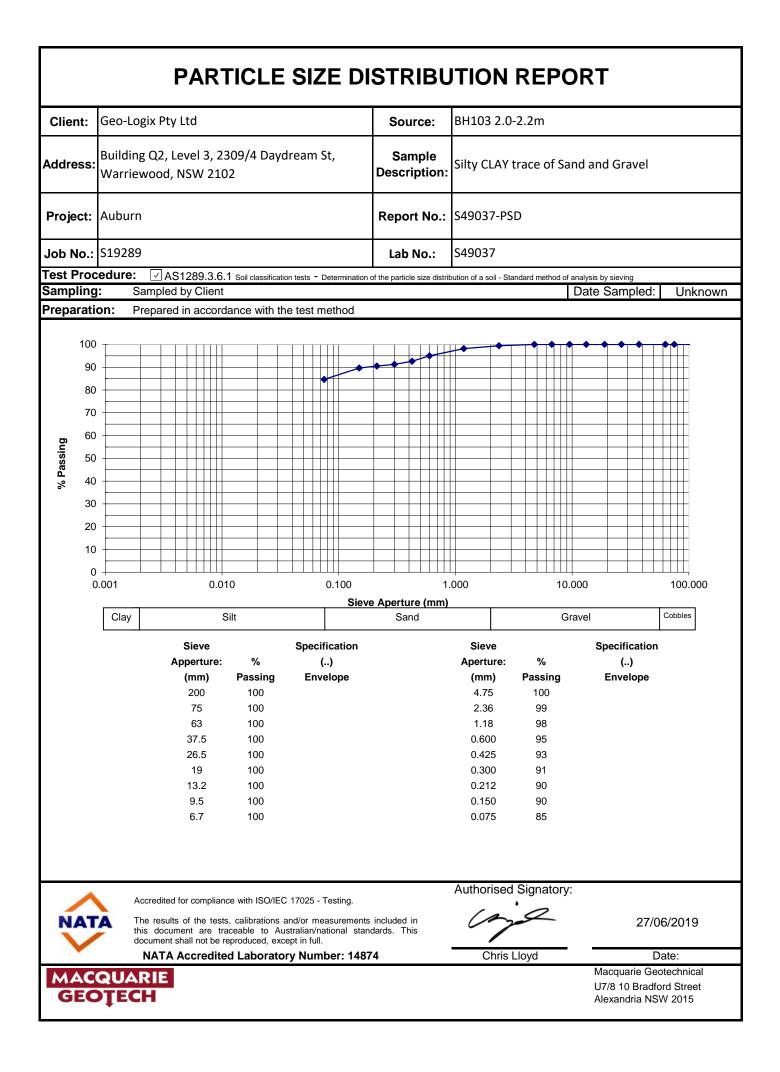
SOIL CLASSIF	ICATION	REPORT		
Client	Geo-Logix Pty Ltd	Source	BH103 2.0-2.2m		
Address	Building Q2, Level 3, 2309/4 Daydream St, Warriewood, NSW 2102	Sample Description	Silty CLAY trace of Sand and Gravel		
Project	Auburn	Report No	S49037-PI		
Job No	S19289	Lab No	S49037		
Test Proce Sam Prepar	AS1289 3.1.1 Soil classification tests - Determination of AS1289 3.1.2 Soil classification tests - Determination of AS1289 3.2.1 Soil classification tests - Determination of AS1289 3.3.1 Soil classification tests - Calculation of the AS1289 3.4.1 Soil classification tests - Determination of pling: Sampled by Client	the liquid limit of a soil - Four p the liquid limit if a soil - One po the plastic limit of a soil - Stand : plasticity Index of a soil	int Casagrande method (subsidiary method) lard method	led: Unknown	
	Liquid Limit (%) 32 Plastic Limit (%) 15	Linear Shri Plast	inkage (%) 8.0 icity Index 17

Plasticity Chart for Classification	40 50 Liquid Limit % E: Dry Sieved C: Oven Dried	Soils	80	
	Accredited for compliance with ISO/IEC 17025 - Testing. The results of the tests, calibrations and/or measurements included i document are traceable to Australian/national standards. This docu shall not be reproduced, except in full. NATA Accredited Laboratory Number: 14874	in this iment	Authorised Signatory: Chris Lloyd	28/06/2019 	
GEOTE	ARIE CH			Macquarie Geotechnical U7/8 10 Bradford Street Alexandria NSW 2015
