Geotechnical Investigation Report

Proposed Museum Discovery Centre Expansion

Building J

Report No: 8325-GR-1-1

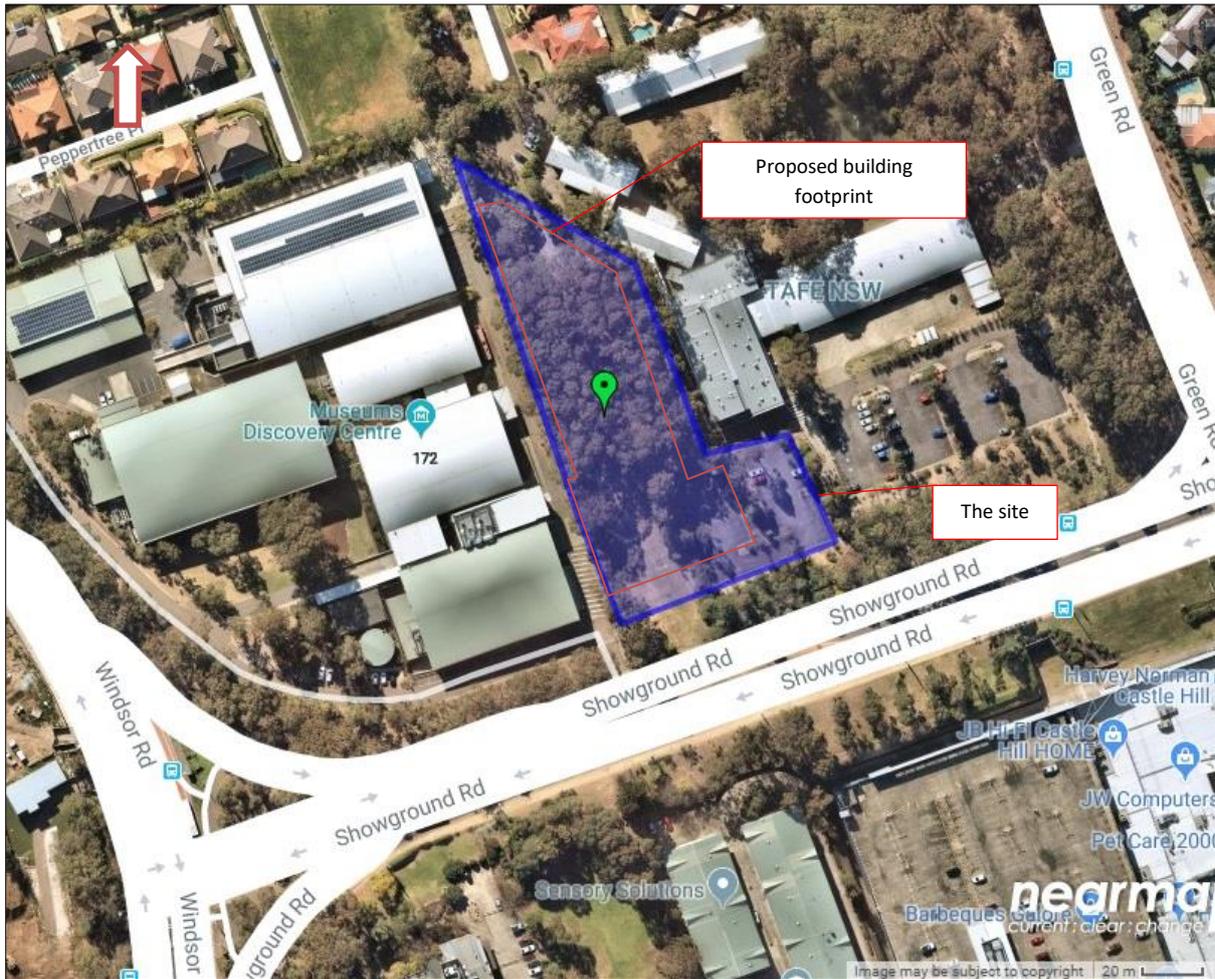
Figure 1- General Site Location

The site location and the proposed basement layout are shown in Figure 1.

The site surface dips to the northeast with an approximate gradient of 3 degrees and ranges in elevation from RL 115.5m (AHD) at the southwestern corner to RL 110m (AHD) at the north-eastern corner.

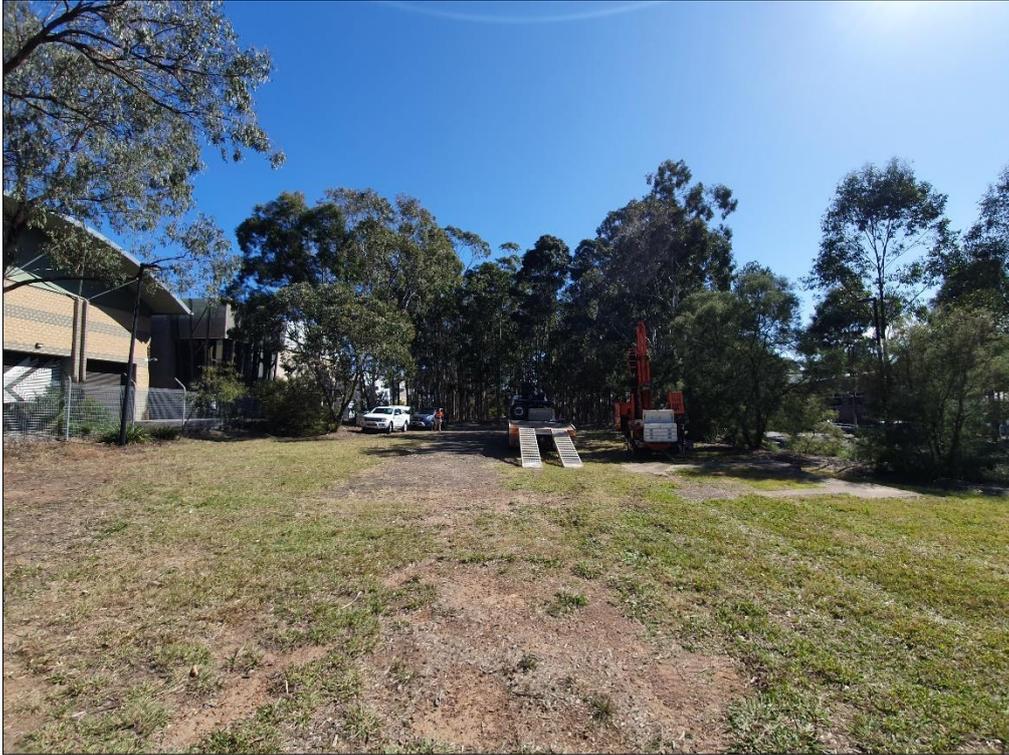
Photo 1 – General Site Overview – Looking North

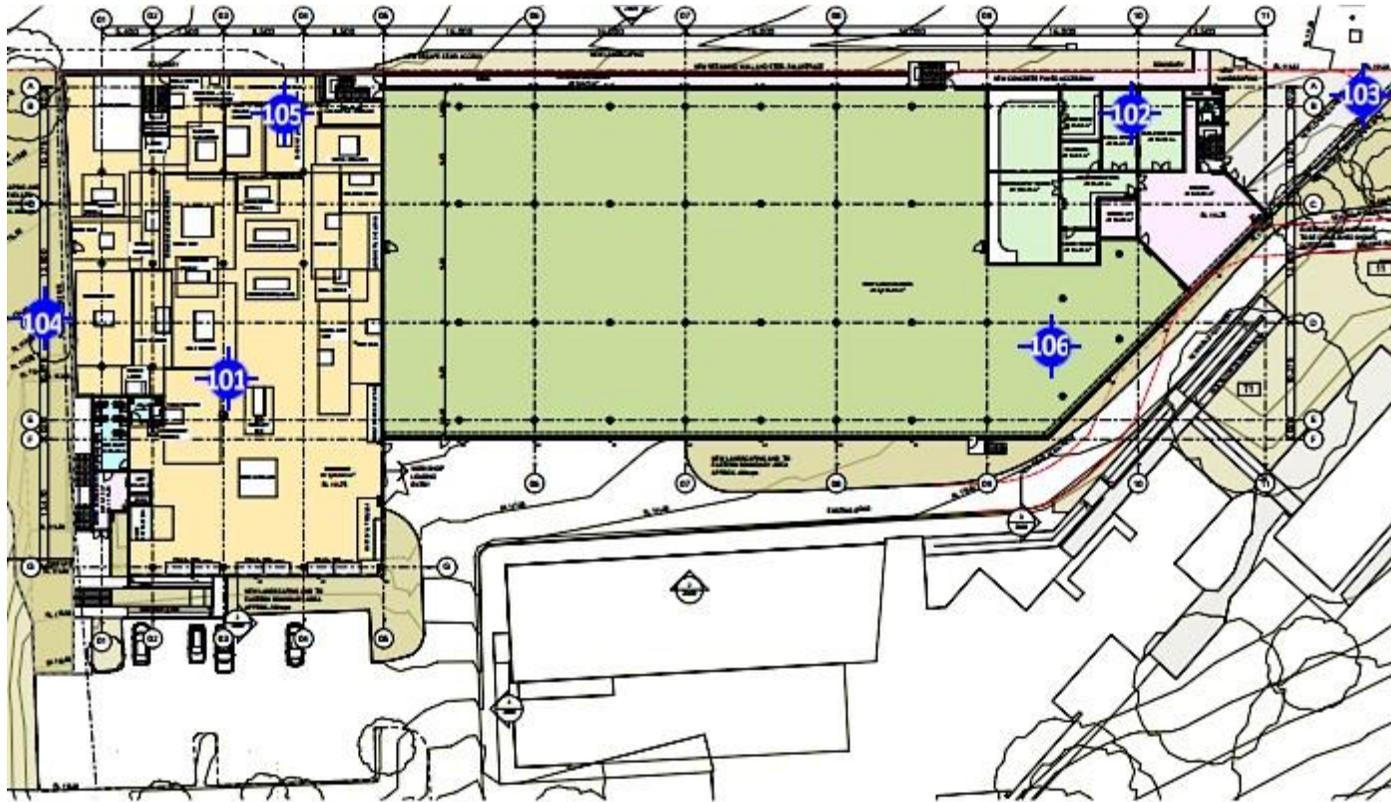
APPENDIX B – Borehole Location Plan (Drawing: 8325-GR-1-A)

The approximate locations of the boreholes are shown on the Borehole Location Plan (Drawing 8325-GR-1-A) presented in Appendix B.

Due to the vegetations and mature trees in the middle of the site, the borehole drilling was limited to the southern and northern sides of the site, within the foot print of the proposed development.

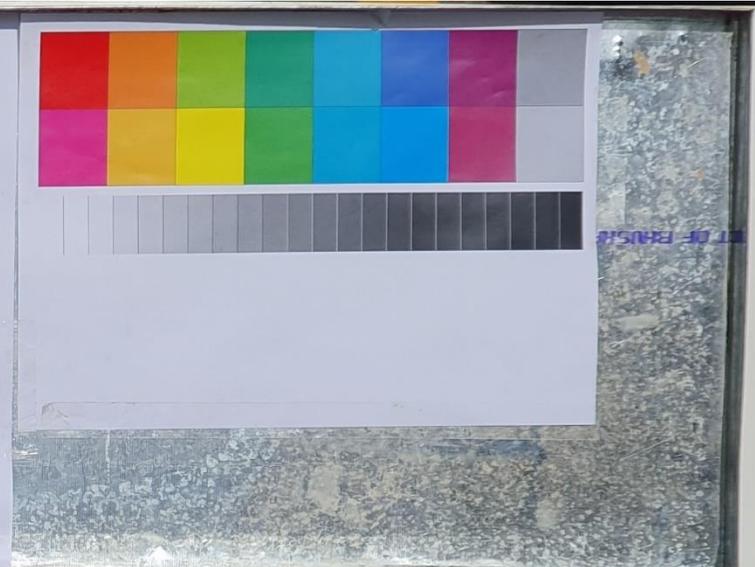
Core Box Photo – BH102

Cored Borehole: BH102

Bedrock defects and seams are listed in the attached logs. There were several clayey seams with a maximum thickness of 90mm at 6m depth in BH102. The joints with dipping angles of 40 to 80 degrees were observed in both cored boreholes.

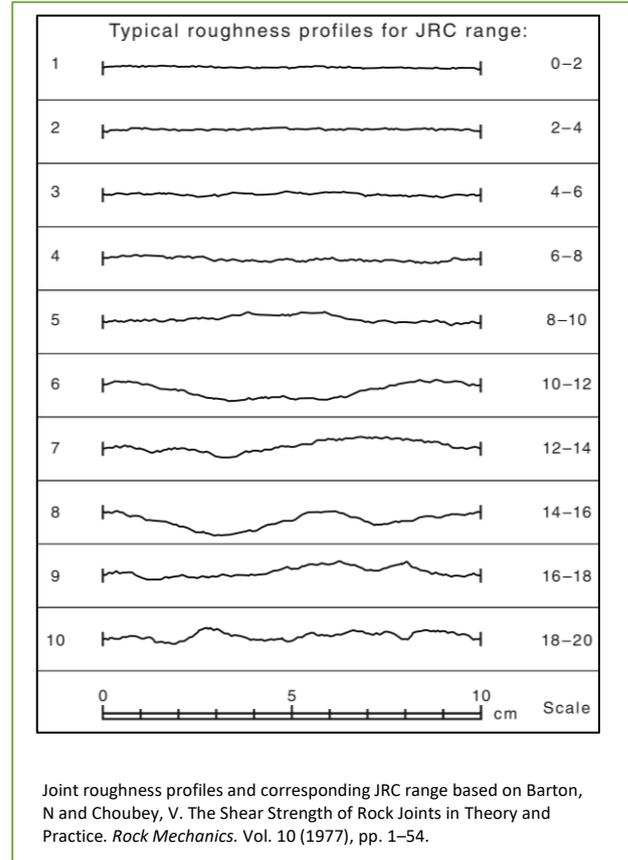
Where applicable Joint Roughness Range (JRC) is provided as follows:
