Geotechnical Investigation Report

Proposed Redevelopment – Marist College North Shore

Marist College North Shore

Report No: 9625.1-GR-1-1

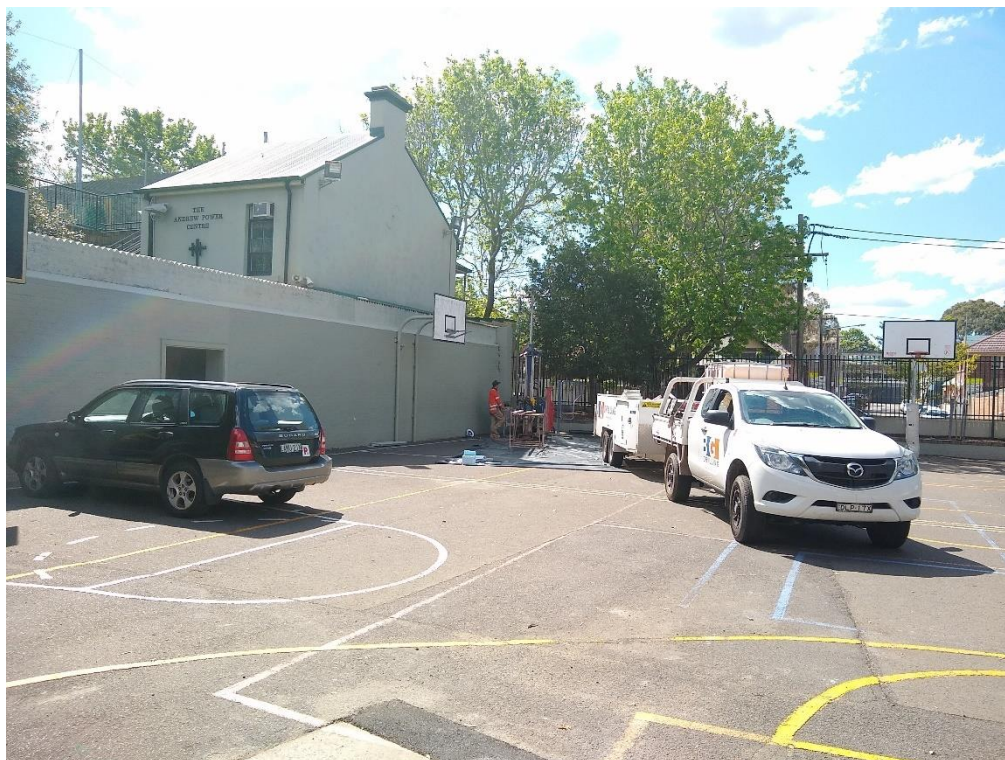
Photo 1 - AG's site investigation – drilling BH02

This geotechnical site investigation was carried out over two days between 1st October and 2nd October 2020. Selected site photographs taken during the fieldwork are presented in Appendix B.

The boreholes were drilled using a drilling rig operated by AG's nominated drilling contractor and were advanced through soil profile by augering with a tungsten carbide (TC) bit. The rock in three boreholes (BH01 to BH03) was recovered by NMLC coring.
