Report on
Salinity Investigation and Management Plan

Proposed Industrial Development
Stage 3, Sydney Business Park, Marsden Park, NSW

Project 94616.01
July 2020

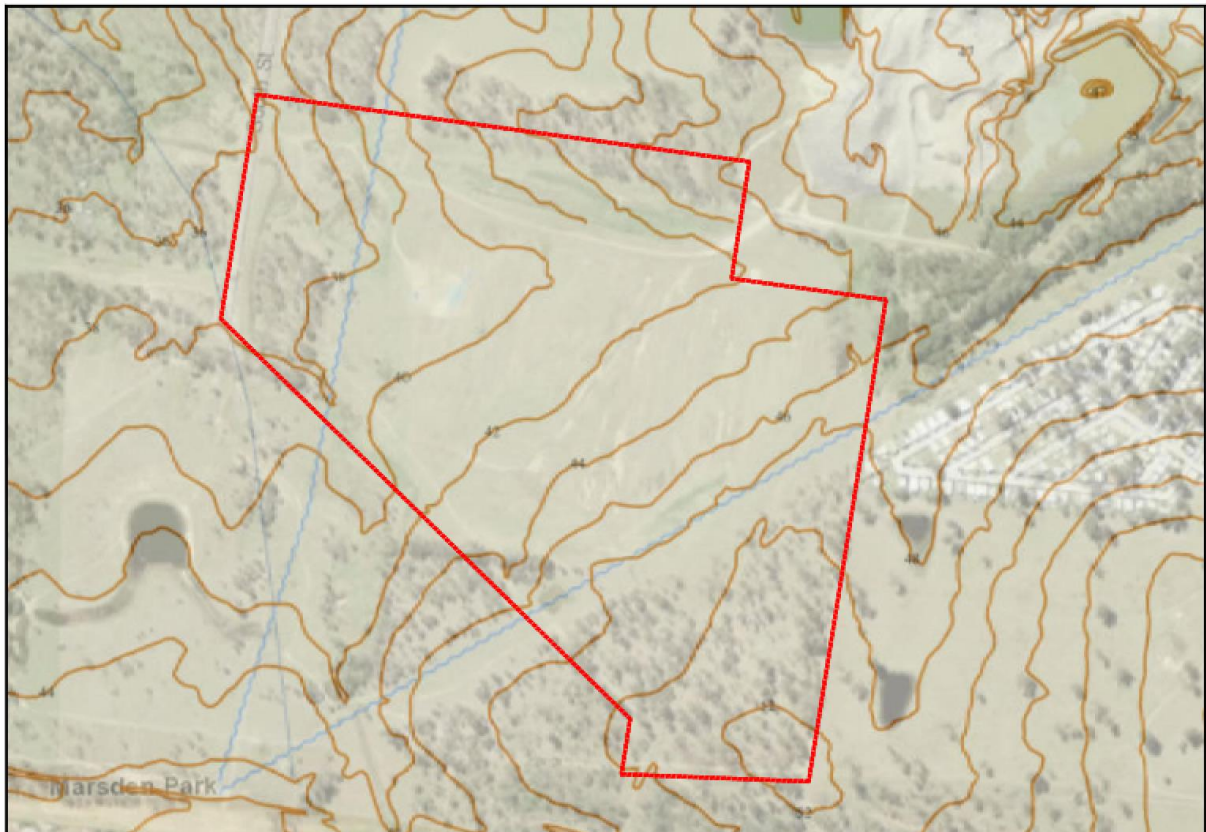
Figure 1: 2 m Topographic Contours at the site

Site topography (Figure 1) generally slopes down from southeast to west from approximately 50 m AHD to 36 m AHD.

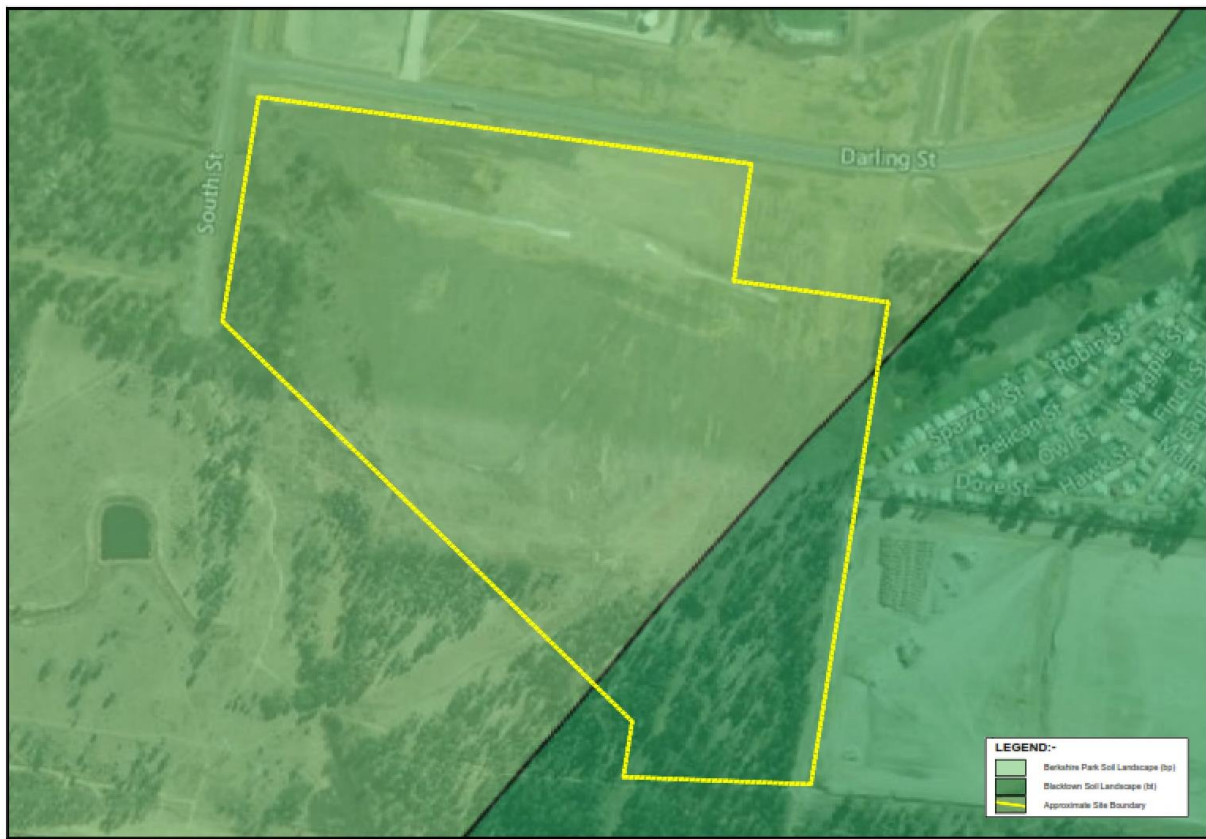
Figure 2: Soil Landscape at the site

Reference to the Penrith 1:100 000 Soil Landscapes Sheet (Figure 2) indicates that most of the site is mapped as alluvial soil of the Berkshire Park soil landscape (mapping unit bp). This soil landscape associated with the Hawkesbury and Nepean River Systems is characterised by orange heavy clays and clayey sands, often mottled and with ironstone nodules common. The south eastern portion of the Site is mapped as the Blacktown soil landscape (mapping unit bt) of the Wianamatta Group of Triassic age which is characterised by red and brown podzolic soils on Wianamatta and Hawkesbury Shales.

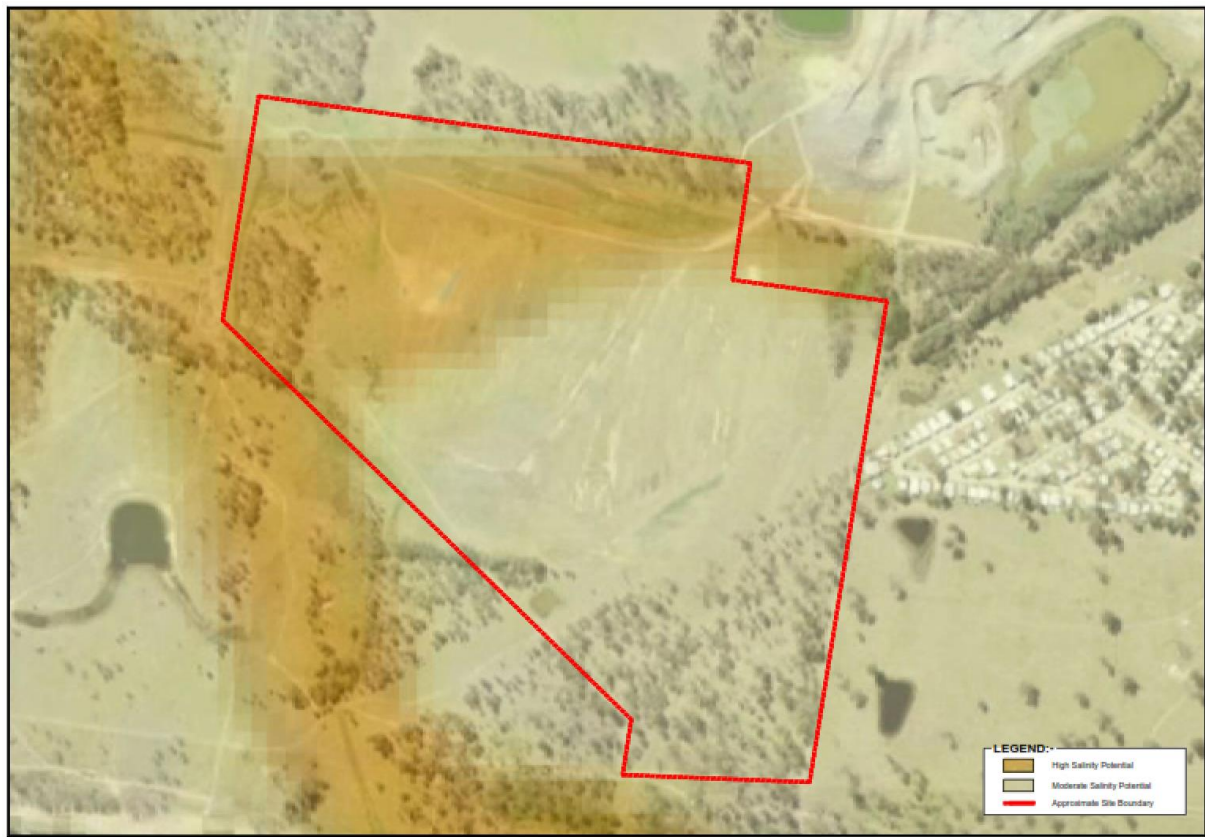
Figure 3: Salinity Potential at the Site

Reference to the Map of Salinity Potential in Western Sydney (Figure 3), indicates that most of the site is located within an area of “moderate salinity potential” where “saline areas may occur which have not yet been identified or may occur if risk factors change adversely”. The western and north western areas of the site are mapped as “high salinity potential” where “conditions are similar to areas of known salinity”.

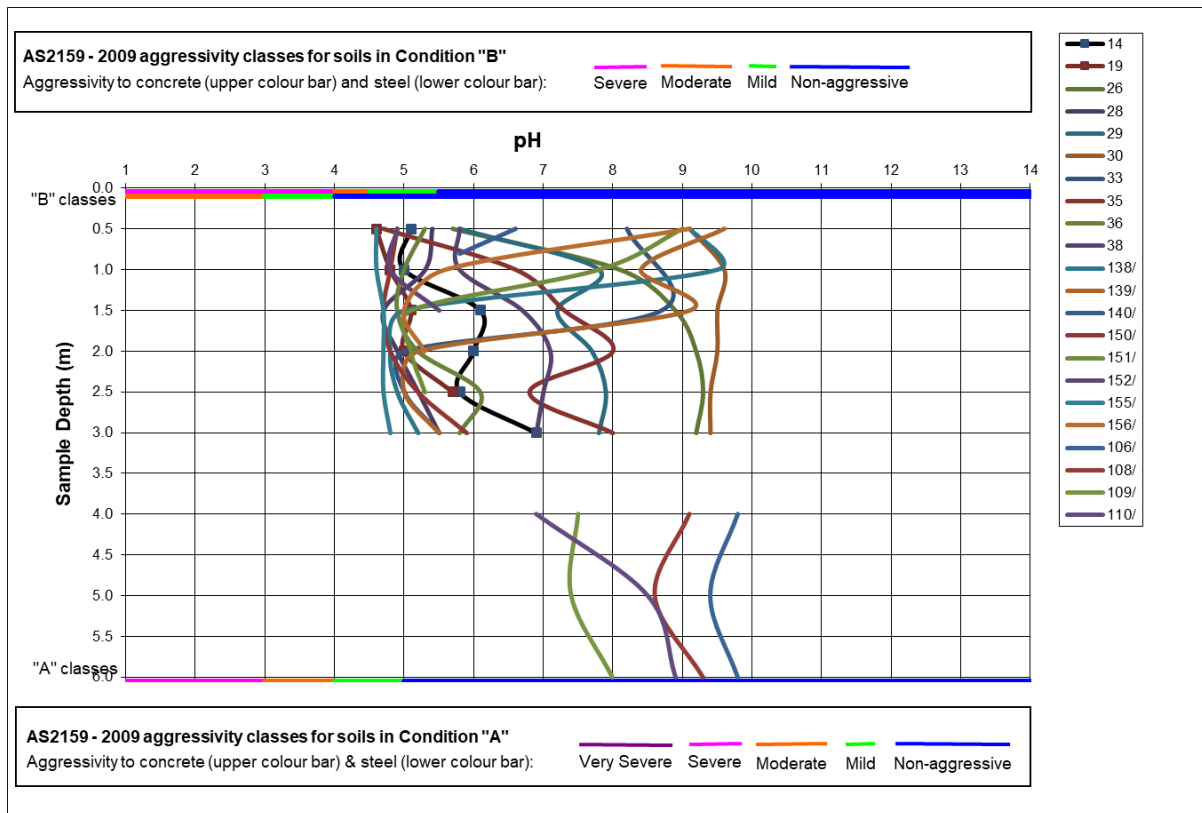
Figure 4: Vertical pH Profiles and Aggressivity Classes

Figure 4 (following page) presents variations of aggressivity with depth, based on pH profiles at salinity test pit and borehole locations, together with the aggressivity class ranges indicated in Australian Standard AS 2159 (2009). The absence of free groundwater from all test locations and the impermeability of the sampled clay-rich soils indicate that soils at all test locations are in Condition “B” as defined by AS 2159.

The pH profiles of Figure 4 indicate that the materials throughout the site, at all investigated depths, are non-aggressive to steel. The chloride concentration guidelines of AS 2159 support this non-aggressive classification. However, based on resistivity criteria (Appendix D), samples were classified as non-aggressive to moderately aggressive to steel.

The Summary Table also indicates that 57% of all samples were non-aggressive to concrete and 43% were mildly aggressive to concrete.

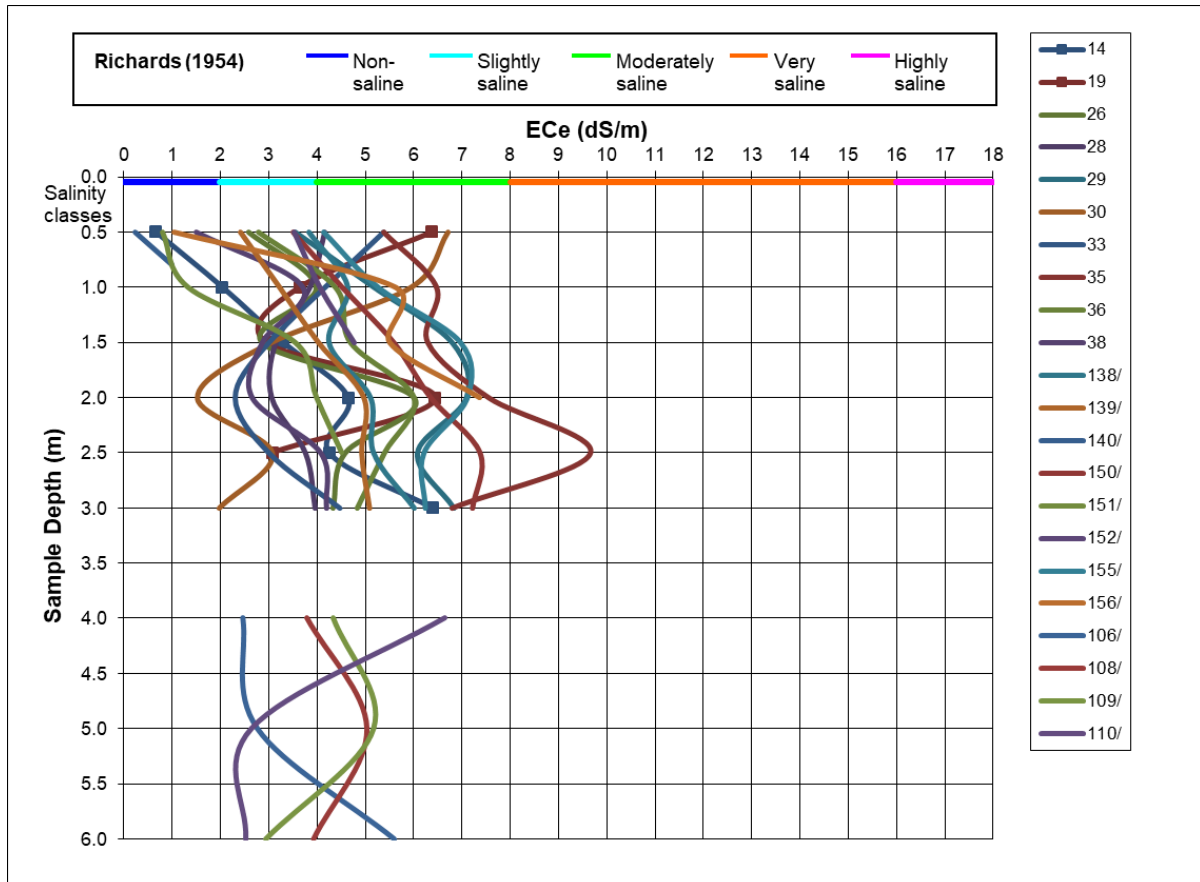
Figure 5: Vertical Salinity Profiles and Salinity Classes

Figure 5 (below) presents the variations of salinity with depth, based on salinity (ECe) profiles at test pit and borehole locations, together with the salinity classifications of Richards (1954).

The Summary Table (Appendix D) indicates that 8% of all soil samples were non-saline, 34% were slightly saline, 56% were moderately saline and 2% were very saline.

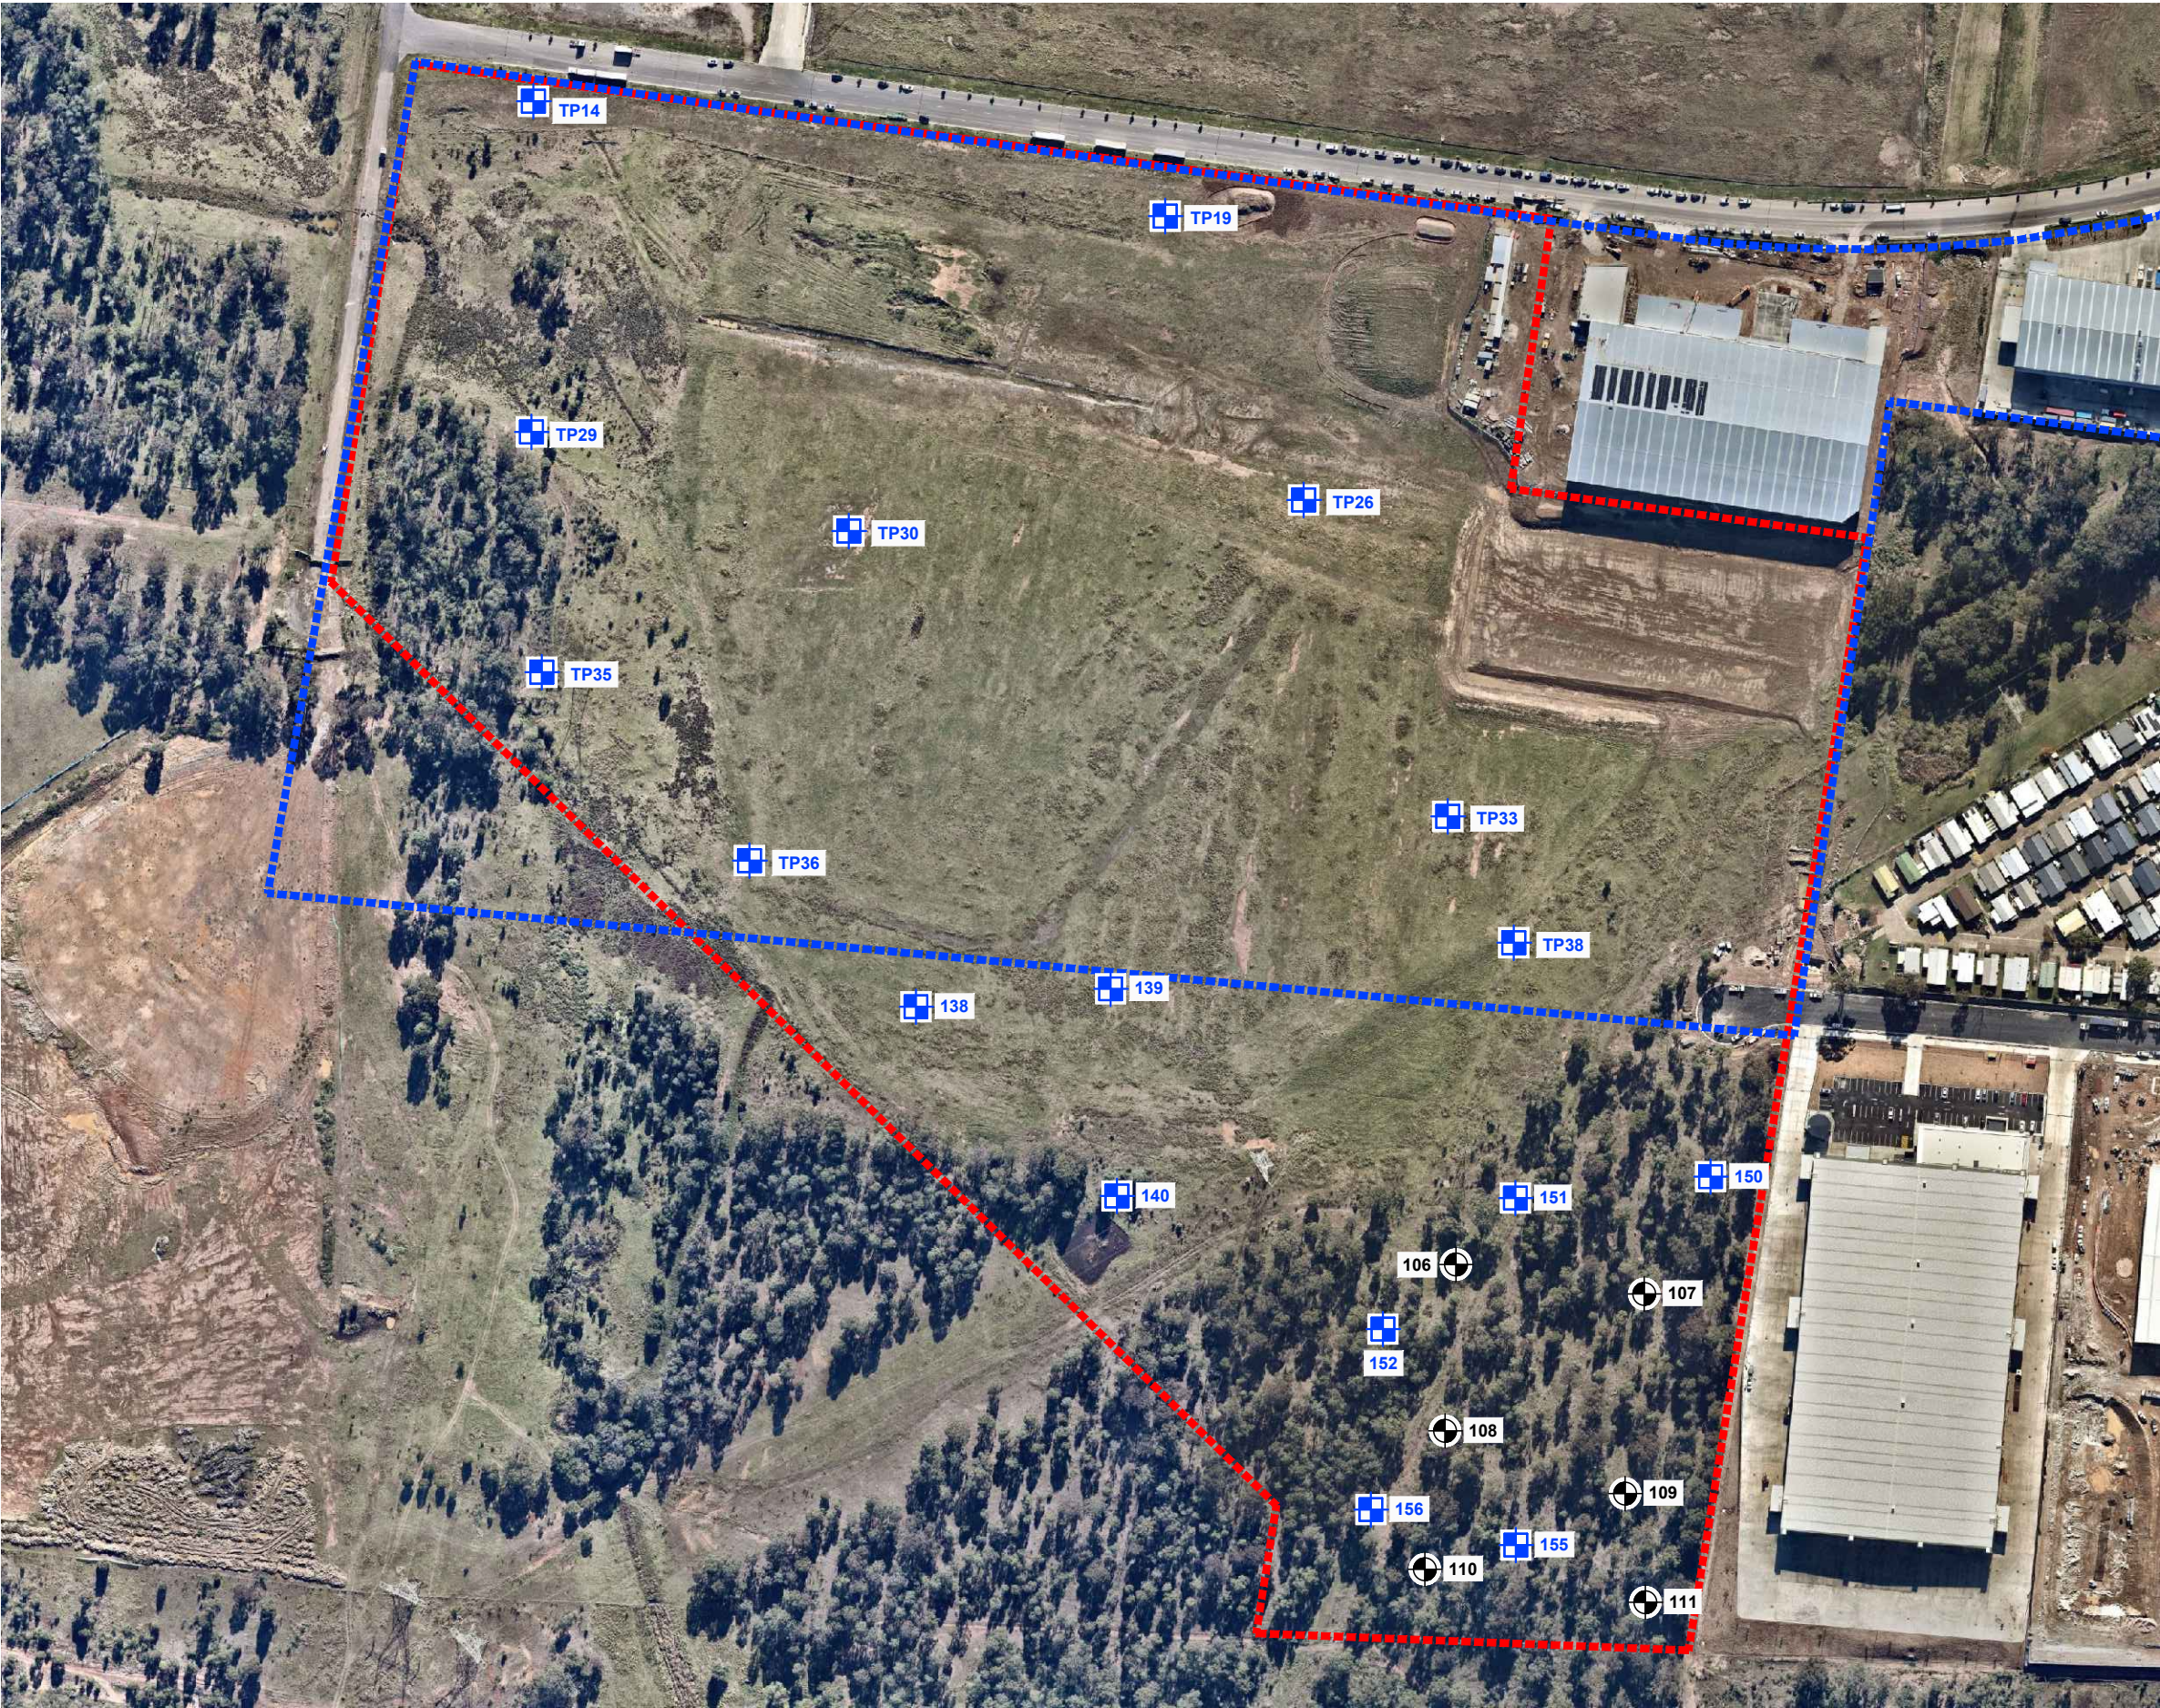
CLIENT: Marsden Park Developments (Construction) Pty Ltd		TITLE: Sampling Locations Sydney Business Park Stage 3 Astoria Street, Marsden Park	PROJECT No: 94616.01	
	OFFICE: North West Sydney	DRAWN BY: JST		DRAWING No: 1	
	SCALE: As shown	DATE: 14 July 2020		REVISION: 0

This report presents the results of a salinity investigation and management plan (SMP) undertaken for a proposed industrial development at Stage 3, Sydney Business Park, Marsden Park, NSW (the site, as shown on Drawing 1, Appendix B). The investigation was commissioned by Mr Michael Gray of Marsden Park Developments Pty Ltd (MPD) and was undertaken in accordance with Douglas Partners Pty Ltd (DP) proposal NWS200092 dated 18 June 2020.

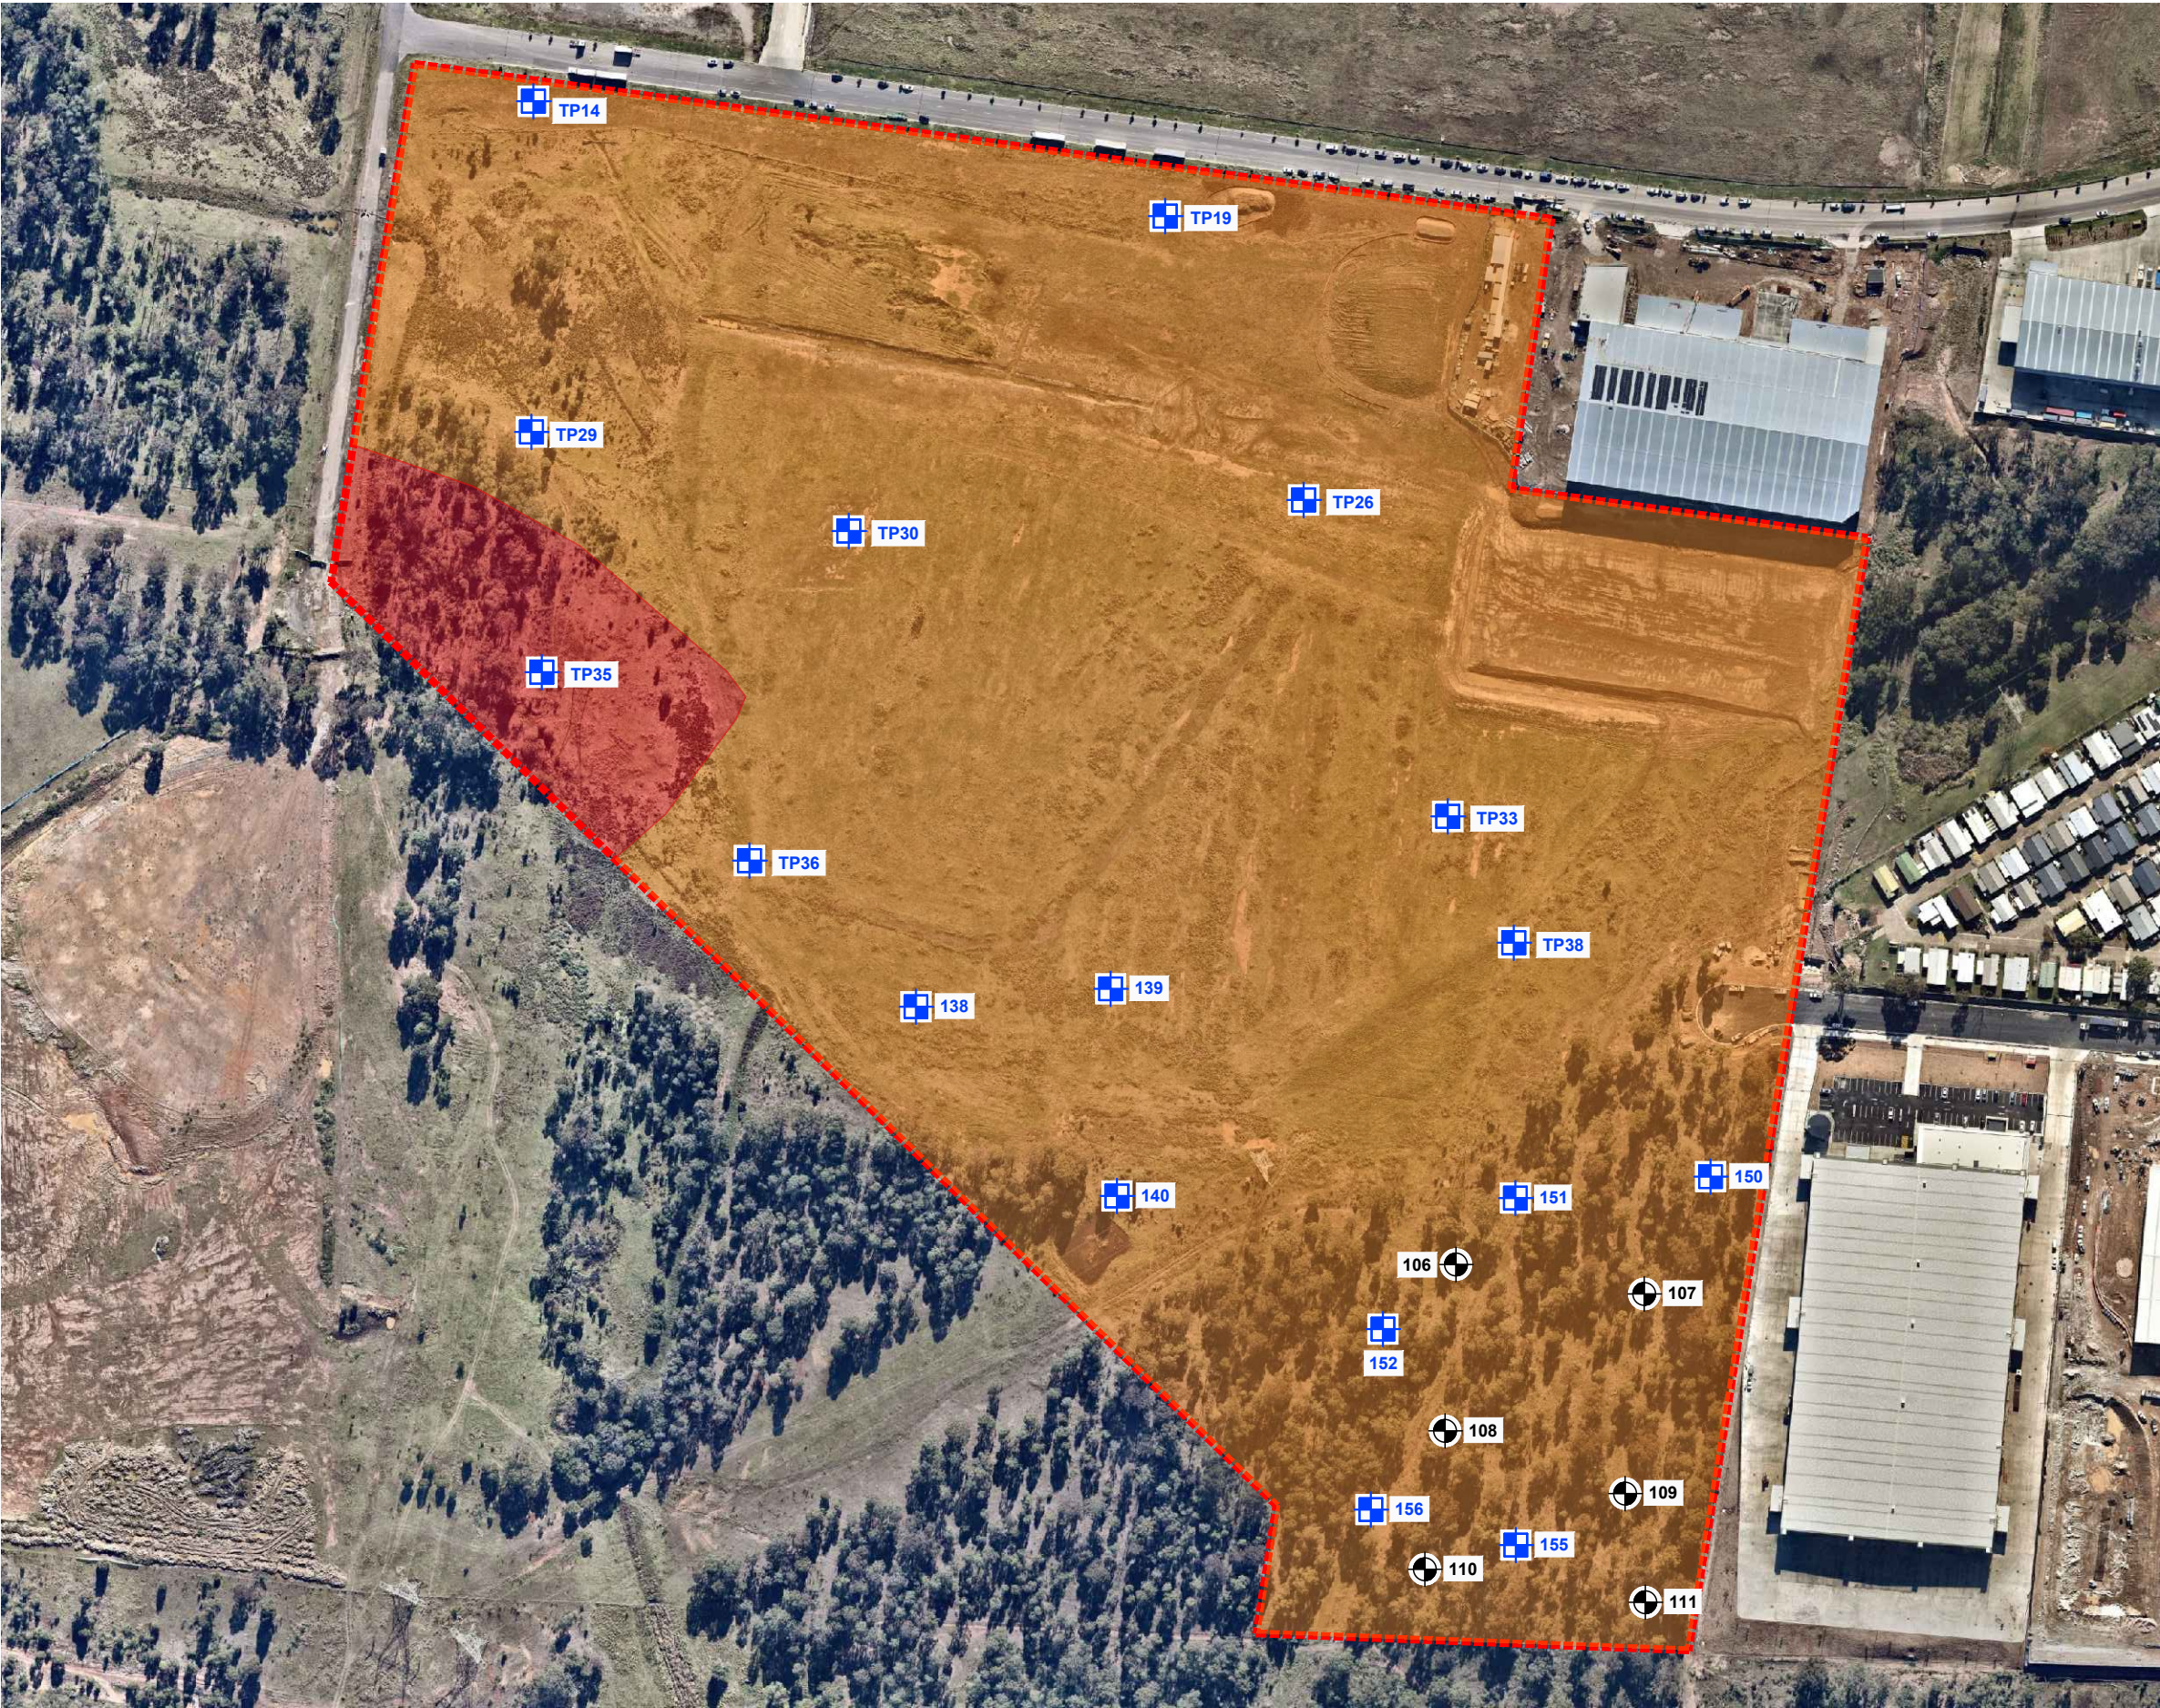
Douglas Partners <i>Geotechnics Environment Groundwater</i>	CLIENT: Marsden Park Developments (Construction) Pty Ltd		TITLE: Salinities within investigated depth zone (0 to 3 m bgl) Sydney business park stage 3 Astoria Street, Marsden Park	PROJECT No: 94616.01	
	OFFICE: North West Sydney	DRAWN BY: JST		DRAWING No: 4	
	SCALE: As shown	DATE: 14 July 2020		REVISION: 0

- J. With regard to concrete structures, for moderately saline soils (soils with salinities of 4 – 8 dS/m - refer Drawing 4) that are classified as non - aggressive and mildly aggressive to concrete , slabs and foundations should have a minimum strength of 25 MPa, a minimum cover to reinforcement of 45 mm from unprotected ground and should be allowed to cure for a minimum of three days (as per AS 3600) to limit the corrosive effects of the surrounding soils.

- K. With regard to concrete structures, for very saline soils (soils with salinities of 8 - 16 dS/m - refer Drawing 4) that are classified as non-aggressive and mildly aggressive to concrete, slabs and foundations should have a minimum strength of 32 MPa, a minimum cover to reinforcement of 50 mm from unprotected ground and should be allowed to cure for a minimum of seven days (as per AS 3600) to limit the corrosive effects of the surrounding soils;

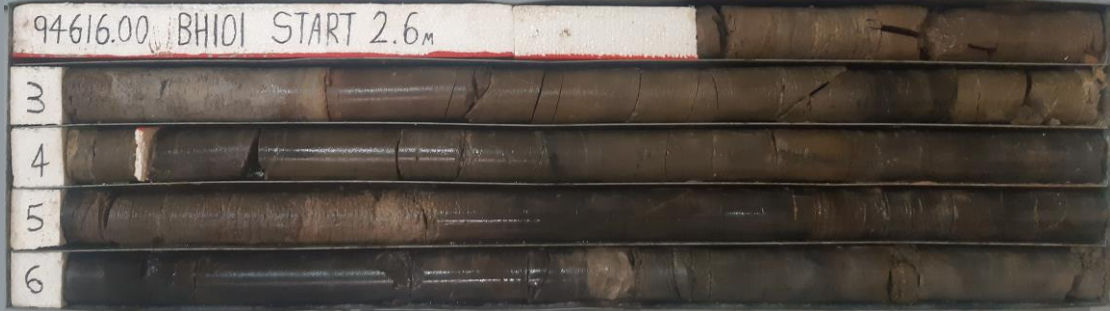
Project No: 94616.00
BH ID: 101
Depth: 2.6-7.0m
Core Box No.: 1/1

0.3																								
	1																								
	39																								
	2																								
	38	2.5																							
	3	SILTSTONE: grey-brown, very low strength, moderately weathered, fractured, trace sandstone laminations Bringelly Shale

3.25	SANDSTONE: fine grained, orange-brown, low strength, moderately weathered, fractured, trace siltstone laminations, Bringelly Shale

3.63																								
	4	SILTSTONE: grey, low strength, moderately then slightly weathered, fractured, with 30% sandstone laminations, Bringelly Shale																							
	5																								
	6																								
	7	7.0																							
	33	Bore discontinued at 7.0m																							
	8																								
	32																								
	9																								
	31

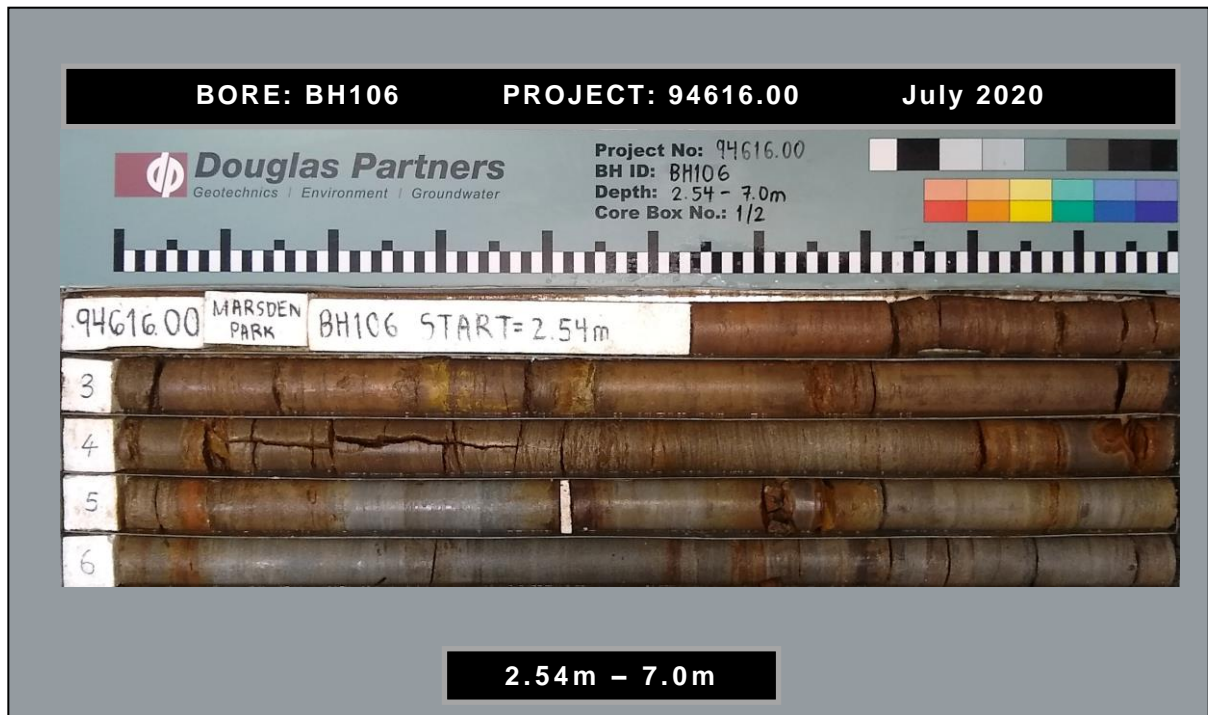
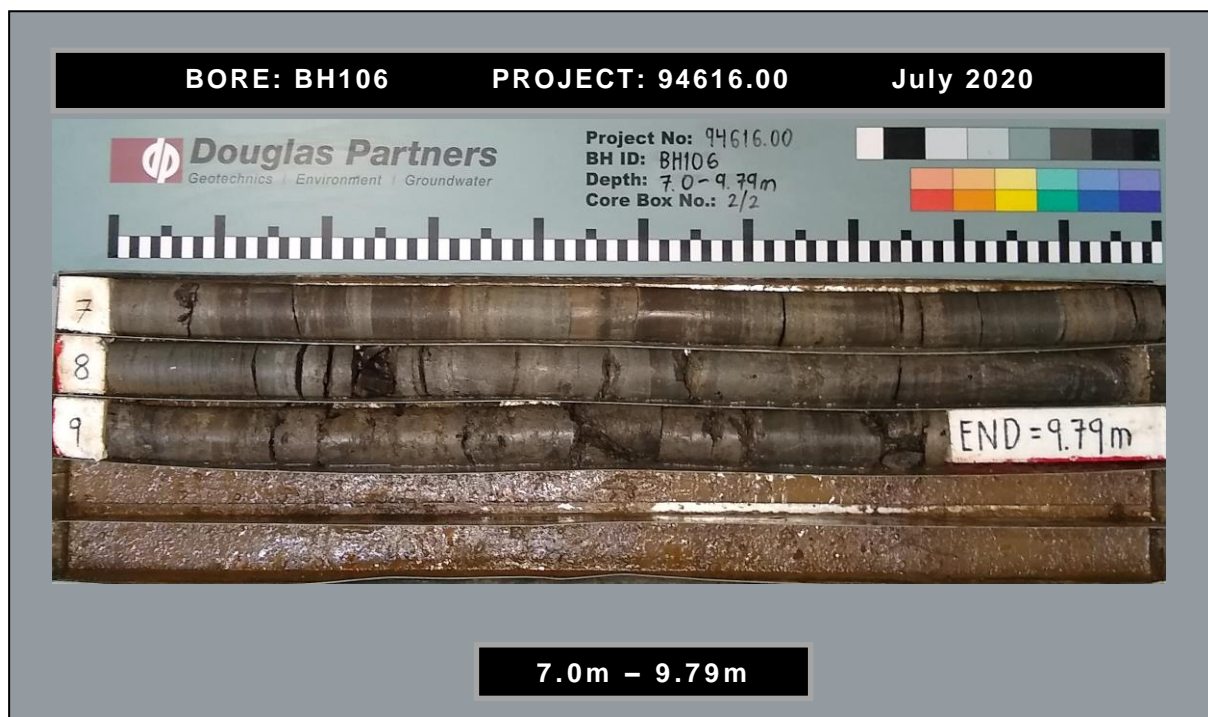
BOREHOLE LOG

CLIENT: Marsden Park Developments Pty Ltd
PROJECT: Proposed Industrial Development
LOCATION: Astoria Street, Marsden Park

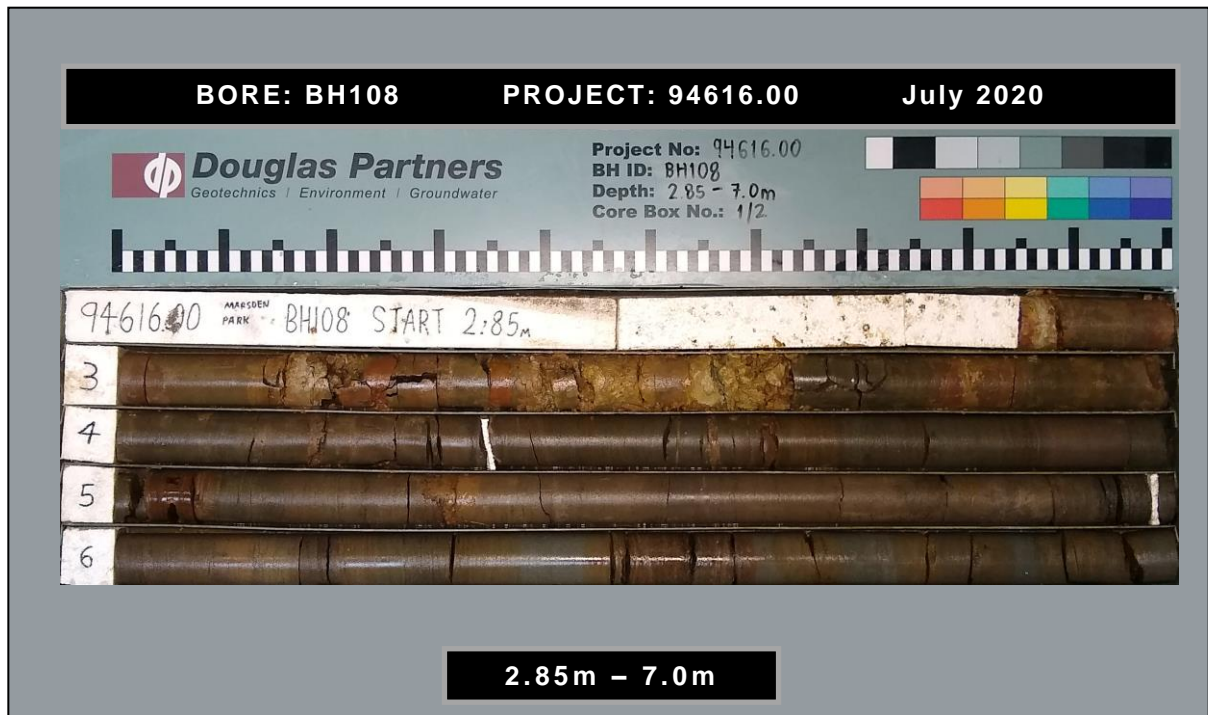
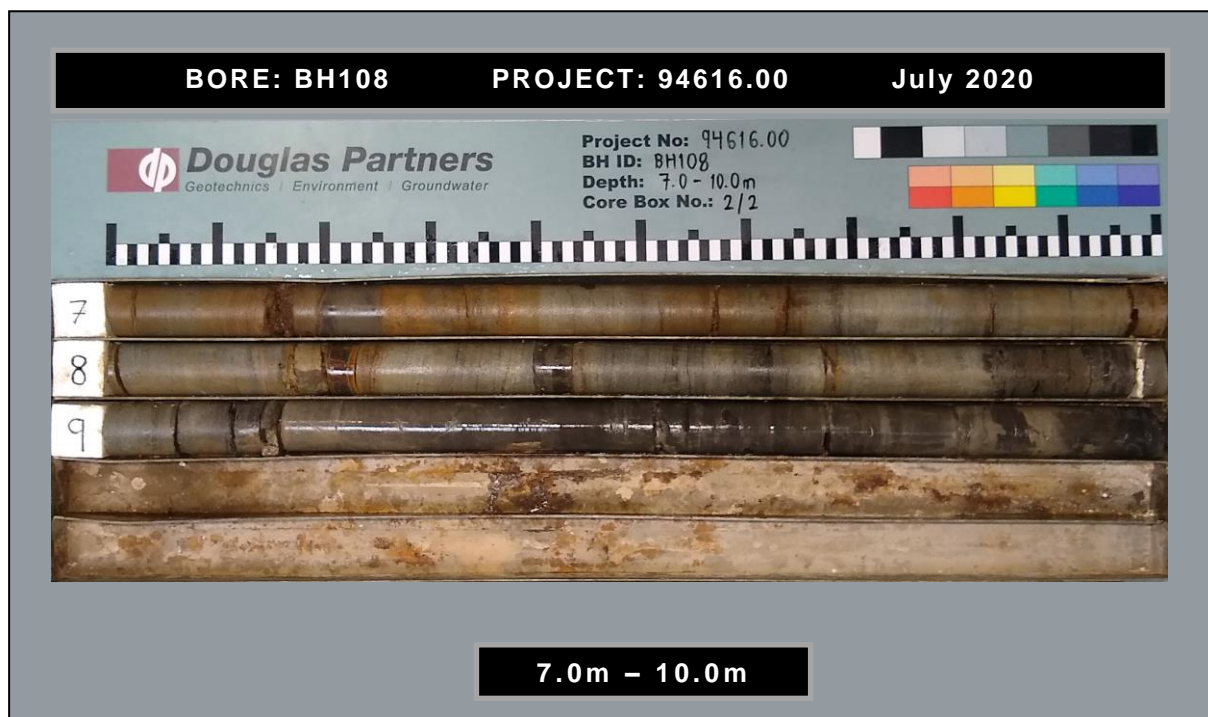
BOREHOLE LOG

CLIENT: Marsden Park Developments Pty Ltd
PROJECT: Proposed Industrial Development
LOCATION: Astoria Street, Marsden Park

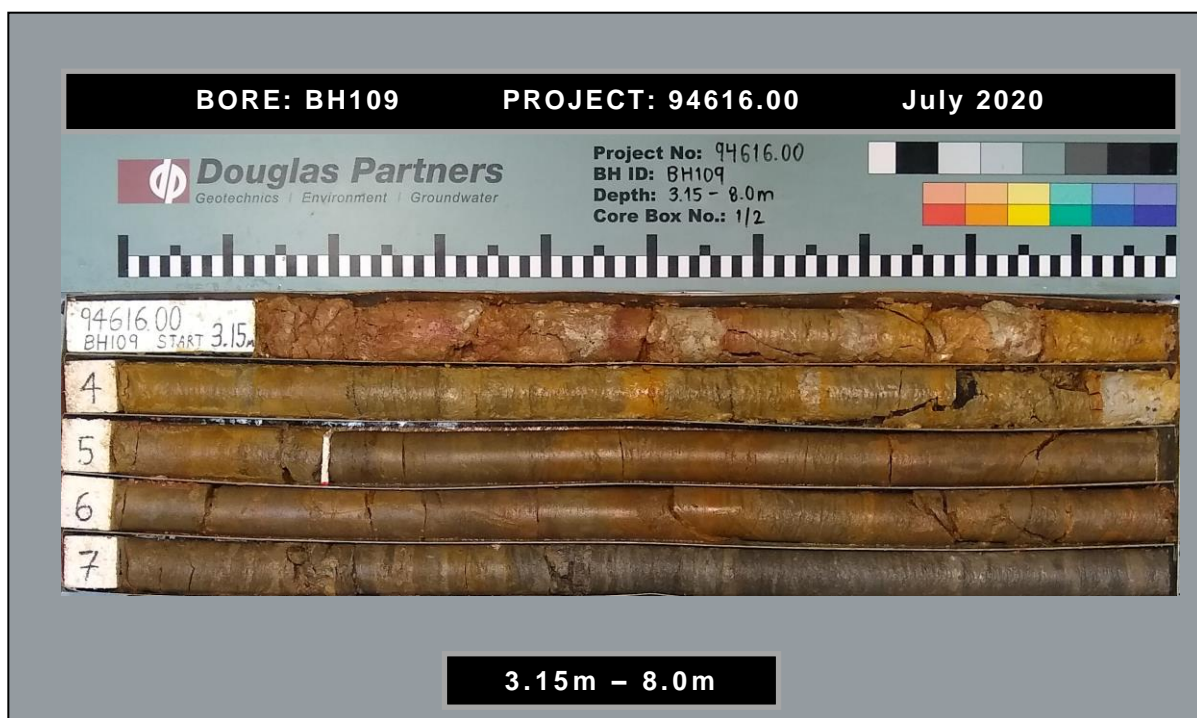
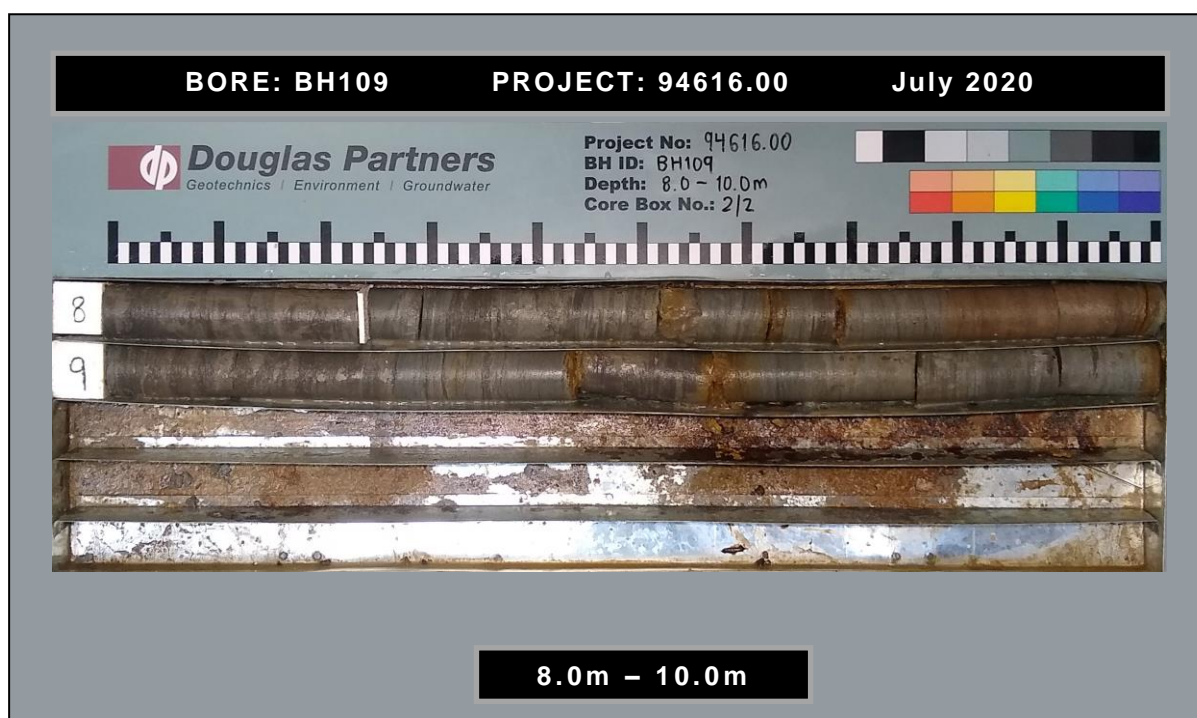
BOREHOLE LOG

CLIENT: Marsden Park Developments Pty Ltd
PROJECT: Proposed Industrial Development
LOCATION: Astoria Street, Marsden Park

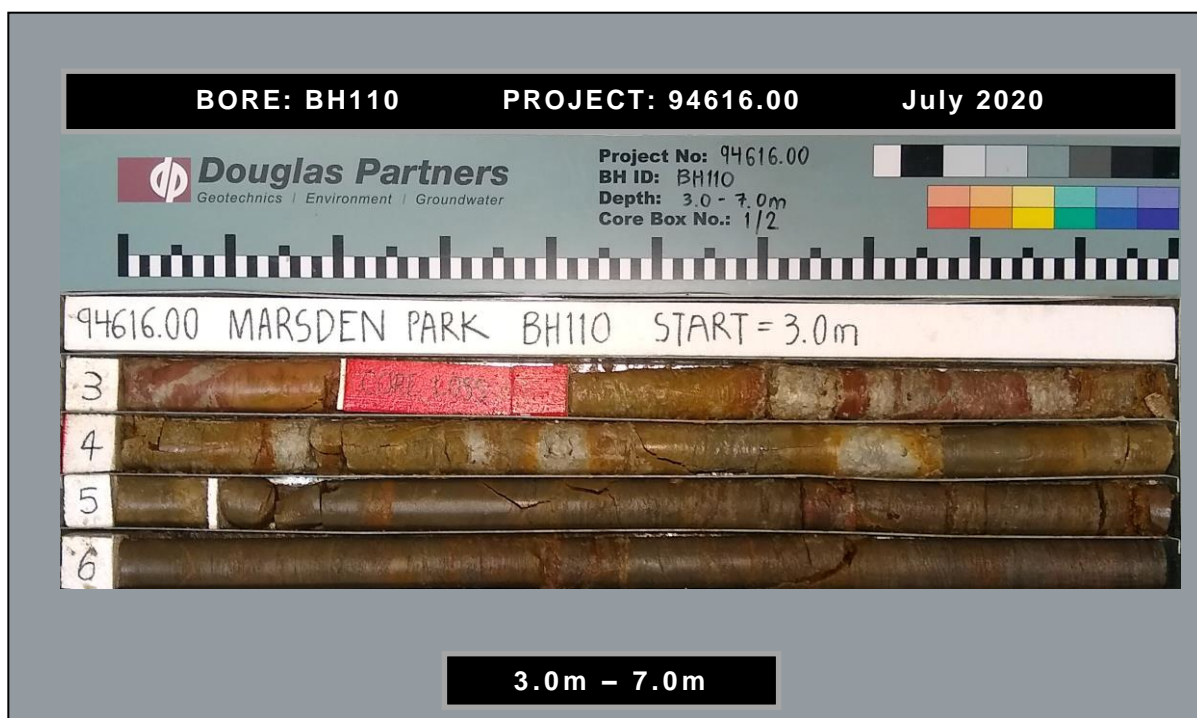
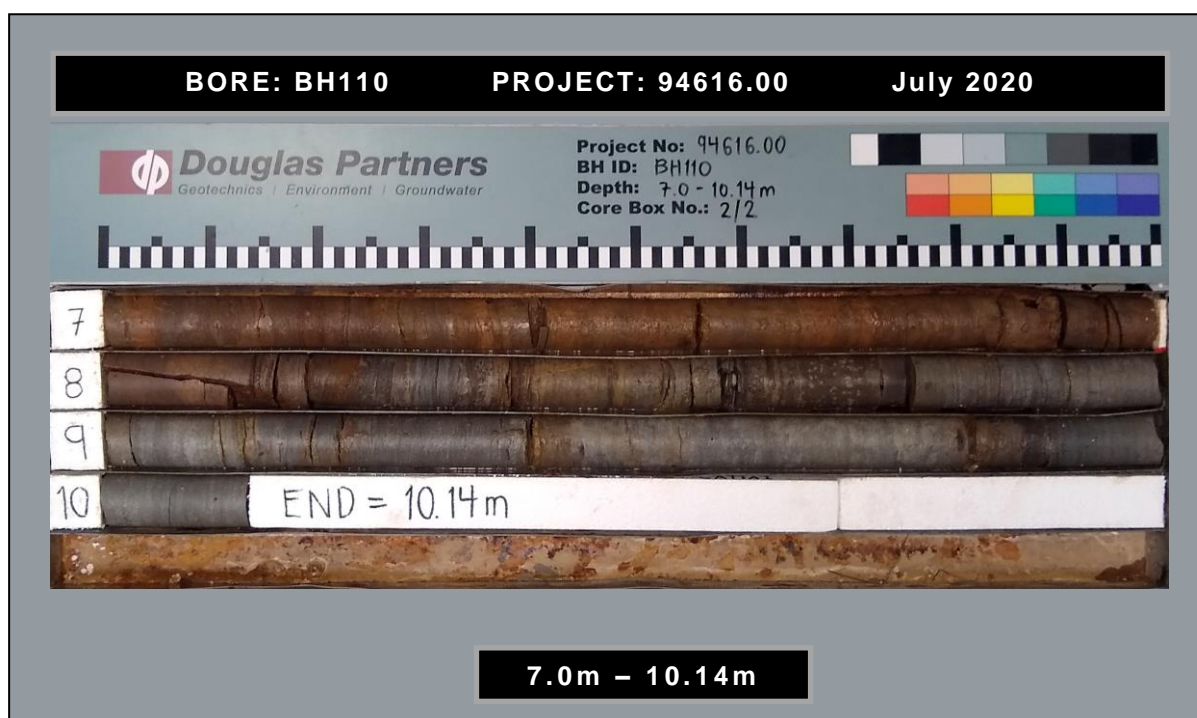
BOREHOLE LOG

CLIENT: Marsden Park Developments Pty Ltd
PROJECT: Proposed Industrial Development
LOCATION: Astoria Street, Marsden Park
