Aldington Road Kemps Creek Riparian Assessment

Fife Kemps Creek Trust

Project Name	Aldington Road Kemps Creek Riparian Assessment
Project Number	20SYD-16452
Project Manager	Kirsten Velthuis
Prepared by	Claire Wheeler
Reviewed by	Peter Hancock
Approved by	David Bonjer
Status	Final
Version Number	3
Last saved on	15 October 2020

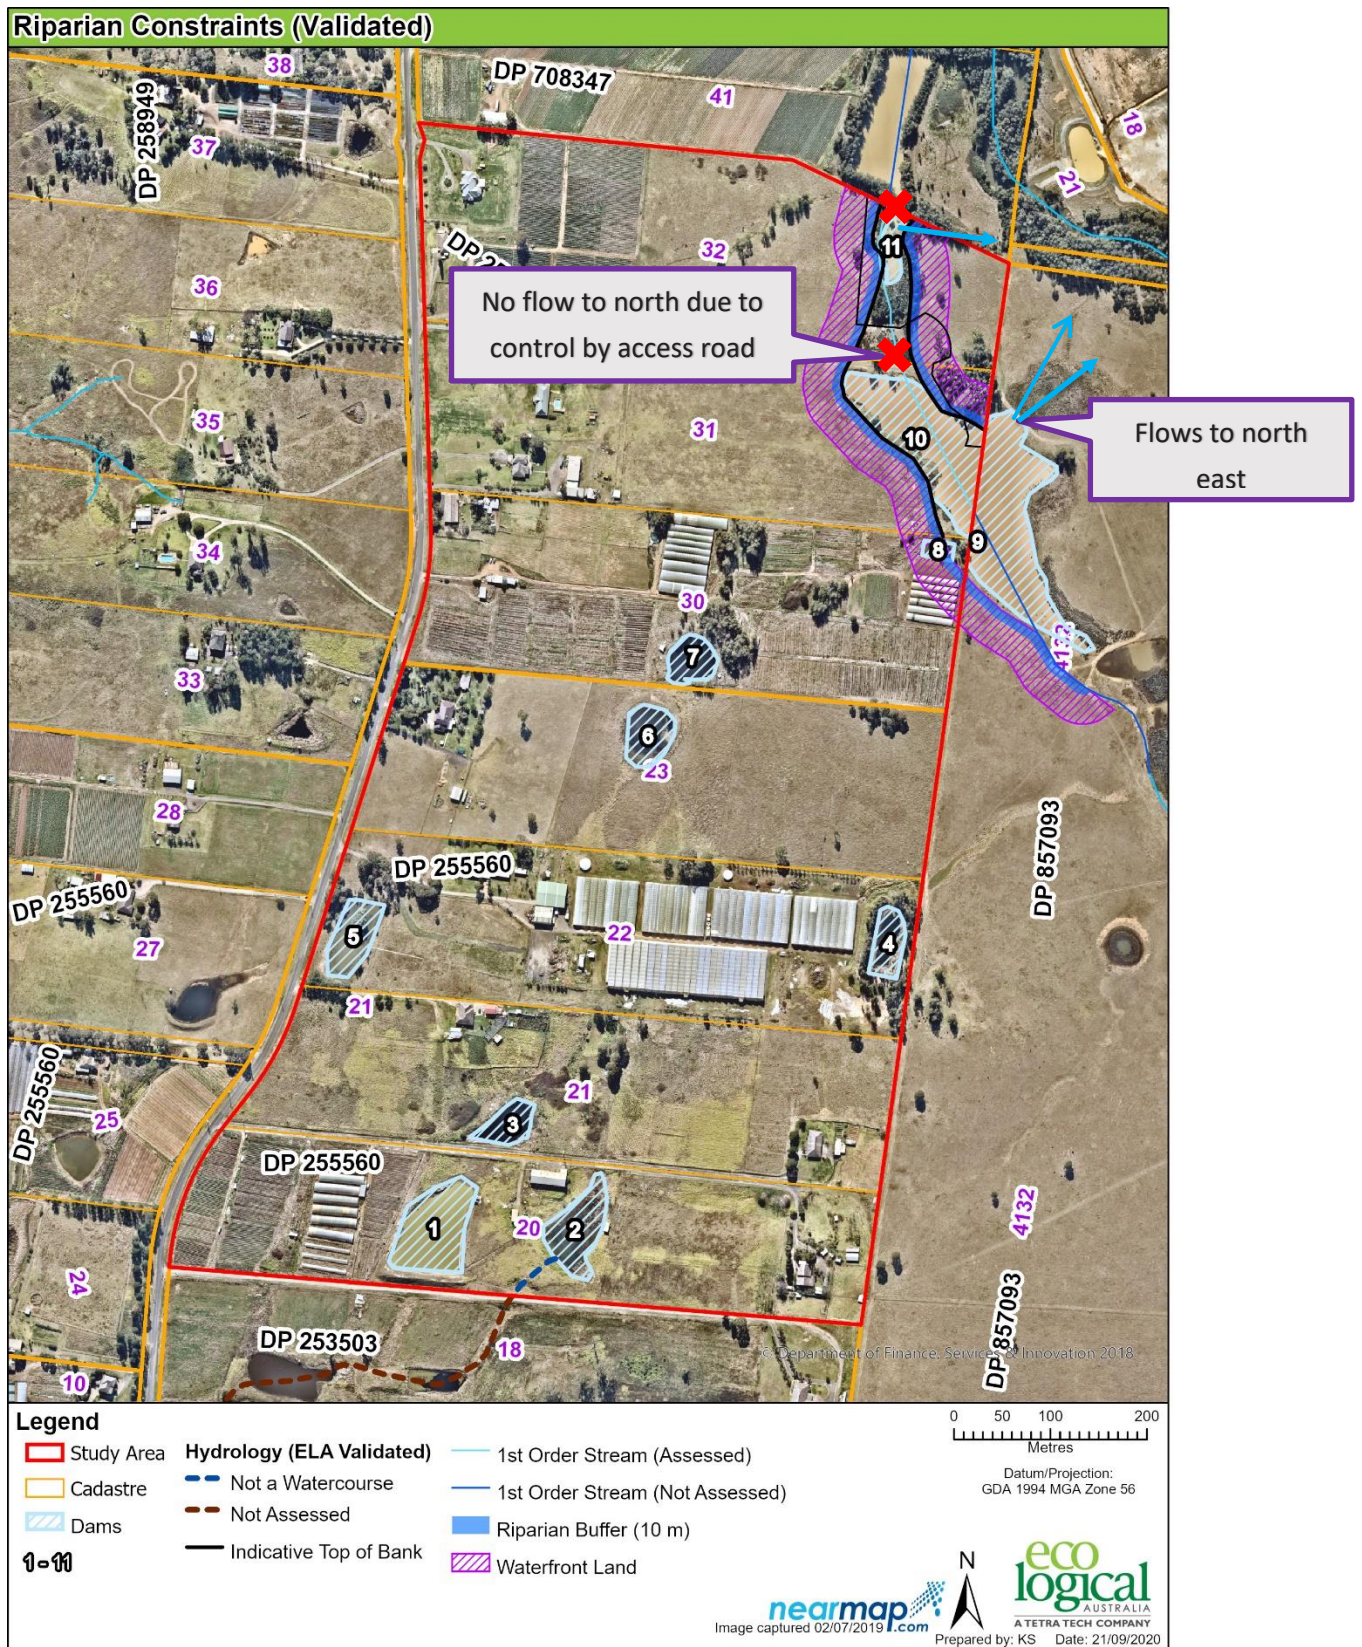
Figure 4: Validated watercourses within study area

Within and adjacent to the development area were eleven farm dams, most of which had limited riparian and/or fringing vegetation surrounding them and poor aquatic habitat values. These dams have been numbered in Figure 4 and are described in Table 6. Dams 9 and 10 are connected following heavy rain and high flow, however are two separate dams in low flow and dry conditions. Examination of aerial photos and overland flow paths identified that these two dams are quite likely fed by two different catchments – Dam 9 from flow to the south east of the study area and Dam 10 from overland flow from the west within the study area. It is important to note that this environment is highly modified and the waterbodies and watercourses in the north east of the site are not representative of their original flow paths.

The 1st order watercourse mapped within the south of the development area had no indicative features of a waterway (such as defined bed and banks or geomorphic features such as erosion and deposition) observed along the length of this mapped watercourse within the SSD boundary.

The mapped 1st order watercourse in the north east corner originated upstream of the development area and flowed in a roughly northerly direction.

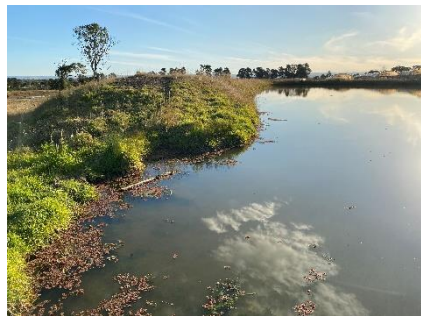
Dam number	Description	Aquatic fauna observed	Aquatic flora observed	Representative photo
1	Dam 1 covered an area of approximately 5,600 m ² and was surrounded by pasture grasses. There was no fringing vegetation surrounding the dam and the banks of the dam was relatively steep.	No aquatic fauna observed.	Floating macrophytes (<i>Azolla pinnata</i>).

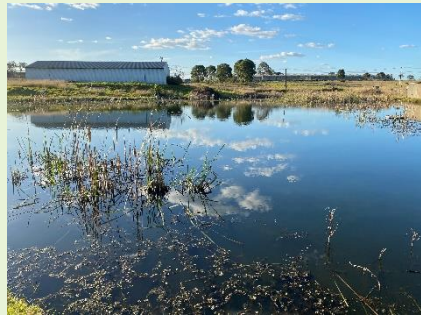
2	Dam 2 covered an area of approximately 2,300 m ² . No grease, oil or sheen was observed on the water's surface. On the northern and southern sides of the dam, it was fringed with dense <i>Typha orientalis</i> (Cumbungi).	No aquatic fauna observed.	Emergent <i>Typha orientalis</i> plus submerged macrophytes.

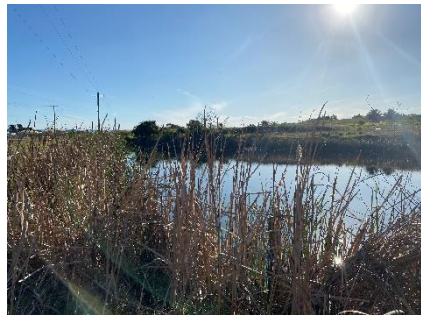
3	Dam 3 covered an area of approximately 1,700 m ² . Two thirds of the edge of the dam were covered in dense <i>Typha orientalis</i> with exotic species such as <i>Rubus fruticosus</i> (Blackberry), <i>Cestrum parqui</i> (Green Cestrum) and pasture grasses growing alongside the remaining edge of the dam	No aquatic fauna observed.	<i>Typha orientalis</i> .

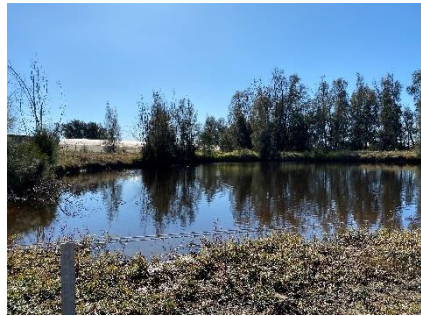
Dam number	Description	Aquatic fauna observed	Aquatic flora observed	Representative photo
7	Dam 7 covered an area of approximately 1,700 m ² . The dam was located approximately 100 m downstream of dam 6, however there was no defined channel observed between these two dams.	Frogs heard calling.	<i>Persicaria decipiens</i> .

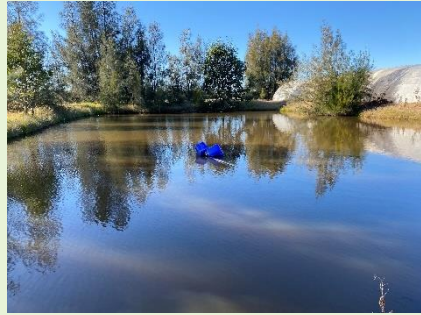
8	Dam 8 covered an area of approximately 650 m ² . There were a few <i>Eucalyptus</i> sp. on the edge of the dam however it was predominantly surrounded by exotic vegetation including <i>Rubus fruticosus</i> , <i>Senecio madagascariensis</i> and pasture grasses.	Pied cormorant.	No aquatic flora observed.

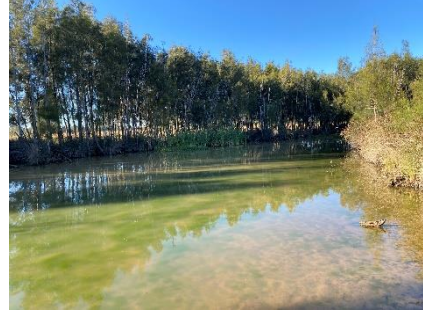
Dam number	Description	Aquatic fauna observed	Aquatic flora observed	Representative photo
11	Dam 11 covered an area of approximately 3,750 m ² . The dam was surrounded by a narrow-vegetated buffer of <i>Casuarina</i> sp., with <i>Juncus acutus</i> and <i>Typha orientalis</i> . Woody debris within the waterbody was present and some of the <i>Casuarina</i> sp. on the edge of the waterbody had roots exposed above the water level and undercut in some areas, which would provide good refuge for aquatic fauna.	Long finned eel.	<i>Typha orientalis</i> in the middle of the dam

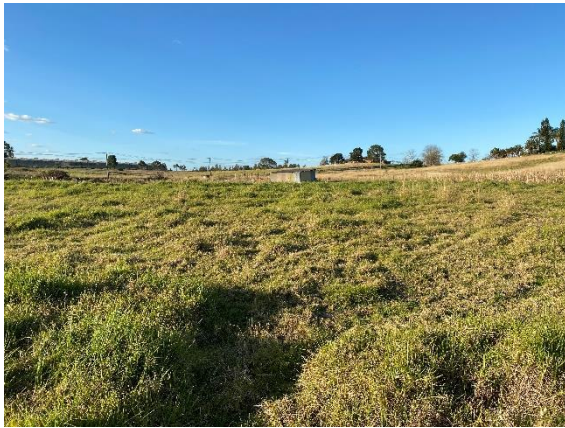
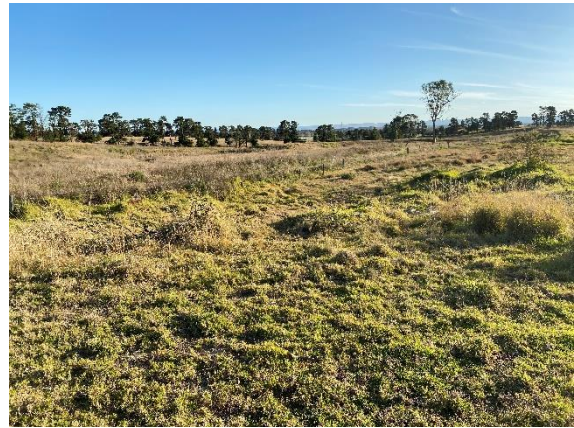
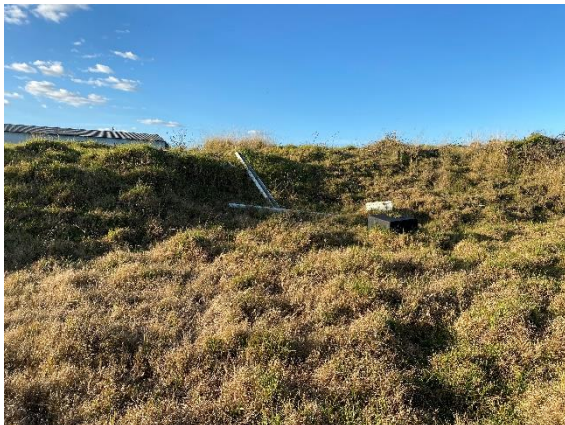
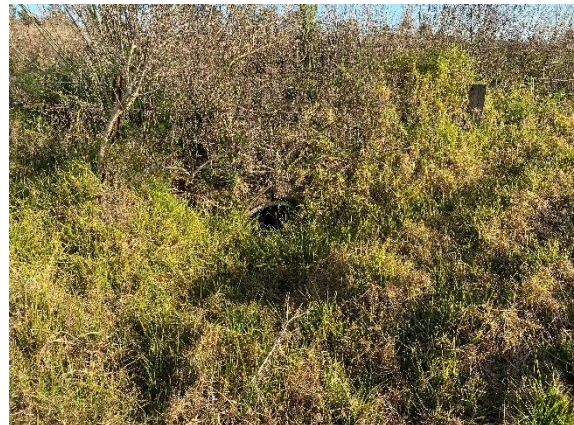
The site inspection identified that there was no defined channel downstream of Dam 2 in the location where a watercourse was mapped on the hydroline dataset. There was an overland flow path that had been channelled towards Dam 1 through a section of concrete pipe. Downstream of the dam there was dense pasture grasses but no defined bed or bank or evidence of geomorphic processes such as erosion and deposition (Figure 5 to Figure 8). A pipe was observed at the southern boundary of the SSD area (Figure 8) to channel the flow into the property to the south. The mapped watercourse within the south of the site does not meet the definition of a 'river' under the WM Act.

Figure 5: Upstream extent of mapped Kemps Creek tributary, looking north east

Figure 6: Upstream extent of mapped Kemps Creek tributary, looking south west

Figure 7: Downstream extent of mapped Kemps Creek tributary, looking north east

Figure 8: Downstream extent of mapped Kemps Creek tributary, looking south west.

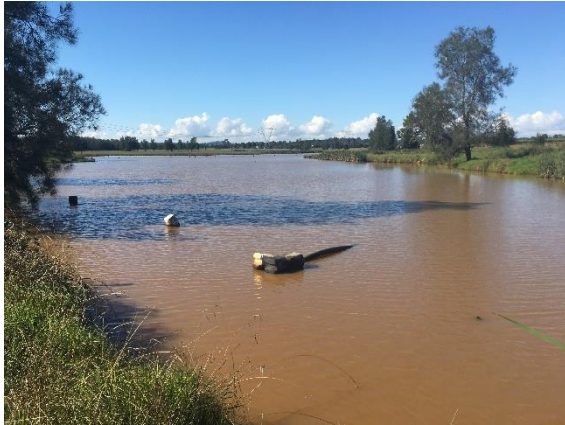
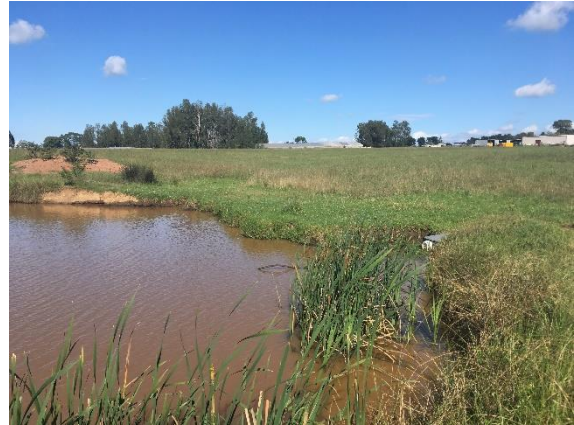
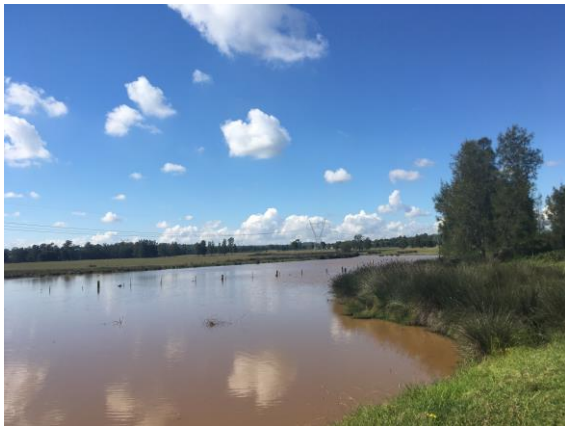
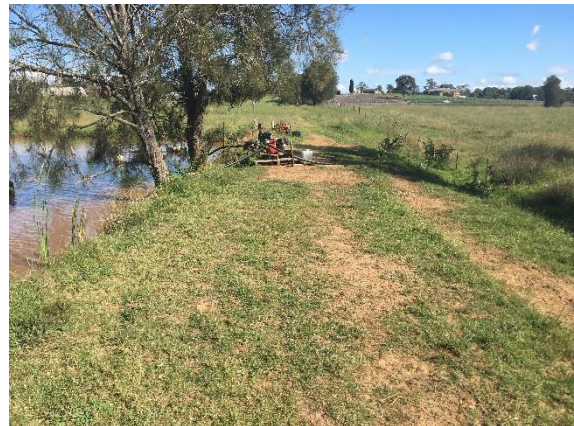
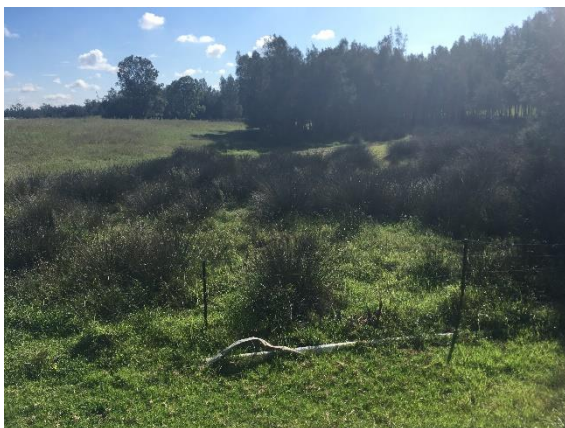
The mapped watercourse within the north east area of the site is located through Dams 10 and 11. Along the extent of the mapped watercourse within the site, there was little evidence of an area that

would meet the definition of a ‘river’ under the WM Act, with no defined channels in between Dams 10 and 11 (Figure 9 to Figure 15).

Figure 9: Dam 10, looking south east

Figure 10: Dam 10, looking south

Figure 11: Boundary fence in between Dams 9 and 10, looking south east

Figure 12: Top of dam wall on northern side of Dam 10, looking west.

Figure 13: No defined channel between Dam 9 and 10, looking north.

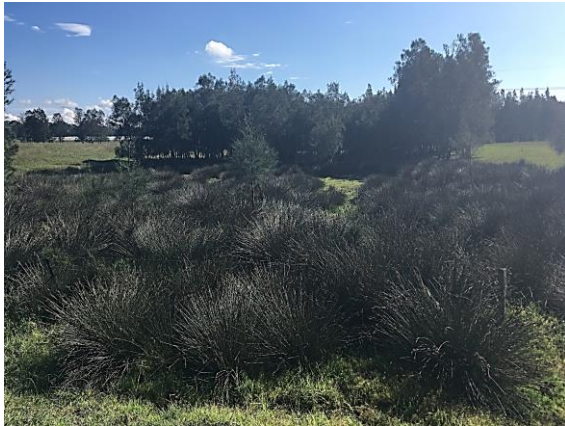
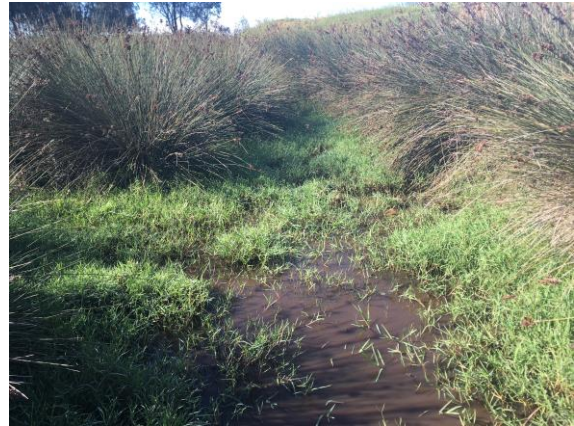
On the downstream side of Dam 11, it was evident that a channel had been blocked at some point to create a dam, however the dam now resembled a wetland environment. There is unlikely to be any low

flows moving through this section of watercourse other than in high flow events. Immediately upstream of Dam 11 was a damp area that would be inundated following heavy rain. There were small isolated pools of water within this area in amongst the dense *Juncus acutus* (Figure 14 and Figure 15) and evidence of pugging from cattle.

Figure 14: Area between upstream of Dam 11 and northern side of Dam 10, looking north

Figure 15: Isolated pools of water between Dams 10 and Dam 11, looking south

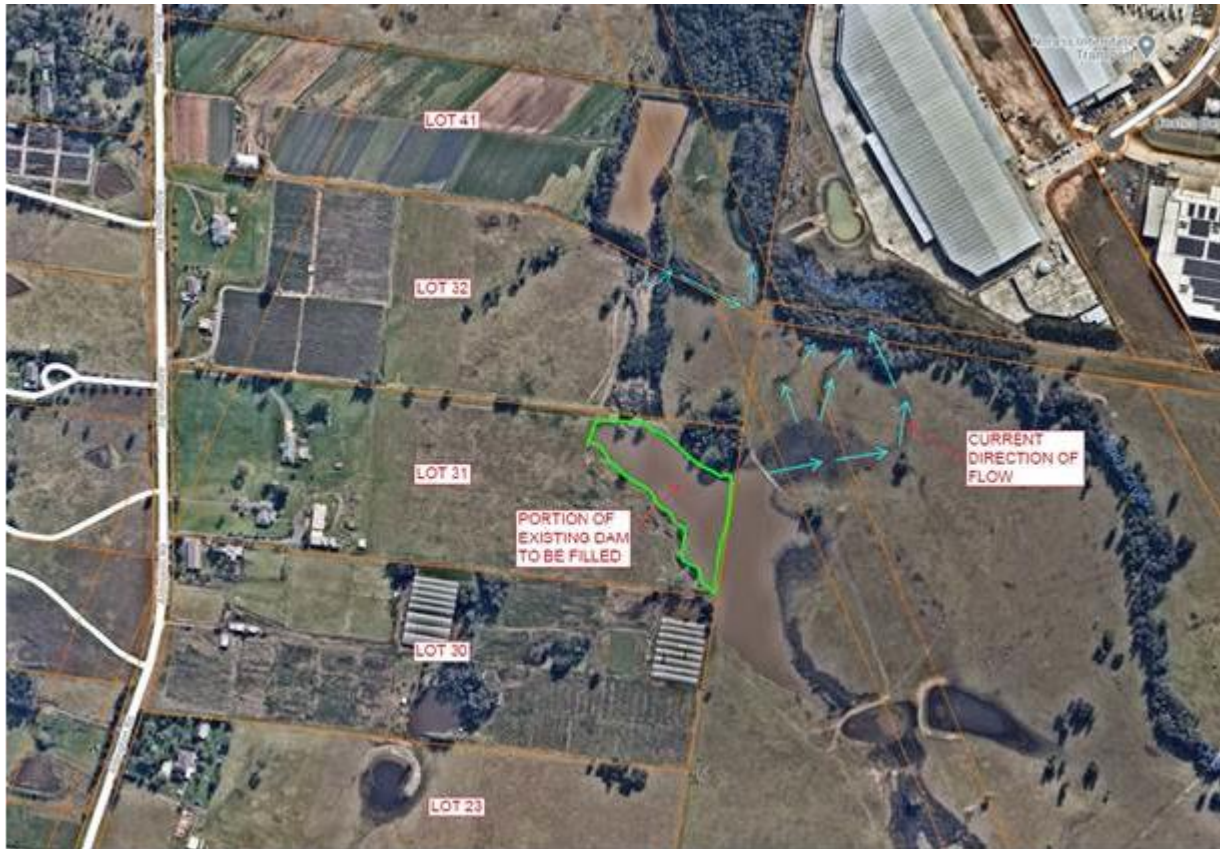
Figure 17: Existing flow directions (provided by AT&L)

The proposed development encroaches into the VRZ of the 1st order watercourse in the north east of the study area, for where the watercourse is mapped on the DPI dataset. However, flood modelling completed by AT&L for Fife Kemps Creek Trust (Figure 17) indicates that the actual flow path of this channel is to the north east of the site and not in the location of the mapped watercourse. Therefore the VRZ of the watercourse is not within the footprint. As Figure 17 shows, half of the large dam that is located on this mapped watercourse (Dam 10) will be filled. The impact of this filling on the 1st order unnamed tributary of Ropes Creek and downstream environments is likely to be minimal, as the current direction of flow is to the north east.

A dam dewatering plan should be prepared prior to the decommissioning of each dam in the development site.
