Report on
Preliminary Site Investigation for Contamination

Proposed Commercial/Industrial Subdivision
106 - 142 Aldington Road, Kemps Creek NSW

Prepared for
Stockland Commercial Property Pty Ltd

Project 92345.00
April 2019

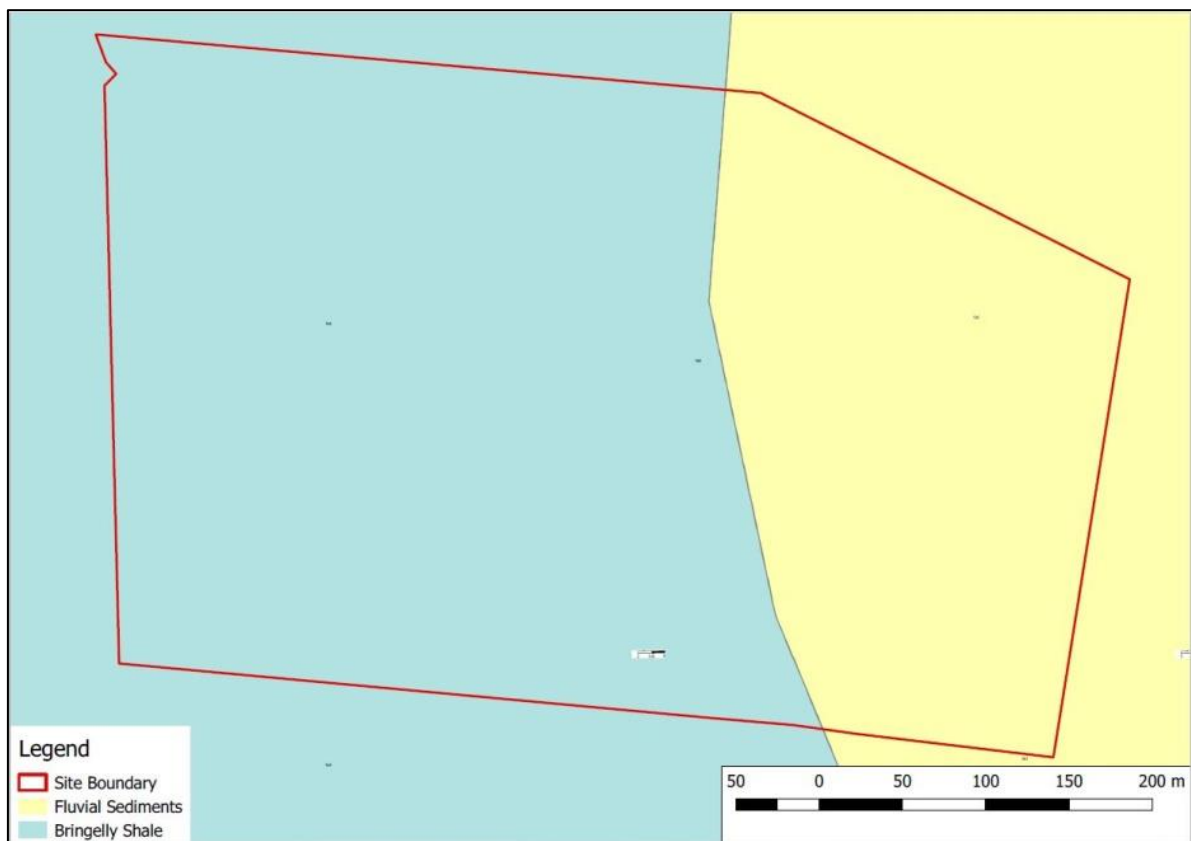
Figure 1. Regional Geology

Reference to the *Penrith 1:100 000 Geological Series Sheet* indicated that the site is underlain by Bringelly Shale (geological code "Rwb") of the Wianamatta Group of Middle Triassic age and Fluvial Sediments (geological code "Qal") of Quaternary Period. Most of the site is underlain by Bringelly Shale formation typically comprising shale, carbonaceous claystone, laminite, fine to medium grained lithic sandstone and some coal bands and tuff, whereas the remaining eastern portion is underlain by fluvial (stream deposited) soils comprising fine grained sand, silts and clays as shown in Figure 1 below.

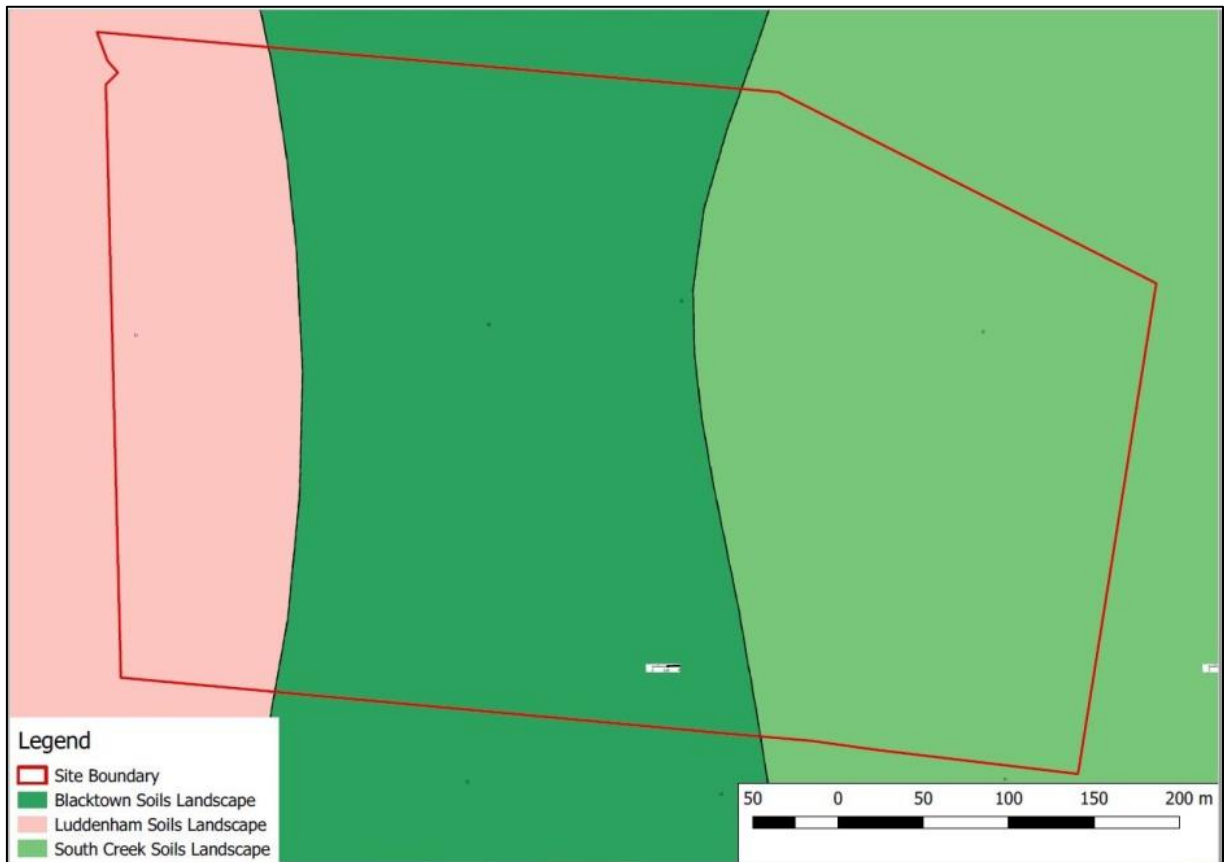
Figure 2. Regional Soils

Reference to *The Penrith 1:100,000 Soil Landscape Series Sheet* indicates that the site is located between the residual soils of the Blacktown Landscape, the erosional soils of the Luddenham Landscape, and alluvial soils of the South Creek Landscape groups as shown on Figure 2 below.

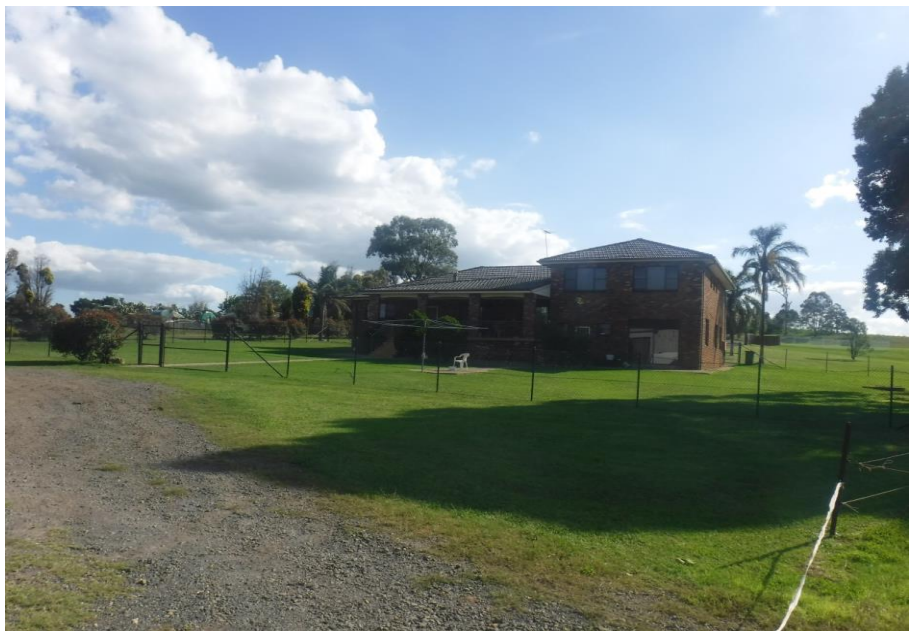
- All houses were constructed of brick, with no hazardous building materials (such as asbestos-containing materials [ACM]) were observed (Photographs 1 to 3);

Photo 1: View of brick house located in the south of Lot 31 (facing east)

Considering the potential for hazardous building materials in the soil from the demolished sheds, further investigation in these areas is recommended. Further investigation is also recommended in the buildings and sheds constructed during the 1970s/1980s for the presence of hazardous building materials prior to demolition or alteration.

To determine the presence of hazardous building materials it is recommended that a hazardous building materials survey is undertaken on the houses and sheds constructed during the 1970s and 1980s prior to demolition. Additional soil sampling for COPC following demolition is recommended; and

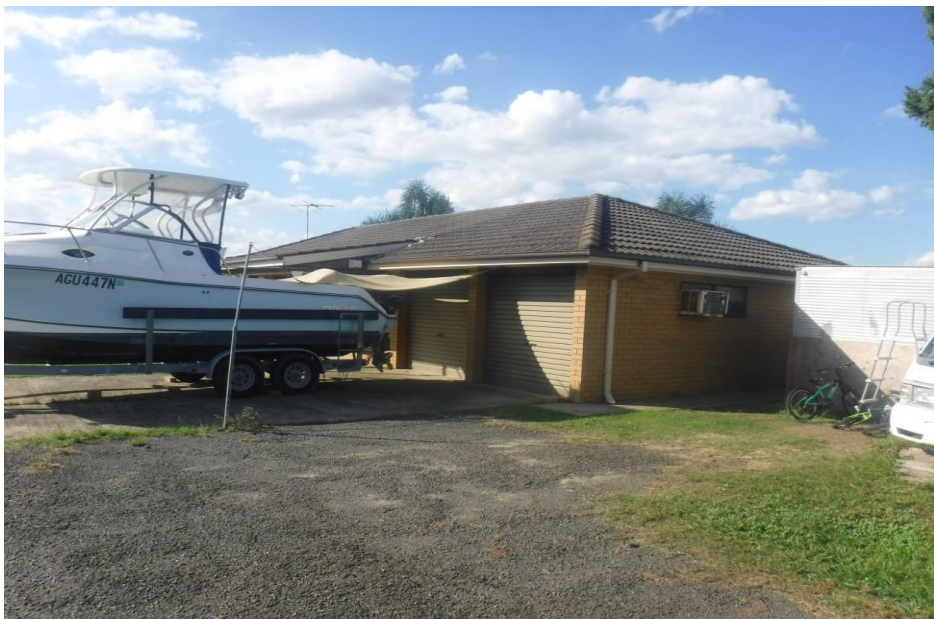
Photo 2: View of brick house located in the south of Lot 32 (facing north east)

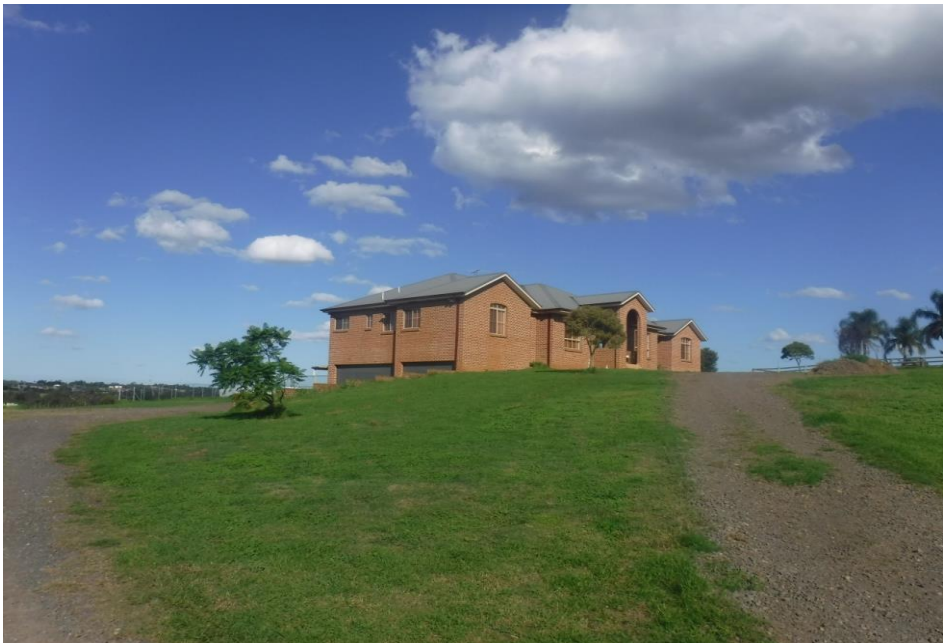
Photo 3: View of brick house located in the north of Lot 32 (facing south east)

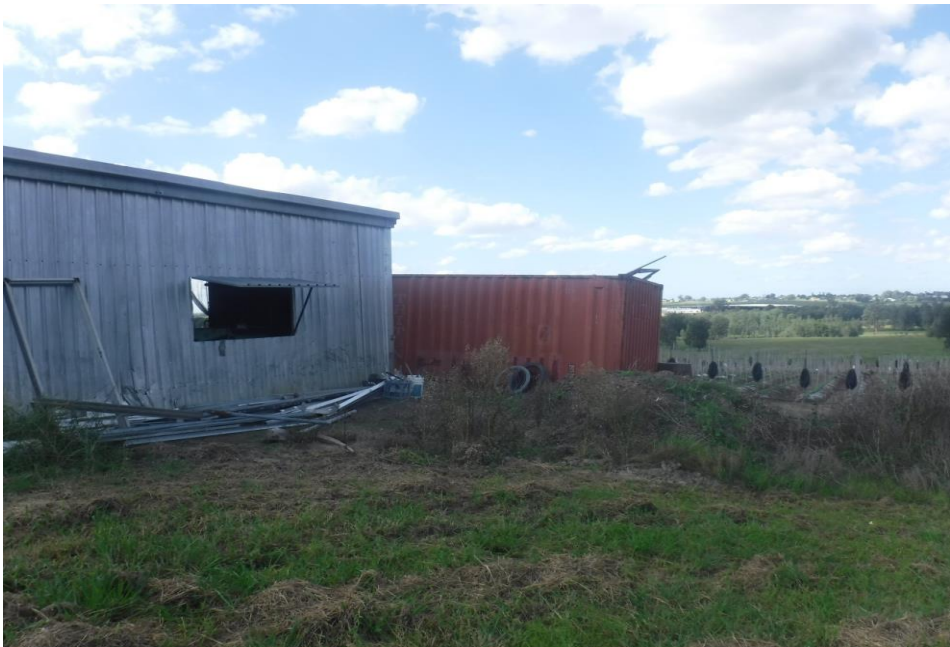
- Sheds and /or shipping containers were present at the rear of all houses with the exception of the northernmost house in Lot 32. Sheds were constructed of metal sheeting. No obvious ACM were observed in the construction materials (Photographs 4 and 5);

Photo 4: Shed and shipping container observed adjacent to the southern house in Lot 32 (facing east)

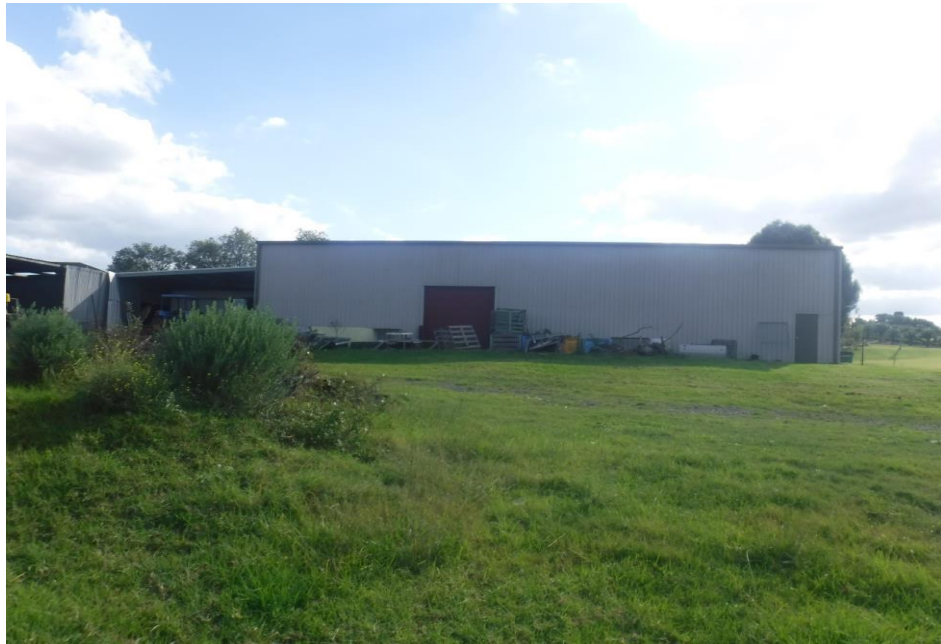
Photo 5: Large shed located behind the southernmost house in Lot 31 (facing west)

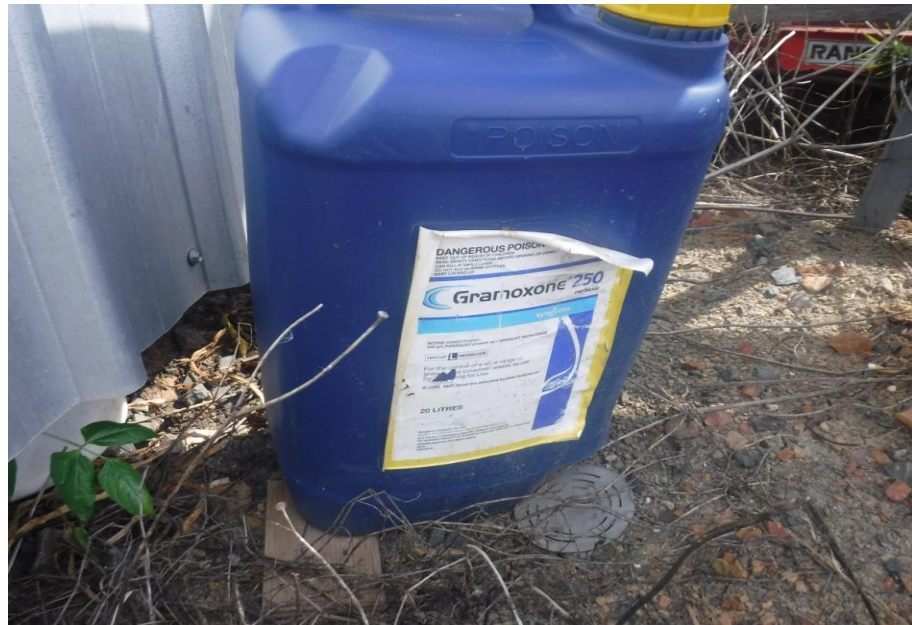
- Chemical and fuel containers were observed adjacent to the sheds in the south of Lots 31 and 32, with an old fridge (use for storage), empty drums, a generator, fuel and chemical containers observed in the centre of the site adjacent to the market gardens (Photographs 9 to 11);

Photo 9: Stored chemicals outside of the shed in the south of Lot 32

Although no stains or olfactory signs of contamination were reported during the site walkover in the vicinities of sheds and chemical/fuel storage areas, considering investigations were limited, further investigation is recommended to provide greater certainty regarding the presence or absence of chemical/fuel related COPC in the vicinity of sites sheds and chemical/fuel storage locations on the site.

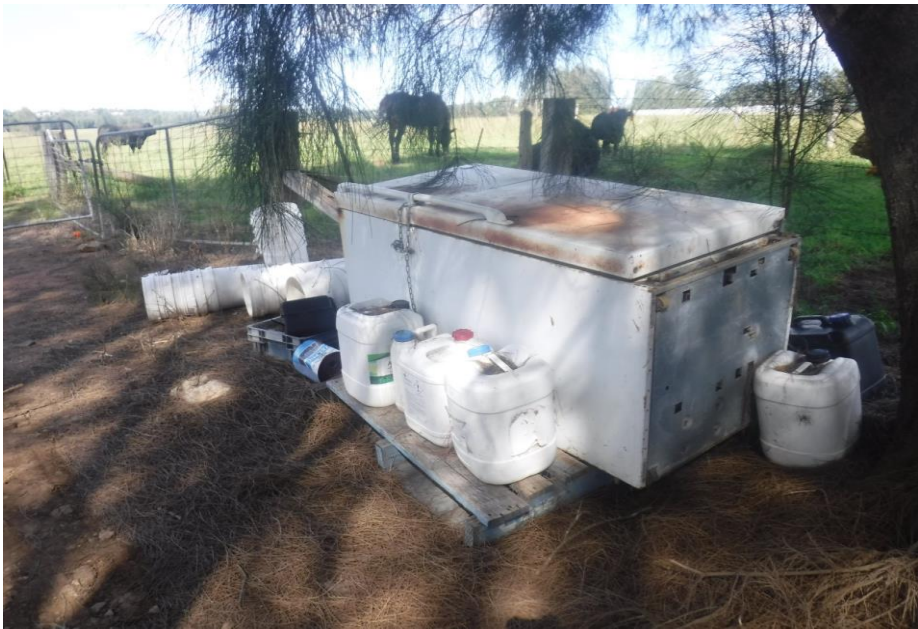
Photo 10: A fridge used for storage and chemical containers observed adjacent to the market garden in the centre of the site (facing southeast)

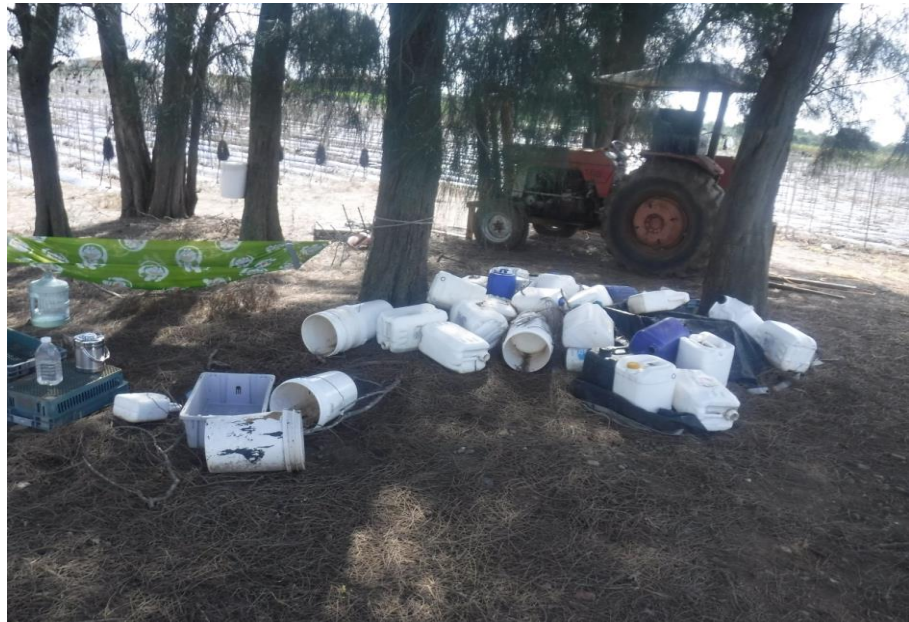
Photo 11: Chemical containers observed adjacent to the marker garden in the centre of the site (facing west)

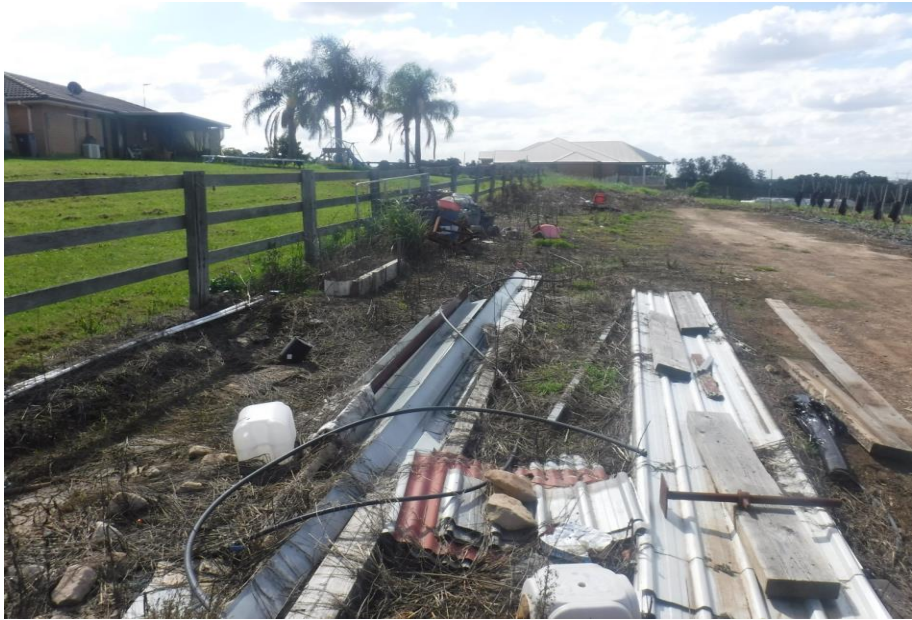
- Surficial waste (metal, wood, general refuse) was observed surrounding the sheds in the south of Lots 31 and 32 (Photographs 12 to 13). Barbed wire, wooden crates, metal sheeting, an old vehicle and general refuse was observed adjacent to the dam in the southeast (Photographs 14 and 15);

Photo 12: Surficial waste to the rear of the southern house in Lot 32 (facing north)

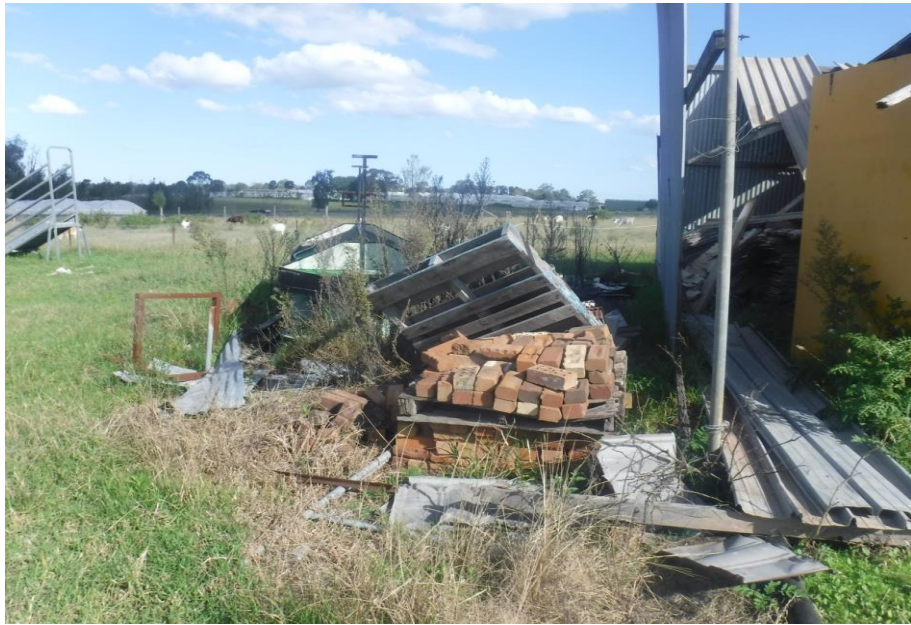
Photo 13: Surfacial waste to the rear of the southern shed in Lot 31 (facing south)

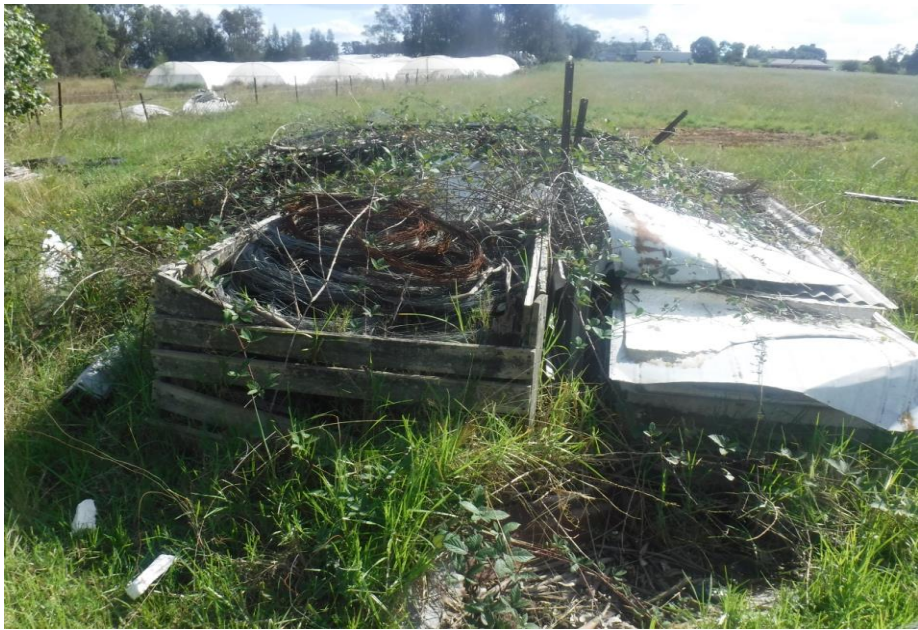
Photo 14: Surfacial waste observed adjacent to the dam in the southeast (facing west)

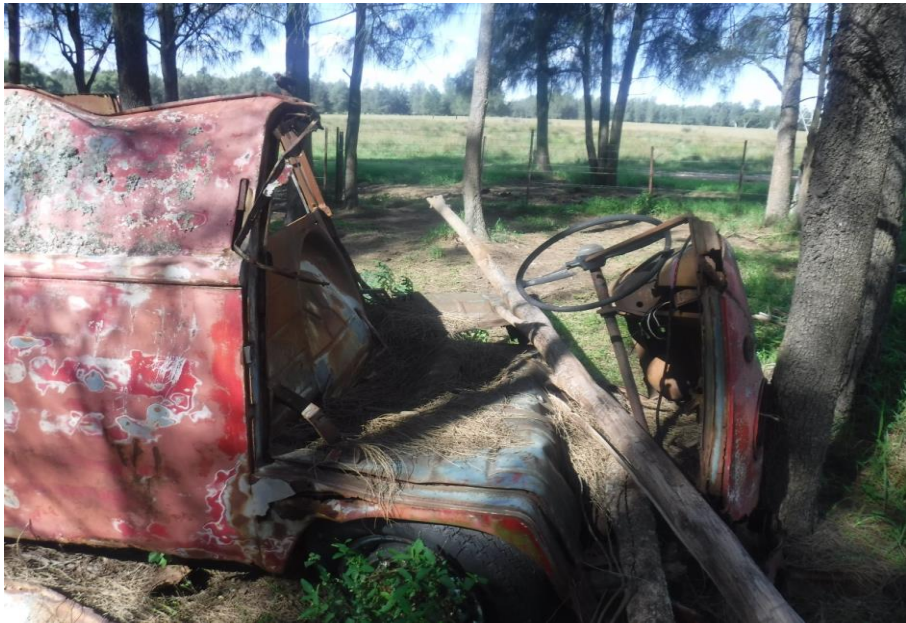
Photo 15: Old vehicle located adjacent to the dam in the southeast (facing east)

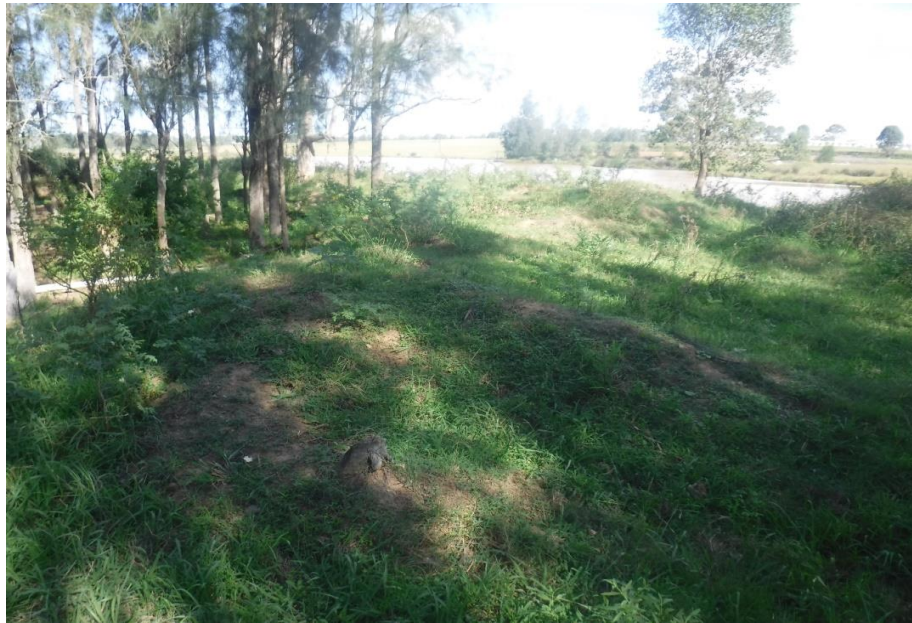
- Multiple (ie: >20) partially vegetated stockpiles of soil were present in the riparian vegetation of the unnamed tributary of Ropes Creek in the northeast covering an area of approximately 600 m². The stockpiles appeared to comprise light brown silty clay and were approximately 1.2 m high. Soil and rock stockpiles (approximately 1 m high) were also observed adjacent to the northern house in Lot 32 and adjacent to the shed in the south of Lot 32. No foreign materials were observed (Photographs 16 and 17);

Photo 16: Multiple soil stockpiles located north of the dam in the southeast (facing east)

More than 20 stockpiles of soil were identified in the riparian corridor of the unnamed tributary of Ropes Creek. No signs of contamination (such as anthropogenic material, staining or odours) were observed. Although it is possible that the stockpiles originated from the excavation of the adjacent dam, investigation is required to confirm the contamination status of these stockpiles.

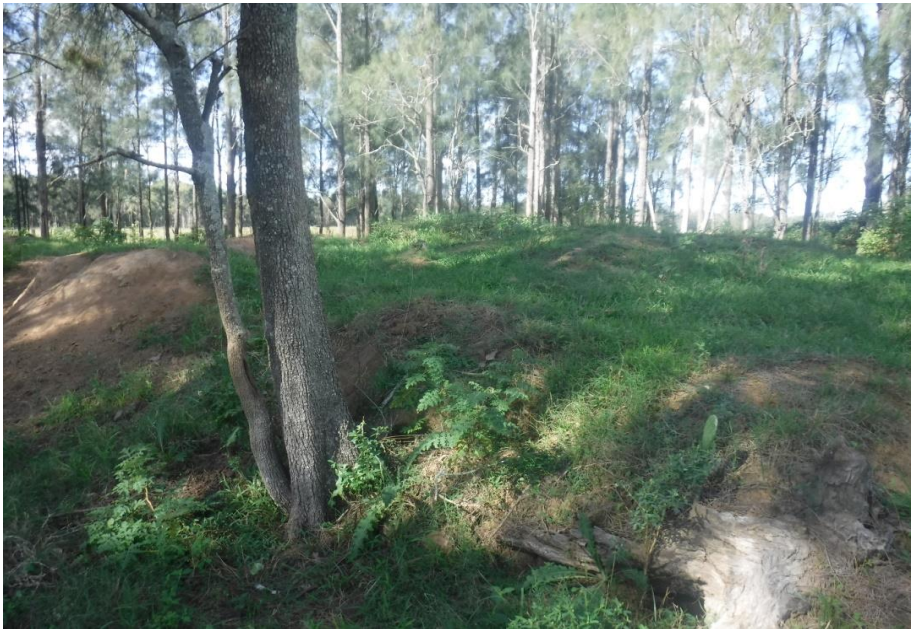
Photo 17: Multiple soil stockpiles located north of the dam in the southeast (facing north)

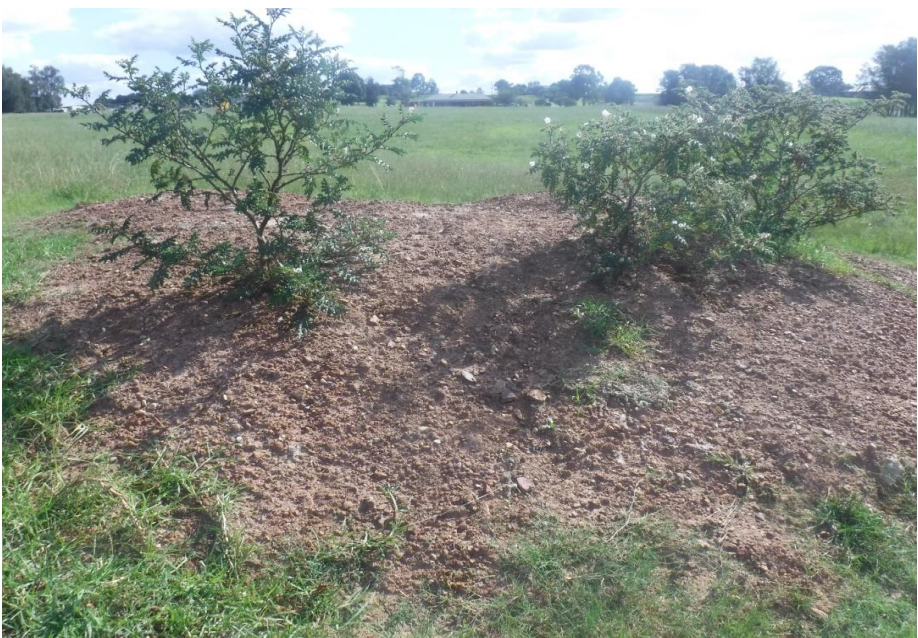
- Multiple (ie: >15) partially vegetated and exposed stockpiles of brown silty clay with mixed gravel soil containing foreign inclusions (brick, concrete, tile, wood) were present along the south of the dam in the south east. The stockpiles covered an approximate area of 1450 m² and were each approximately 0.8 m to 1 m high. One fragment of suspected ACM was observed on the surface of one stockpile (Photographs 18 to 20);

Photo 18: Exposed stockpile in the southeast with a fragment of ACM on the surface (facing south)

Multiple stockpiles containing demolition rubble (bricks, concrete, tile, terracotta and steel) were observed adjacent to the dam in the southeast, and to the rear of the large shed in the southwest. Multiple fragments of ACM were also recovered from stockpiles in these locations. Although vegetation prevented full inspection of the surface of stockpiles in the southeast, the presence of asbestos is likely considering the stockpiles appeared similar in composition and the presence of demolition rubble in the vicinity.

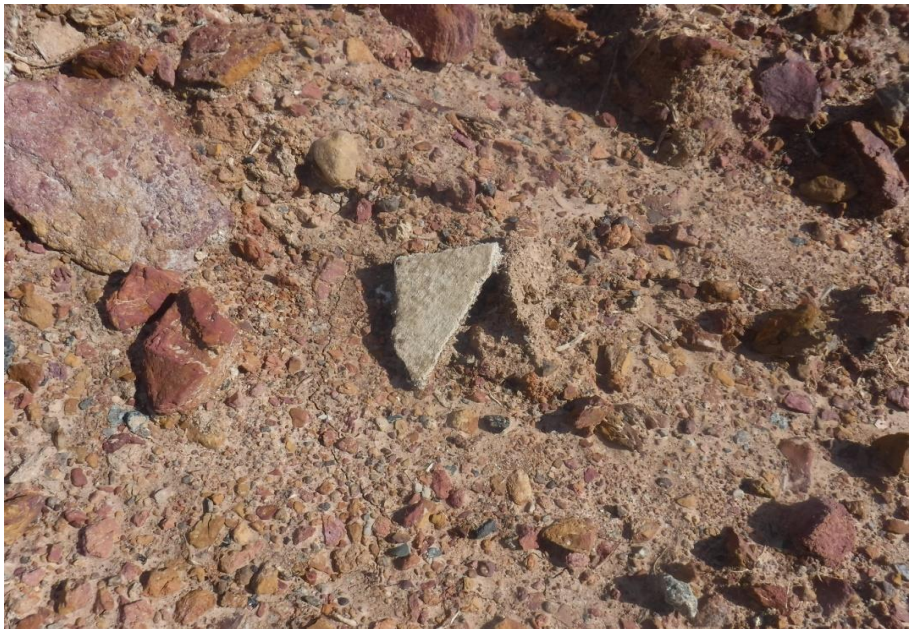
Photo 19: Fragment of ACM on the surface of a stockpile in the southeast

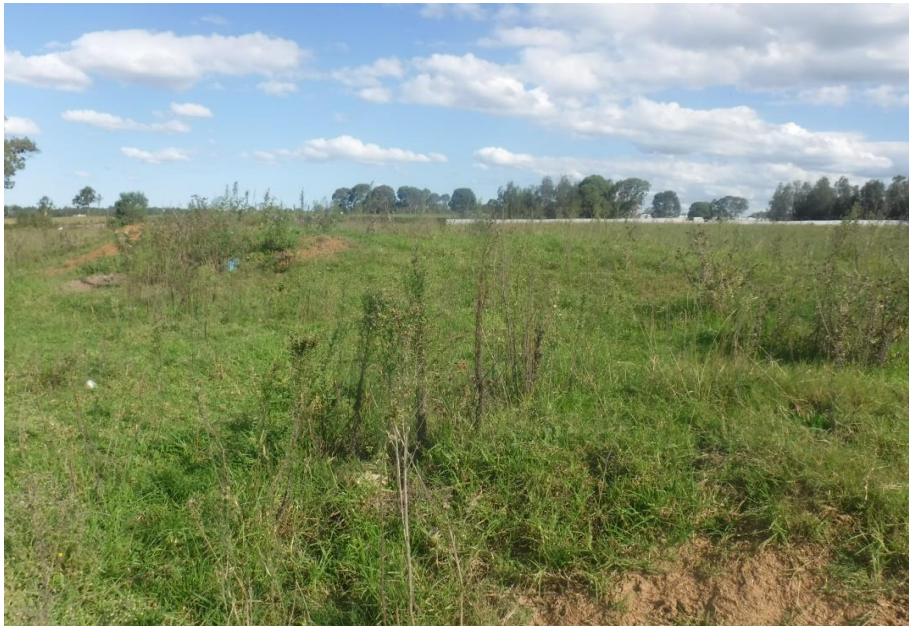
Photo 20: View of vegetated stockpiles with exposed foreign inclusions on the surface in the southeast

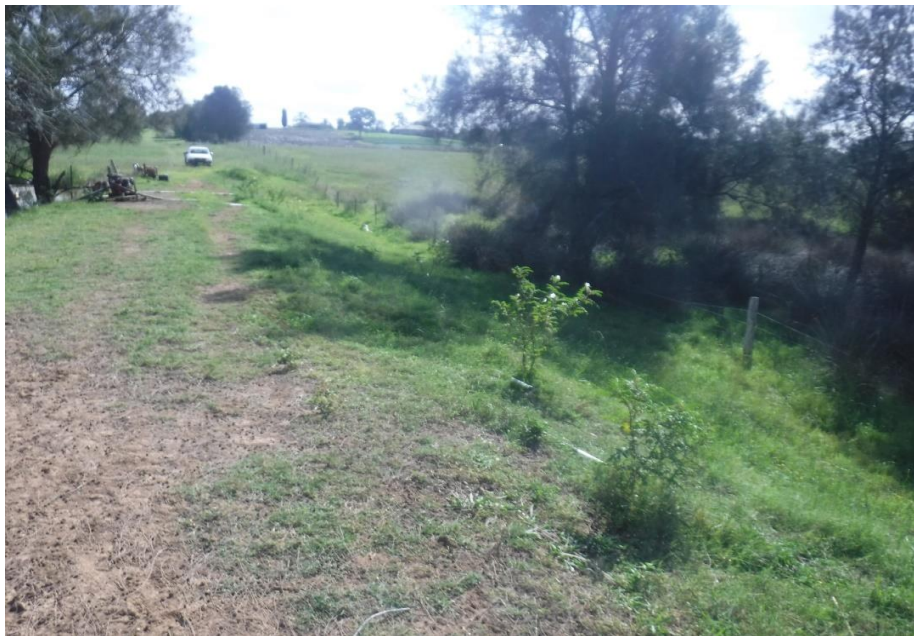
- The dam wall constructed along the Ropes Creek Tributary was approximately 1.7 m high and appeared to be constructed of soil. No foreign inclusions were observed, however the batter of the wall was obscured due to grass coverage (Photograph 21). The area to the immediate north of the dam wall does not appear to be filled. Although vegetation prevented inspection of the ground surface in this location, no foreign materials were observed in exposed soils (Photograph 22);

Photo 21: View of the dam wall in the southeast (facing west)

The historical investigation reported that the construction of the dam wall occurred prior to 1982. No foreign materials were observed in the surface of the dam wall, however, as much of it was vegetated, full inspection was not possible. Although it is likely that the wall was constructed of site-won material excavated during construction of the dam, further investigation would be required to confirm the contamination status of the dam wall.

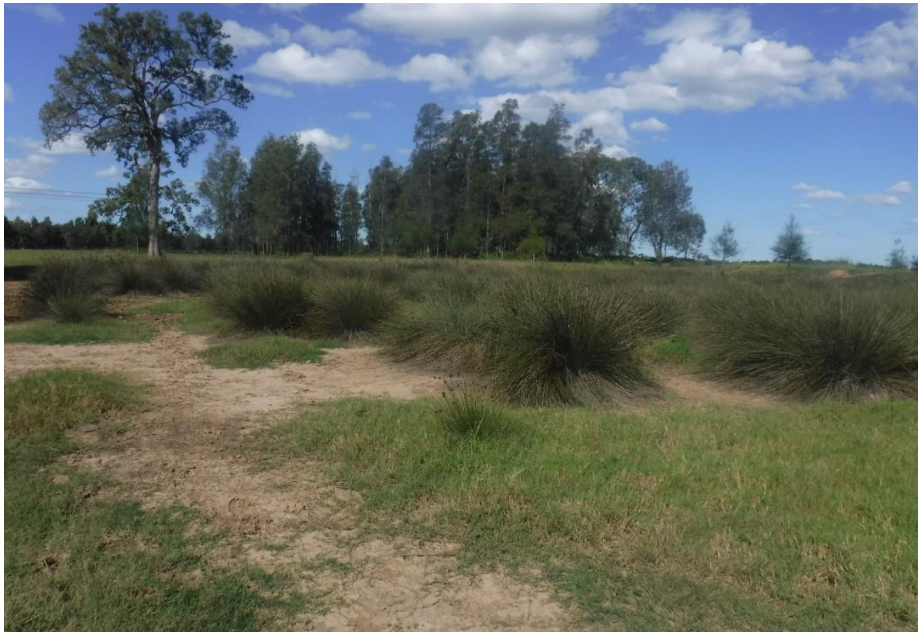
Photo 22: Filled area north of the dam wall. No foreign materials were observed in the exposed areas (facing east)

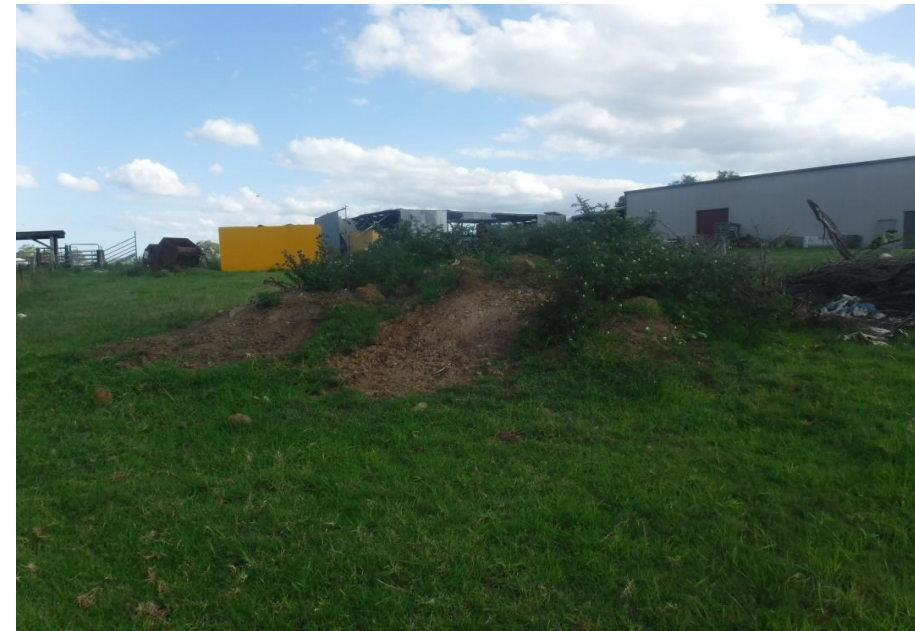
- A partially vegetated stockpile of soil (approximately 1.5 m high covering an area approximately 50 m²) containing large volumes of foreign inclusions (brick, concrete, tile and multiple fragments of ACM) was observed behind the largest shed in Lot 31 (Photographs 26 and 27). Multiple waste stockpiles (wood and refuse) were located in the vicinity of the soil stockpile (Photograph 28);

Photo 26: Stockpile of soil containing foreign inclusions (including ACM) was observed in the southwest of Lot 31 (facing south)

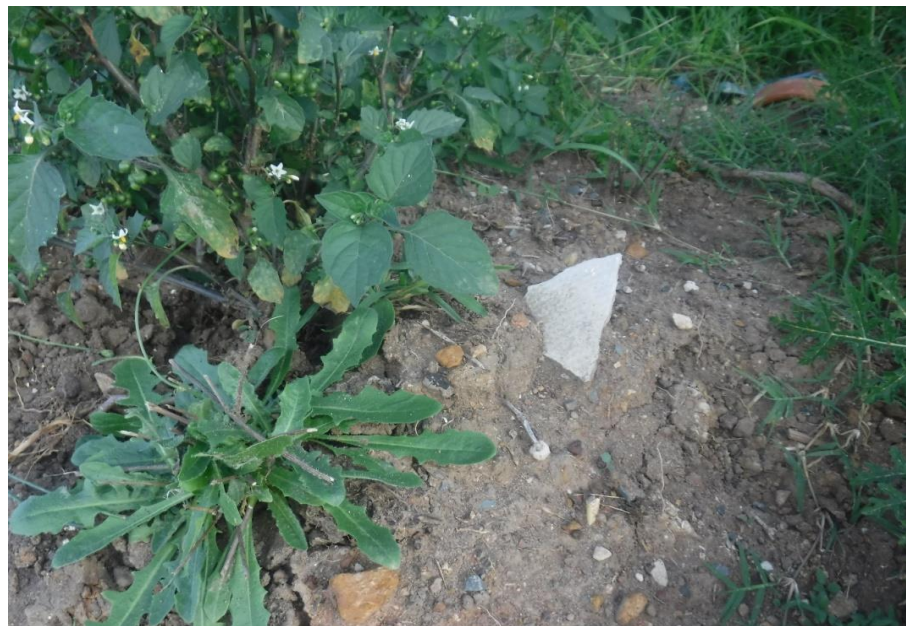
Photo 27: ACM fragment on the surface of the soil stockpile in the southwest.

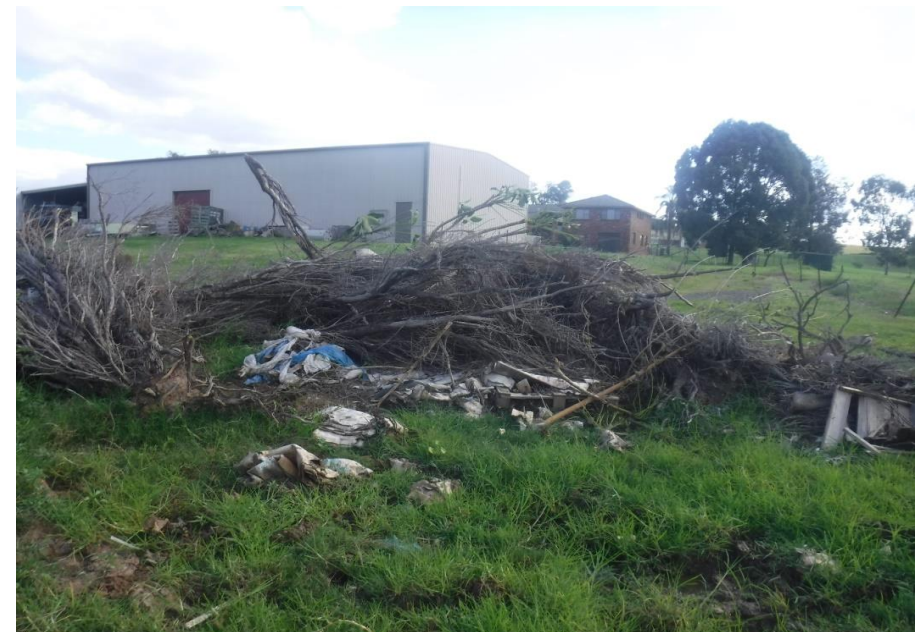
Photo 28: Stockpile of refuse and dead vegetation located in the southwest of Lot 31 (facing west)

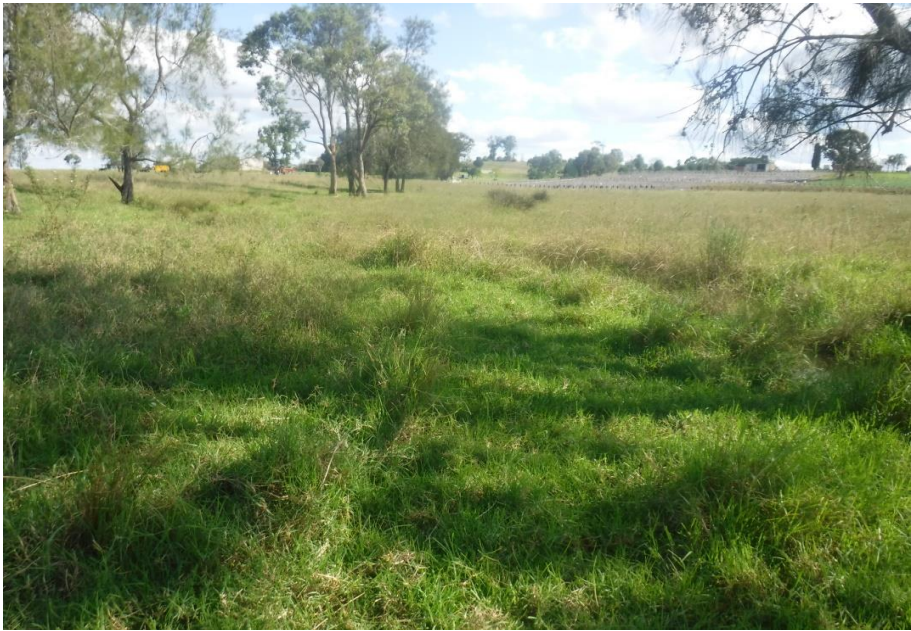
- A fill area (potential soil footbridge) was observed in a small drainage gully in the north. Bricks and concrete were also observed on the surface in this location (Photographs 29 and 30);

Photo 29: : Potential fill area in a drainage gully in the northadjacent to the fill area in the drainage gully (facing west)

An area within a drainage gully in the north appeared to be filled, potentially to create a footbridge for cattle. Demolition waste such as bricks and concrete was observed on the surface and partially buried in the vicinity of the filling area. Due to the presence of demolition waste, and the prevalence of historic waste being deposited in gullies, there is a potential for COPC (primarily asbestos) being present in fill material at this location. Investigation along the gully is recommended.

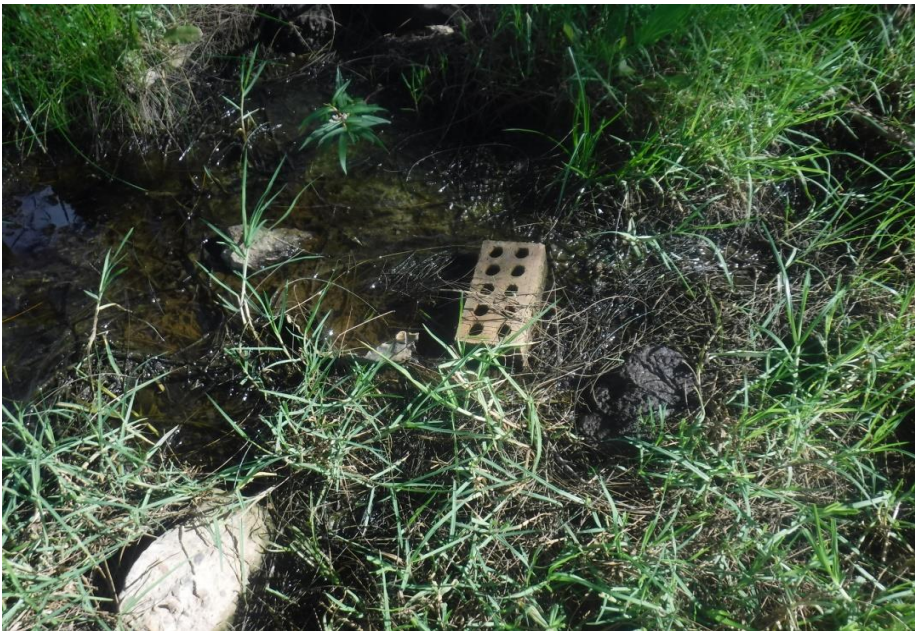
Photo 30: Bricks and concrete observed on the surface immediately adjacent to the fill area in the drainage gully

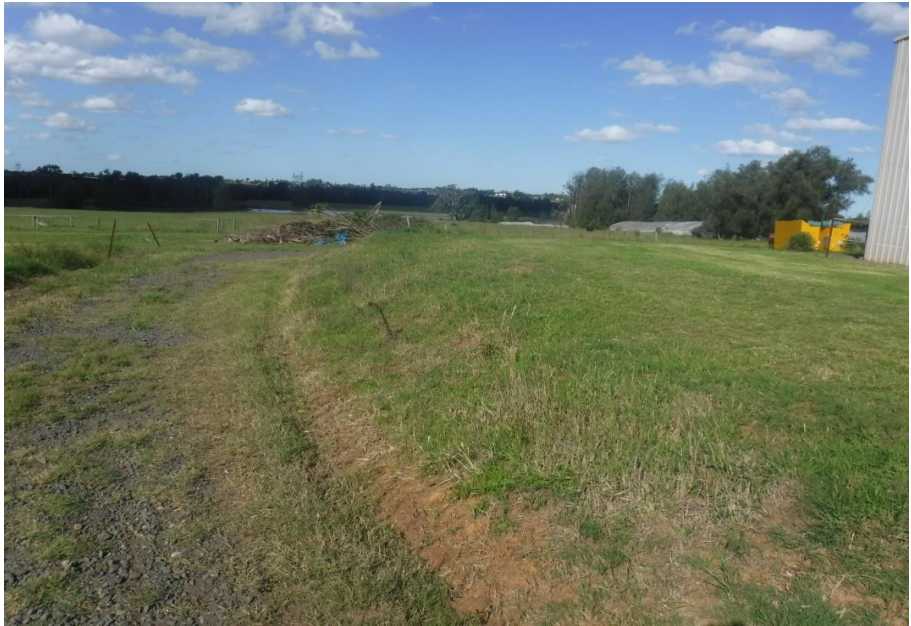
- The large shed in the southwest of Lot 31 was constructed on a fill platform (Photograph 31)
- Two septic tanks and stockpiles of soil were observed adjacent to the northern house in Lot 32 (Photographs 32 and 33);

Photo 31: The large shed in the southwest of Lot 31 was constructed on a fill platform (facing east)

The large shed in the southwest of Lot 31 was constructed on top of a filling platform. No investigations were undertaken in this area due to the limited nature of this investigation. Investigation is recommended to confirm the contamination status of the platform.

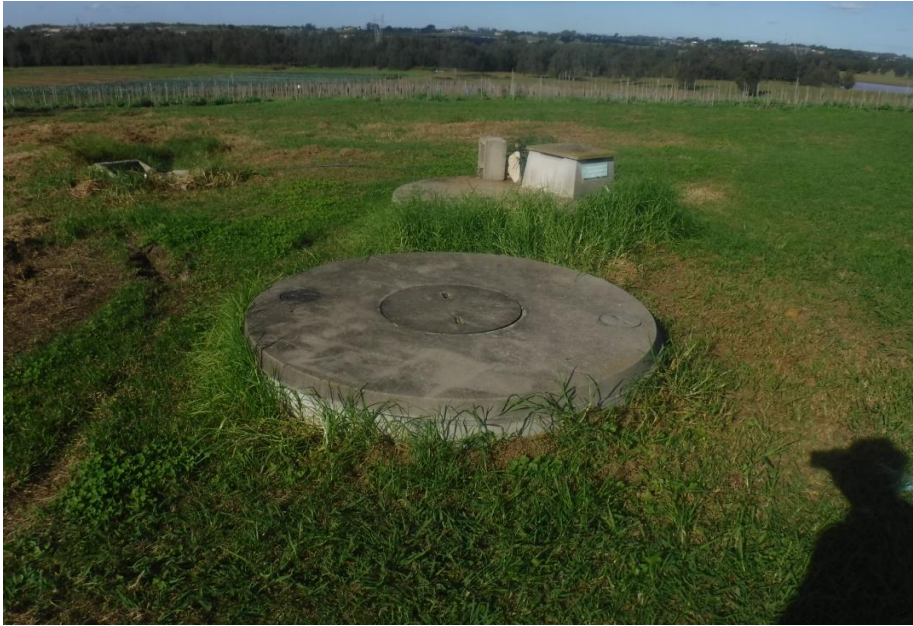
Photo 32: Two septic tanks located adjacent to the northern house in Lot 32 (facing east)

The desktop study and site inspection reported the presence of two septic tanks in the northwest of the site. Removal, following the decommissioning of the tanks, is recommended prior to development.

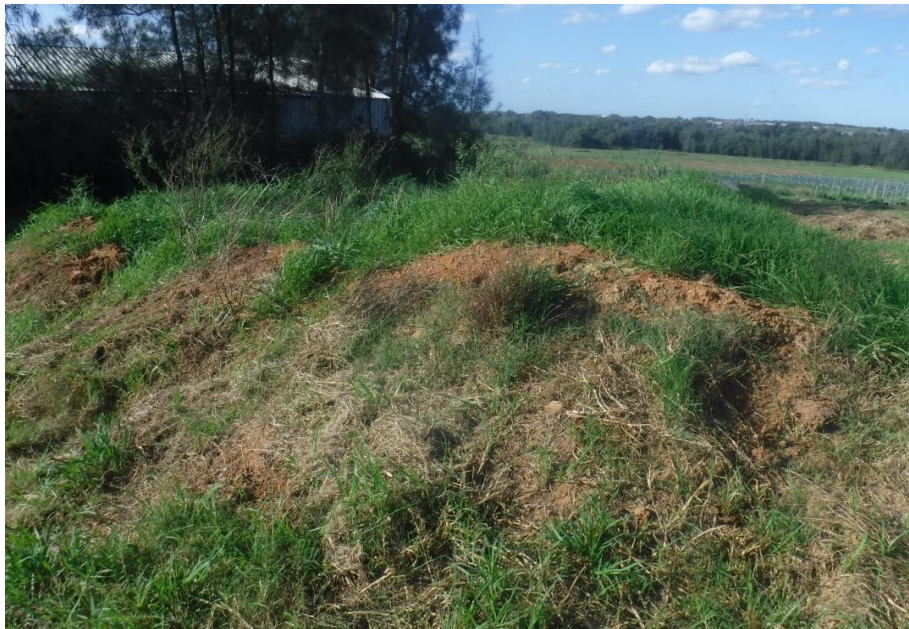
Photo 33: Vegetated soil stockpiles adjacent to the northern house in Lot 32 (facing northeast)

Approximately four small stockpiles of soil and rock were identified adjacent to the shed and the house in the north of Lot 32. Although no signs of contamination were observed, no intrusive investigations or sampling was undertaken within the stockpiles. Further investigation is recommended to confirm the contamination status of these stockpiles.

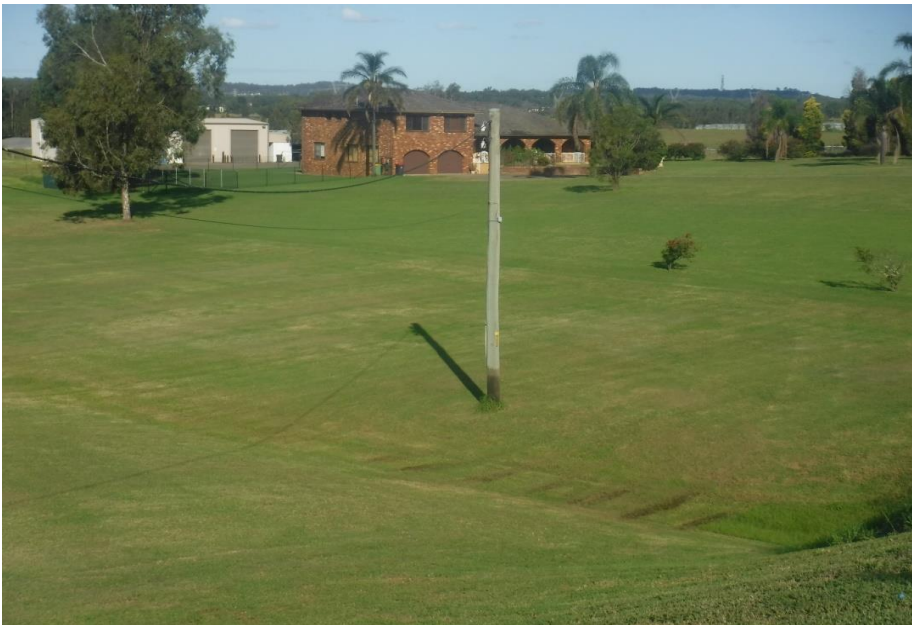
Photo 34: Timber power pole located in the northwest of Lot 31 (facing southeast)

Given the preliminary nature of the investigation, the soil sampling was limited across the site and soils in the vicinity of power poles were not collected and tested. Timber power poles are known as a source of localised contamination to shallow soils due to the numerous treatment chemicals used specifically in the base of the power poles to prevent damage by termites, insects and moisture. Further assessment in the form of shallow soil sampling in the vicinity of power poles is required to confirm the presence or absence of related COPC.

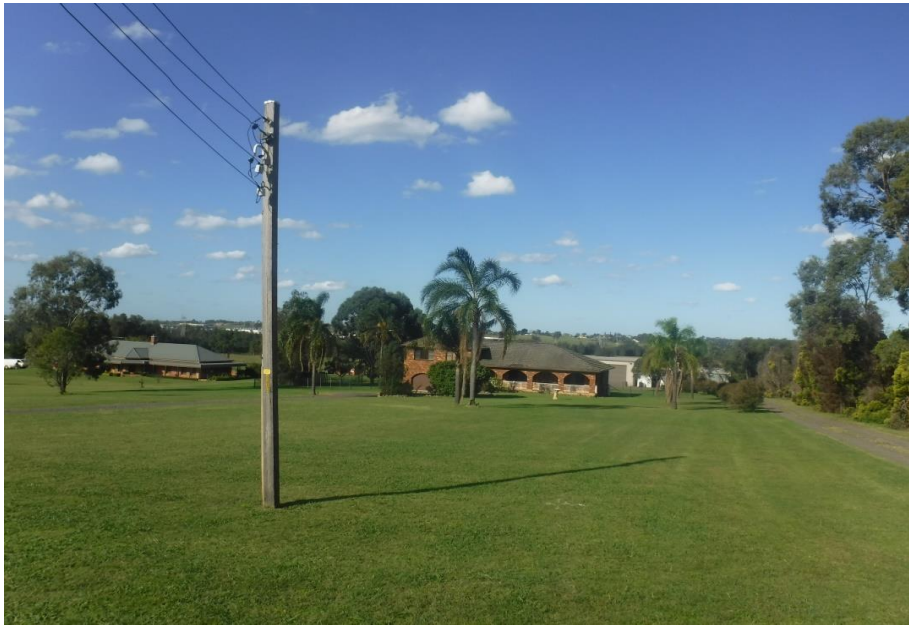
Photo 35: Timber power pole located in the southwest of Lot 31 (facing east)

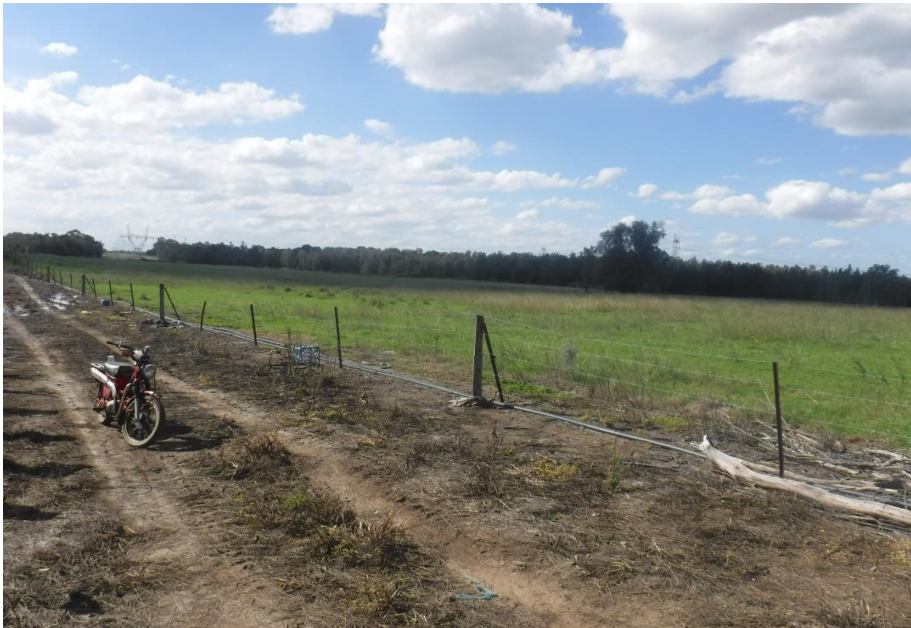
Photo 36: The corridors and surrounds of the market garden appeared to have been sprayed with herbicide

Current market gardens have been in operation since 2015, with former market gardens also observed in the 1991 aerial photograph. Surface soils from test pits TP2, TP3, TP6, TP7, and TP9 to TP12 were collected in the locations of the current and former market gardens and tested for COPC. All samples were below the LOR and SAC for pesticides (OPP and OCP) and within the SAC for all remaining COPC. Based on these results, the potential impact to soils related to market garden COPC is considered to be low, and therefore, the market gardens are no longer considered an AEC. DP does not consider that further investigation into the market gardens is necessary.
