Report on
Preliminary Site Investigation for Contamination

Proposed Commercial/Industrial Subdivision
106 - 142 Aldington Road, Kemps Creek NSW

Prepared for
Stockland Commercial Property Pty Ltd

Project 92345.00
April 2019

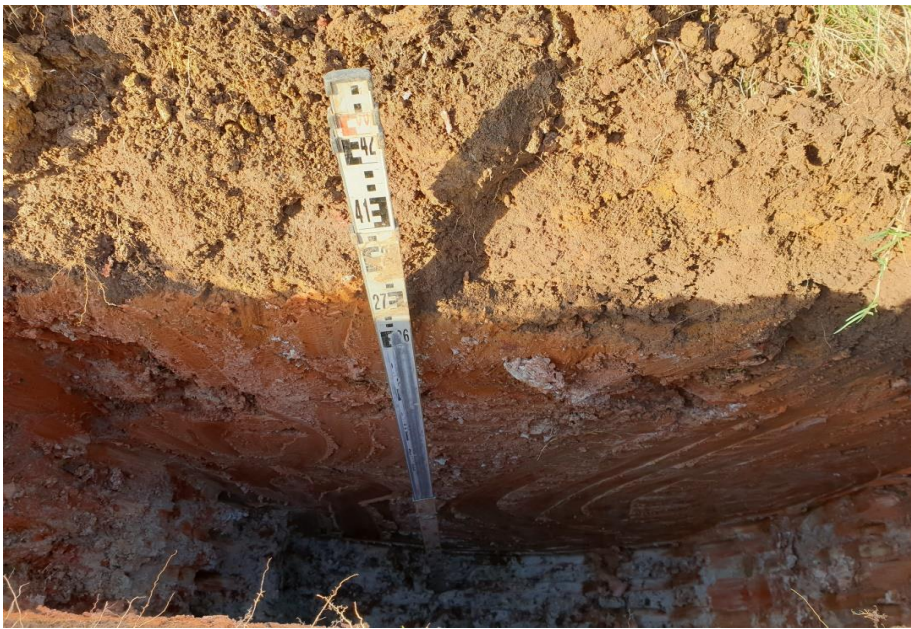
Filling was reported in TP1, BH5 and TP9 to depths ranging between 0.2 m and 0.8 m bgl. Although the filling in TP1 and BH5 did not report the presence of foreign inclusions, TP9 reported the presence of tile fragments. Considering that TP9 is also located adjacent to a stockpile impacted with demolition rubble and ACM, it is possible that the fill (and stockpile) resulted from the demolition of a former structure in the vicinity of TP9 (ie. the former shed). Therefore, further investigation of the fill in the vicinity of TP9 is recommended.

Photo 37: Filling overlying natural clays at TP9

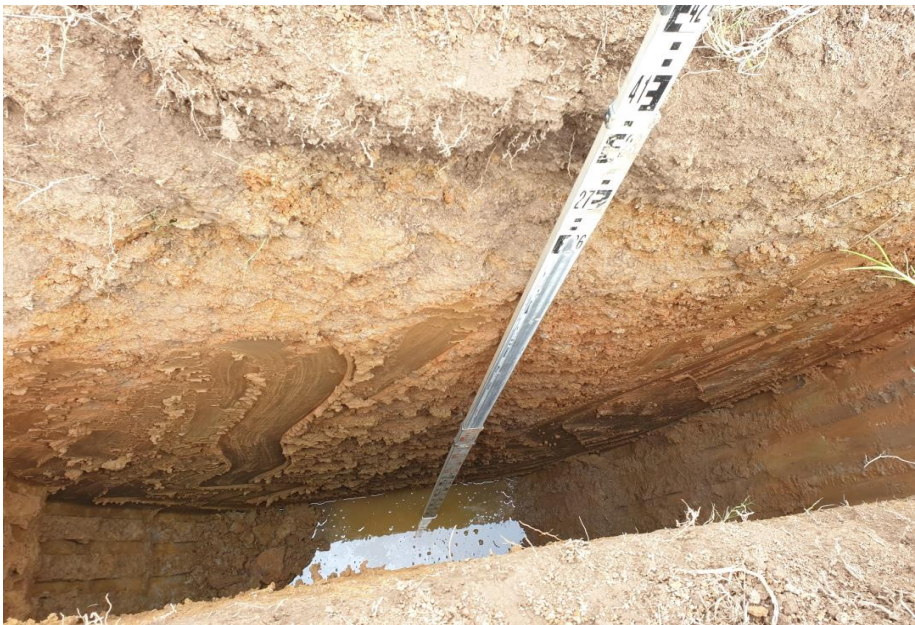
Groundwater was intersected at depths of 2.5 m (RL59.1 AHD) in TP4 and 3 m (RL61 AHD) in TP11 and TP12 during excavation. No free groundwater was observed in the pits for the short time that they were left open. No groundwater was intersected in BH5 and BH8 whilst auger drilling. The use of water as a drilling fluid precluded groundwater observations whilst core drilling. It is also noted that the pits and boreholes were immediately backfilled following excavation which precluded longer term monitoring of groundwater levels. Groundwater levels are affected by factors such as soil permeability and weather conditions, and can therefore vary with time.

Photo 38: Groundwater observed in the base of TP11

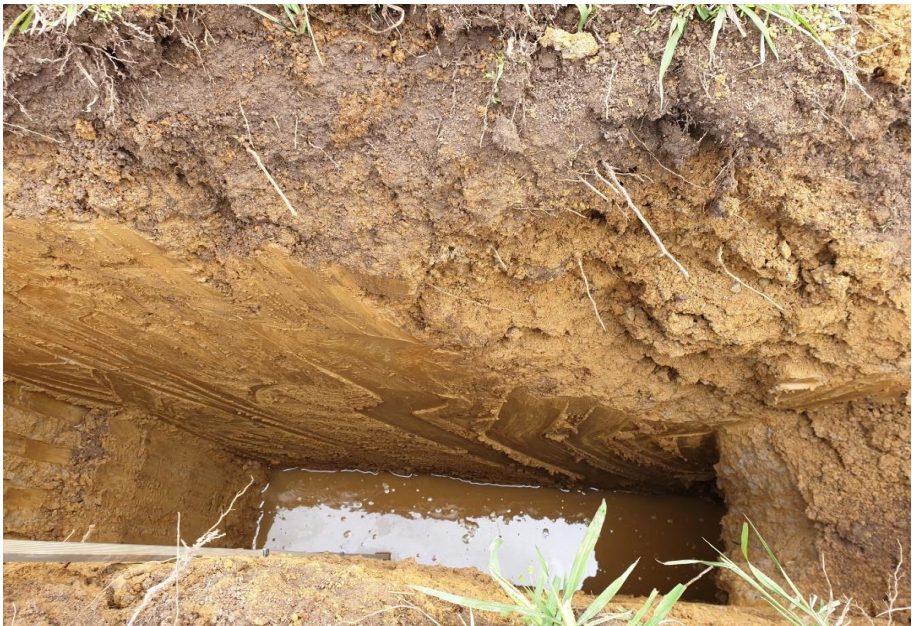
Photo 39: Groundwater observed in the base of TP4
