# 475 Badgerys Creek Road, Bradfield

## Remedial Action Plan

Document Number:  
26008955-001-R2-Rev1-RAP Bradfield 260421

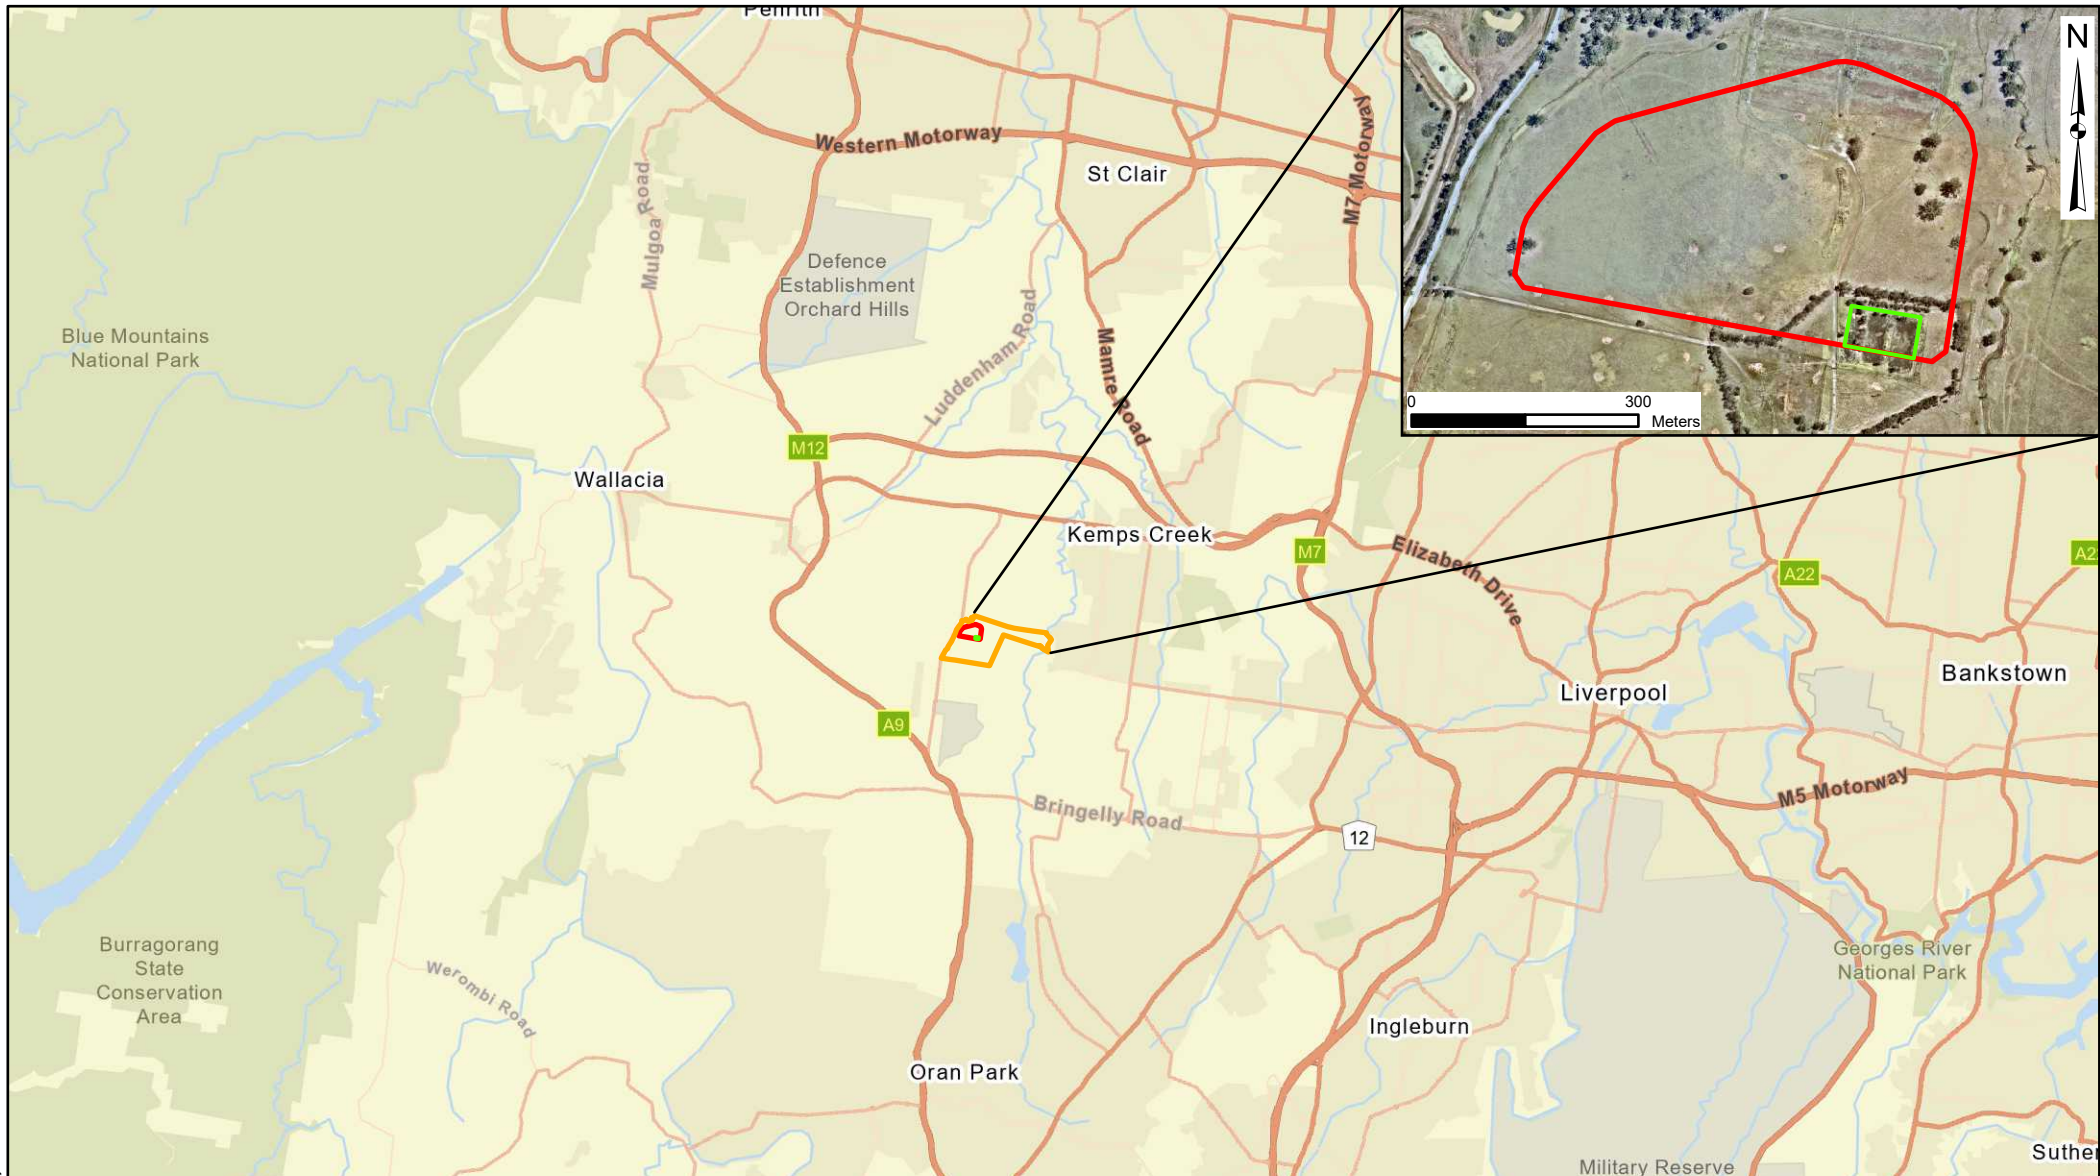
**Figure**  
**1**

The broader landholding has an area of approximately 184 hectares (ha) and is subject to an approved Master Plan prepared by Inghams Property Group (IPG) (the master site). The proposed ADC will be located in Stage 2 of the master site. The site is legally identified as part of Lot 102 and Lot 105 in Deposited Plan (DP) 1316278 and forms part of the master site area, shown in Attachment A, Figure 1. The site occupies an approximate area of 17.2 ha.

The master site has an area of approximately 184 hectares and is subject to an approved Master Plan prepared by Inghams Property Group (IPG). The proposed ADC will be located in Stage 2 of the IPG master plan site. The application site has an area of approximately 172,000m<sup>2</sup>. The location of the application site is presented in Figures 1 and 2.

The land to which this report relates is referred to as 475 Badgerys Creek Road, Bradfield, which has direct interface with the Western Sydney International Airport (WSI), legally described as part Lot 102 and Lot 105 in DP 1316278. It is noted that the ADC will be located on future lots within the 475 Badgerys Creek Road landholding. For the purpose of this Report, reference to 'the site' will relate primarily to the area within the broader lot proposed to be developed for the ADC, as shown in red in Figure 1, unless otherwise specified.

| Item | Details | Source |
|---|---|---|
| <b>Site Description:</b> | The Site is currently vacant land.<br>The Site location and layout are shown in Figures 1 and 2 | Site Inspection<br>Near Map<br>Google Website |

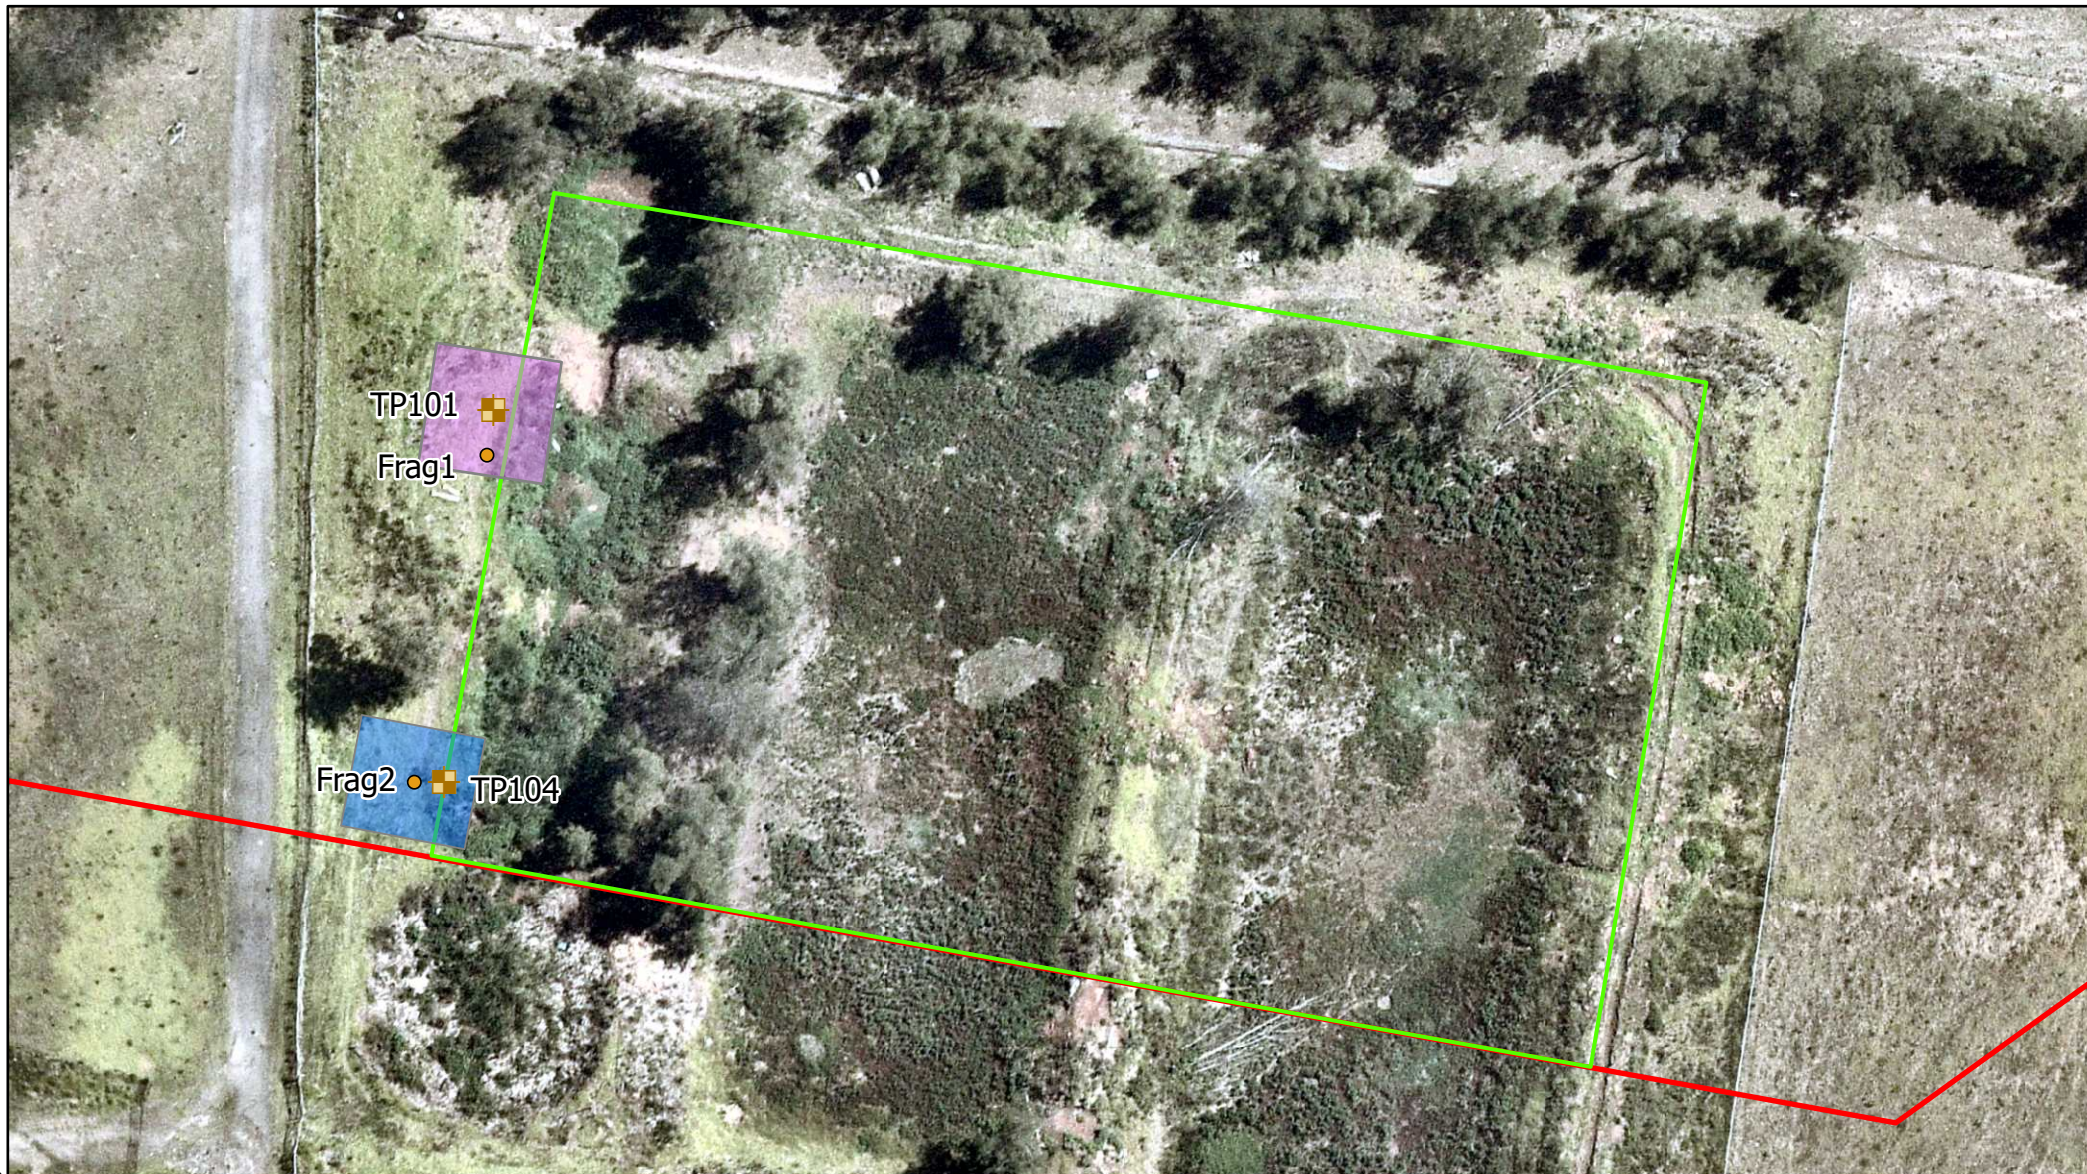
- ▭ Approximate Site Boundary
- ▭ Former Sediment Pond Area
- ▣ Soil Investigation Locations
- Surface Fragments
- ▭ Soil Remediation Area
- ▭ Surface Remediation Area

Previous investigations identified asbestos on the ground surface (Frag2/TP104) and in the soil (TP101) exceeding the human health screening levels for commercial/industrial land uses requiring remediation (Geosyntec, 2026).

- On-site treatment of surface fragments by hand picking; and
- Removal of contaminated soil material to an approved site or facility.

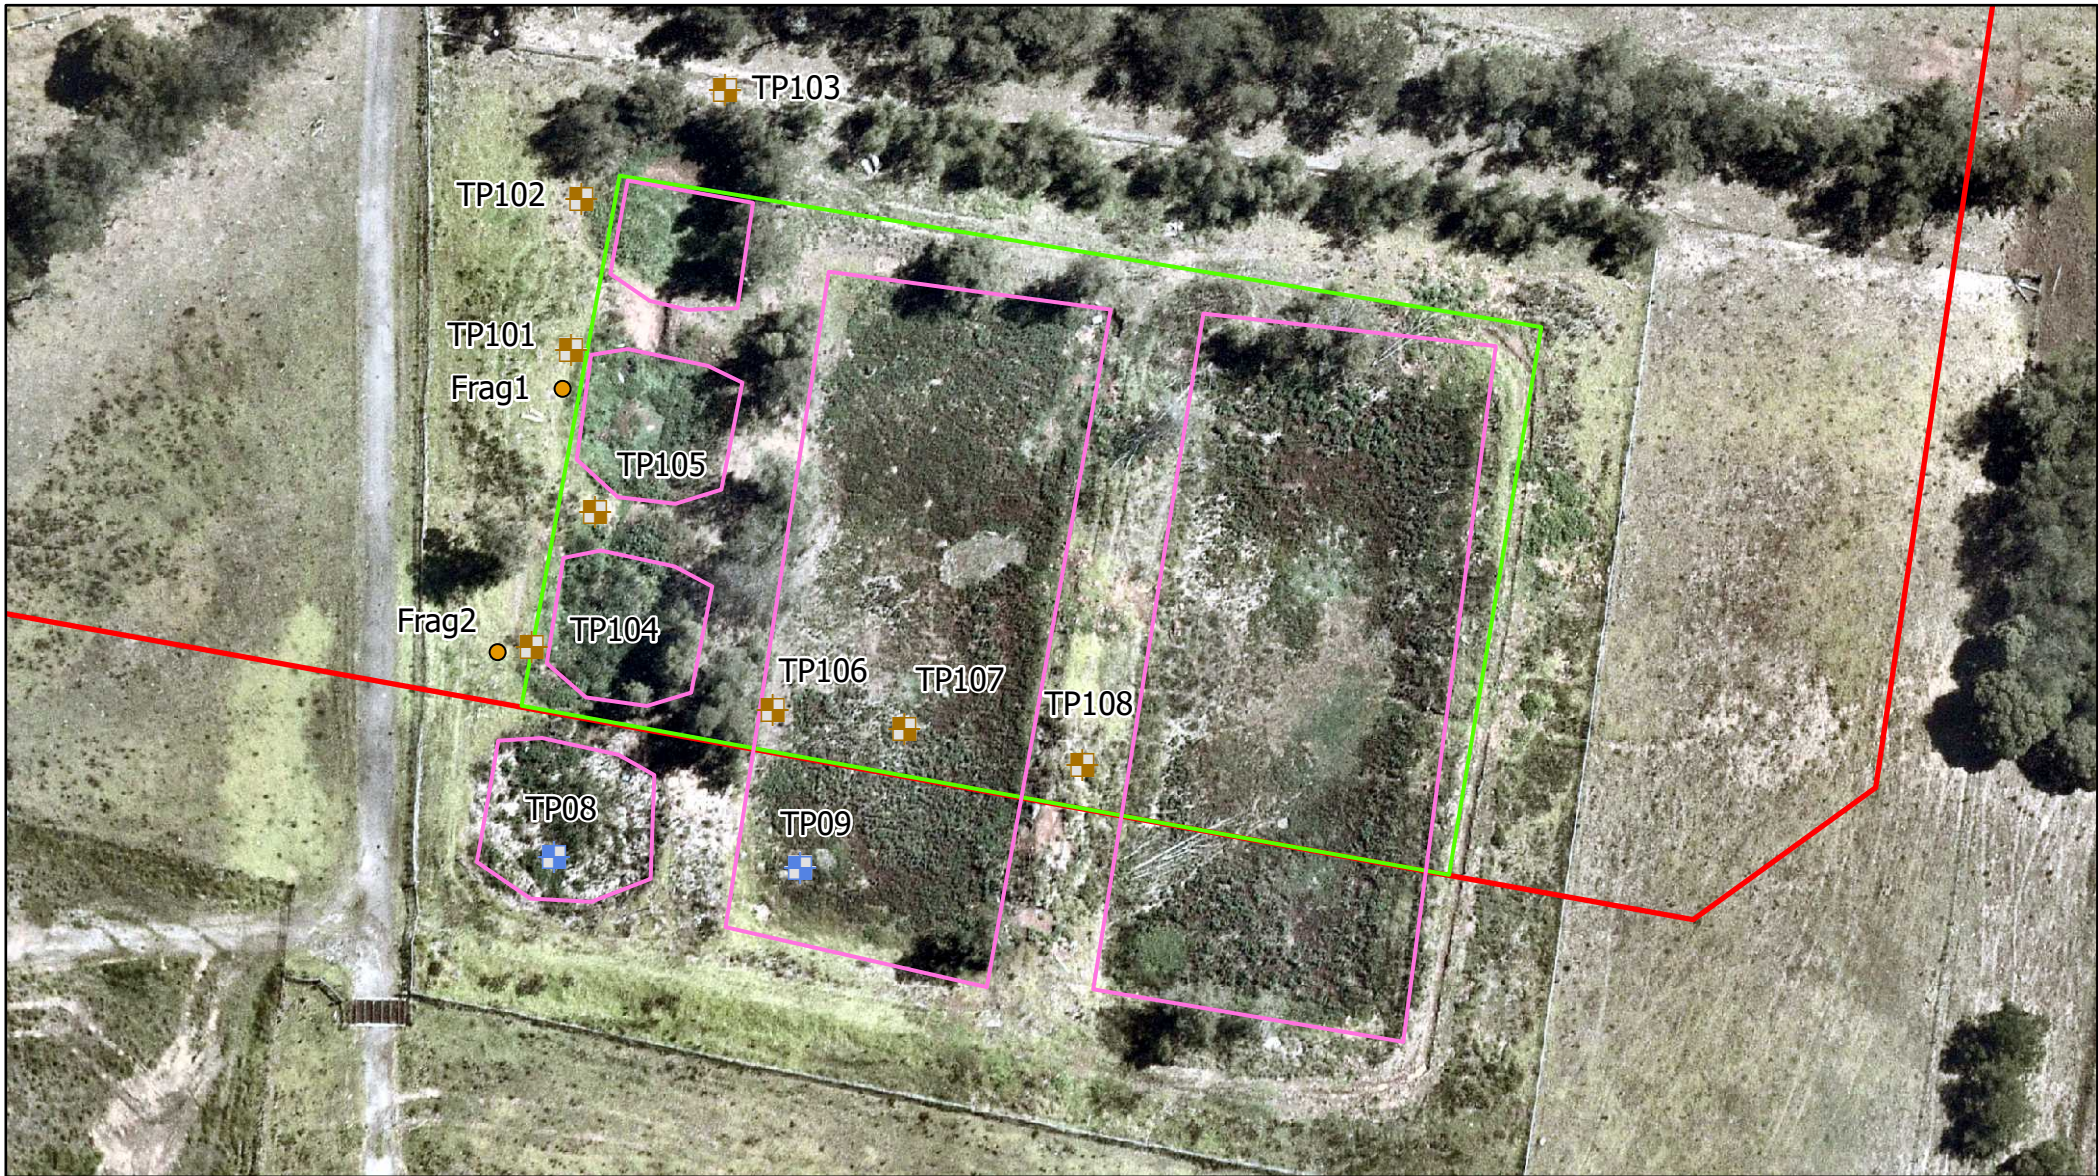
### Previous Investigation Results and Figures

- ▬ Approximate Site Boundary
- ▬ Former Sediment Pond Area
- ▬ Former Sediment Ponds
- Soil Investigation Locations
- Historical Soil Investigation Locations (Senversa 2025)
- Surface Fragments
