## Preliminary Site Investigation

35 - 39 Darley Street East, Mona Vale NSW

**Report Title:** Preliminary Site Investigation; 35 - 39 Darley Street East, Mona Vale NSW  
**Report No:** E26992.E01\_Rev0

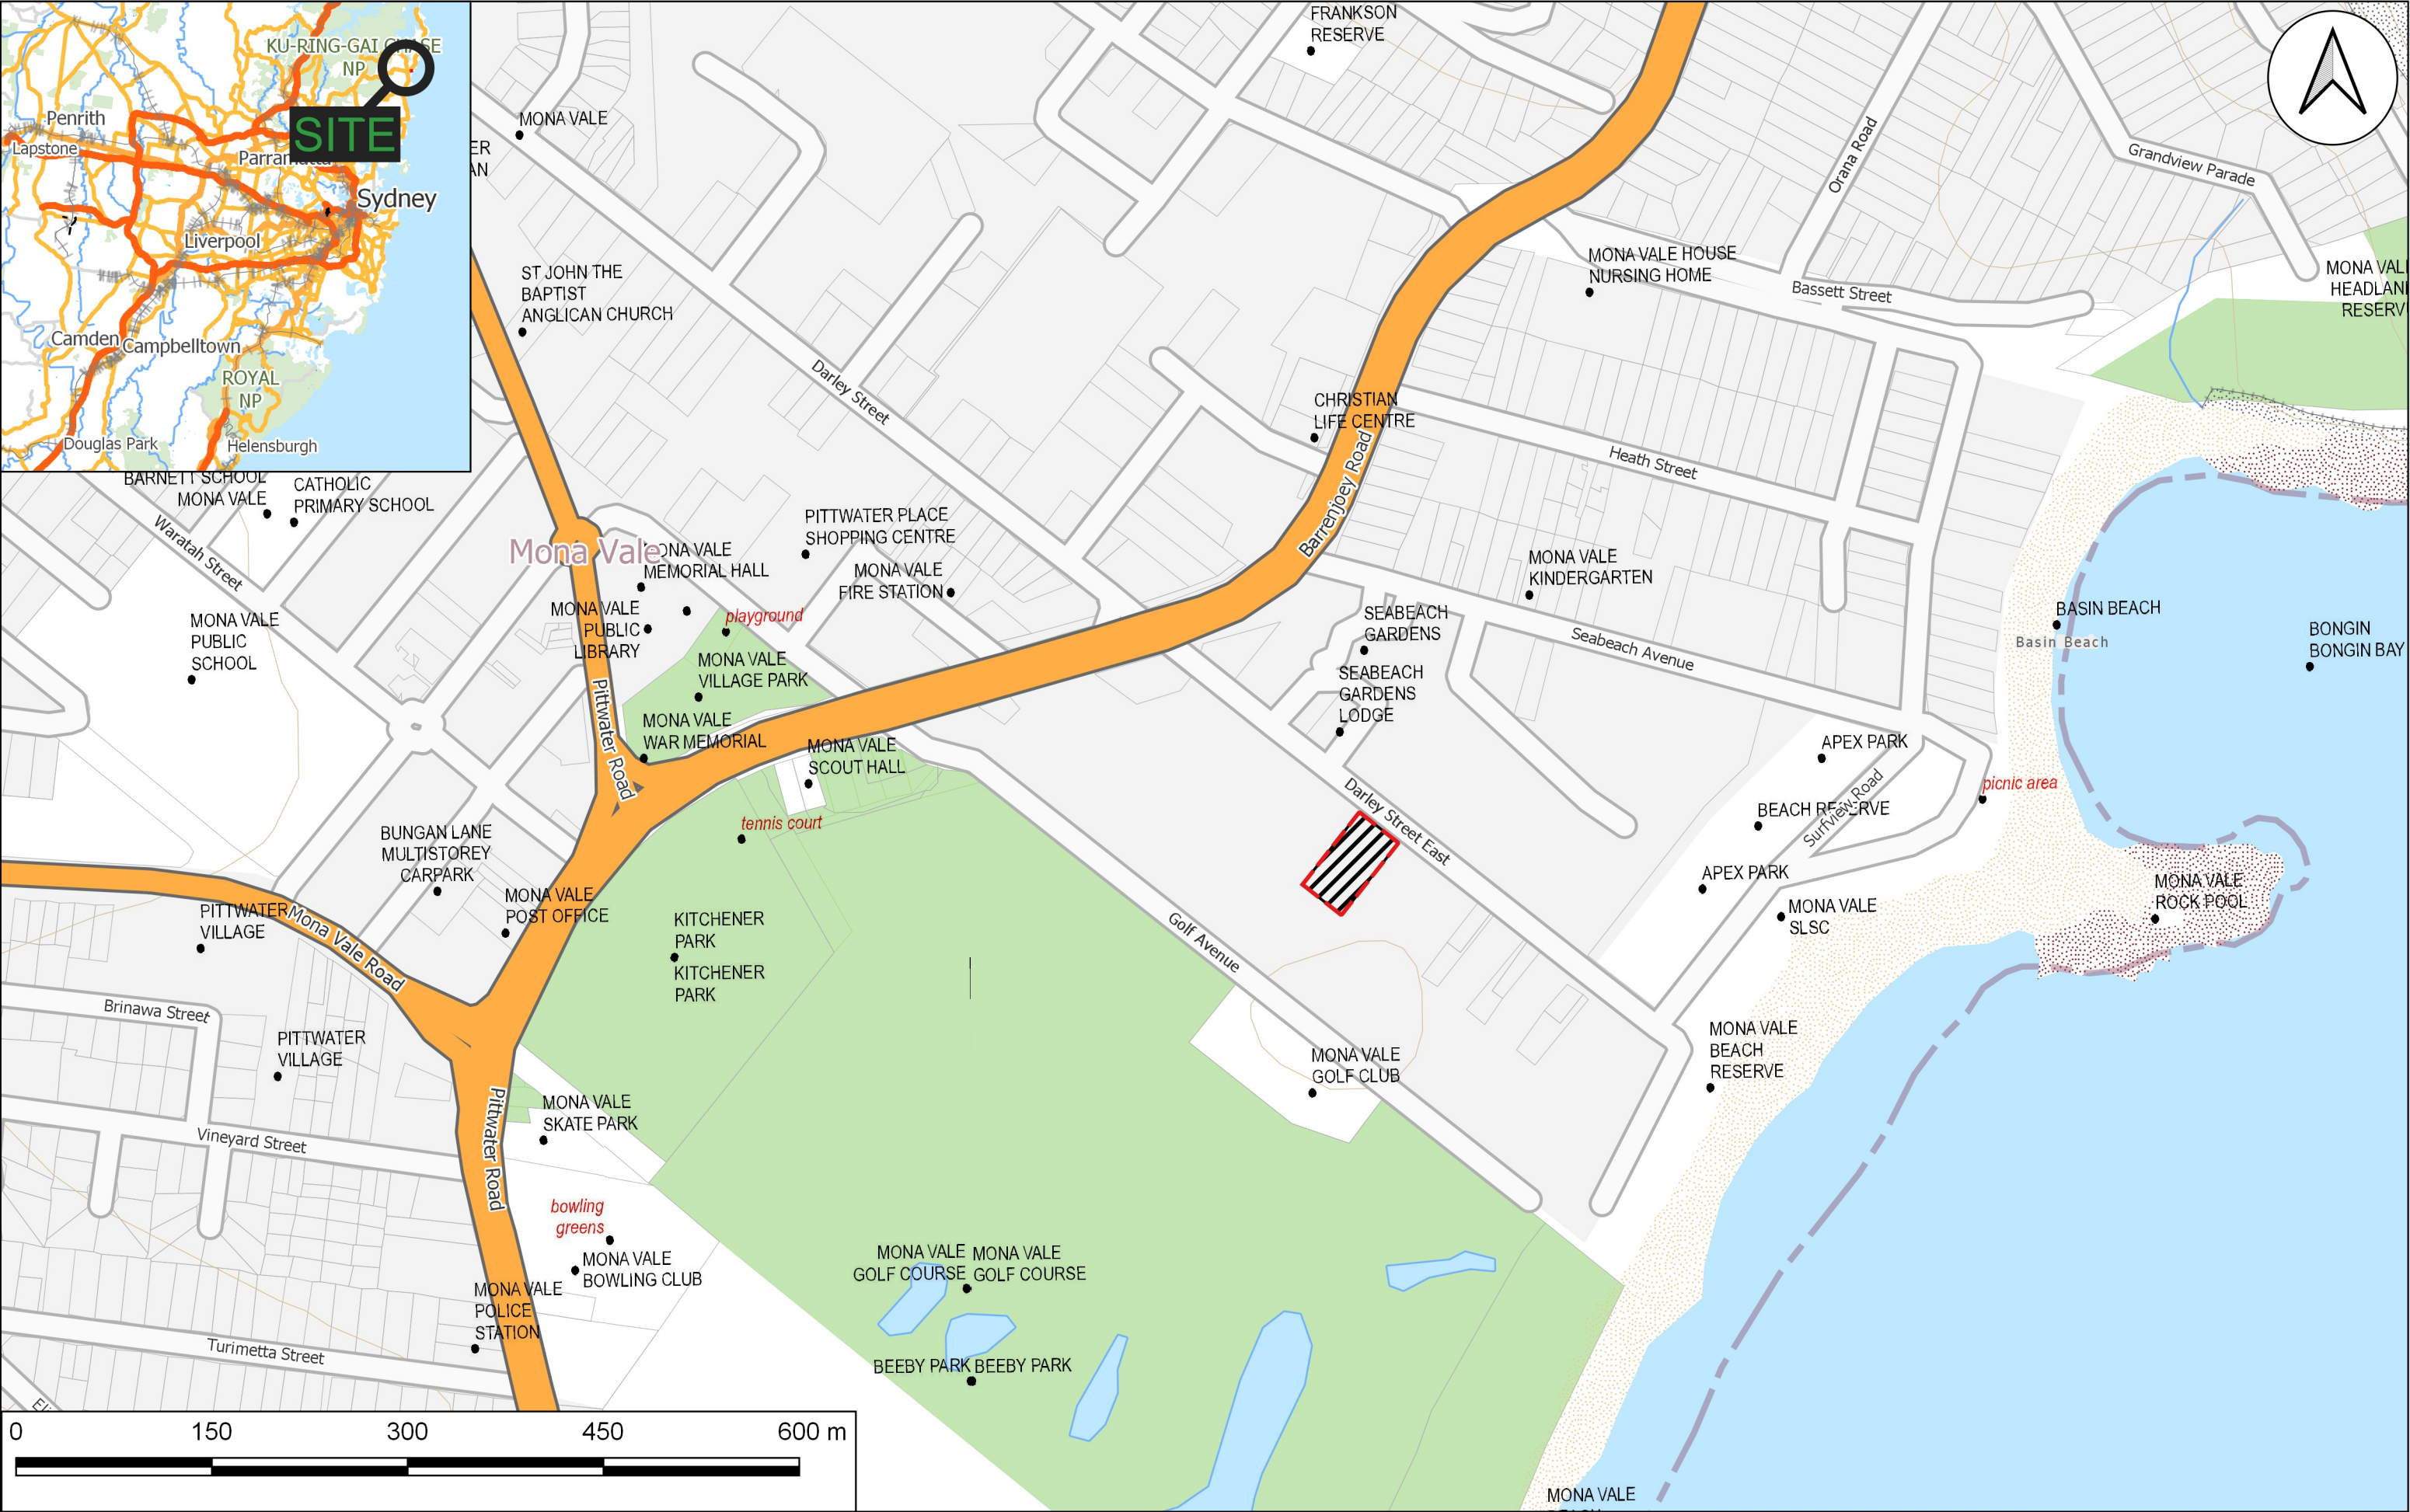
| <b>LEGEND</b> Note: All locations are approximate<br> Site Boundary | | <br>Practical Solutions for Built Environments<br>Suite 6.01, 55 Miller Street, PYRMONT 2009<br>Ph (02) 9516 0722 Fax (02) 9518 5088 | | Drawn: J.M. | <b>The Trustee for IPG Dev2 Unit Trust &amp; GOP AFF 1 Unit Trust &amp; IPG AFF 1 Unit Trust</b><br>Preliminary Site Investigation<br>35-39 Darley Street, Monavale NSW<br><br>Site Locality Plan | Figure:<br><b>1</b> |

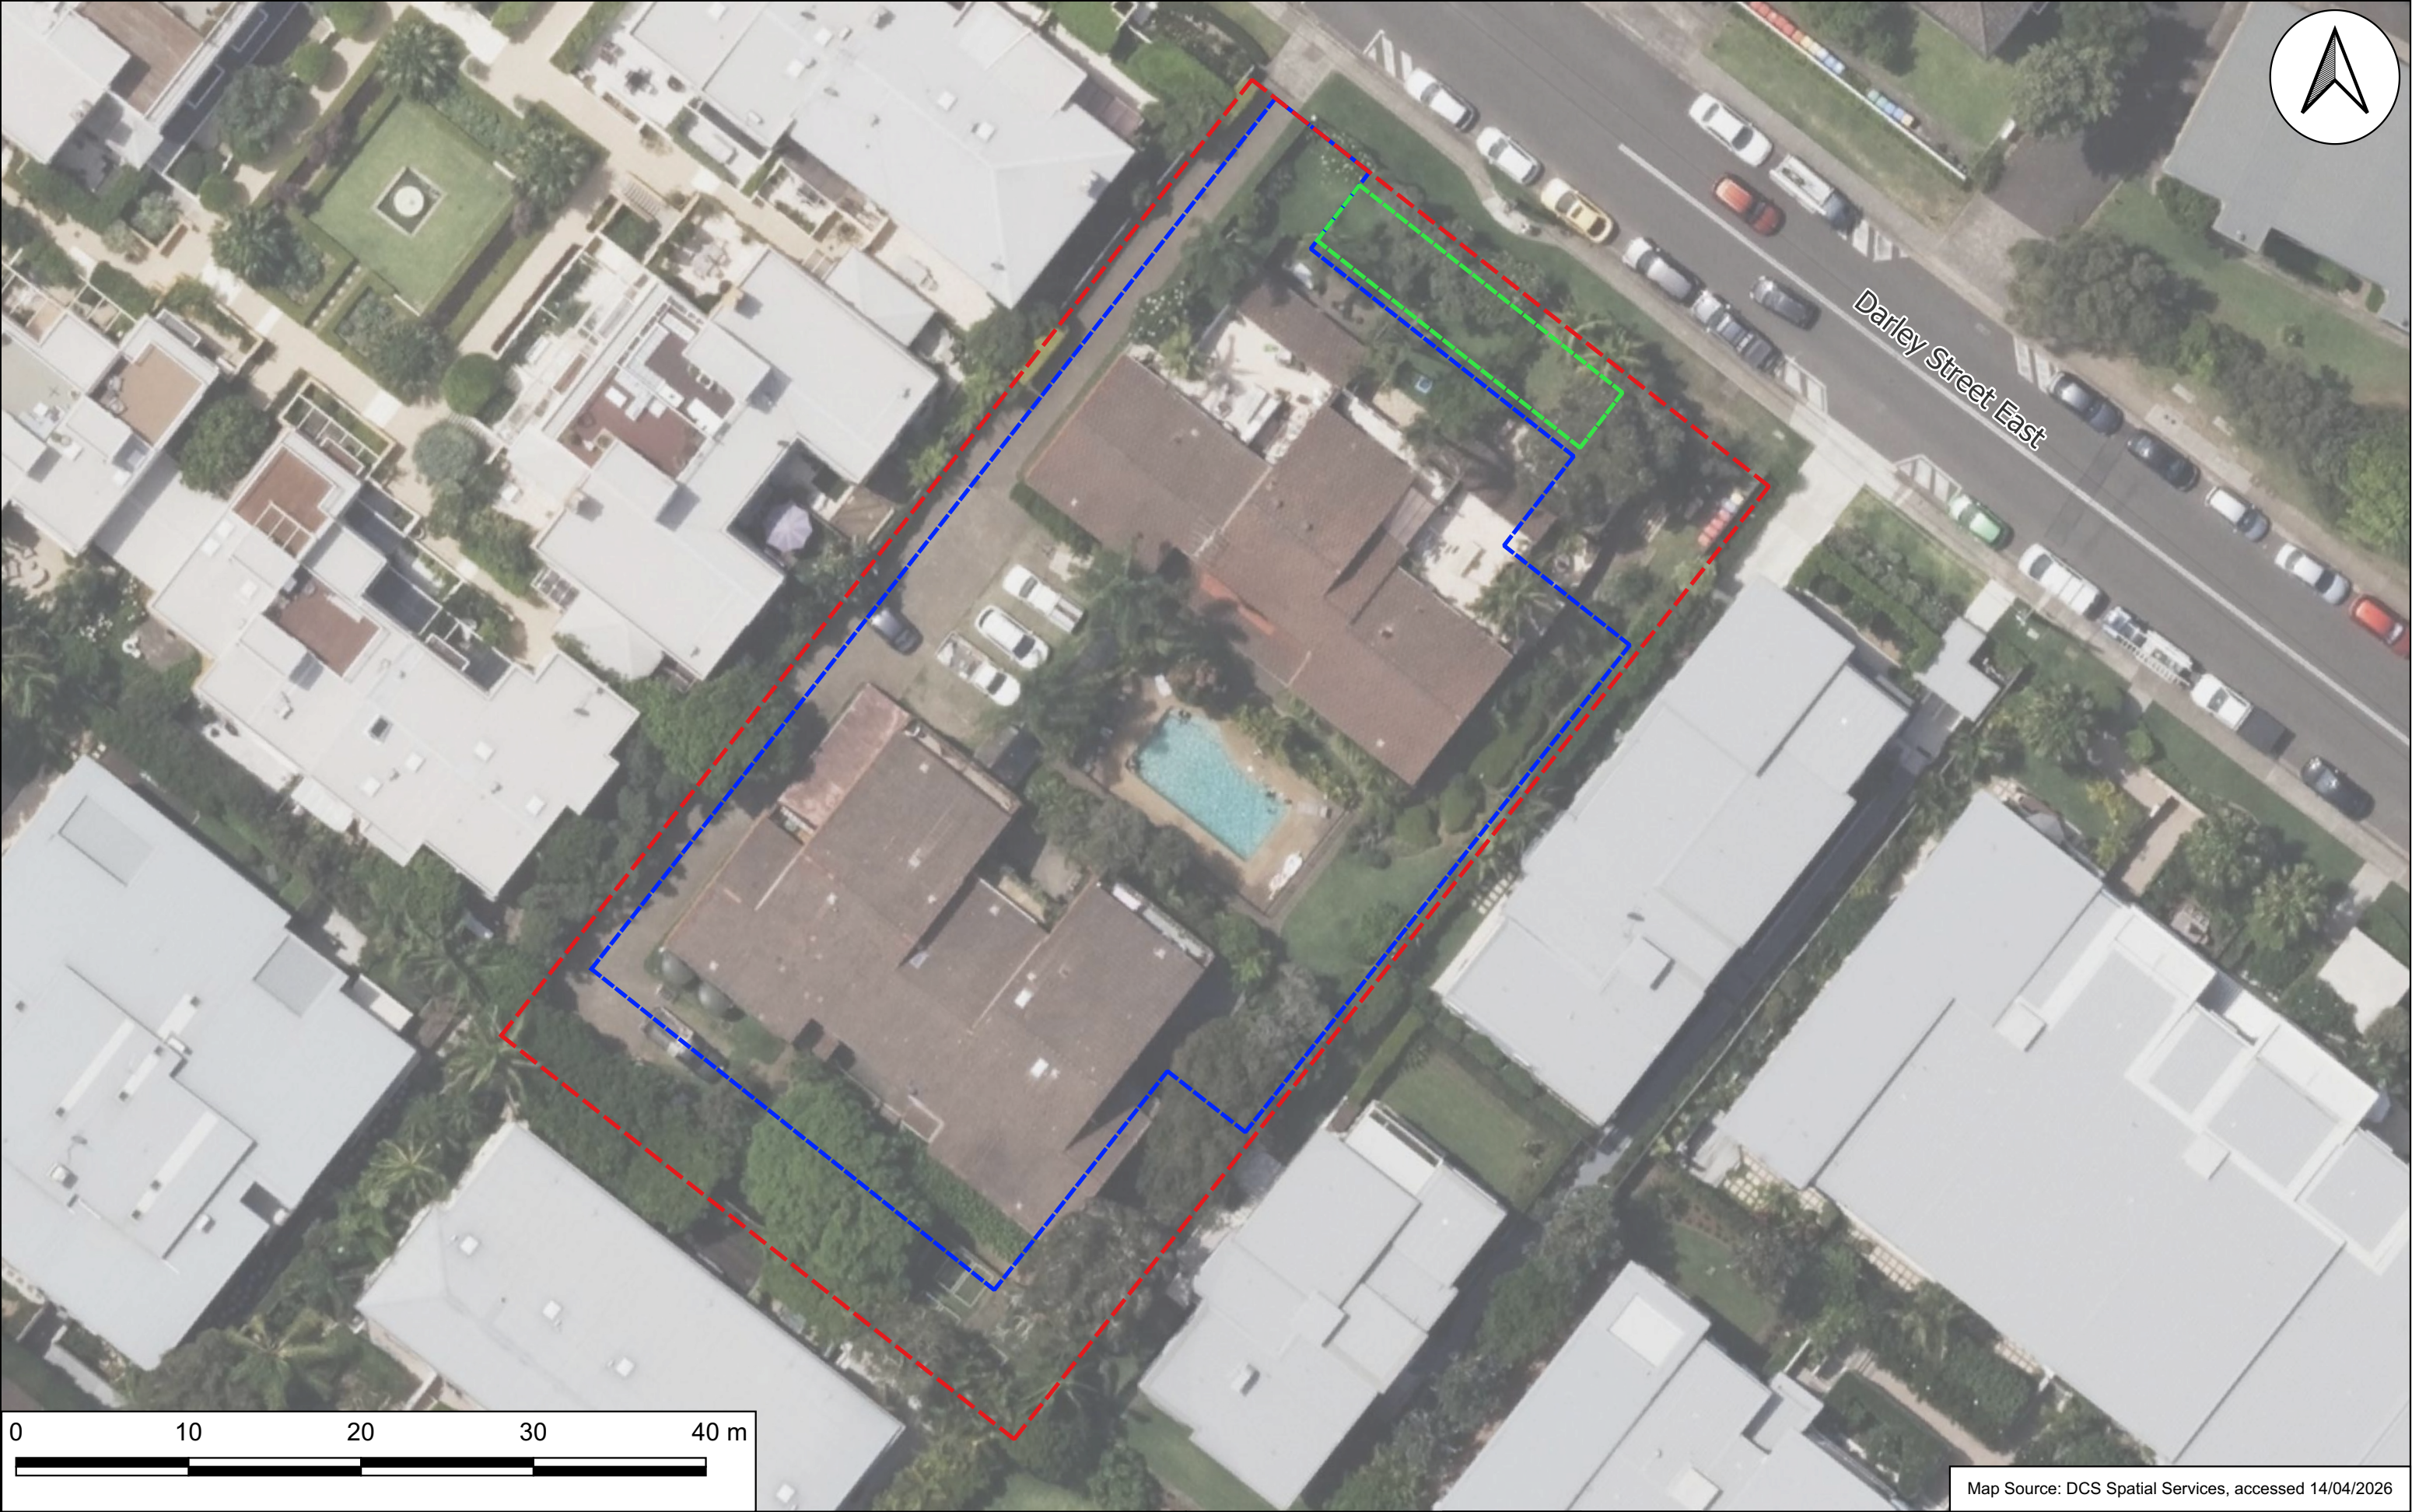
| <b>LEGEND</b> Note: Areas are approximate<br><div><div></div> Site Boundary<br/><div></div> Proposed Basement Boundary<br/><div></div> Proposed Fire Water Tank</div> | <div><b>eiaustralia</b><br/>Practical Solutions for Built Environments<br/>Suite 6.01, 55 Miller Street, PYRMONT 2009<br/>Ph (02) 9516 0722 Fax (02) 9518 5088</div> | Drawn: | J.M. | <b>The Trustee for IPG Dev2 Unit Trust &amp; GOP AFF 1 Unit Trust &amp; IPG AFF 1 Unit Trust</b><br>Preliminary Site Investigation<br><br>35-39 Darley Street, Mona Vale NSW<br><br>Site Layout Plan | Figure:<br><div>2</div> |

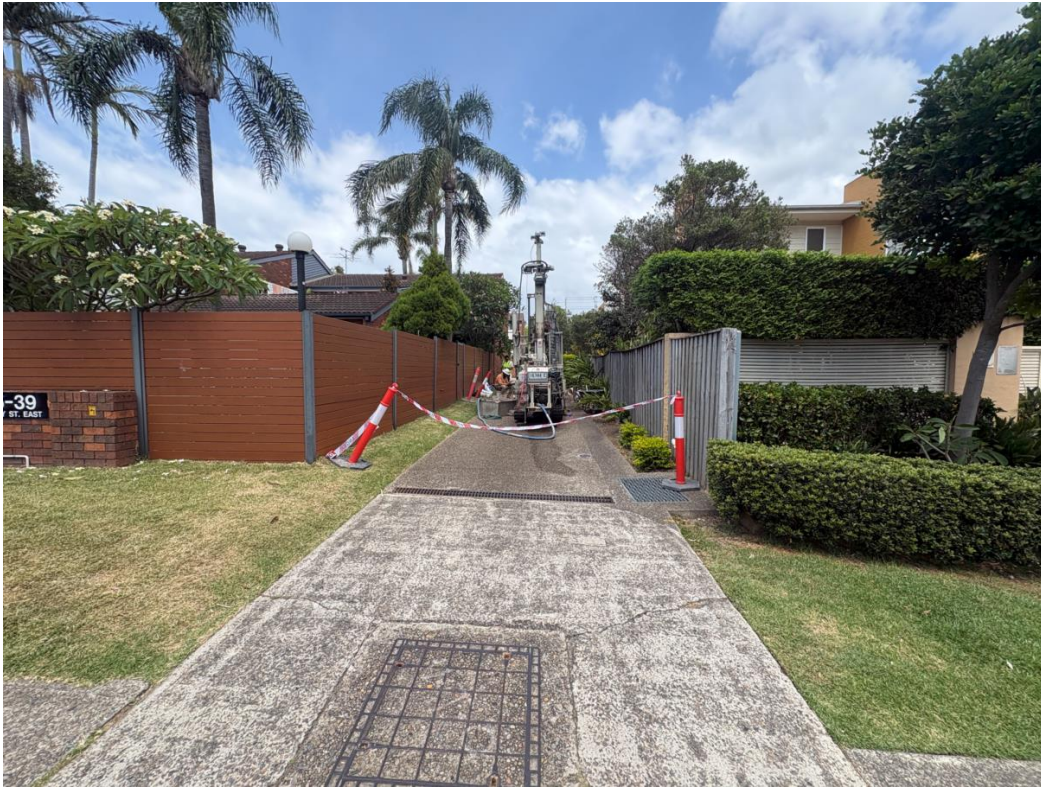
**Photograph 1** View of residential buildings at 35-39 Darley Street East, with concrete driveway, Looking south-west.

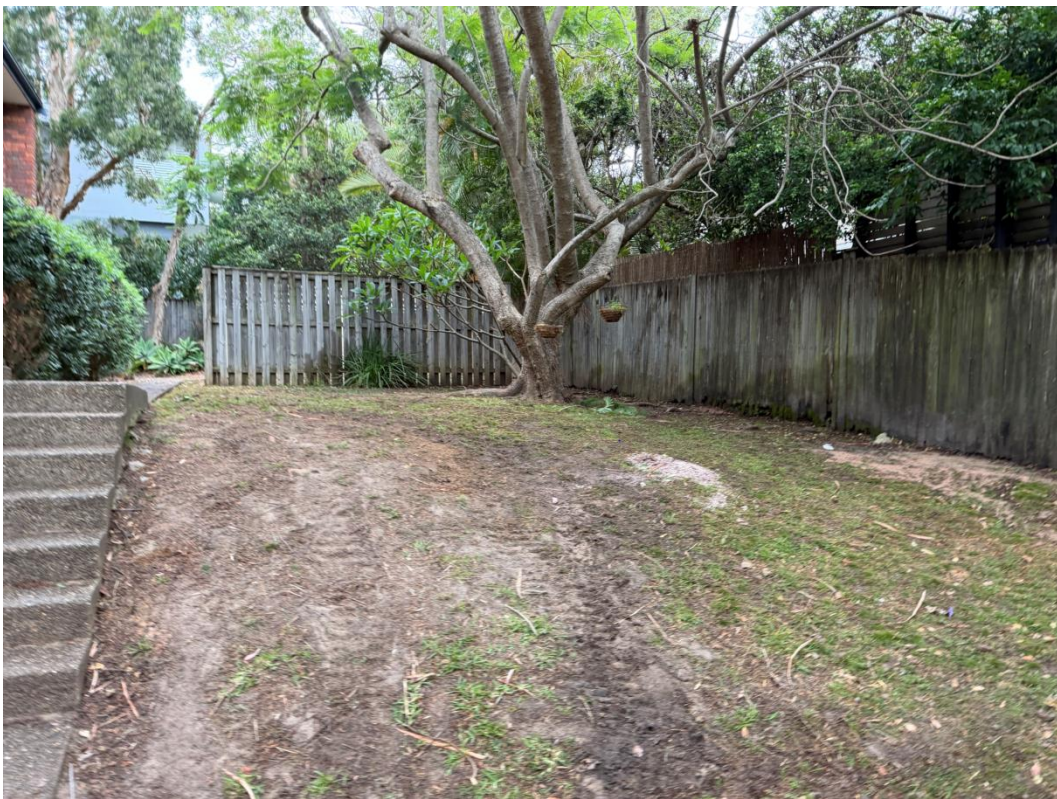
- Accessible soil was observed within the backyard. No visual evidence of gross contamination was identified across the site (**Photograph 2**).
- No visible signs of stressed vegetation were noted.

**Photograph 2** Accessible soil areas, located along southern boundary.

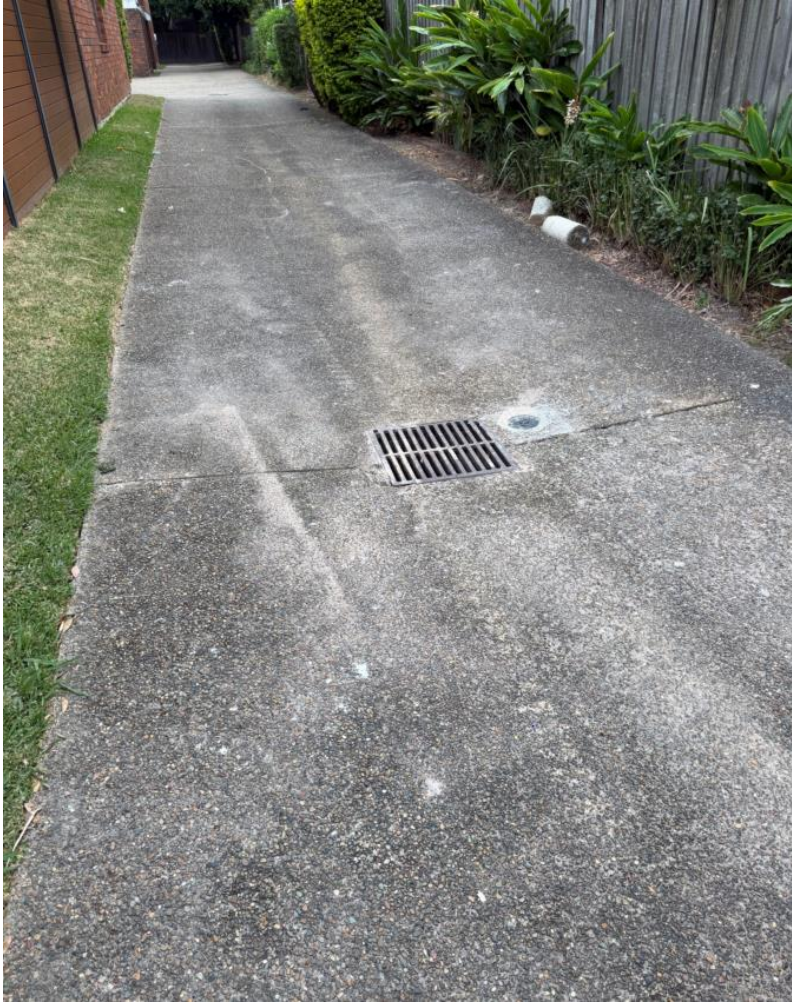
- The driveway was observed to be in good condition, with no evidence of cracking and oil staining (**Photograph 3**).
- A swimming pool was located in the eastern-central portion of the site, between the buildings.

**Photograph 3** View of the concrete driveway with associated stormwater drainage and a groundwater monitoring well (installed as part of the geotechnical investigation).

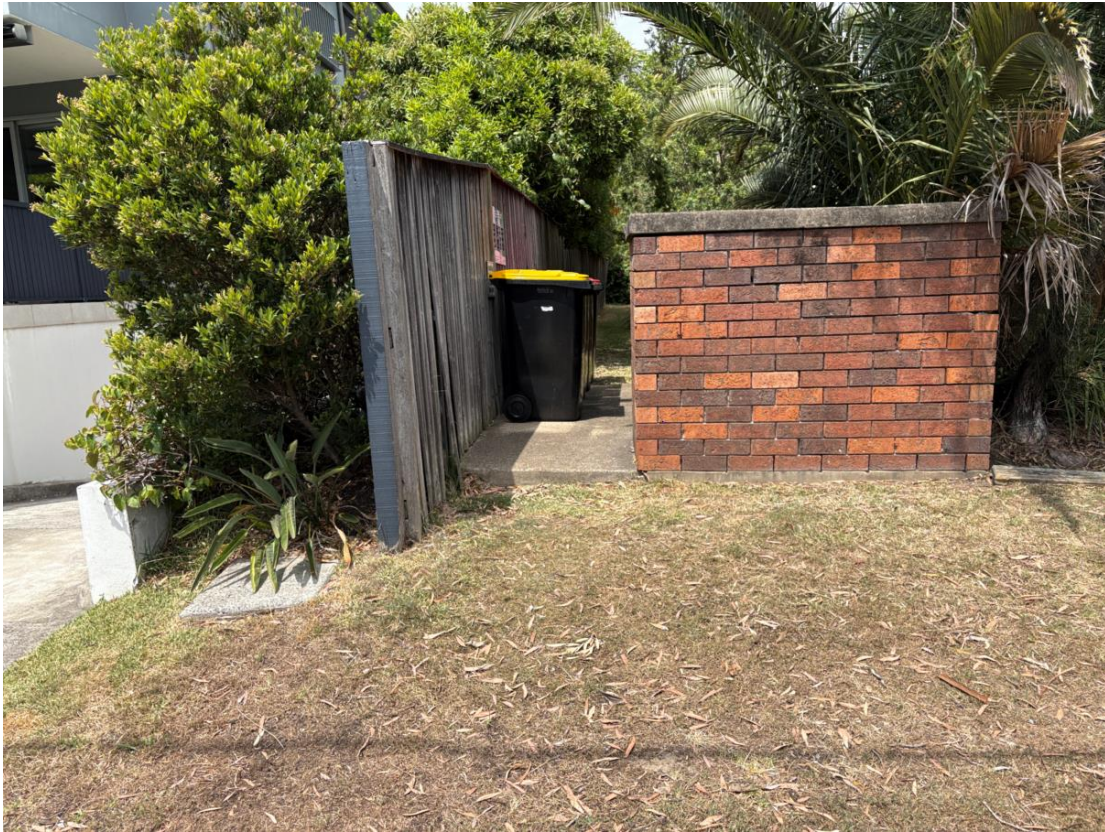
**Photograph 4** Residential waste storage area (garbage bins) located adjacent to the building along the north-eastern boundary
