Stage II Detailed Site Investigation

26-42 Eden Street, Arncliffe NSW

Prepared for: Arncliffe Eden Property Pty Ltd

STC-2151-18730 | DSI.v2f | Date: 01.07.2021

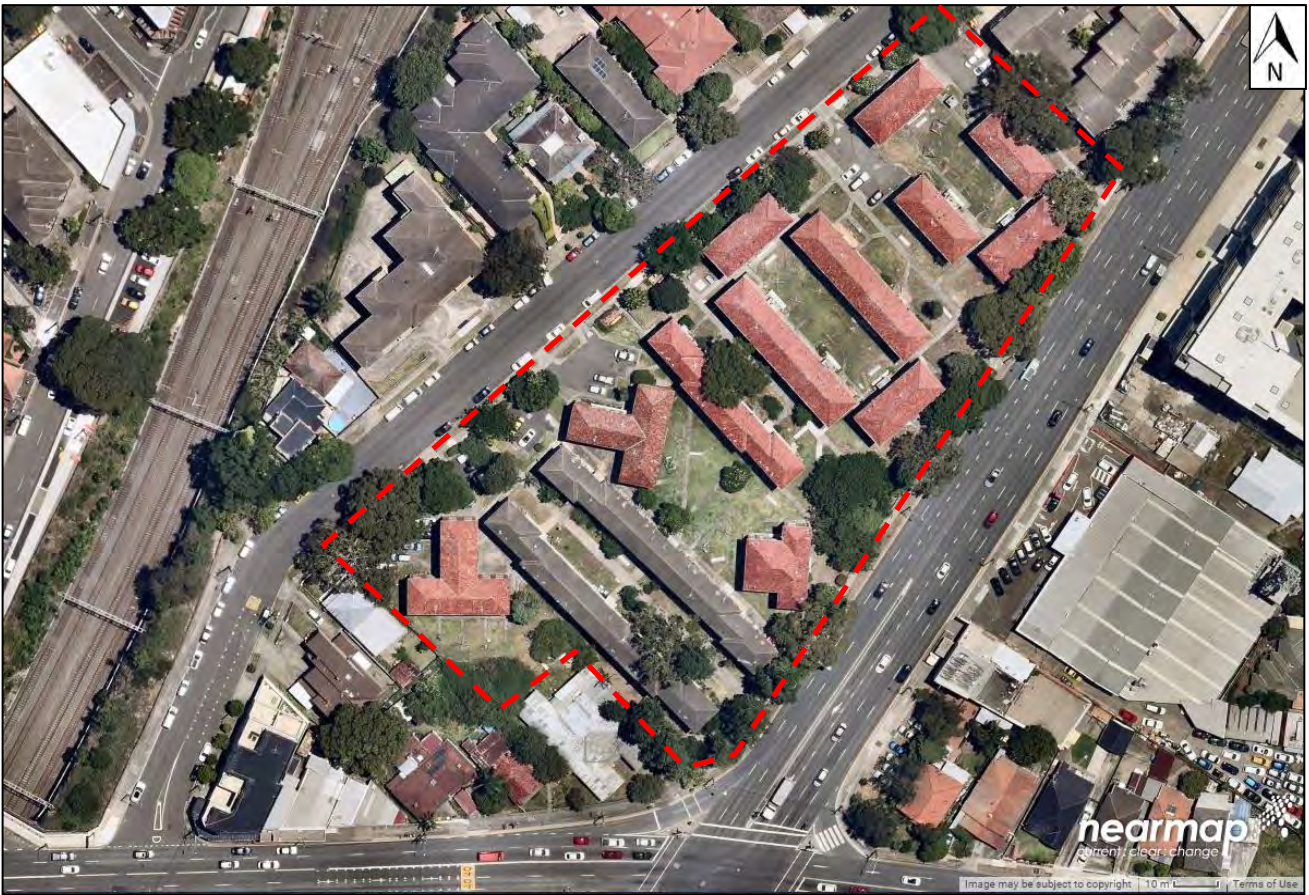
Figure 1. Site Identification (image adapted from *Nearmap*; accessed on 16.12.2020).

The Site is owned by the NSW Land and Housing Corporation who are proposing to redevelop the site in partnership with Arncliffe Eden Property P/L into a mixed-use high density precinct that includes approximately 180 contemporary social housing dwellings. The location of the Site is defined below in Figure 1 and provided in *Appendix I - Aerial Figures*.

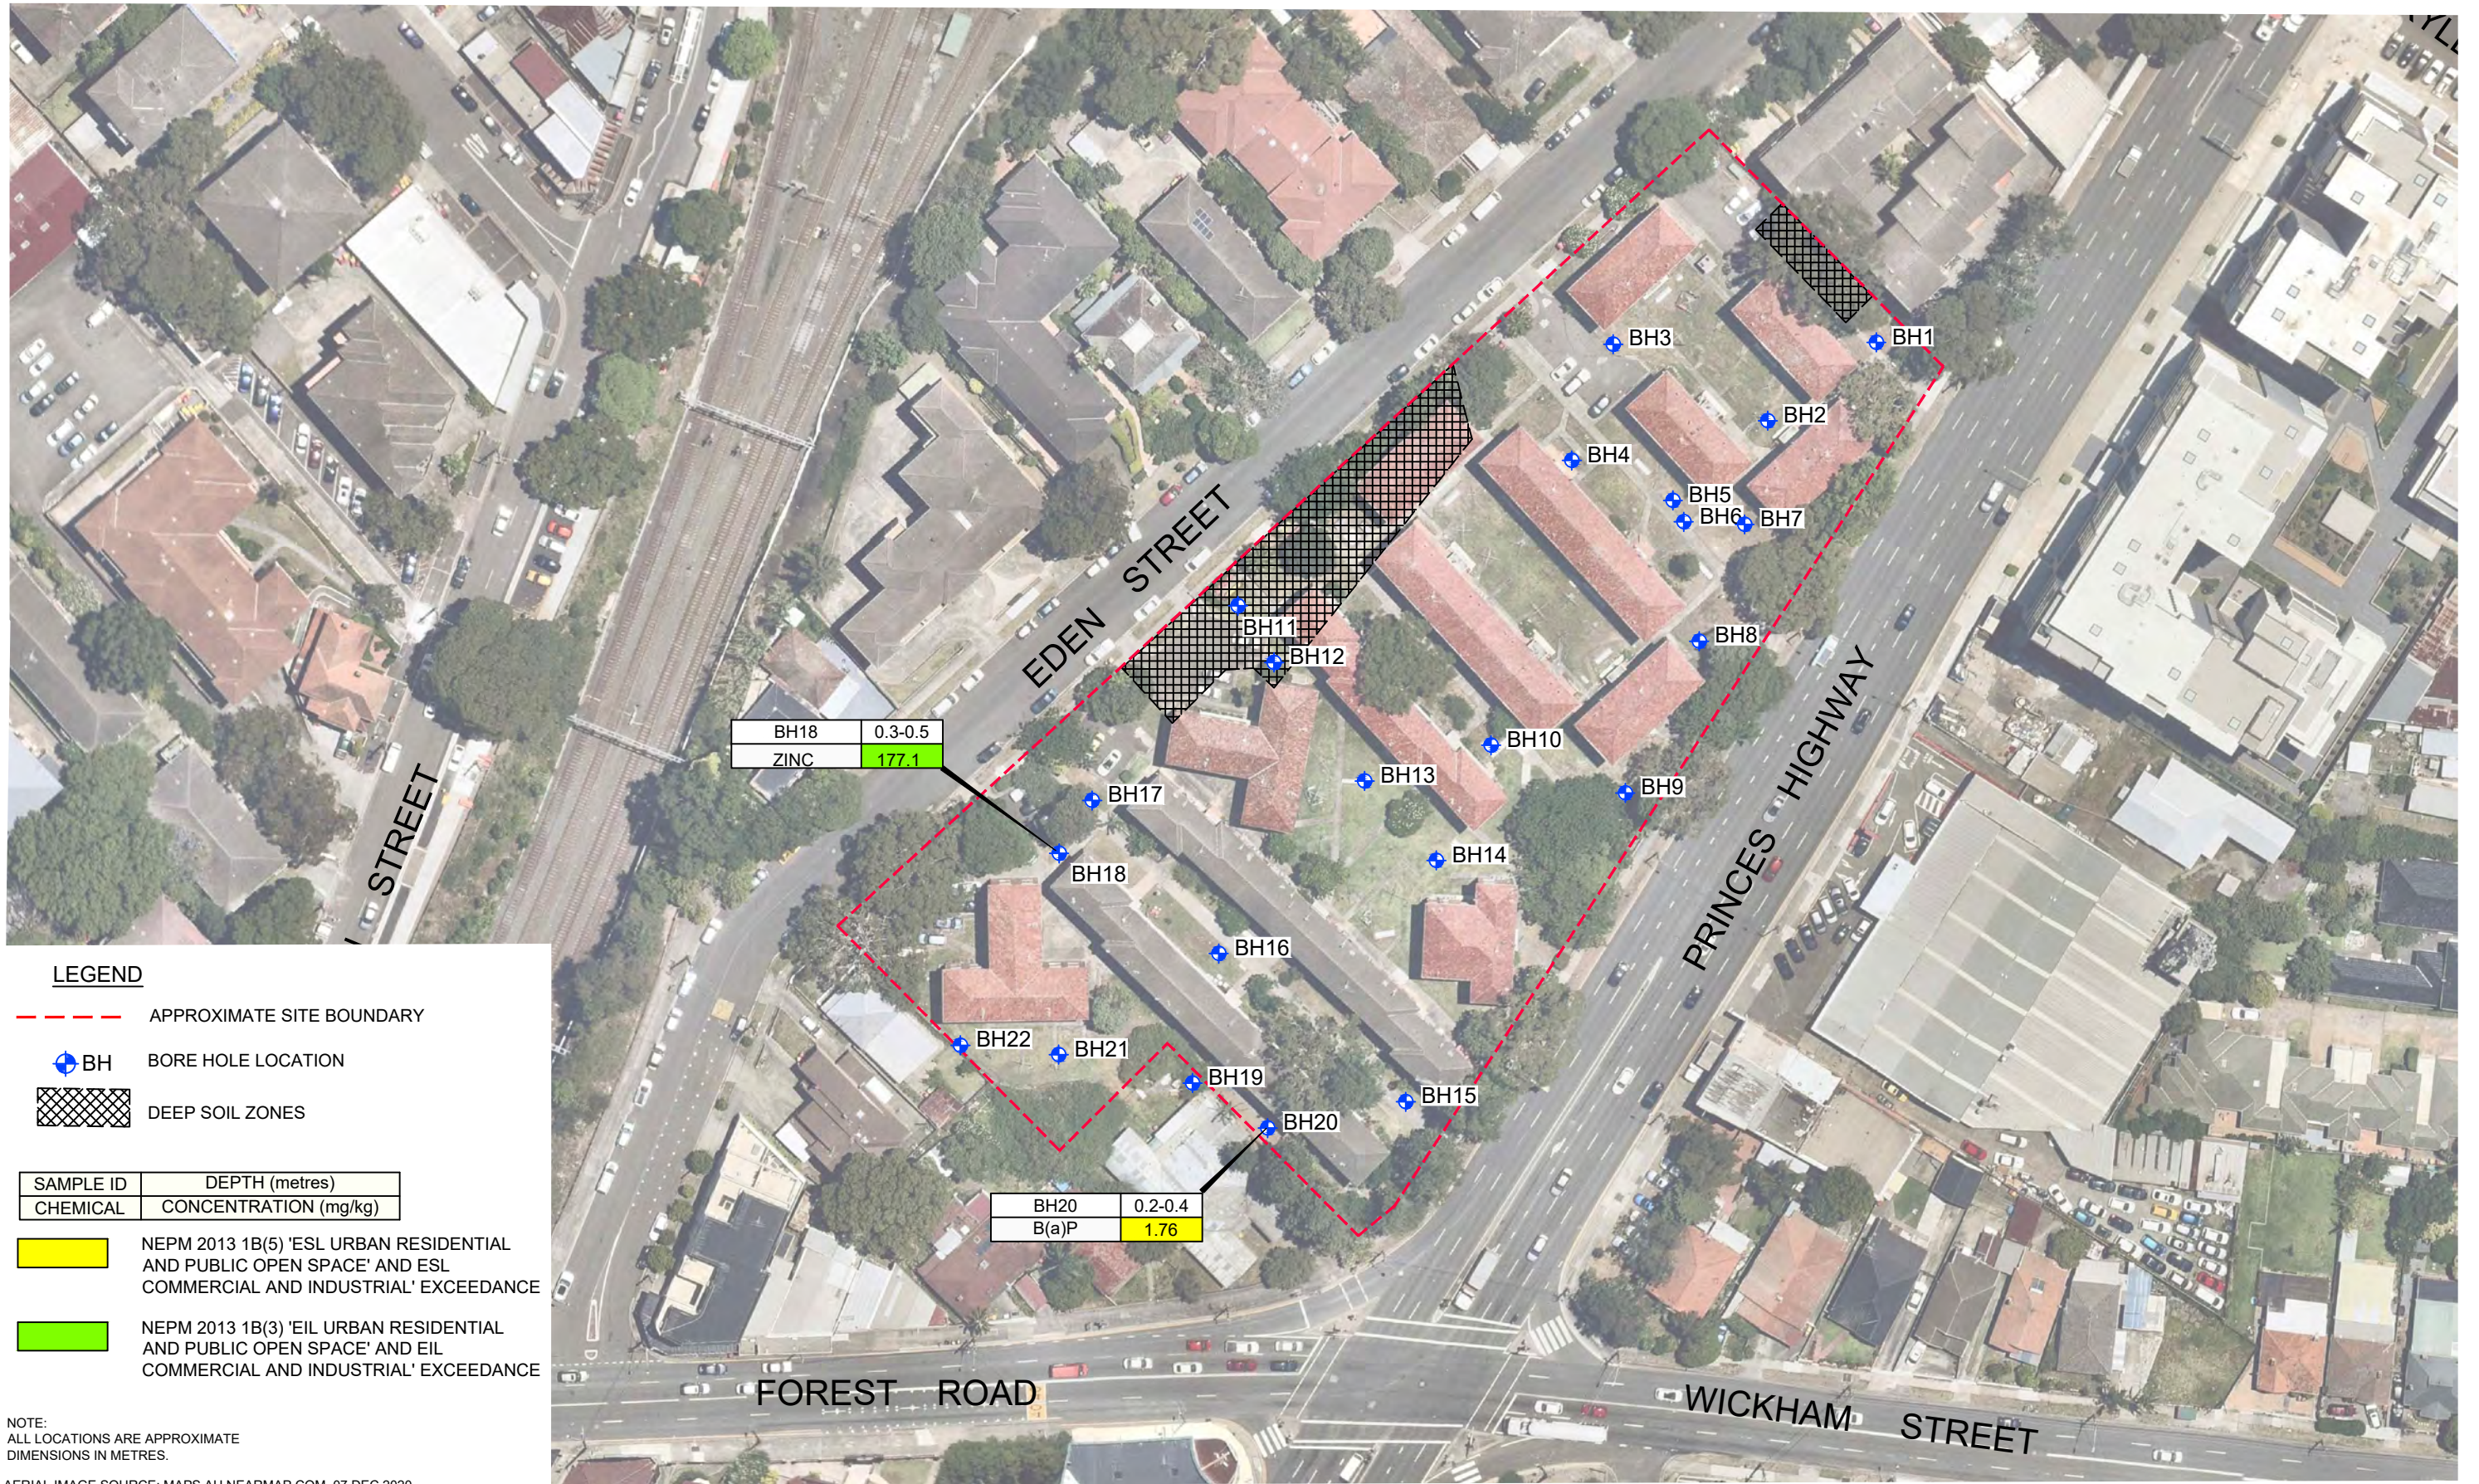
- APPROXIMATE SITE BOUNDARY
- + BORE HOLE LOCATION
- DEEP SOIL ZONES

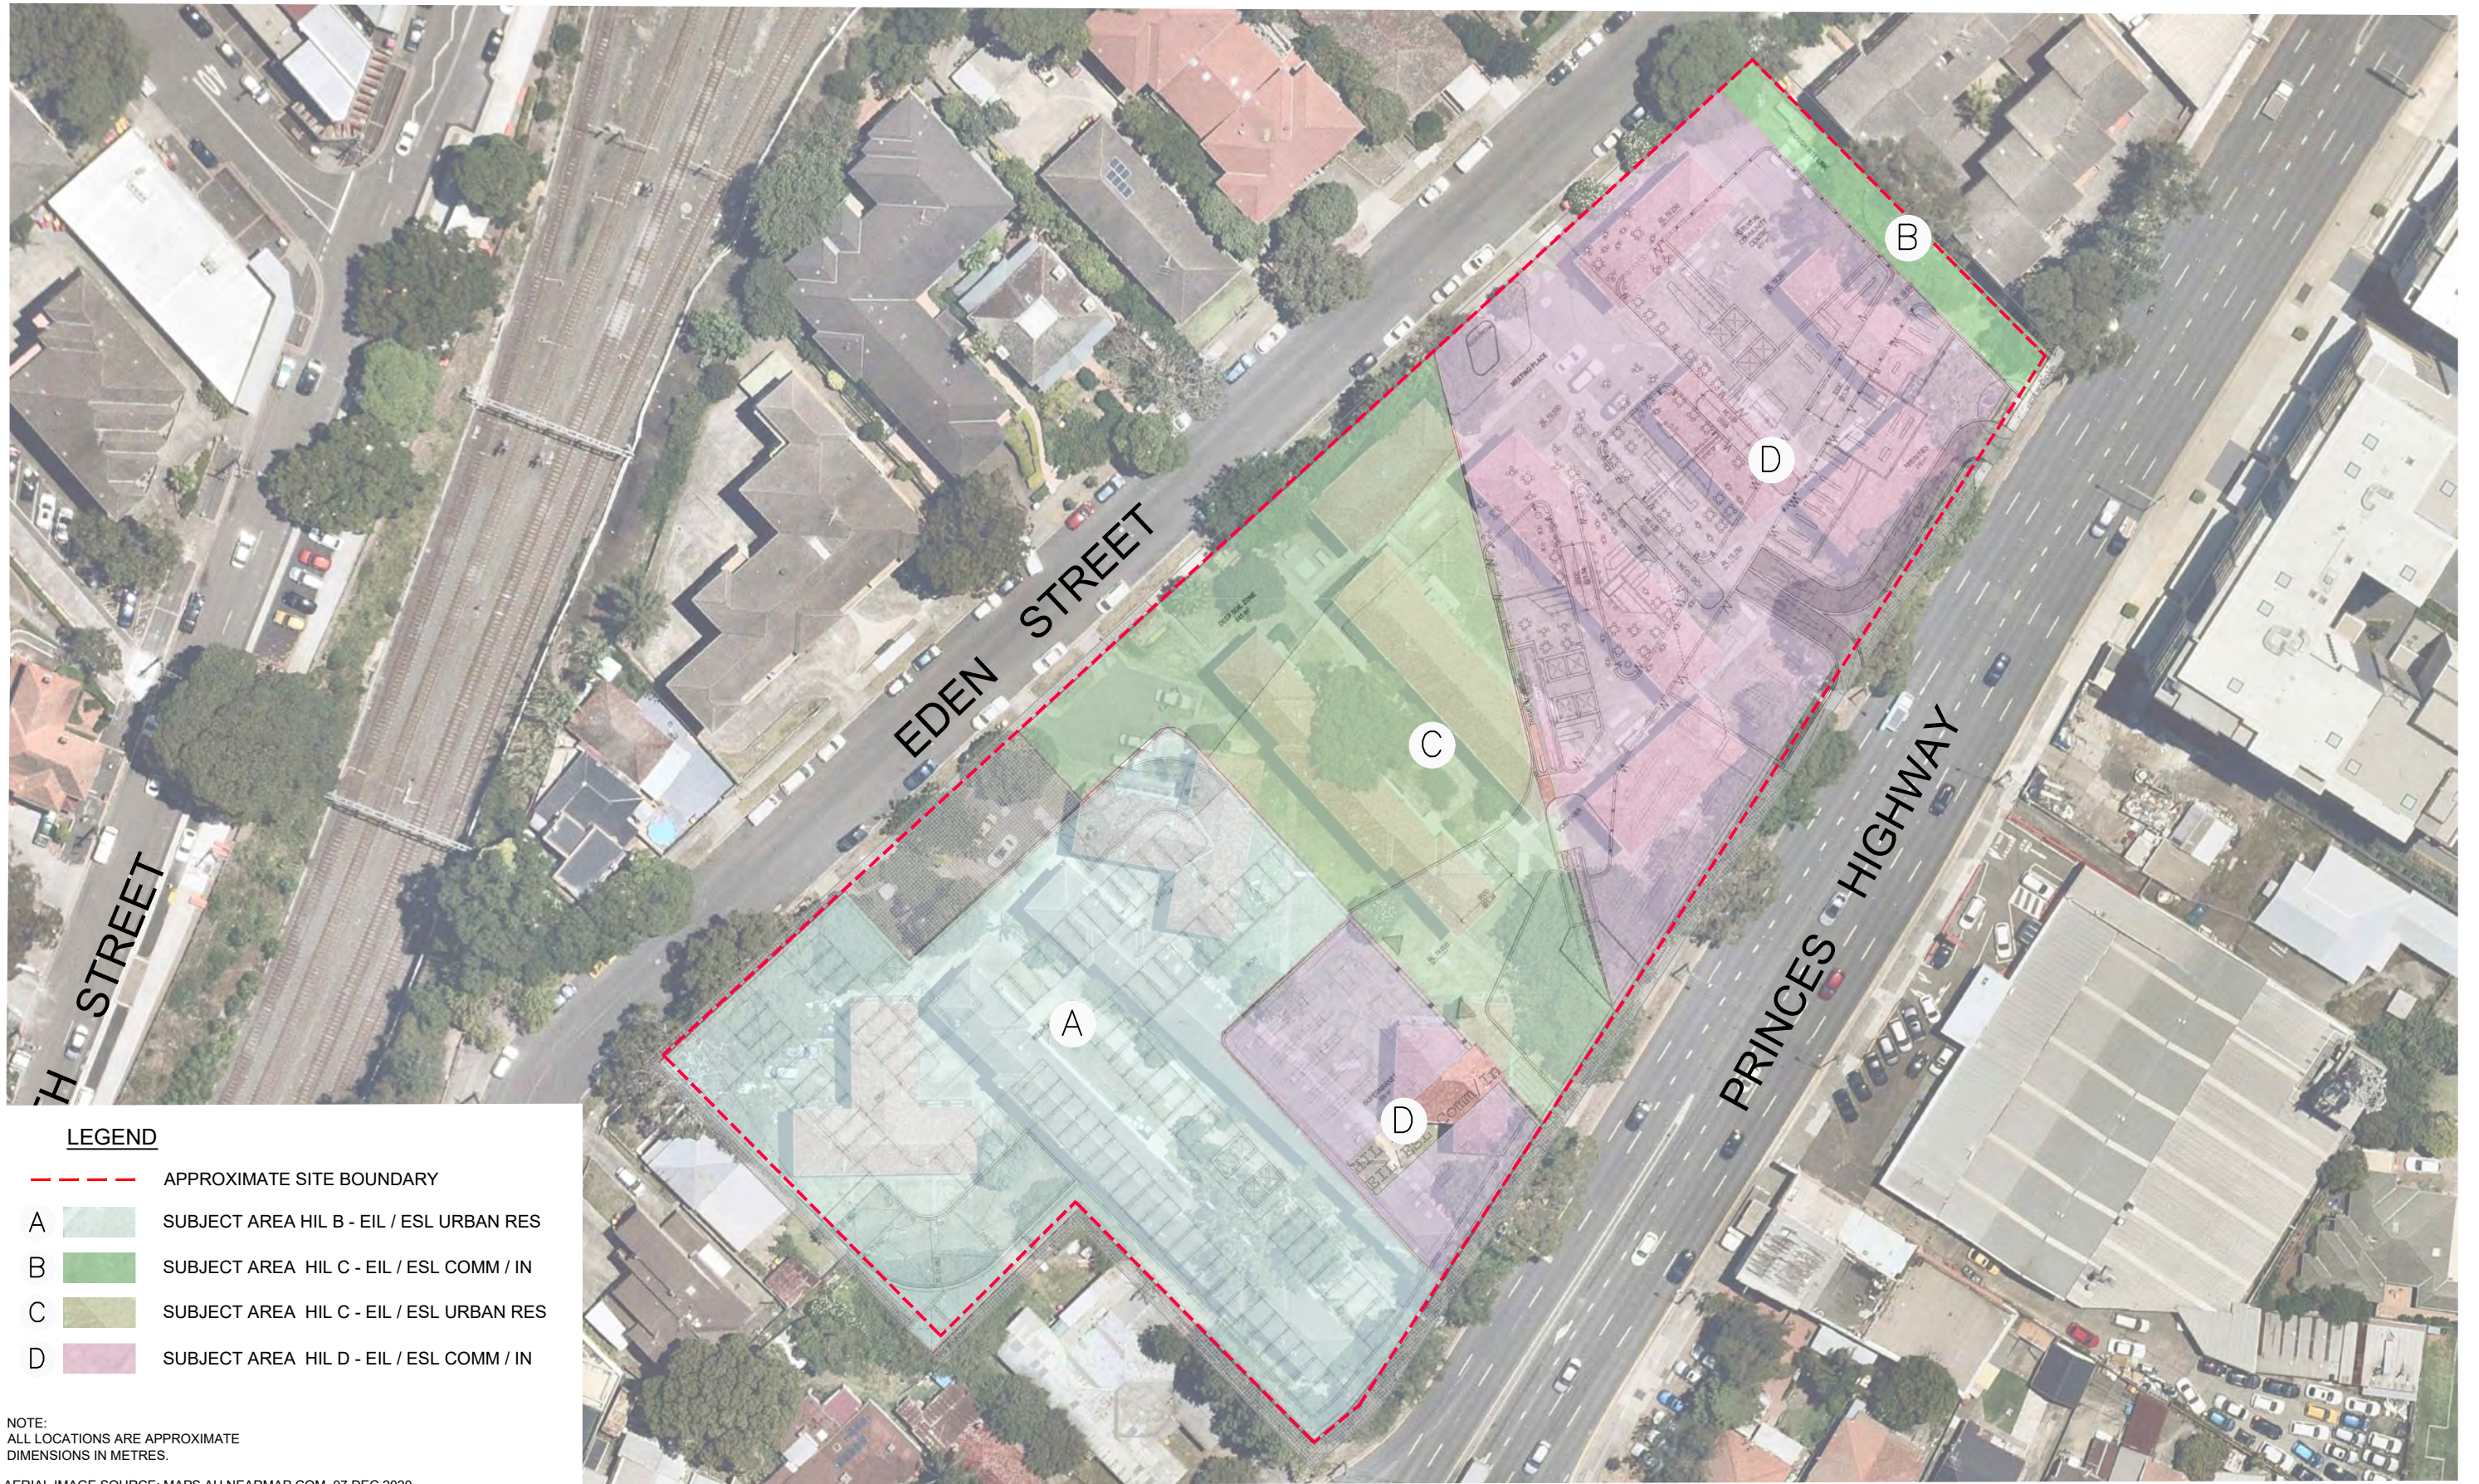
- - - APPROXIMATE SITE BOUNDARY
- SUBJECT AREA HIL B - EIL / ESL URBAN RES
- SUBJECT AREA HIL C - EIL / ESL COMM / IN
- SUBJECT AREA HIL C - EIL / ESL URBAN RES
- SUBJECT AREA HIL D - EIL / ESL COMM / IN

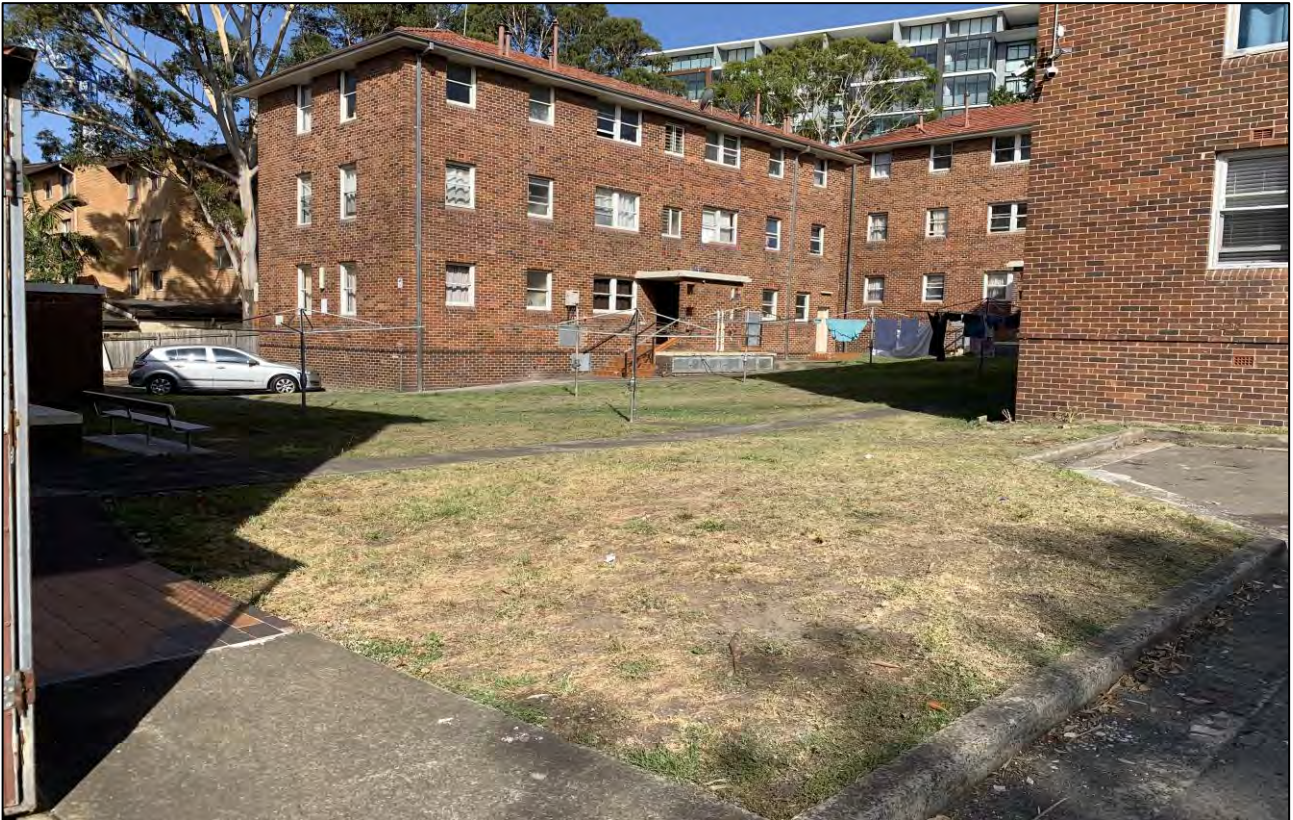
Photograph 1. Blocks 8, 7, 6 and communal gardens of the northern portion of the subject site (facing north east). Date: 01.12.2020.

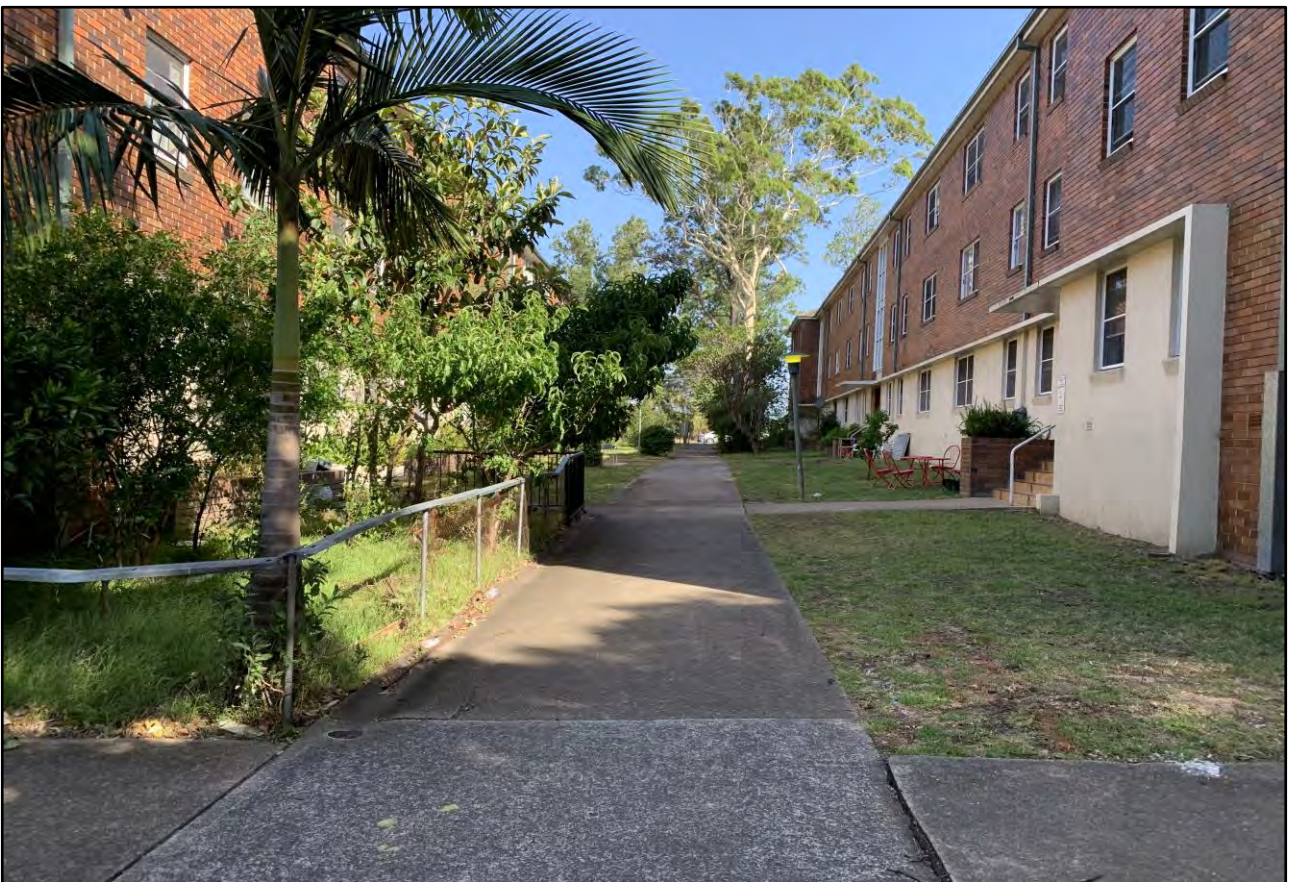
Photograph 2. Walkway between blocks 5 and 10 of the southern portion of the subject site (facing north east). Date: 01.12.2020.

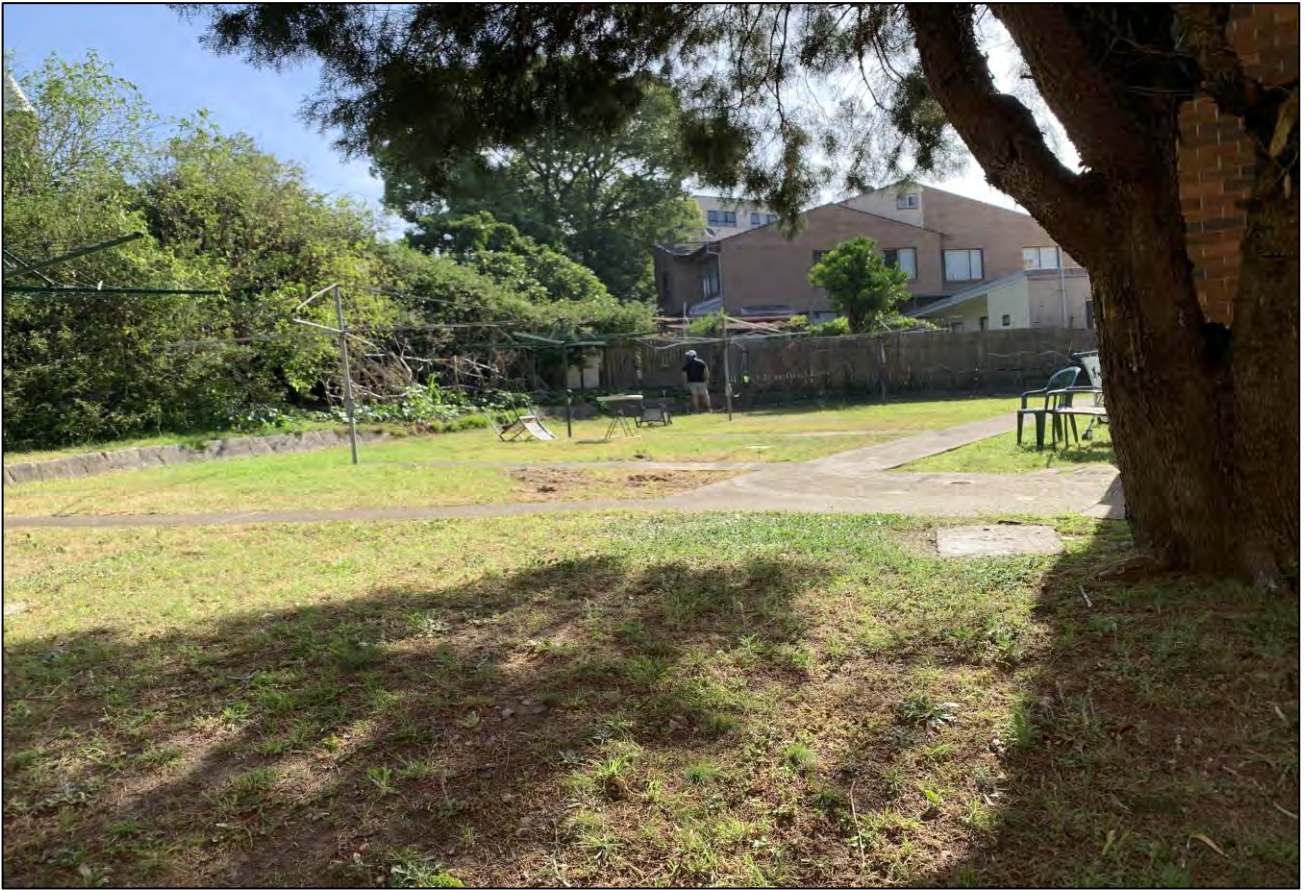
Photograph 3. Communal garden and washing lines south-east of block 11 within the southern portion of the subject site. Date: 01.12.2020.

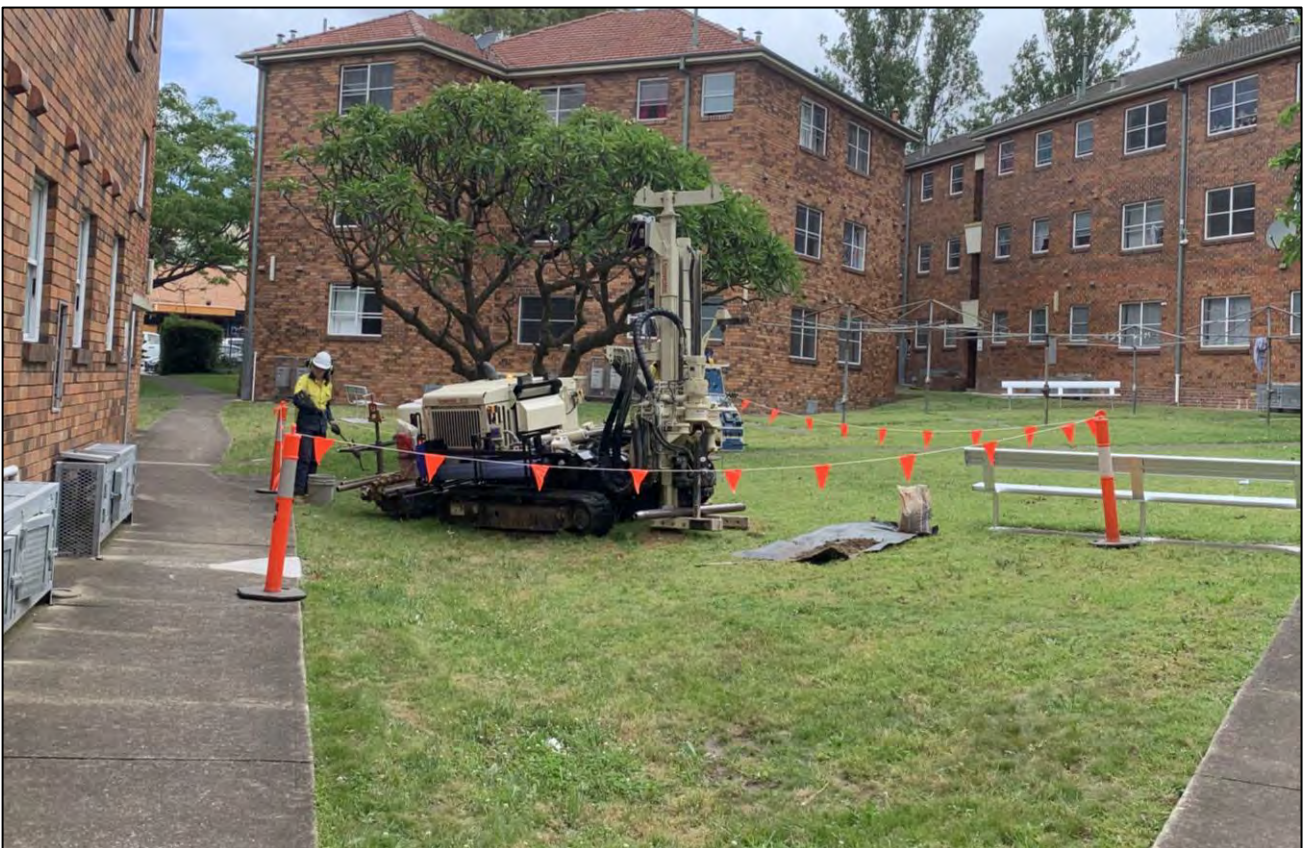
Photograph 4. Drill rig setup and work zone delineation area. Date: 30.12.2020.

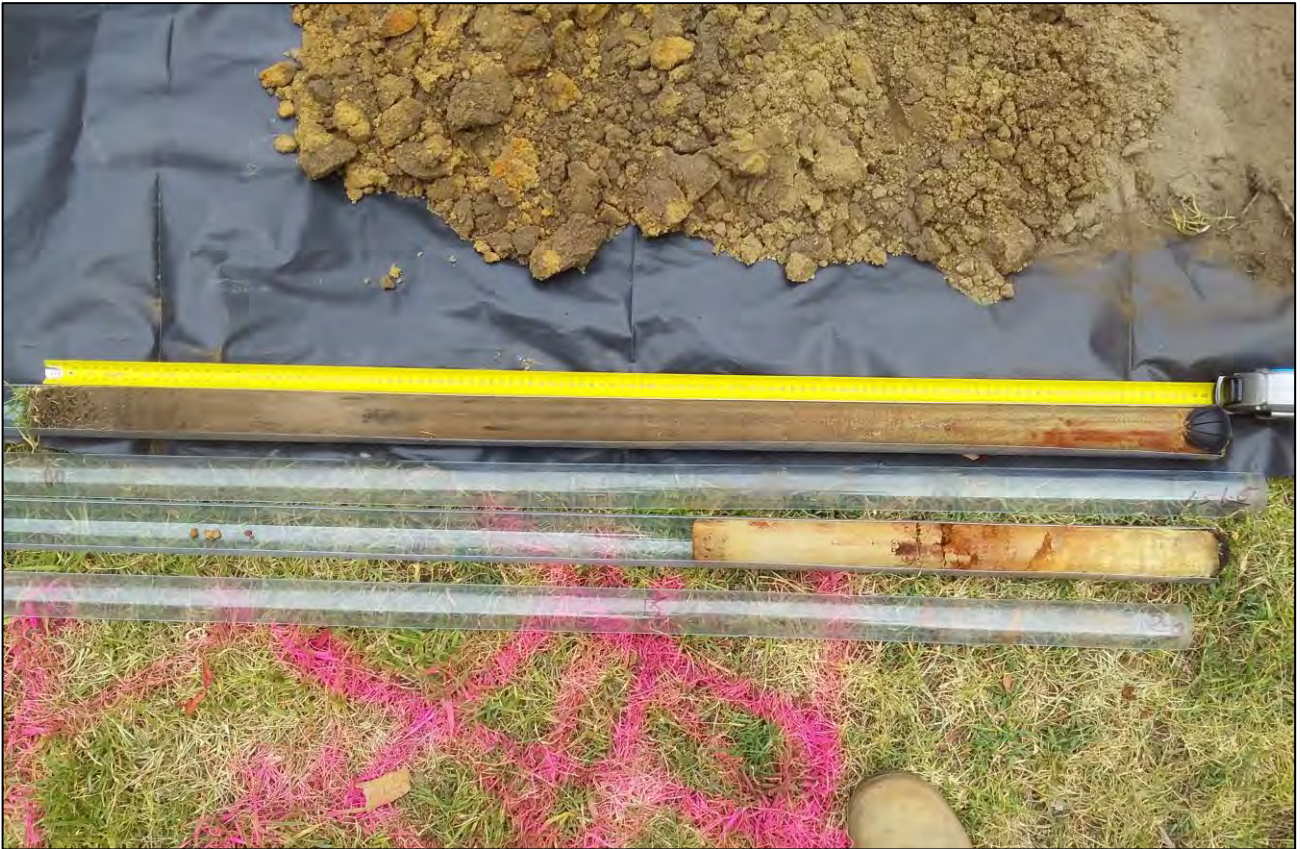
Photograph 5. Soil profile depicting the fill / natural matrices encountered within BH2 (0.0-2.0 m). Date: 30.11.2020.

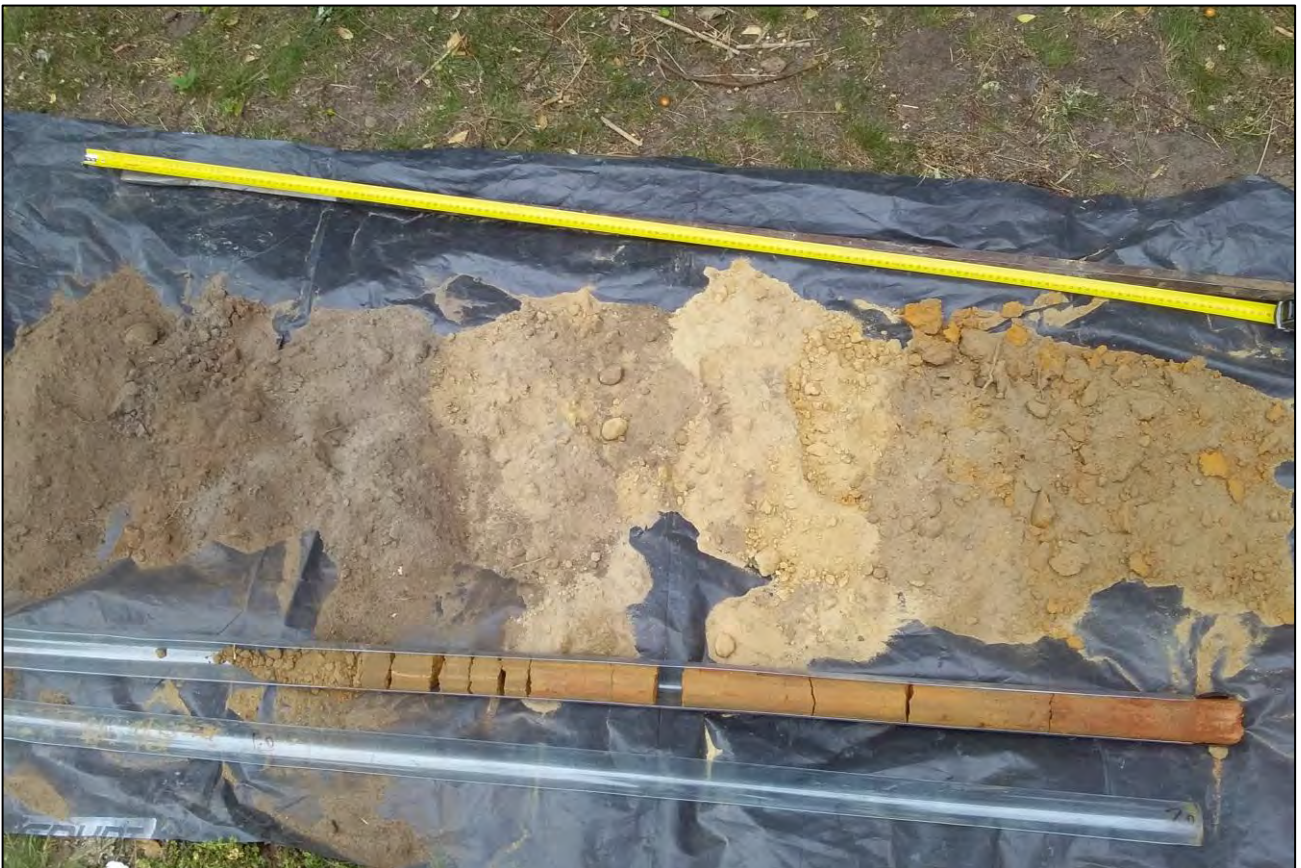
Photograph 6. Soil profile depicting the fill / natural matrices encountered within BH11 (0.0-2.0 m). Date: 30.11.2020.

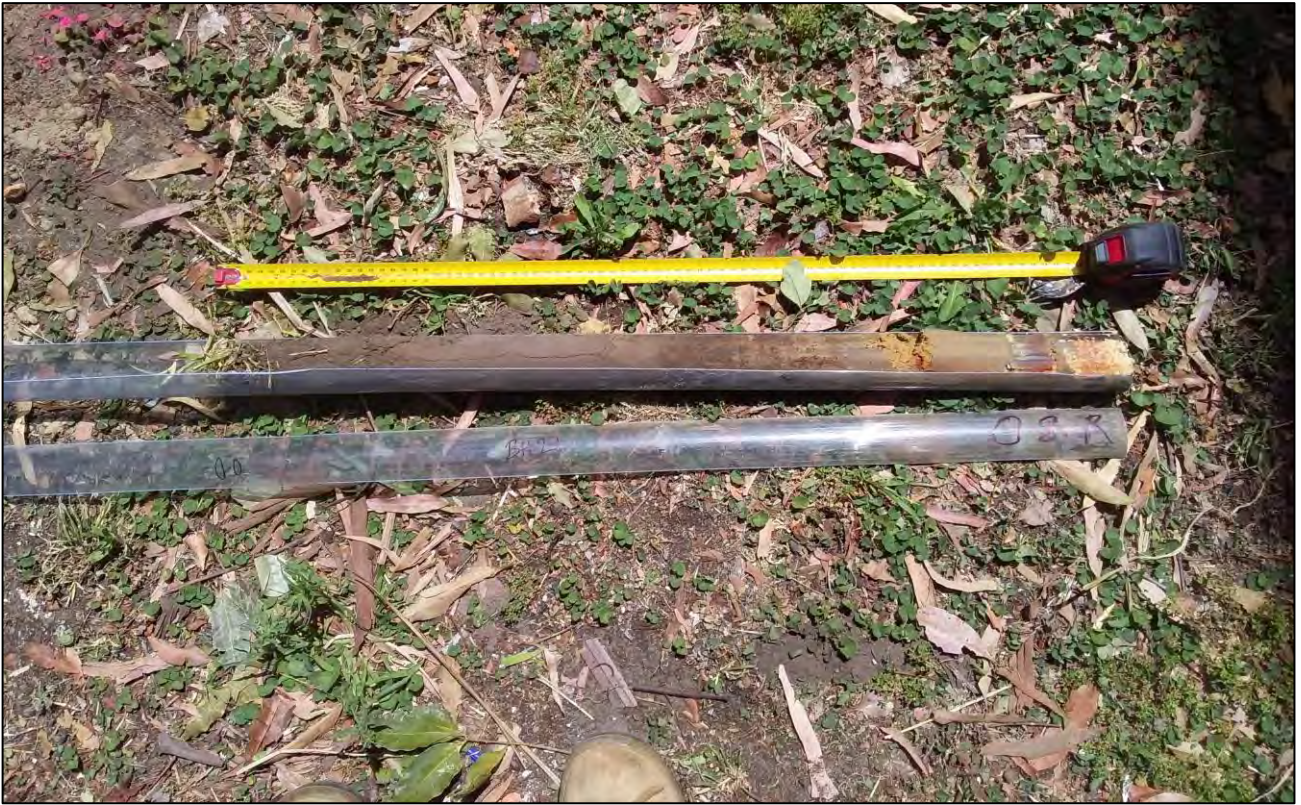
Photograph 7. Soil profile depicting the fill / natural matrices encountered within BH21 (0.0-0.8 m). Date: 01.12.2020.

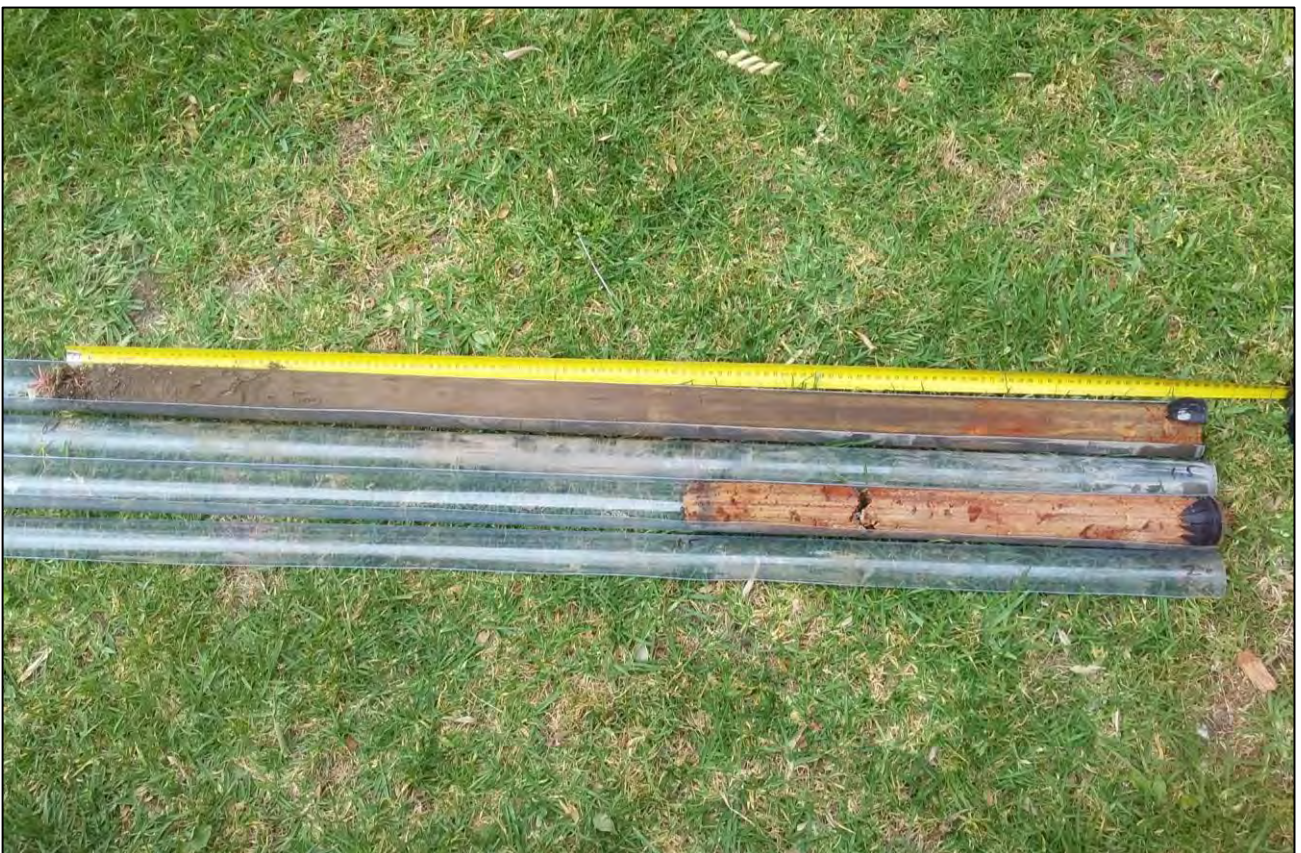
Photograph 8. Soil profile depicting the fill / natural matrices encountered within BH13 (0.0-0.8 m). Date: 30.11.2020.

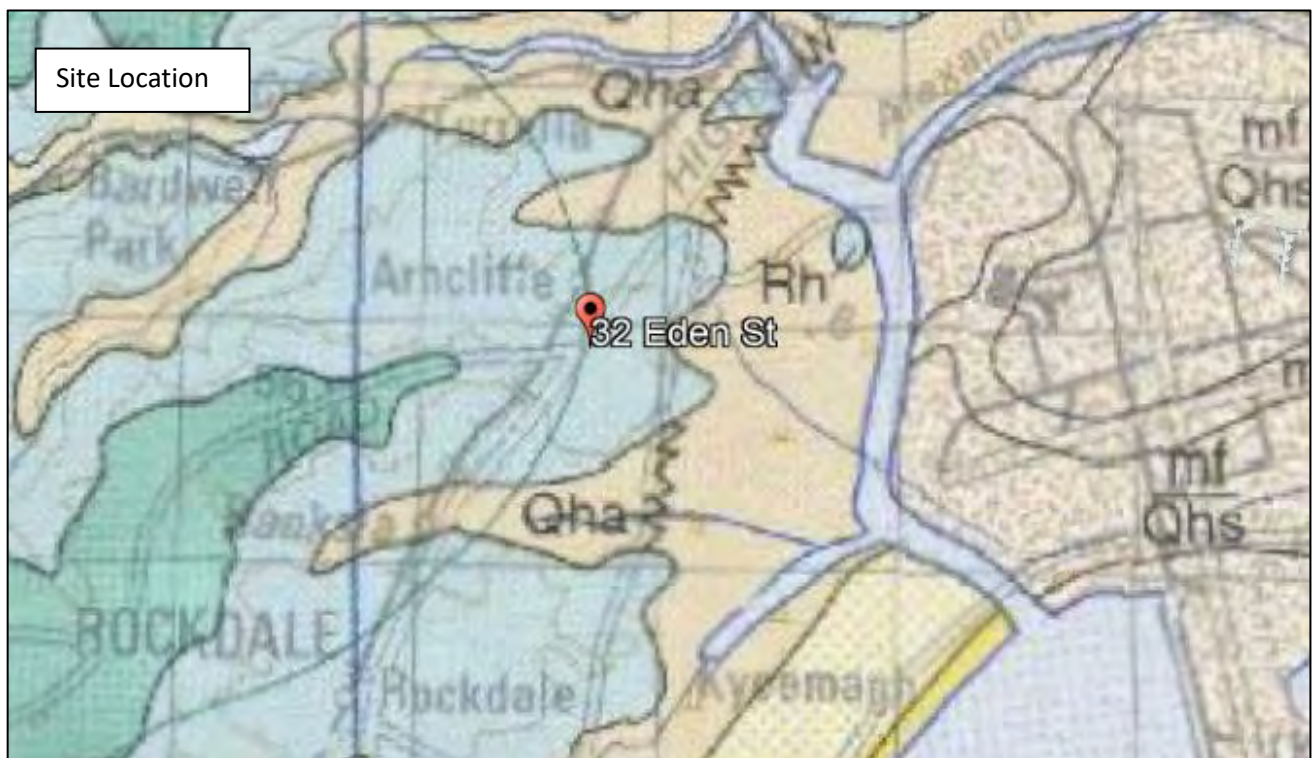
Figure 1: Excerpt of Geological Map of Sydney 1:100 000 (sourced from NSW Government, Department of Resources and Energy on 11.11.2020)

Hawkesbury Sandstone is described by the map as “medium to coarse grained quartz sandstone, very minor shale and laminate lenses”, while the alluvium is described as “silty to peaty quartz sand, silt and clay”. Figure 1 below shows an excerpt of geological map of Sydney around the site under this investigation.

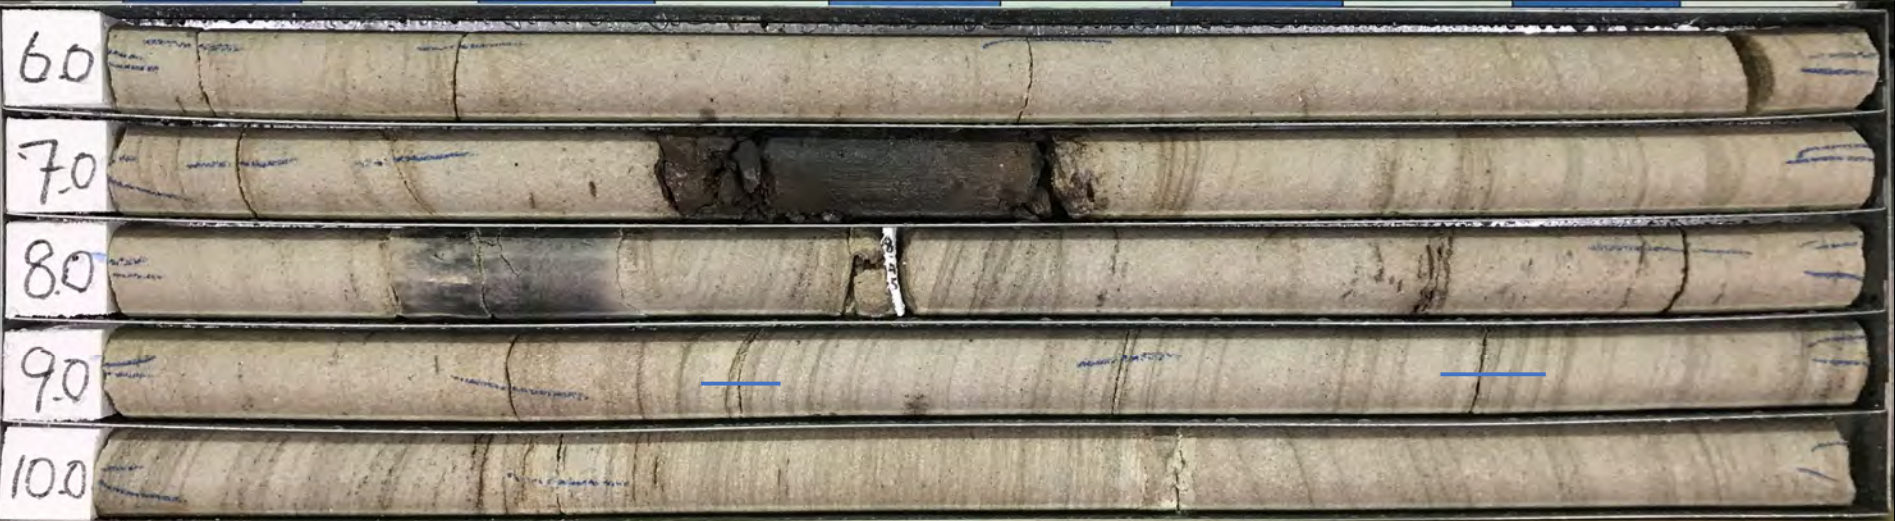
Project : Billbergia Pty Ltd
 Job No. : STC-2148-18709
 Borehole : Arncliffe Site - Geotechnical Investigation
 Depth : 6.0 m – 11.0 m
 Core Photo : No. 2

Client:	Billbergia Pty Ltd	Borehole No:	BH 101
	Project:	Arncliffe Site - Geotechnical Investigation	Depth:	6.0 m – 11.0 m
	Title:	Core Photographs	Photograph By:	NH
	Location:	31 Eden St. Arncliffe, NSW	Date:	23.11.2020

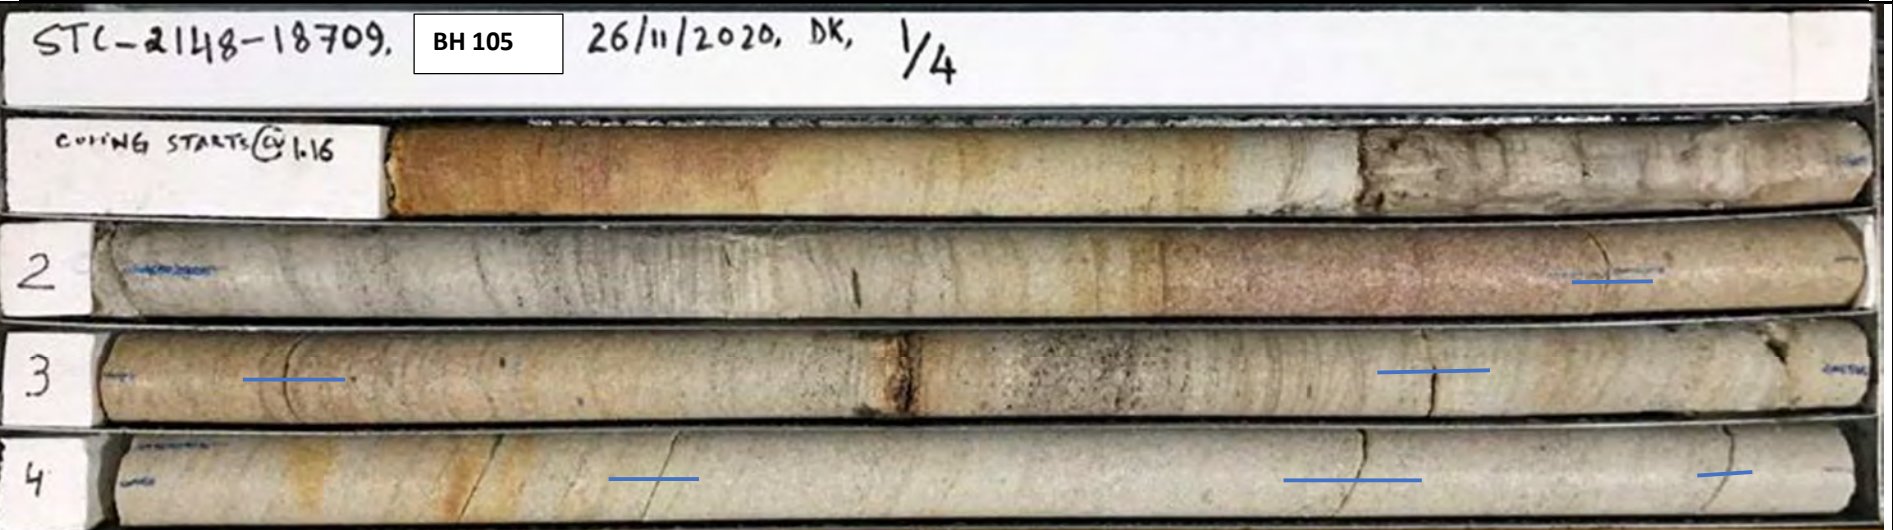
Project : Billbergia Pty Ltd
 Job No. : STC-2148-18709
 Borehole : Arncliffe Site - Geotechnical Investigation
 Depth : 1.16 m – 5.0 m
 Core Photo : No. 1

ADECONSULTINGGROUP <small>SOLUTIONS THROUGH INNOVATION</small>	Client:	Billbergia Pty Ltd	Borehole No:	BH 105
	Project:	Arncliffe Site - Geotechnical Investigation	Depth:	1.16 m – 5.0 m
	Title:	Core Photographs	Photograph By:	DK
	Location:	31 Eden St. Arncliffe, NSW	Date:	26.11.2020

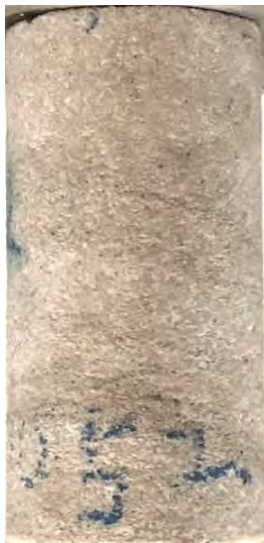
10.43 to 10.57 m

All samples were tested in an "As Received" condition.
 Top platen 228 mm, Bottom platen 75 mm
 The sample at 10.43 m was shorter than the Standard's recommendation.
