# APPENDIX O: RESOURCE EVALUATION INVESTIGATION

**Geological & Indicative Staged  
Assessment  
for  
Deep Creek Quarry  
Ironstone Developments Pty Ltd**

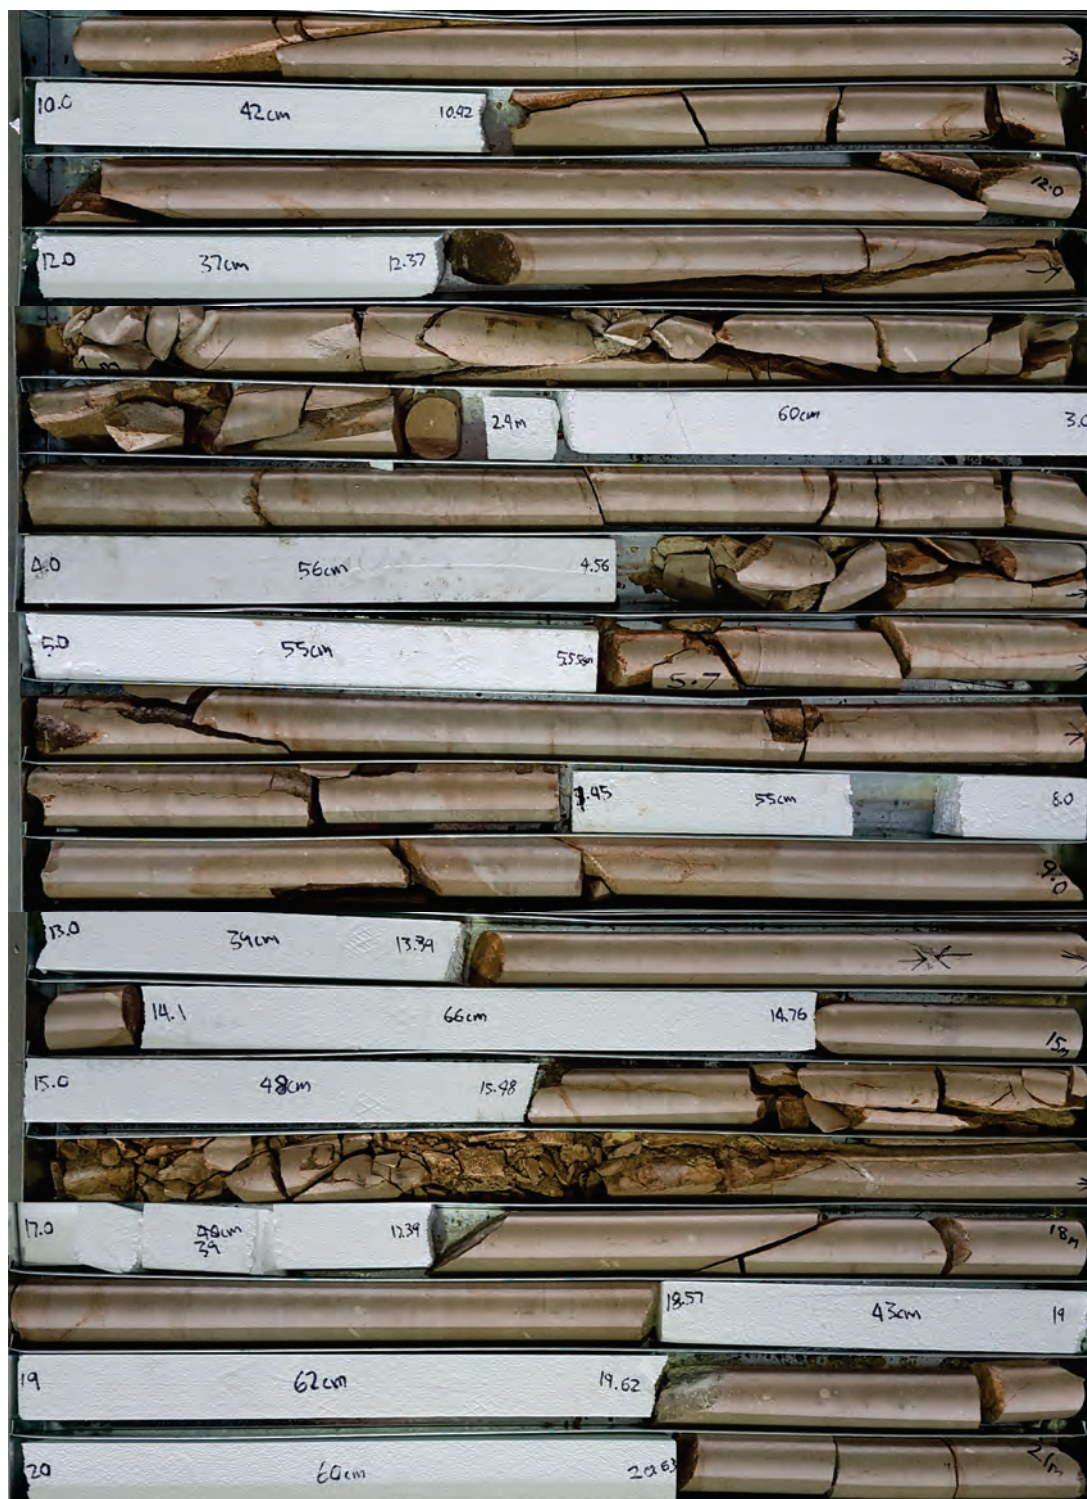
| <b>Plan of:</b> | Deep Creek Quarry - DDH17 Drill Core Samples Taken | This figure may be based on third party data which has not been verified by vgt and may not be to scale. Unless expressly agreed otherwise, this figure is intended as a guide only and vgt does not warrant its accuracy. <div style="text-align: right;"> </div> | | | |

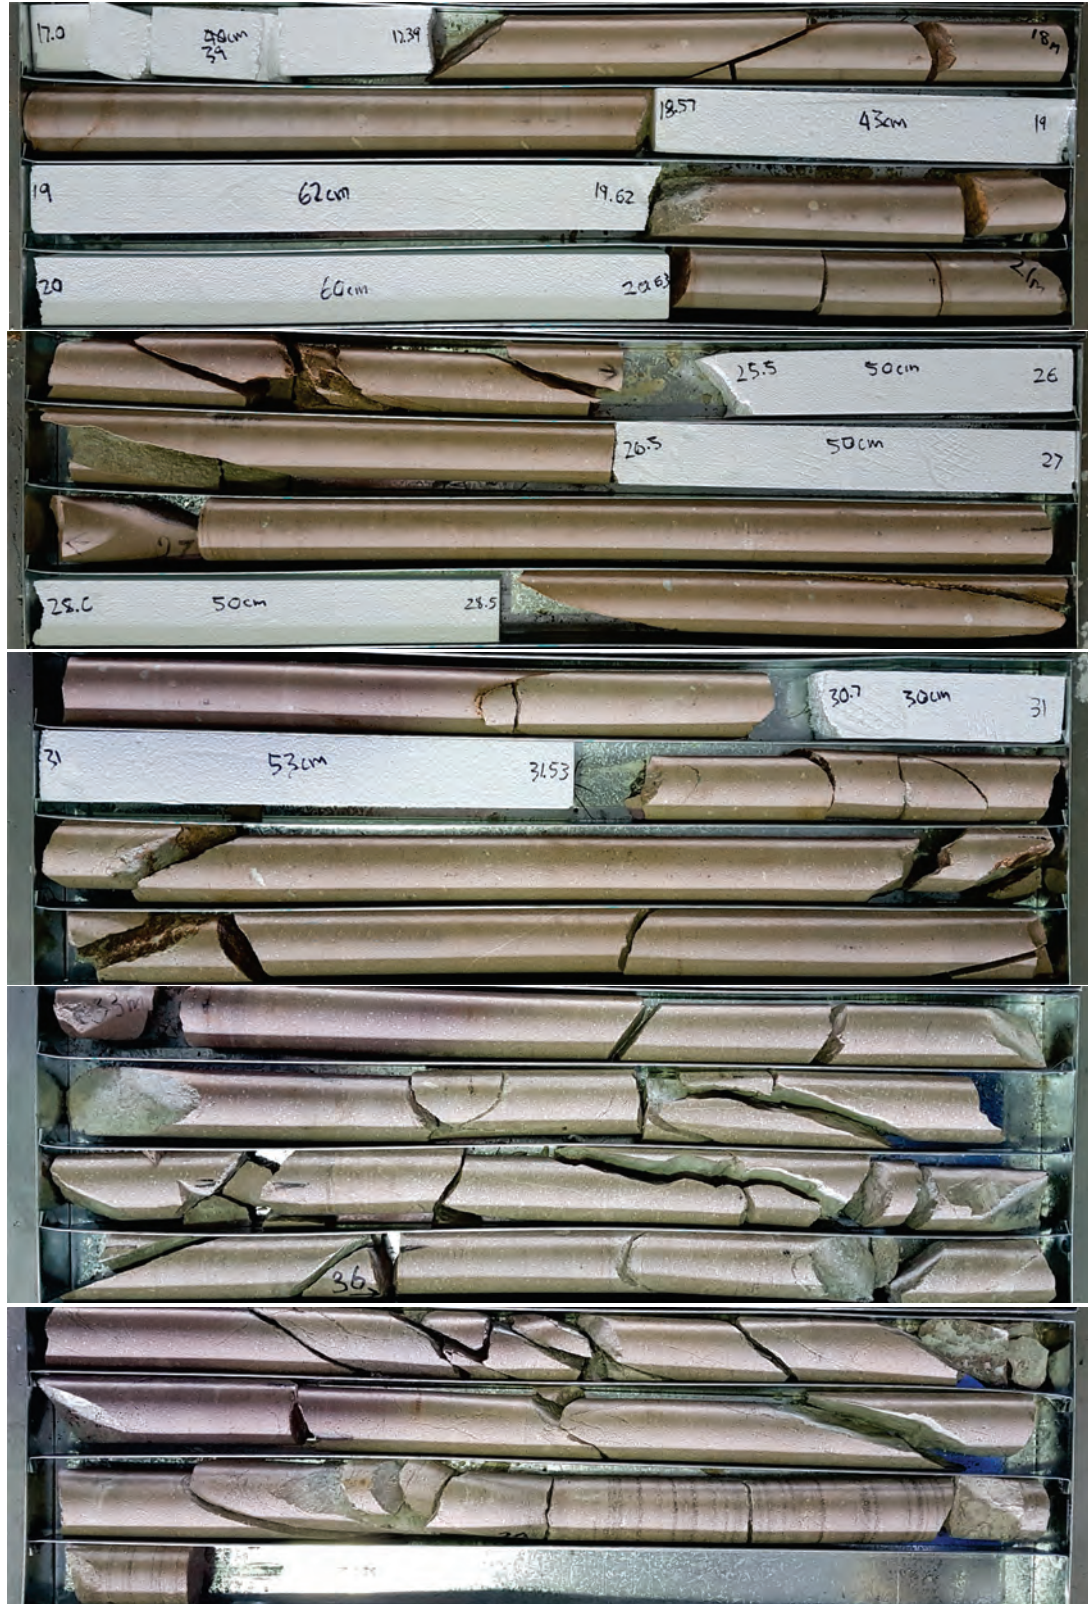
| <b>Plan of:</b> | Deep Creek Quarry - DDH18 Drill Core Samples Taken |

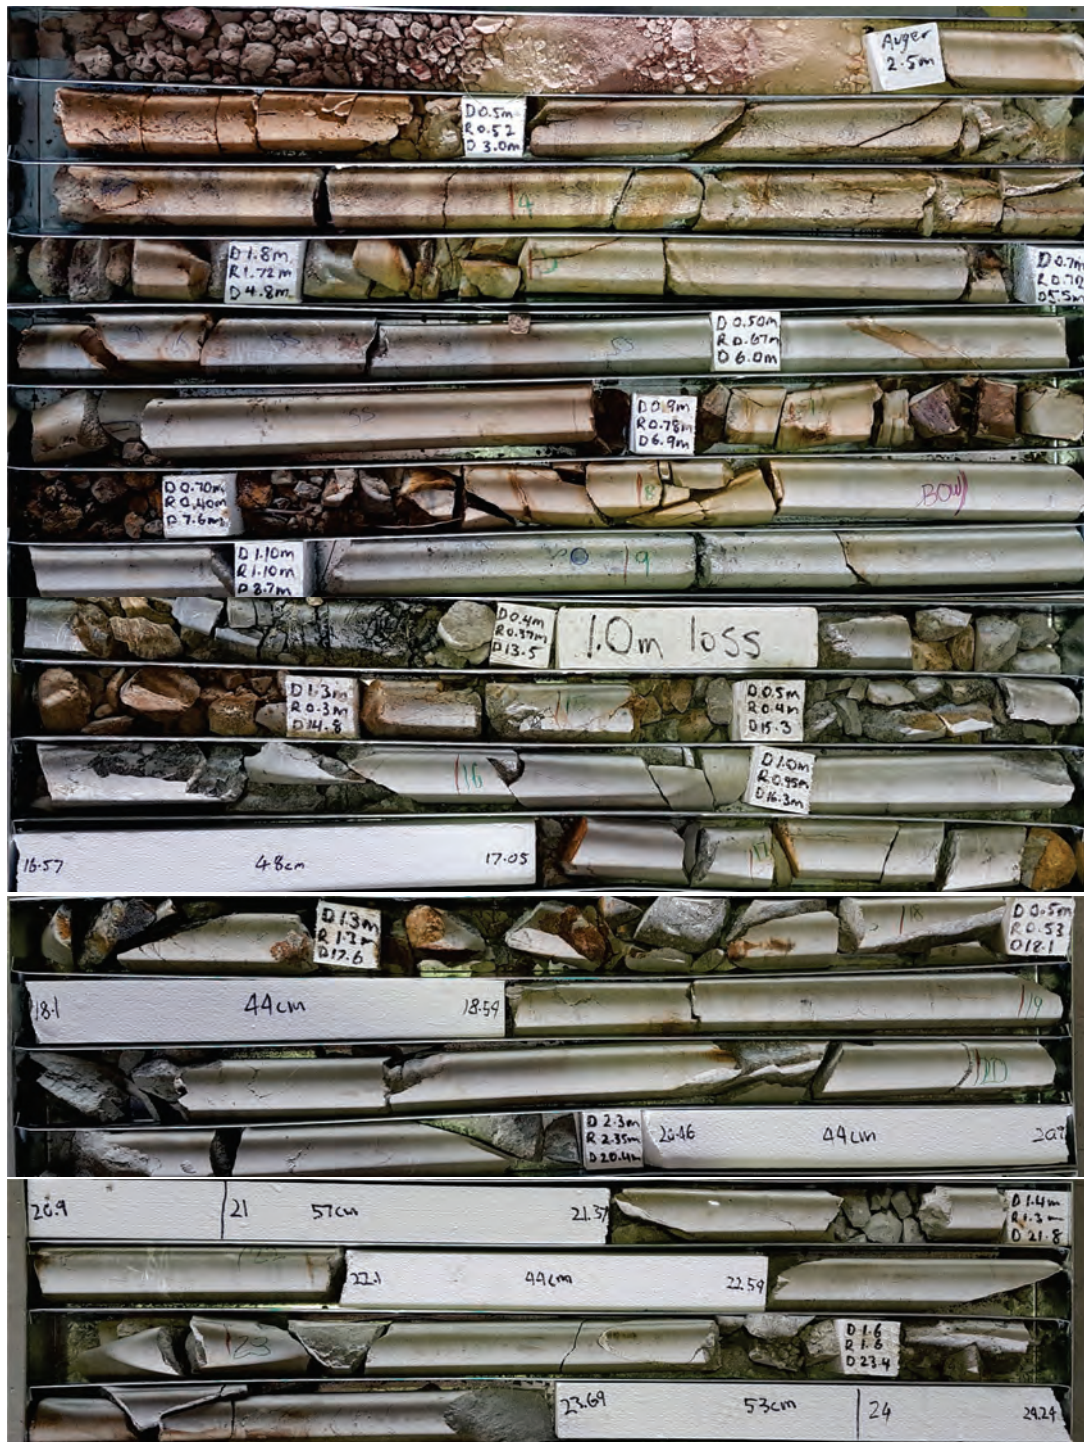
| <b>Plan of:</b> | Deep Creek Quarry - DDH18 Drill Core Samples Taken |

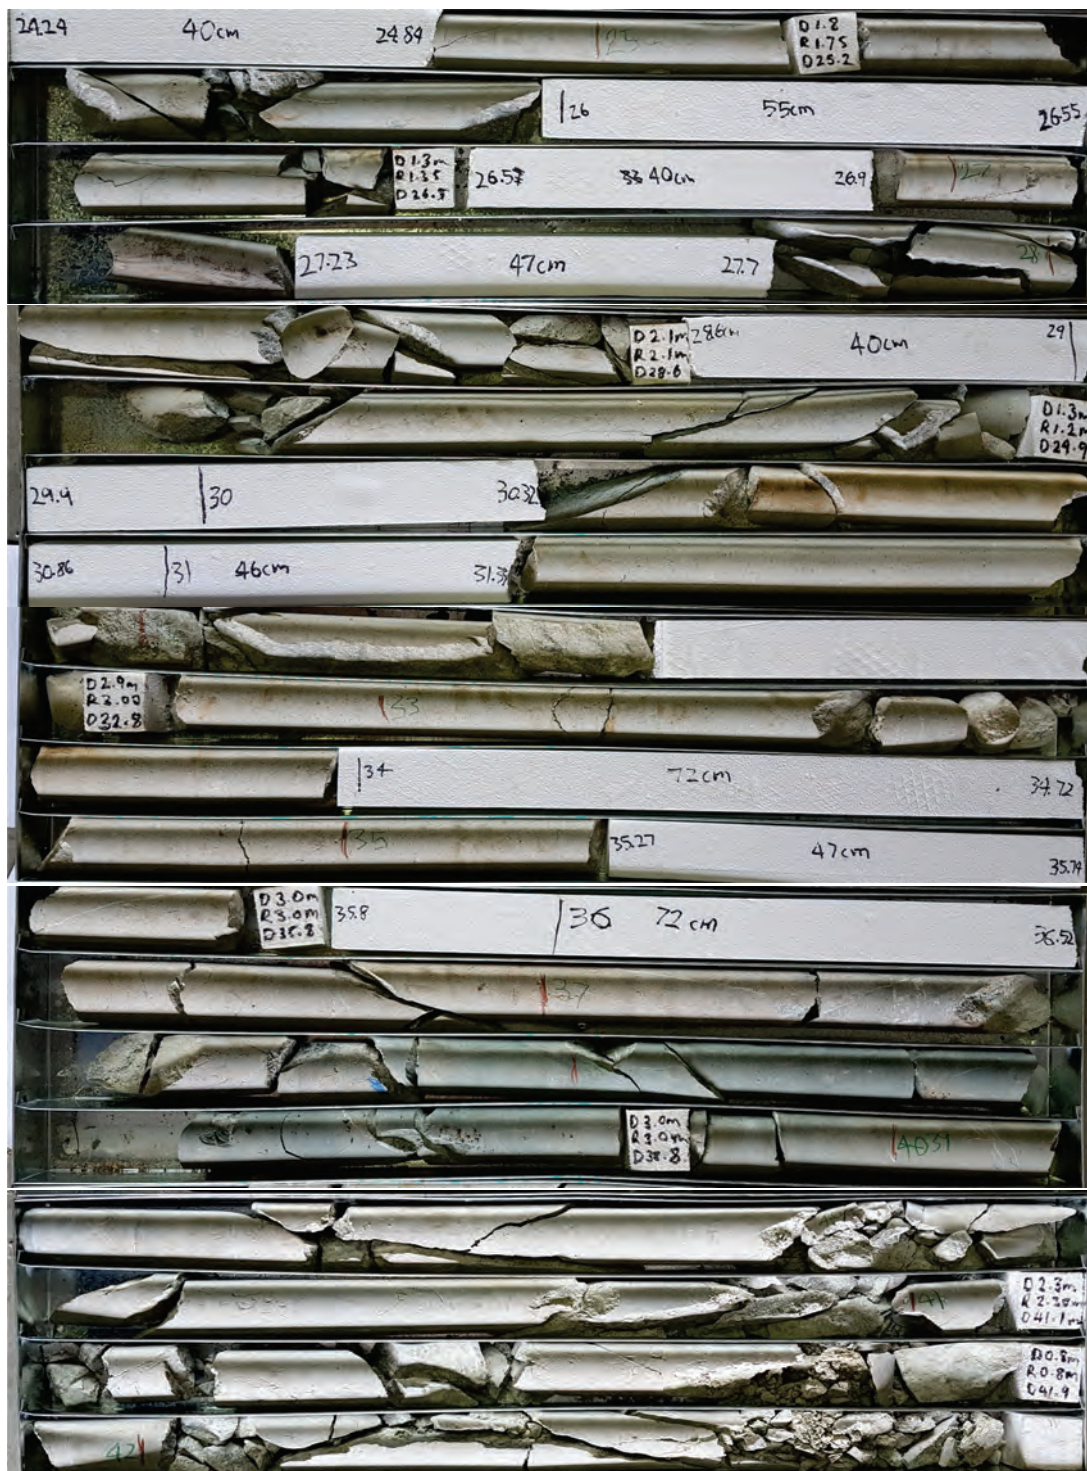
| <b>Plan of:</b> | Deep Creek Quarry - DDH18 Drill Core Samples Taken |

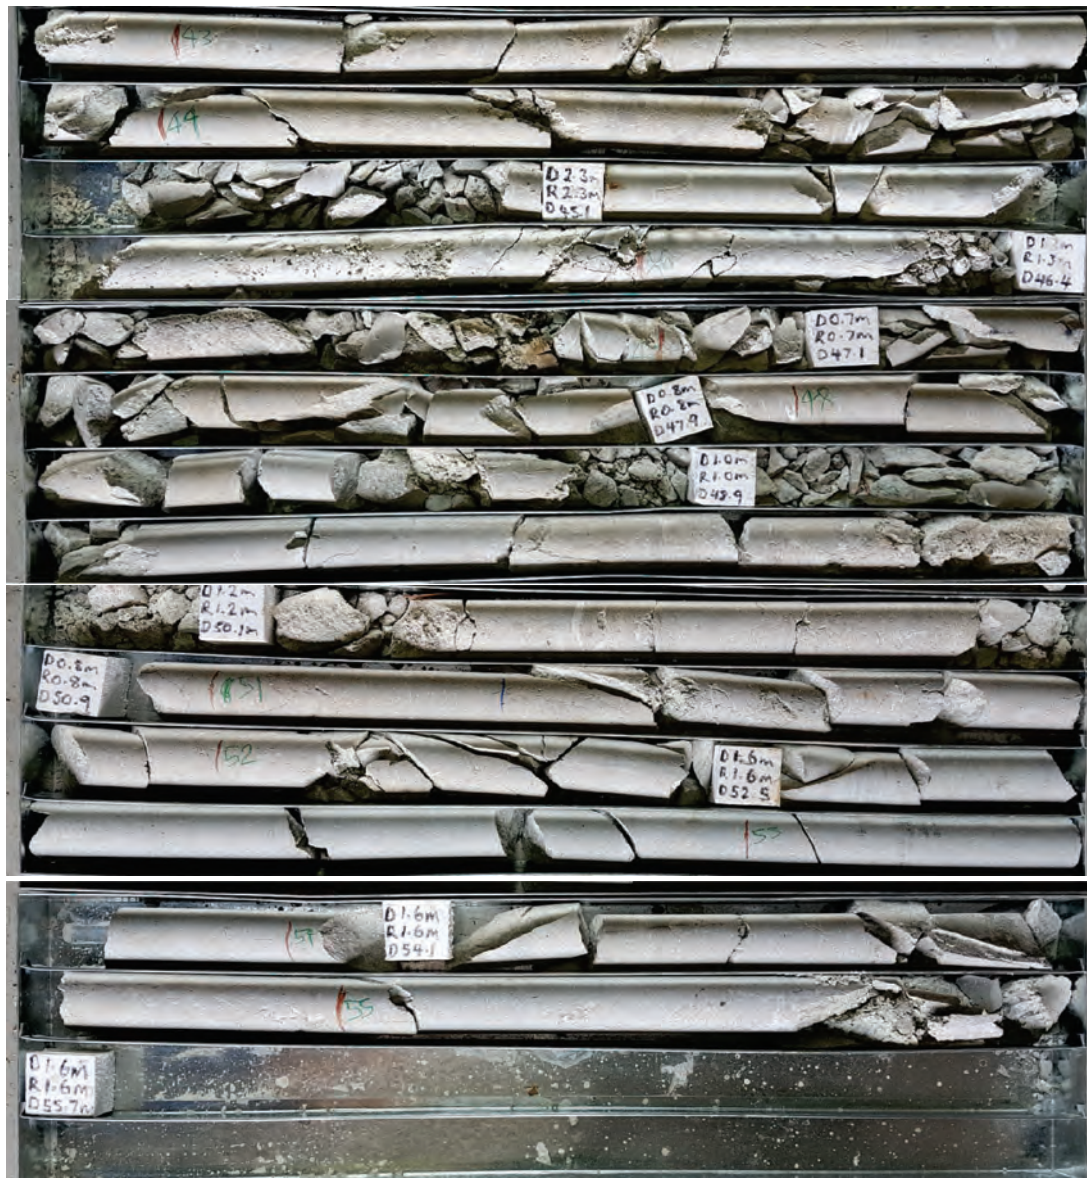
| <b>Plan of:</b> | Deep Creek Quarry - DDH19 Drill Core Samples Taken | This figure may be based on third party data which has not been verified by vgt and may not be to scale. Unless expressly agreed otherwise, this figure is intended as a guide only and vgt does not warrant its accuracy. <div style="text-align: right;"> </div> | | | |

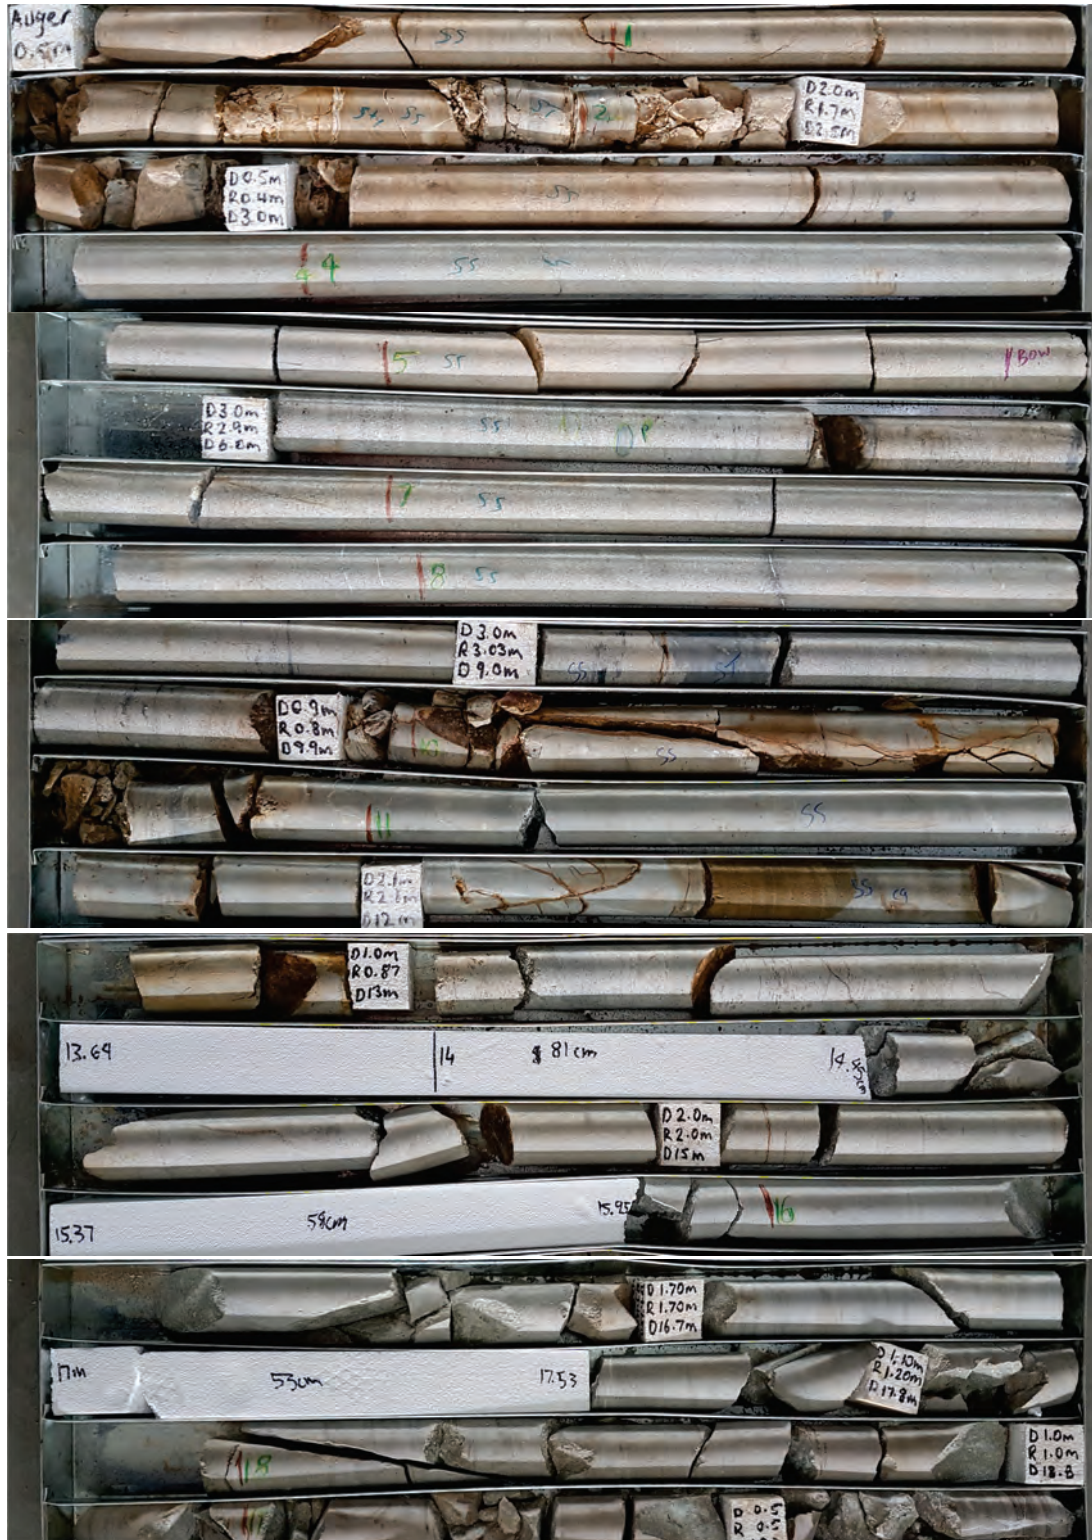
| <b>Plan of:</b> | Deep Creek Quarry - DDH19 Drill Core Samples Taken | <p>This figure may be based on third party data which has not been verified by vgt and may not be to scale. Unless expressly agreed otherwise, this figure is intended as a guide only and vgt does not warrant its accuracy.</p> | | | |

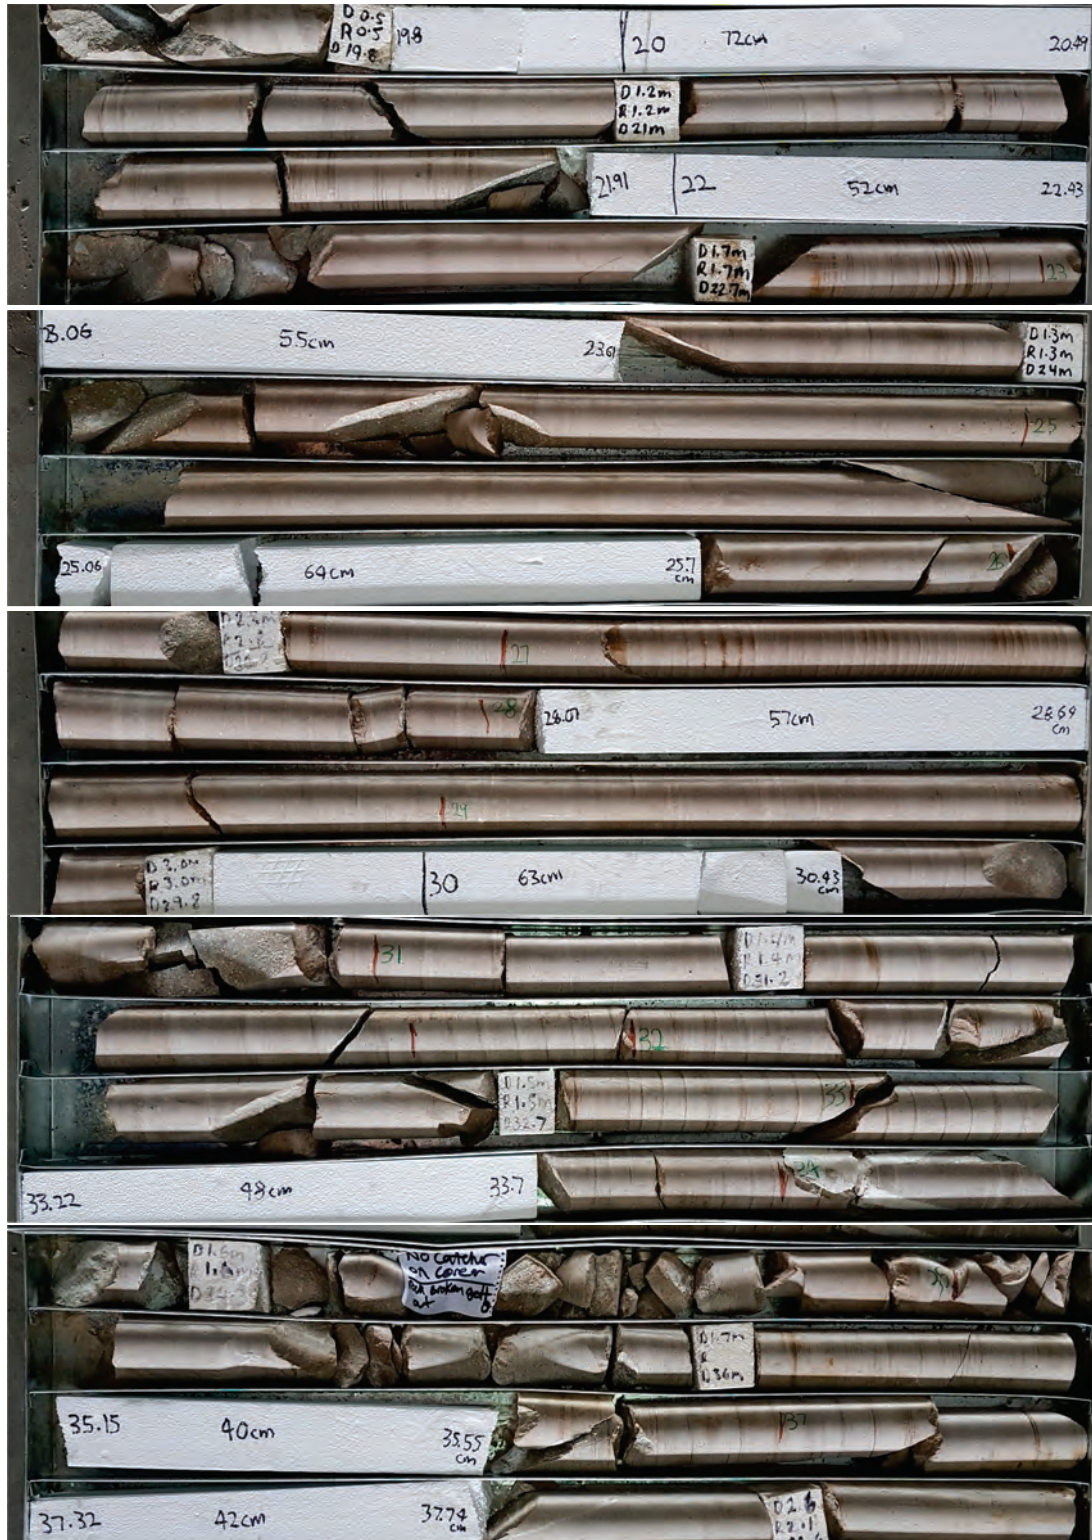
| <b>Plan of:</b> | Deep Creek Quarry - DDH19 Drill Core Samples Taken | This figure may be based on third party data which has not been verified by vgt and may not be to scale. Unless expressly agreed otherwise, this figure is intended as a guide only and vgt does not warrant its accuracy. | | | | | |

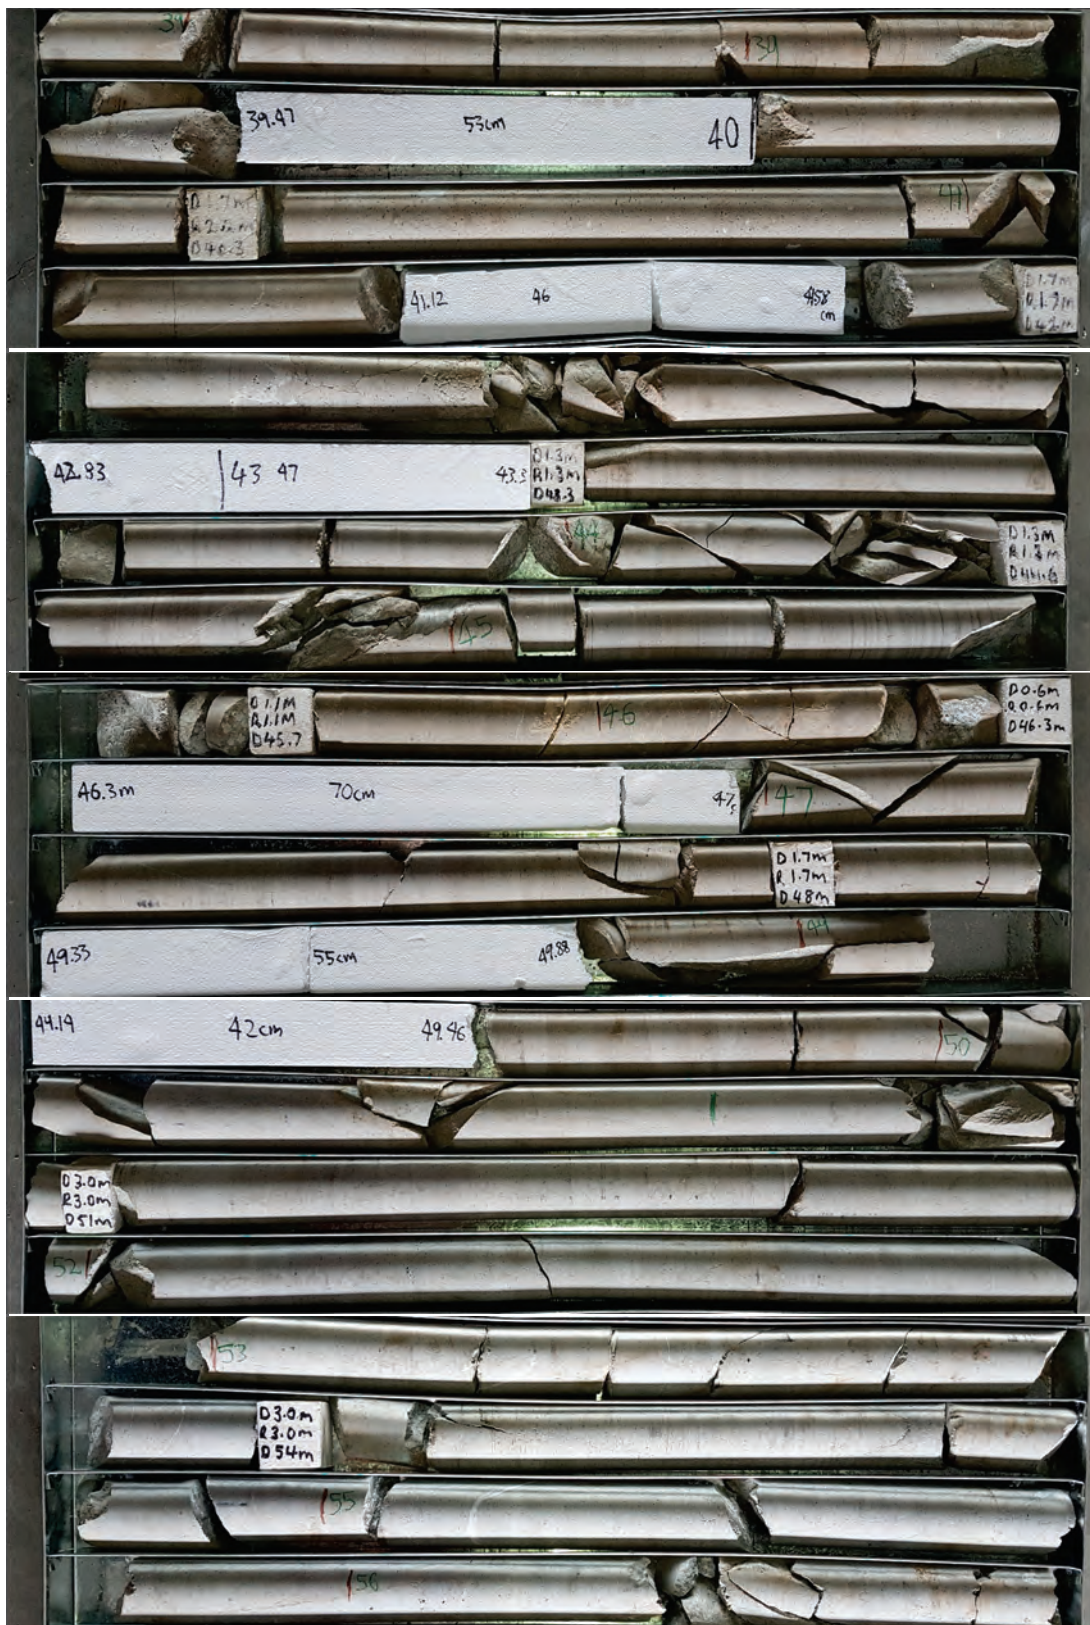
| <b>Plan of:</b> | Deep Creek Quarry - DDH19 Drill Core Samples Taken | This figure may be based on third party data which has not been verified by vgt and may not be to scale. Unless expressly agreed otherwise, this figure is intended as a guide only and vgt does not warrant its accuracy. <div style="text-align: right;"> <br/> <small>Environmental Compliance Solutions Pty Ltd</small> </div> | | | |

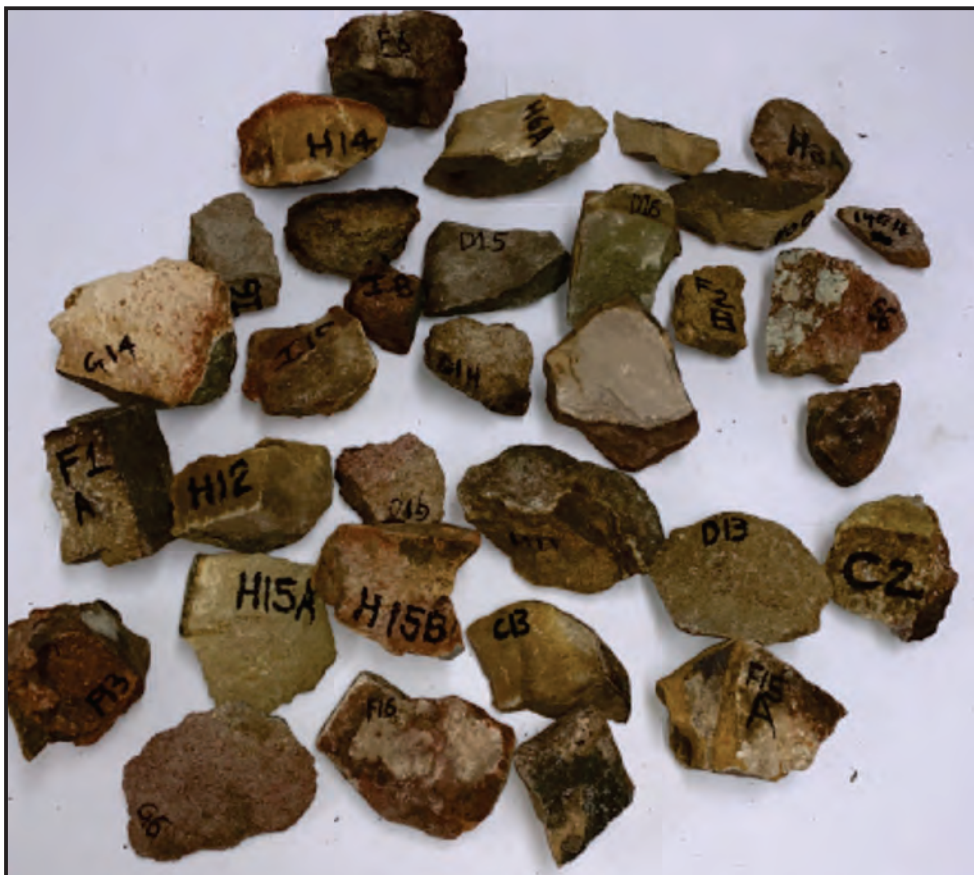
Photograph 3

Sedimentary

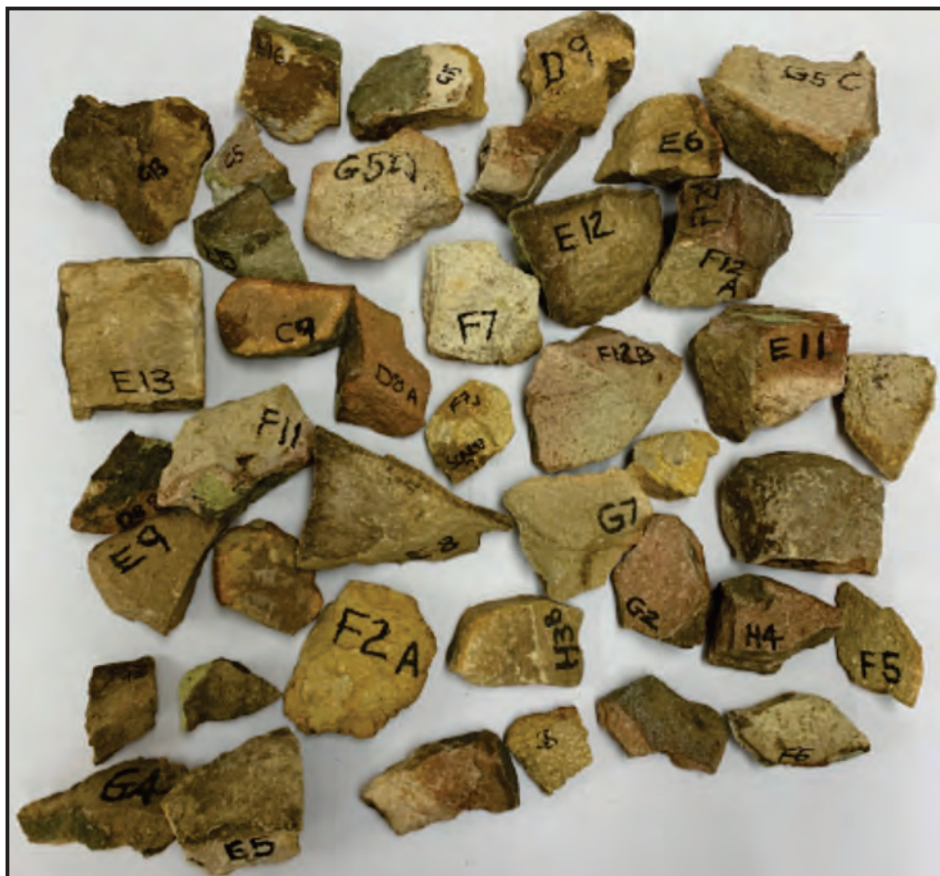
Photograph 4

Volcanics

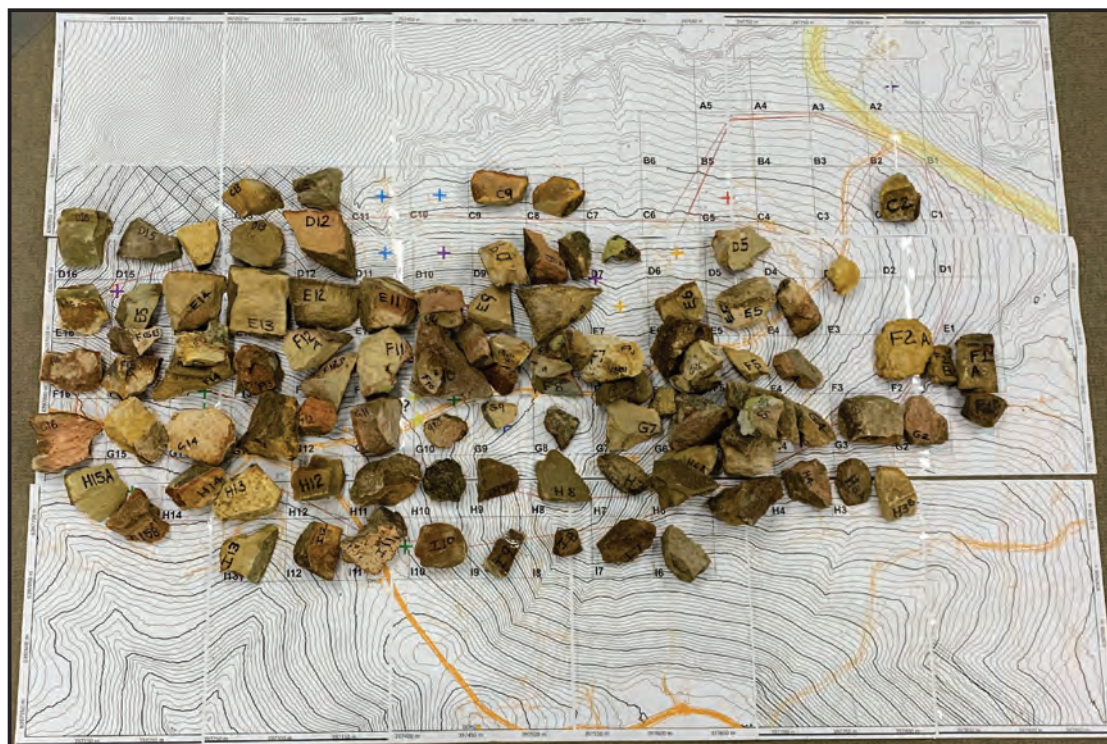
Photograph 5

Surface Sample Map

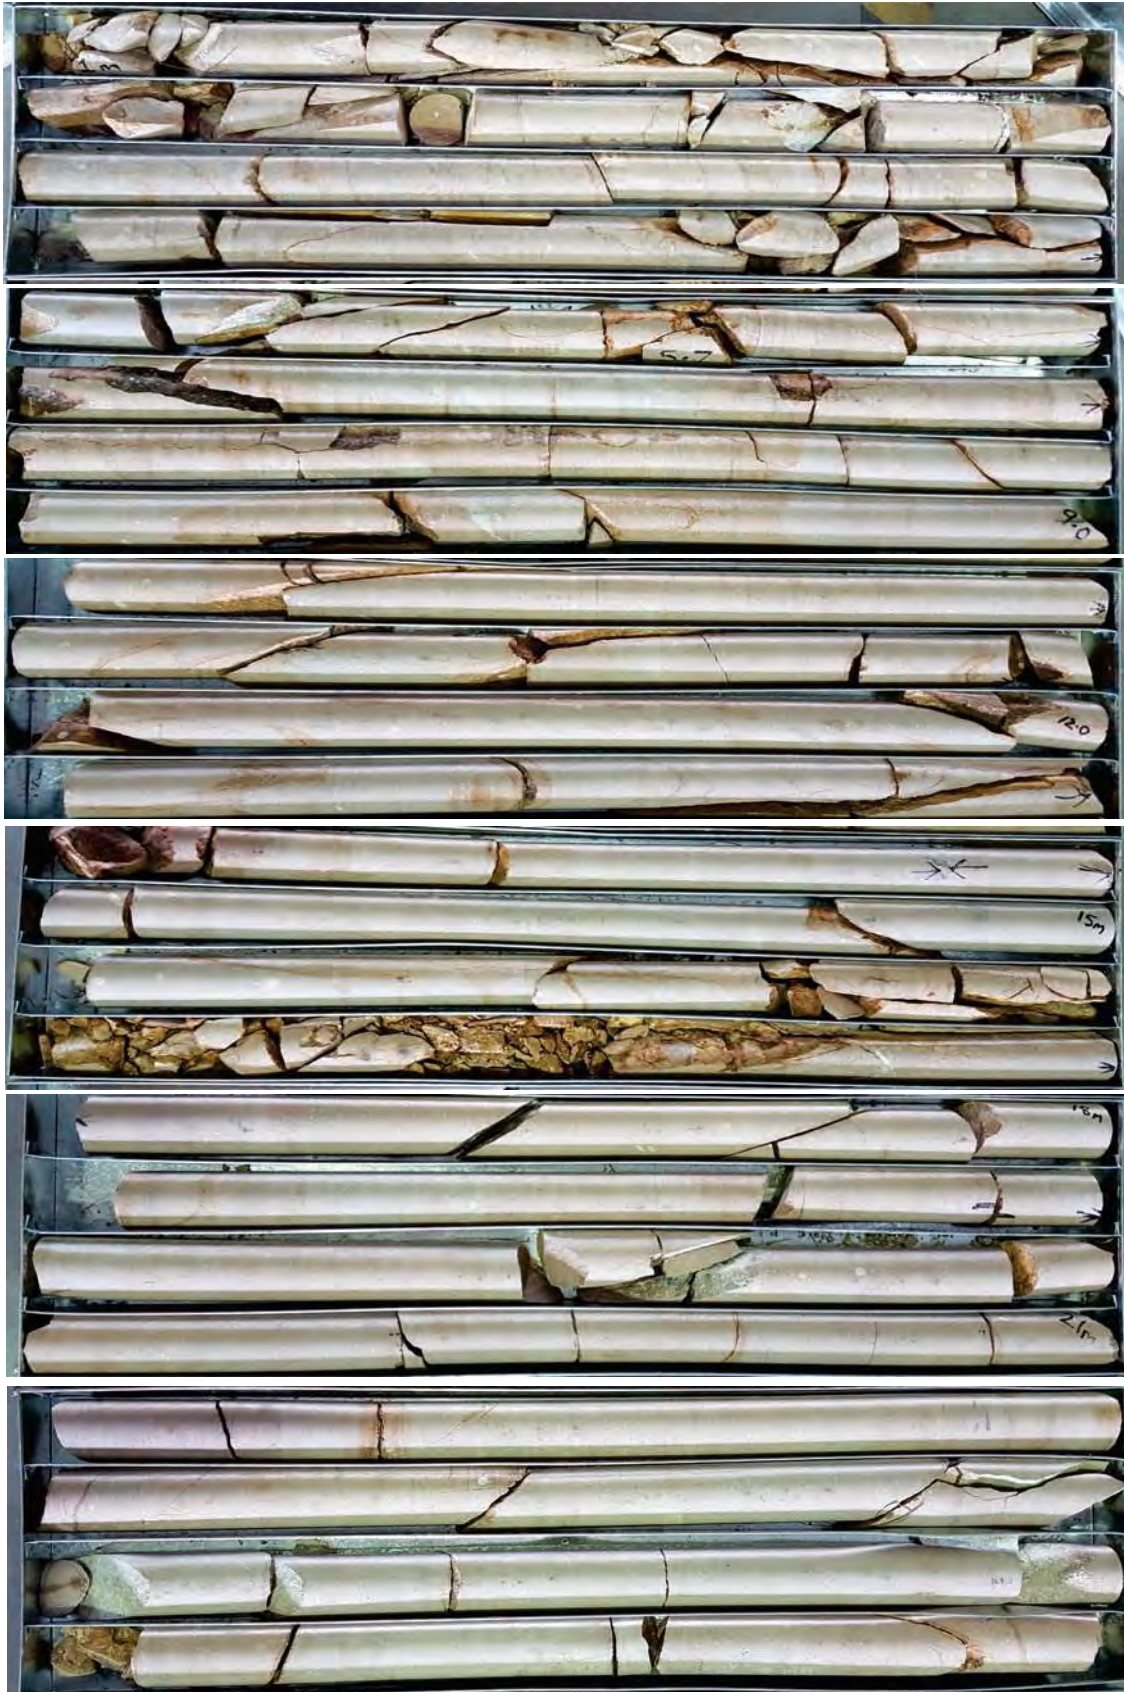
| <b>Plan of:</b> | Deep Creek Quarry Resource Review 2019 - DDH17 Drill Core | This figure may be based on third party data which has not been verified by vgt and may not be to scale. Unless expressly agreed otherwise, this figure is intended as a guide only and vgt does not warrant its accuracy. <div style="text-align: right;"> <br/> <small>Environmental Compliance Solutions Pty Ltd</small> </div> | | | |

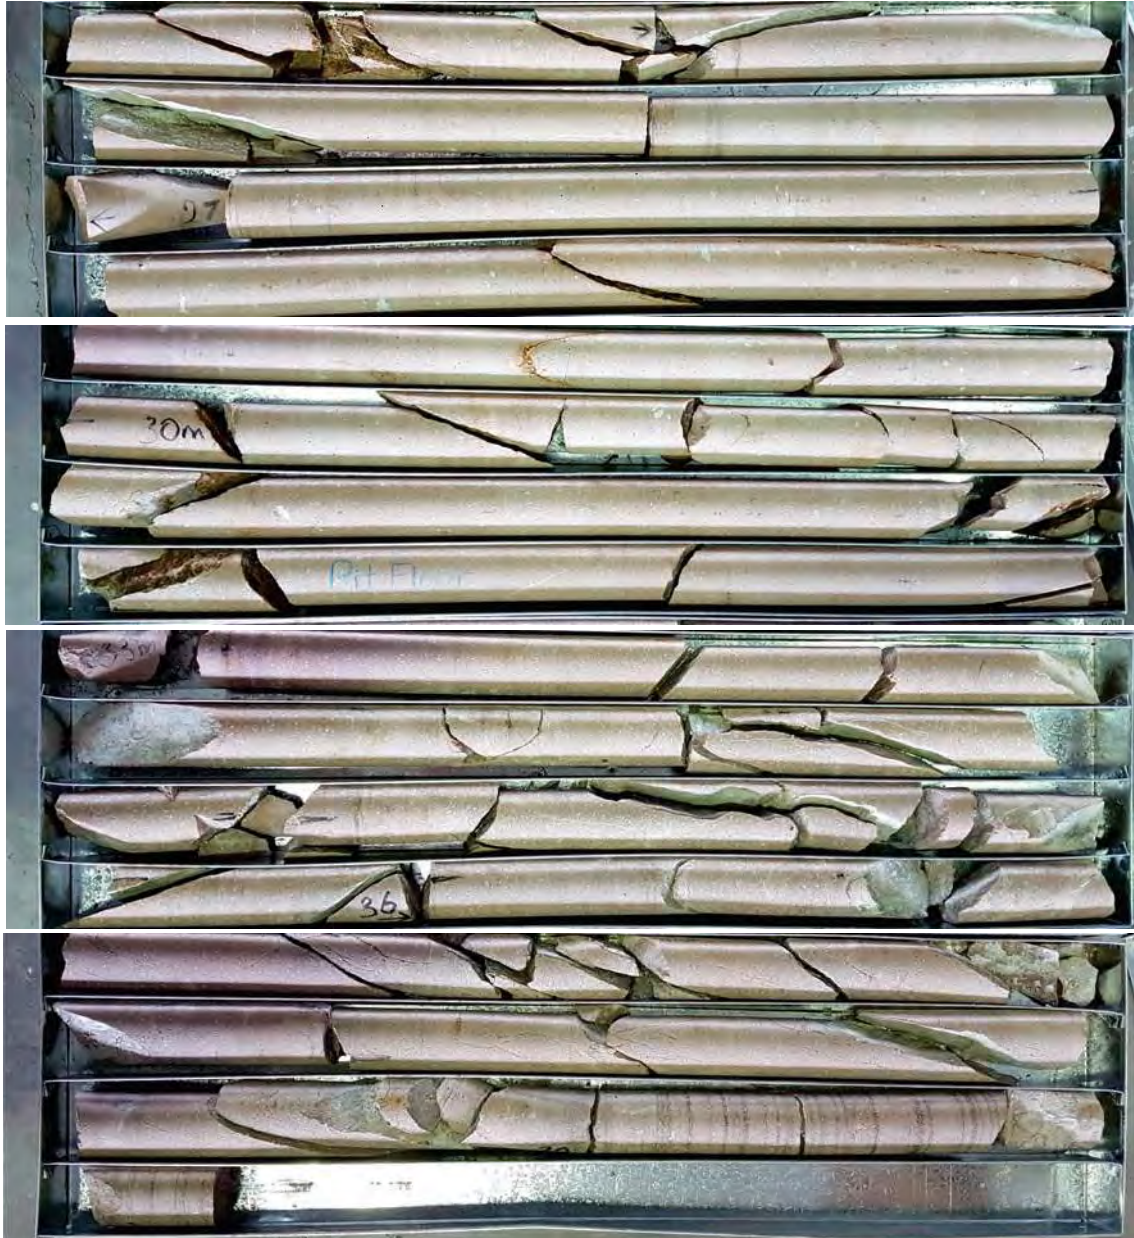
| <b>Plan of:</b> | Deep Creek Quarry Resource Review 2019 - DDH18 Drill Core |

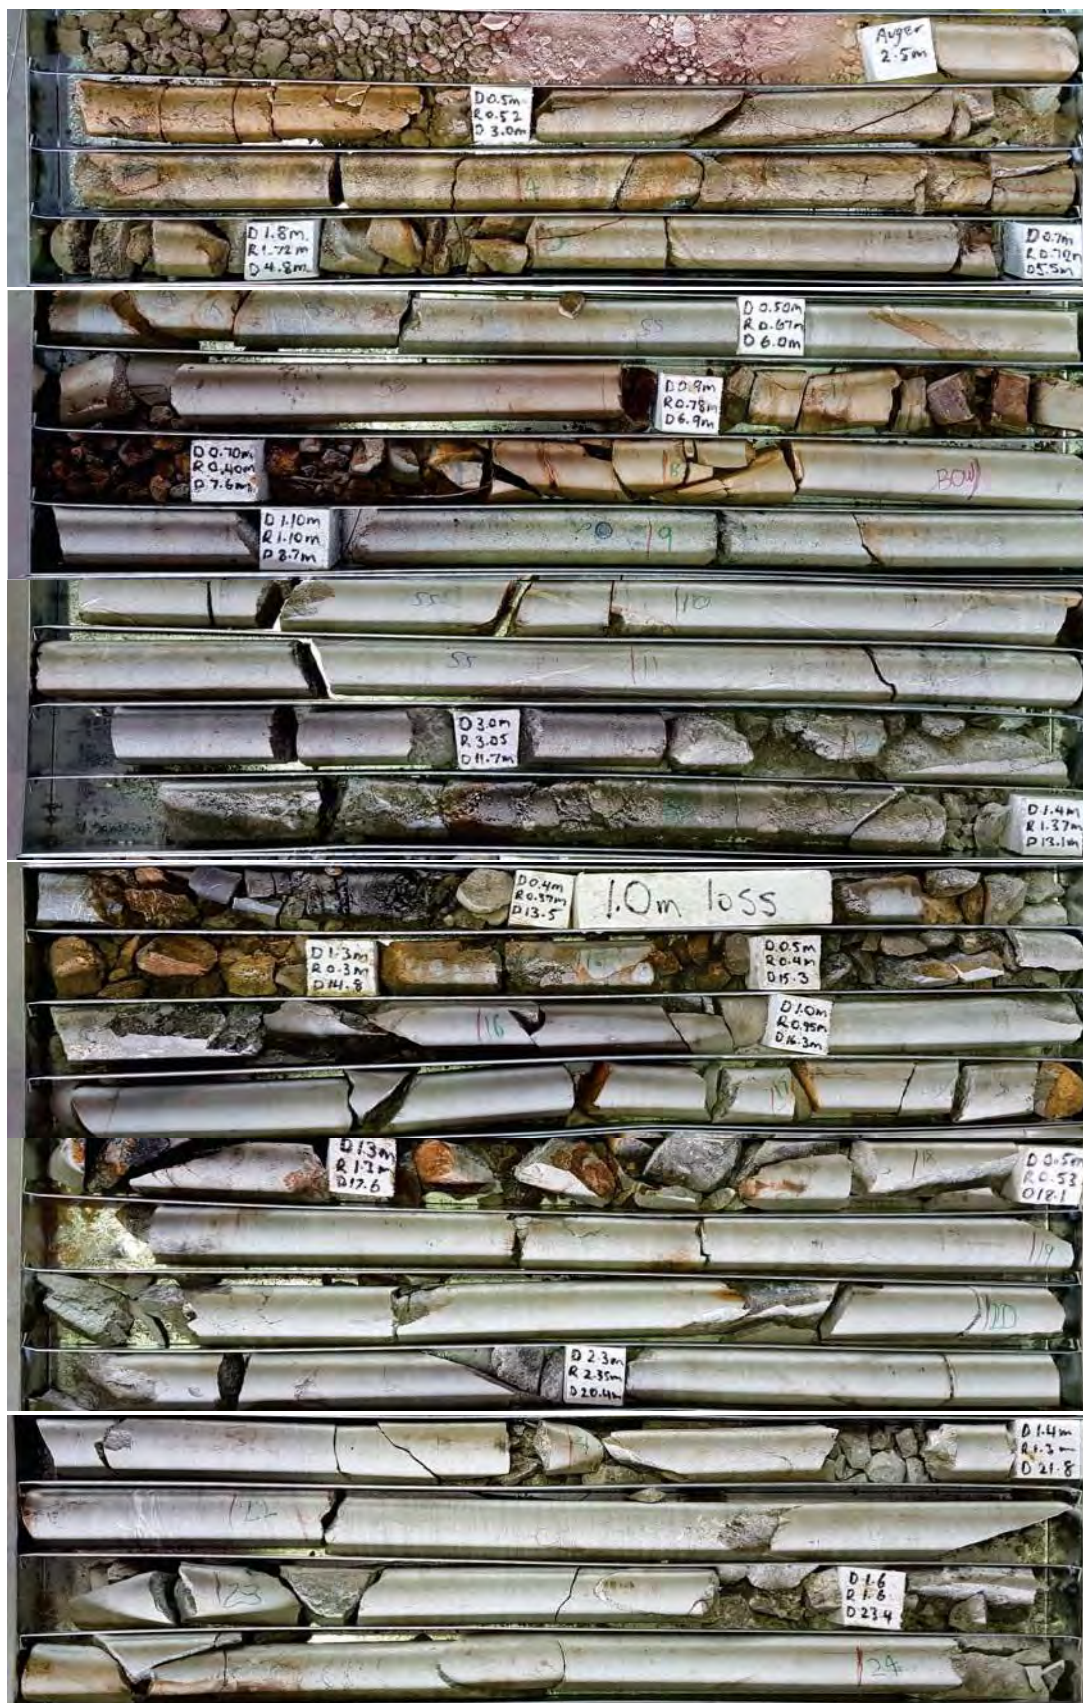
| <b>Plan of:</b> | Deep Creek Quarry Resource Review 2019 - DDH18 Drill Core | This figure may be based on third party data which has not been verified by vgt and may not be to scale. Unless expressly agreed otherwise, this figure is intended as a guide only and vgt does not warrant its accuracy. <div style="text-align: right;"> </div> | | | |
