# Eastern Creek Recycling Ecology Park Recycling Infrastructure Optimisation Project

## Appendix Q Aboriginal Heritage Due Diligence Assessment

**RE: DRAFT Eastern Creek Resource Ecology Park —Aboriginal Heritage Due Diligence Assessment**

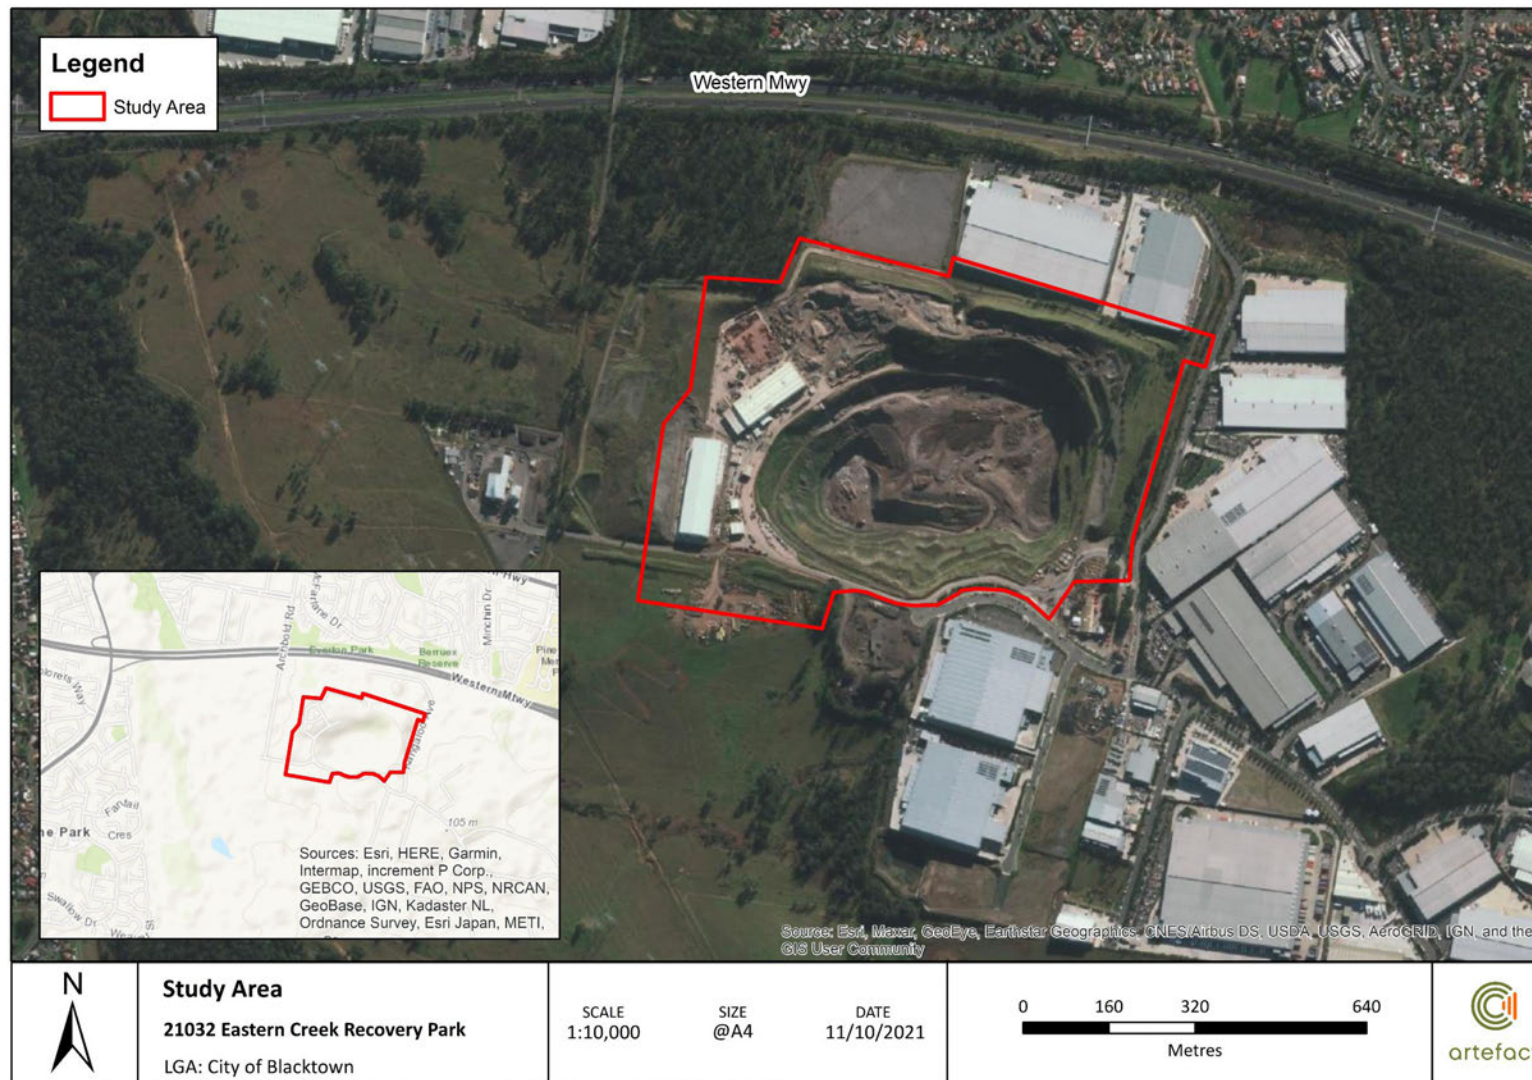
Figure 1. Location of study area

The study area, as shown in Figure 1, consists of 54 hectares within Lot 1 DP 1145808 and Lot 2 DP 1247691. This aligns with the Proposal Site in the scoping report. It is located east of Archbold Road, and south of the M4 Western Motorway, Eastern Creek. The study area is located within the Blacktown Local Government Area (LGA), the Parish of Melville, and the County of Cumberland. It is within the boundaries of the Deerubbin Local Aboriginal Land Council (LALC). The study area is illustrated in Figure 1.

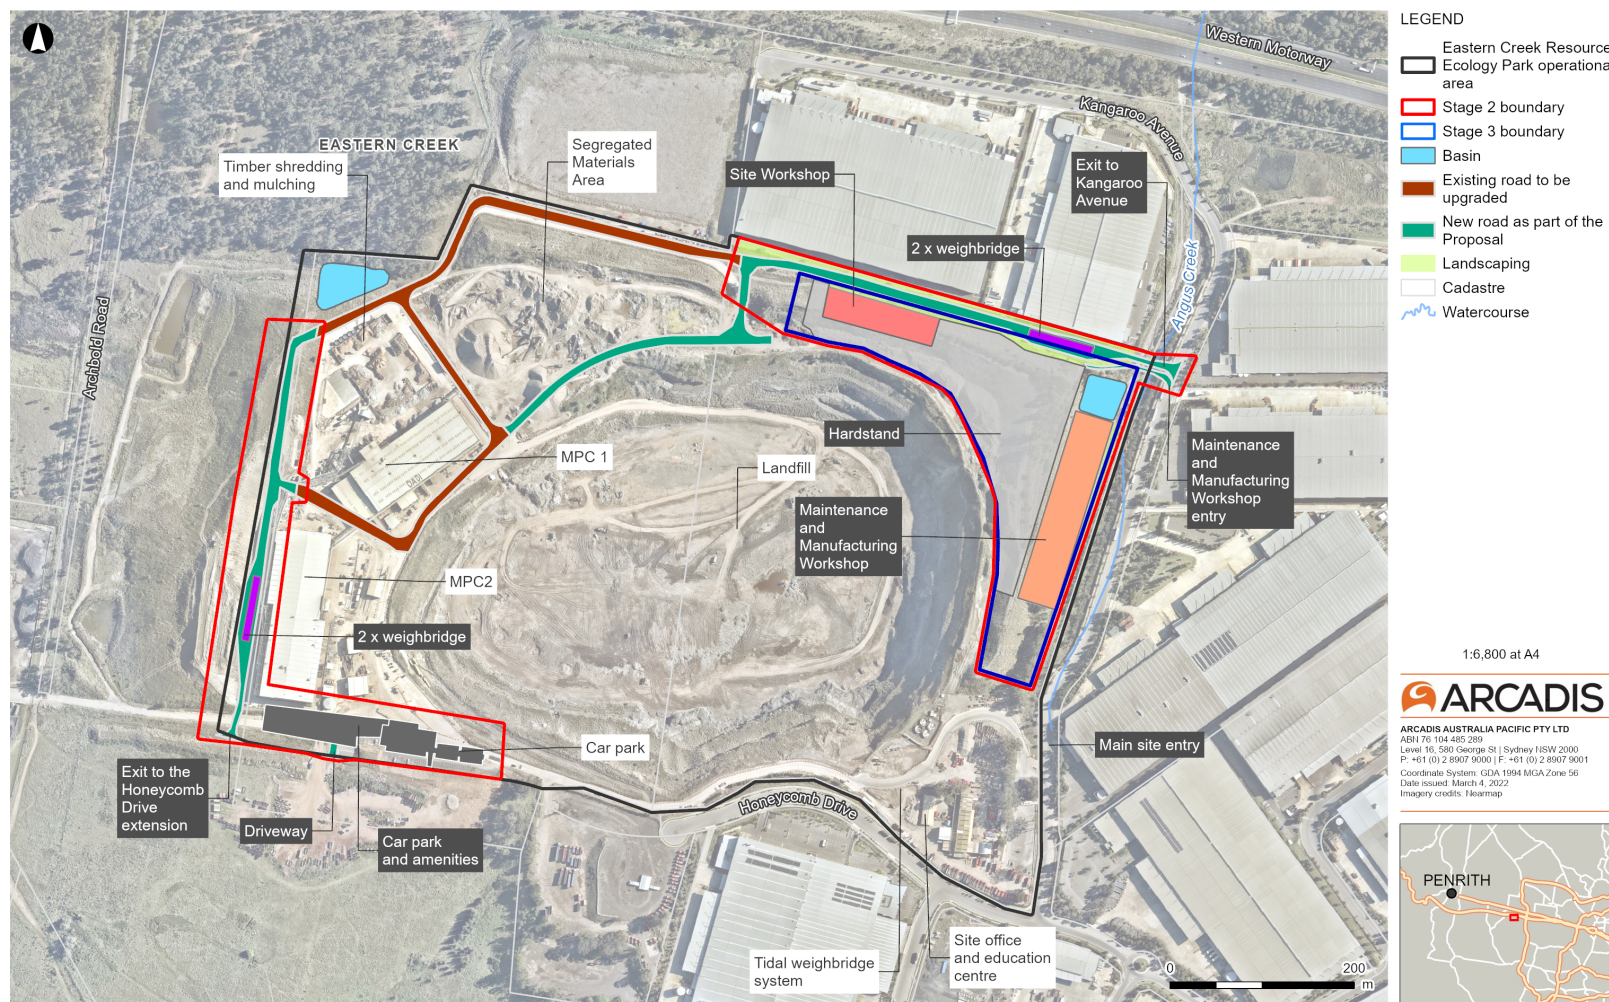
Figure 2: Proposed works

The Applicant is seeking approval of its proposed development as SSD (Eastern Creek Recycling Ecology Park Expansion – Scoping Report (Arcadis 2020 page iii). The Applicant is proposing to enhance resource recovery outcomes across the Greater Sydney area by increasing throughput at the Eastern Creek REP to capitalise on the underutilised state-of-the-art processing facilities (namely MPC2), and plant and equipment within the Eastern Creek REP. The Proposal would include the upgrade and construction of supporting infrastructure to optimise the current operation at the Eastern Creek REP and facilitate an increase in throughput of 950,000 tpa. As outlined in Figure 2, the following construction activities are proposed:

- site establishment
- clearing and grubbing
- earthworks
- installation of two new exit connections and associated weighbridges and offices
- internal road upgrades and necessary water management infrastructure
- provision of new staff parking and amenities
- construction of Site Workshop and skip bin Maintenance and Manufacturing Workshop
- installation of landscaping, signage, security fencing and perimeter works

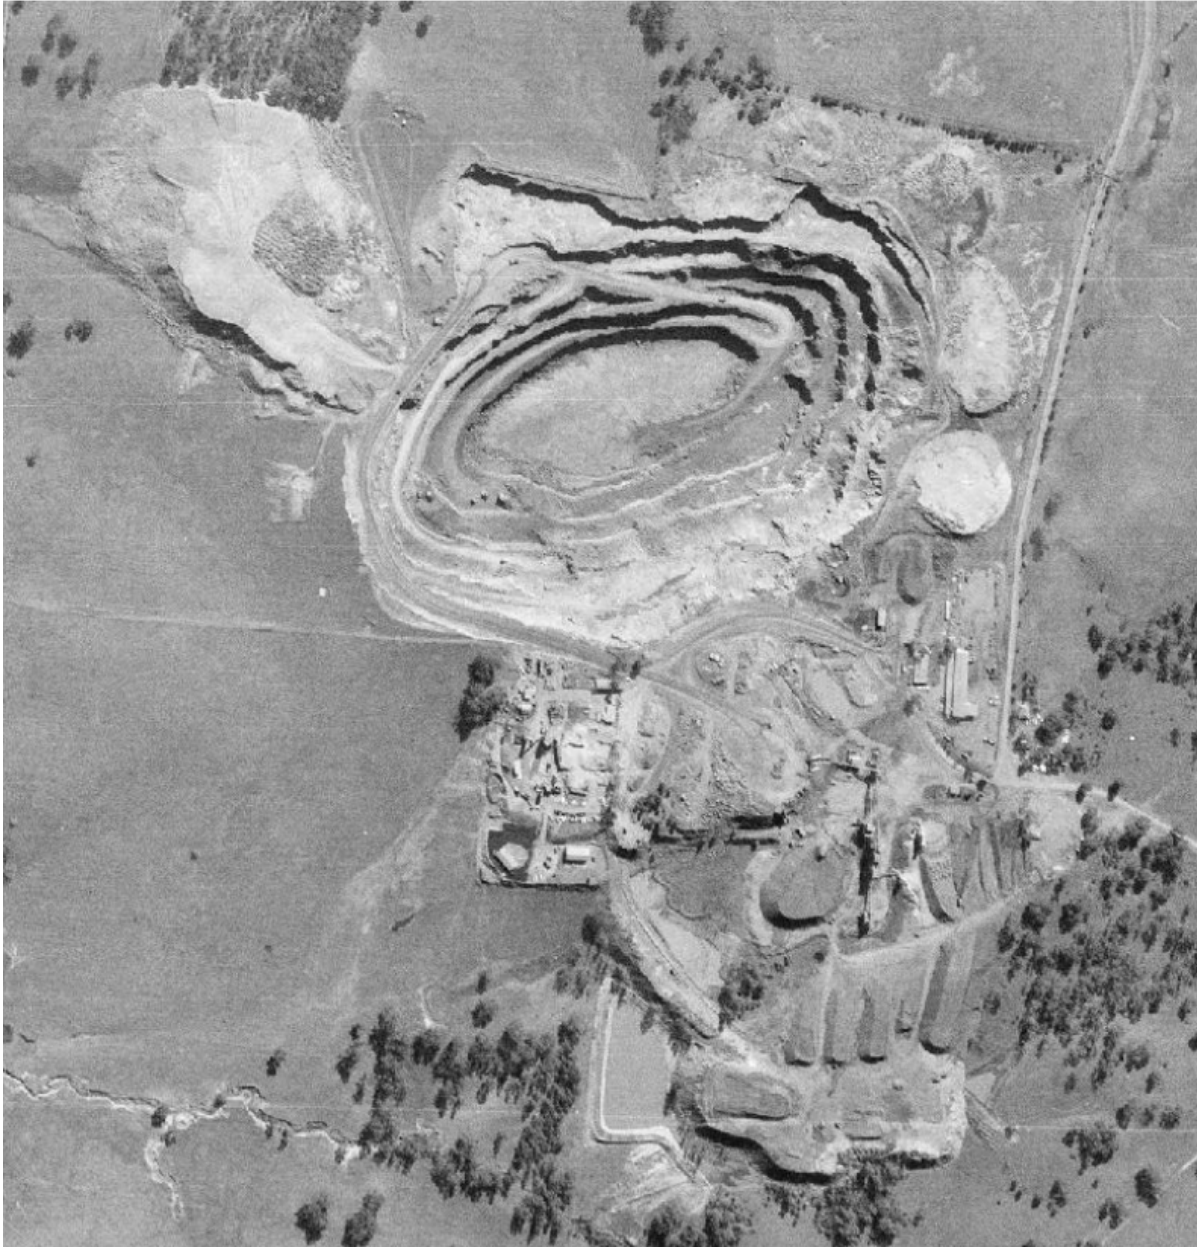
Figure 3 illustrates the extent of land disturbance by 1975, revealing extensive surface and subsurface excavation. Signs of this excavation are now obscured by the regrowth of vegetation on the site. Figure 4 shows that the eastern portion of the site which is now vegetated has been subject to extensive disturbance in the past which would have removed any potential intact deposits.

**Figure 3. Quarry site in 1975 (Source: Historical Imaging item number 2327\_05\_67, photographed 6/8/1975)**

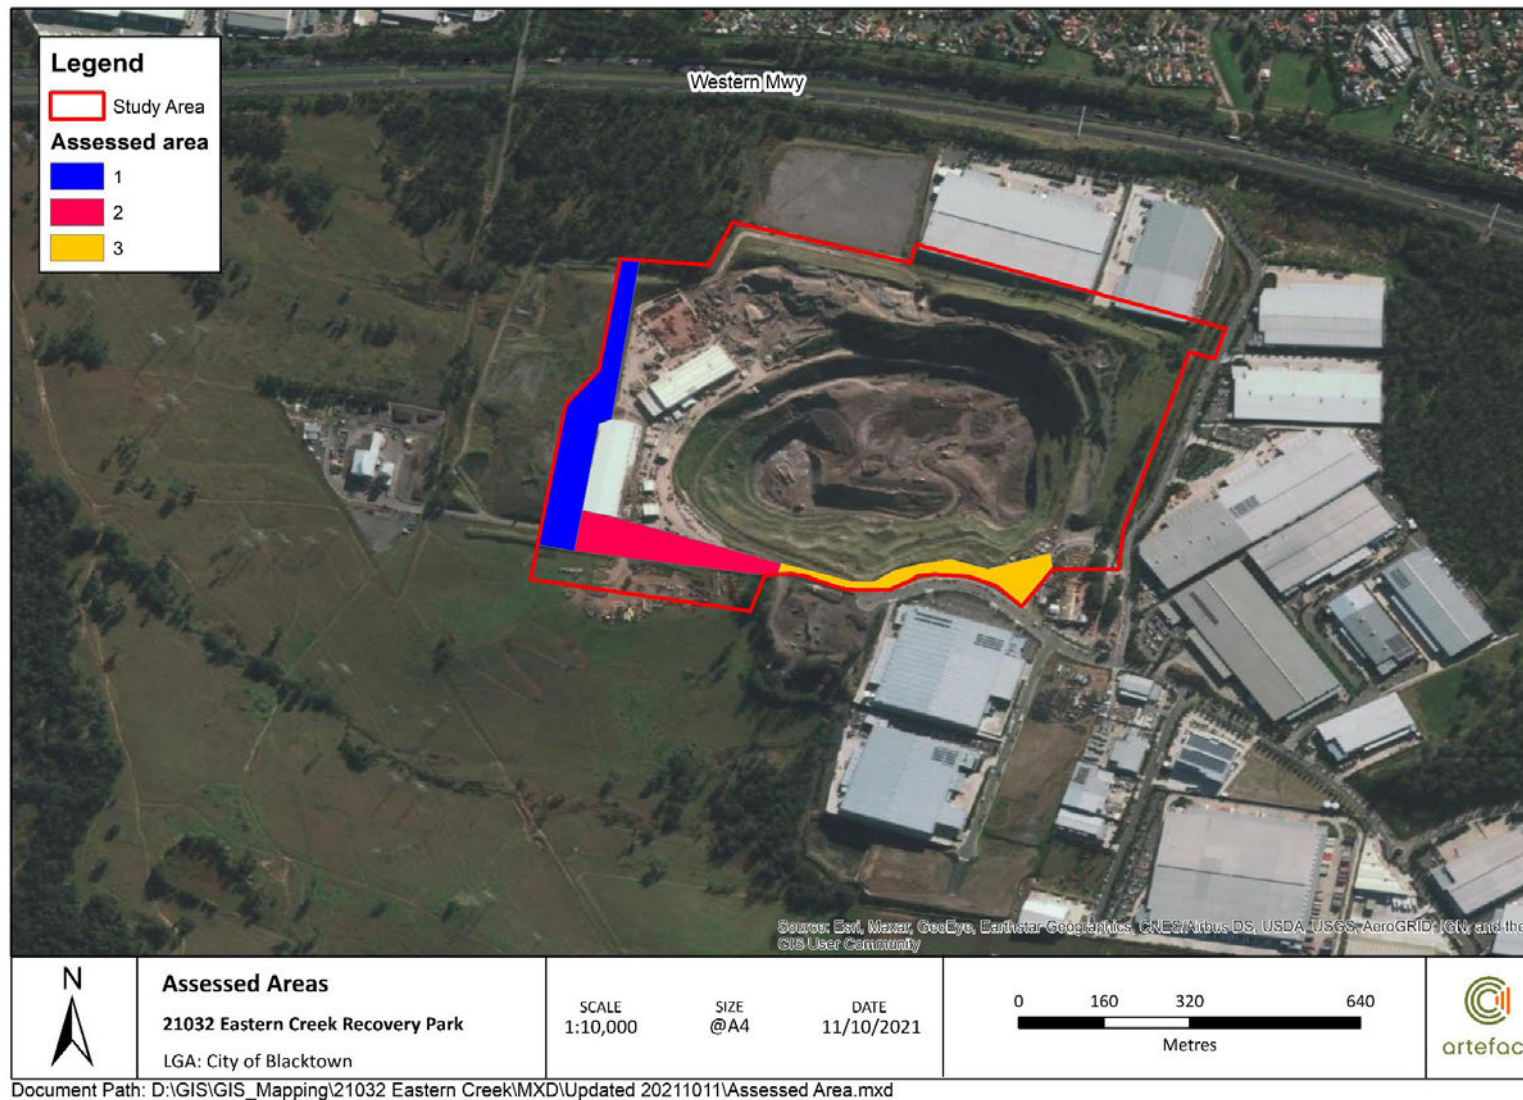
Figure 5. Areas selected for assessment given safety conditions on the day of the visit

Areas selected for inspection are shown in Figure 5 (assessed areas 1, 2 and 3) while the remaining areas were unable to be inspected due to ongoing site operations. Assessed area 1 was reached by vehicle (escorted); assessed areas 2 and 3 were visited unaccompanied and comprised road verges and car park areas.

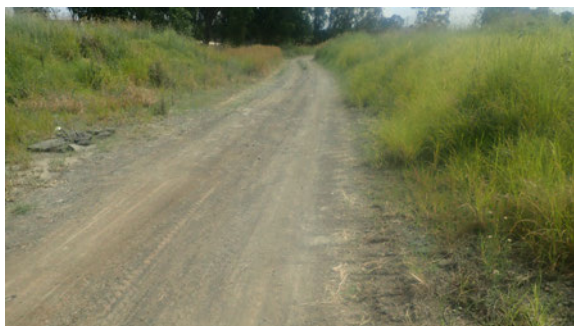
Work areas and buildings are located on the east side of assessed area 1. The western side runs parallel to Archbold Road beginning at its intersection with Honeycomb Drive. Access to this area was achieved from Archbold Road. The road is unsurfaced and rocky in many places and infilled with blue stone and road aggregate (Figure 6). Off the road, the grassy vegetation was up to one metre high and visibility less than five per cent. Wet areas lay on either side of the road with several small ponds on the western side with higher grasses growing (Figure 7). These ponds were in close proximity to a perimeter fence. The land on the eastern side of the road rose to a ridge, which formed the boundary of the study area, and overlooked buildings and a worksite with heavy equipment (Figure 8 and Figure 9). The gradient of the slope increased from a slight slope to a steep ascent towards the top. The area was rocky, had high growing weed and vegetation, pot holes and poor visibility and provided good sanctuary for animals such as snakes and wallaby. The top of the ridge was marked by excavator tracks. A pond receiving run off and overflow was located towards the base of the eastern slope and was fenced off from the road. Parts of the road had been stabilised against run off and debris and were fenced. There appeared to be no undisturbed ground in this area, including along the ridgetop.

**Figure 6. Archbold Road looking in northerly direction, unsurfaced road.**

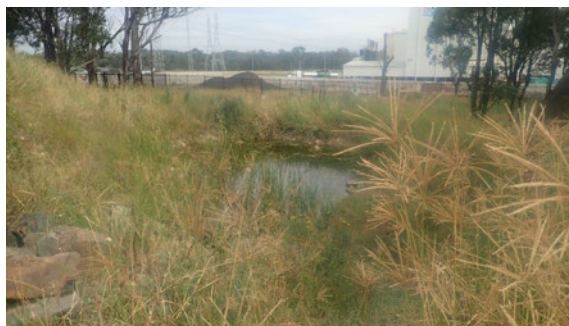
**Figure 7. Ponds and perimeter fence along west side of Archbold Road.**

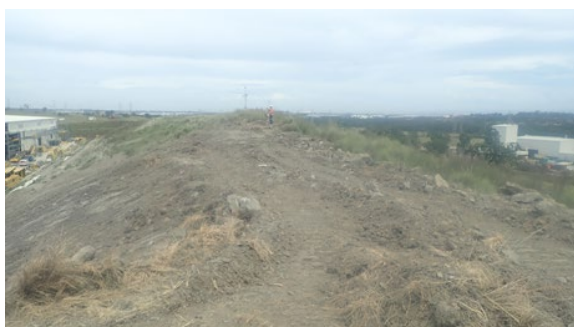
**Figure 8. Top of ridge along the eastern boundary parallel to Archbold Road.**

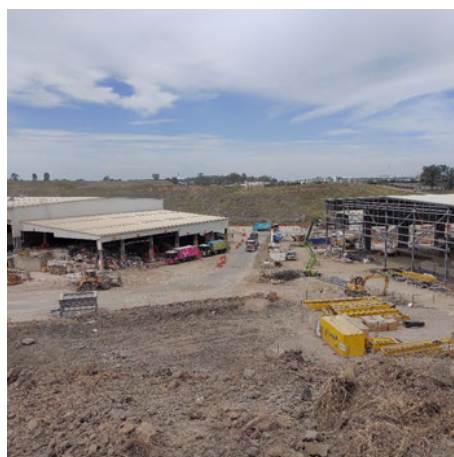
**Figure 9. Top of ridge along the eastern boundary parallel to Archbold Road**

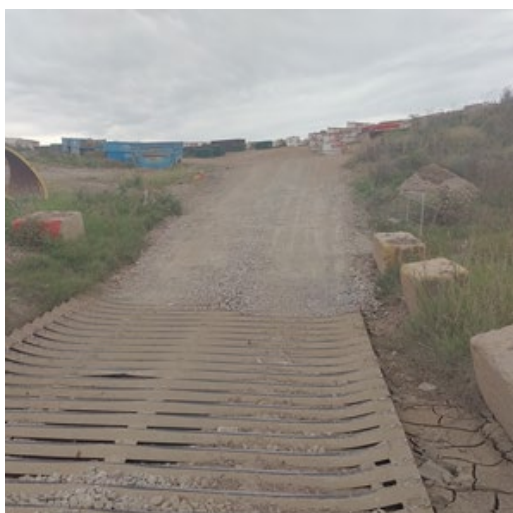
Assessed area 2 comprised the entrance to an area used to store skips (Figure 10) which were stacked throughout the site to allow access for large trucks. The ground was largely heavily compacted dirt and gravel with disturbance caused by trucks (Figure 11 and Figure 12); the area had narrow grass verges and islands of weedy vegetation. There appeared to be no undisturbed ground in this area.

**Figure 10. Entrance to skip area**

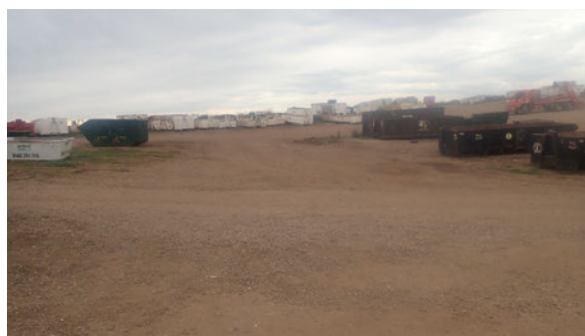
**Figure 11. Skip storage site showing denuded ground and gravel**

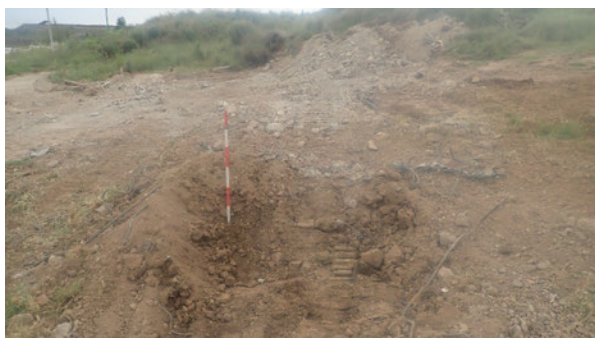
**Figure 12. Ground disturbance in skip storage area**

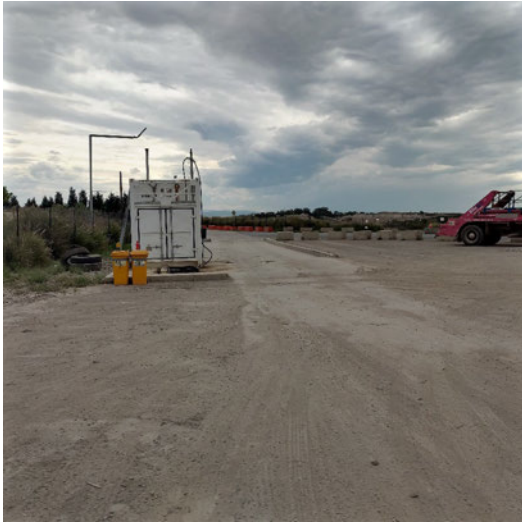
Assessed area 3 comprised two car parks and the verges of the road in the vicinity of the Learning Centre. The car park in front of the Learning Centre (Figure 13) was compacted dirt, with concrete blocks used to demarcate edgings and had little vegetation. The road verge (Figure 14) most distant to the quarry had been replanted with European trees at regular intervals and was interspersed with grass and weeds. Large concrete blocks delineated an access path in this area of heavy traffic. The similarly marked access way on the other side of the road, adjacent to the quarry, was fenced off (Figure 15). A small recess area where apparently redundant large equipment was housed, was grassed over in part. A second car park, with two tiers, had been surfaced with a rough gravel material. There appeared to be no undisturbed ground in this area.

**Figure 13. Carpark in front of Learning Centre**

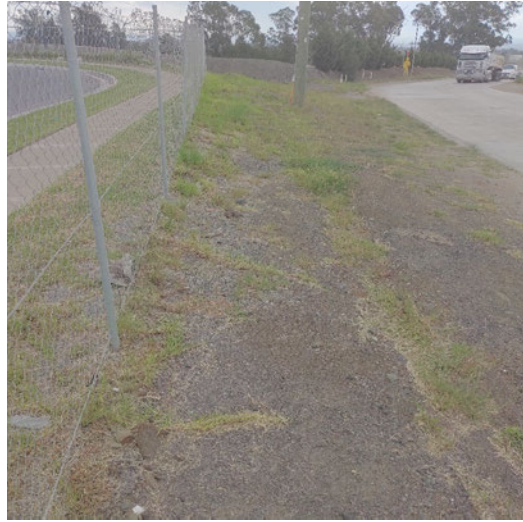
**Figure 14. Verges along road with replanted trees along edges**

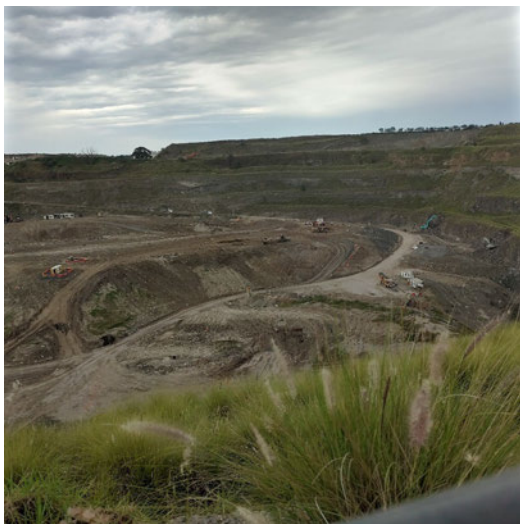
**Figure 15. View over quarry from road opposite Learning Centre**

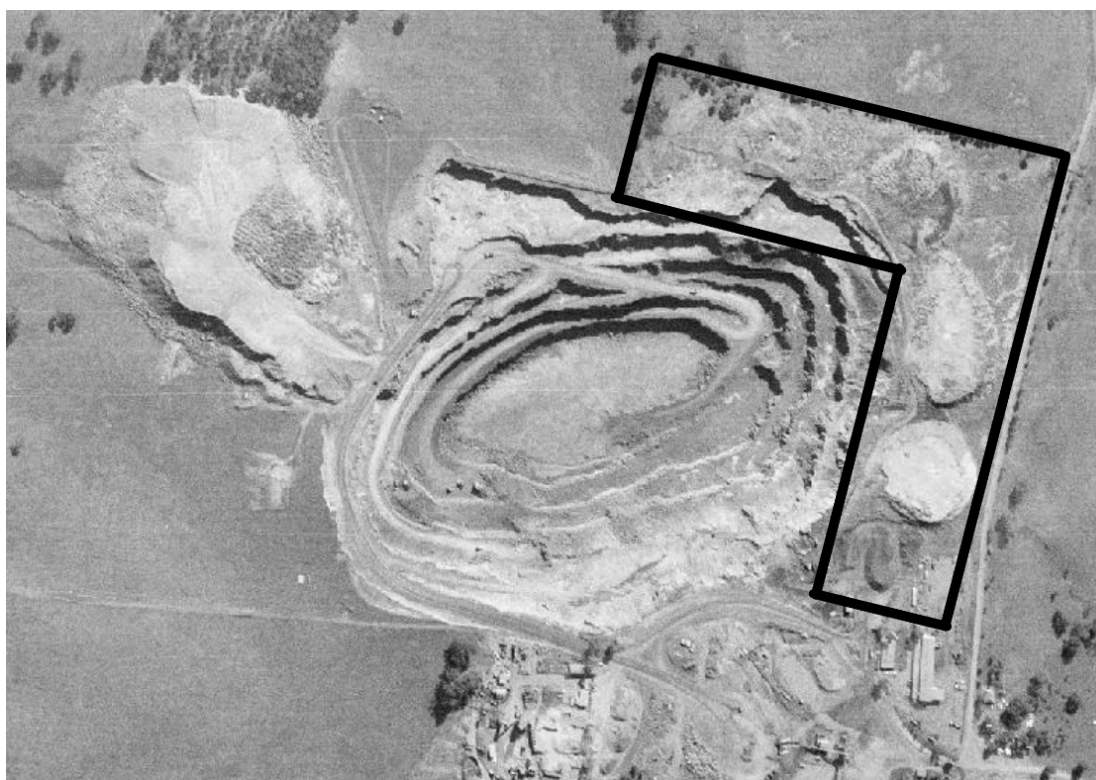
Examination of assessed areas 1, 2 and 3 did not reveal any Aboriginal objects or areas of archaeological potential, largely due to the heavily disturbed ground. Due to the constraints on the day of the visit, a site survey of the northern and eastern perimeter was not carried out. This area currently has areas of vegetation present. An examination of historical aerial maps was undertaken to establish the nature of the ground subsurface in the unvisited sections. Figure 16 is evidence of extensive ground disturbance currently not visible due to regrowth in this area especially in the perimeter area adjacent to the quarry void (see outline in black). In addition, the remainder of the northern perimeter has also been subject to industrial excavation. This part of the boundary formed part of the previous archaeological investigations and assessments as discussed above (Section 1.6). In summary, the study area is a heavily modified environment with little, if any, natural landscape remaining.

**Figure 16. Subsurface features of northern and eastern perimeters of study area apparent in aerial map taken in 1975 (Historical Imaging item number 2327\_05\_67, photographed 6/8/1975).**

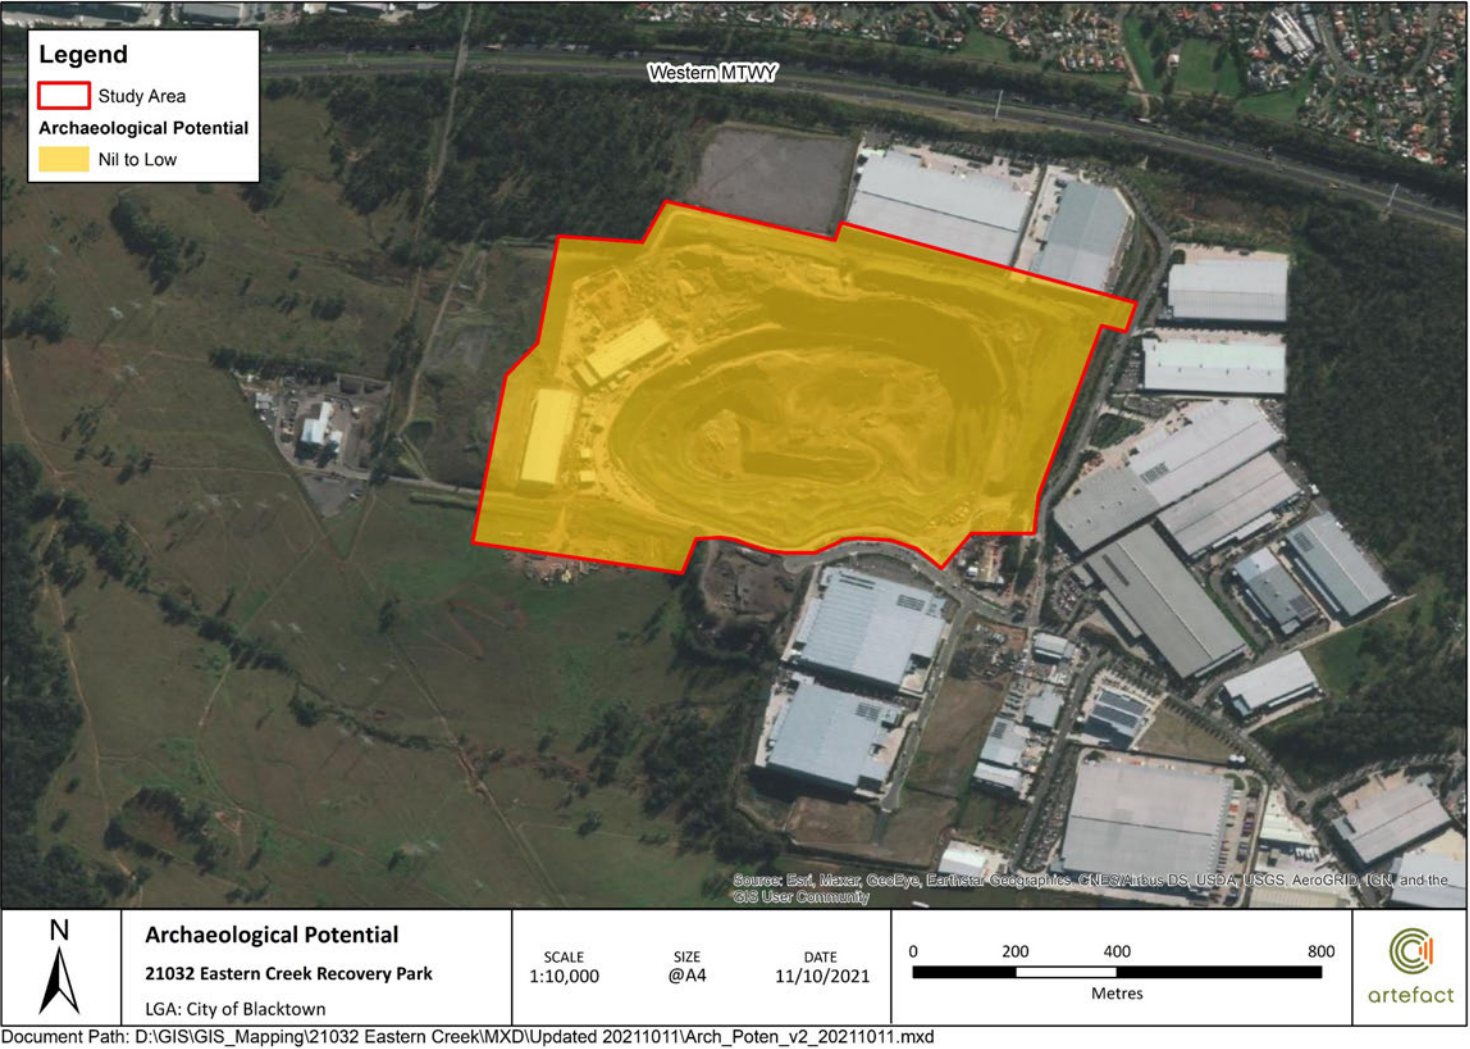
Figure 17. Areas of archaeological potential

This due diligence assessment has identified, within the Due Diligence Code of Practice, that the sections of the study area accessible on the day of the survey, together with the evidence of the historical aerial photographs, have been subject to past and continuing ground disturbance through past quarrying and construction activities and current operation of a waste management facility and associated activities that support this industrial process. This has resulted in the complete modification of the ground surface. Overall, the study area is assessed as having nil to low Aboriginal archaeological potential (Figure 17).

- As the study area was found to be comprehensively disturbed and to have a nil-low potential for Aboriginal objects to be located within it, it is recommended that further assessment is not required.
