**Re: Aboriginal Heritage Due Diligence Report – 72 and 82-86 Menangle Park Road, Camden**

Artefact Heritage and Environment Pty Ltd (Artefact) have been engaged by Homes NSW to prepare an Aboriginal Heritage Due Diligence Report for a housing development located at 72 and 82-86 Menangle Park Road, Camden.

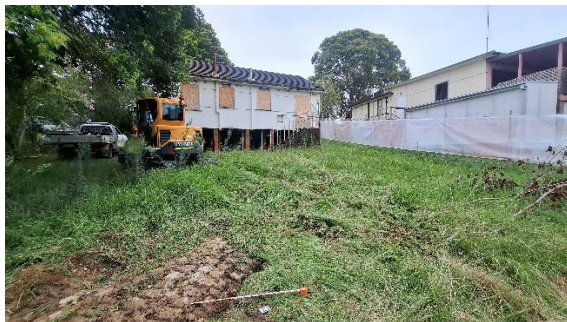
The visual inspection began at the property situated at 86 Menangle Road. The property is occupied by a mid to late 20<sup>th</sup> century fibro dwelling constructed on raised brick supports (Figure 8). The property naturally slopes from west to east down the side of the ridge line. Ground visibility was generally nil due to overgrown lawns in the west, south, and east of the property. The ground surface underlying the dwelling was exposed, showing a mid-brown clayey soil containing dispersed modern fill material (Figure 9). There was no disturbance identified in the rear of the property to the east. Due to the apparent construction of the building on brick piers, minimal ground levelling was involved in the structure of the house. No obvious subsurface services were identified in this portion of the study area.

**Figure 8: Rear of the property at 86 Menangle Road, facing northwest.**

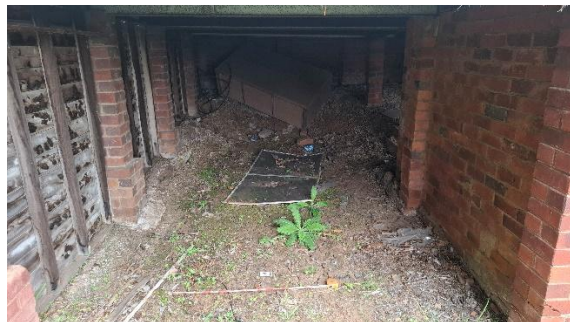
**Figure 9: Exposure under dwelling at 86 Menangle Road, facing west.**

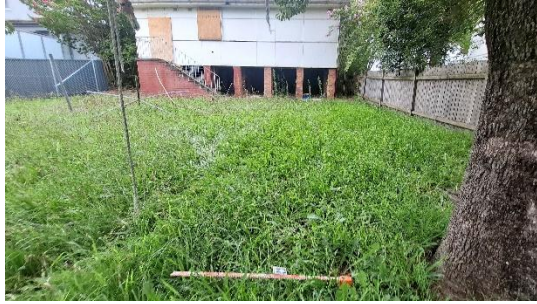
The visual inspection continued to the property located at 84 Menangle Road. The property was situated on a gradual slope orientated west to east. The property was occupied by a fibro building contemporary with 86 Menangle Road, constructed on brick piers. Ground visibility was generally nil across both the west and eastern portions of the property due to extensive grass coverage (Figure 10). The ground surface underlying the dwelling was exposed, showing a similar mid-brown clayey soil to the property at 86 Menangle Road (Figure 11). There was no obvious landform modification involved in the construction of the dwelling, due to its construction on brick piers. No subsurface services were identified in this portion of the study area.

**Figure 10: Rear of property at 84 Menangle Road, facing west.**

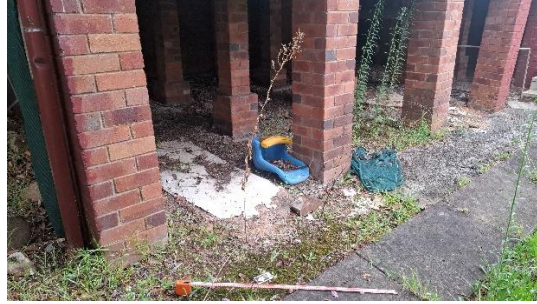
**Figure 11: Exposure underneath dwelling located at 84 Menangle Road.**

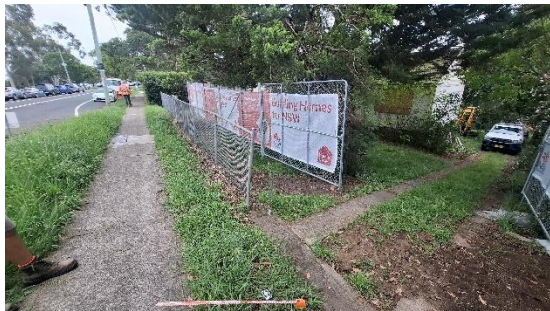
The visual inspection proceeded north into the property located at 82 Menangle Road. The property contains a fibro property constructed upon brick piers. 82 Menangle Road was situated on a gradually sloping landform orientated west to east from the edge of Menangle Road (Figure 12). Ground visibility was generally nil due to extensive grass coverage and concrete paving forming the rear garden space and alley to the east and north of the property (Figure 13, Figure 14). However, the south-eastern corner of the property featured an exposure, with mid-brown clayey topsoil visible (Figure 15). Underneath the property the ground surface was additionally exposed and showed a light-brown clayey soil. Overall, minimal landform modification occurred to facilitate the construction of the dwelling at 82 Menangle Road. The western and southern edges of the property also demonstrated minimal signs of disturbance. Several subsurface services were identified within the northern and eastern portion of the property, potentially disturbing the subsurface soil profiles there.

**Figure 12: Sloping landform from the edge of Menangle Road outside 82 Menangle Road, facing north.**

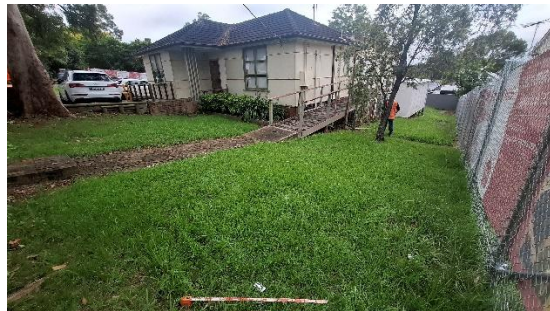
**Figure 13: Front of property at 82 Menangle Road, facing northeast.**

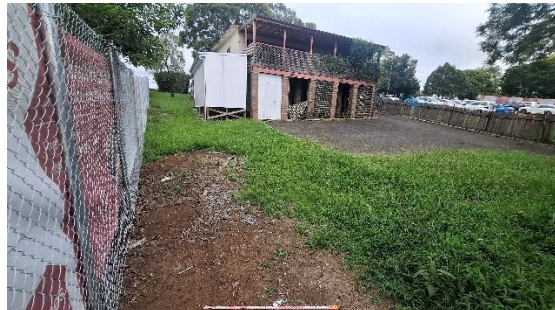
**Figure 15: Rear of property at 82 Menangle Road, facing west.**

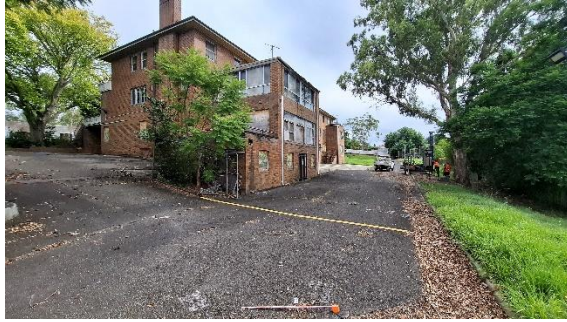
The site inspection then moved north into the property located at 80 Menangle Road. The property slopes steeply from the edge of Menangle Road towards the east. The property was occupied by a large brick structure (Figure 16, Figure 17). The western portion of the property contained a grassy verge sloping eastwards, bordered by a concrete path (Figure 18). Directly east of the structure was an open garden space, containing a large non-native tree. The property was situated upon a gradually sloping landform from west to east.

Figure 16: Southern carpark and structure at 72 Menangle Street, facing north.

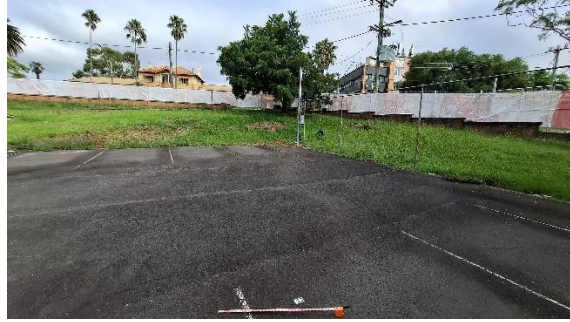
Figure 17: Northern carpark within 72 Menangle Road, facing northwest.

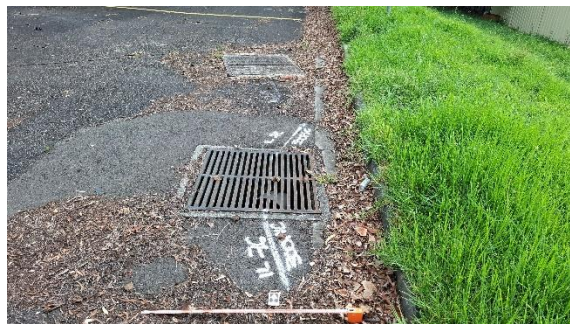
Portions of the property indicated signs of disturbance. Several subsurface services were identified running through carparks to the north and south (Figure 19). The eastern side of the property was bordered by a steep, grassy embankment, which gradually sloped down to the east (Figure 20). The eastern portion of the property was potentially cut and reformed to create a level surface for the construction of the structure, redepositing fill to create the embankment. Similarly, the northern carpark was likely created through levelling the sloping landform. The embankments surrounding the northern carpark contained loose blocks of sandstone. The sandstone was likely not natural, as it was worked and not associated with the natural geology of the area. Therefore, the sandstone was likely placed as a garden retaining wall, associated with an earlier phase of the property. The landform underlying the structure and the concrete path to the west was additionally levelled during construction.

Figure 19: Services located in south of 72 Menangle Road, facing north.

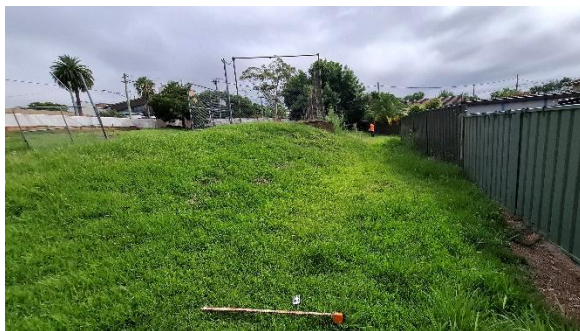
Figure 20: Sloping embankment located at eastern portion of 72 Menangle Road, facing north.
