## **Report on Geotechnical Investigation**

### **Proposed Residential Development**

**72 and 82-86 Menangle Road, Camden  
NSW**

**Project 239951.01**

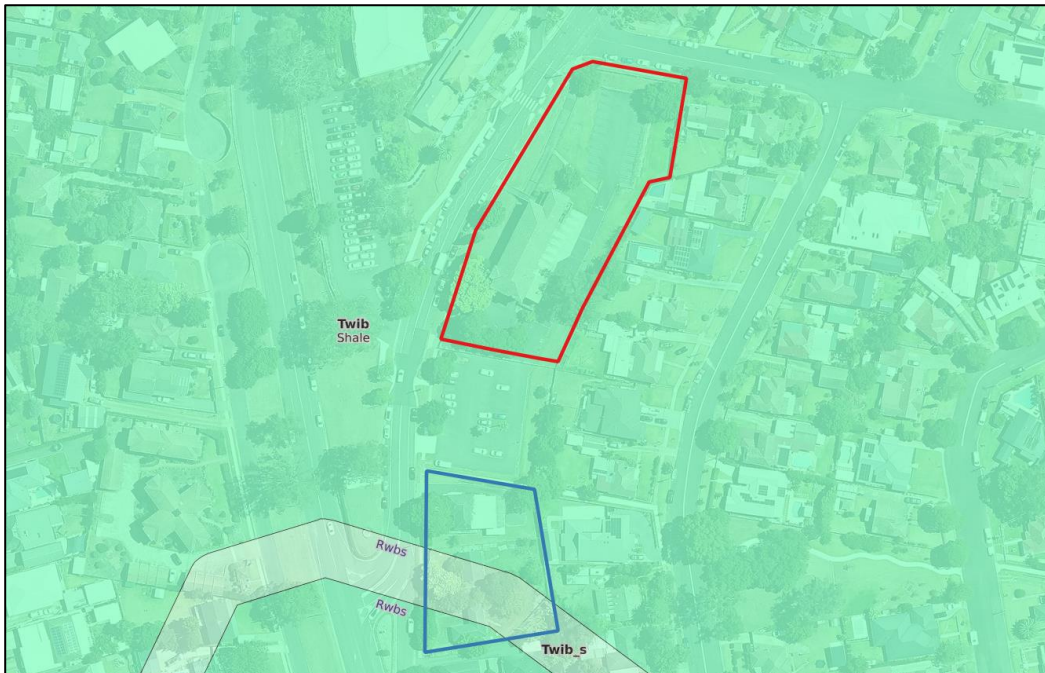
**Figure 1: Regional geology**

The NSW Seamless Geological Series (GSNSW, 2019) indicates that the site is underlain by Triassic aged Bringelly Shale (mapping unit Twib) of the Wianamatta Group. Bringelly Shale typically comprises shale, carbonaceous claystone, claystone, laminite and fine to medium-grained lithic sandstone with occasional coal and tuff. A portion of the southern site (at 82-86 Menangle Road)

is underlain by Bringelly Shale sandstone of the Triassic age and Wianamatta Group (mapping unit 'Twib\_s') which is typically comprised of fine to medium grained quartz-lithic sandstone.

Where: Dark green = Bringelly Shale (Twib)  
Light green – Bringelly Shale Sandstone (Twib\_s)
