## **Remediation Action Plan**

### **Proposed Residential Development**

**72 & 82-86 Menangle Road, Camden NSW**

**Project 239951.00**

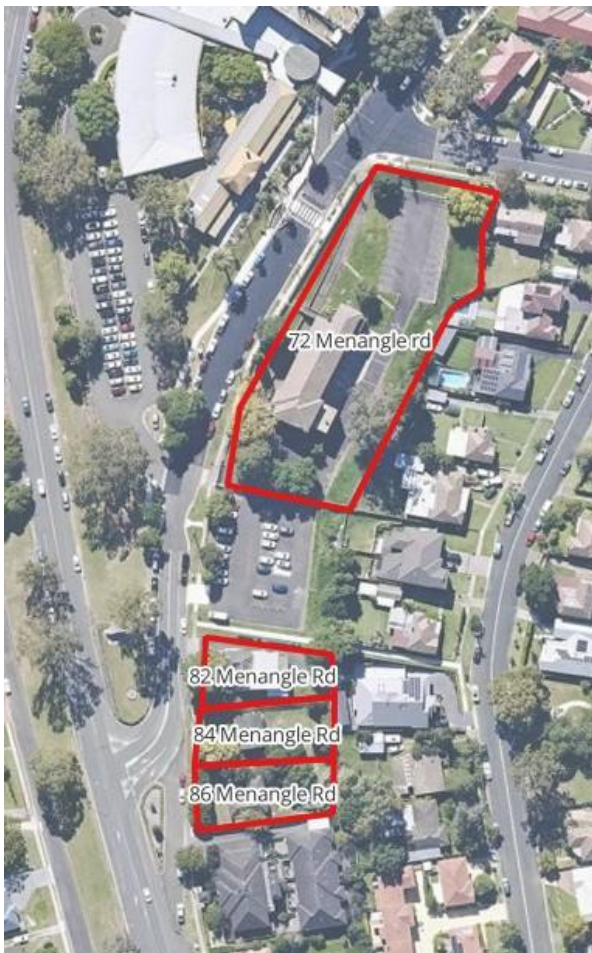
**Figure 1: Site location**

The site boundary is shown on Figure 1.

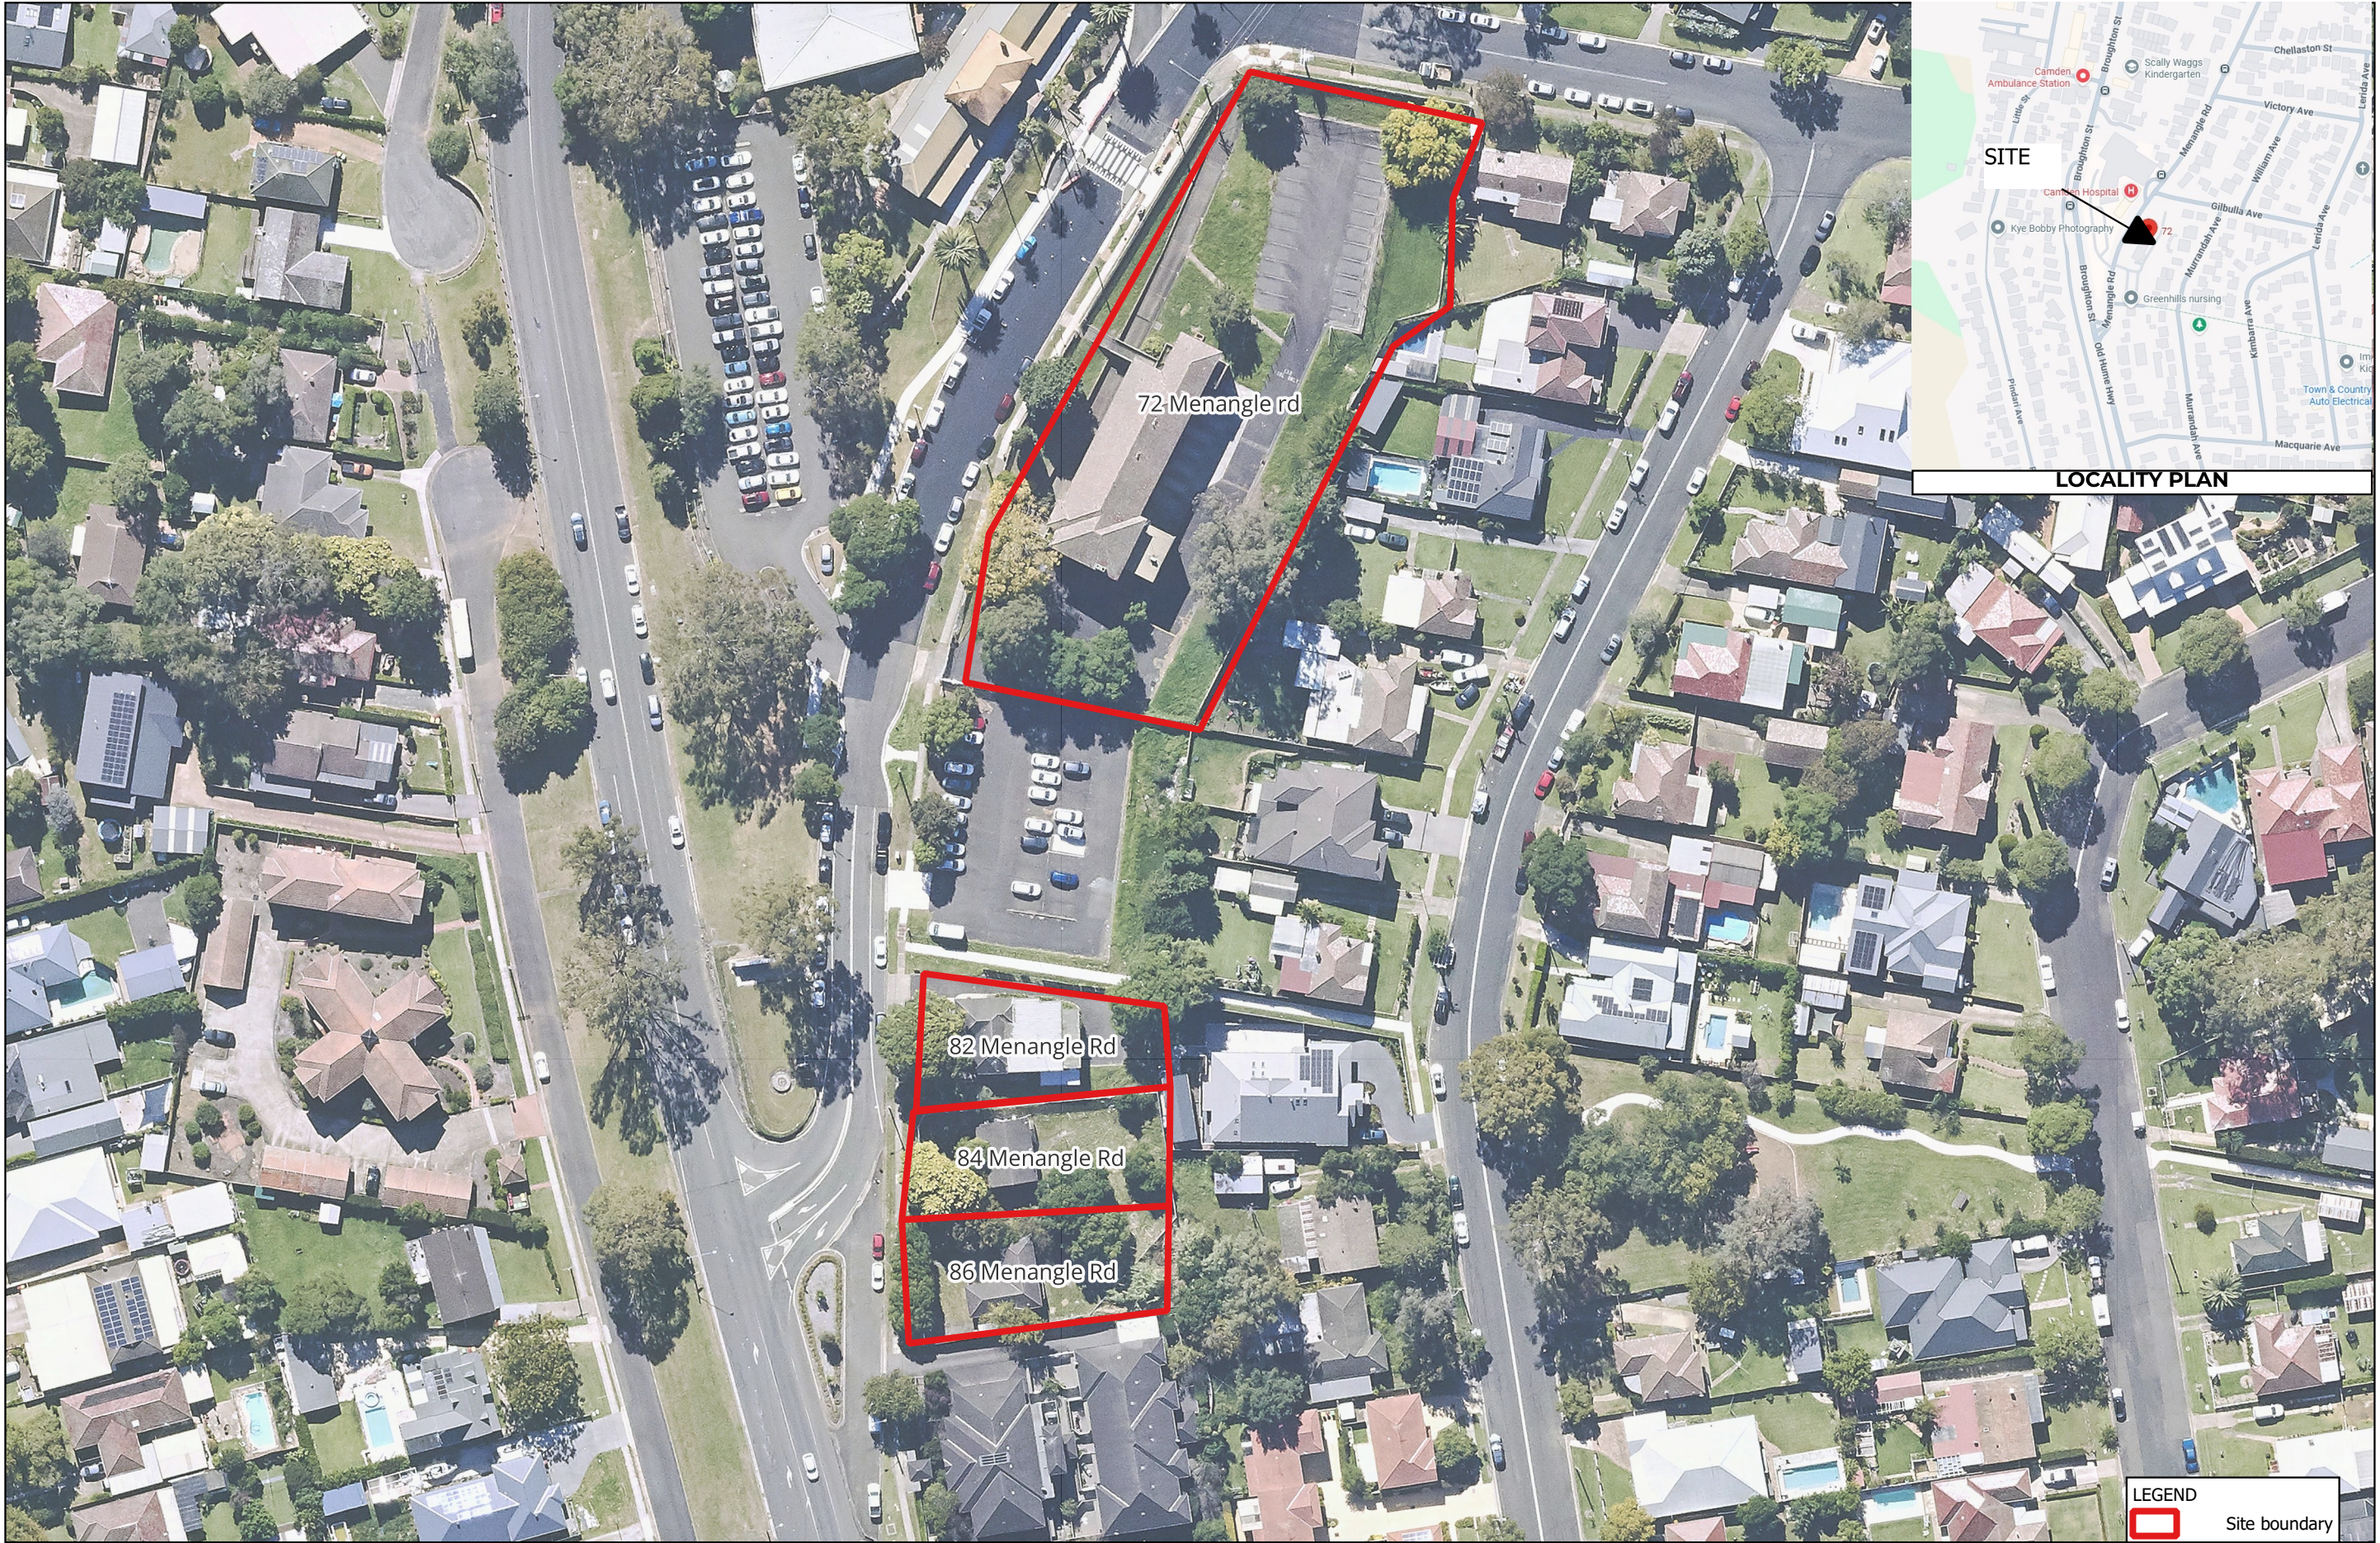
| REV | PSI | DATE | DRAWN BY | <br>OFFICE: MACARTHUR<br>18 Waler Crescent, Smeaton Grange NSW 2567<br>(02) 4647 0075 | CLIENT:<br><br>Homes NSW | NOTE:<br>1: Basemap from MetroMap (Dated 30.09.2025) | PROJECT NAME:<br><br>Proposed Redevelopment | DRAWING TITLE:<br><br>SITE LOCATION AND LAYOUT | PROJECT NO:<br><br>239951.00 | |

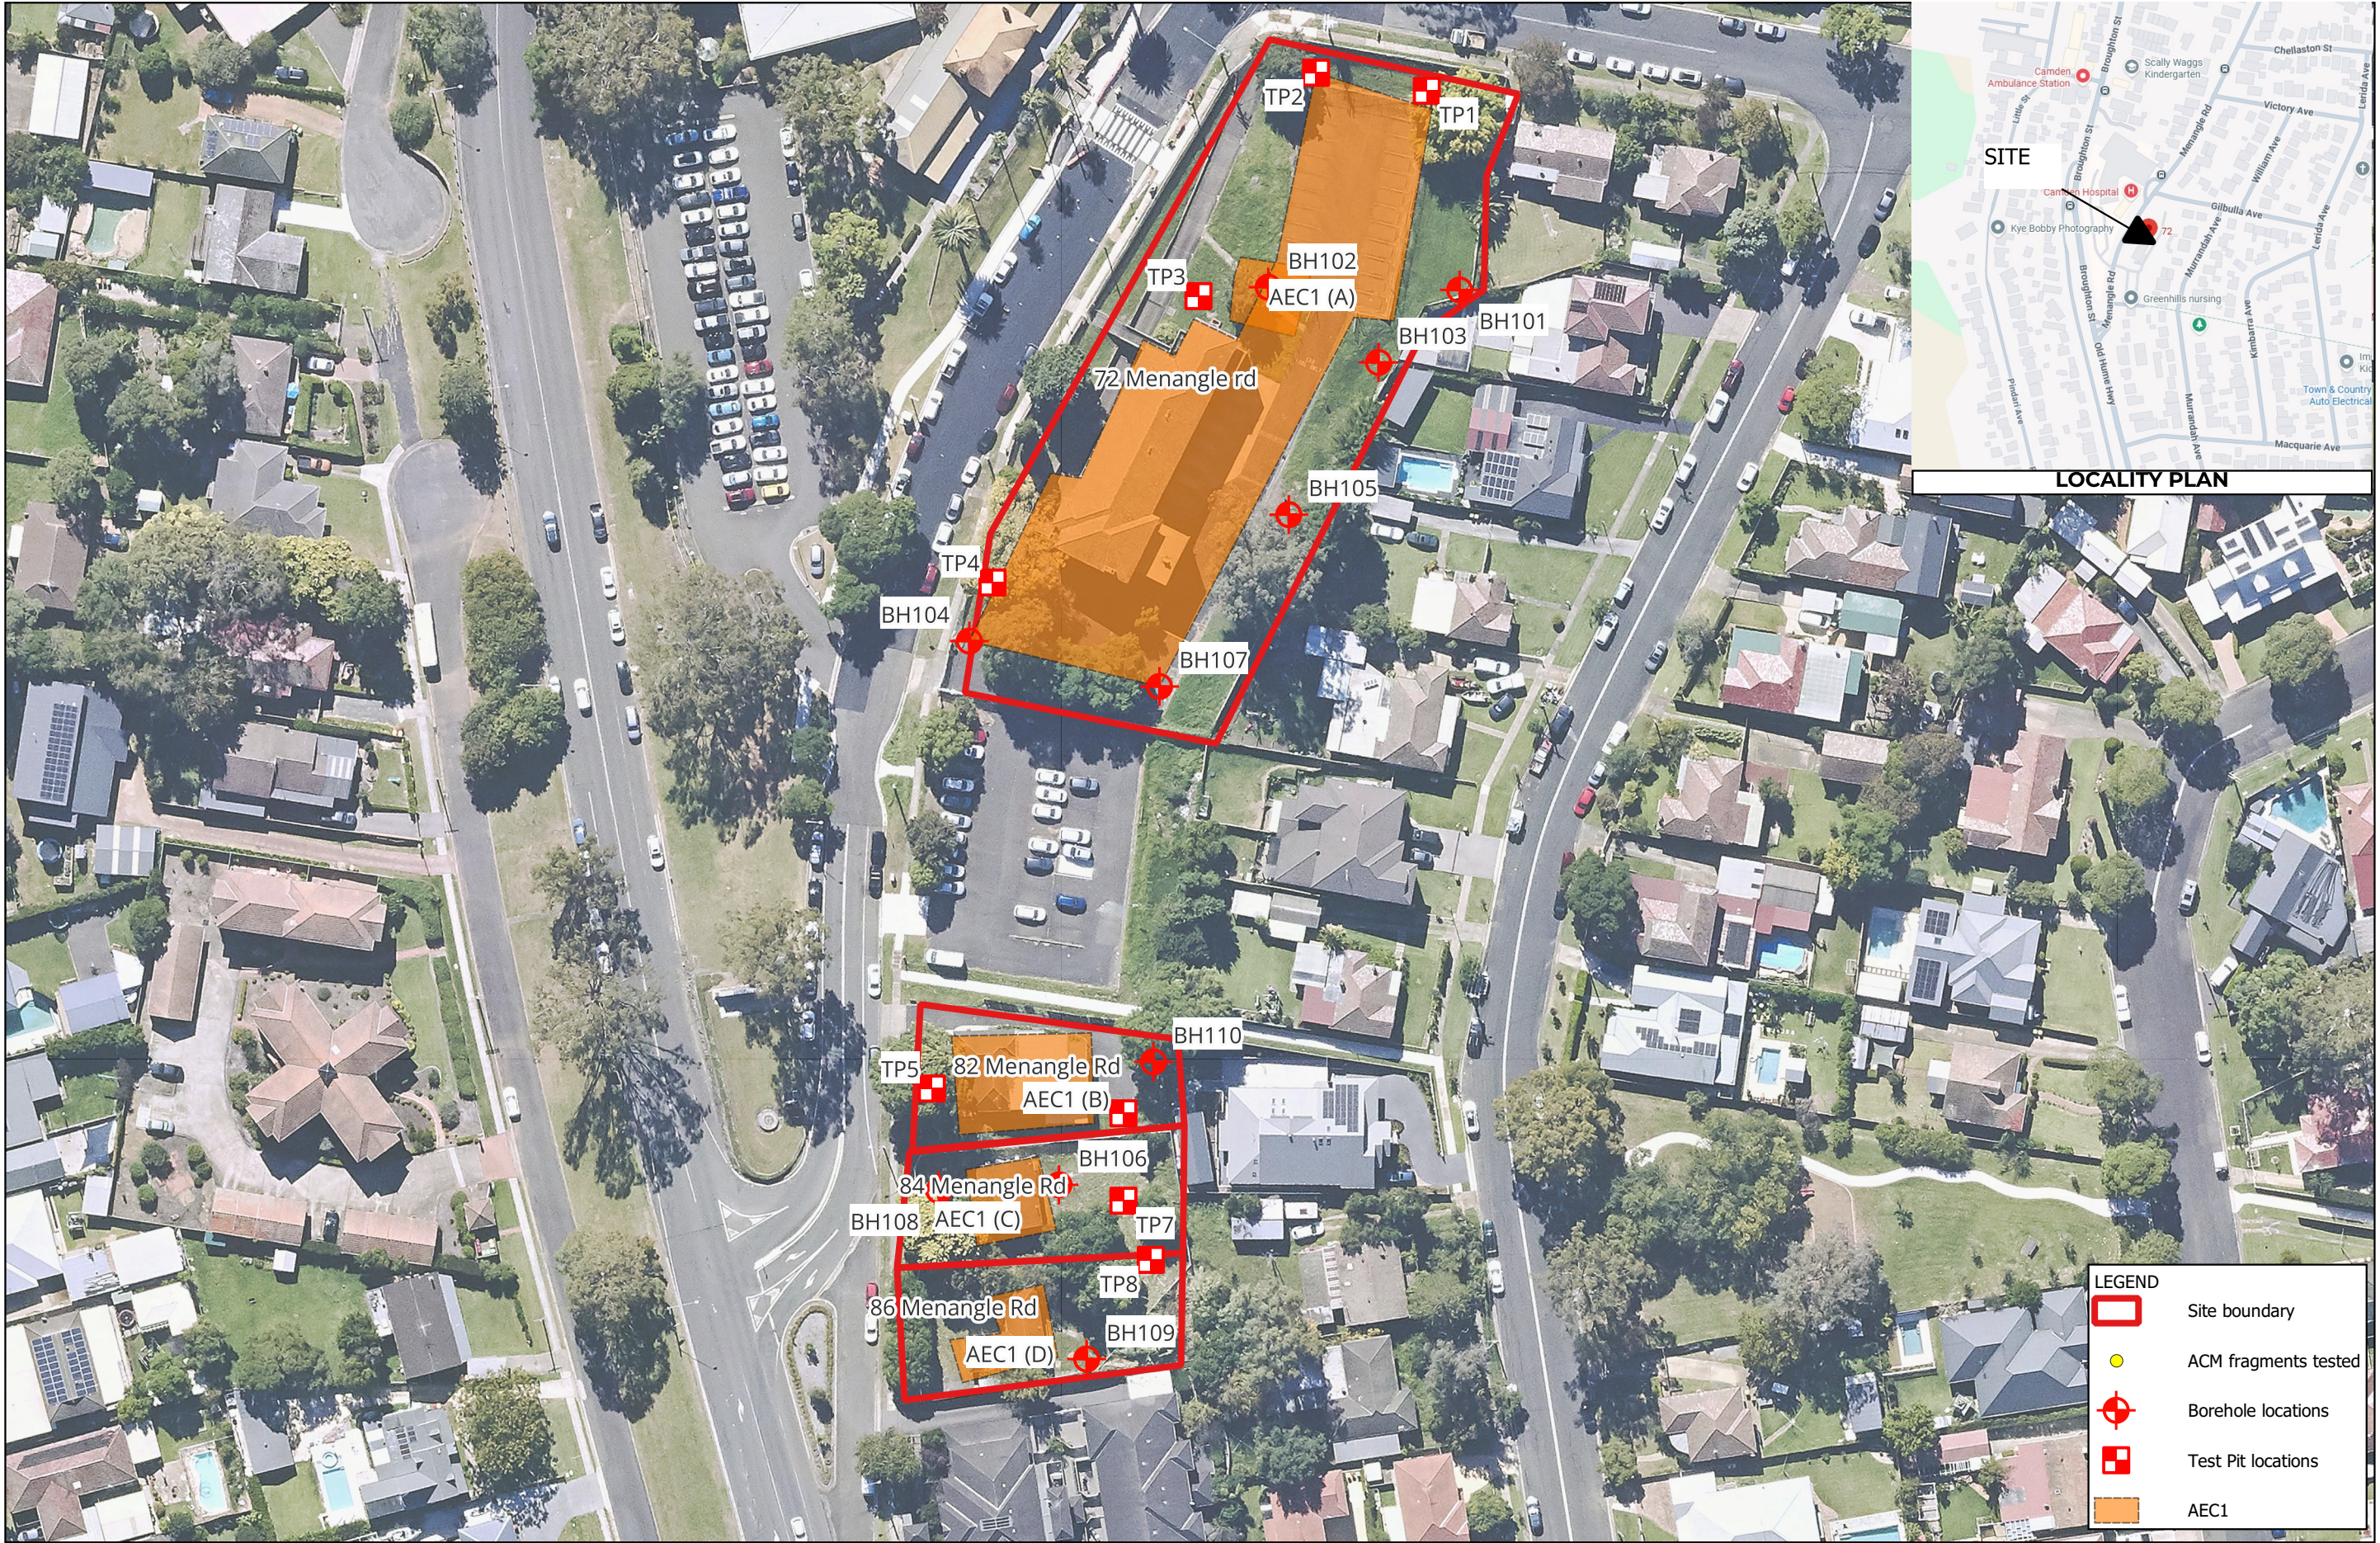
| REV | PSI | DATE | DRAWN BY | <br><b>Douglas</b><br>PARTNERS<br>OFFICE: MACARTHUR<br>18 Waler Crescent, Smeaton Grange NSW 2567<br>(02) 4647 0075 | CLIENT:<br><br>Homes NSW | NOTE: | PROJECT NAME: | <br>COORDINATE REFERENCE SYSTEM:<br>GDA2020, MGA ZONE56 | DRAWING TITLE:<br><br><b>Sample Location Map and<br/>identified Areas of<br/>Environmental Concern (AEC)</b> | PROJECT NO: |
