ACID SULFATE SOILS MANAGEMENT PLAN

August 2021
J169135

SCHOOL
INFRASTRUCTURE
NSW (SINSW) -
DEPARTMENT OF
EDUCATION

Proposed Sydney Olympic Park High
School

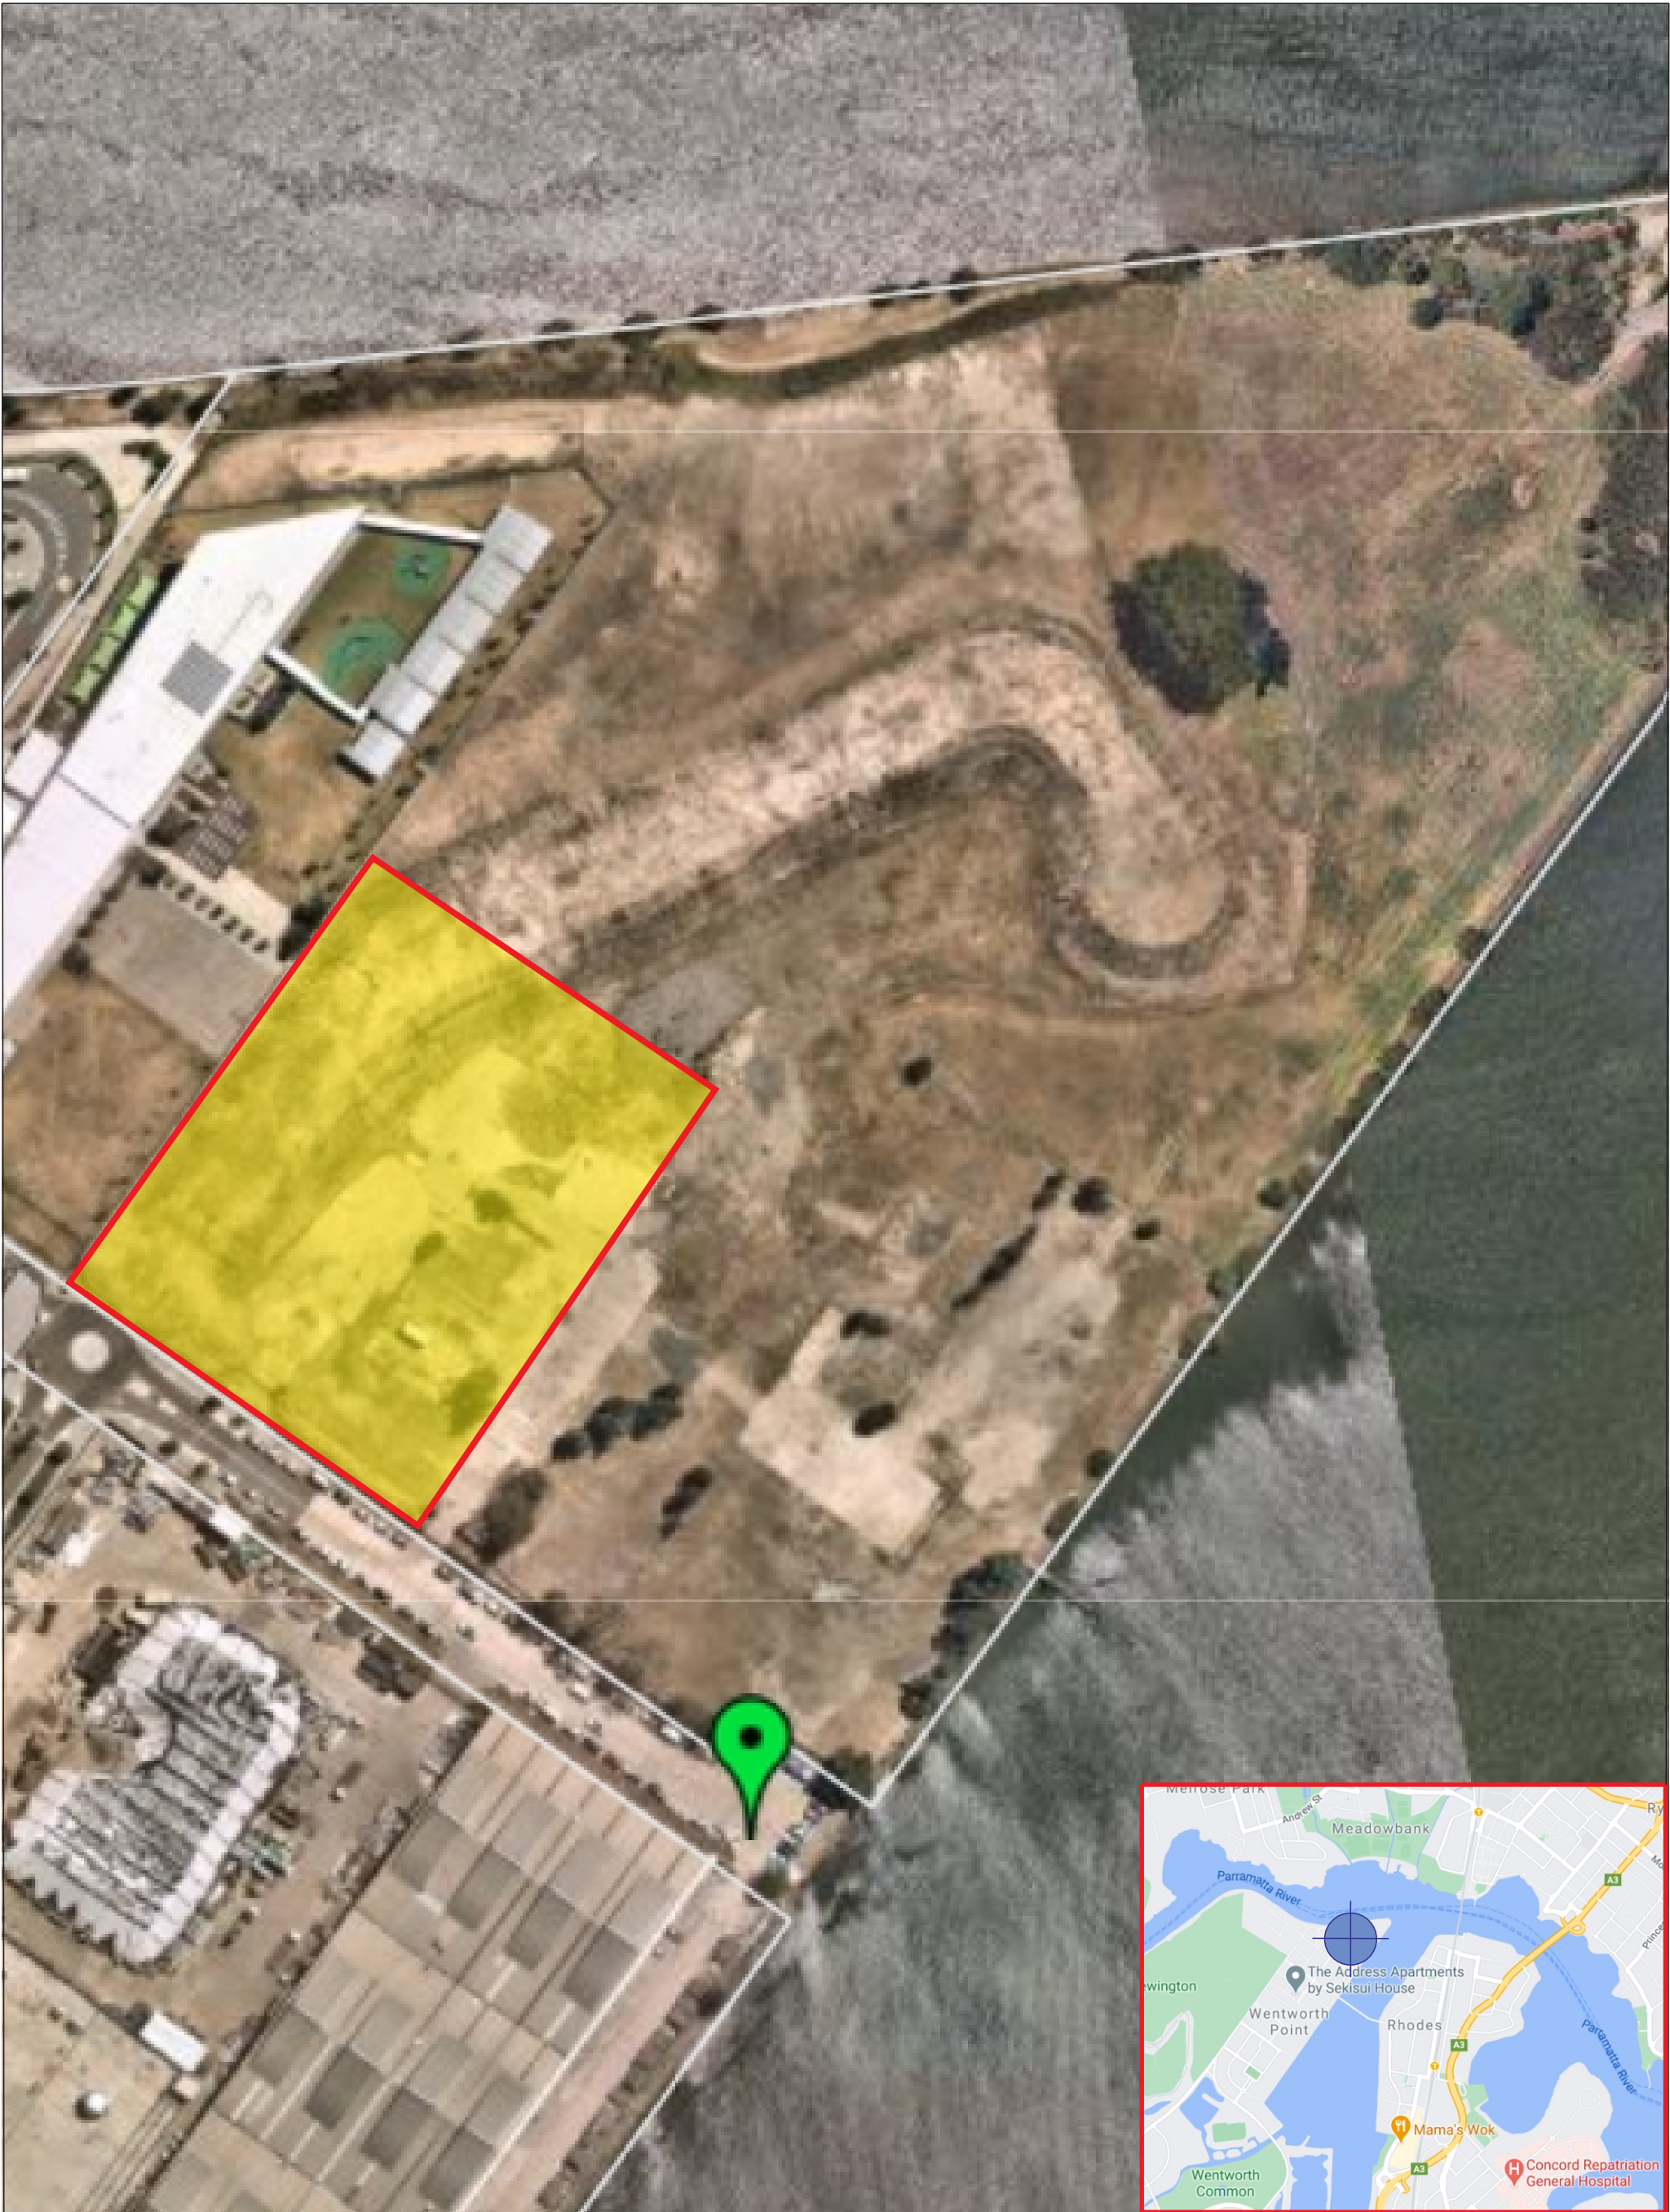
<div><div><div></div><div>New Site Boundary</div></div><div><div></div><div>Site Location</div></div></div> <div><div>015304560</div><div>Metres</div><div></div></div>	<div><div><div>GREENCAP</div><div>Going Further in Managing Risk</div></div><div>G, N - Building, 22 Giffnock Ave Macquarie Park, NSW 2113</div><div>Ph: 02-9889-1800</div><div>Fx: 02-9889-1811</div></div>	Client Name:		Department of Education (School Infrastructure NSW)							
		Client Number:		C123934			Project Number:		J169135		
		Project Description:		Acid Sulfate Soils Management Plan - SOPHS							
		Address:		Proposed Sydney Olympic Park High School, 7-11 Burroway Road, Wentworth Point, NSW 2127							
		Prepared:		SW		Reviewed:		MB		Version Date:	
Figure 1		Site Location and Regional Context

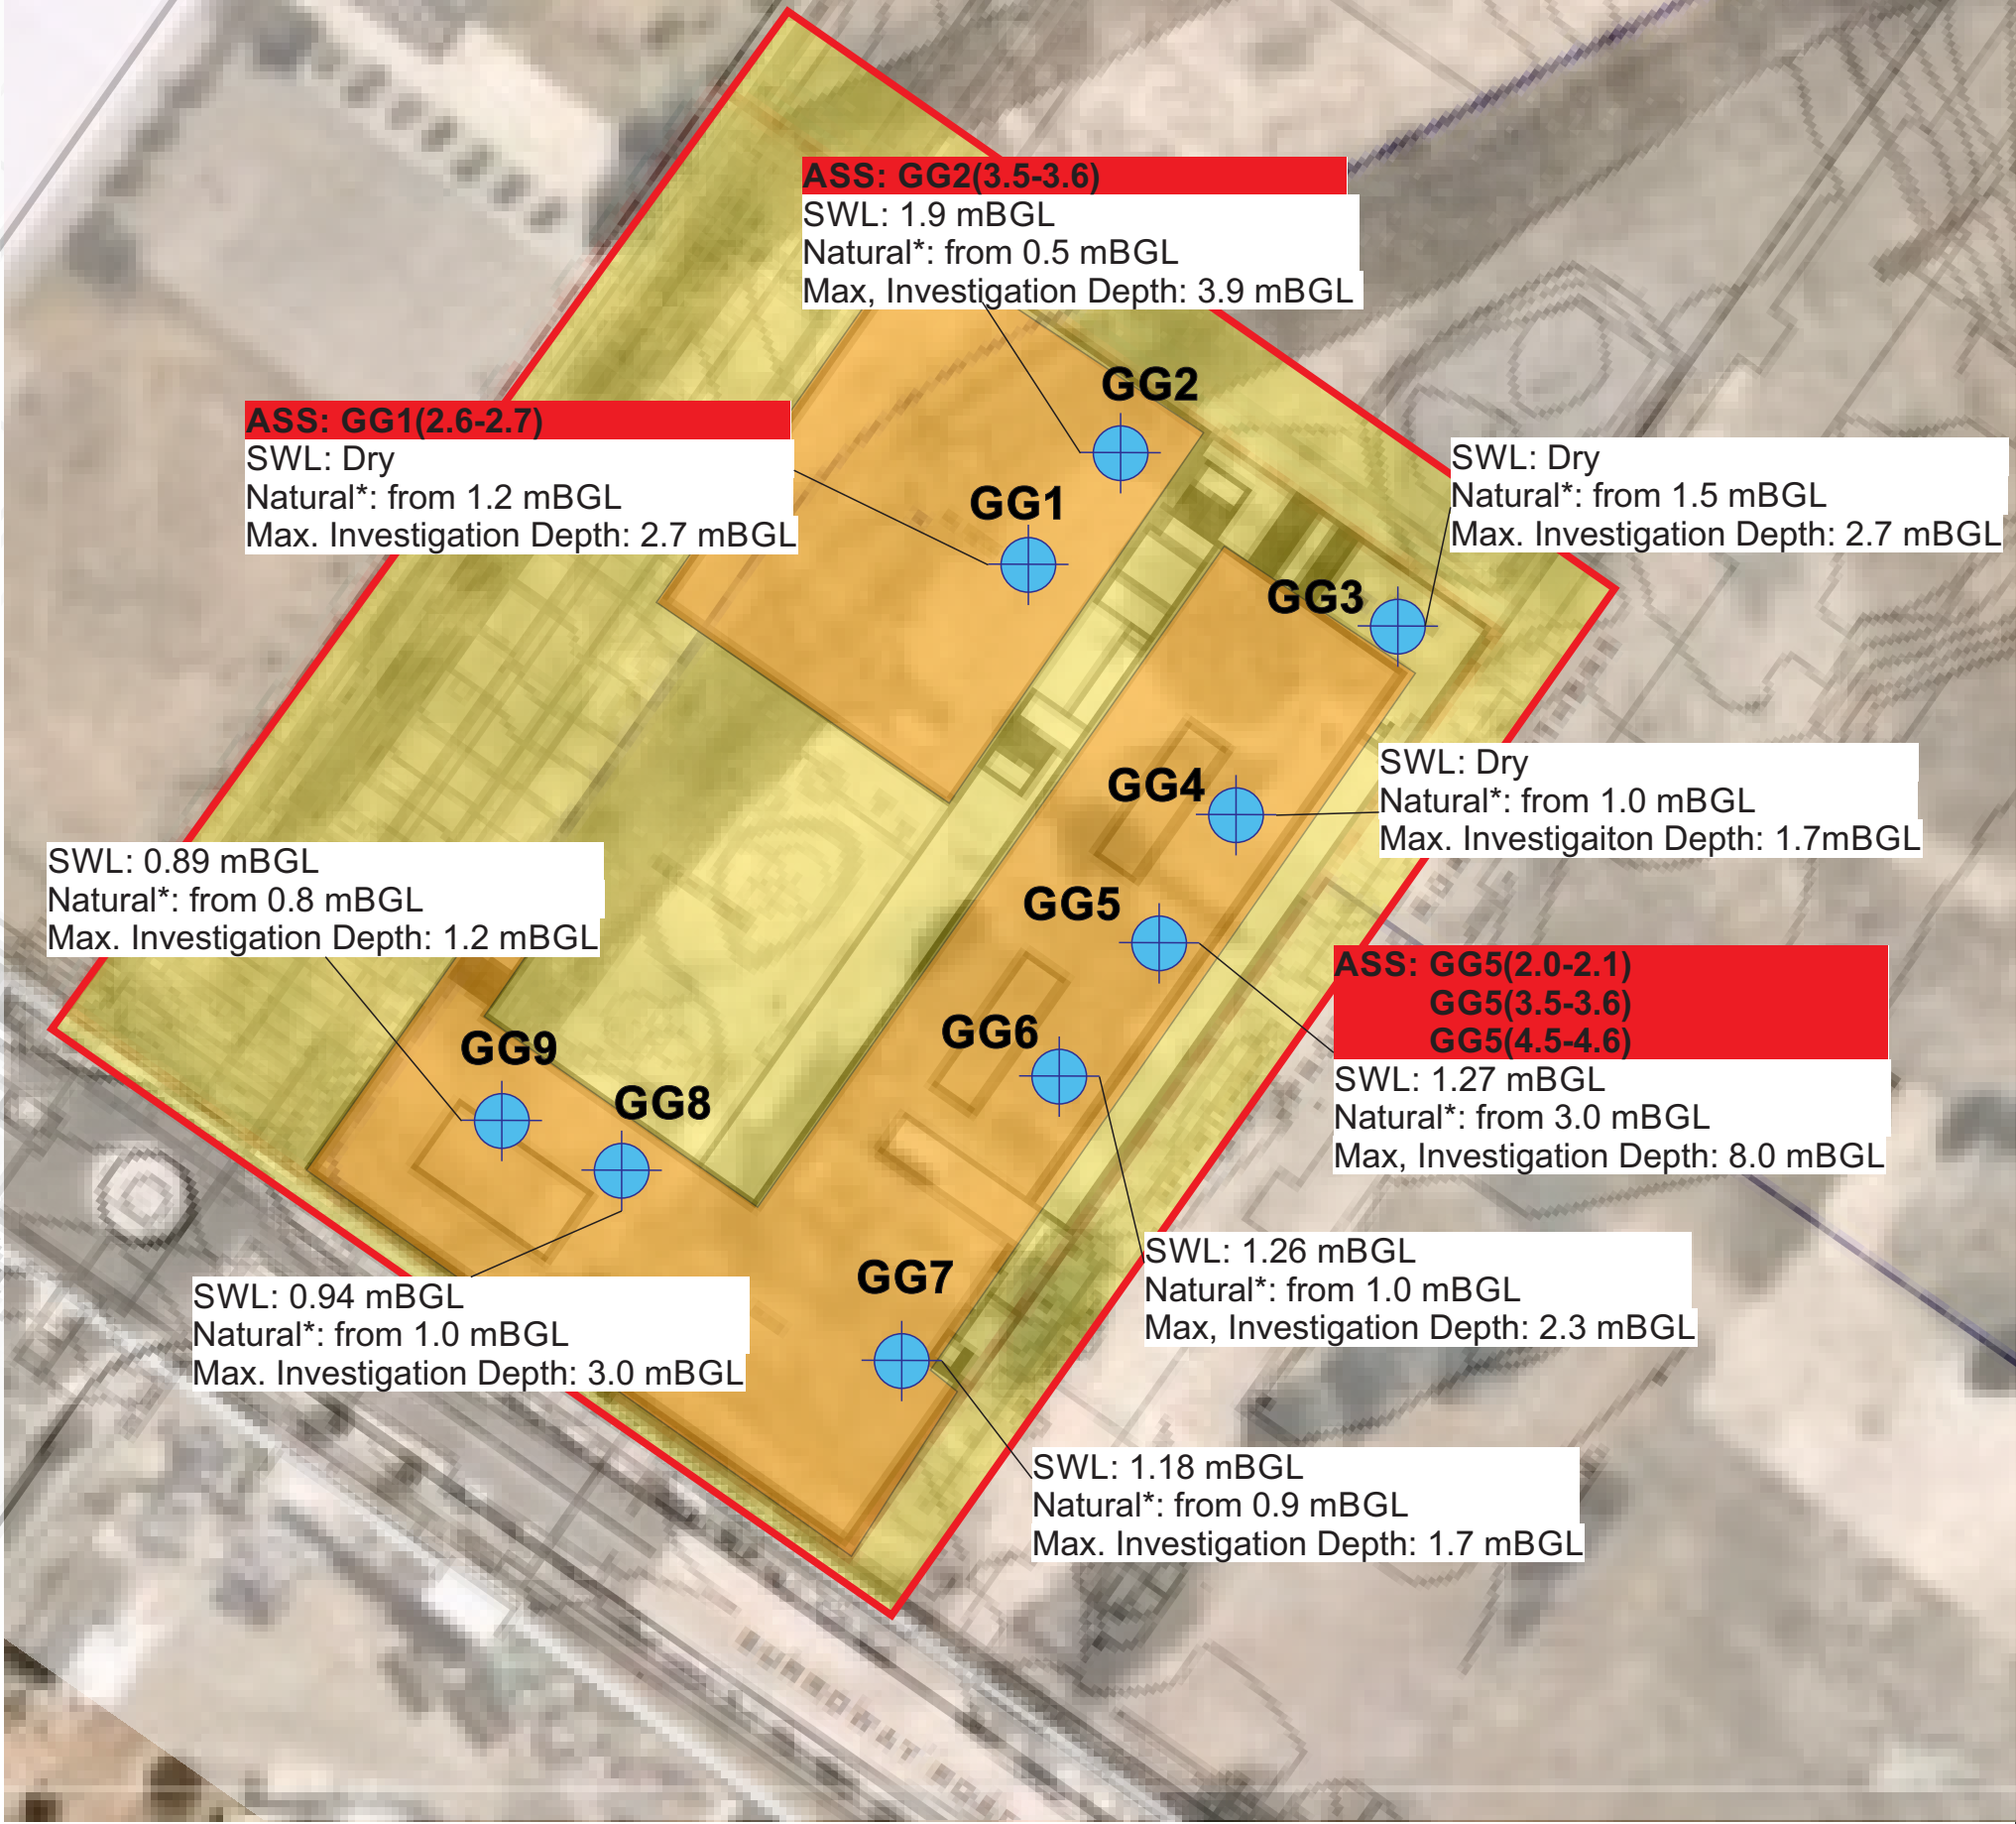
NOTE: Acid sulfate soils are expected at the entire site (not only at the investigation locations where exceedance were recorded), generally in depths ranging bet ween 1.0 mBGL to 6.0 mBGL.

Field sampling and analysis was undertaken in general accordance with the *NSW Acid Sulfate Soil Assessment Guideline 1998*. Nine boreholes targeted proposed building footprint were drilled, logged by Greencap at the locations shown on **Figure 2**. Borehole Logs are included in **Appendix A**. Fill Material was recorded at all locations. Dredged natural material in the form of wet loose sand was encountered below fill layer and it was followed by grey to black high plasticity natural clay. 13 samples were collected from 7 boreholes where hydrogen sulfide odour was detected. The soil had hydrogen sulfide odour was noted as dark brown to dark grey sandy clay and clayey silt with inclusion of shells. 13 samples sealed in zipped plastic bags without void were stored in an esky with ice and were sent to Eurofins (A NATA Accredited Laboratory) within same day for ASS pH screening to assess the presence of PASS and AASS. Refer to **Appendix B** for pH screening results.

The previous ASS investigation indicated that ASS comprised of dark grey sandy clay and clayey sand (with shells) presents at generally > 1 (below Standing Water Levels) - < 6 mBGL on site. As the distribution of ASS is not consistent, all natural soils including both dredged natural sandy soils underneath the fill layer and high plasticity clay should be considered as ASS and treated with lime. Excavated ASS should be stockpiled separately and managed under an Acid Sulfate Soils Management Plan. Based on the lab results, it was recommended that soils be neutralised with lime at a recommended rate up to 38 kg lime per tonne of soil (a field safety factor of **1.5** should be applied to the liming requirement rate).
