# North Sydney Public School

## Geotechnical Desktop Study

NSW Department of Education

**Report reference number: SYDG290593AB**

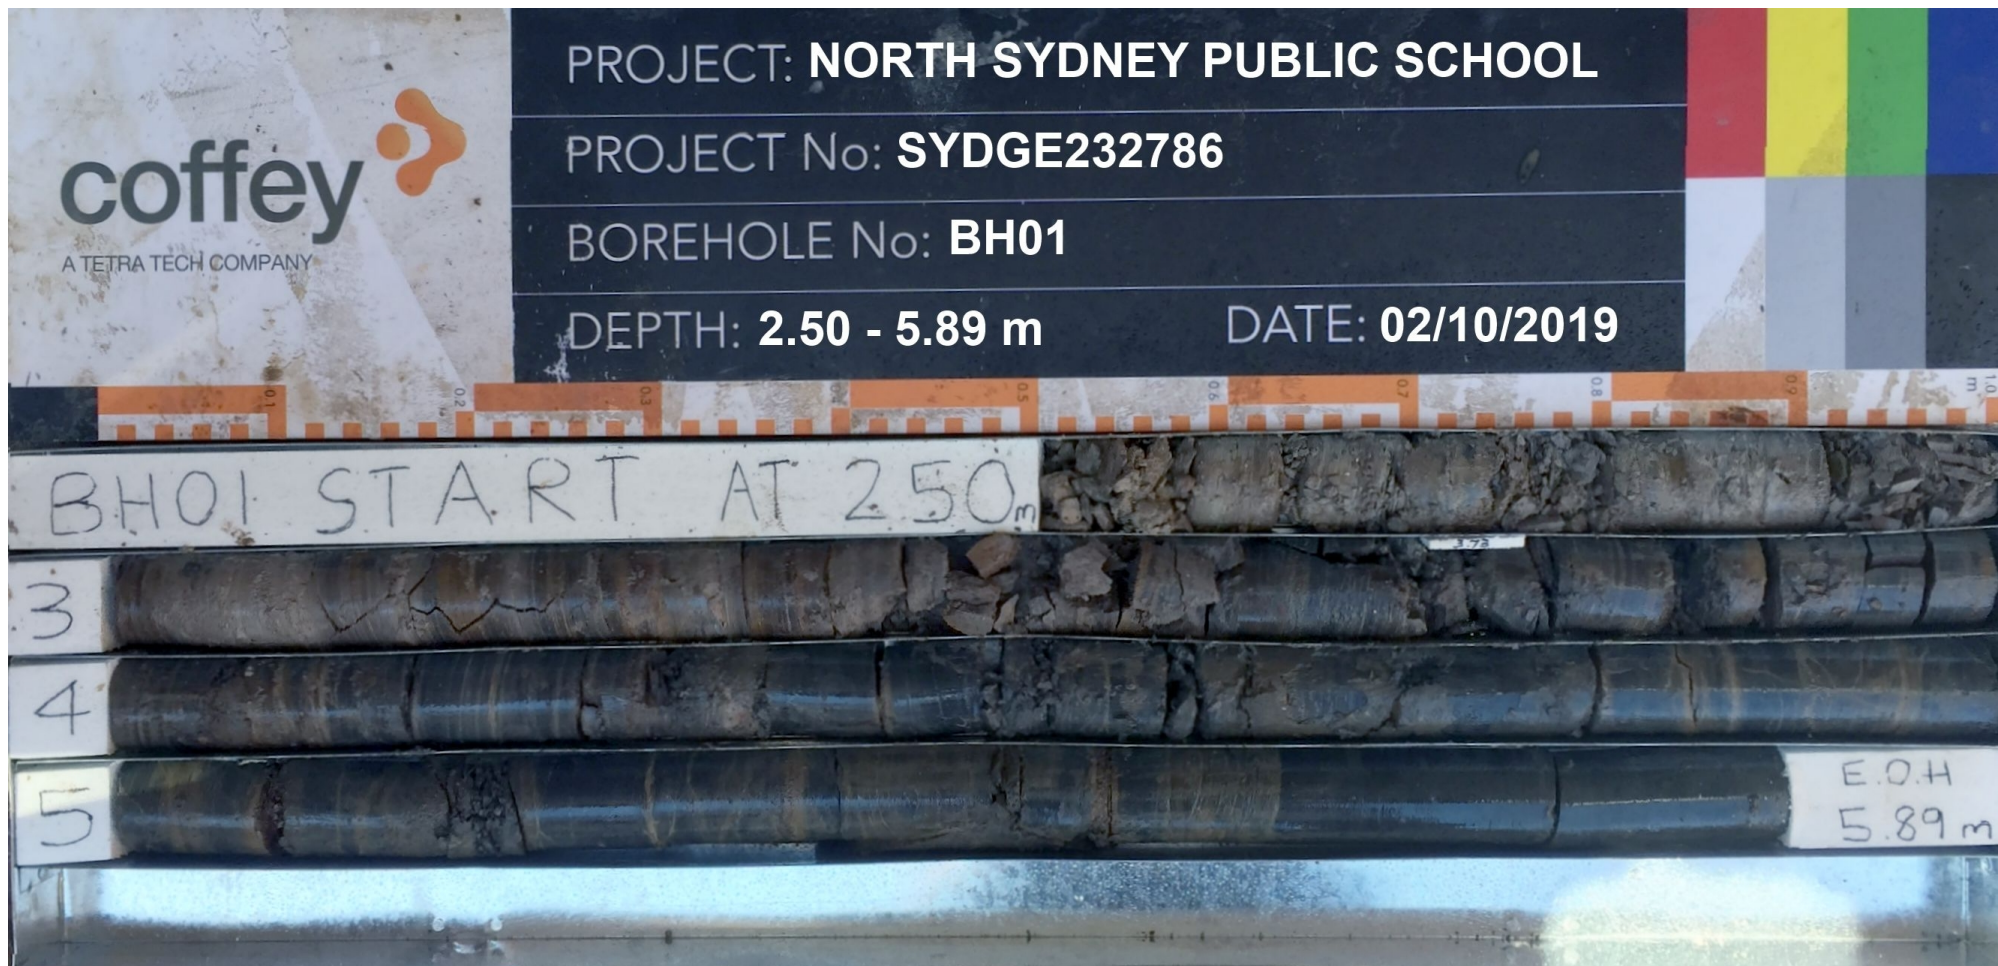
BH01 2.50 - 5.89 m

drawn			client:	NSW Department of Education		
approved			project:	North Sydney Public School North Sydney		
date	17-10-2019		title:	<b>CORE PHOTOGRAPH BH01</b>		
scale	N.T.S.		project no:	SYDGE232786	fig no:	<b>FIGURE 1</b>
original size	A4				rev:

1.0								
			2.0								
			3.0		started coring at 2.50m						
			4.0		SHALE: pale brown, pale grey, distinctly laminated at 0° - 10°, with iron staining.	HW - MW					CS, 0°, IR, RO, CN CS, 0°, IR, RO, CN CS, 0°, IR, RO, CN CS, 0°, IR, RO, CN CS, 0°, IR, RO, CN
