North Sydney Public School

Geotechnical Investigation

Report reference number: SYDGE290593-AE

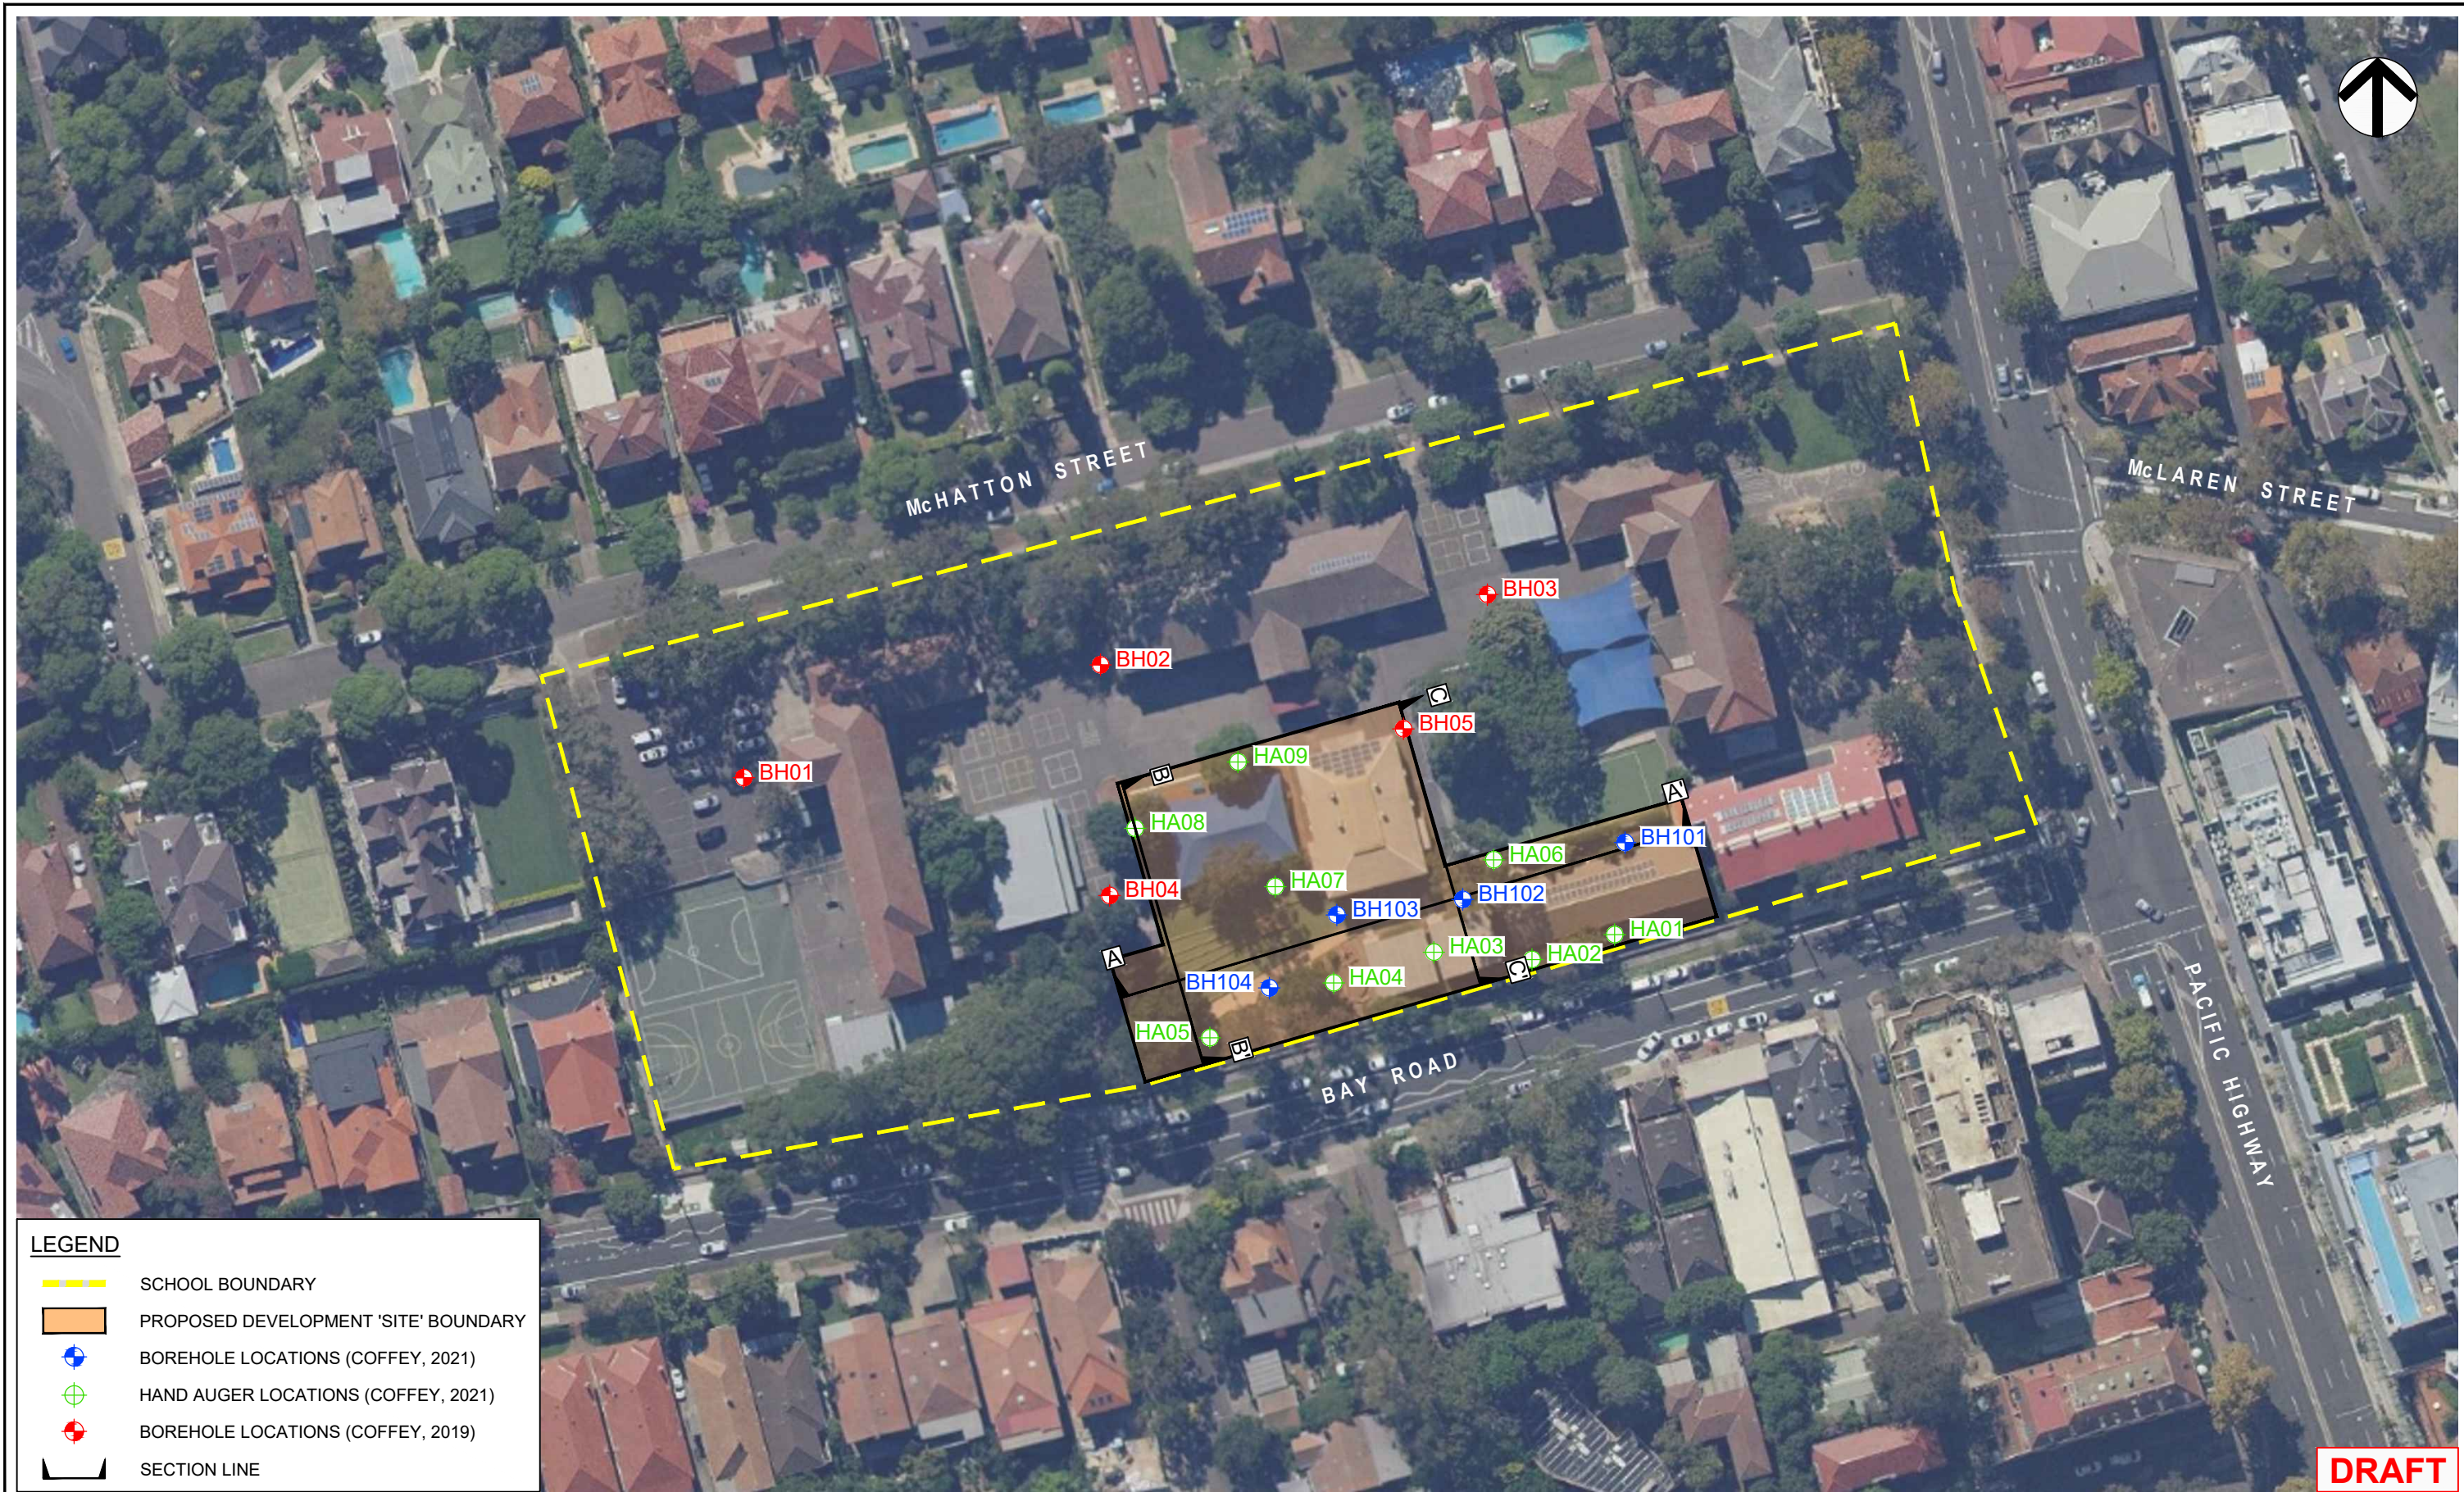
Figure 1: Borehole Location Plan

Figure 1 attached shows the proposed development 'site' within the school. Architectural drawings of the proposed development provided by the client are shown in Appendix D.

client:	SCHOOL INFRASTRUCTURE NSW		
project:	NORTH SYDNEY PUBLIC SCHOOL DETAILED SITE INVESTIGATION PACIFIC HIGHWAY, NORTH SYDNEY, NSW		
title:	BOREHOLE LOCATION PLAN		
project no:	754-SYDGE290593-AE	figure no:	FIGURE 1
		rev:	A

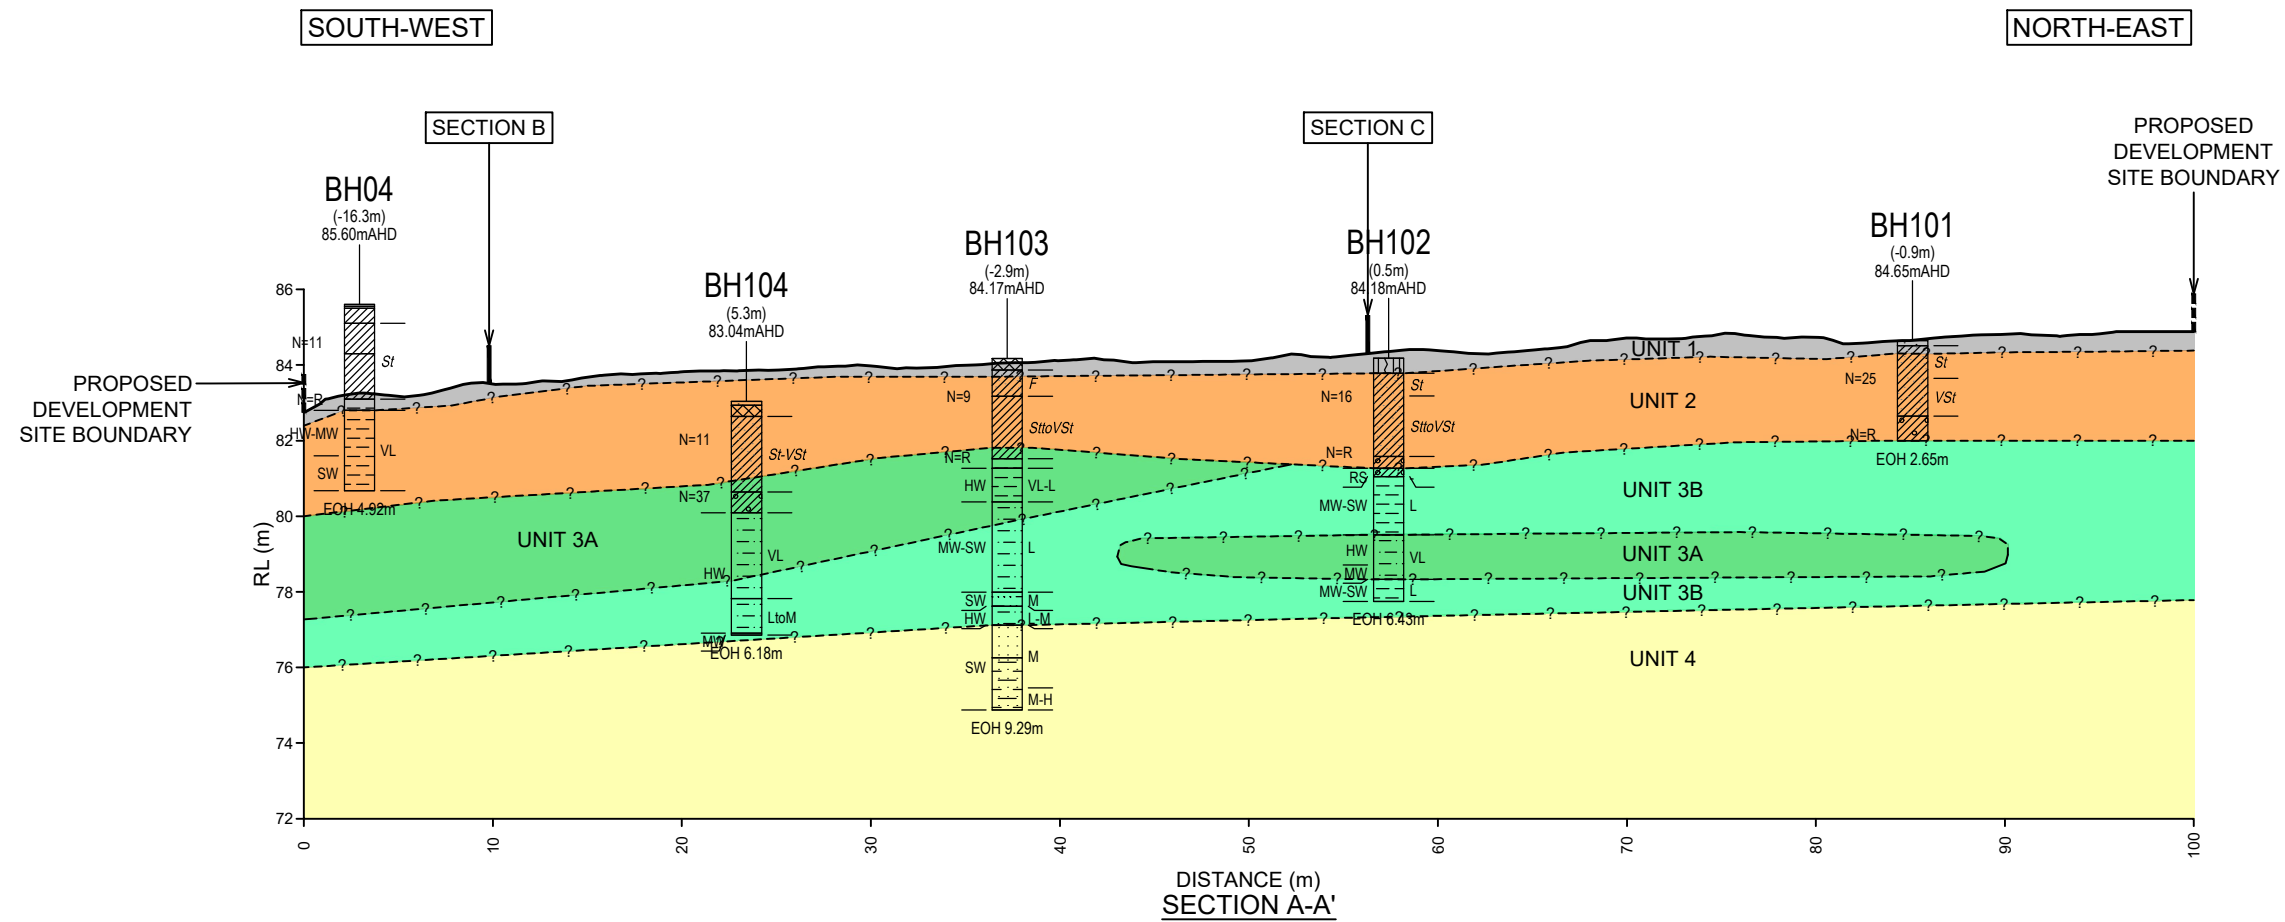
Figure 2: Section A-A'

revision	no.	description	drawn	approved	date	 Horizontal Scale (metres) 1:400 Vertical Scale (metres) 1:200	drawn	AM / AW		client:	SCHOOL INFRASTRUCTURE NSW		
	A	ORIGINAL ISSUE					approved	-		project:	NORTH SYDNEY PUBLIC SCHOOL DETAILED SITE INVESTIGATION PACIFIC HIGHWAY, NORTH SYDNEY, NSW		
							date	06/10/2021		title:	SECTION A-A'		
							scale	AS SHOWN		project no:	754-SYDGE290593-AE	figure no:	FIGURE 2
							original size	A3		rev: A

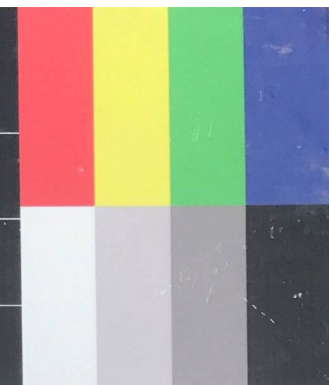
BOREHOLE No: BH102

DEPTH: 2.91 - 6.43m DATE: 20/9/21

SYDGE290593 BH102 START CORING AT 2.91m

A Coffey geotechnical engineer was present on site for the duration of works to observe the drilling, record test results, box and photograph the rock core samples, and log the encountered ground conditions.

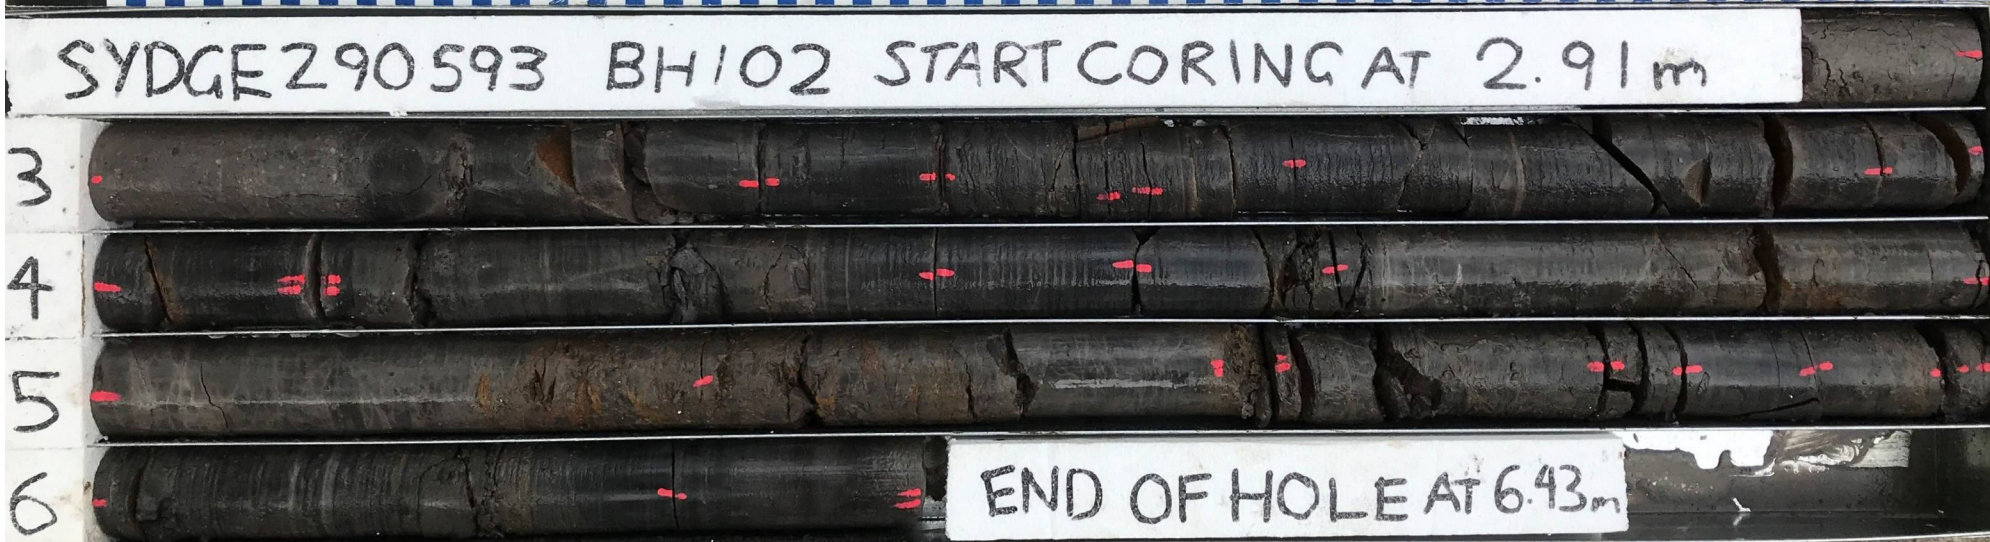
END OF HOLE AT 6.43m

drawn	AM		client:	NSW Department of Education		
approved	AM		project:	North Sydney Public School 182 Pacific Highway, North Sydney 2060		
date	1/10/2021		title:	CORE PHOTOGRAPH BH102		
scale	N.T.S.		project no:	754-SYDGE290593	fig no:	FIGURE 1
original size	A4		rev:

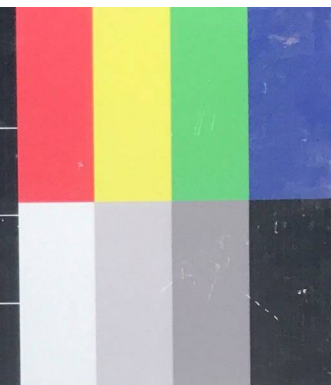
BOREHOLE No: BH104

DEPTH: 2.95-6.18m DATE: 20/9/21

SYDGE290593 BH104 START CORING AT 2.95m

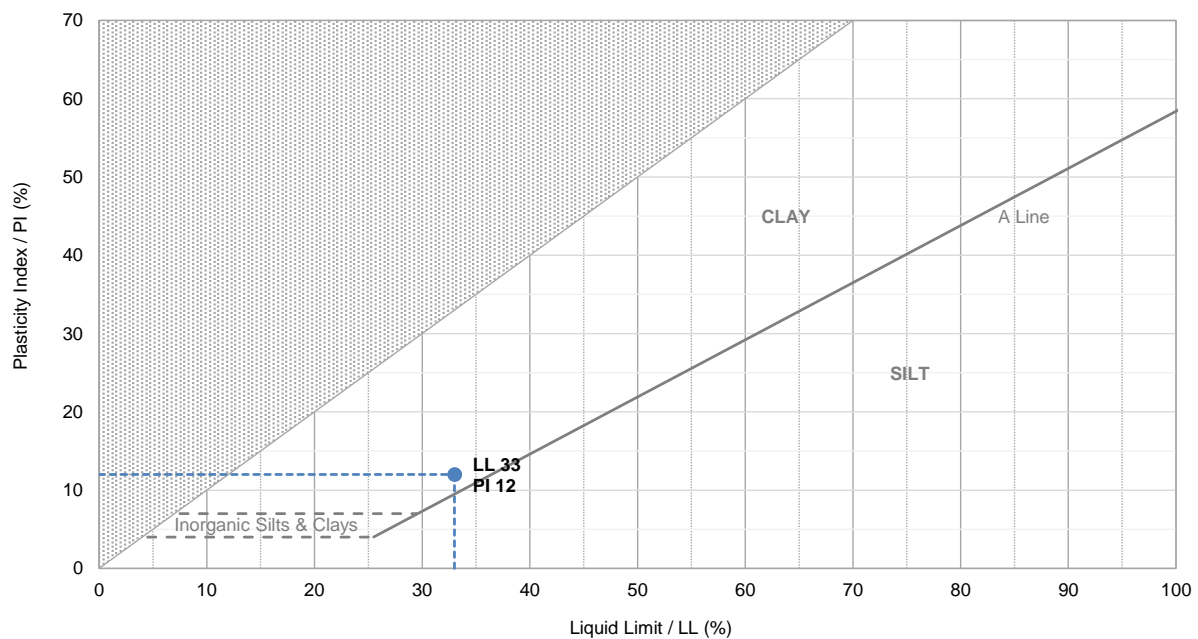
Plasticity Chart for Classification of Fine-Grained Soils

Preparation		Results	
Method of Preparation	Dry Sieved	Liquid Limit / LL (%)	33
History of the Sample	Air Dried	Plastic Limit (%)	21
		Plasticity Index / PI (%)	12
		Linear Shrinkage (%)	5.5
		Condition upon Drying	Linear

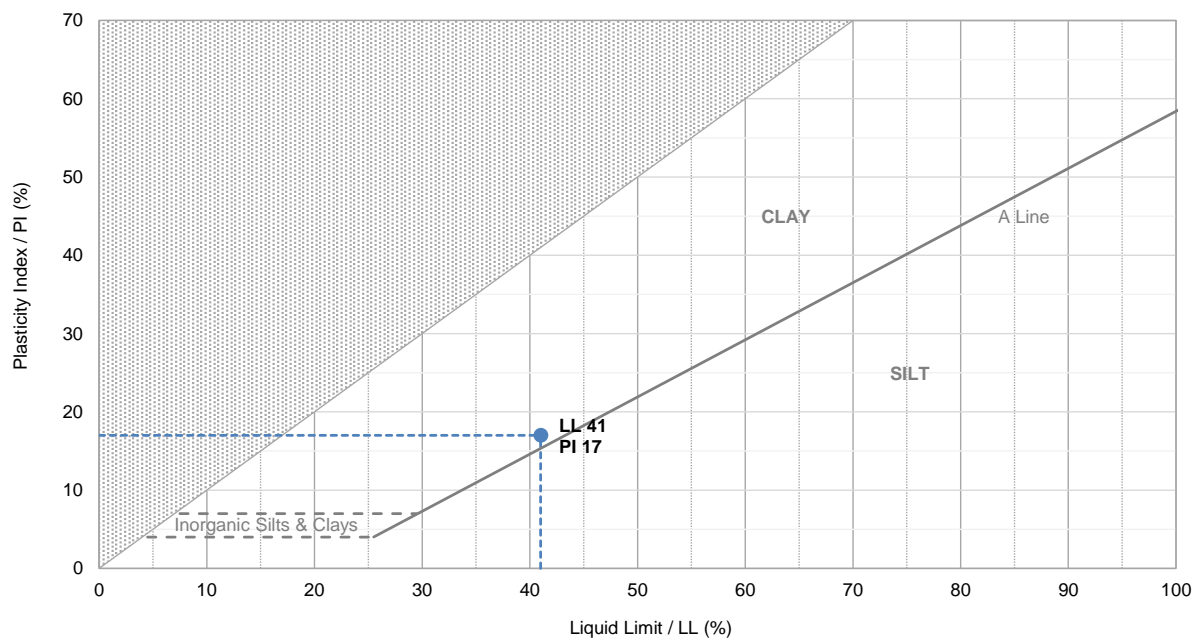
Plasticity Chart for Classification of Fine-Grained Soils

Preparation		Results	
Method of Preparation	Dry Sieved	Liquid Limit / LL (%)	41
History of the Sample	Air Dried	Plastic Limit (%)	24
		Plasticity Index / PI (%)	17
		Linear Shrinkage (%)	8.0
		Condition upon Drying	Linear

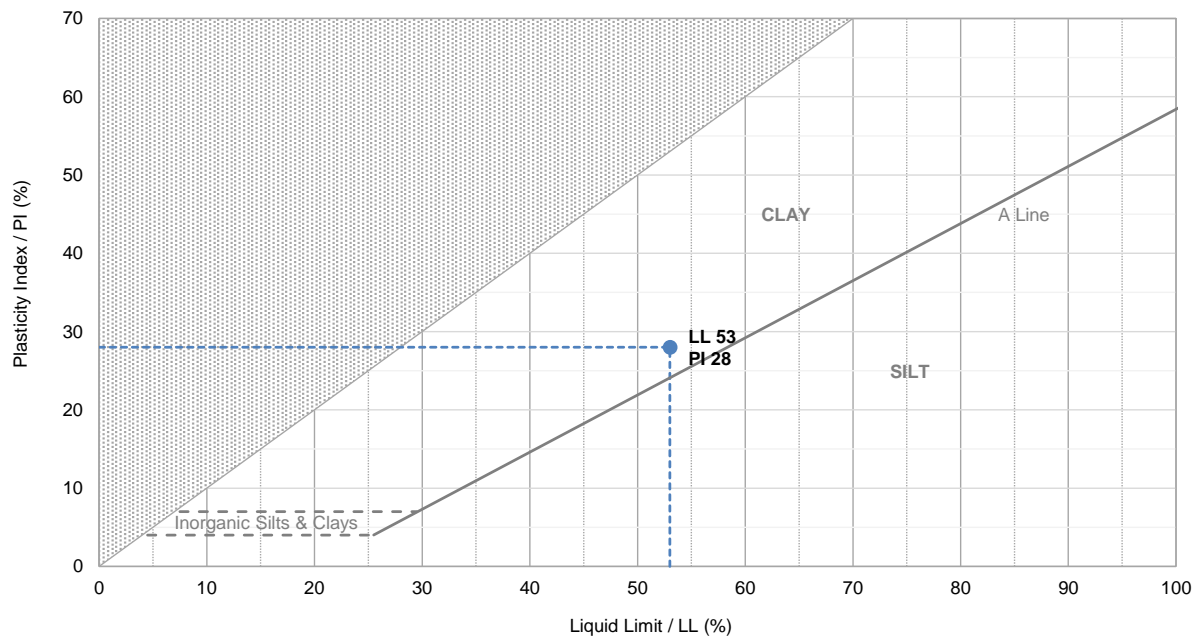
Plasticity Chart for Classification of Fine-Grained Soils

Preparation		Results	
Method of Preparation	Dry Sieved	Liquid Limit / LL (%)	53
History of the Sample	Air Dried	Plastic Limit (%)	25
		Plasticity Index / PI (%)	28
		Linear Shrinkage (%)	9.5
		Condition upon Drying	Linear

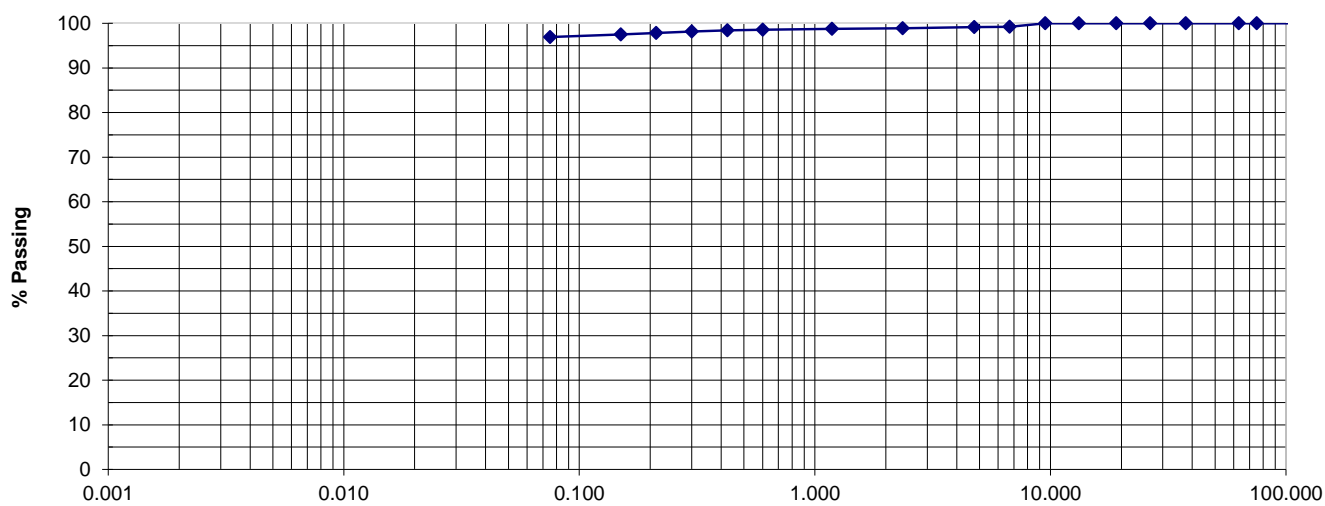
Client	Tetra Tech Coffey	Source	BH104 1.0-1.45m
Address	Citadel Tower, Level 19, Tower B/799 Pacific Hwy, Chatswood NSW 2067	Sample Description	Silty CLAY, trace of Sand and Gravel
Project	North Sydney Public School (SYDGE290593)	Report No	S71006-PSD
Job No	S21364-1	Lab No	S71006

Test Procedure	AS 1289.3.6.1 Determination of the particle size distribution of a soil - Standard method of analysis by sieving		
Sampling	Sampled by Client - results apply to the sample as received	Date Sampled	20/09/2021
Preparation	Prepared in accordance with the test method	Date Tested	6/10/2021

Sieve Aperture: (mm)	% Passing	Specification (..) Envelope	Sieve Aperture: (mm)	% Passing	Specification (..) Envelope
200			4.75	99	
75			2.36	99	
63			1.18	99	
37.5			0.600	99	
26.5			0.425	98	
19			0.300	98	
13.2	100		0.212	98	
9.5	100		0.150	97	
6.7	99		0.075	97
