Report on  
Geotechnical Investigation

Proposed Hastings Secondary College Port Macquarie  
Campus Upgrade  
16 Owen Street, Port Macquarie

Prepared for  
School Infrastructure NSW  
c/- Currie & Brown

Project 89754.03  
May 2021

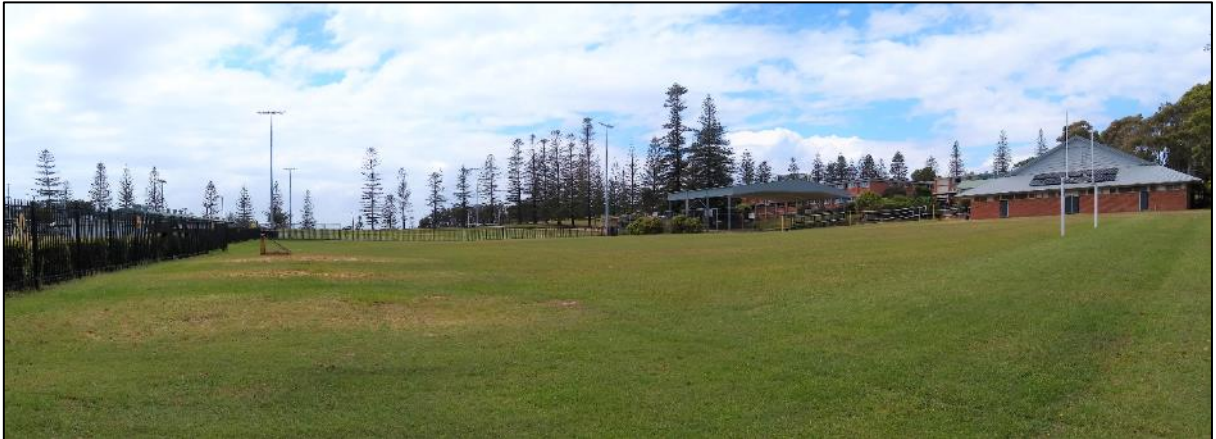
**Figure 2: View of Area 1 from north-western corner of the site**

This area has a good covering of grass and is currently used as a playing field. The area is generally flat and level.

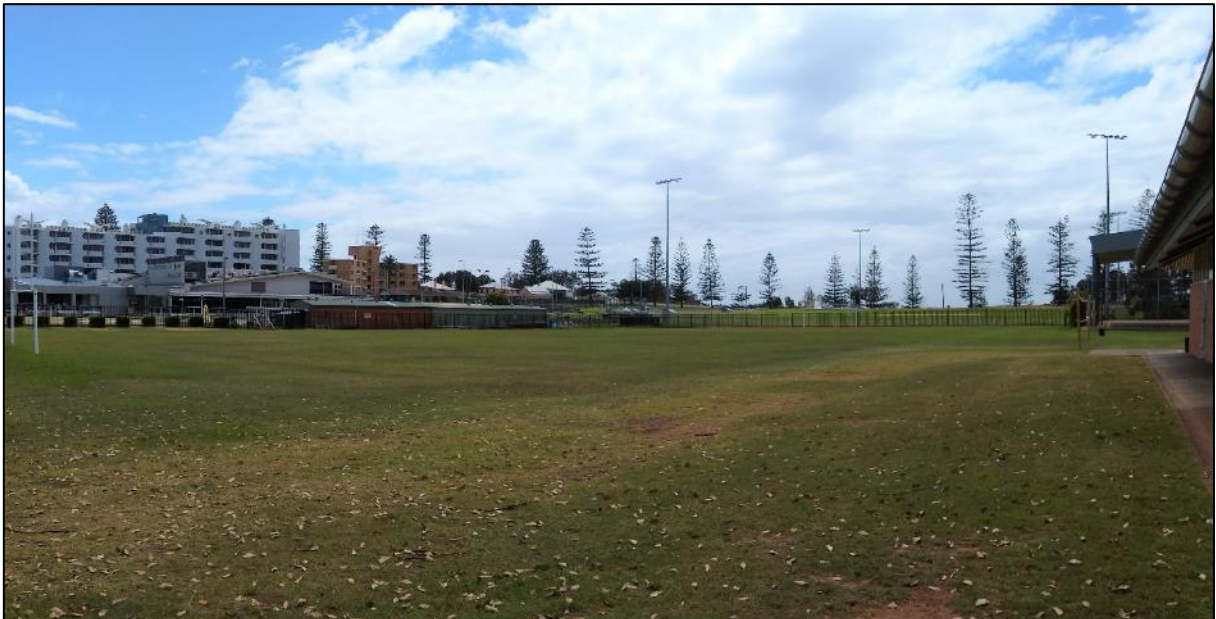
**Figure 3: View of Area 1 from south-western corner of Area 1**

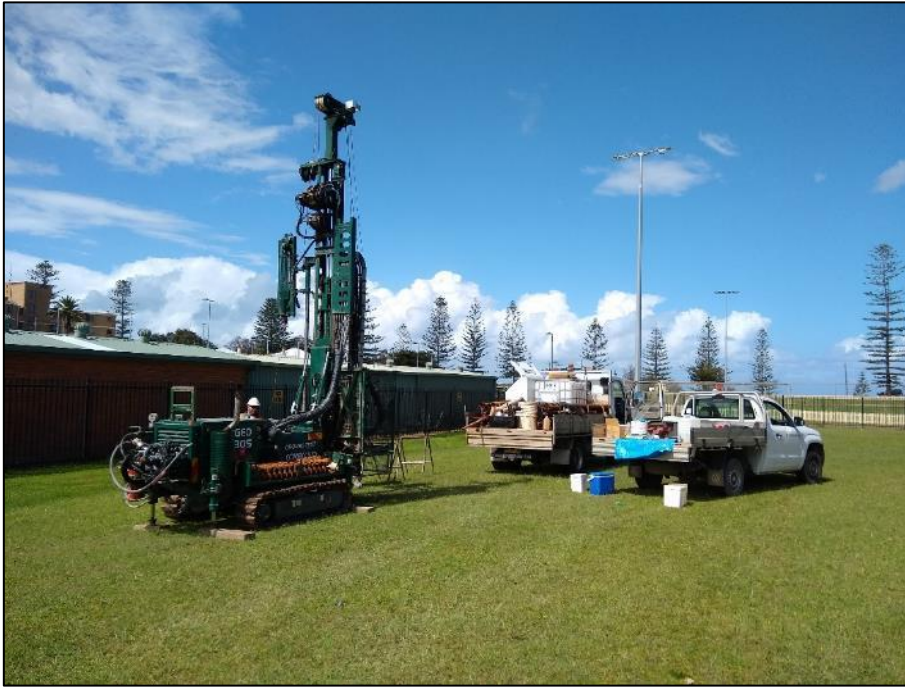
**Figure 4: Drill rig on Bore 202 within Area 1 near the north-western boundary of the site**

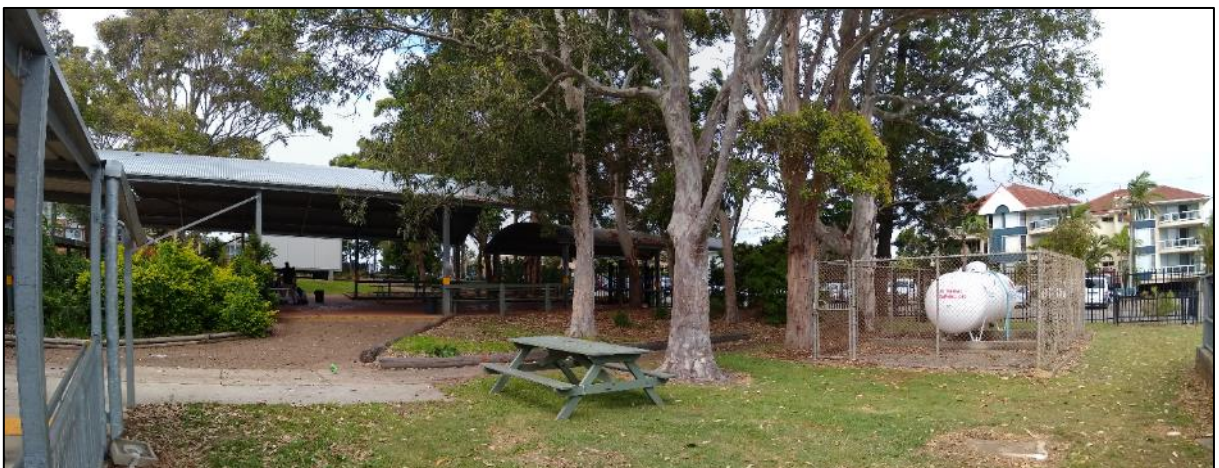
**Figure 5: View from the north-eastern corner of Area 2 with table and chairs, and above ground gas cylinder**

This area consisted of a grassed area with some trees and a concrete and paver footpath. A wooden table and chairs, and above ground gas cylinder, were also present in the area. A retaining wall up to approximately 2 m in height is located along the northern boundary of the area adjacent to the existing MPC Hall building.

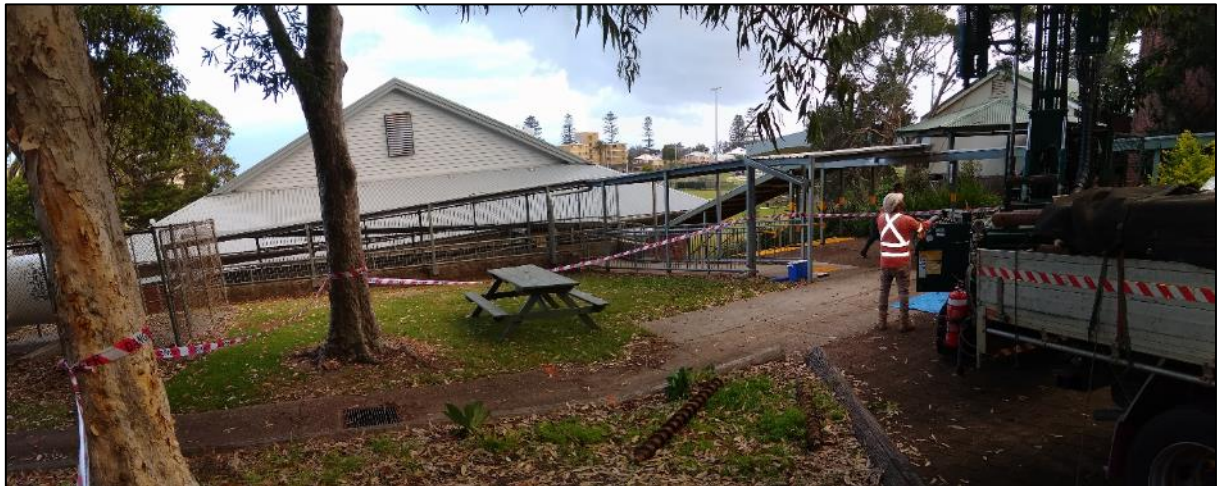
**Figure 6: Drill rig on Bore 203 within Area 2 near the western boundary of the site**

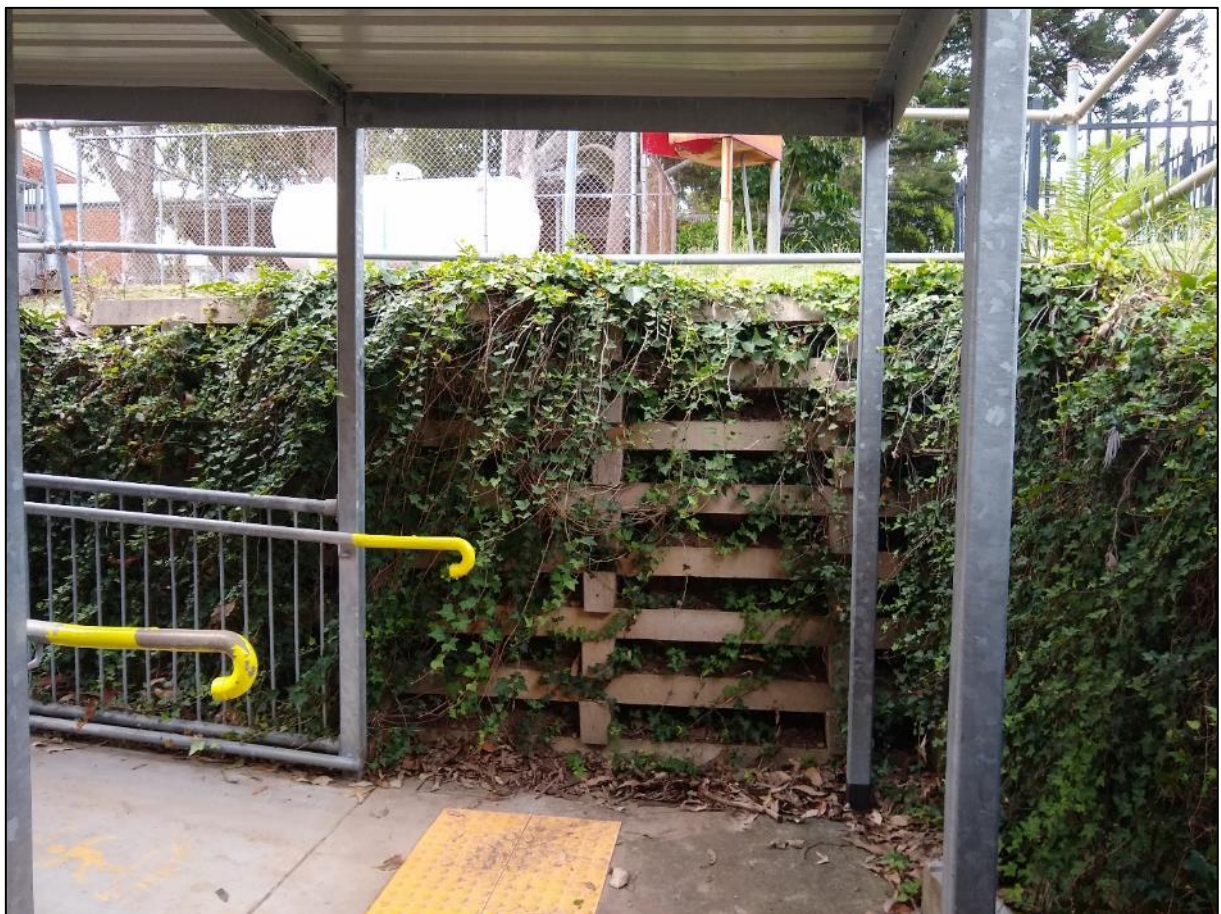
**Figure 7: View of retaining wall along the northern boundary of Area 2**

It should be noted that a retaining wall up to 2 m in height was observed near the proposed CAPA building (Area 2, refer Figure 7). All footings should be founded below a 45° line from the toe of the wall unless the retaining wall has been designed to accommodate the additional load from the building.

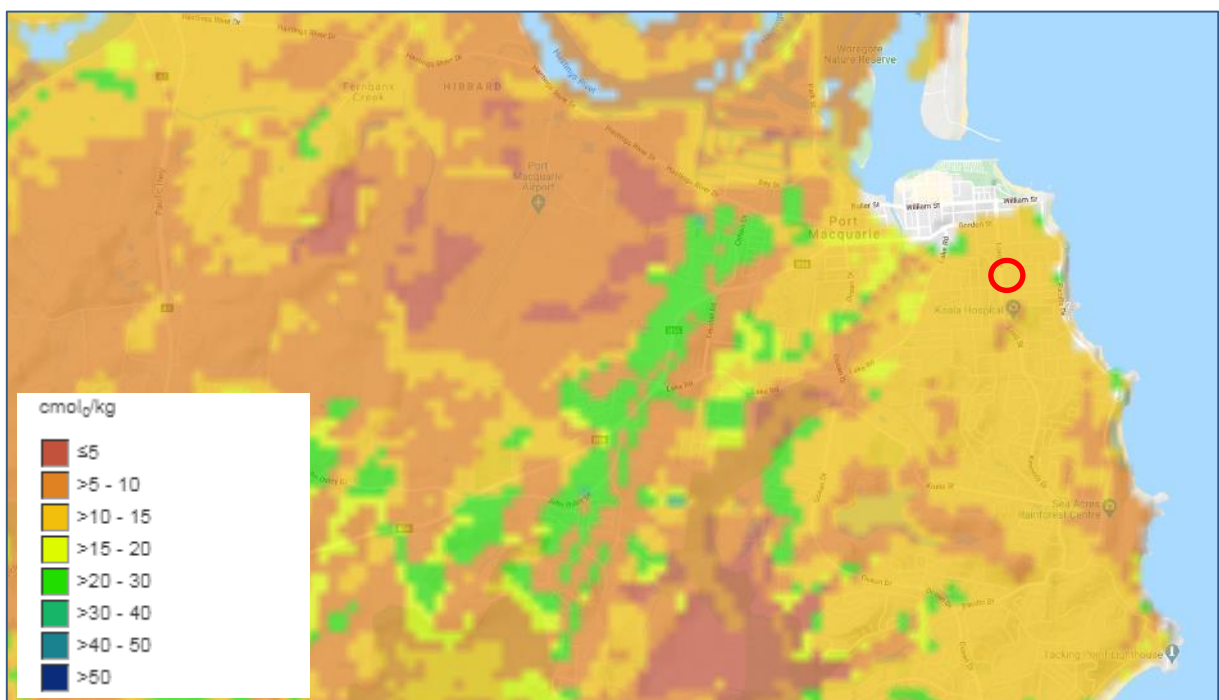
The following figures from eSPADE show modelled soil properties for soils 0.3 m to 1 m below the ground surface for Cation exchange capacity (CEC), electrical conductivity (EC) and exchangeable sodium percentage (ESP).

**Figure 9: Modelled cation exchange capacity with approximate site location (red outline)**

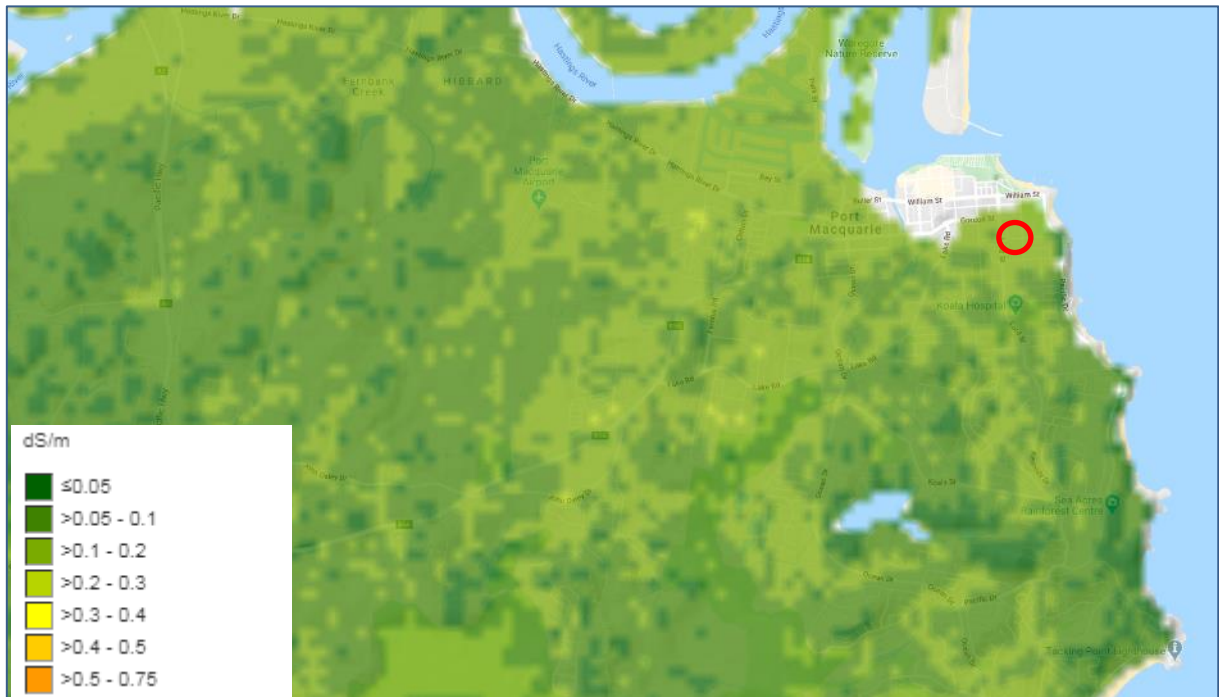
Figure 10: Modelled electrical conductivity with approximate site location (red outline)

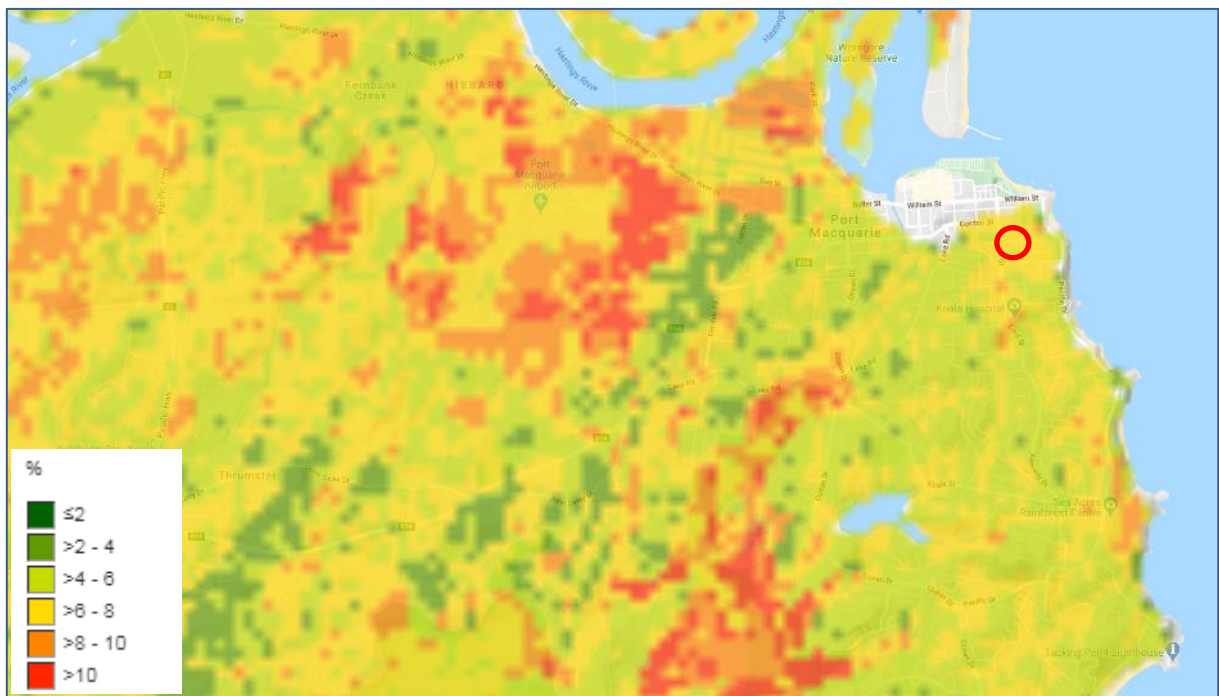
Figure 11: Modelled exchangeable sodium percentage with approximate site location (red outline)

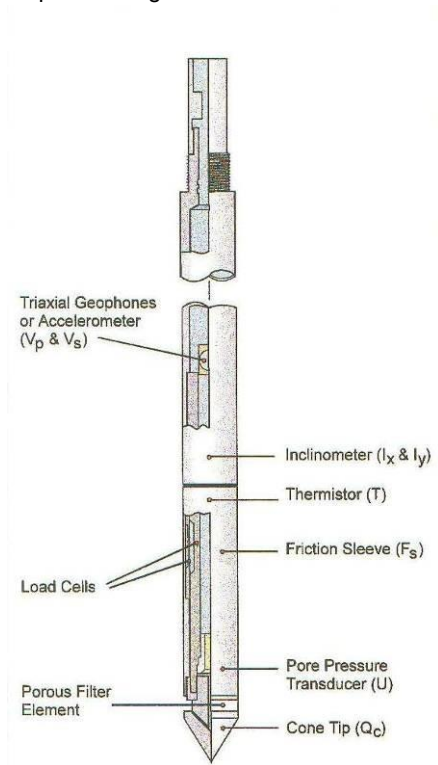
- Cone tip resistance  $q_c$
- Sleeve friction  $f_s$
- Inclination (from vertical)  $i$
- Depth below ground  $z$

Figure 1: Cone Diagram

The inclinometer in the cone enables the verticality of the test to be confirmed and, if required, the vertical depth can be corrected.

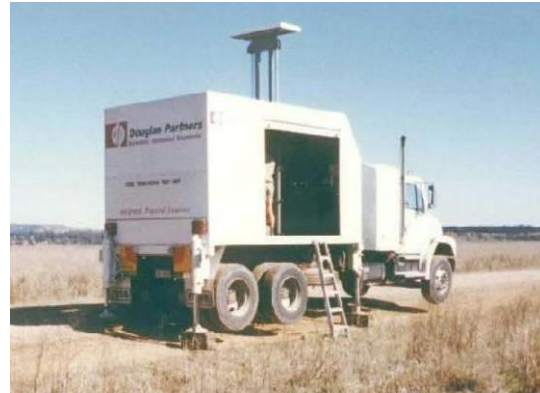
The cone is thrust into the ground at a steady rate of about 20 mm/sec, usually using the hydraulic rams of a purpose built CPT rig, or a drilling rig. The testing is carried out in accordance with the Australian Standard AS1289 Test 6.5.1.

Figure 2: Purpose built CPT rig

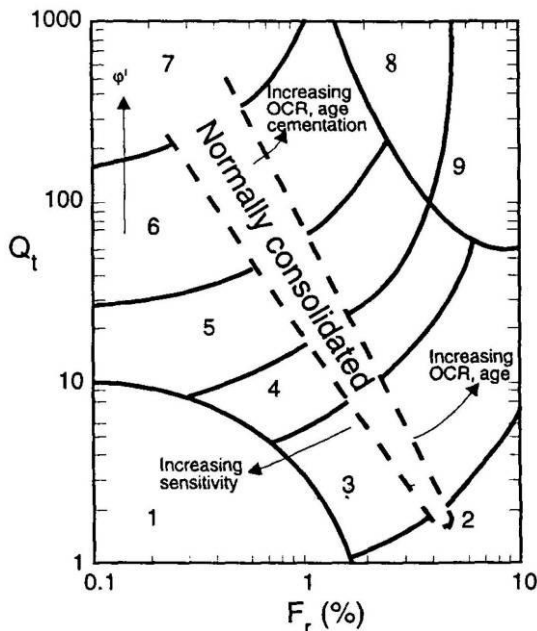
The CPT parameters can be used to infer the Soil Behaviour Type (SBT), based on normalised values of cone resistance ( $Q_t$ ) and friction ratio ( $Fr$ ). These are used in conjunction with soil classification charts, such as the one below (after Robertson 1990)

Figure 3: Soil Classification Chart

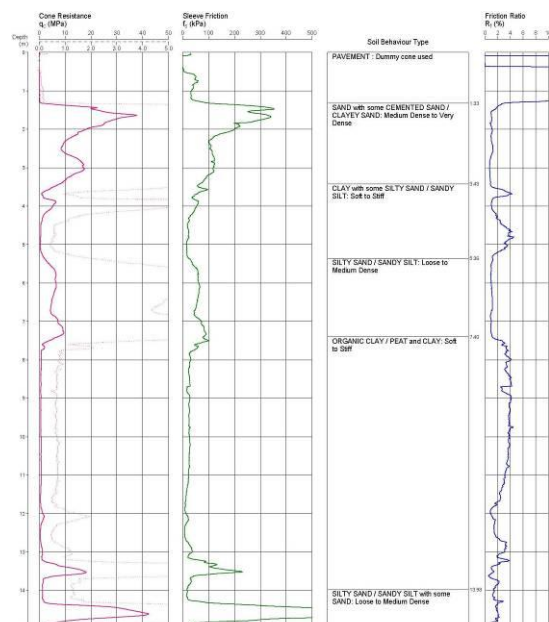
Figure 4: Sample Cone Plot
