# Geotechnical Investigation

40-76 William Street, Leichhardt, NSW

Report Title: Geotechnical Investigation

Report No: E24470.G03\_Rev8

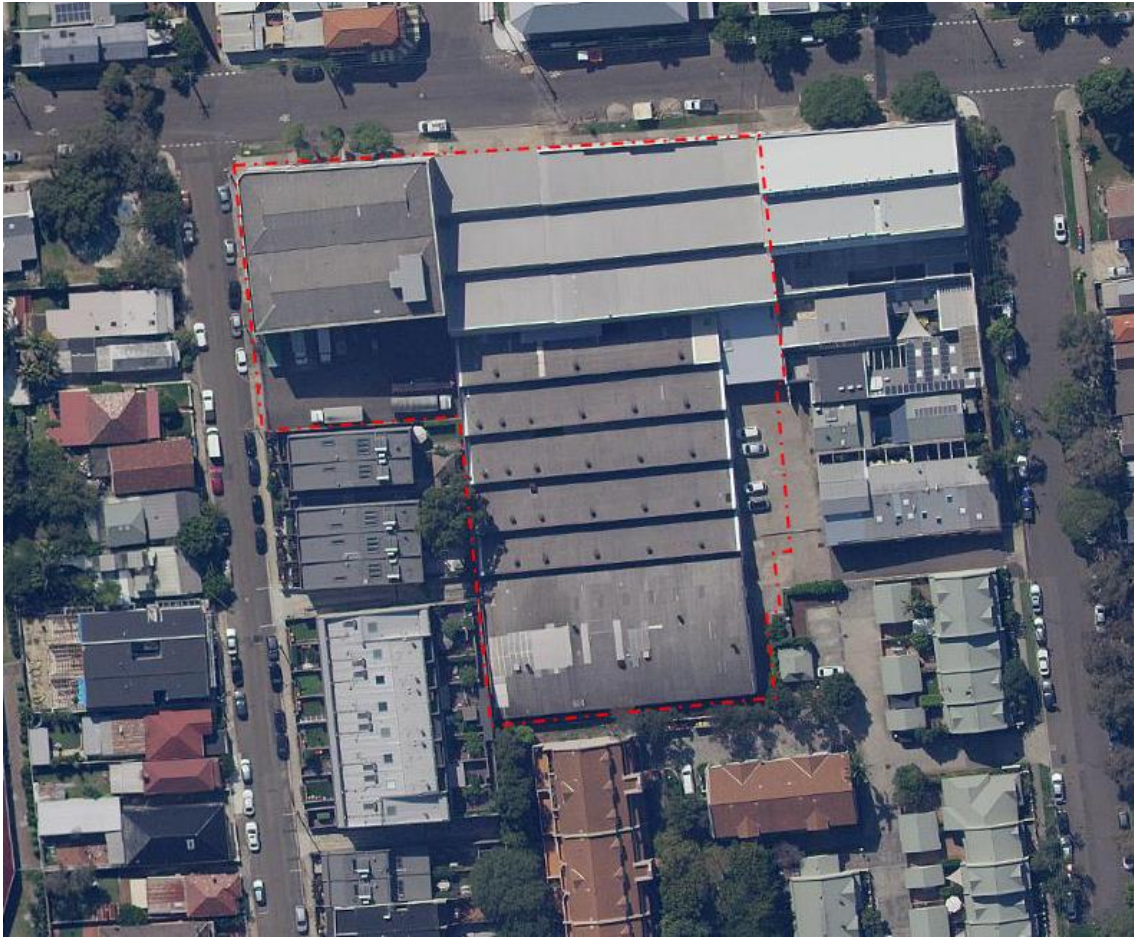
**Plate 1: Aerial photograph of the site (source: SIX Maps, accessed 20/1/20)**

| Information | Detail |
|---|---|
| Brief Site Description | At the time of our investigation, the site was occupied by a three, one to four-storey brick warehouse buildings. The building structures appeared to be in reasonable condition based on a cursory inspection, with stepped cracking in the brickwork visible on the exterior walls. A concrete paved driveway and parking area was present at the western end of the site, as well as along the southern half of the eastern site boundary. Vehicular access to the site is via these driveways from North Street on the west side and Francis Street on the east side. A Sydney Water main runs across the site in a north-south direction, extending along the south western portion of the western site boundary and across to the northern site boundary. This site has also been noted to be a flood control site. |

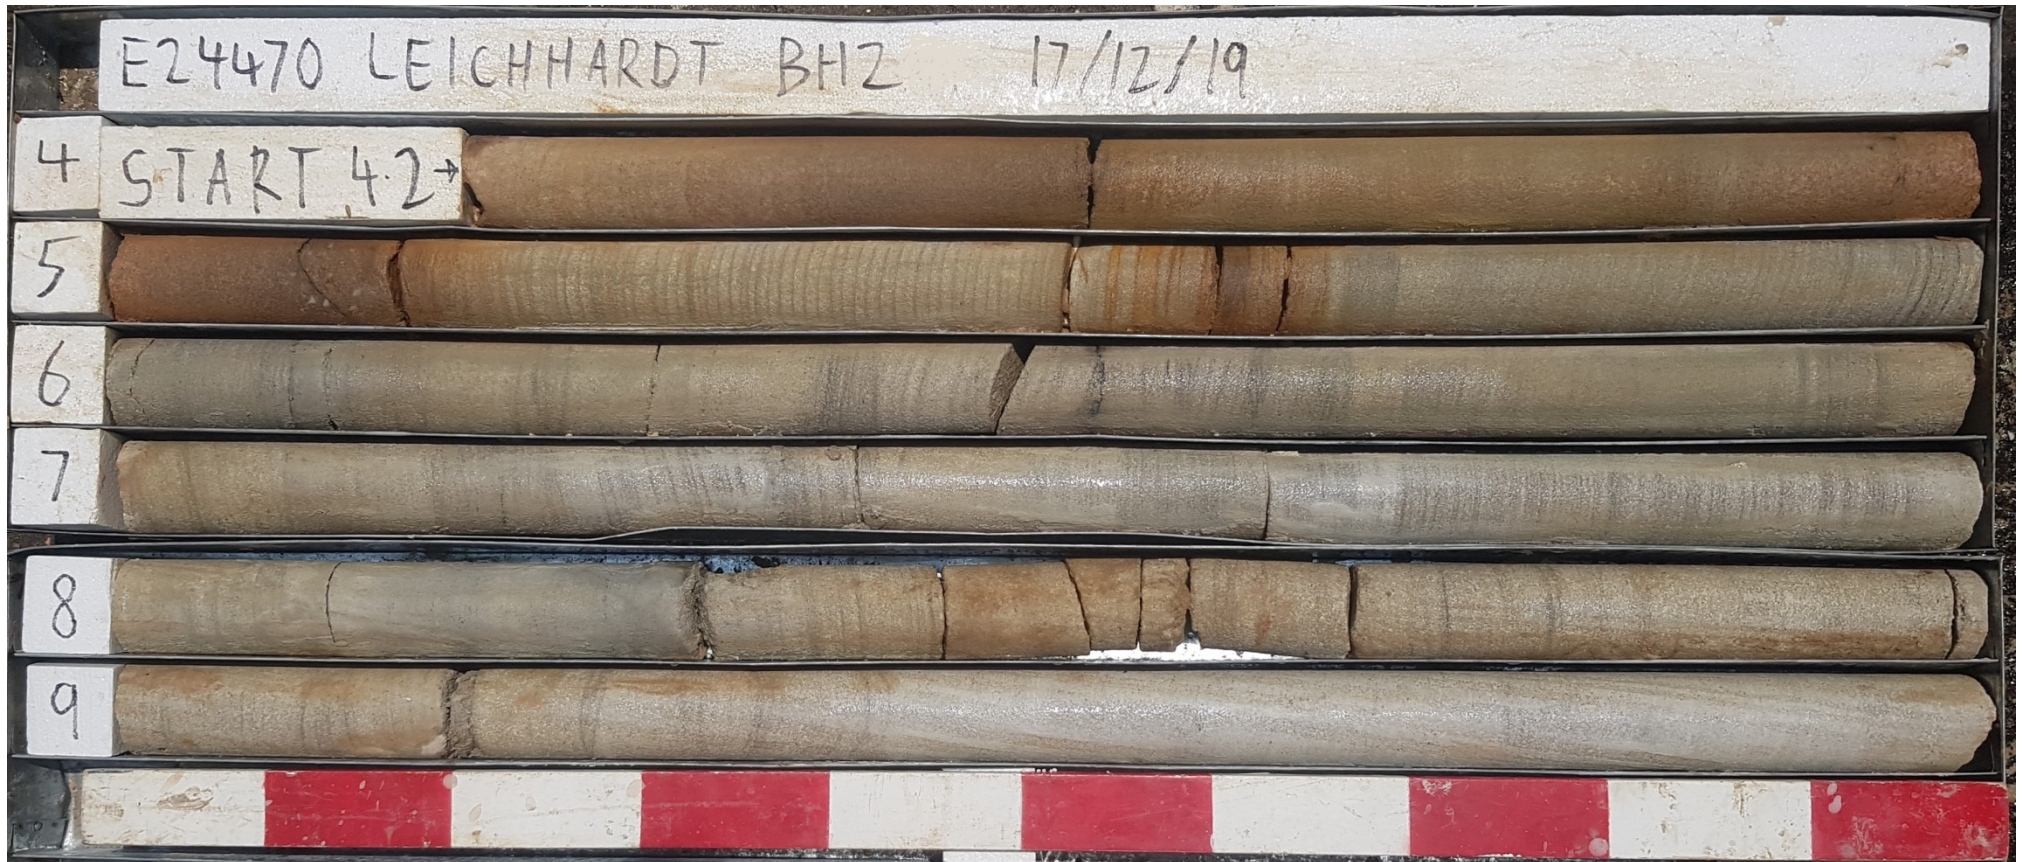
| <b>Job No.</b> | E24470.G03 | <b>Logged</b> | DS | <b>Date</b> 16 / 12 / 2019 |
| <b>Client</b> | Anprisa Pty Ltd | <b>Box</b> | 1-2 of 2 | <b>Checked</b> BL <b>Date</b> 22 / 01 / 2020 |

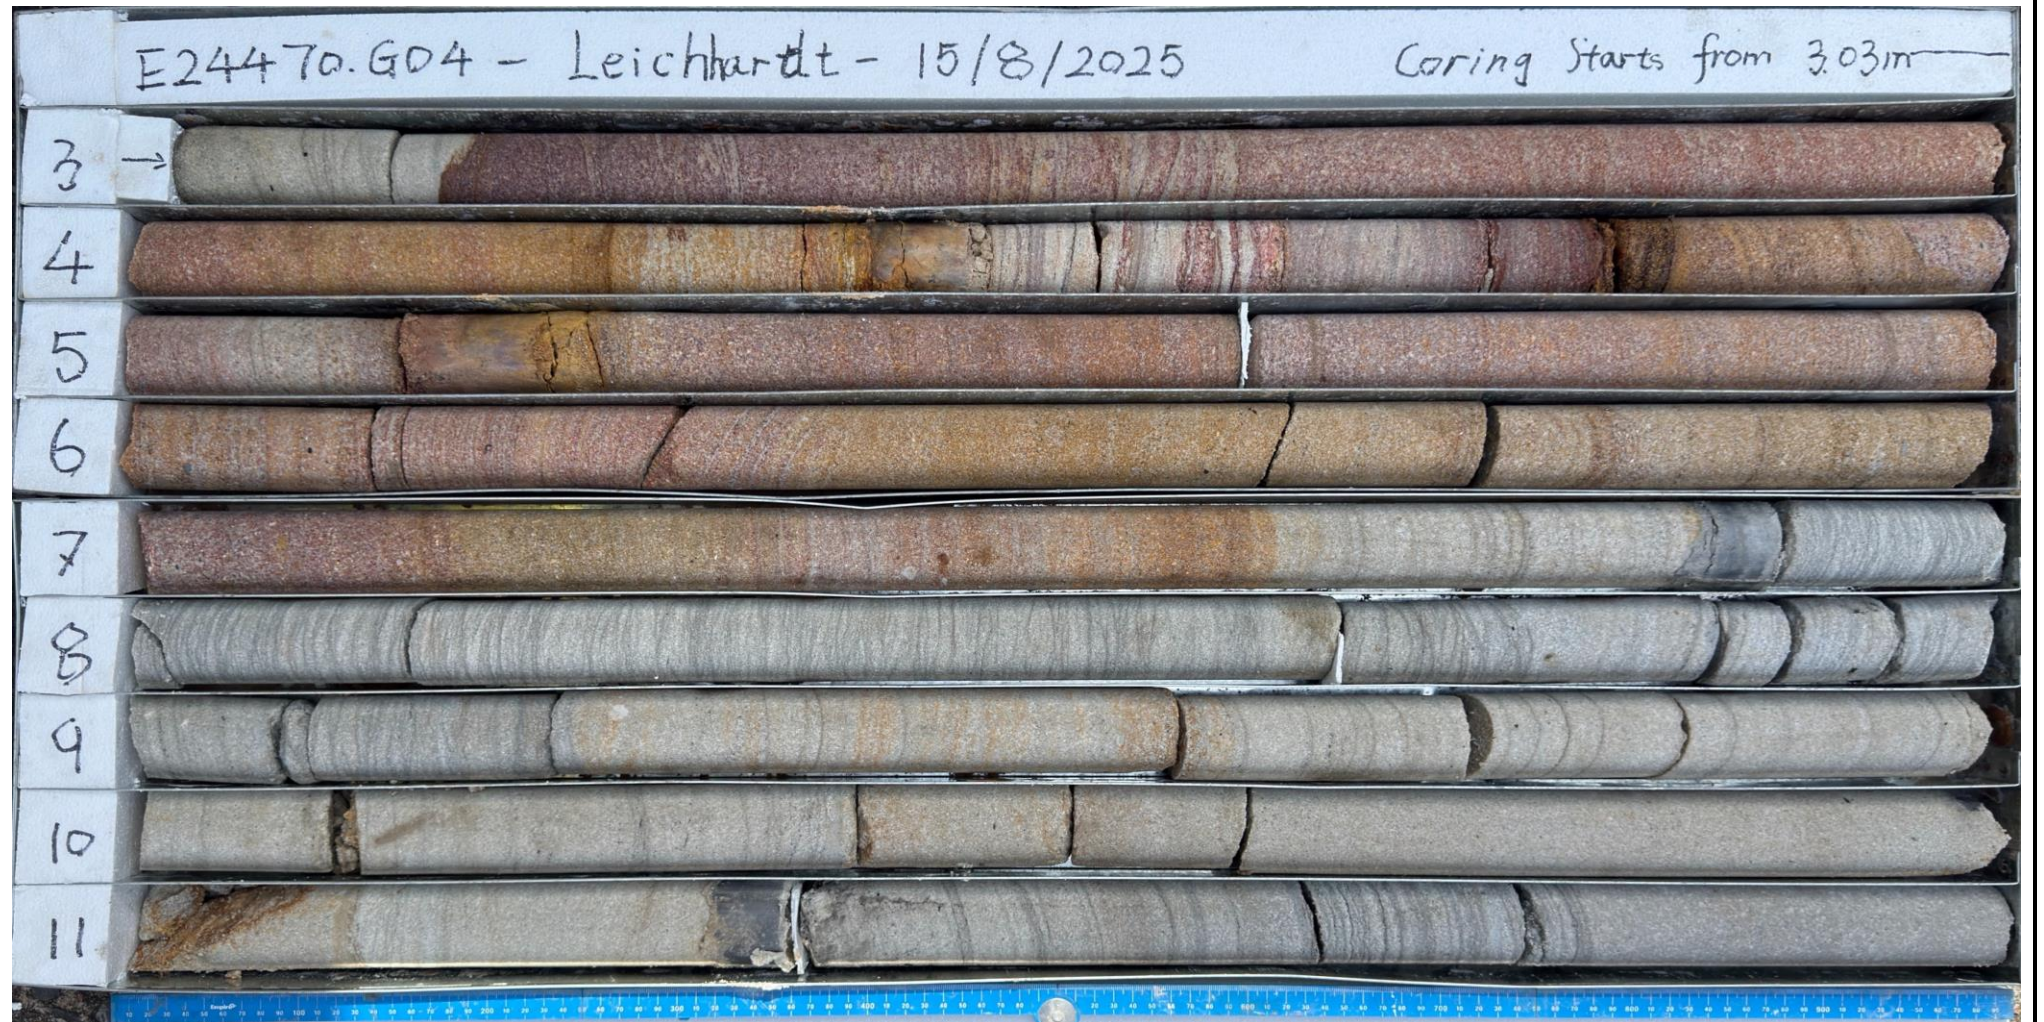
# CORE PHOTOGRAPH OF BOREHOLE: BH101M

| <b>Project</b> | Proposed Development | <b>Depth Range</b> | 3.03m to 15.56m BEGL | |
