Report on
Geotechnical Investigation

Proposed Student Accommodation
104-116 Regent Street, Redfern

Project 99740.01
December 2021

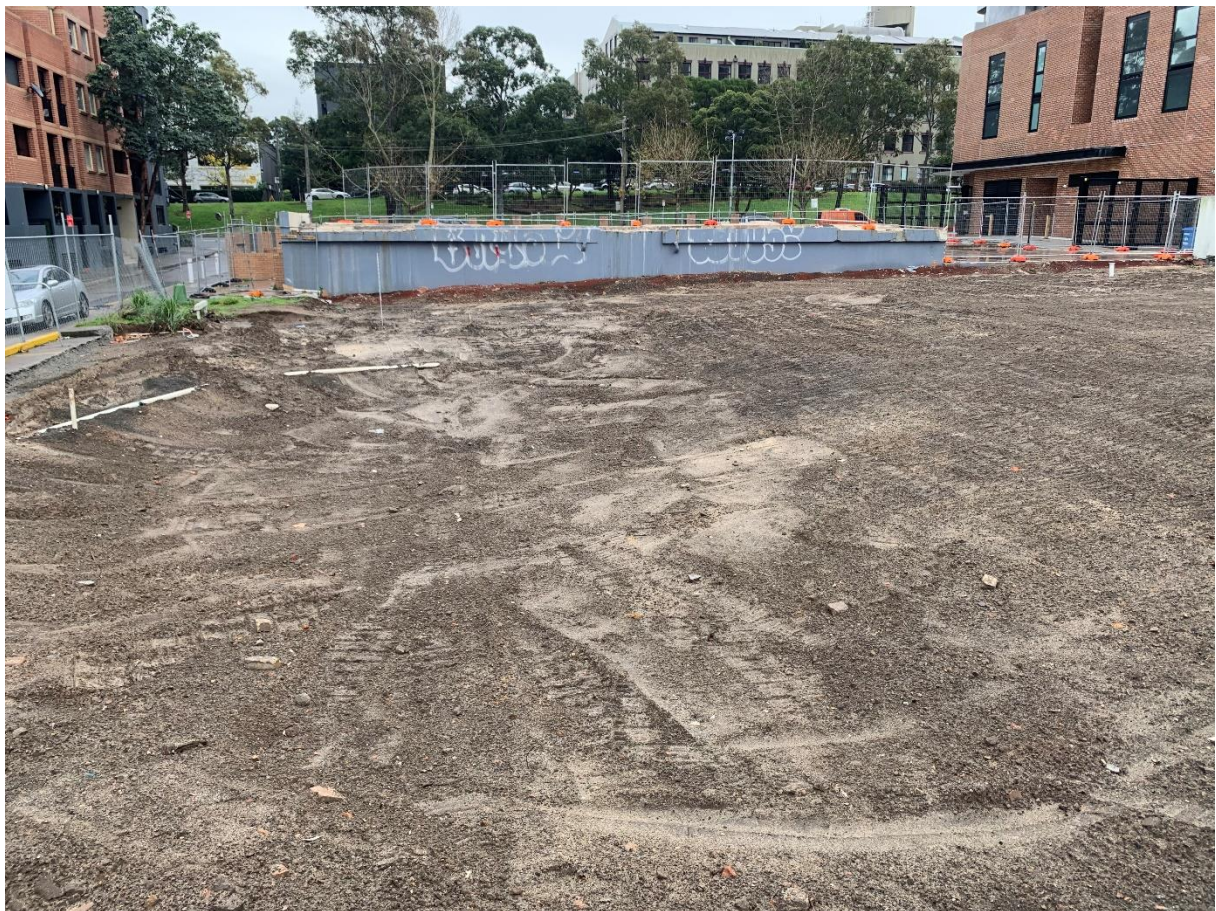
Figure 1 – Site Photo, looking towards west and south-western corner

Prior to the remediation work, the site sloped gently towards the south-west with the surface elevations from approximately RL 25 m to RL 23 m, relative to Australian height datum (AHD). The remediation work created a minor depression in site level towards the southern site boundary, with an approximately 1 m maximum drop from the original ground surface levels. A photo showing the site conditions after remediation is in Figure 1 below.

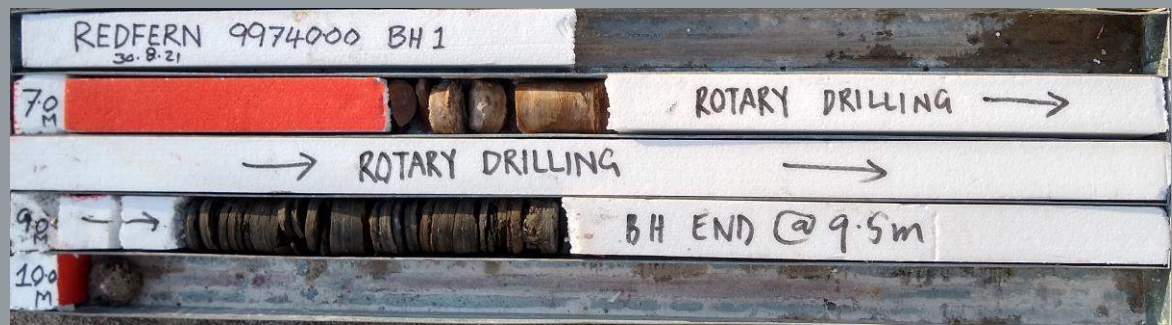
7.50 – 9.50m

7.3	LAMINITE: pale grey brown, approximately 70% siltstone interlaminated with 30% fine grained sandstone, medium strength, highly to moderately weathered, fragmented to fractured, Ashfield Shale																C	40		PL(A) = 0.5

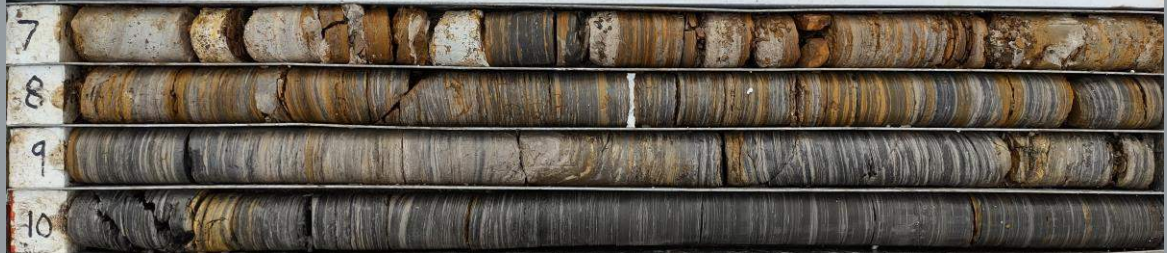
7.00 - 11.00m

99740.01 REDFERN BH2 START 7.0 m

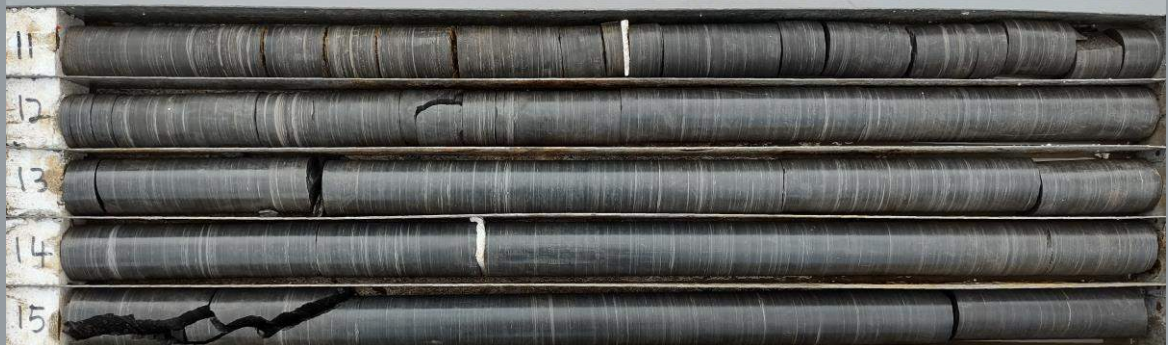
11.00 - 16.00m

Project No: 99740.01
BH ID: BH2
Depth: 11.0 - 16.0 m
Core Box No.: 2

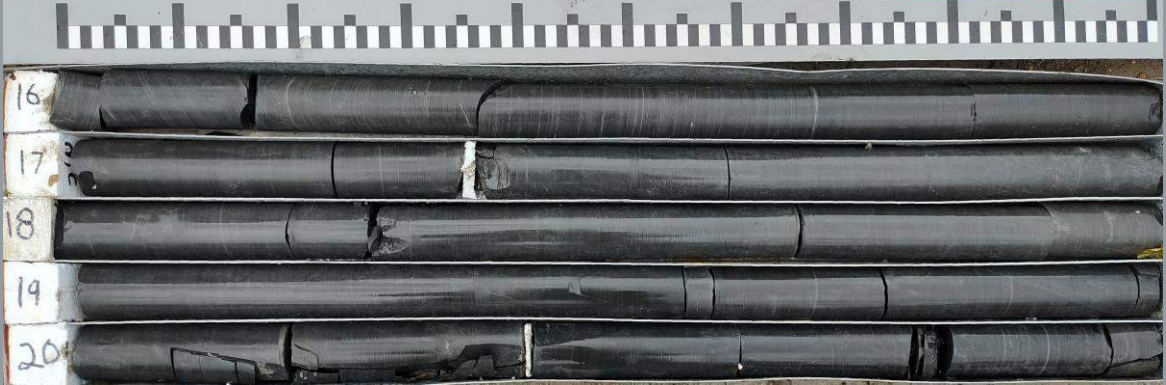
16.00 – 21.00m

Depth: 16.0 - 21.0 m

Core Box No.: 3

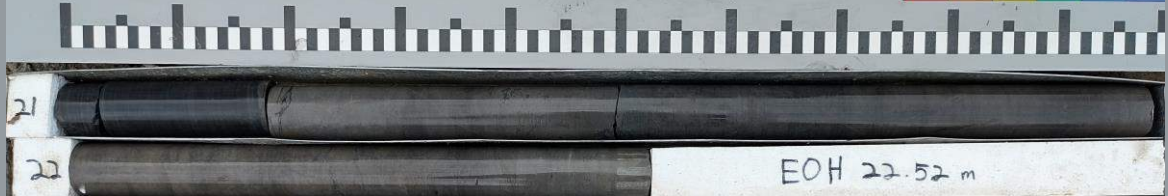
21.00 – 22.52m

Depth: 21.0 - 22.52 m

Core Box No.: 4

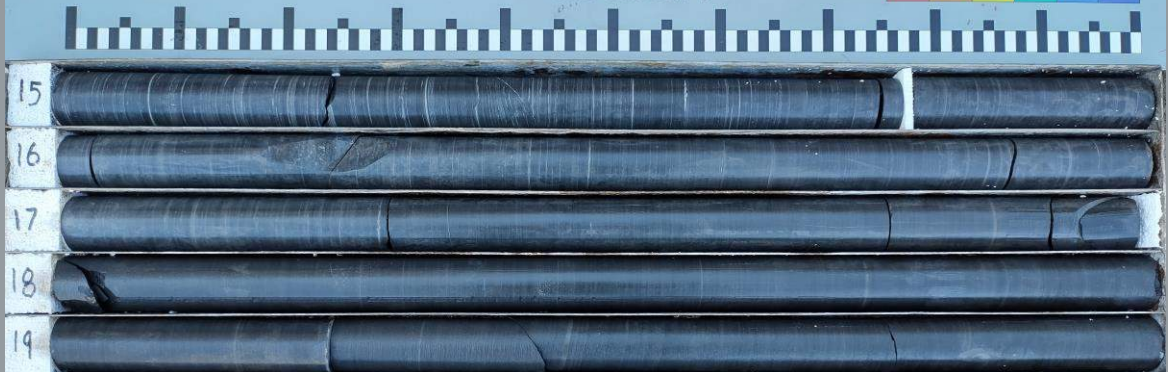
15.00 – 20.00m

Project No: 99740.01
BH ID: BH3
Depth: 15.0-20.0m
Core Box No.: 3

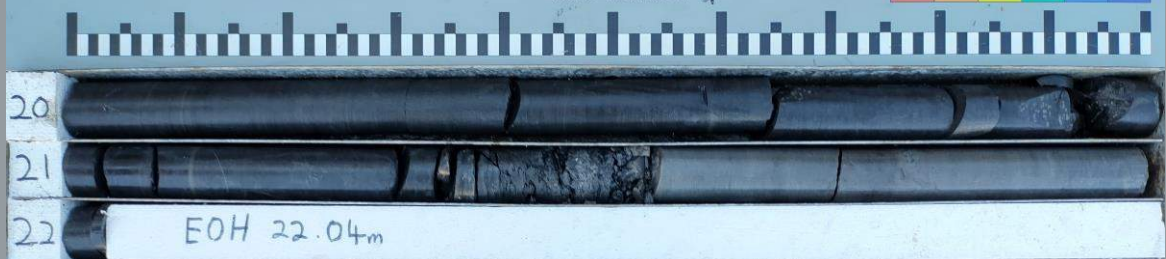
20.00 – 22.04m

Project No: 99740.01
BH ID: BH3
Depth: 20.0-22.04m
Core Box No.: 4

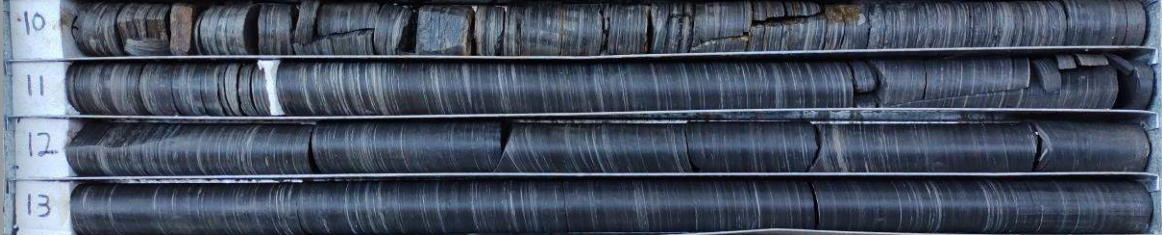
9.50 – 14.00m

99740.01 REDFERN BH4 START 9.50m

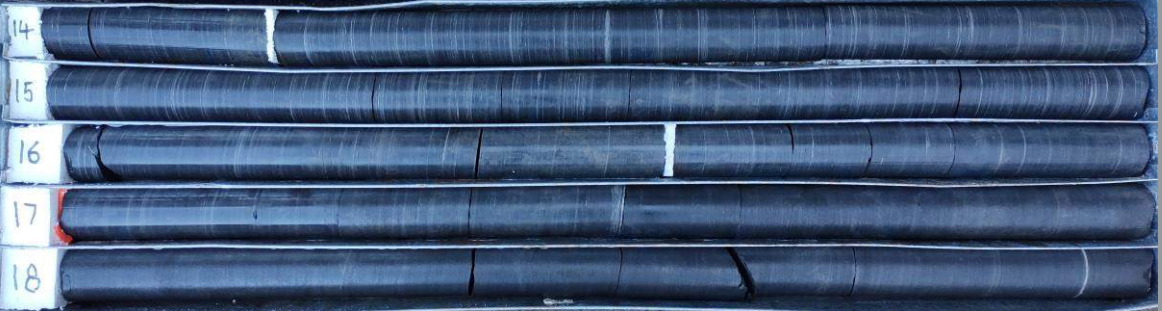
14.00 – 19.00m

Depth: 14.0-19.0m

Core Box No.: 2

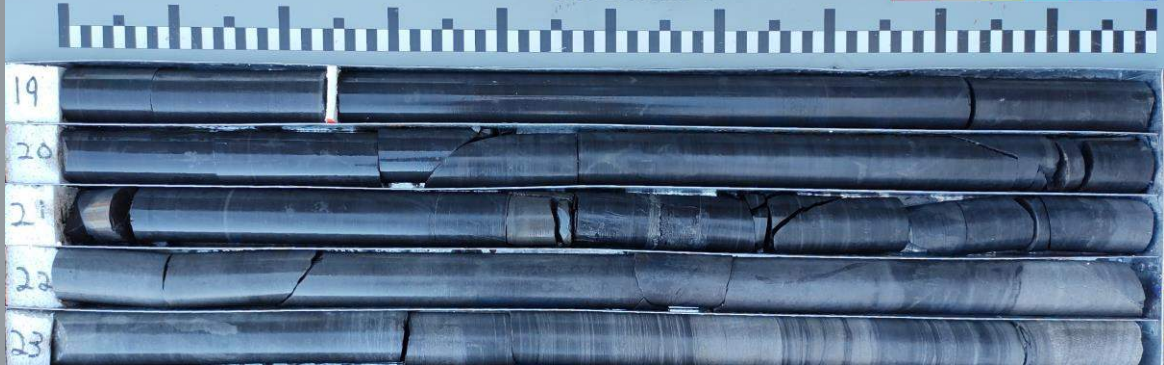
19.00 – 24.00m

Project No: 99740.01
BH ID: BH4
Depth: 19.0-24.0m
Core Box No.: 3

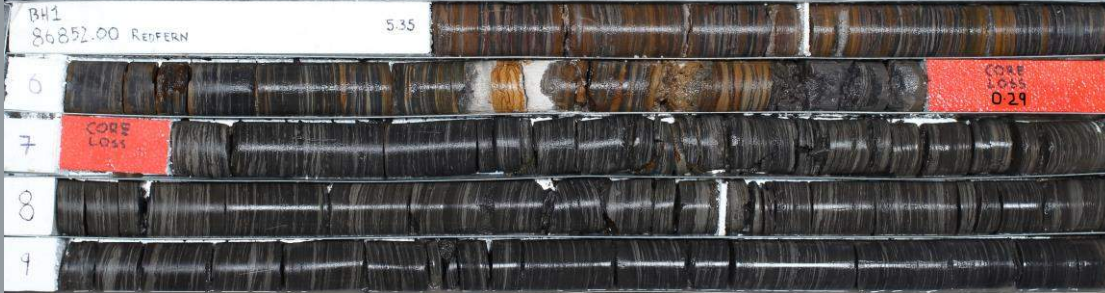
5.35-10.0m

Project No: 86852.00
BH ID: BH1
Depth: 5.35-10
Core Box No.: Box 1 of 1

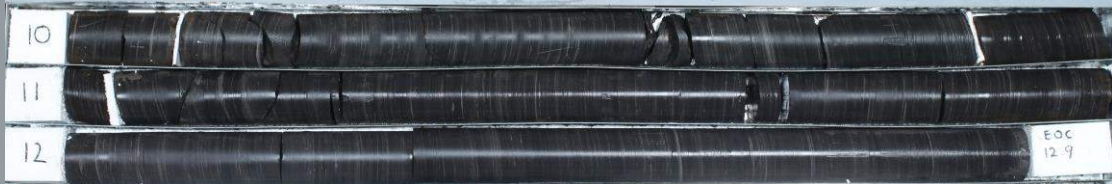
10.0-12.9m

Project No: 86852.00
BH ID: BH1
Depth: 10-12.9
Core Box No.: Box 2 of 2

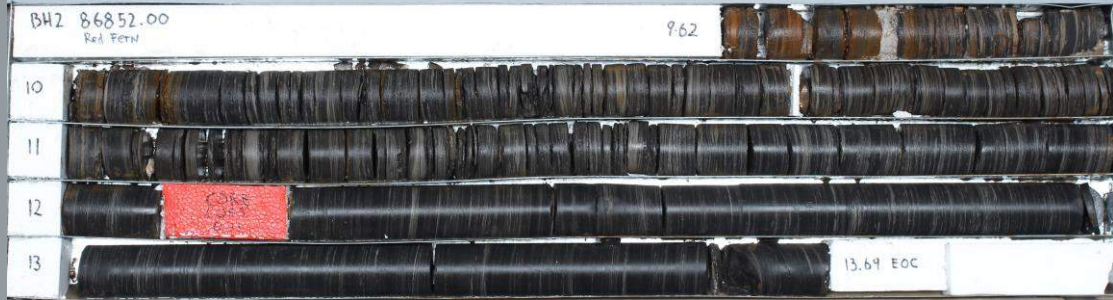
Project No: 86851.00
BH ID: BH2
Depth: 9.62-13.69m
Core Box No.: 1 of 1

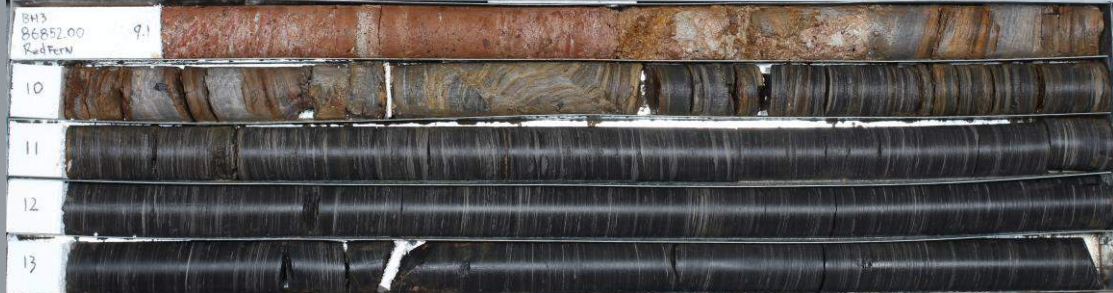
9.1-14.0m

Project No: 86852.00
BH ID: BH3
Depth: 9.1-14
Core Box No.: Box 1 of 3

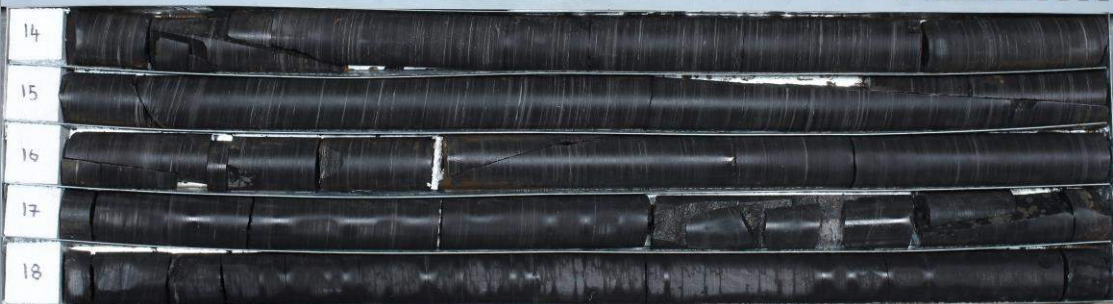
14.0-19.0m

Project No: 86852.00
BH ID: BH3
Depth: 14-19
Core Box No.: 2 of 3

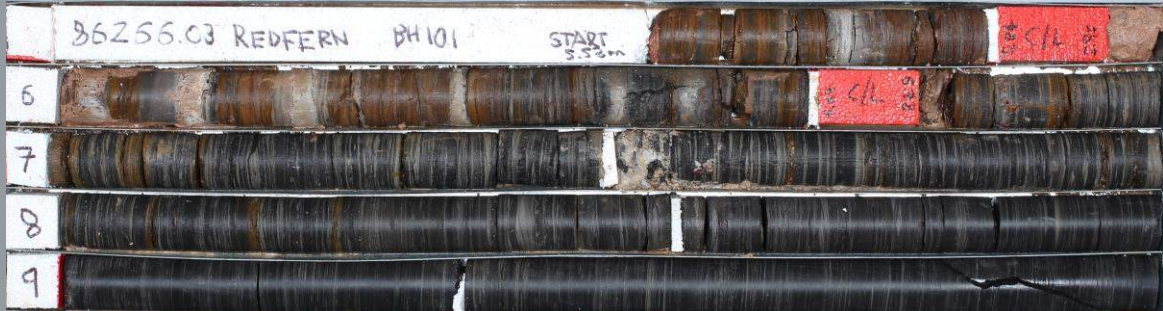
5.53 - 10.00 m

Project No: 86266.03
BH ID: BH101
Depth: 5.53 - 10.0m
Core Box No.: 1

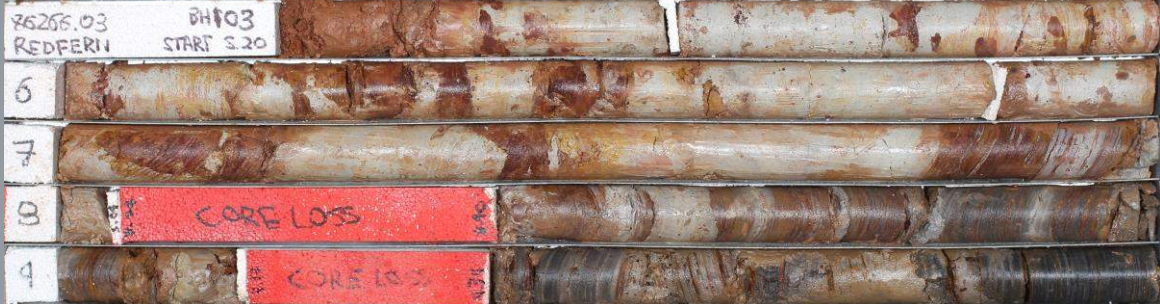
5.20 - 10.00 m

Project No: 86266.03
BH ID: BH103
Depth: 5.2 - 10.0m
Core Box No.: 1

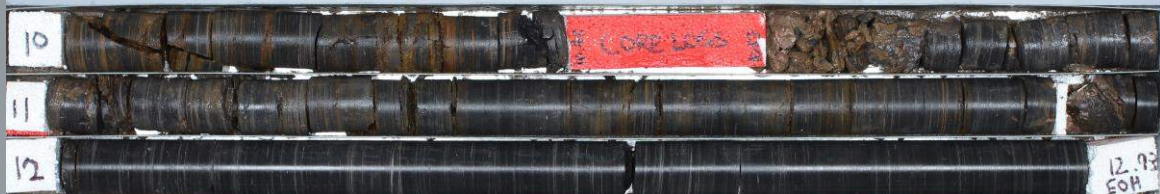
10.00 - 12.93m

Project No: 86266.03
BH ID: BH103
Depth: 10.0 - 12.93
Core Box No.: 1
