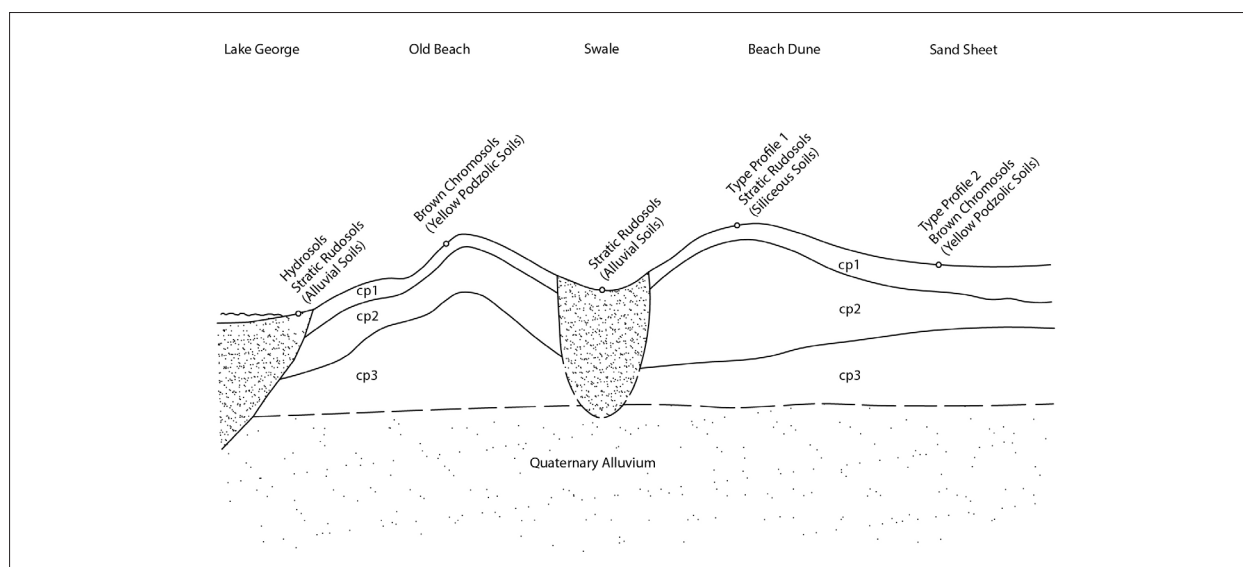
□ Distribution diagram of Coopers soil landscape illustrating occurrence and relationship of dominant soil materials.

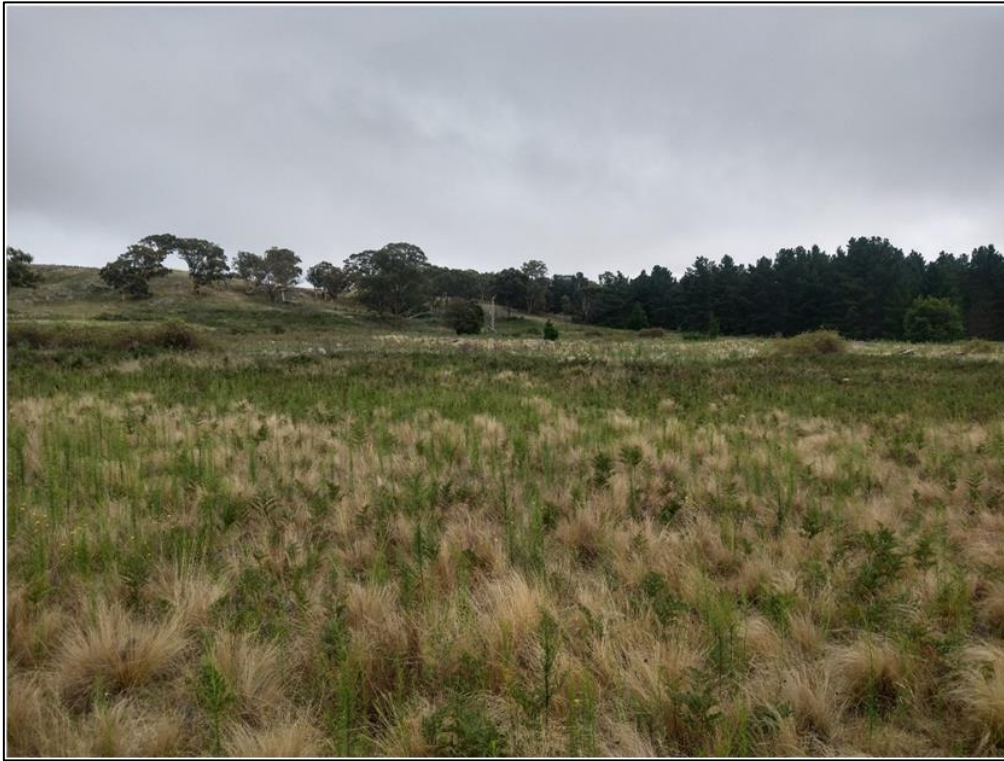
Figure 1: View of proposed substation location

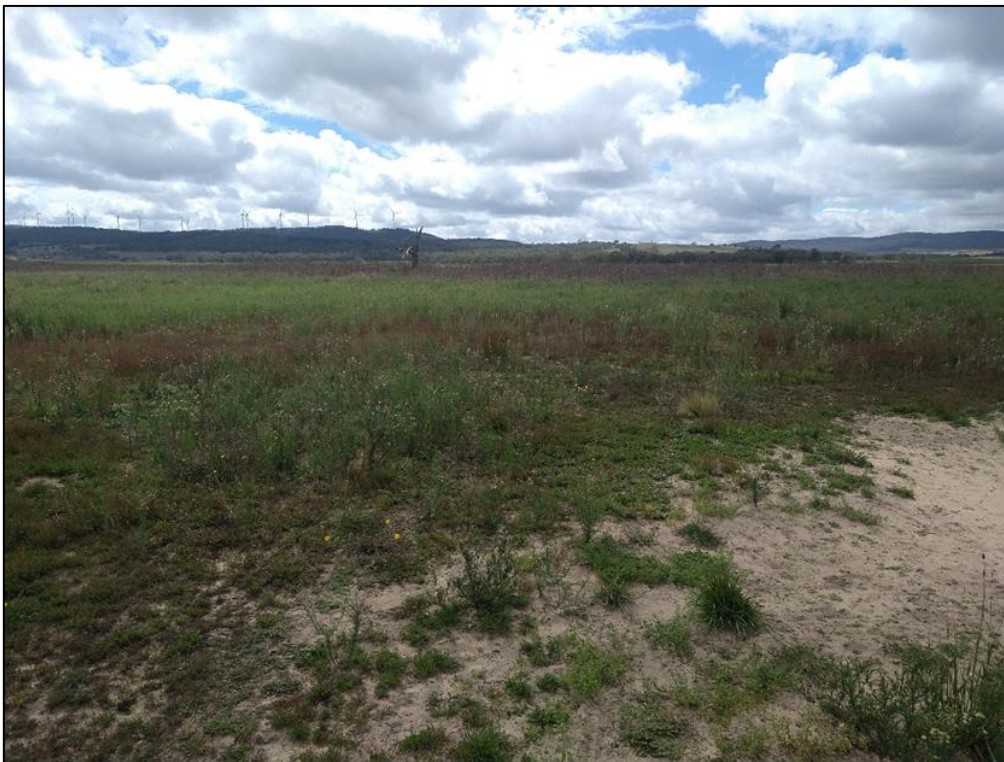
Figure 2: View looking north from Bore 6

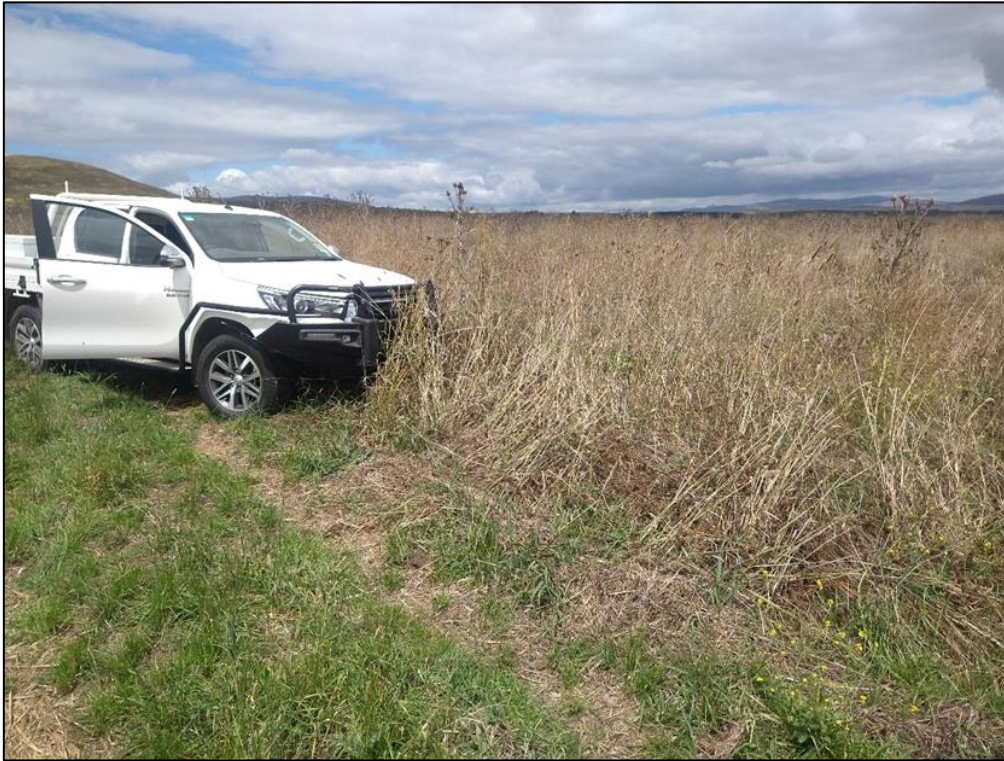
Figure 3: View of dense vegetation along a farm track
