**REPORT TO
HAMMONDCARE**

**ON
ACID SULFATE SOIL ASSESSMENT**

**FOR
PROPOSED HOSPITAL REDEVELOPMENT**

**AT
GREENWICH HOSPITAL, 97-115 RIVER ROAD,
GREENWICH, NSW**

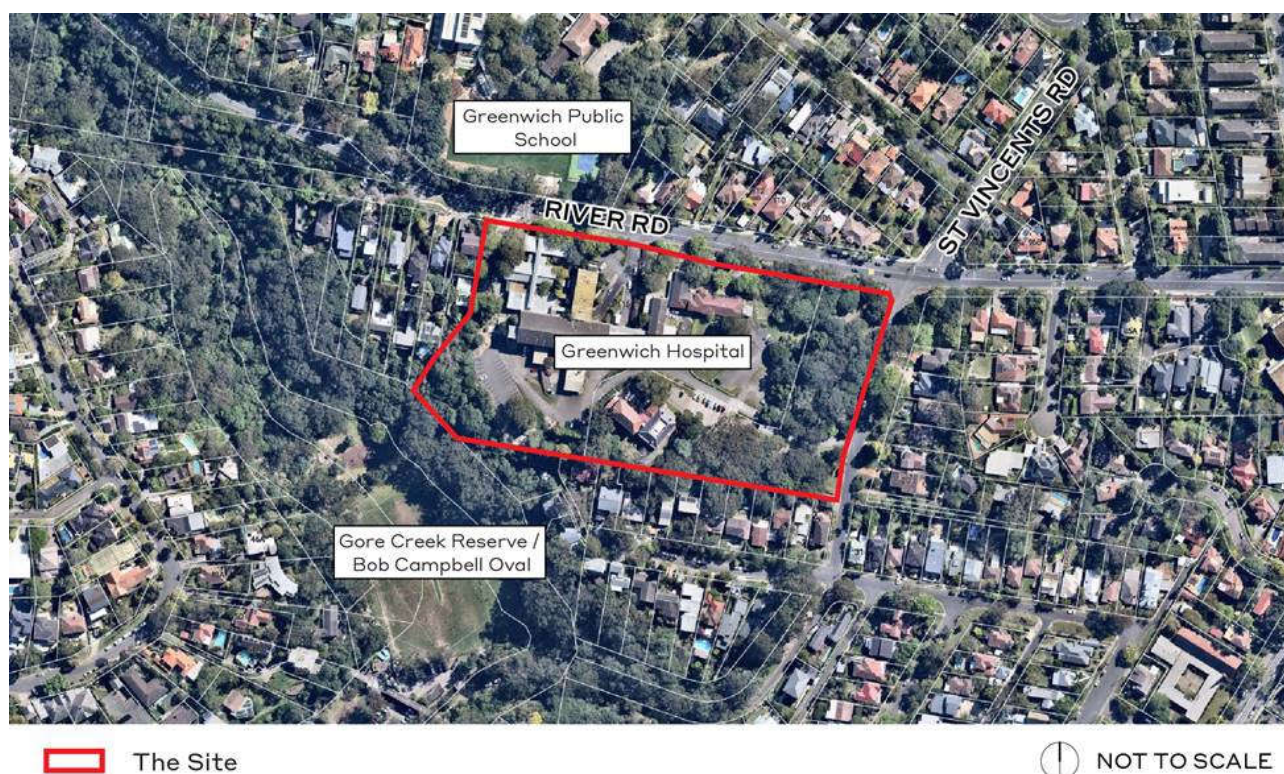
This ASS assessment report is to be submitted to the Department of Planning and Environment (DPE) in support of a State Significant Development Application (SSD-13619238) for the redevelopment of Greenwich Hospital into an integrated hospital and seniors living facility on land identified as 97-115 River Road, Greenwich, NSW (the site). The extent of the site is shown below.
