**REPORT TO
HAMMONDCARE**

**ON
REMEDIATION ACTION PLAN**

**FOR
PROPOSED HOSPITAL REDEVELOPMENT**

**AT
GREENWICH HOSPITAL, 97-115 RIVER ROAD,
GREENWICH, NSW**

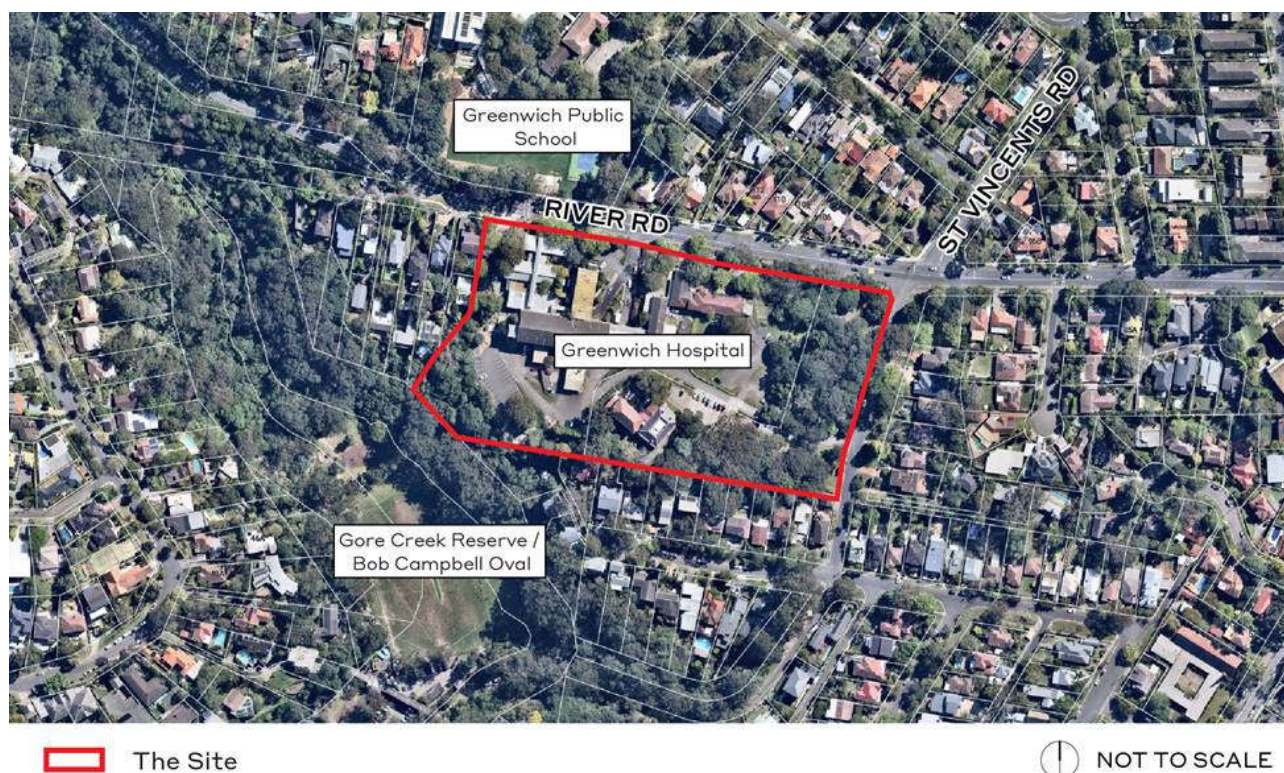
This RAP is to be submitted to the Department of Planning and Environment (DPE) in support of a State Significant Development Application (SSD-13619238) for the redevelopment of Greenwich Hospital into an integrated hospital and seniors living facility on land identified as 97-115 River Road, Greenwich, NSW (the site). The extent of the site is shown below.

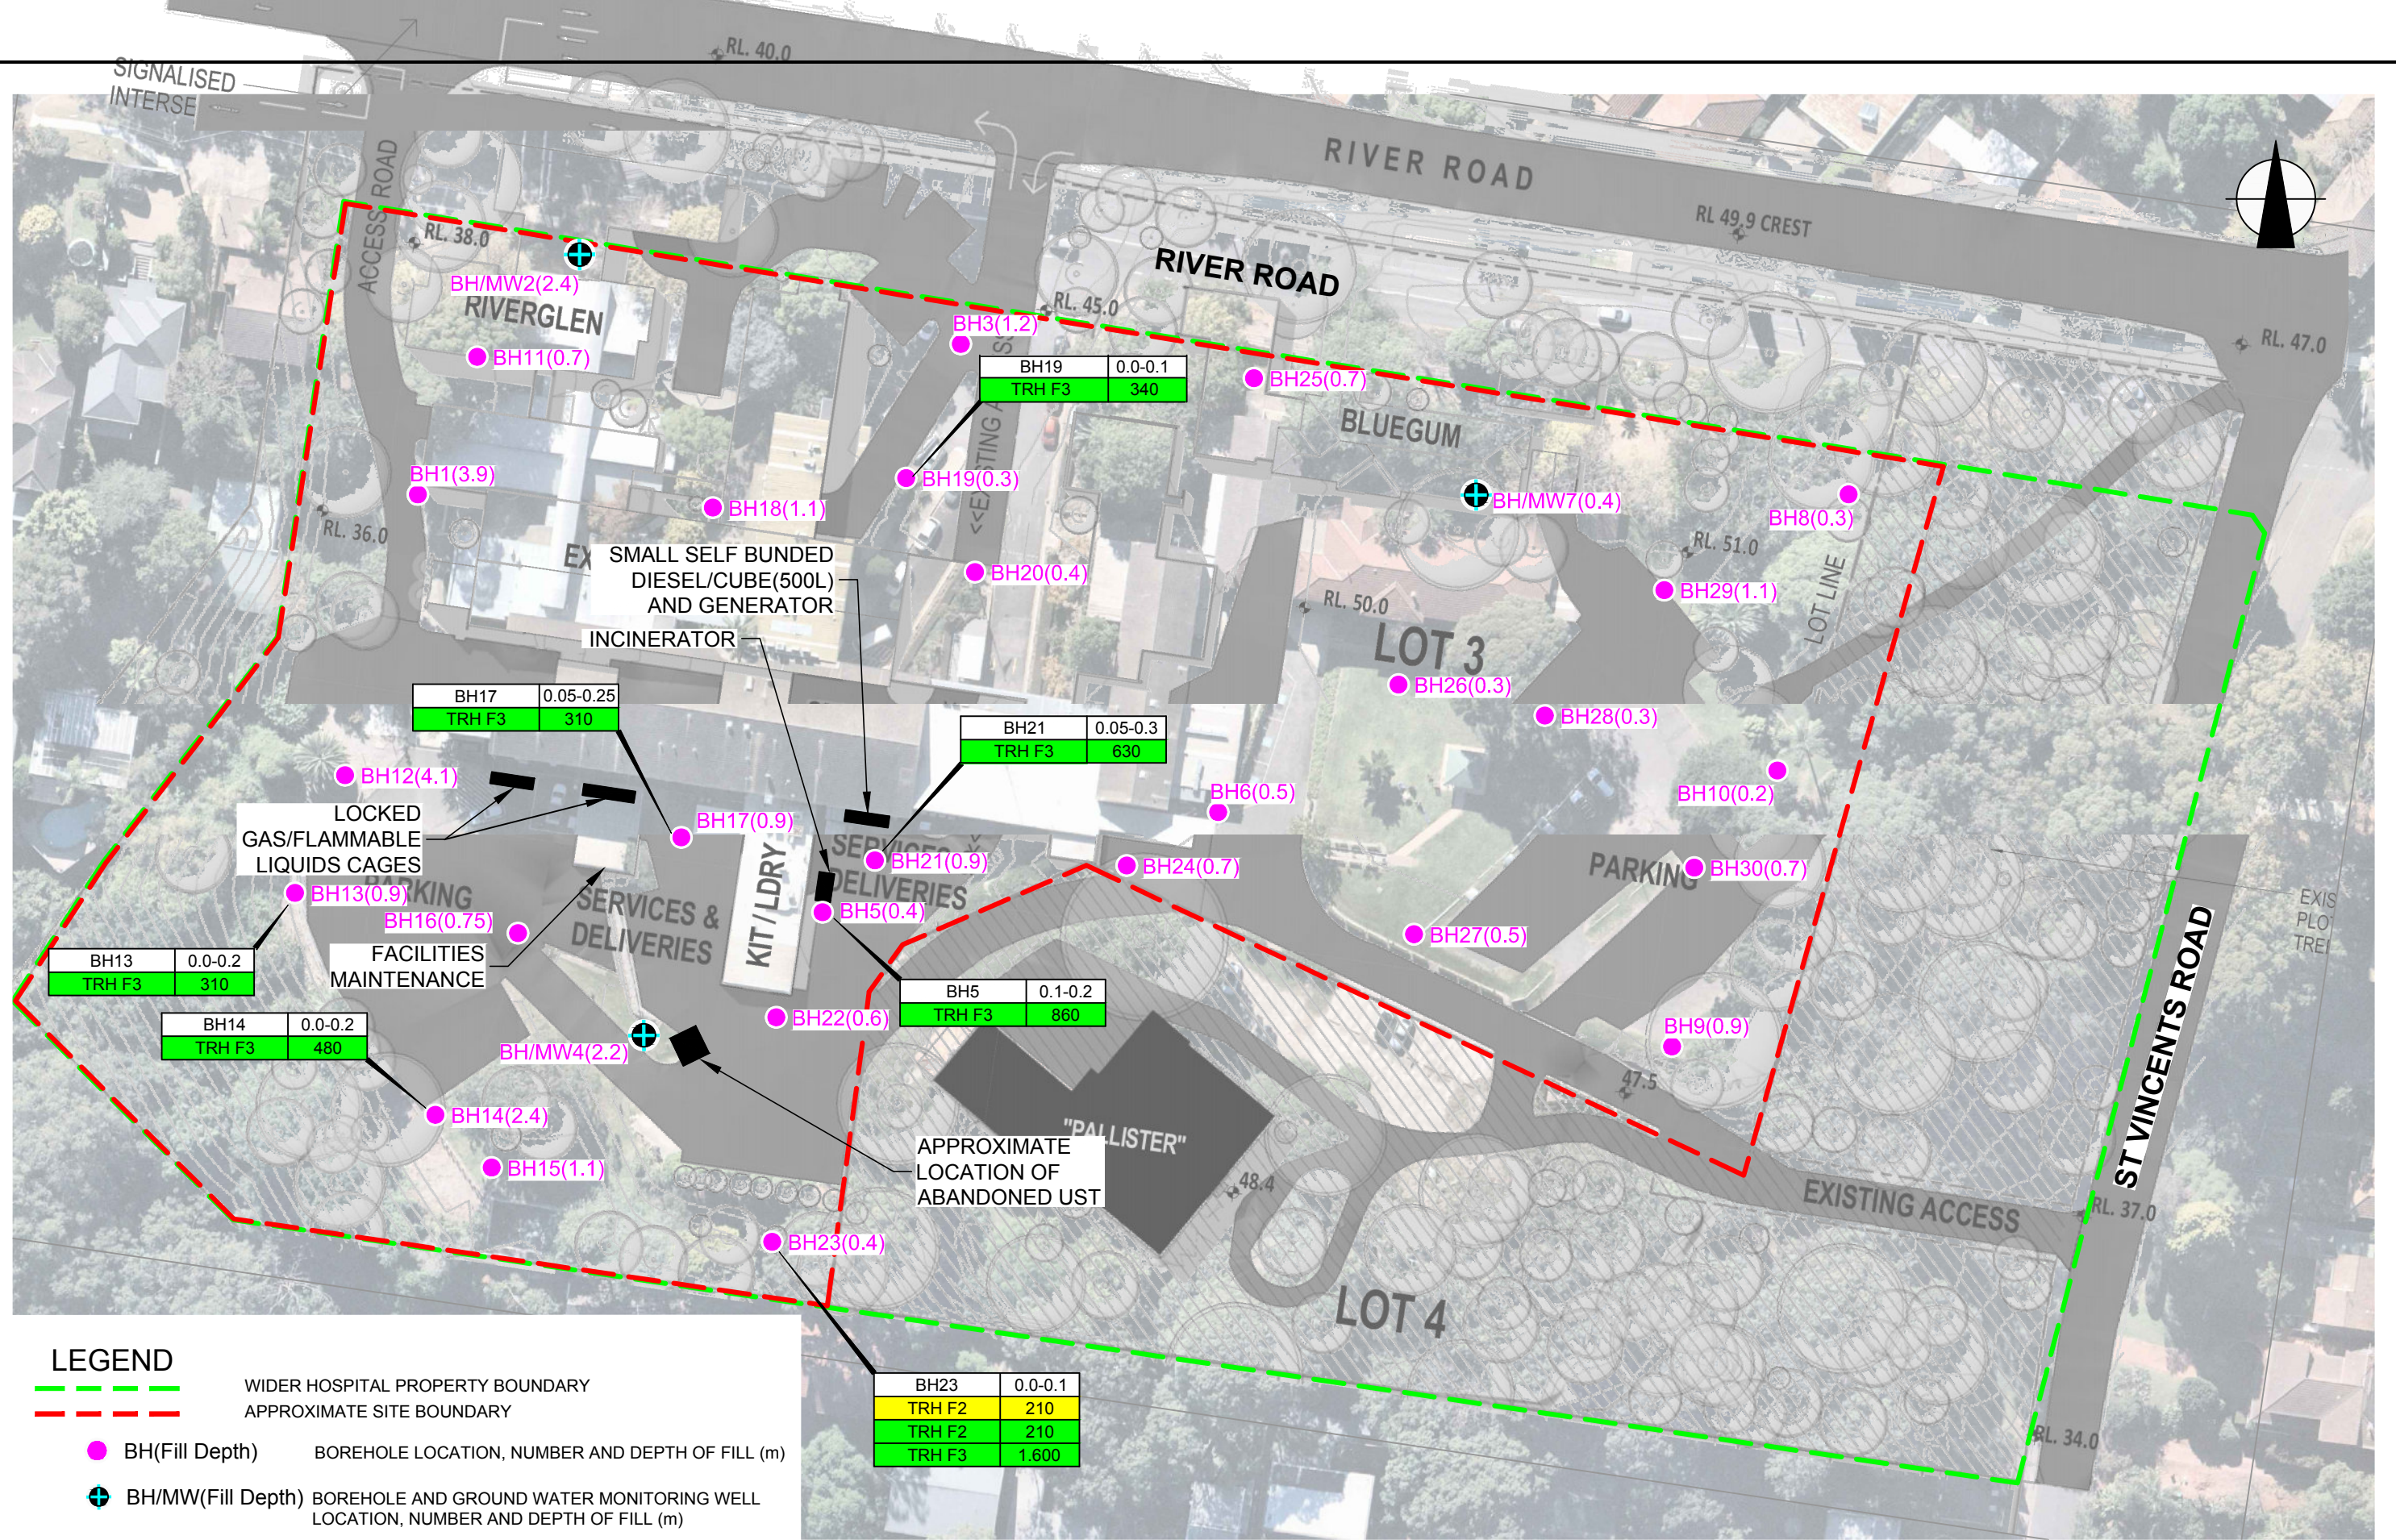
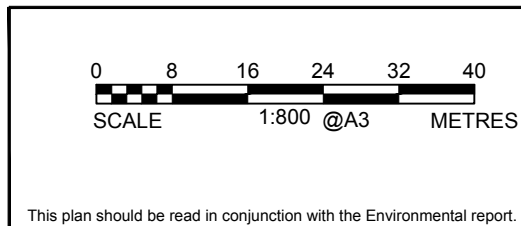
Title: DSI SAC EXCEEDANCE PLAN	
Location: 97-115 RIVER ROAD GREENWICH, NSW	
Report No: E32507BT	Figure No: 3B
JKEnvironments

- A TRH F1 concentration above the human health-based SAC in residual soil at BH103;
- TRH F3 concentrations above the ecological-based SAC in fill soils at BH104 and BH108. It is noted that following silica gel cleanup analysis of the sample to remove interference from non-petroleum-based hydrocarbons (i.e. organic compounds), the TRH F3 concentration in BH108 was below the ecological-based SAC;
- Concentrations of heavy metals (cadmium, copper, nickel and/or zinc) above the ecological SAC in the groundwater; and
- pH readings outside (i.e. below the lower threshold) of ecological SAC in the majority of the groundwater samples.

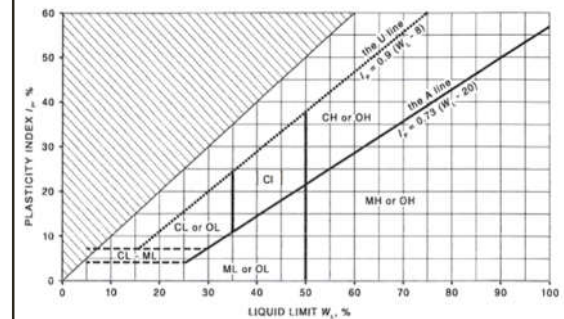
Modified Casagrande Chart for Classifying Silts and Clays according to their Behaviour

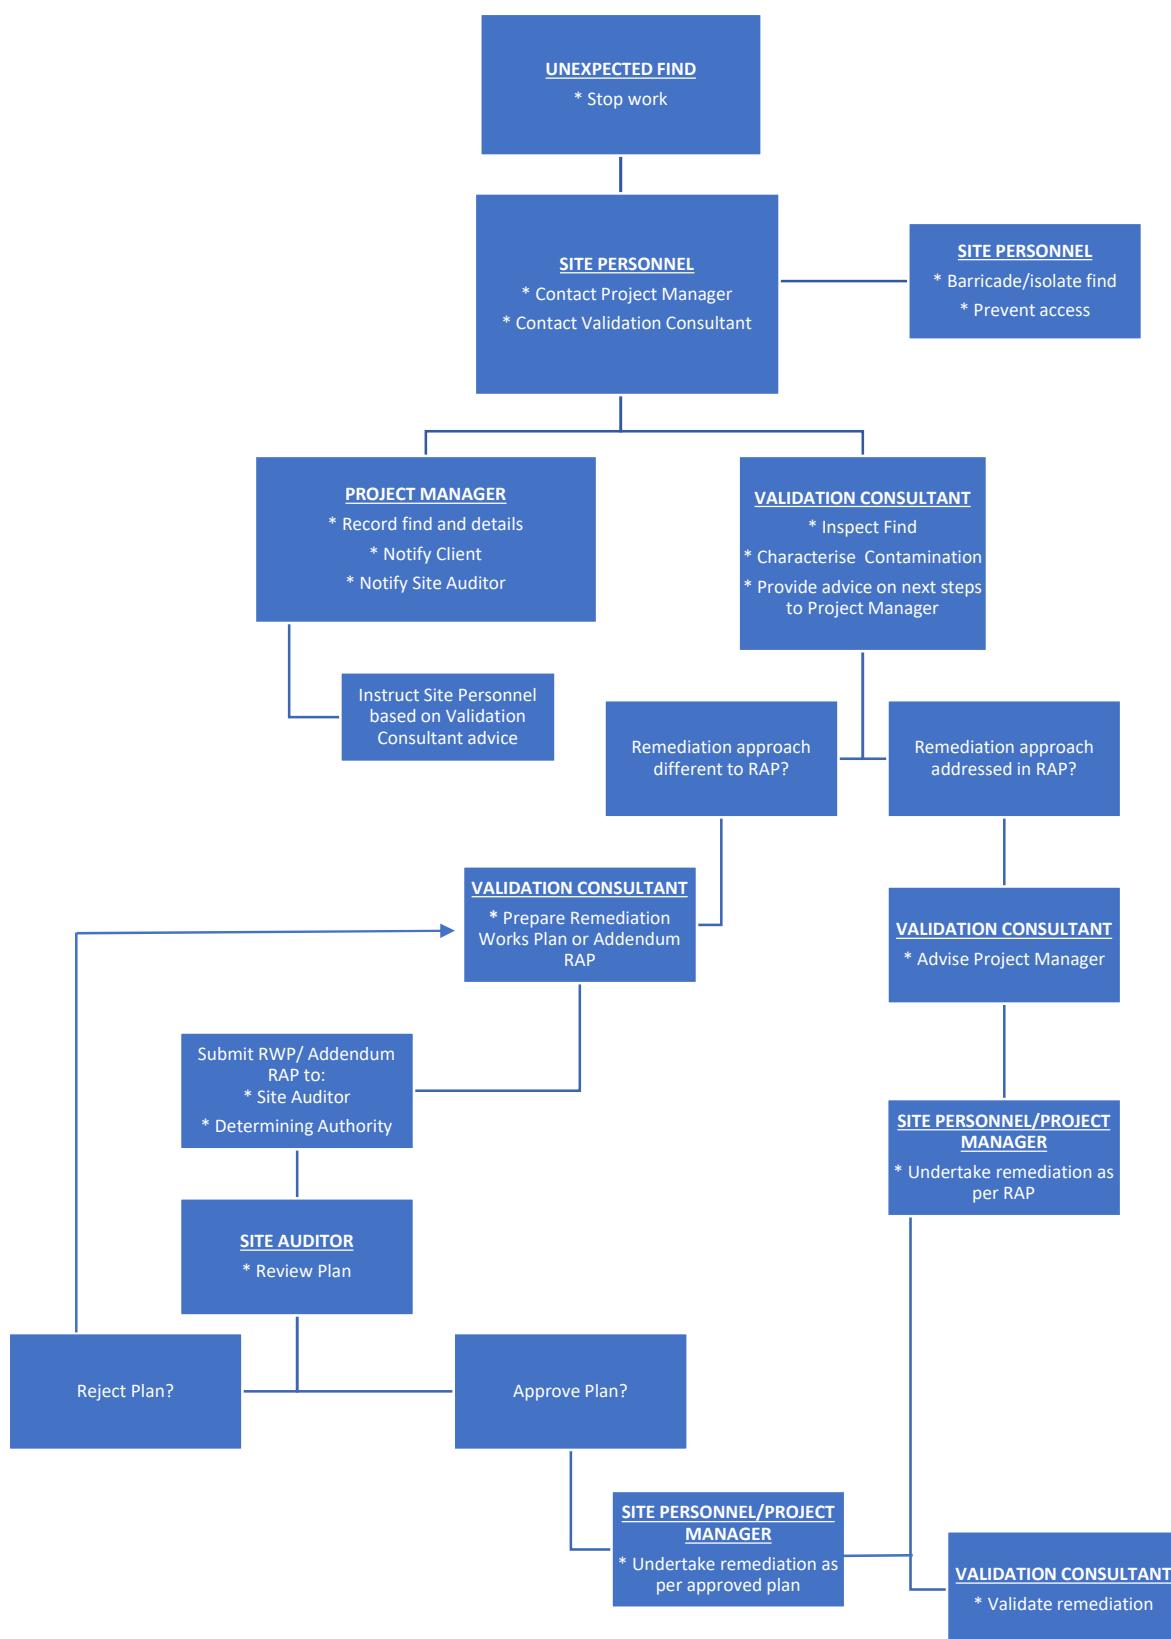
UNEXPECTED FINDS PROTOCOL FLOW-CHART
