SALINITY INVESTIGATION

PROPOSED HOSPITAL REDEVELOPMENT

GREENWICH HOSPITAL, 97-115 RIVER ROAD, GREENWICH, NSW

Date: 8 April 2022 Ref: E32507BRpt4Rev1

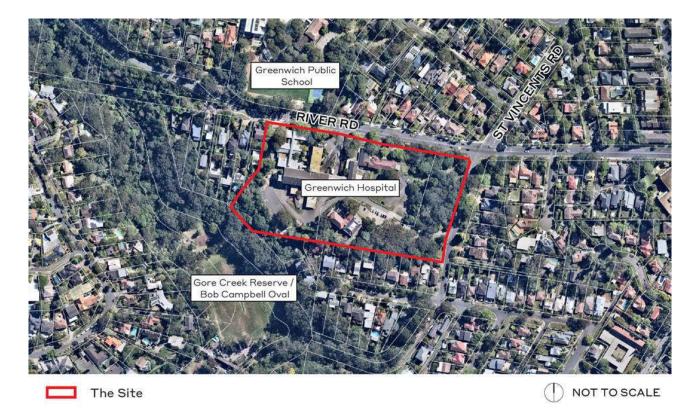
This salinity investigation report is to be submitted to the Department of Planning, Industry and Environment (DPIE) in support of a State Significant Development Application (SSD-13619238) for the redevelopment of Greenwich Hospital into an integrated hospital and seniors living facility on land identified as 97-115 River Road, Greenwich, NSW (the site). The extent of the site is shown below.

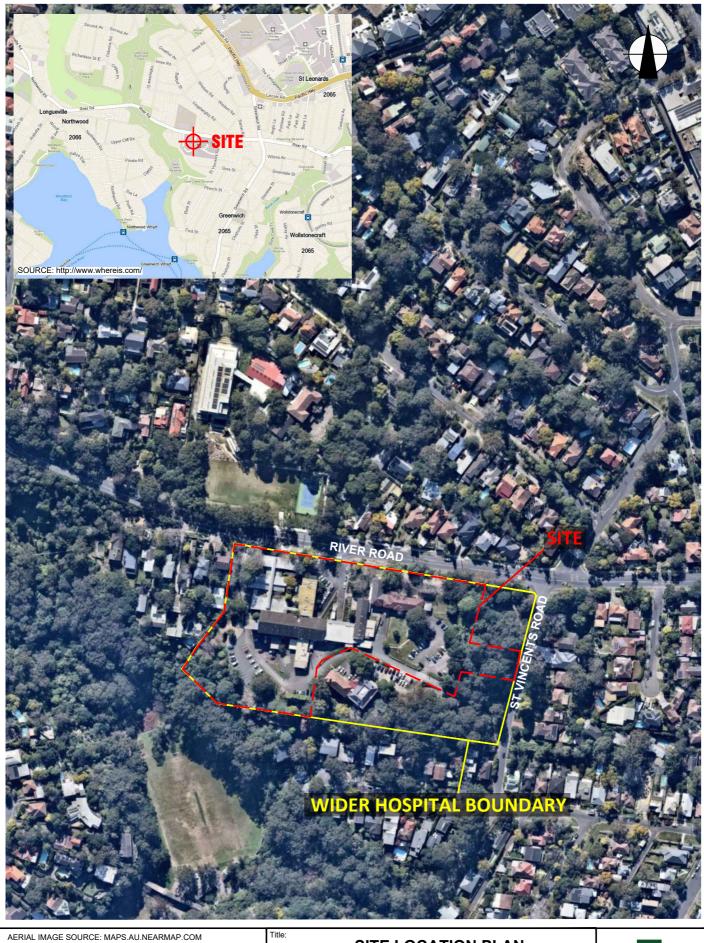
Figure No: 1

SITE LOCATION PLAN

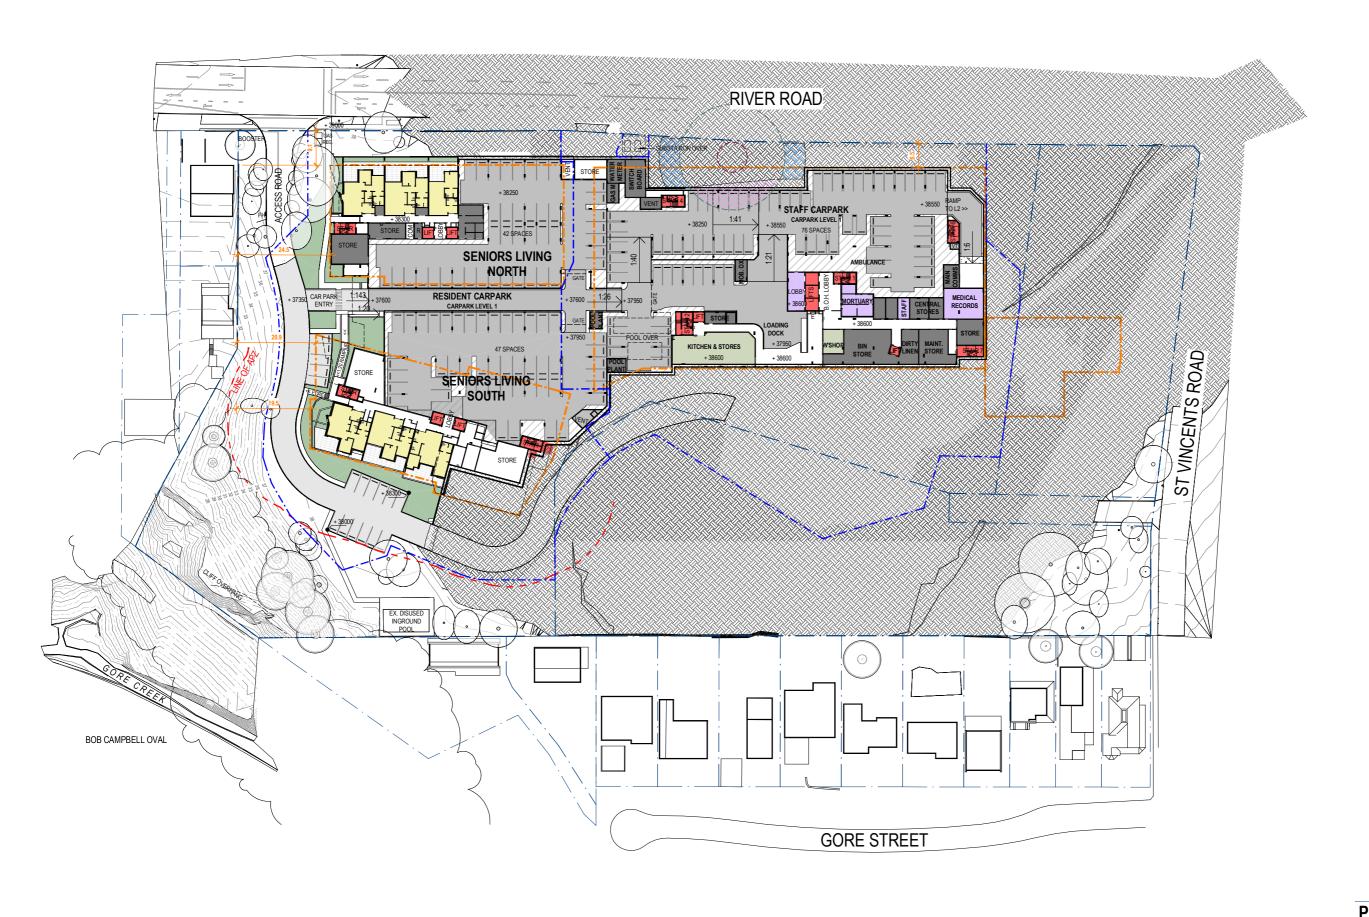
DD-SW-0200 P19 DATE: 01/11/21

SITE LEVEL PLAN - LEVEL 1 (BASEMENT) CHECKED: SCALE: 1:500 @A1
