**REPORT TO
FRASERS PROPERTY AUSTRALIA**

**ON
PREDICTION OF GROUND MOVEMENTS UNDER
RAIL CORRIDOR**

**FOR
PROPOSED HOUSING RENEWAL**

**AT
Stage 1A, LOT 5-7 POLDING PLACE, TELOPEA,
NSW**

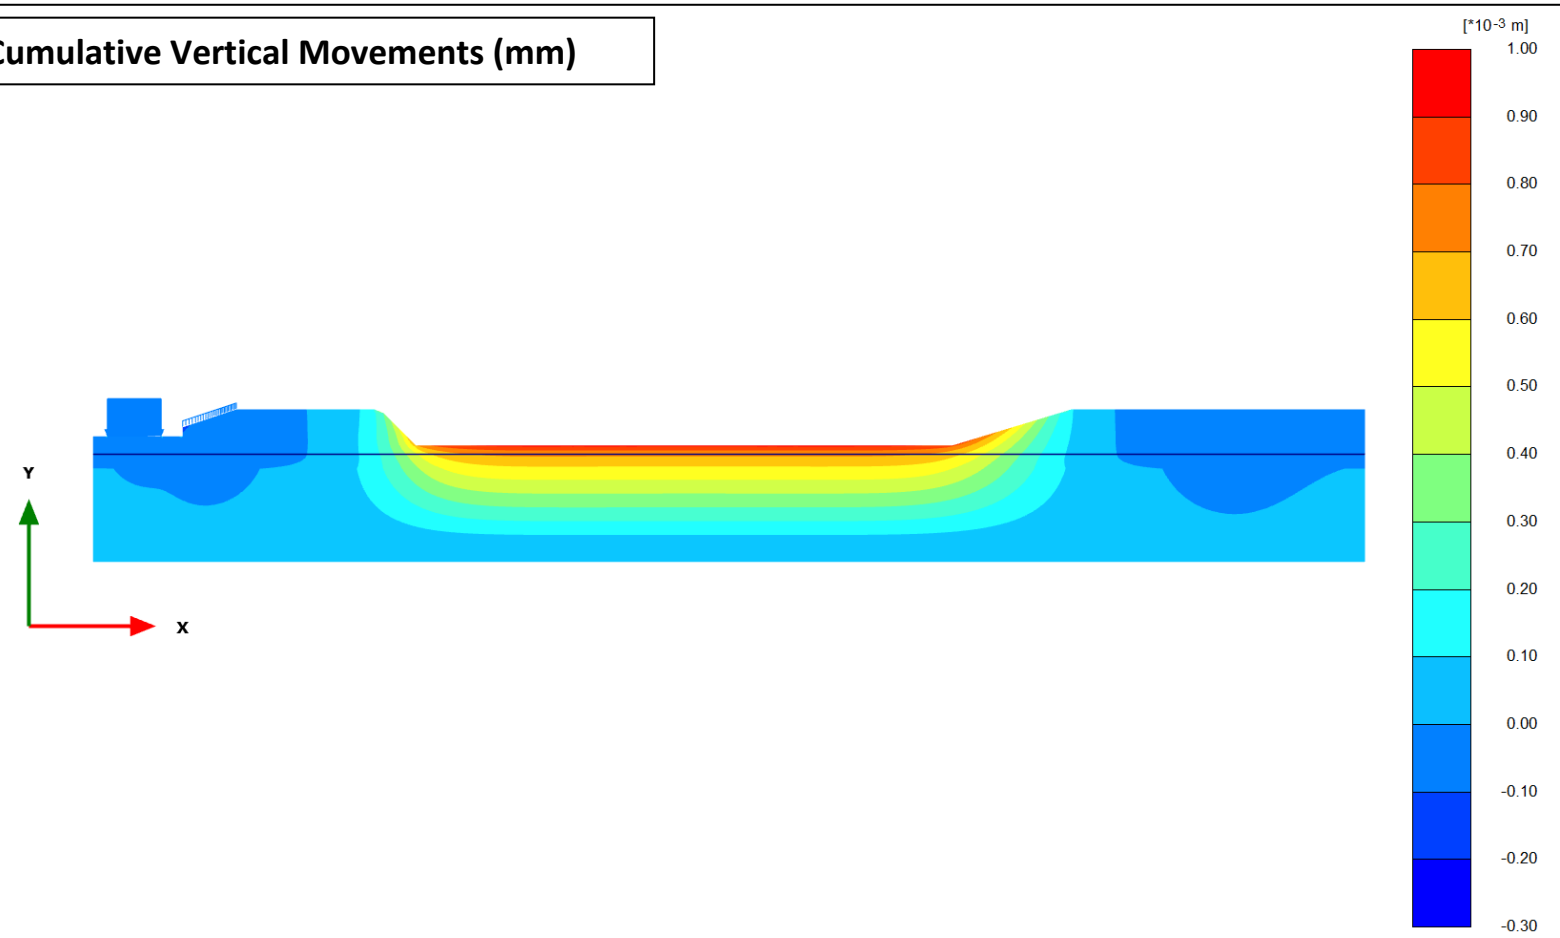
Cumulative Horizontal and Vertical Movements (mm)
Stage 3: Excavate to RL52.5m

The analysis results for the modelled section are tabulated below. We note that on completion of analysis *Stage 3 Existing Conditions*, all displacements were reset to zero. This zeroing of movements allows only the movement induced by the excavation, retaining walls, floor slab, building loads and backfill to be analysed. In the table below we have provided results of the modelling for Stages 3, 5 and 6. The results summarise the movements induced below the rail line.

Cumulative Horizontal Movements (mm)

Cumulative Vertical Movements (mm)

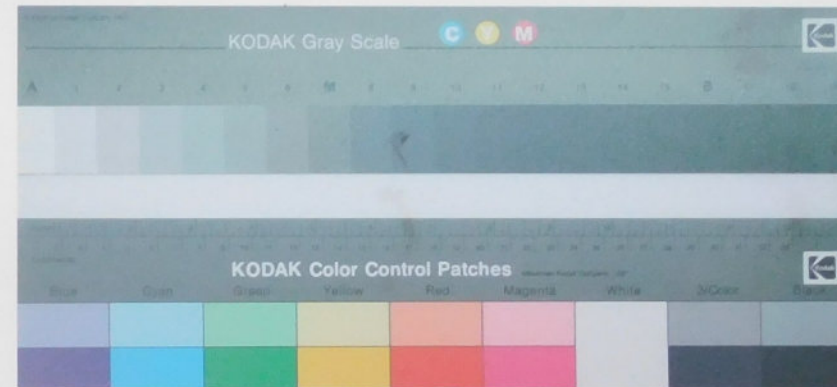
Job No: 33097SC
Borehole No: BH7
Depth: 5.70m - 8.80m

Water Loss/Level	Barrel Lift	RL (m AHD)	Depth (m)	Graphic Log	CORE DESCRIPTION Rock Type, grain characteristics, colour, texture and fabric, features, inclusions and minor components	Weathering	Strength	POINT LOAD STRENGTH INDEX $I_p(50)$	DEFECT DETAILS		Formation
									SPACING (mm)	DESCRIPTION Type, orientation, defect shape and roughness, defect coatings and seams, openness and thickness	
								VL-0.1 L-0.3 M-1 H-3 VH-10 EH	600 200 60 20	Specific General	
		50			START CORING AT 5.70m						
		49	6		Extremely Weathered siltstone: silty CLAY, high plasticity, light an dark grey and red brown, trace of fine to medium grained ironstone gravel.	XW	Hd	0.10		(6.50m) Be, 0°, P, S, Fe Sn, 150 mm.t	Ashfield Shale
					SILTSTONE: dark grey.	MW	VL - L				
		48	7		Extremely Weathered siltstone: silty CLAY, high plasticity, light an dark grey and orange brown.	XW	Hd	0.030			
					SILTSTONE: dark grey, bedded up to 15°.	MW	VL	0.60

47	8		SANDSTONE: fine to medium grained, dark grey, bedded at 5-10°.	SW	M			(7.80m) Be, 7°, Ir, R, Fe Sn	
						FR	H	2.9			
								3.9			
					END OF BOREHOLE AT 8.70 m						
		46	9								
		45	10								
		44	11

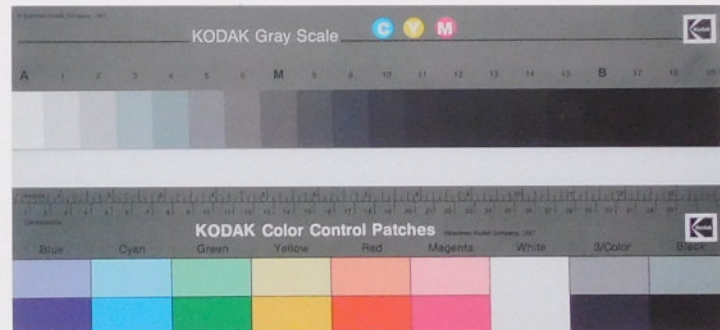
Job No: 33079SC
Borehole No: BH8
Depth: 5.80m - 8.60m

(6.45-6.50m) XWS, 0°, 50 mm.t	
											(6.56m) Be, 8°, P, R, Fe Sn	
											(6.59m) J, 12°, P, R, Fe Sn	
		49									(6.95m) Be, 7°, Ir, R, Fe Sn

(7.08m) J, 40°, Ir, R, Fe Sn	
											(7.25m) J, 48°, Ir, R, Fe Sn	
											(7.33m) J, 38°, Ir, R, Fe Sn	
											(7.55m) Be, 6°, P, R, Fe Sn	
			8		SILTSTONE: dark grey, bedded up to 5°.	FR	M - H					
		48			END OF BOREHOLE AT 8.60 m							
			9									
		47										
			10									
		46										
			11									
		45
