**PRELIMINARY SITE  
INVESTIGATION AT TELOPEA,  
NSW  
FRASERS PROPERTY AUSTRALIA**

27 AUGUST 2020  
120034  
VERSION 3

**Preliminary site investigation at Telopea, NSW**

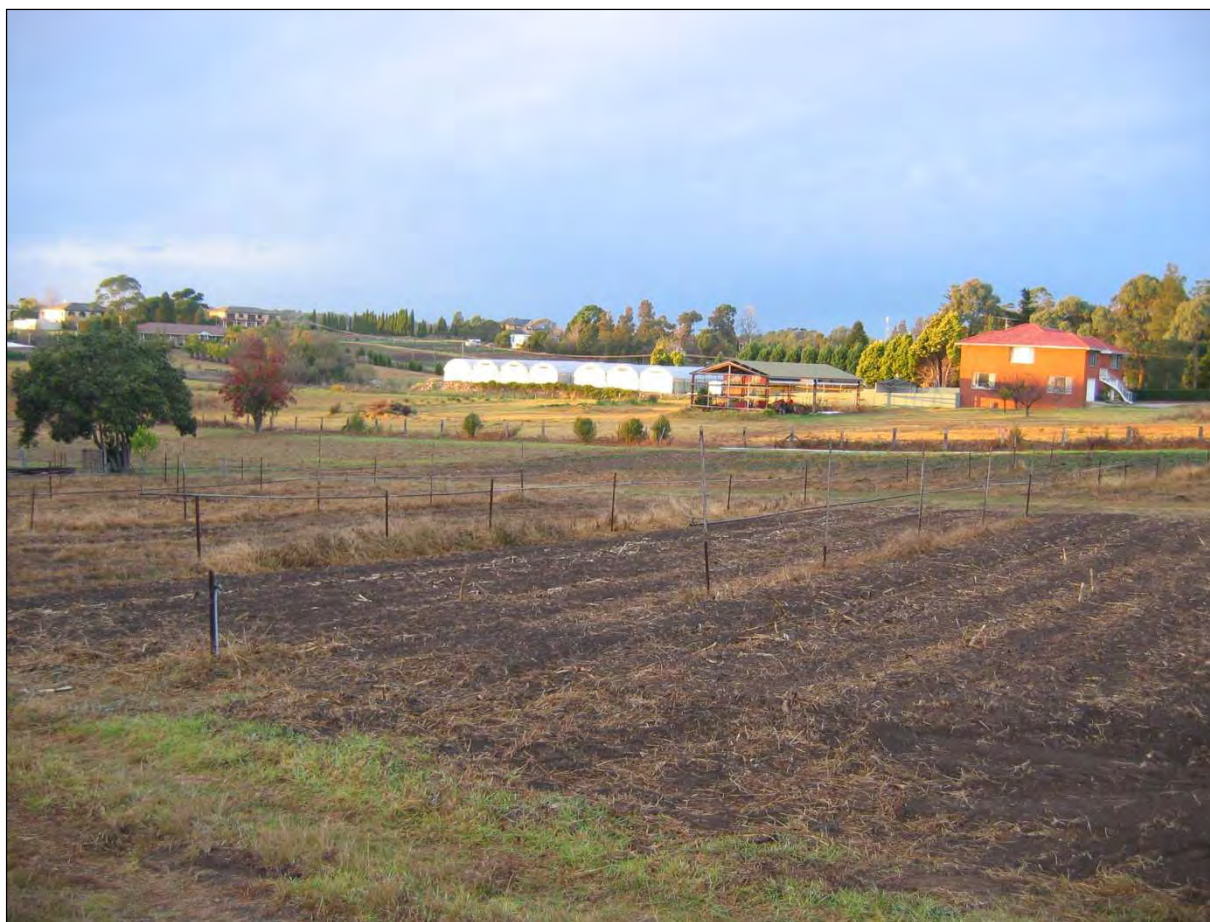
**Landscape**— undulating to rolling low hills on Wianamatta Group shales. Local relief 50-80 m, slopes 5-20%. Narrow ridges, hillcrests and valleys. Extensively cleared tall open-forest (wet sclerophyll forests).

The majority of the soils observed at the site incorporate soils classified in the Soil and Land Resources of the Hawkesbury-Nepean Catchment as belonging to the Glenorie Soil Landscape. Characteristics of these natural soils include shallow to moderately deep (<100 cm) red and brown podzolic soil on upper slopes crests grading to yellow podzolic soils and prairie soils on lower slopes and drainage lines. Limitations for Glenorie soils include moderate reactive highly plastic subsoil, high soil erosion hazard, localised seasonal water logging and moderate surface swelling potential.

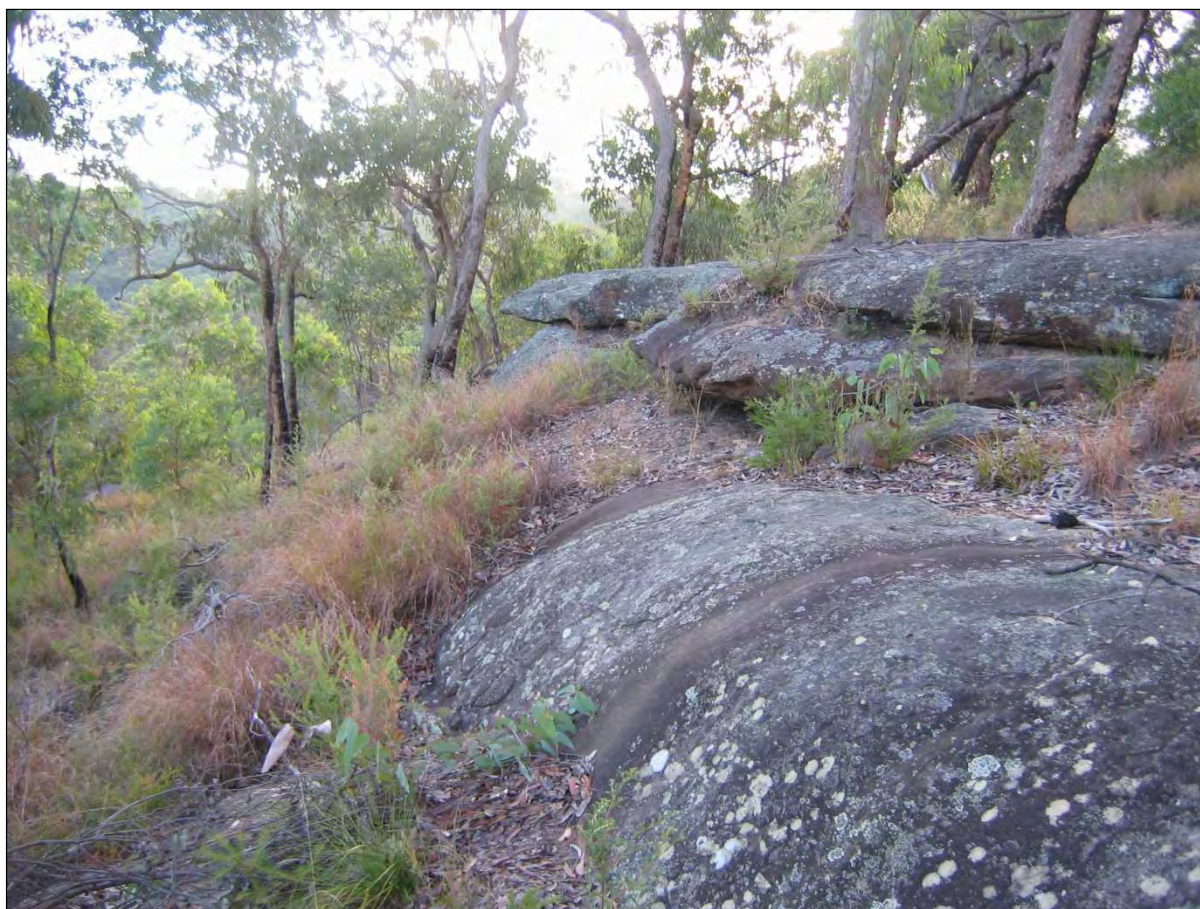
**Landscape**— undulating to rolling rises and low hills on Hawkesbury Sandstone. Local relief 20-80 m, slopes 10-25%. Rock outcrop <25%. Broad convex crests, moderately inclined sideslopes with wide benches, localised rock outcrop on low broken scarps. Extensively cleared open-forest (dry sclerophyll forest) and eucalypt woodland.

According to Soil and Land Resources of the Hawkesbury-Nepean Catchment, characteristics of the Gymea Landscape include undulating to rolling rises and low hills on Hawkesbury Sandstone with local relief of 20 – 80 m and slopes between 10% to 25%. Natural soils of this landscape include shallow to moderately deep yellow earths and earthy sands, shallow siliceous sands, localised podzolic soils, shallow to moderately deep siliceous. Limitations for Gymea soils include localised steep slopes, high soil erosion hazard, rock outcrop, shallow highly permeable soil, very low soil fertility.

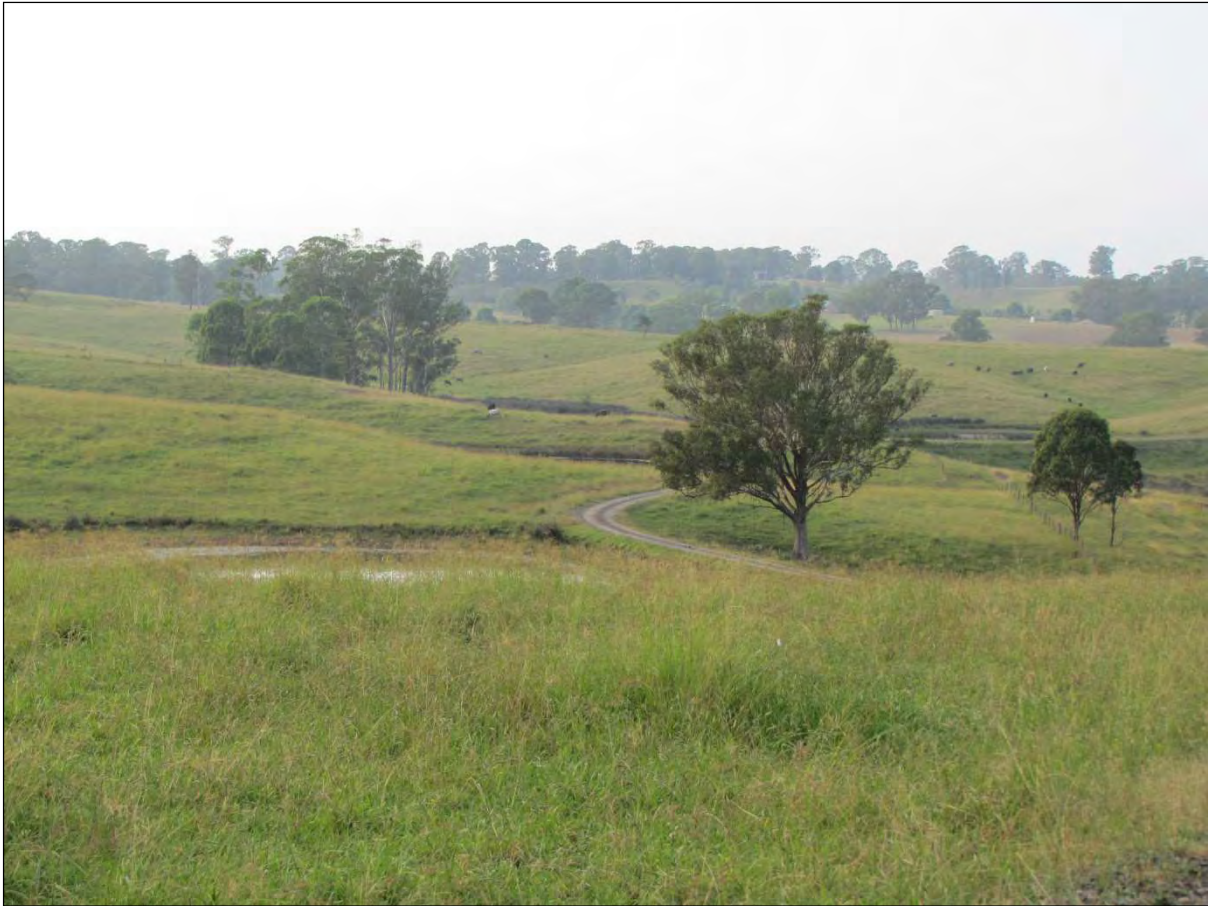
**Landscape**— gently undulating rises on Wianamatta Group shales and Hawkesbury shale. Local relief to 30 m, slopes are usually <5%. Broad rounded crests and ridges with gently inclined slopes. Cleared eucalypt woodland and tall open-forest (wet sclerophyll forests).

The soils observed at Stage 3B (Lots 126 – 129) incorporate soils classified in the *Soil Landscapes of the Penrith 1:100 000 sheet* as belonging to the residual Blacktown Soil Landscape with gently undulating rises on Wianamatta Group shales and Hawkesbury shale. These soils are characterised by being shallow to moderately deep (<100cm) red and brown Podzolic soils on crests, supper slopes and well drained areas. Limitations of Blacktown soils include a moderately reactive and highly plastic subsoil with low fertility and poor drainage. However, they do still have a high capability for urban development given appropriate foundation design.

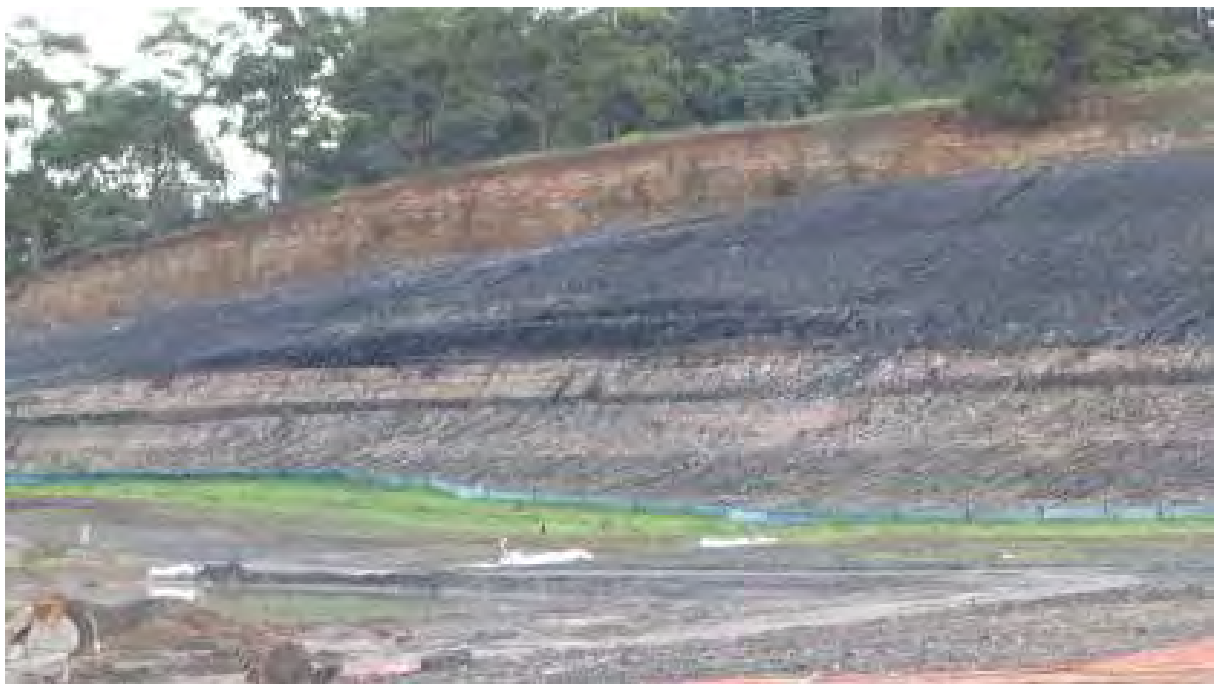
*Glenhaven HGL – Quarry on Shaftsbury Road, Eastwood showing weathered Ashfield Shale (upper red soil in profile), Ashfield Shale (black layer) and underlying sandstones, towards upper slope of HGL. (Photo: DECCW/Marion Winkler).*

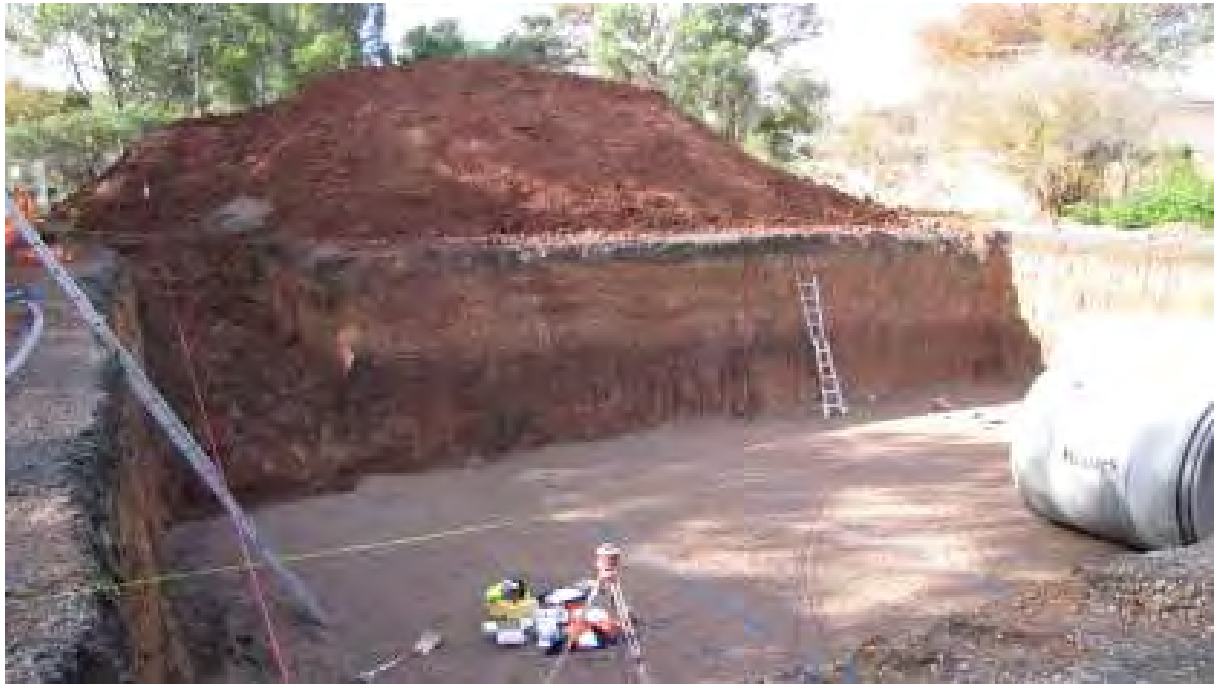
*Deep soils of Glenhaven HGL on lower slopes – deep, red clay soils of weathered Ashfield Shale on lower slopes of HGL, as seen in excavated rainwater tank pit (>5m deep) within grounds of Ryde TAFE. (Photo: DECCW/Marion Winkler).*

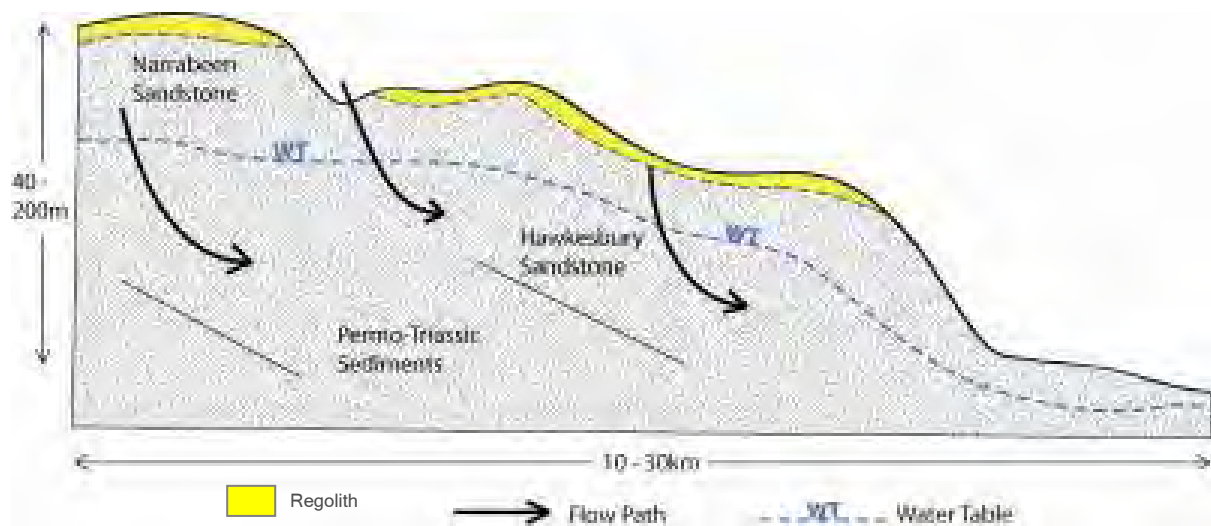
Conceptual Hawkesbury Hydrogeological Landscape cross-section showing the distribution of regolith, landforms, salt sites and flow paths.

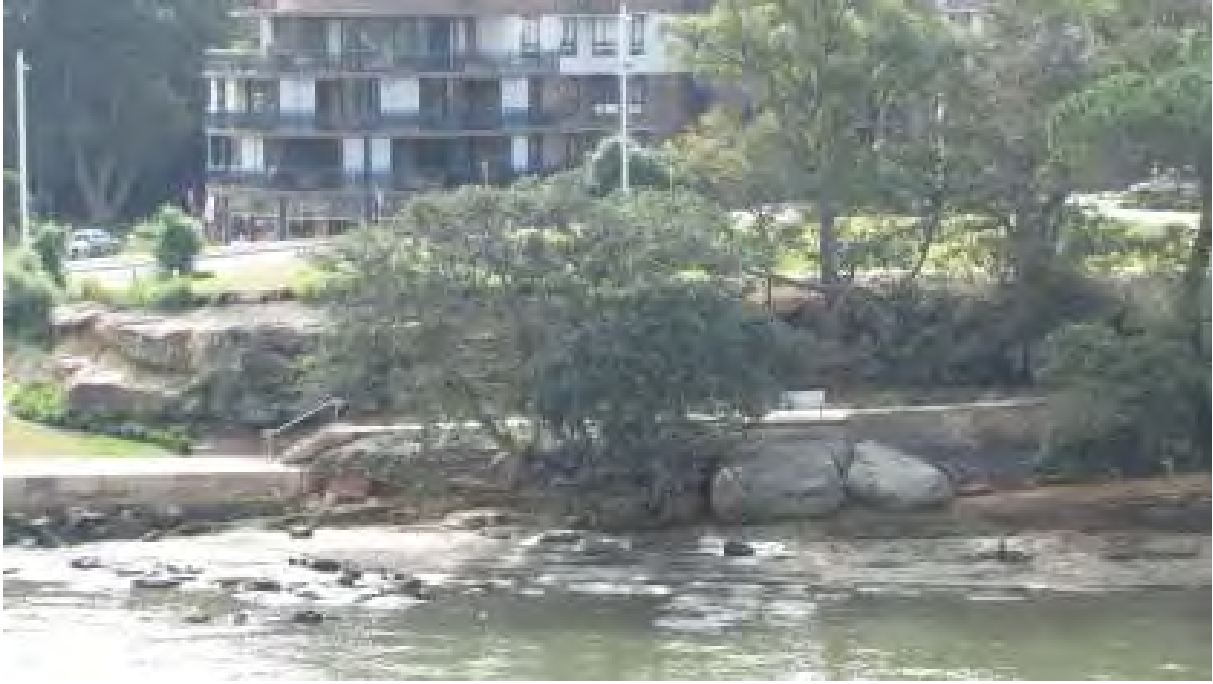
*Hawkesbury HGL – Bedrock exposed along Parramatta River, Meadowbank, bordering Glenhaven HGL. Photo taken from Ryde Bridge looking north-east towards Parsonage Street, Meadowbank (Photo: DECCW/Marion Winkler).*

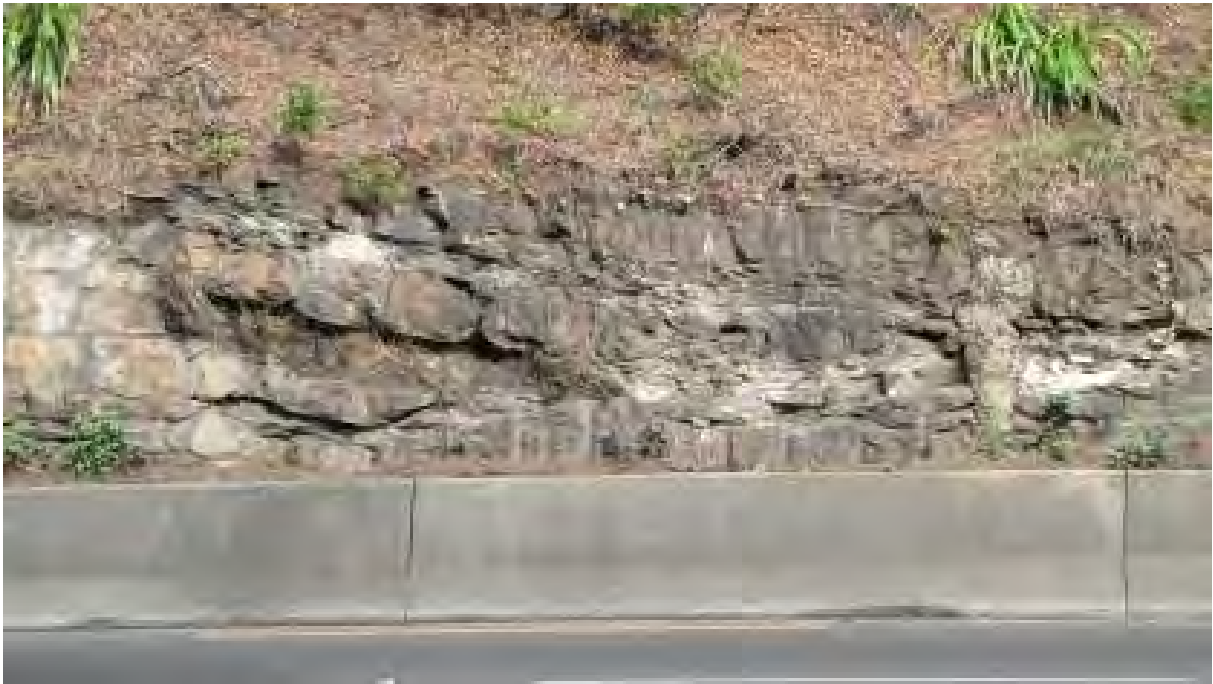
*Hawkesbury HGL – Sandstone bedrock cutting boundary with Glenhaven HGL under rail bridge at Victoria Road, West Ryde (Photo: DECCW/Marion Winkler).*

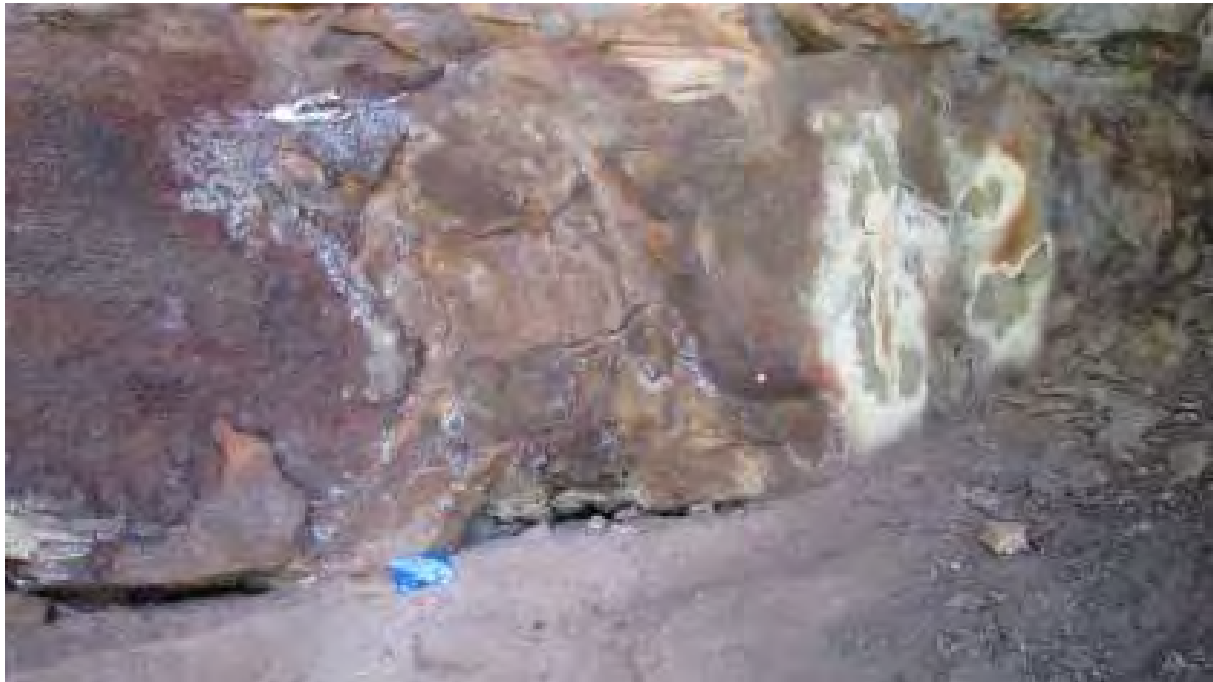
*Hawkesbury HGL, salt outbreak in sandstone rocks, northern side of Wedderburn Gorge (Photo: DECCW/Marion Winkler).*

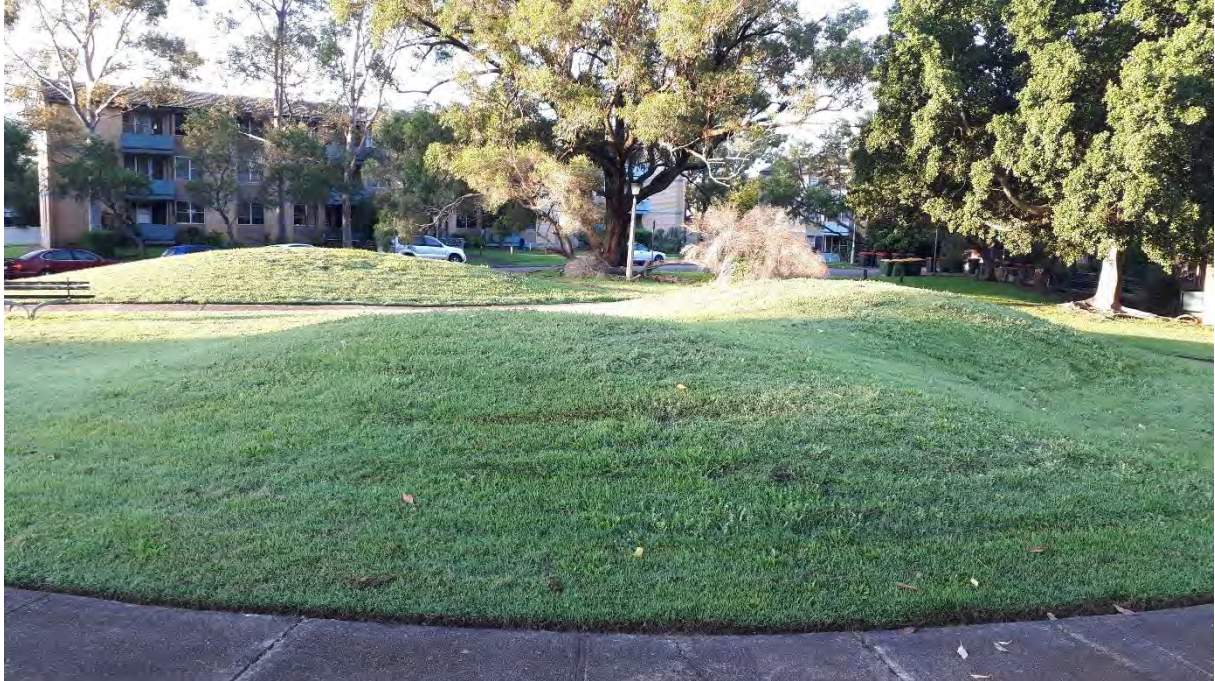
**1. Recreational area of Stage 1A (facing south).**

Recreational area of Stage 1A consists of stockpiles (Photo Plates 1 and 2). There are five large residential properties in Stage 1A with grass covered areas and concrete pavements with trace brick noted on the surface (Plate 3). Building and demolition material consisting of brick, concrete, ACM was observed in the northern grassland area. ACM is also noted in the roof of at least one of the residential properties.

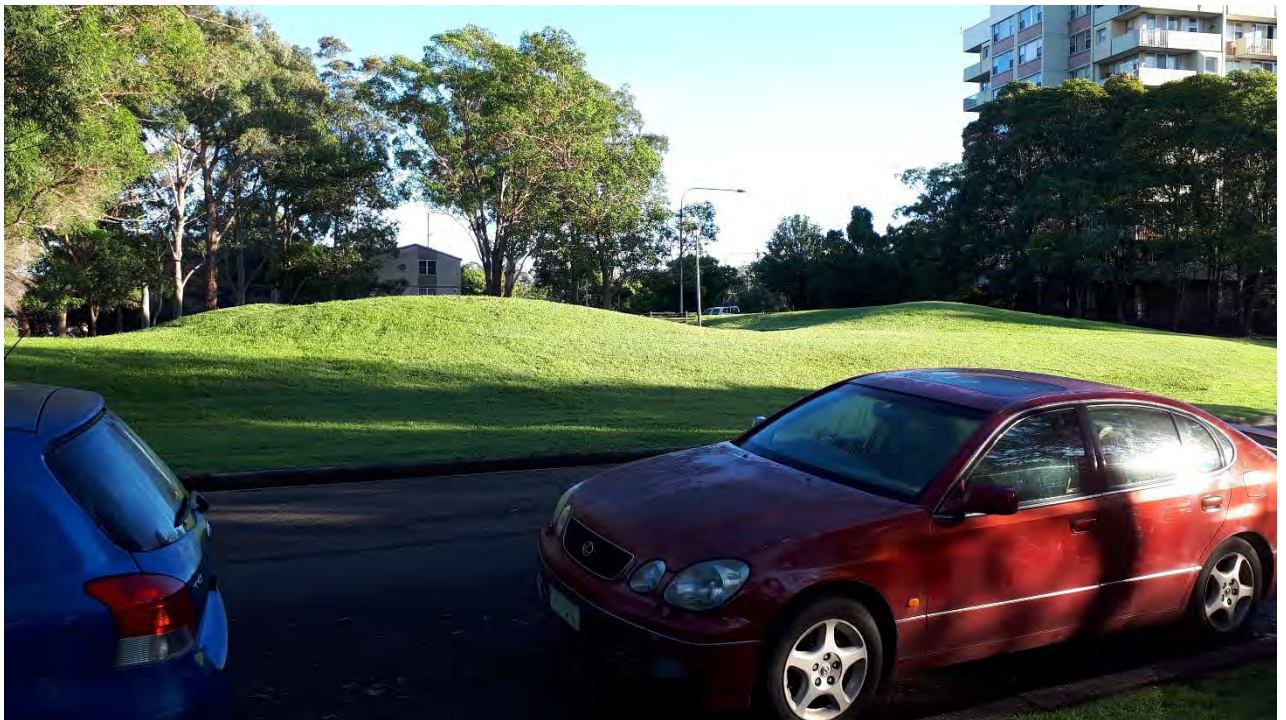
**2. Recreational area of Stage 1A (north of Polding Place).**

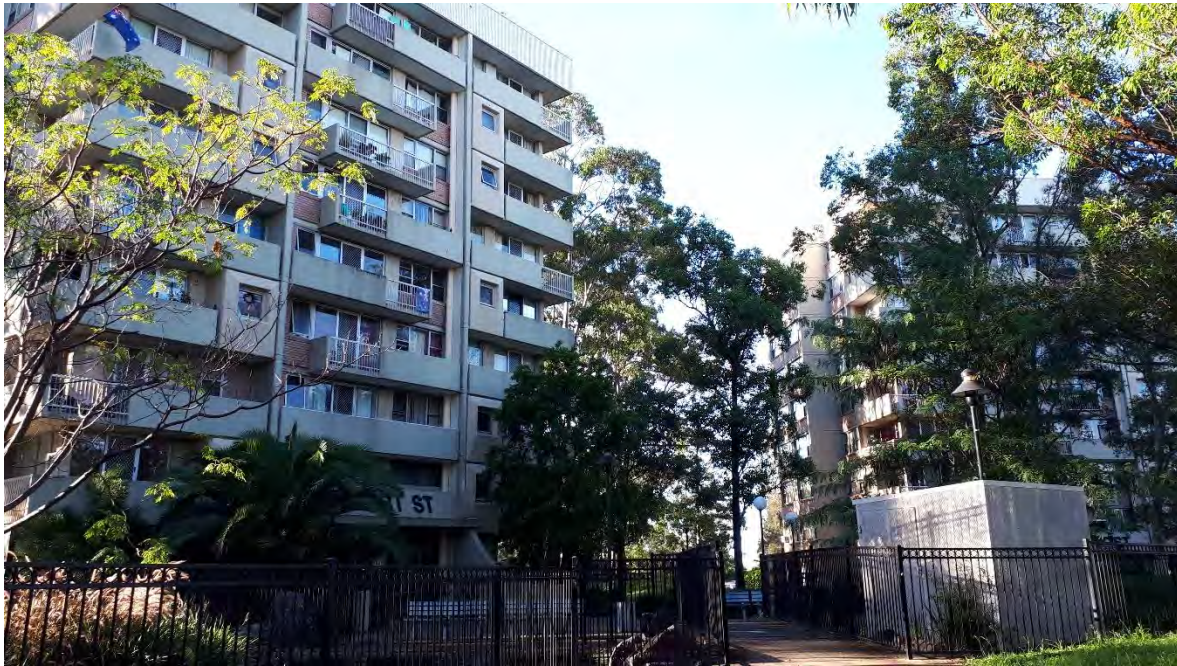
**4. Currently 33 Sturt Street – proposed to be Stage 1C (facing south east).**

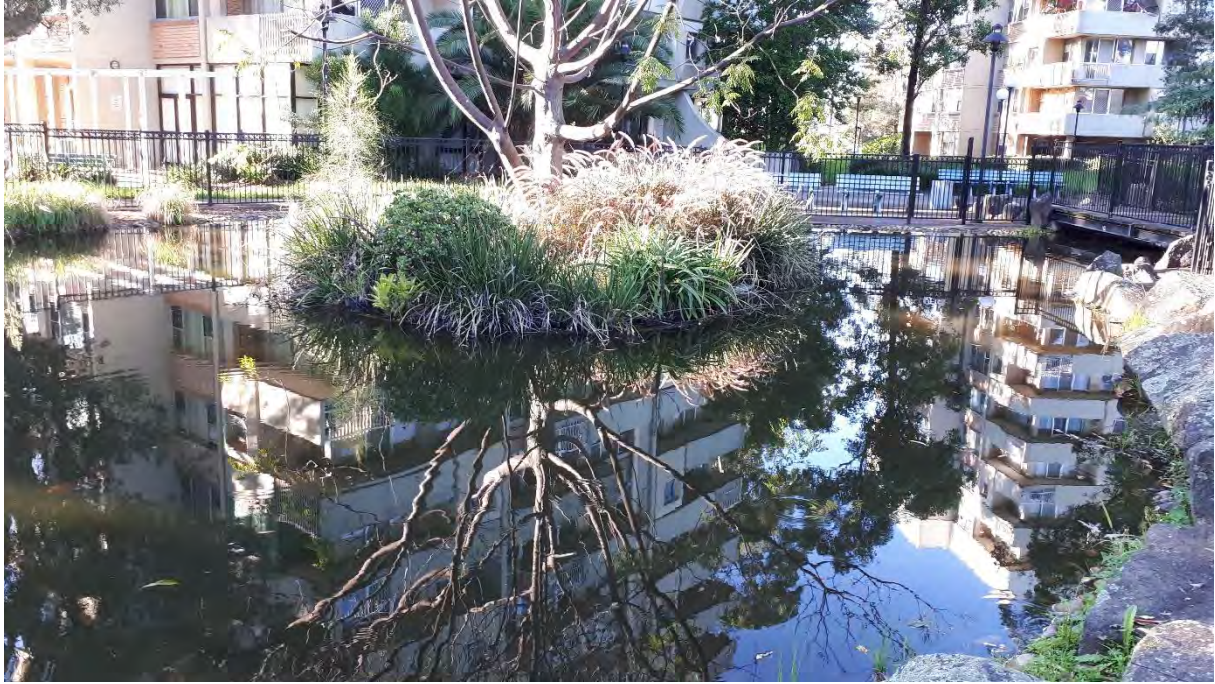
5. Water feature in western area of Stages 1B / 1C (facing east).

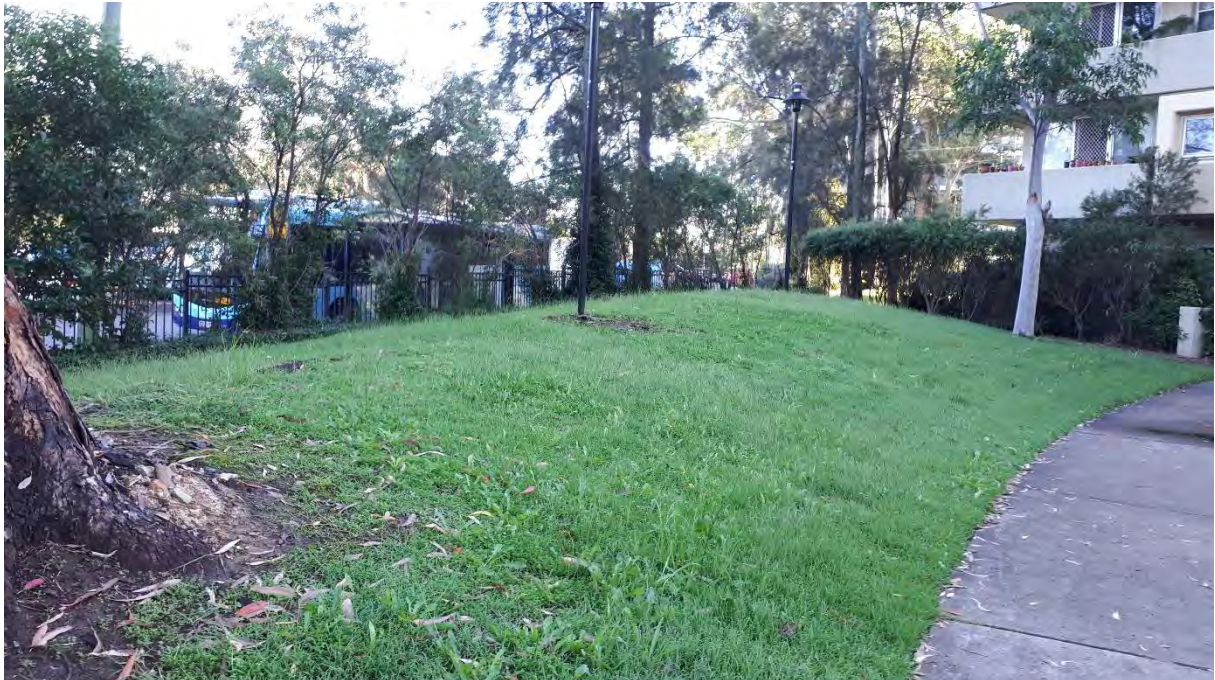
6. West of entrance to 33 Sturt Street residential complex (facing north east).

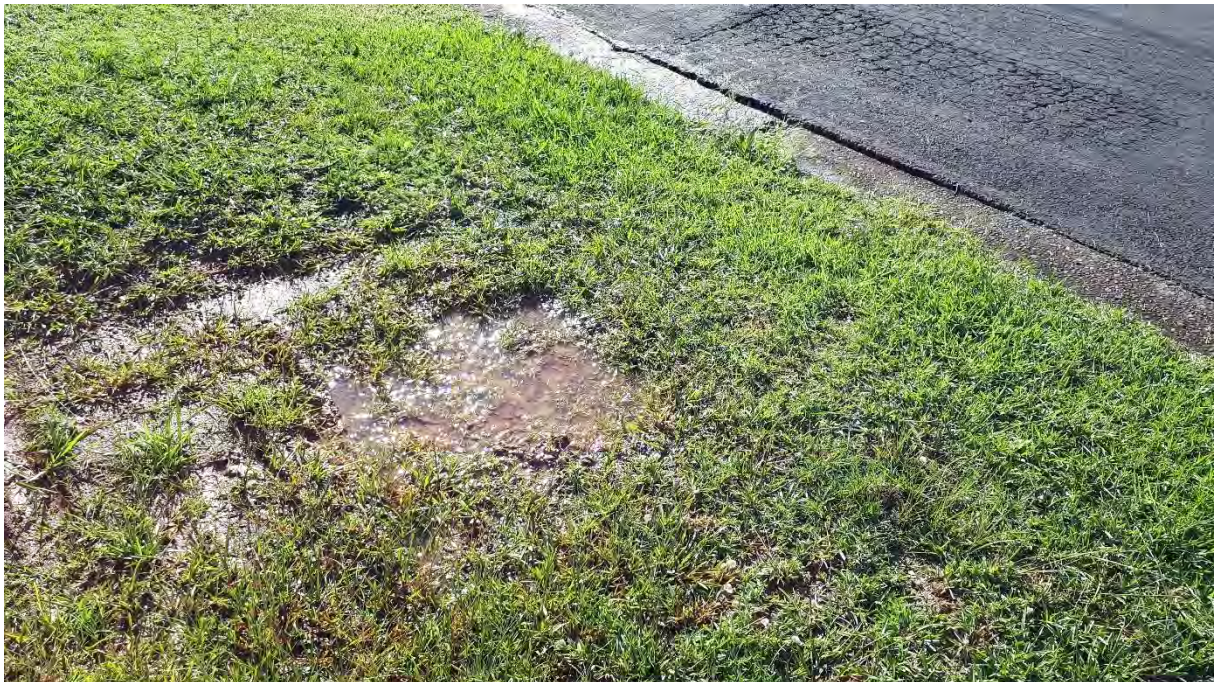
Plates 14 to 20 are typical of the residential properties within Stage 2A with broken windows and deteriorated paint on the outer walls. A foul odour was noted from surface water present along south eastern area of Stage 2A (Plate 16). The properties at Stage 2A were constructed between 1955 and 1965 and several of the properties were constructed using ACM.

**16. Foul odour noted on ground surface of Stage 2A.**

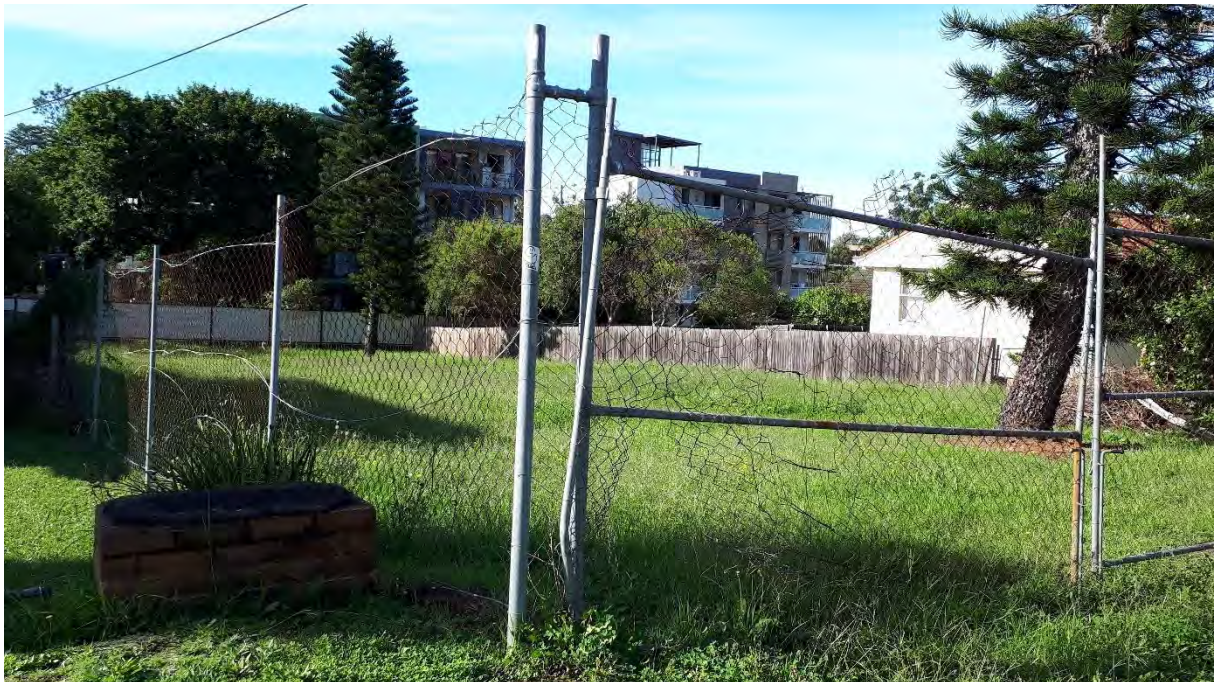
**30. Stage 2D: empty lot, with anthropogenic material around the base of the tree, potential for ACM fragments.**
