11 June 2021

Frasers Property Australia

Update to Detailed Site Investigation for Stage 1A, Telopea NSW

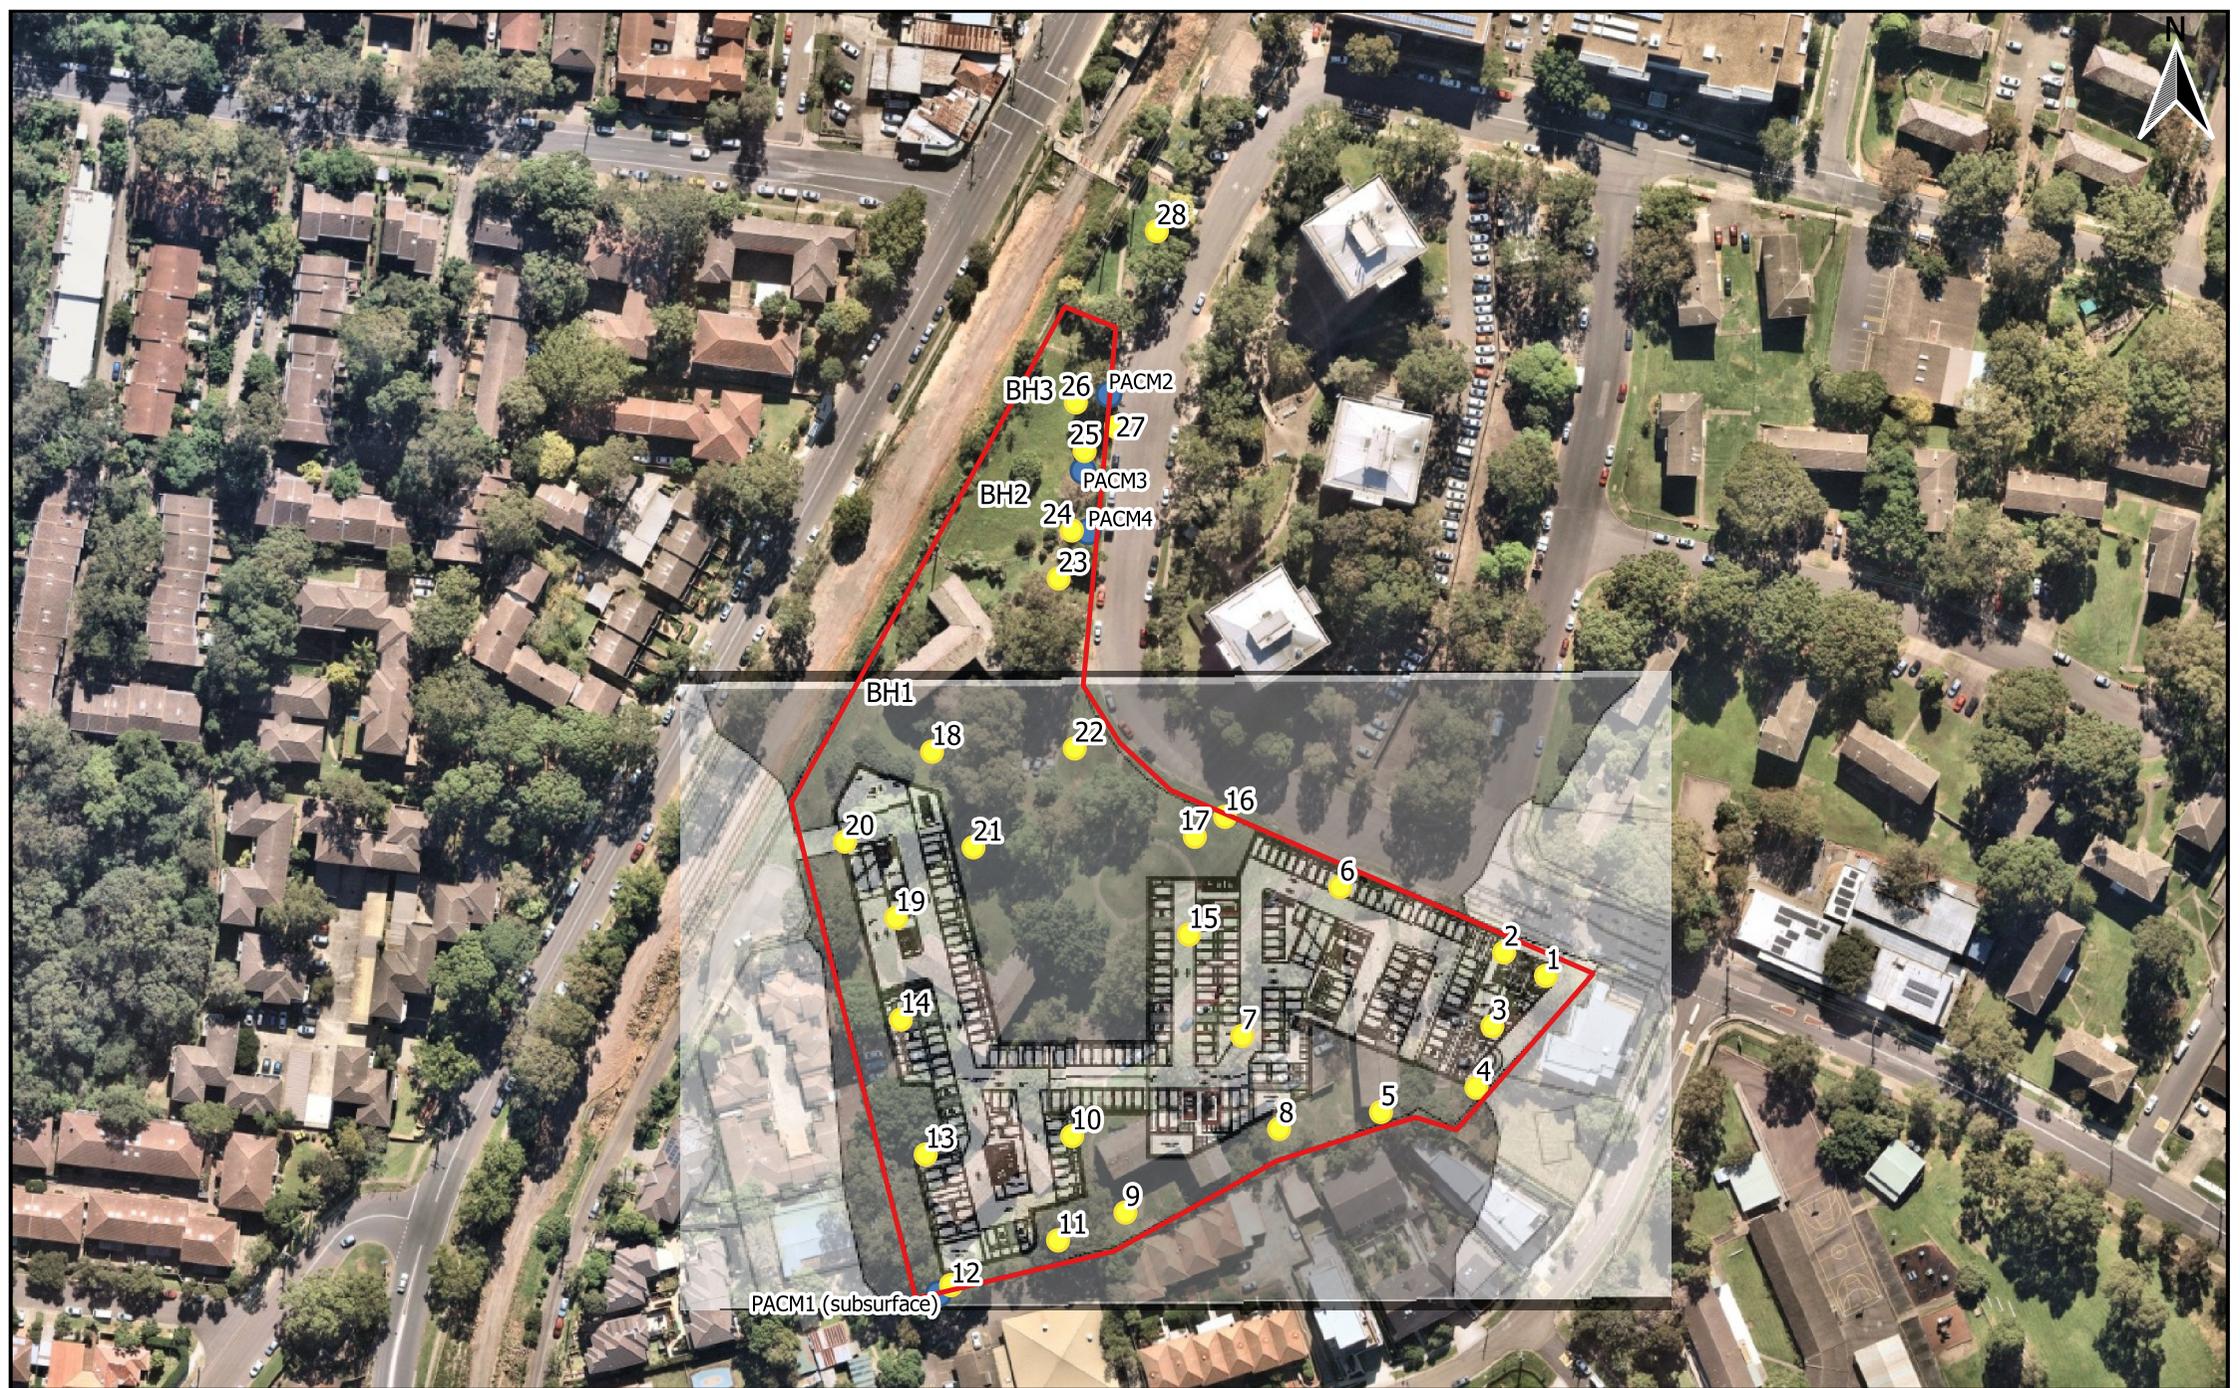
Figure 1

Refer to **Figure 1** for site features and sampling locations.

- ACM was located on the ground surface and within stockpiled fill material in the northern fenced off area of site (IDs: PACM-2 – PACM-3). Building rubble located here is likely due to the demolition of two historic buildings noted in aerial photographs.
- Poor quality fill including the presence of bonded ACM encountered in the south-western corner of site up to 0.5 m depth (IDs: 12 and PACM-1).

Title: Site Features and Sample Locations

It is recommended that prior to the proposed development works, surficial ACMs (ID: PACM-2 – PACM-4) be removed by a suitably licensed contractor. As part of the development works, the poor quality fill material in southwest of the site area (ID: 12 / PACM-1) will require excavation and assessed for either onsite reuse or offsite disposal. Following the removal of these ACMs, the land would be considered **Low Risk** and suitable for the proposed high density residential and recreational, open space land use.

Environmental Earth Sciences recommends the preparation of an Asbestos Management Plan (AMP) for the removal of the ACM impacted fill material in both the northern portion of site and the south-western corner. Following this an inspection and validation of surrounding residual soils prior to development works to ensure bonded fragments are removed from both areas.
