Report on  
Geotechnical Investigation

New High School in Bungendore  
Majara Street, Bungendore

Prepared for  
NSW Department of Education - School Infrastructure  
NSW

Project 202107.02  
September 2021

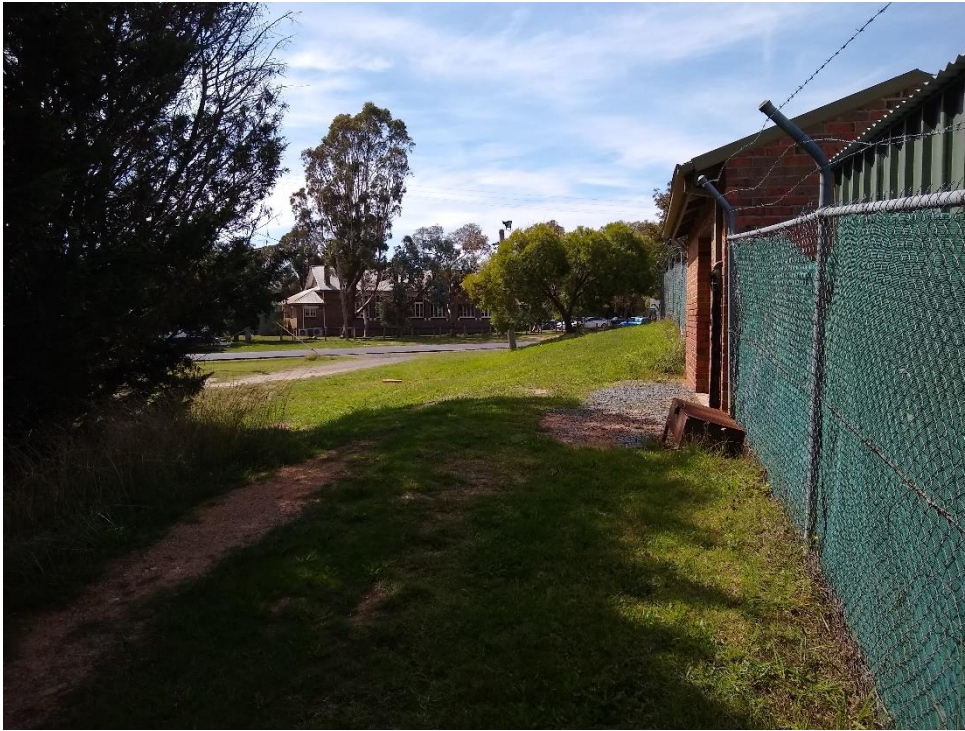
**Figure 3: View of the fill mound alongside the western boundary of the swimming pool**

Figures 3 – 7 show the general conditions of the site at the time of the site walkover.

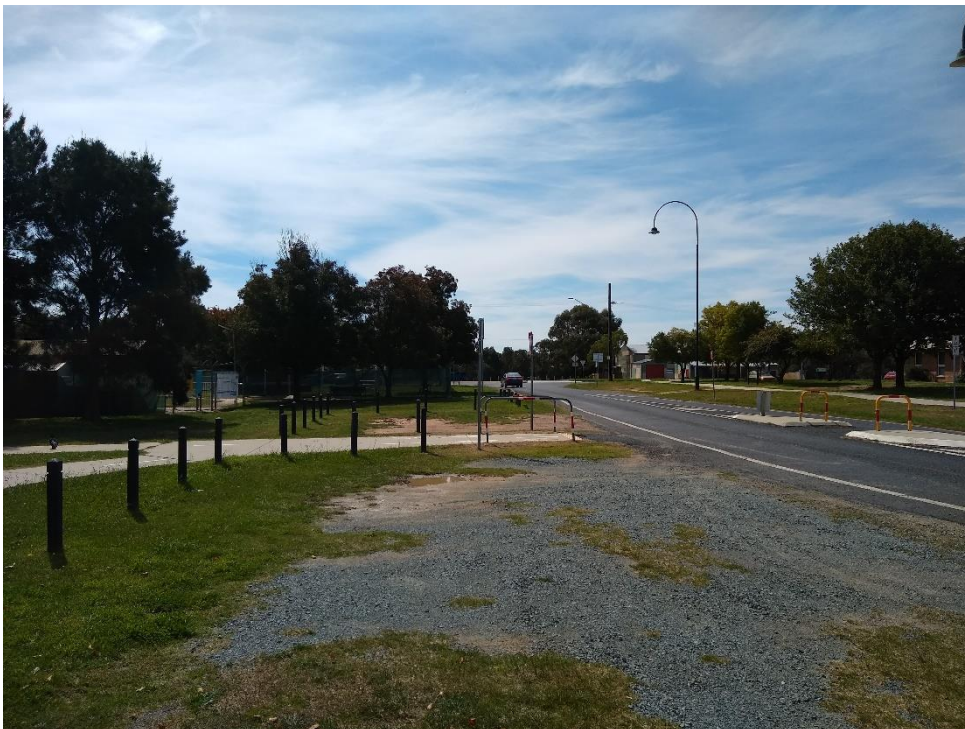
**Figure 4: General view of the northern area of the site, looking north. Swimming pool to the left, community centre to the right).**

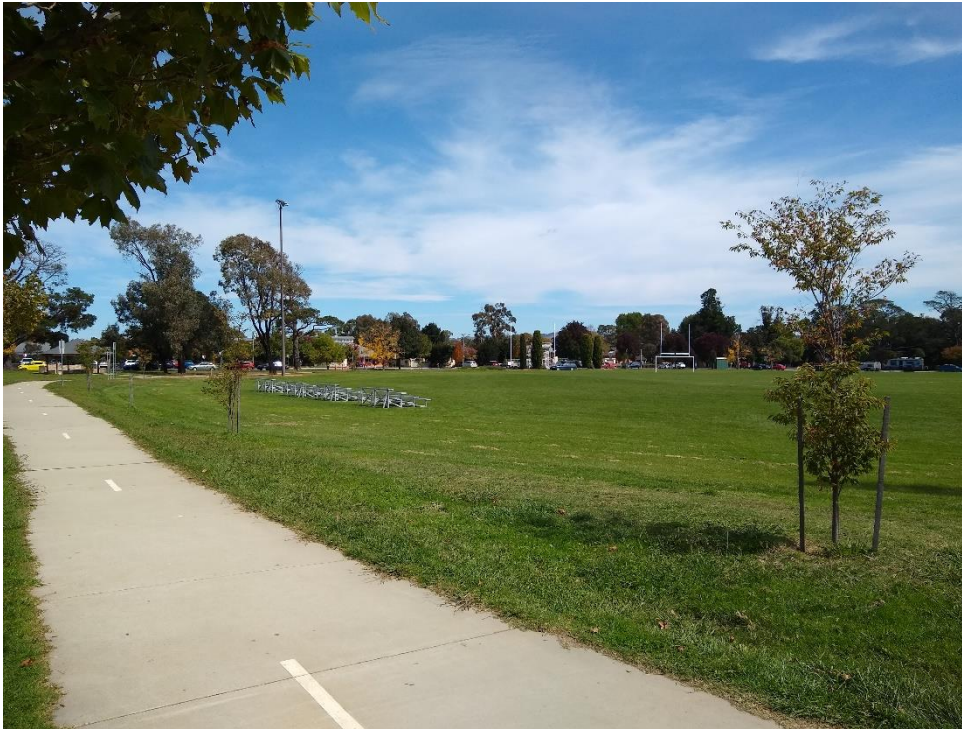
**Figure 5: View of the Mick Sherd Oval, looking south west.**

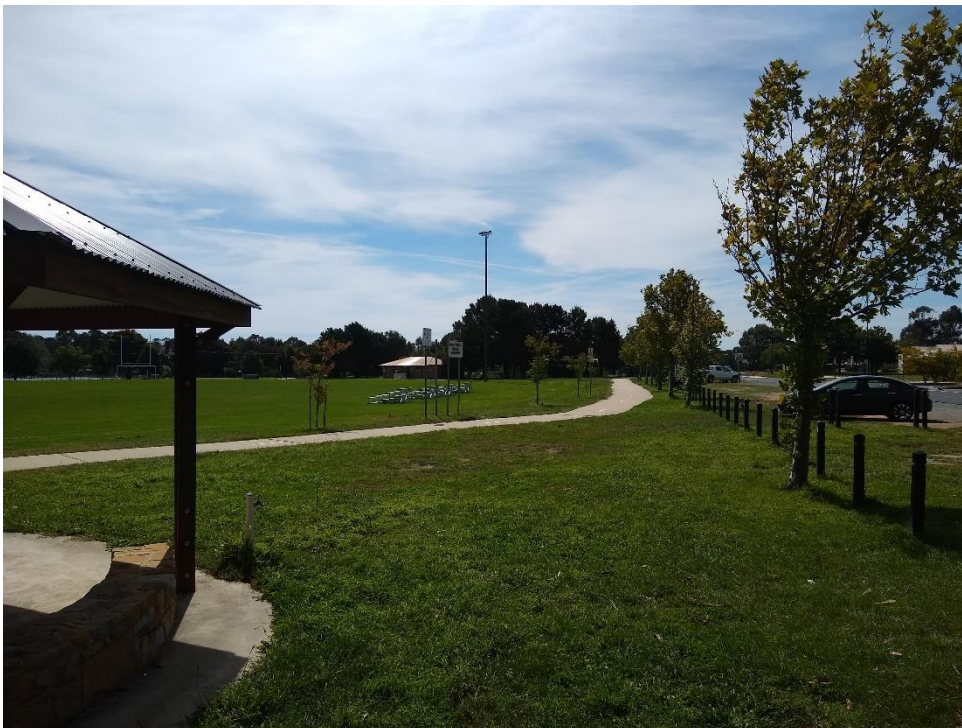
**Figure 6: View of the Mick Sherd Oval, looking north.**

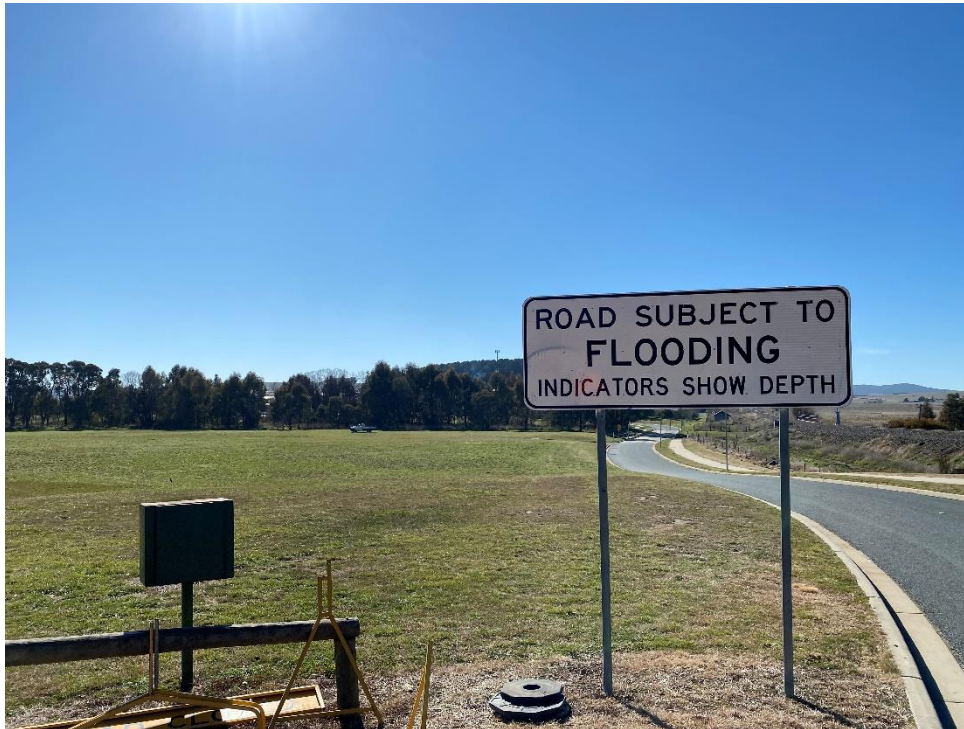
Figure 7: View of the northern portion of the site (between Turallo Creek and Turallo Terrace)

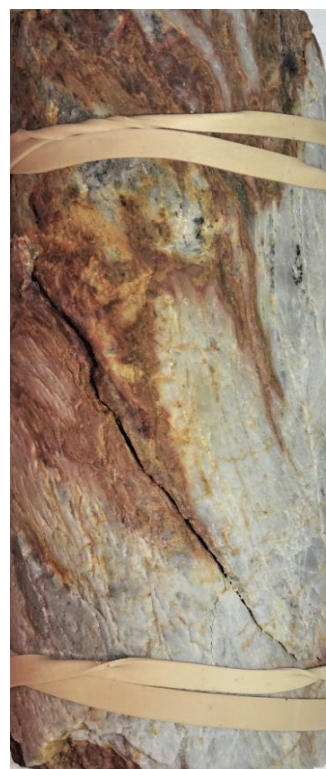
## Uniaxial Compressive Strength

Sample Number	NC-6634A
Sample Location	BH01
Depth (m)	3.65 - 3.9
Rock Description	Siltstone
Storage History and Environment	Tested as Received
Orientation to Bedding	-
Compression Machine	Automax Multitest
Date of Testing	06.04.2021
Duration of Test (seconds)	4
Average Diameter (mm)	51.9
Average Height (mm)	128
Height to Diameter Ratio	2.5 : 1
Moisture Content (%)	3.2
Wet Mass / Unit Volume (t/m <sup>3</sup> )	2.42
Dry Mass / Unit Volume (t/m <sup>3</sup> )	2.34
Uniaxial Compressive Strength (MPa)	4.9
Comments

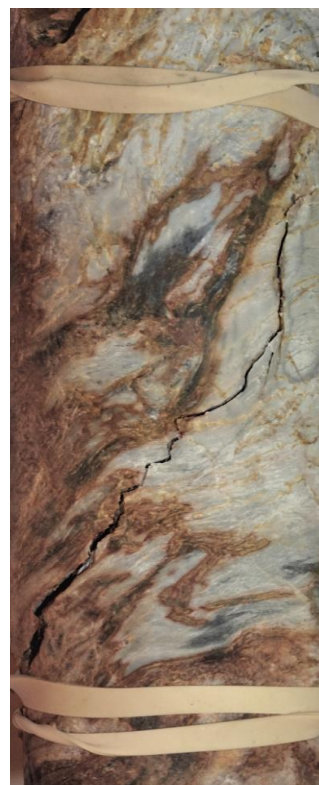
## Uniaxial Compressive Strength

Sample Number	NC-6634B
Sample Location	BH01
Depth (m)	4.27 - 4.51
Rock Description	Siltstone
Storage History and Environment	Tested as Received
Orientation to Bedding	-
Compression Machine	Automax Multitest
Date of Testing	06.04.2021
Duration of Test (seconds)	13
Average Diameter (mm)	51.9
Average Height (mm)	135
Height to Diameter Ratio	2.6 : 1
Moisture Content (%)	3.8
Wet Mass / Unit Volume (t/m <sup>3</sup> )	2.48
Dry Mass / Unit Volume (t/m <sup>3</sup> )	2.39
<b>Uniaxial Compressive Strength (MPa)</b>	<b>7.3</b>
Comments

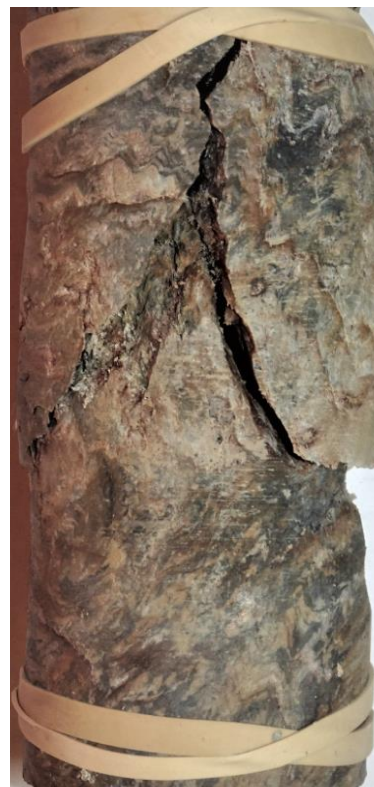
## Uniaxial Compressive Strength

Sample Number	NC-6634C
Sample Location	BH02
Depth (m)	2.18 - 2.38
Rock Description	Siltstone
Storage History and Environment	Tested as Received
Orientation to Bedding	-
Compression Machine	Automax Multitest
Date of Testing	06.04.2021
Duration of Test (seconds)	8
Average Diameter (mm)	51.5
Average Height (mm)	129
Height to Diameter Ratio	2.5 : 1
Moisture Content (%)	9.0
Wet Mass / Unit Volume (t/m <sup>3</sup> )	2.36
Dry Mass / Unit Volume (t/m <sup>3</sup> )	2.17
<b>Uniaxial Compressive Strength (MPa)</b>	<b>1.9</b>
Comments

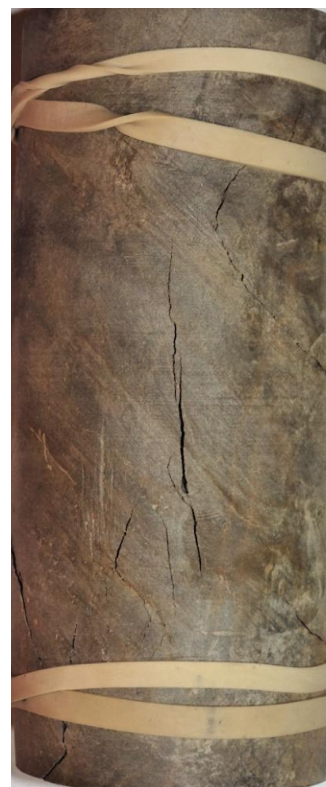
## Uniaxial Compressive Strength

Sample Number	NC-6634D
Sample Location	BH02
Depth (m)	4.02 - 4.28
Rock Description	Siltstone
Storage History and Environment	Tested as Received
Orientation to Bedding	-
Compression Machine	Automax Multitest
Date of Testing	06.04.2021
Duration of Test (seconds)	7
Average Diameter (mm)	51.6
Average Height (mm)	132
Height to Diameter Ratio	2.5 : 1
Moisture Content (%)	9.7
Wet Mass / Unit Volume (t/m <sup>3</sup> )	2.38
Dry Mass / Unit Volume (t/m <sup>3</sup> )	2.17
<b>Uniaxial Compressive Strength (MPa)</b>	<b>6.1</b>
Comments
