# New High School in Bungendore: Arboricultural Impact Assessment

**School Infrastructure NSW**

<b>Project Name</b>	New High School in Bungendore Arboricultural Impact Assessment
<b>Project Number</b>	21CAN - 18598
<b>Project Manager</b>	Skye O'Brien
<b>Prepared by</b>	Jessica Lawn, Kris Rixon & Kirsten McLaren
<b>Reviewed by</b>	Beth Medway, Skye O'Brien
<b>Approved by</b>	Beth Medway
<b>Status</b>	Final
<b>Version Number</b>	5
<b>Last saved on</b>	8 September 2021

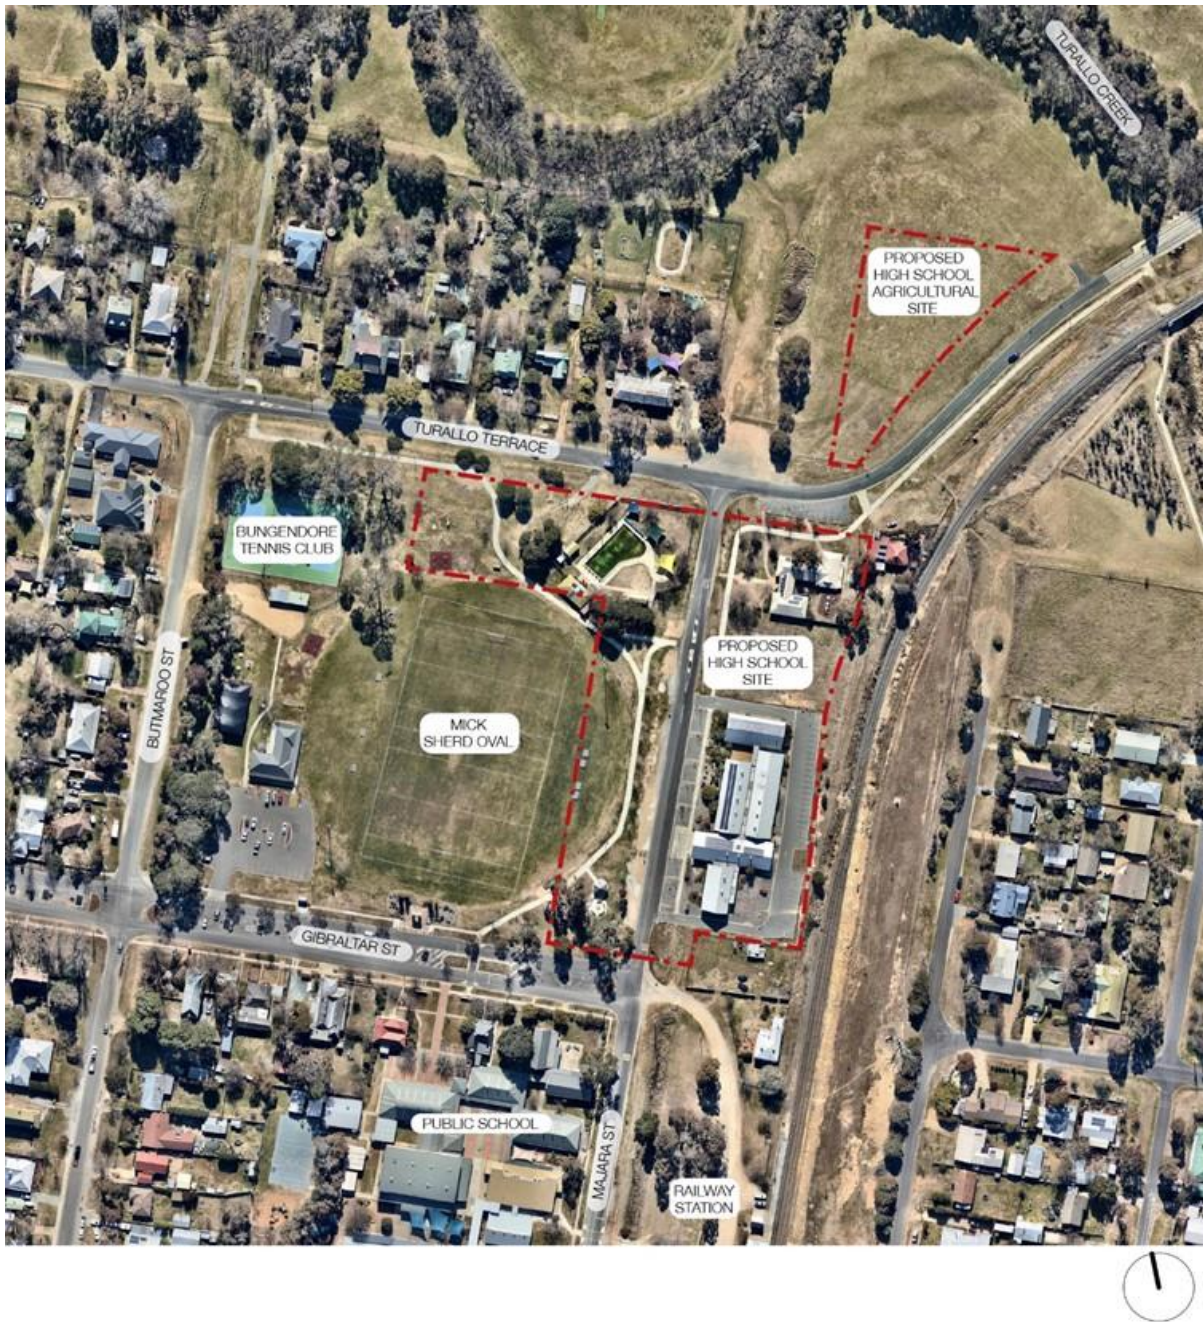
Figure 2: Site aerial depicting the land subject to the proposed High School (Source: TKD Architects)

The site is approximately 29,205 m<sup>2</sup> in area and consists of a relatively flat topography. It contains part of Bungendore Park, existing Council buildings and maintained public open space areas. The land is mostly cleared of vegetation with some mature trees interspersed throughout subject lots. The existing canopy cover within the proposed high school site (Figure 2 & 3) is approximately 11%.

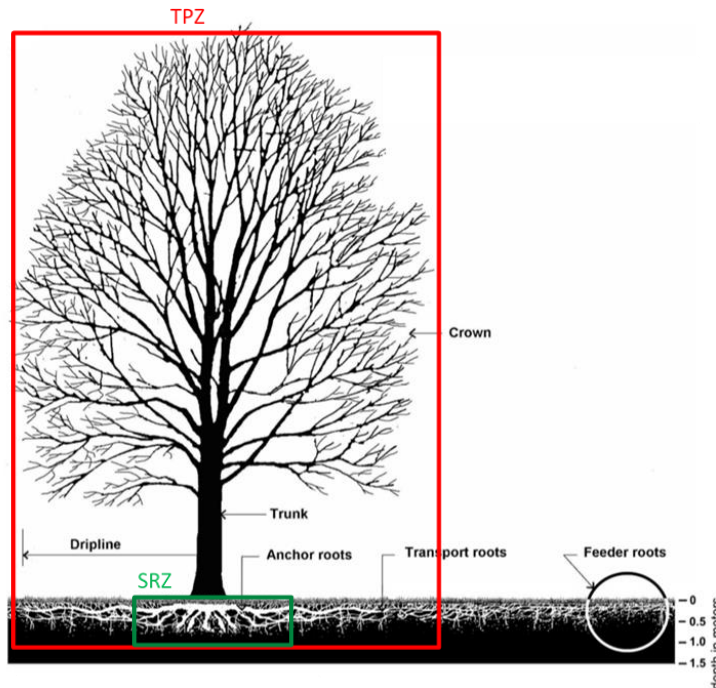
The TPZ is a specific area above and below ground and at a distance from the trunk set aside for the protection of a tree's roots and crown to provide for the viability and stability of a tree to be retained where it is potentially subject to damage by the development. The radius of the TPZ is calculated for each tree by multiplying its DBH (trunk diameter measures at 1.4 m above ground) x 12. The radius is measured from the centre of the stem at ground level.

The SRZ is the area of the root system (as defined by AS 4970-2009) used for stability, mechanical support and anchorage of the tree. It is critical for the support and stability of trees. Severance of roots within the SRZ is not recommended as it may lead to the destabilisation and/or decline of the tree.

Figure 4: Representative tree structure and indicative TPZ and SRZ

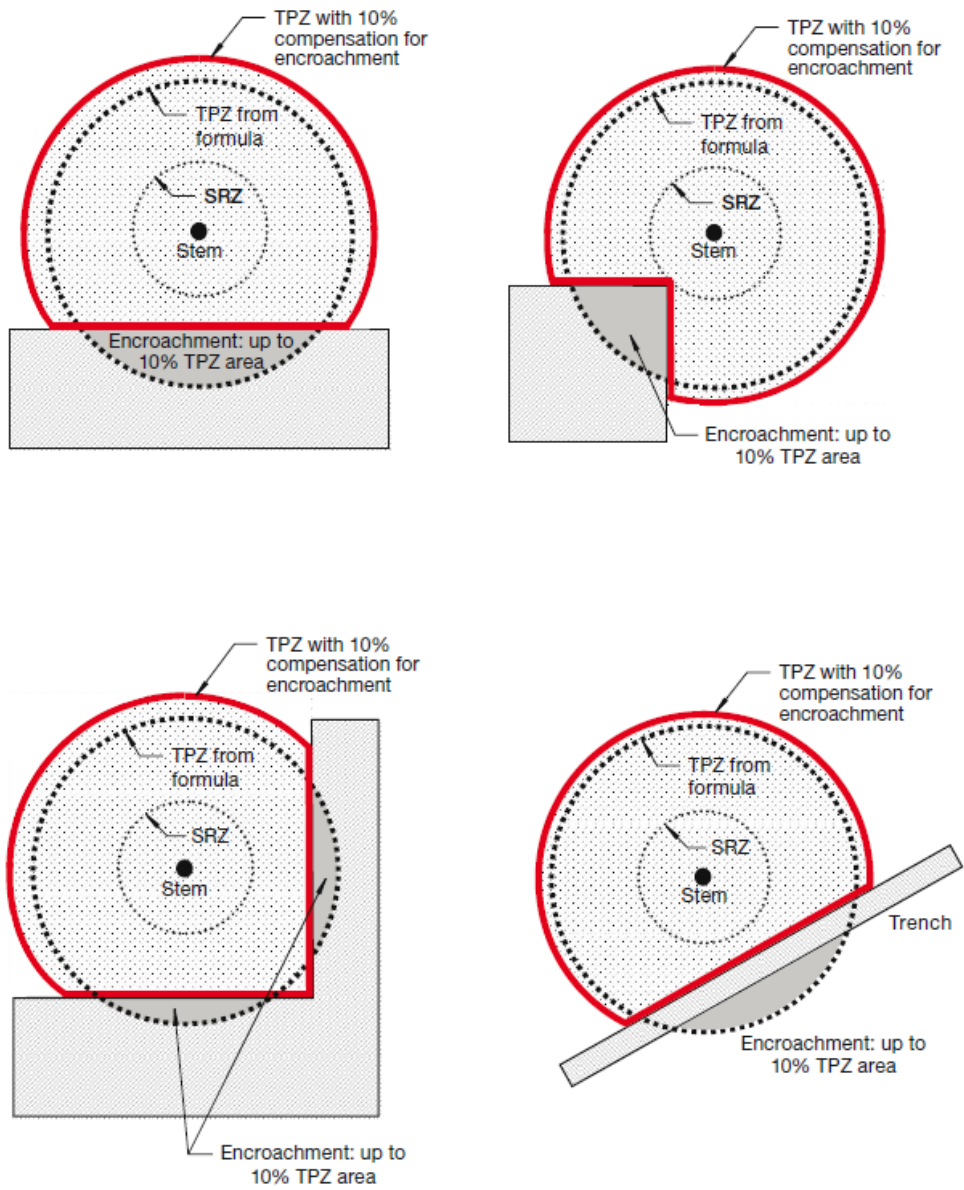
## Appendix B Encroachment into tree protection zones - AS 4970-2009

Trees may be impacted by physical or chemical damage to roots or above tree parts. Examples include impacts associated with site grading, soil compaction, excavation, stock piling within TPZ as well as changes in site hydrology, changes in soil level and site contamination. The extent of encroachment to the TPZ and SRZ determines the level of potential impact. AS 4970-2009 defines types of encroachment as follows and as illustrated in Appendix B:

- Major encroachment** - If the proposed encroachment is greater than 10% of the TPZ or inside the SRZ, the project arborist must demonstrate that the tree(s) would remain viable. The location and distribution of roots may be determined through non-destructive excavation (NDE) methods such as hydro-vacuum excavation (sucker truck), Air Spade or manual extraction. The area lost to this encroachment should be compensated for elsewhere and contiguous with the TPZ.

- **Minor encroachment** – If the proposed encroachment is less than 10% of the TPZ, and outside of the SRZ, detailed root investigations should not be required. The area lost to this encroachment should be compensated for elsewhere and contiguous with the TPZ.

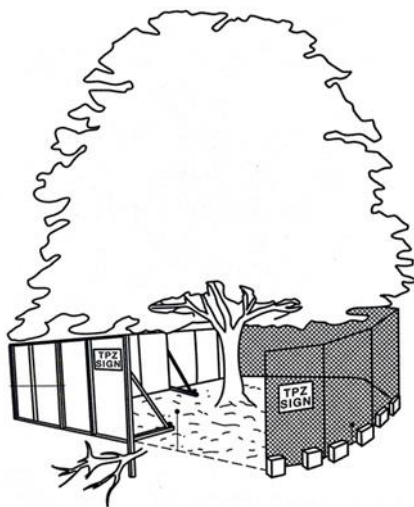
- Enclosed to the full extent of the TPZ (or as specified in the Recommendations and Tree Protection Plan).
- Cyclone chain wire link fence or similar, with lockable access gates.
- Certified and Inspected by the Project Arborist.
- Installed prior to any machinery or material are brought to site and before the commencement of works.
- Prominently sign posted with 300 mm x 450 mm boards stating, "NO ACCESS - TREE PROTECTION ZONE".

Tree protection fencing

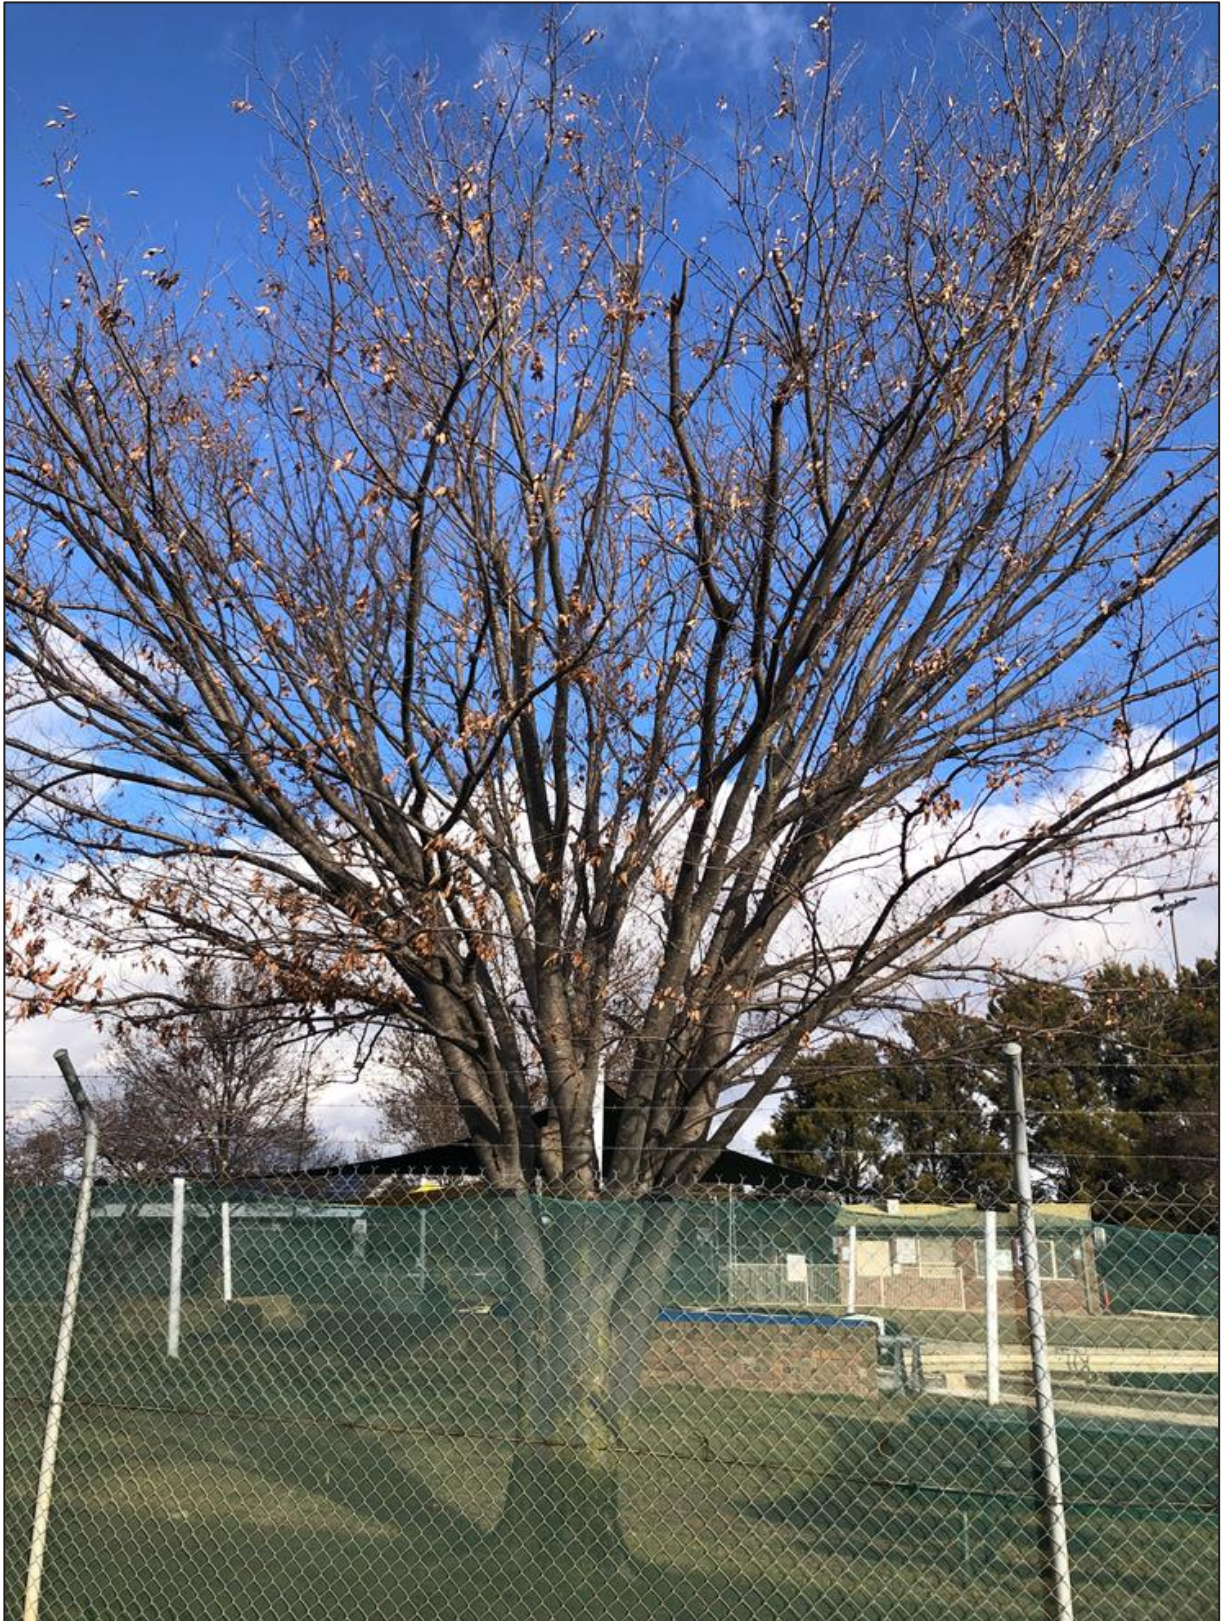
**Figure 10: Medium retention value tree, Tree 107**

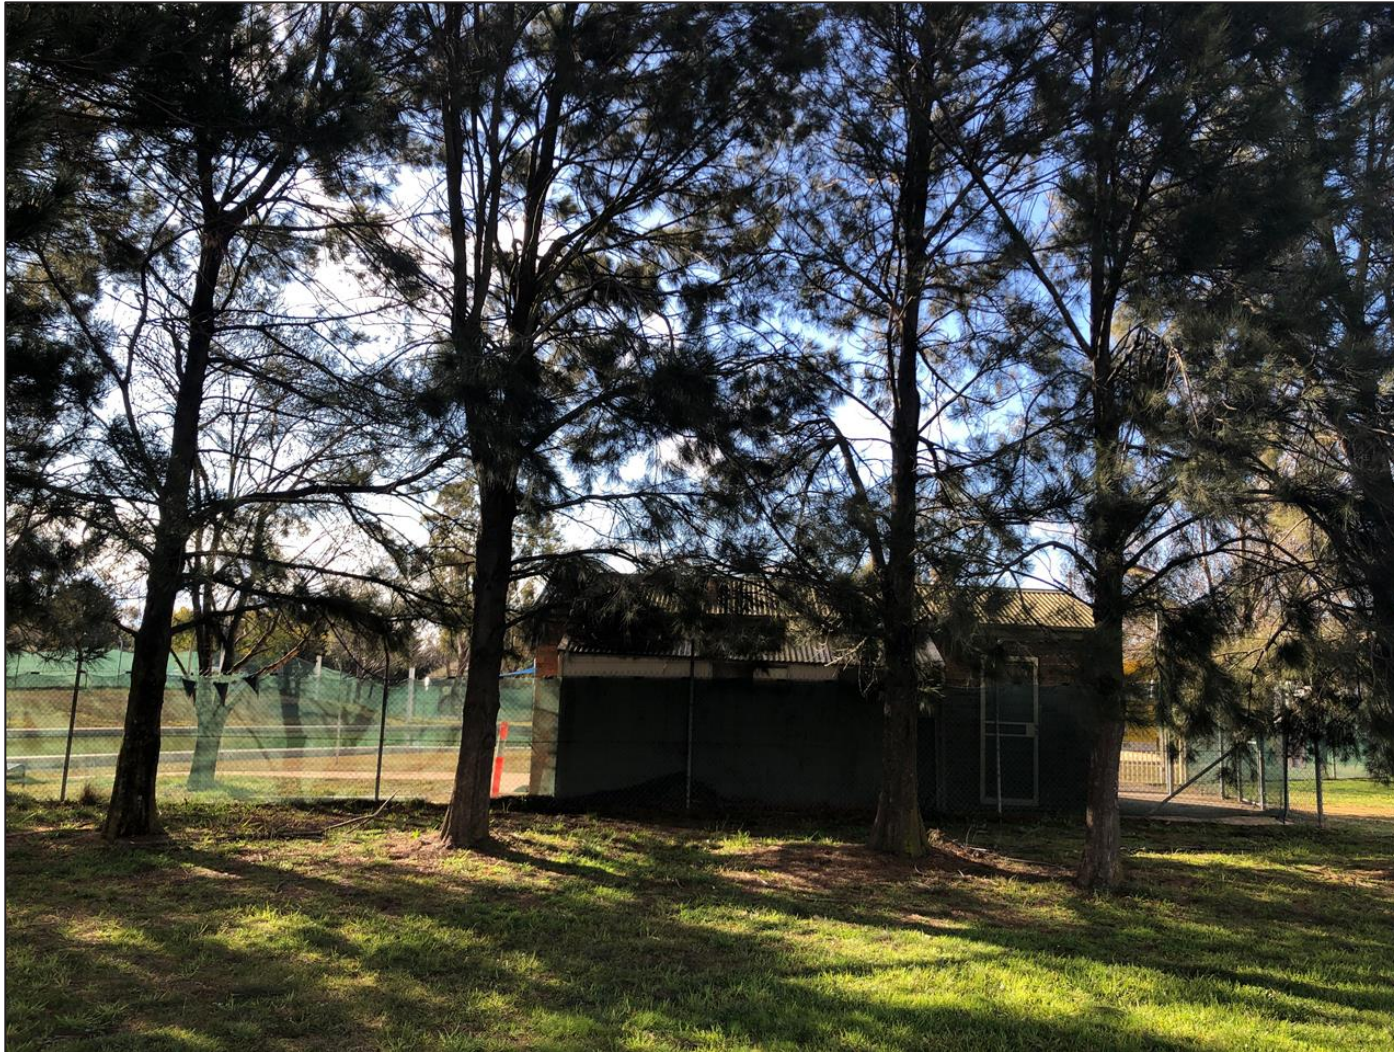
**Figure 11: Medium retention value trees 114.1, 114.2, 114.3, 114.4, 114.5, 114.6, 114.7 and 114.8**

- **High impact (>20% TPZ encroachment and/or SRZ encroachment)**
  - **High retention: four** (Trees 118, 172, 175 & 183)
  - **Medium retention: 38** trees
    - Trees 114.1-114.3, 114.7, 114.8, 115 – 117, 125, 126, 128, 180, 212 (group of 10), 214 (group of 10), 216 and 217 (group of 5)
  - **Low retention: three** (Trees 218, 221 and 223)
- **Medium impact (>10% and <20% TPZ encroachment)**
  - **Medium retention: 2** (Trees 114.6 and 179)

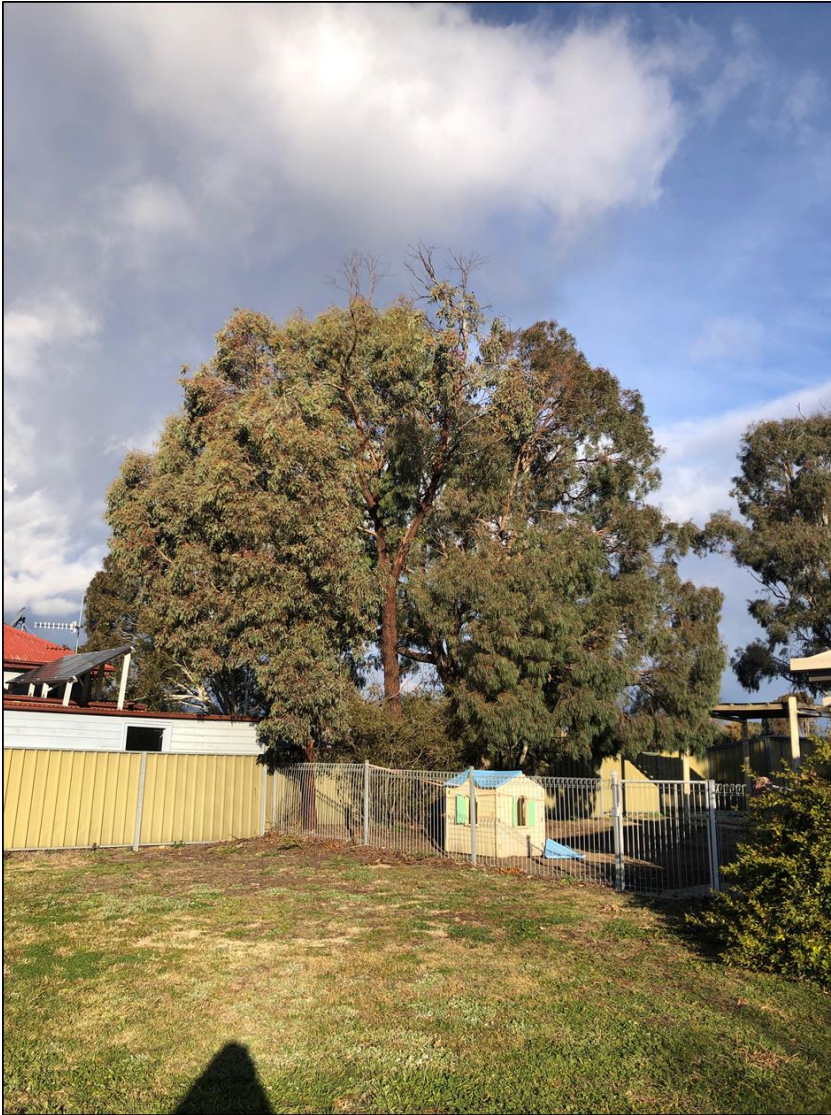
**Figure 12: Low retention value tree, Tree 140**

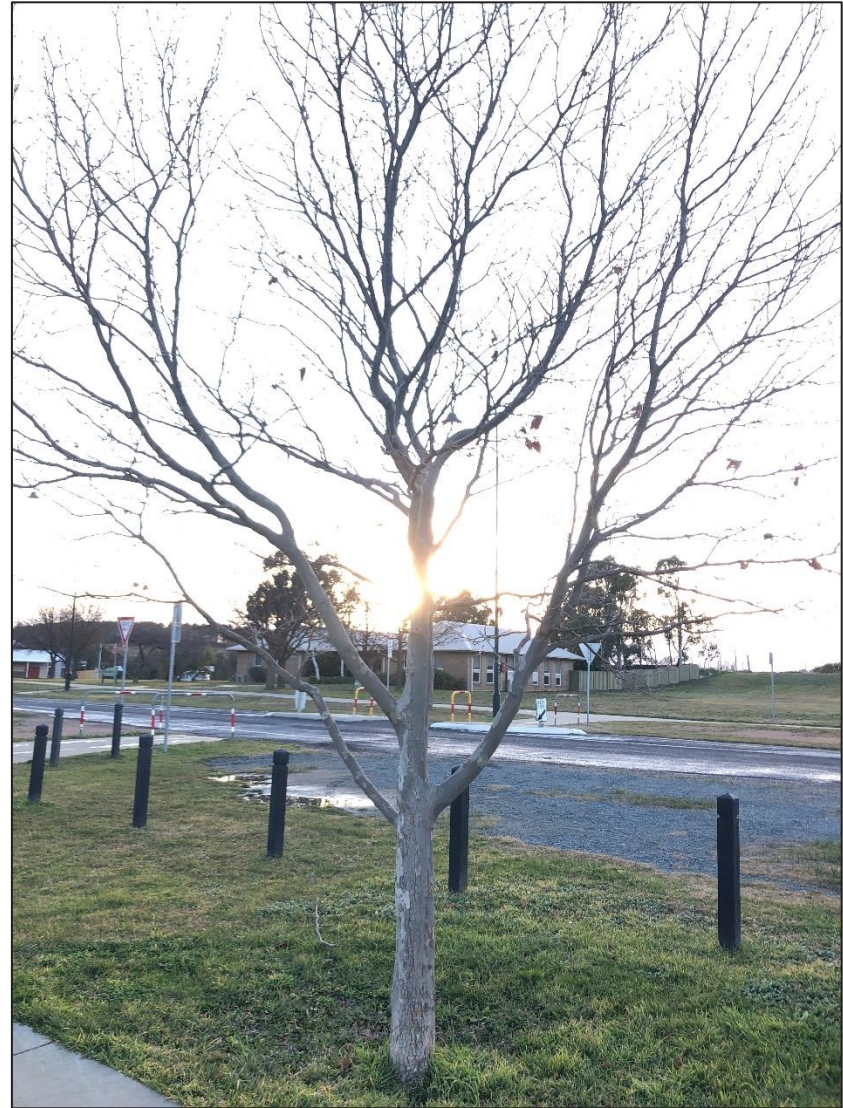
**Figure 13: Medium retention value tree, Tree 153**

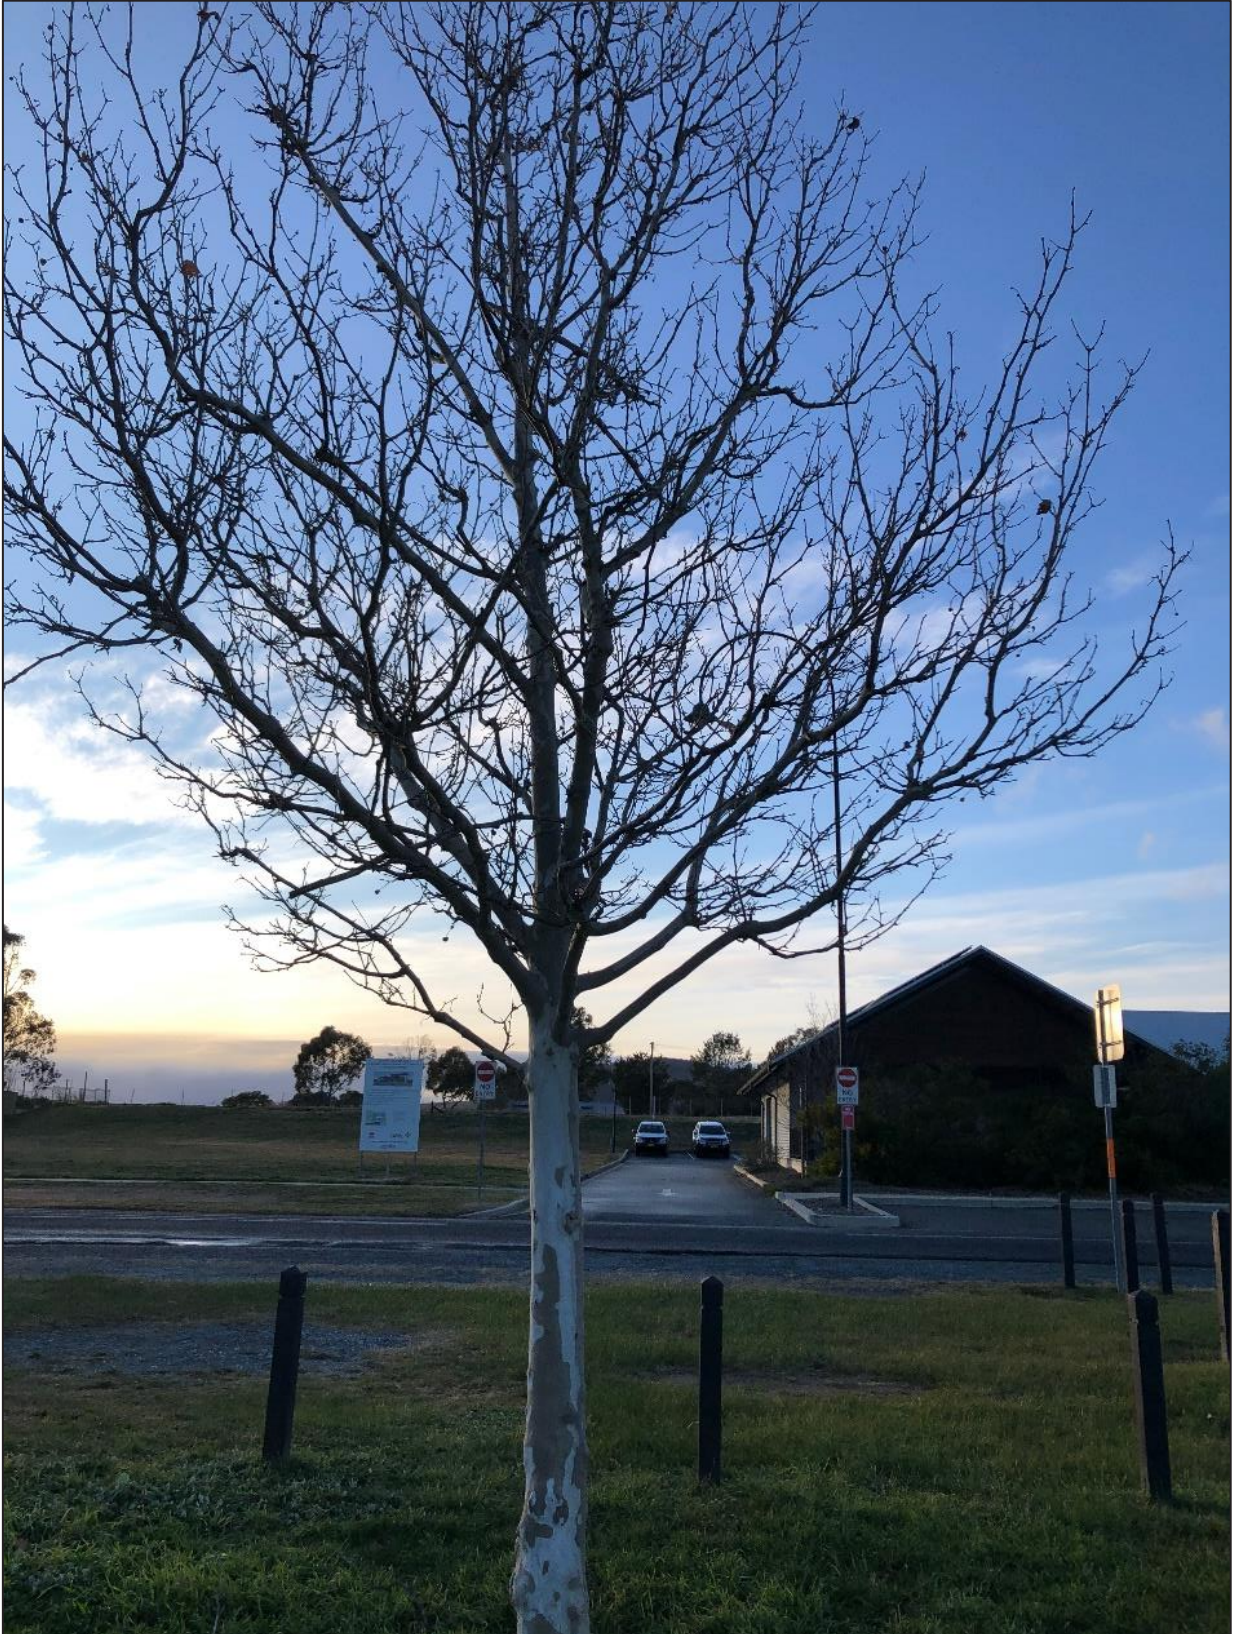
**Figure 14: Medium retention value tree, 154**

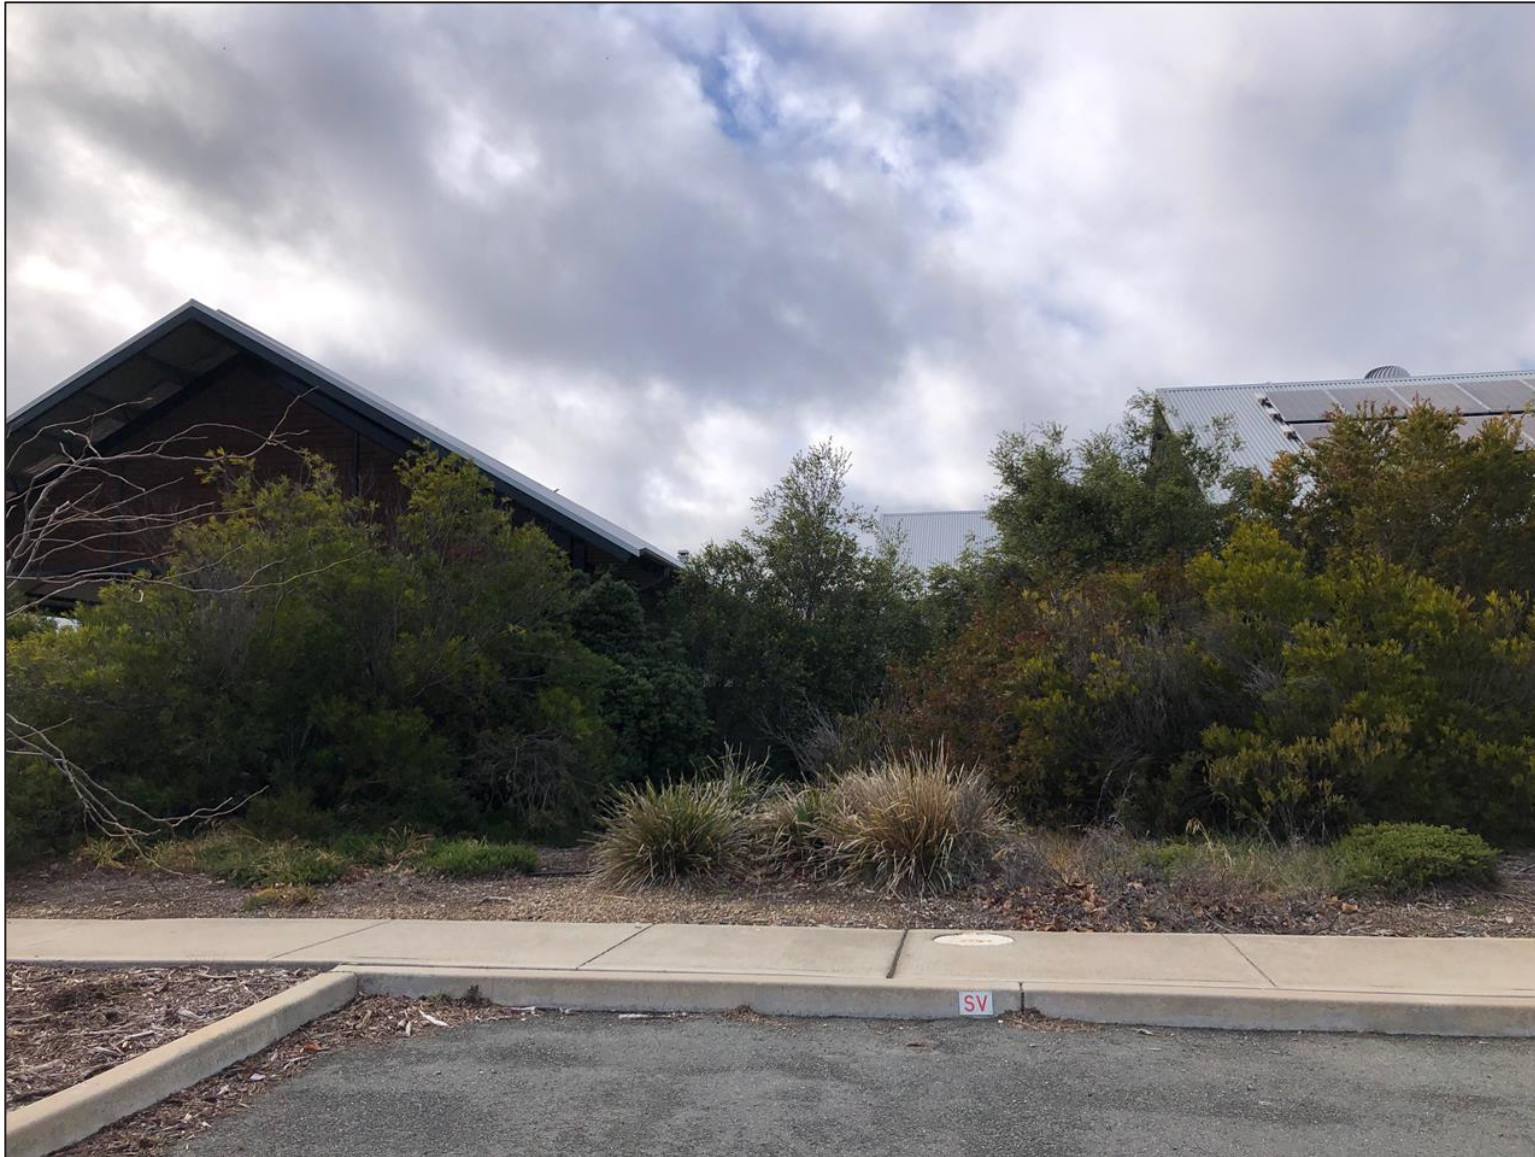
**Figure 15: Group of 10 medium retention value mix native spp. (Tree 212)**

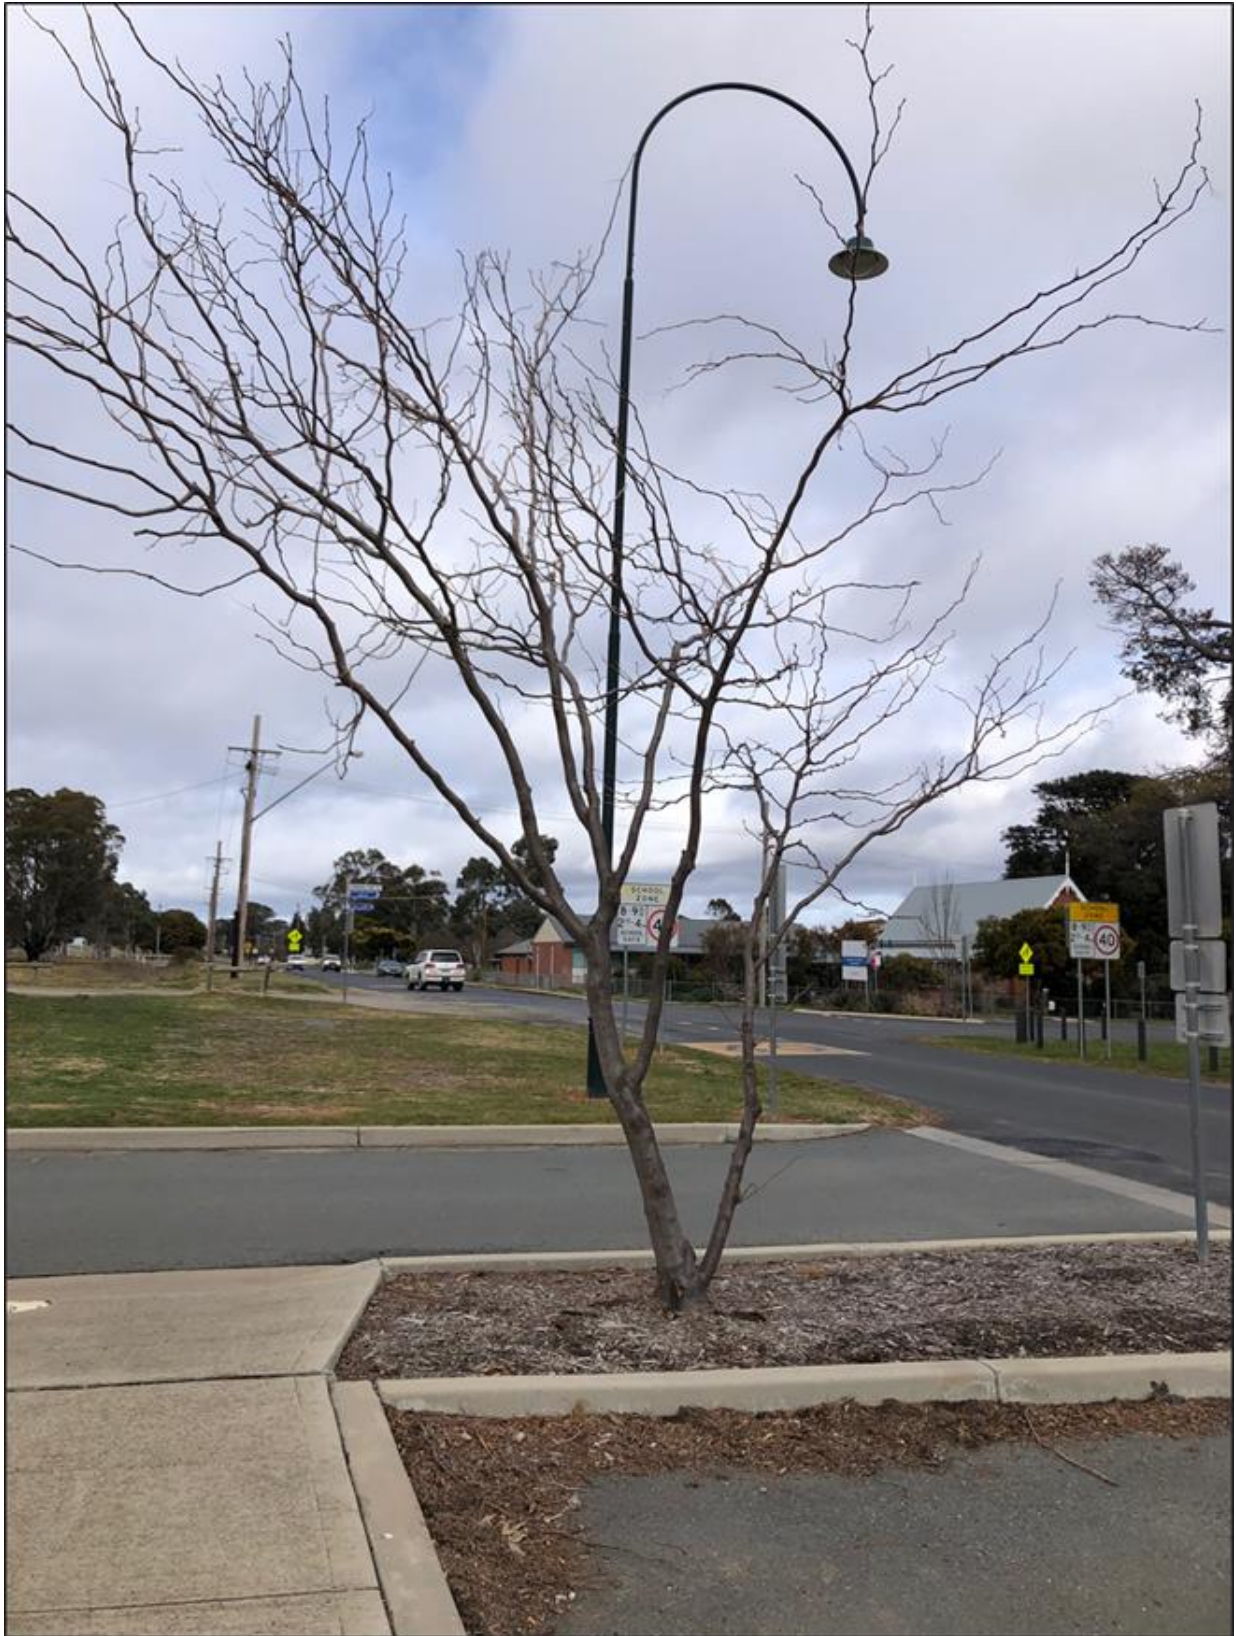
**Figure 16: Medium retention value tree, Tree 227**
