# Detailed Site Investigation, 65-73 Dunheved Circuit, St Marys

Borg Manufacturing Pty Ltd

11 February 2019

DRC DSI 65 Dunheved Crt 110219

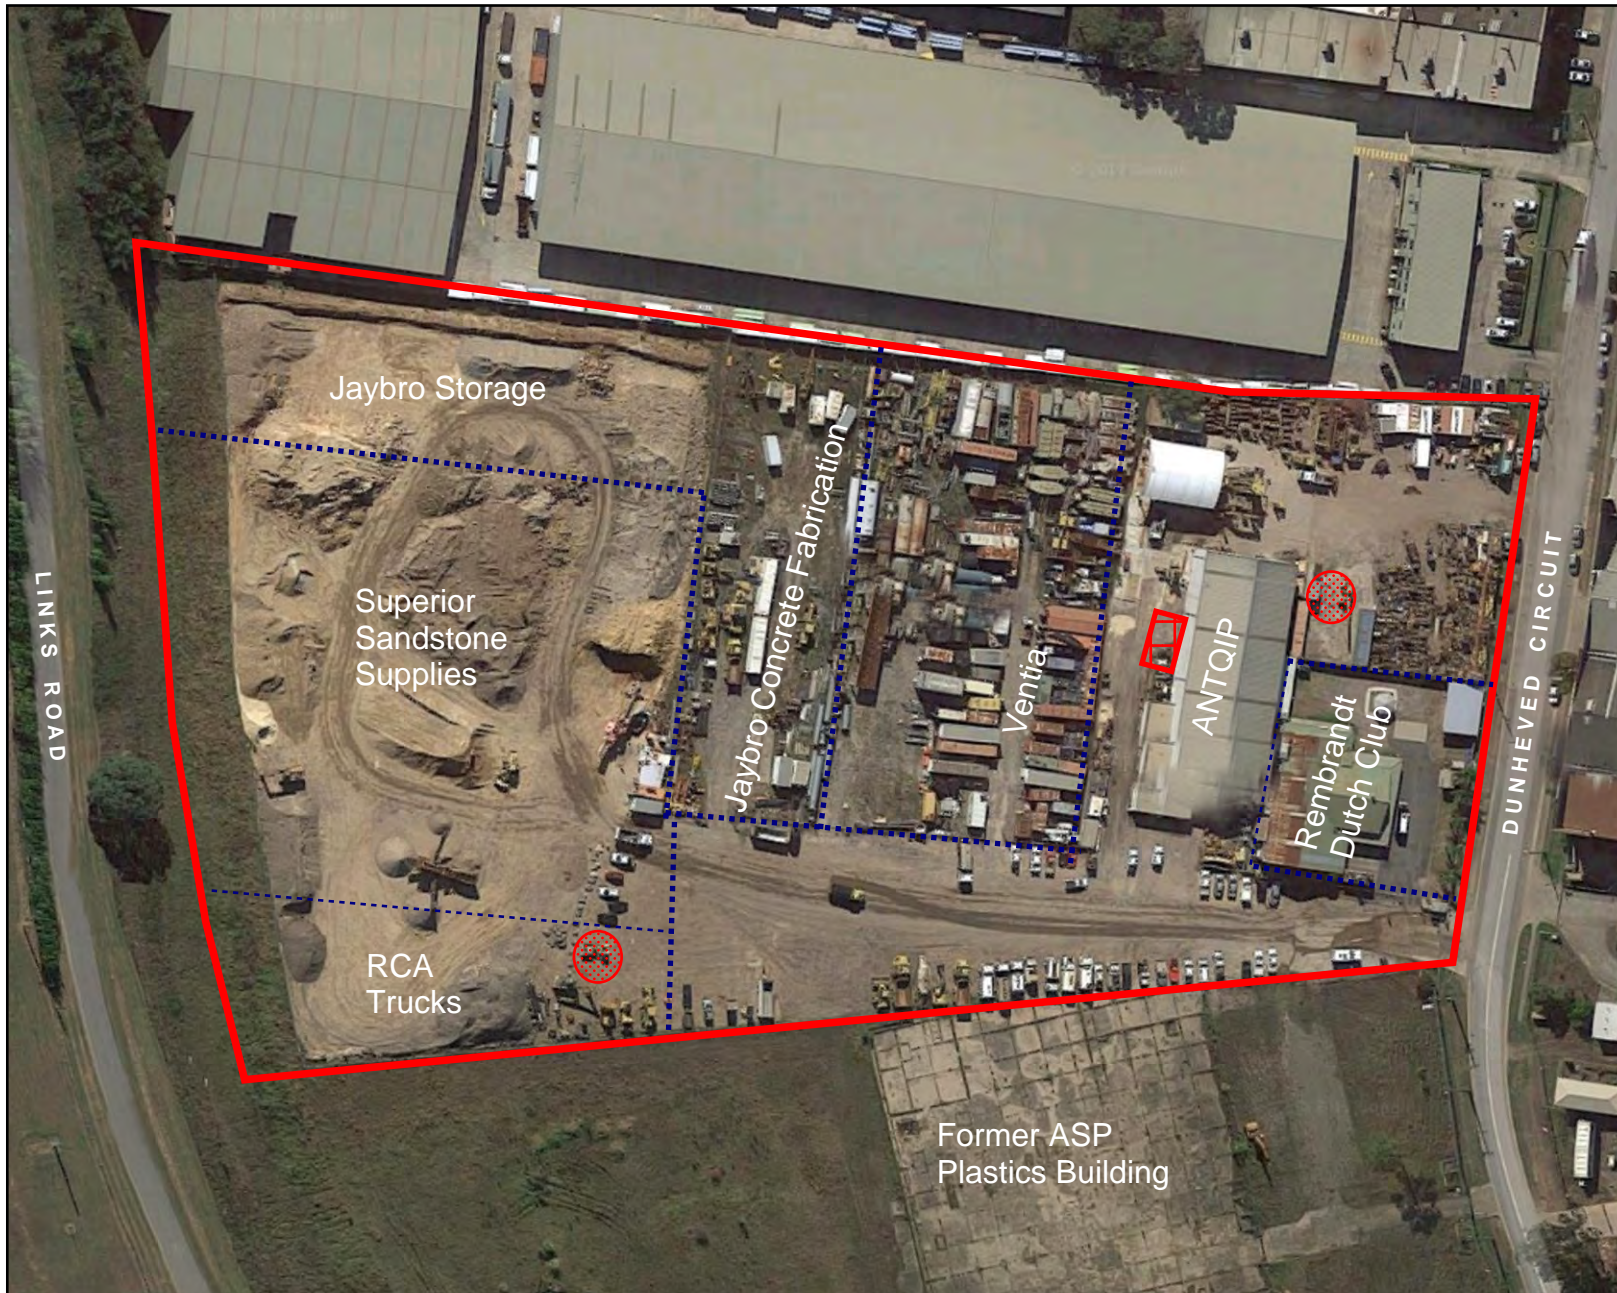
FIGURE: **5A**

The following features were observed during the first site inspection for each lease area. Details are also presented on **Figure 5A**.

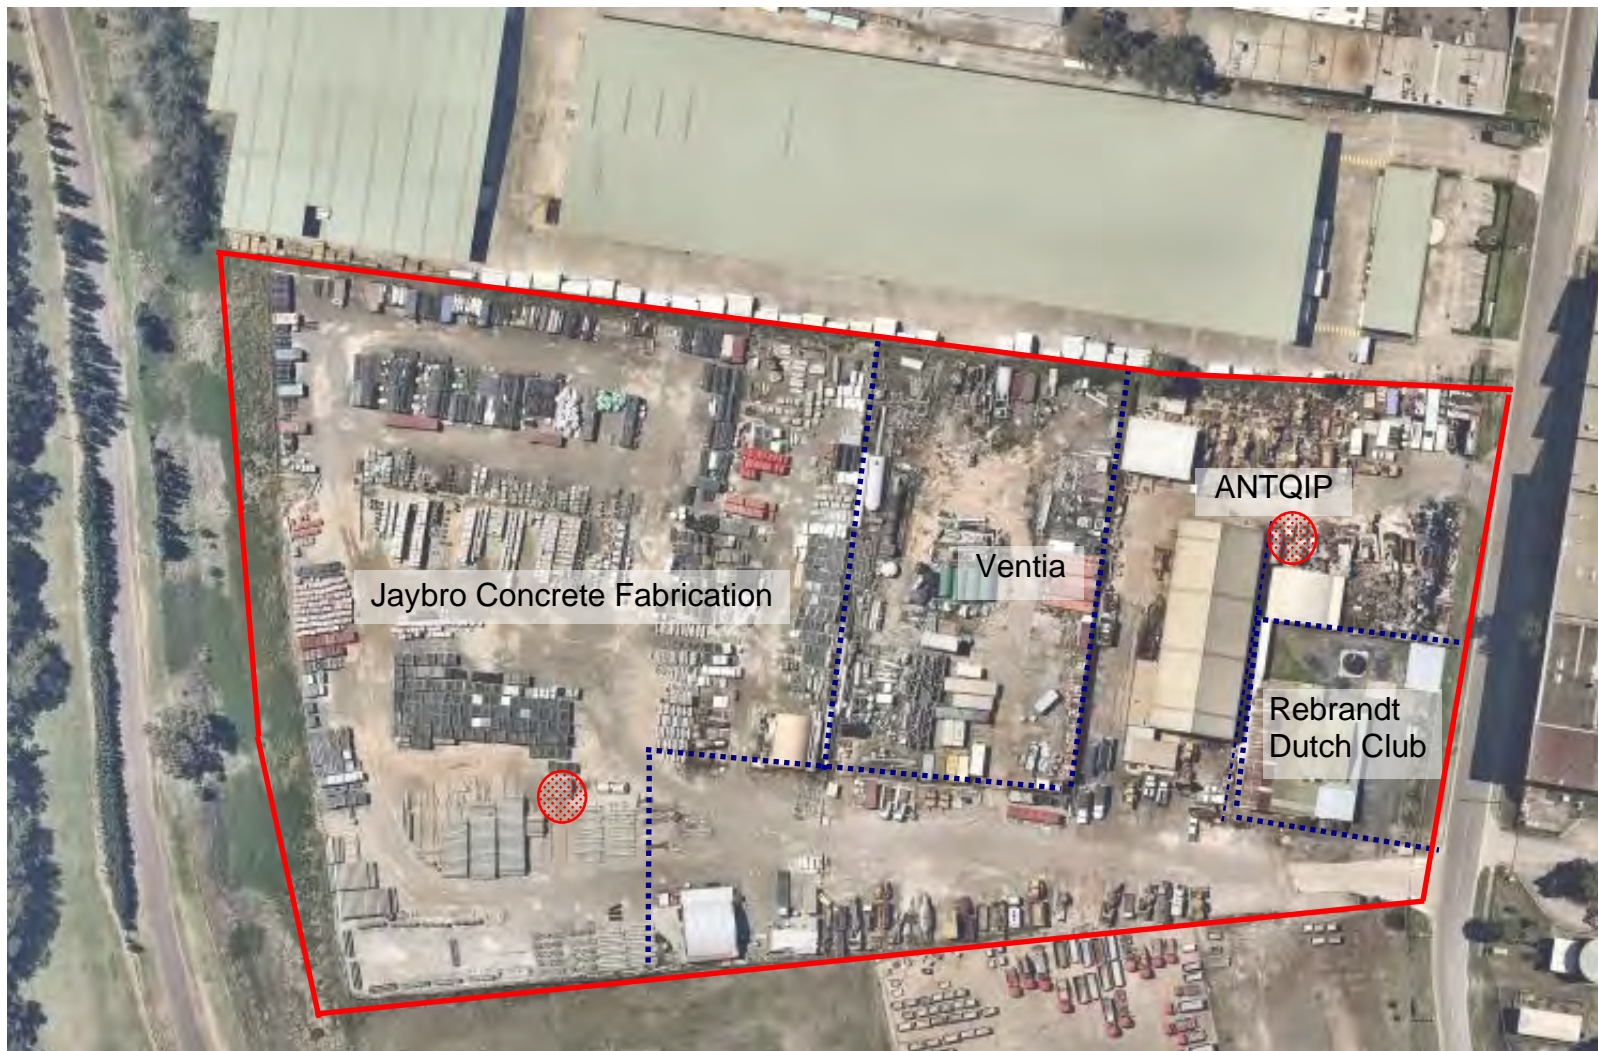
FIGURE: **5B**

An additional site visit was undertaken by DRC on 24 January 2019 to inspect if any changes had occurred at the site since March 2017. The following was observed, details are presented on **Figure 5B**:

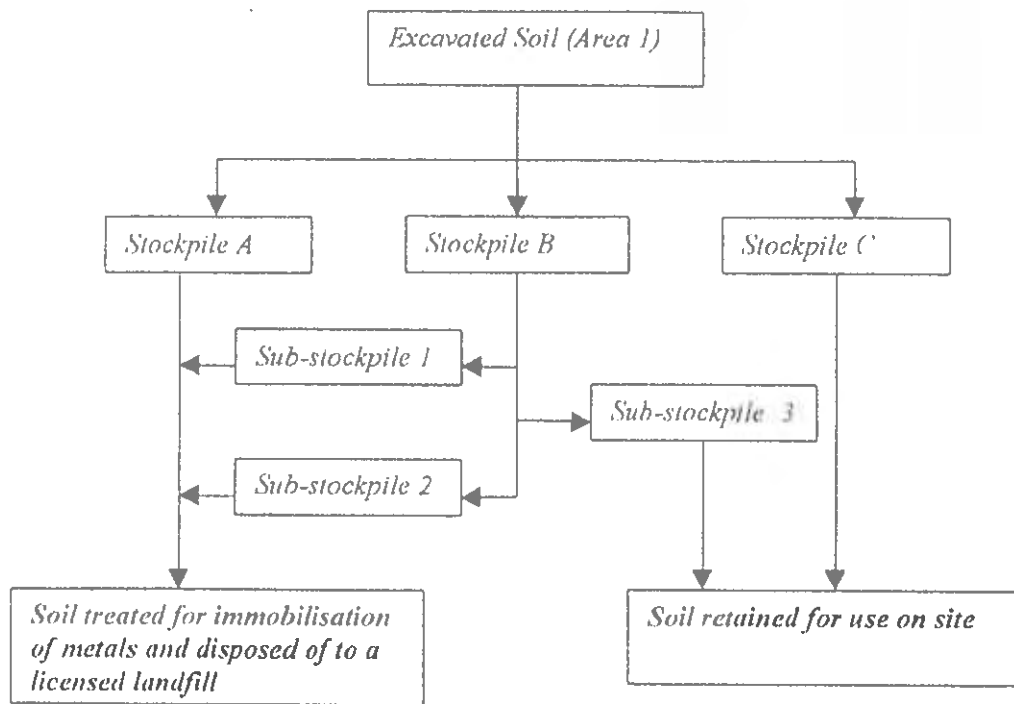
*Figure 1 Management of Excavated Soil*

Based on visual observations, odour and further sampling and analysis, the excavated soil was segregated into stockpiles according to those that could be retained on site and those that needed to be disposed off-site. The management of the excavated soil is presented in Figure 1 below.

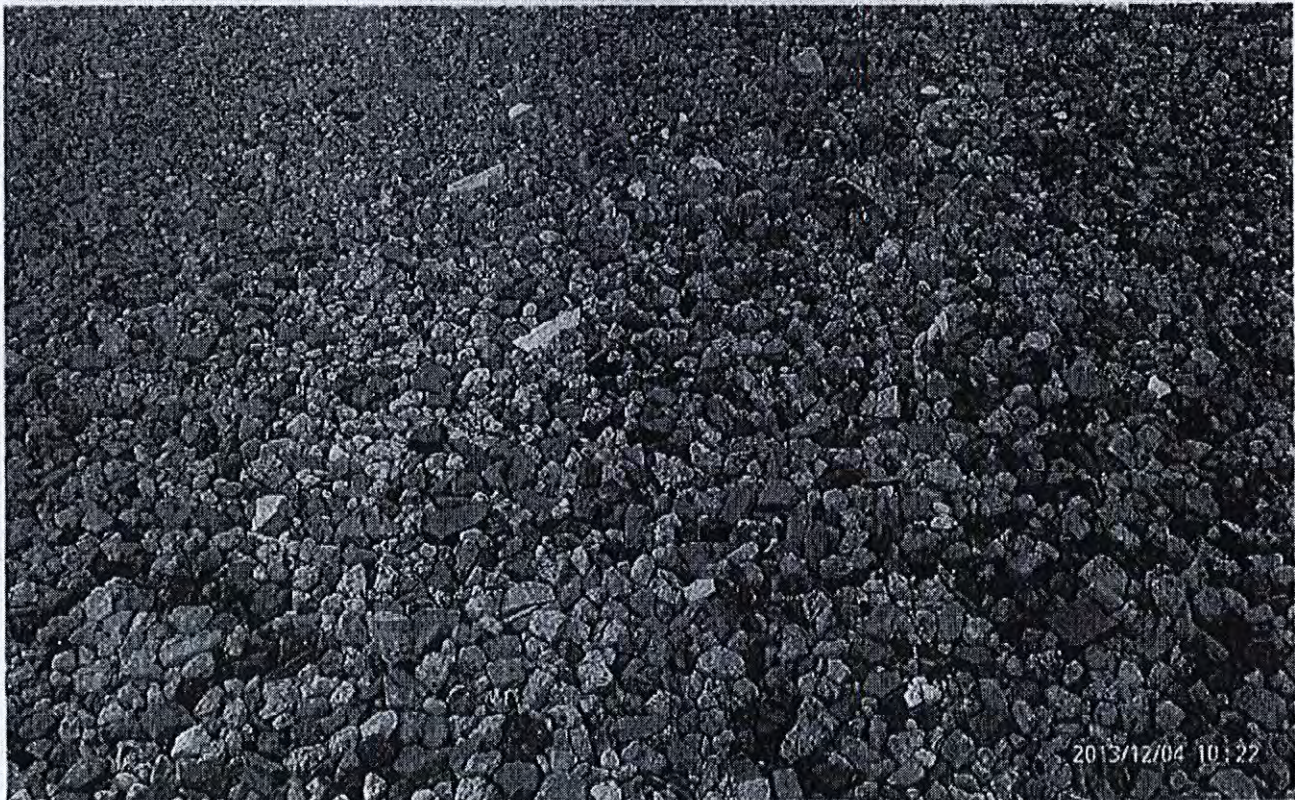
B: Recycled Crushed Concrete; marked sampling location; TP119

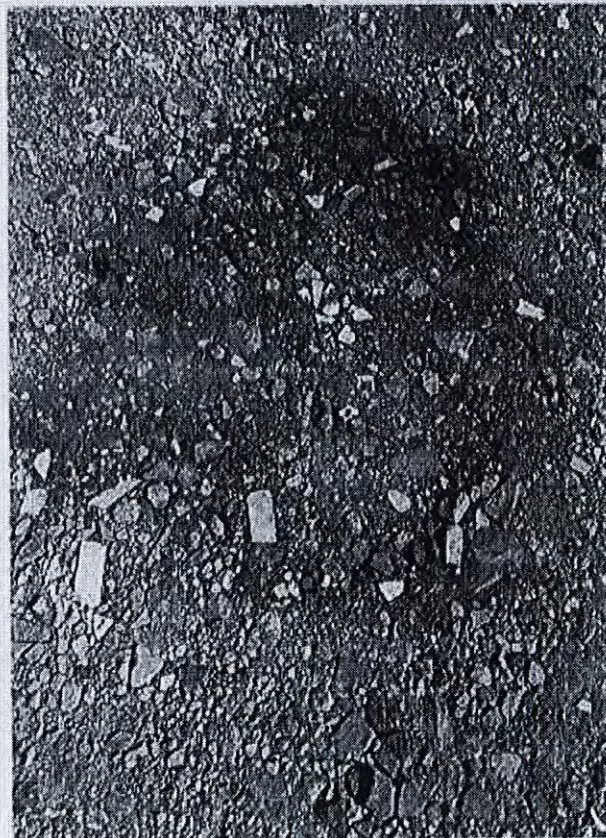
D: Stain 1

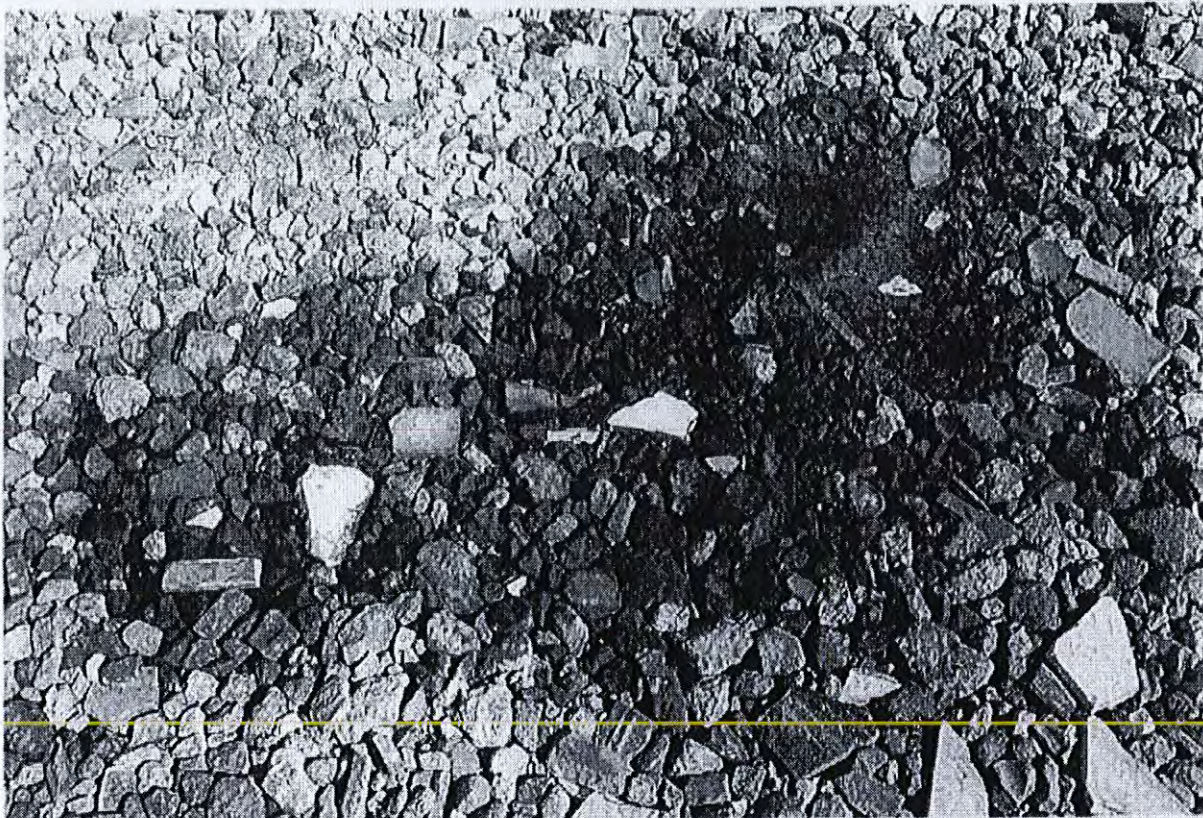
E: Stain 2

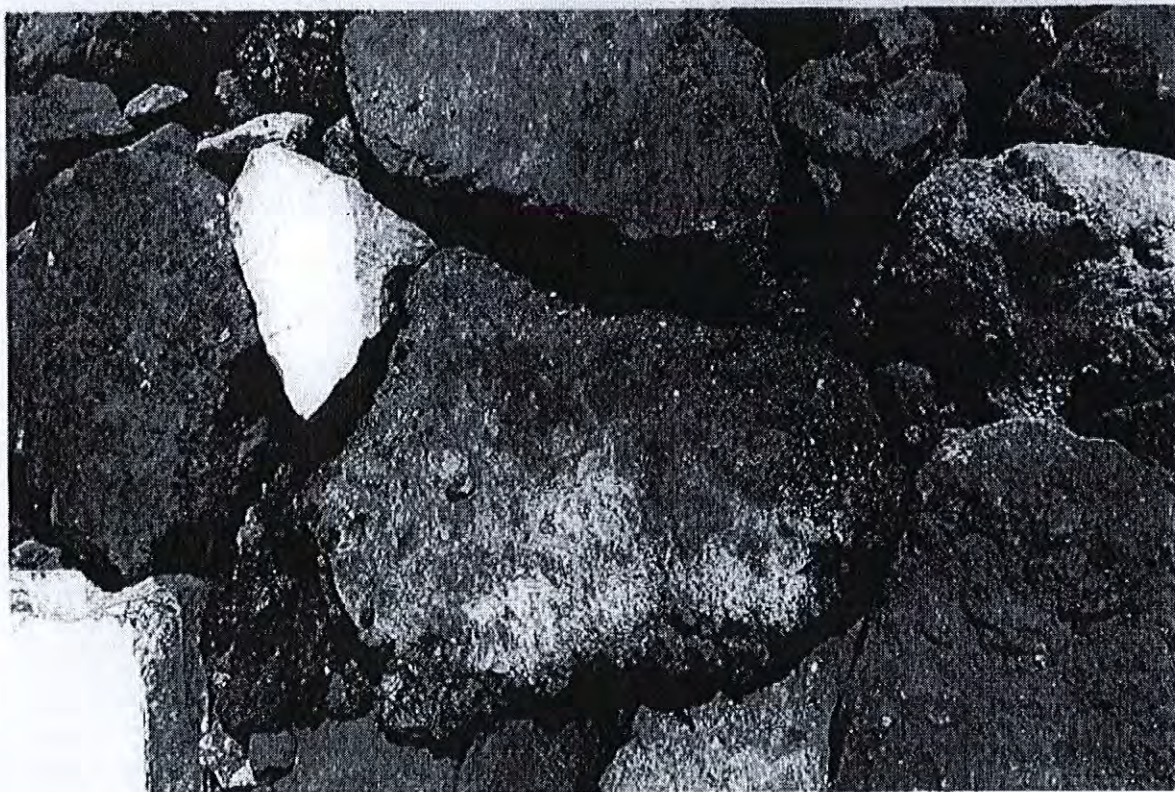
F: Stain 2 - Asphalt

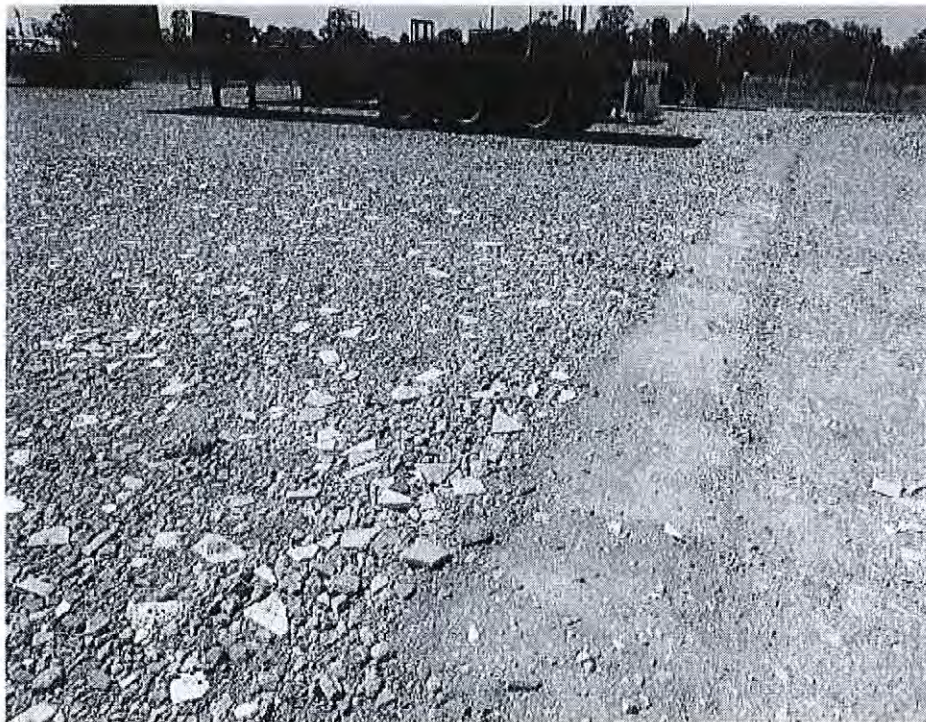
B: Recycled Crushed Concrete & Interface of Recycled Crushed Concrete and Underlying Material.

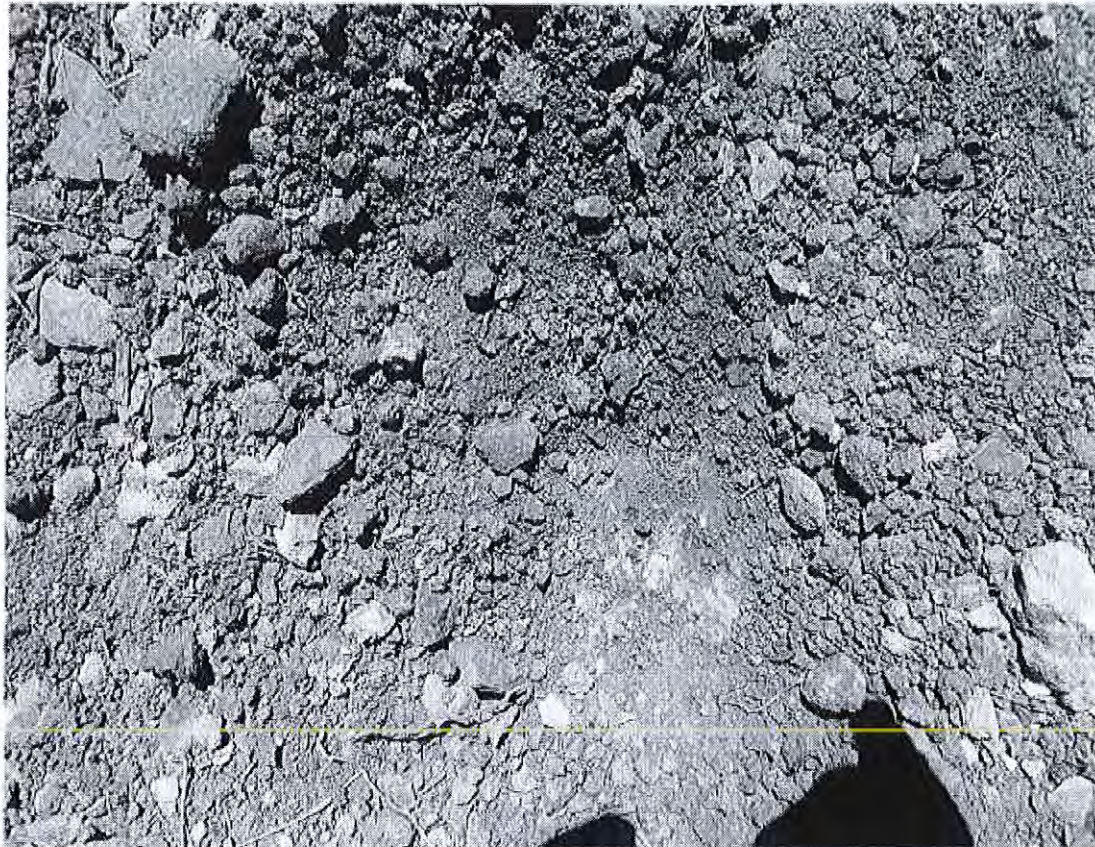
E: Material Condition – Close Up

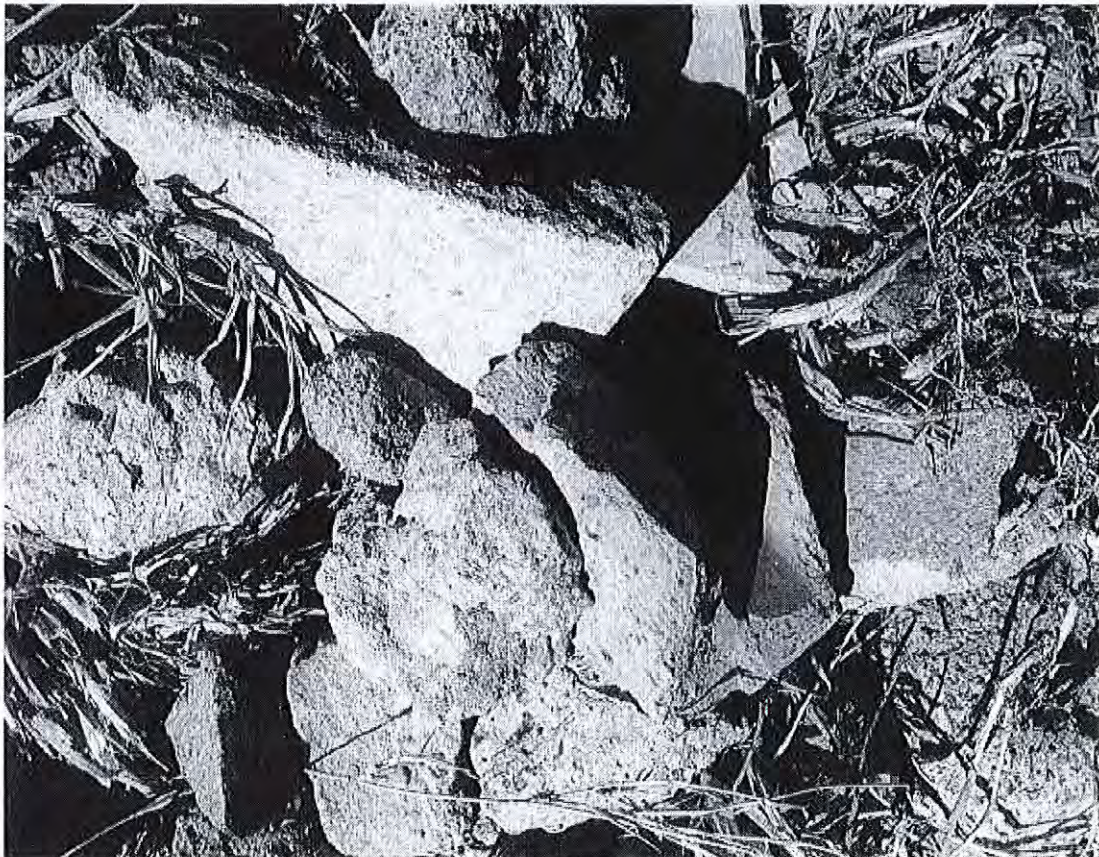
F: Material Condition – Close Up

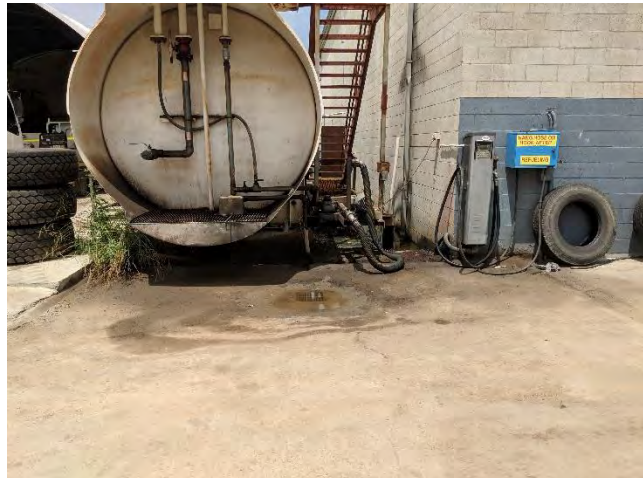
- A large diesel AST was noted to the east of the workshop, staining was noted on and around the AST.
- Outside the north-western corner of the warehouse steel racking was noted, beneath the racking oily residue was noted on the ground and floating on puddles (in an area of approximately 3m x 2m).

**65 Dunheved Circuit, St Marys – ANTQIP diesel AST – 2017 & 2019**

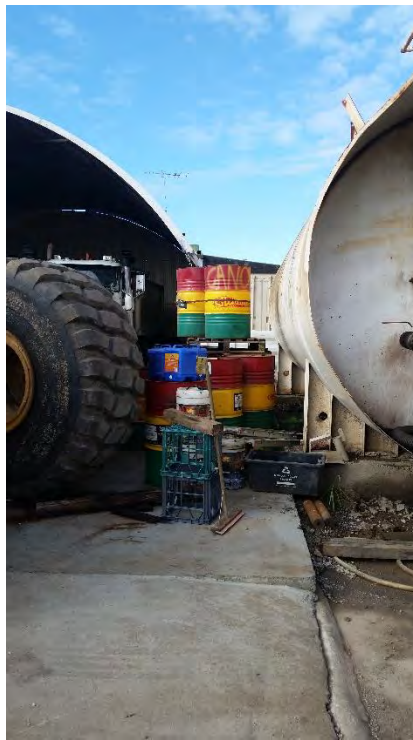
- Several large shipping containers were observed, these appeared to be used for storage.
- Several drums on pallets were noted within the concrete area.

**65 Dunheved Circuit, St Marys – ANTQIP drum storage - 2017**

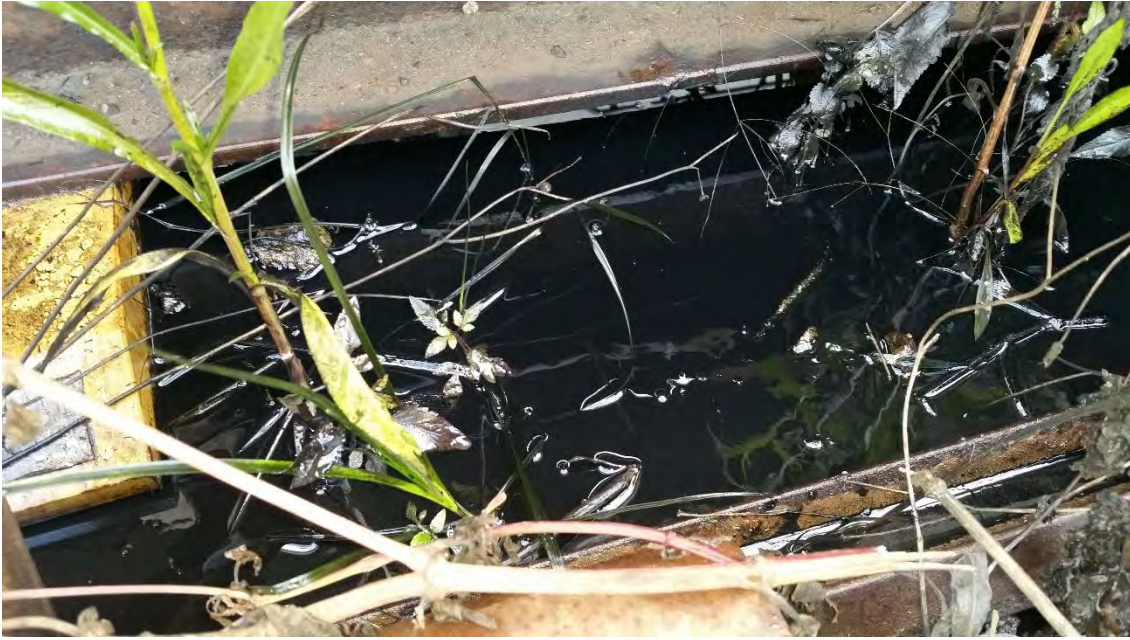
During a site walkover in 2016 staining was noted on the ground behind the ANTQIP warehouse, together with an oily residue pooled on the ground surface on the western edge of the warehouse building. The pooled oil residue was not observed in 2018.

**Dunheved Circuit, St Marys – Oily Residue ANTQIP - 2017**

- No waste stockpiles were noted across the subject property and there was no evidence of waste or transfer station use at the site;
- Remedial works required to remove oil stained soils and soils in the vicinity of SS01 and TPO6 are envisaged to be minor in nature and would be achievable using standard equipment without a significant cost ramification; and

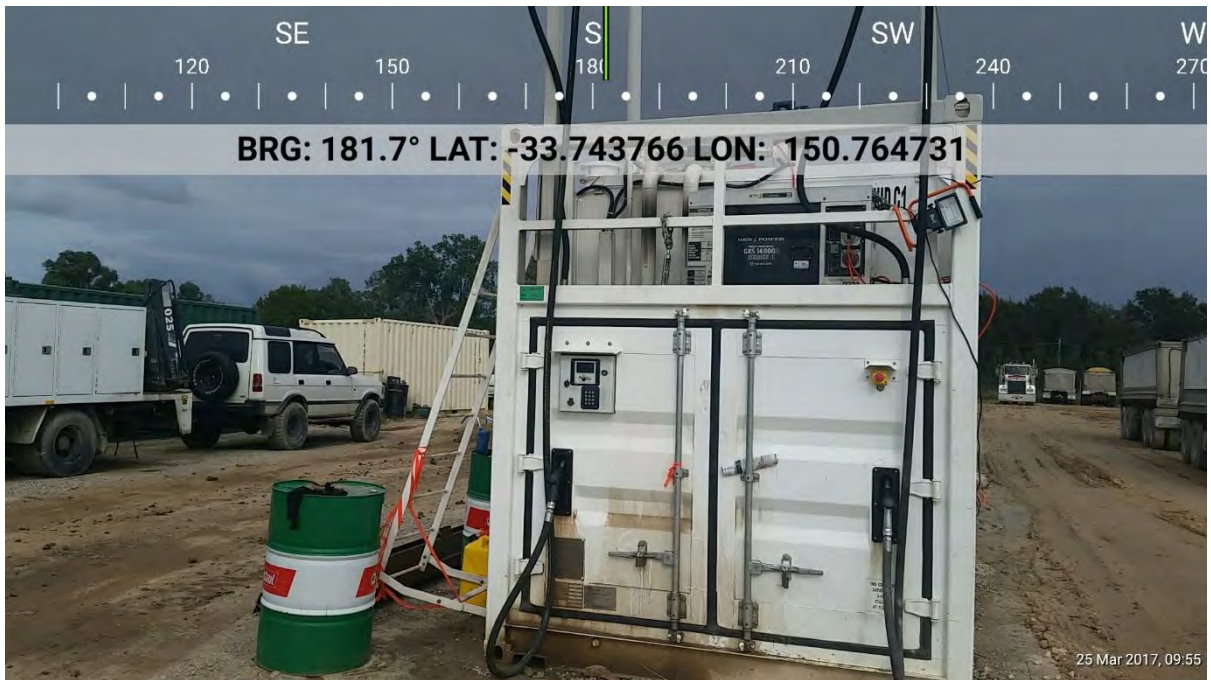
- Parking area and site hut were viewed on this portion of the site.
- Trucks with trailers used the area to park overnight after deliveries.
- Ground was generally covered in large ballast size material. Further importation of crushed rock was to be undertaken to cover the western most portion of the site within the week.
- A large diesel AST was present to refuel trucks, AST was in good condition and powered by an internal generator. Several drums of oil were also noted. No staining was noted on surface gravels.

**65 Dunheved Circuit, St Marys – RCA Trucks diesel AST and oil drum storage - 2017**

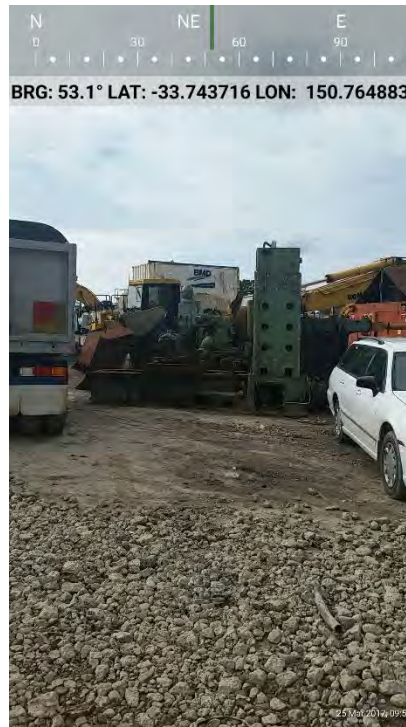
- Staining was noted on graveled surfaces to the north and east of the workshop area – in areas used for truck parking.
- Equipment parking was also noted along the southern boundary of the site. Due to the amount and size of equipment and muddy ground conditions it was difficult to view the ground surface beneath. Based on the age (and some ill-repair) of the equipment there may be some surficial staining of the gravel beneath the equipment, however this would need to be confirmed once equipment was removed.

**65 Dunheved Circuit, St Marys – ANTQIP truck parking along southern site boundary- 2017**

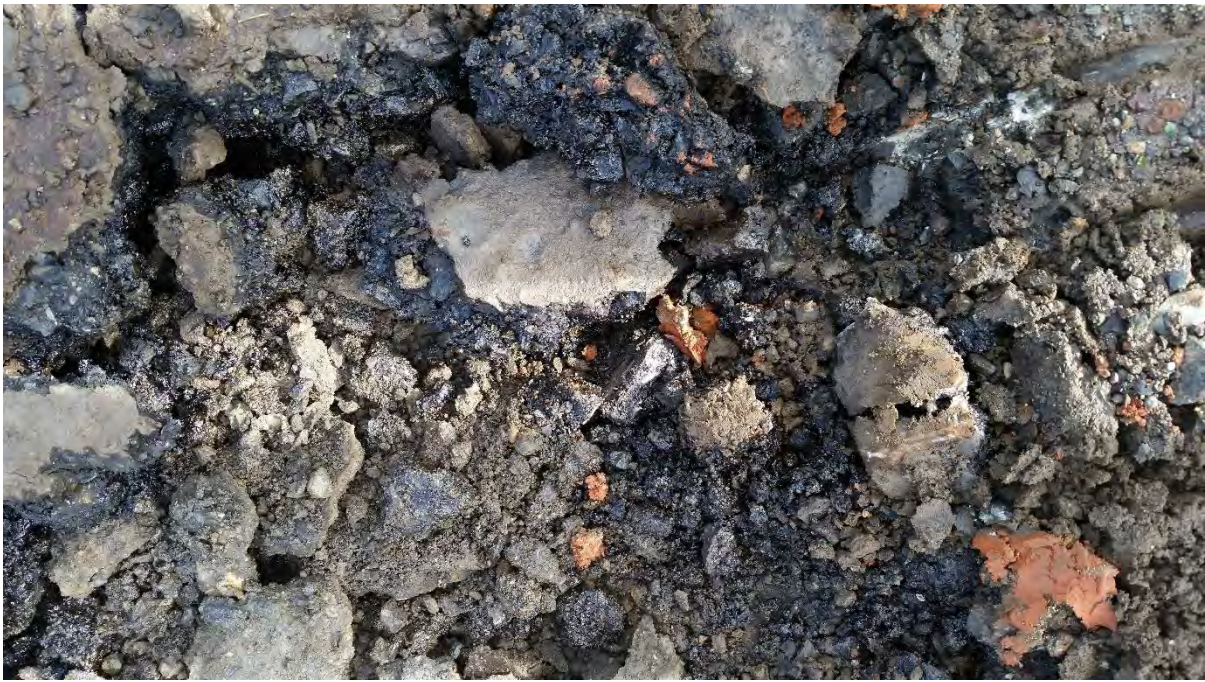
**65 Dunheved Circuit, St Marys – TP06 Spoils – note surface staining**
