Report on
Geotechnical Investigation

Jindabyne Central School
Part Lot 101 DP1019527, Jindabyne

Prepared for
NSW Department of Education - School Infrastructure
NSW

Project 103109.02
December 2021

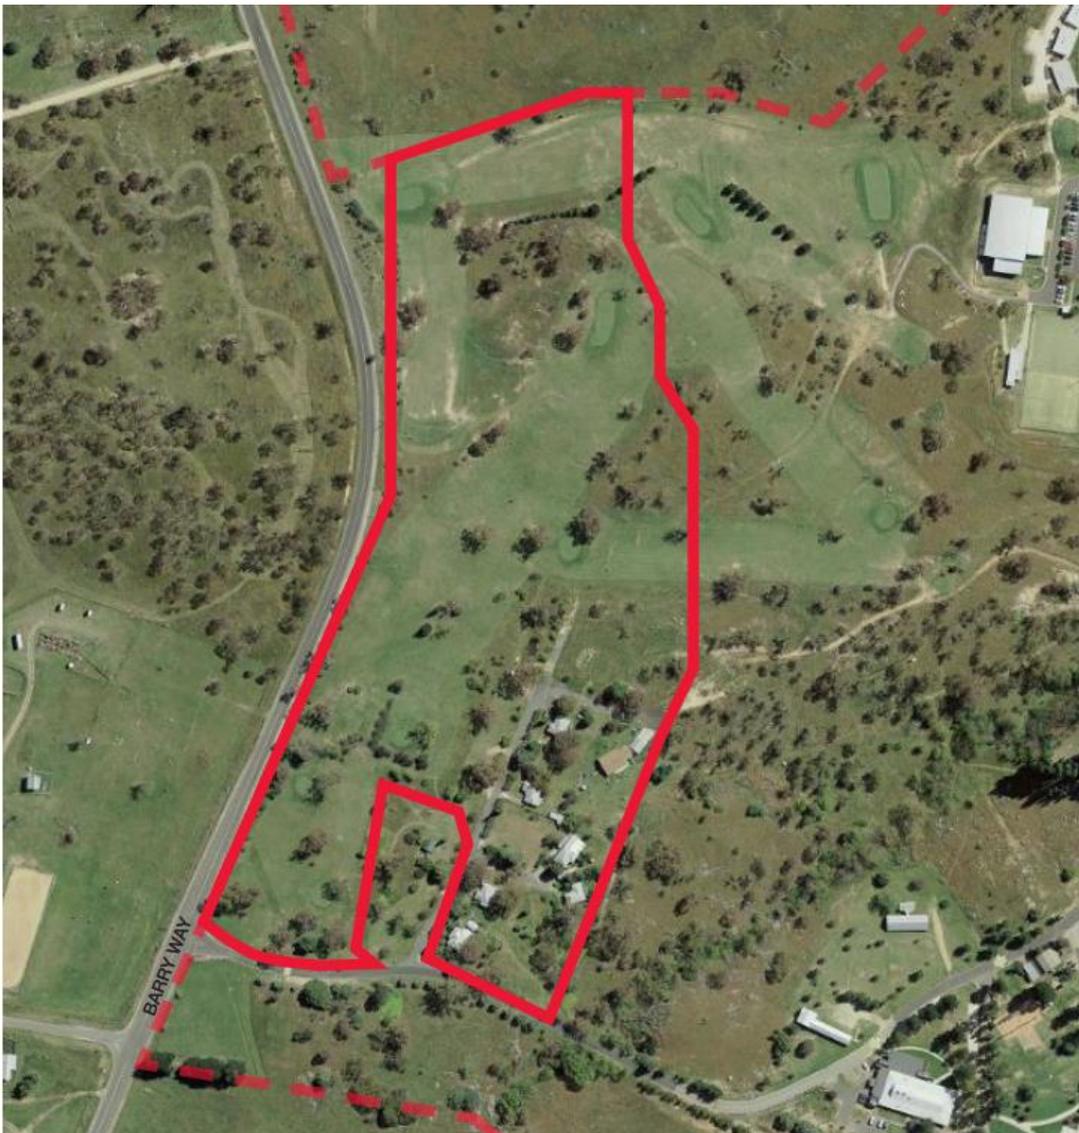
Figure 1: Site aerial - new education campus within the Jindabyne Sport and Recreation Centre.
Source: DJRD

remaining parts of the golf course are located to the north-east of the site. Part of the site also comprises former and present residential areas. Barry Way is located to the west of the site and a service road to the Jindabyne Sports and Recreation Centre is located to the south of the site and open space is located to the north and east of the site. The maximum north-south dimensions and east-west dimensions are approximately 550 m and 200 m, respectively. The site generally slopes from west to east with surface levels ranging from approximately 1000 m to 985 m AHD. A more detailed site description of the original site is presented in the desktop geotechnical assessment report (DP, 2021). Further observations of the updated site boundaries are outlined in Section 3.1. Figure 1 below shows the proposed extent of the site for the JCS.
