Report on  
Preliminary Site Investigation (Contamination) with  
Limited Sampling

Jindabyne Central School  
Part Lot 101, DP1019527, Jindabyne

Prepared for  
NSW Department of Education - School Infrastructure  
NSW

Project 103109.03  
December 2021

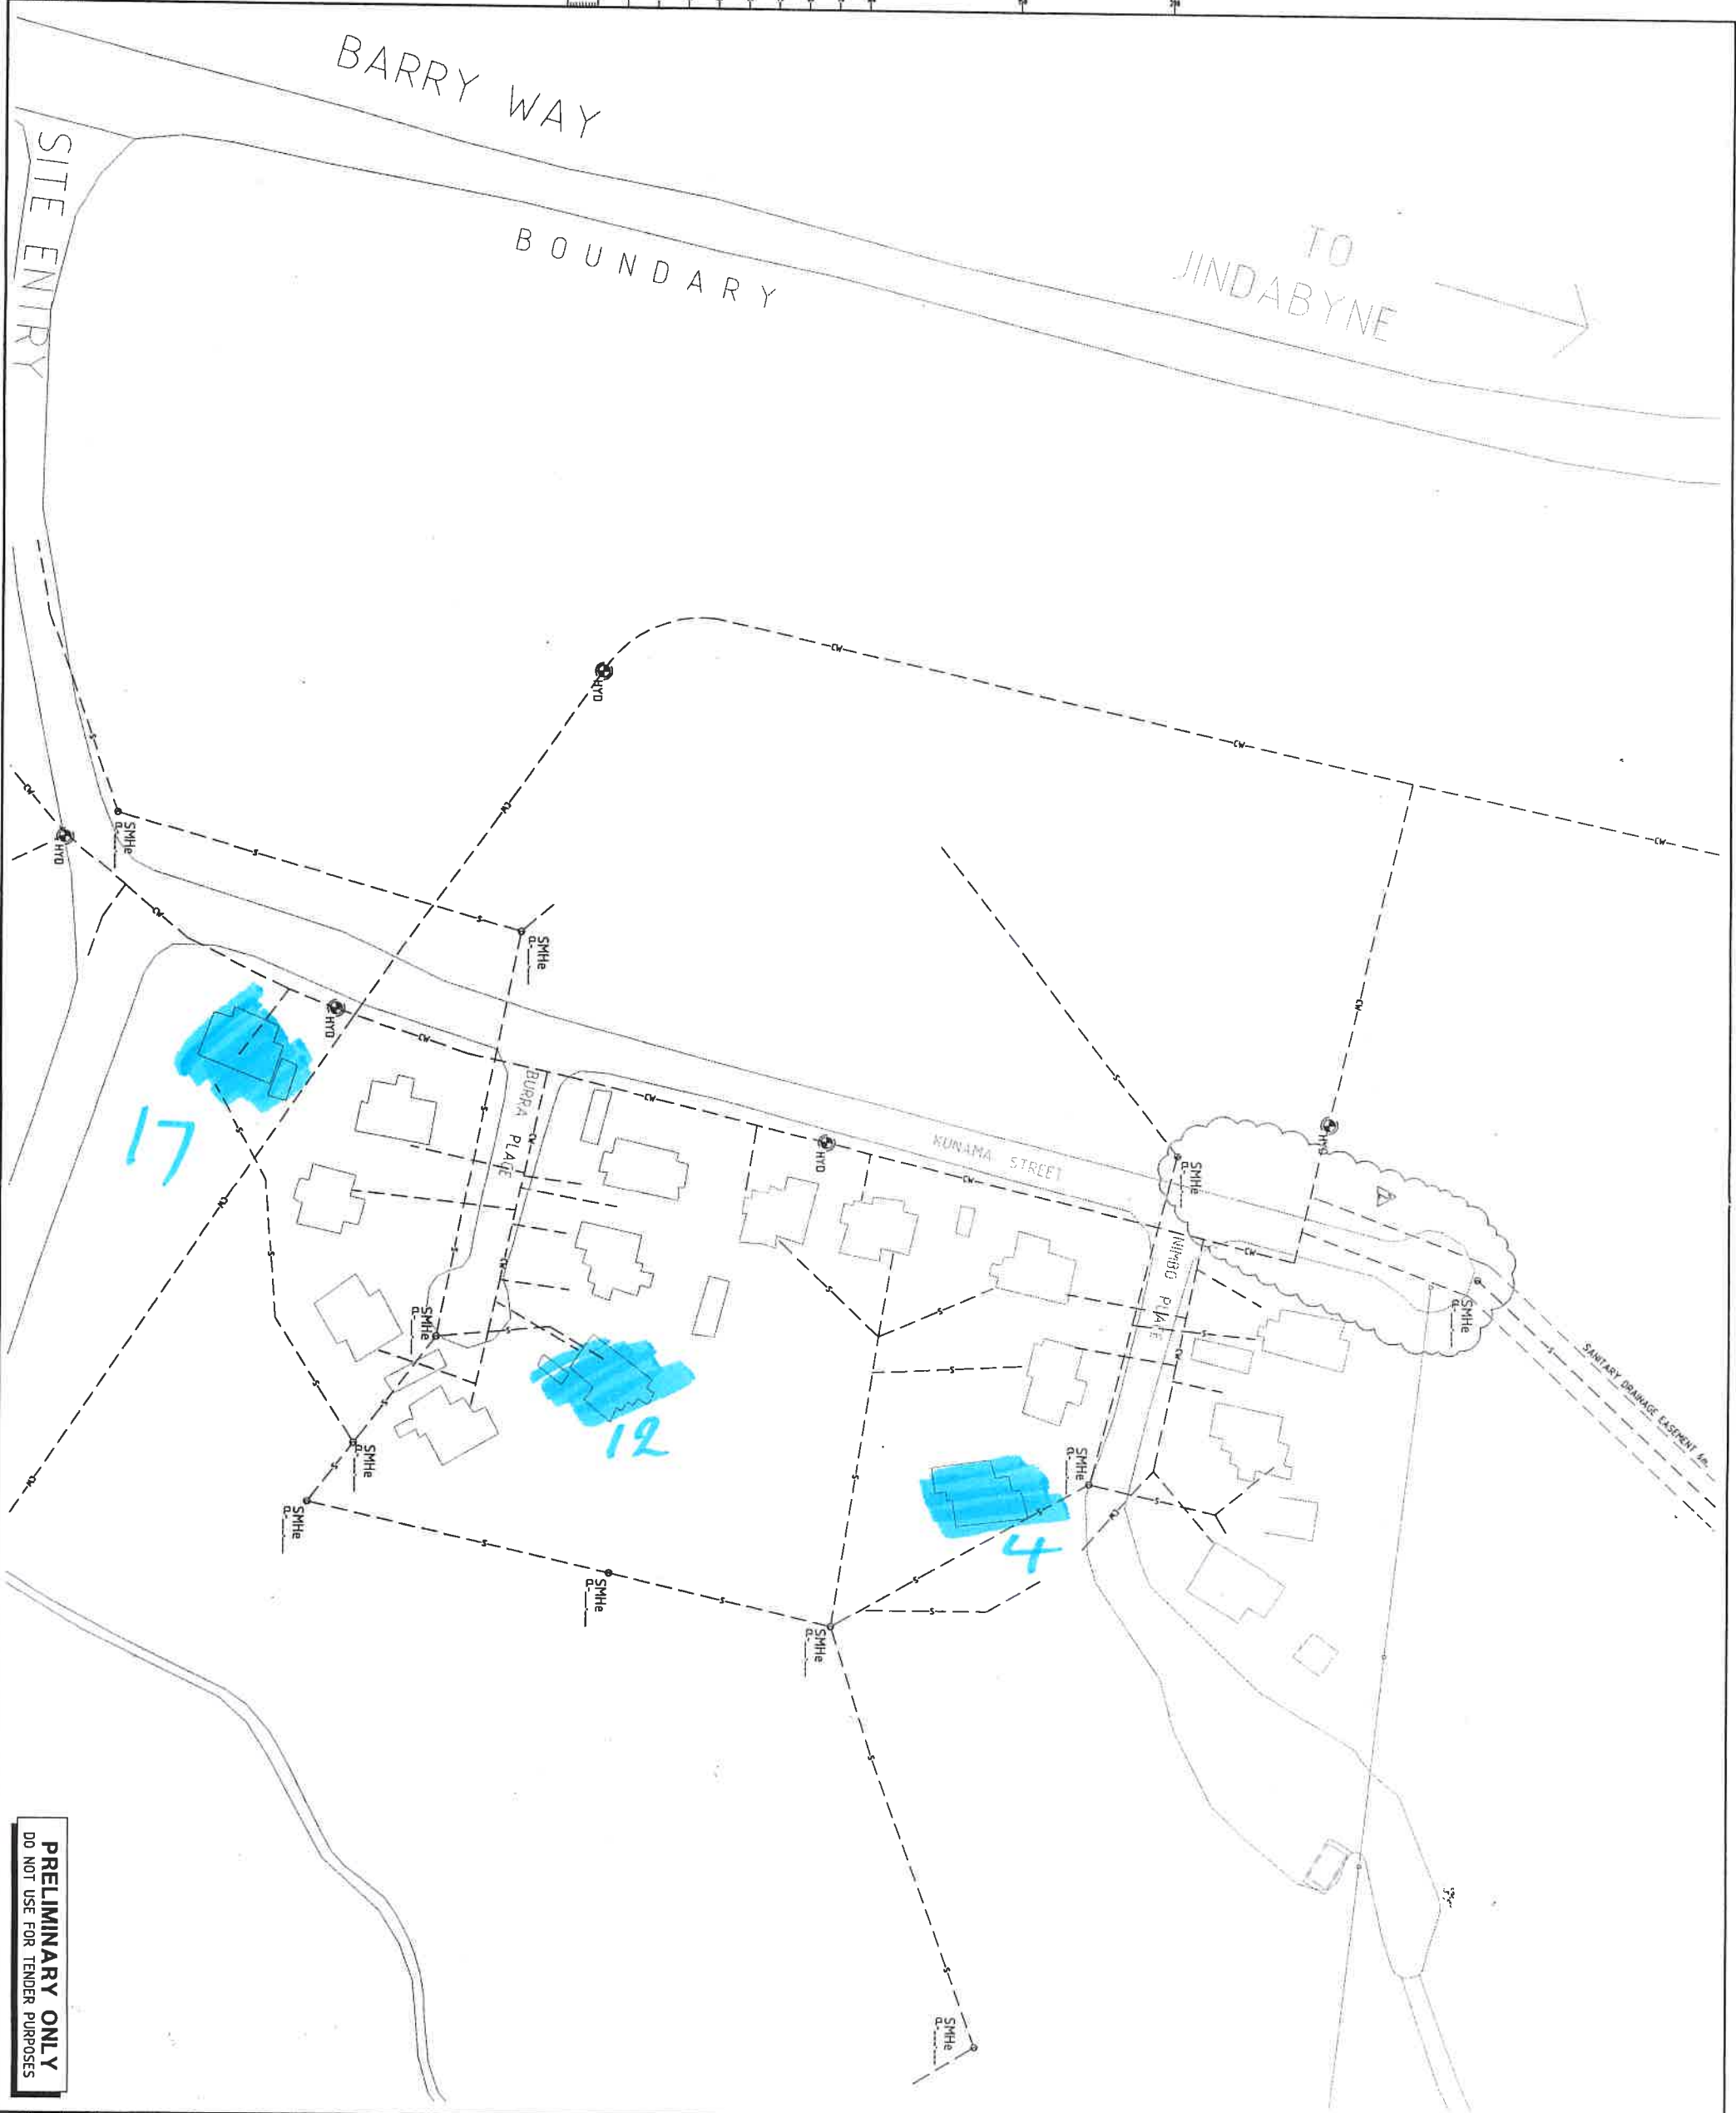
<b>THOS</b> A CONSULTING ENGINEERING BUILDING HYDRAULIC SERVICES CONSULTANTS THOS (ACN) PTY LTD (A.B.N. 32 124 812 390)				<b>JINDABYNE SPORT &amp; RECREATION CENTRE. PROPOSED STAFF ACCOMMODATION SITE.</b>			
<b>HYDRAULIC SERVICES</b> INDICATIVE LOCATION OF SANITARY & WATER MAINS				<b>DATE</b> August '07			
<b>SCALE</b> 1:500 @ A1 1:1000 @ A3				<b>STATUS</b> PRELIMINARY			
<b>PROJECT</b> 71795 HO1 2				<b>DATE</b> August '07			
<b>SCALE</b> 1:500 @ A1 1:1000 @ A3				<b>STATUS</b> PRELIMINARY

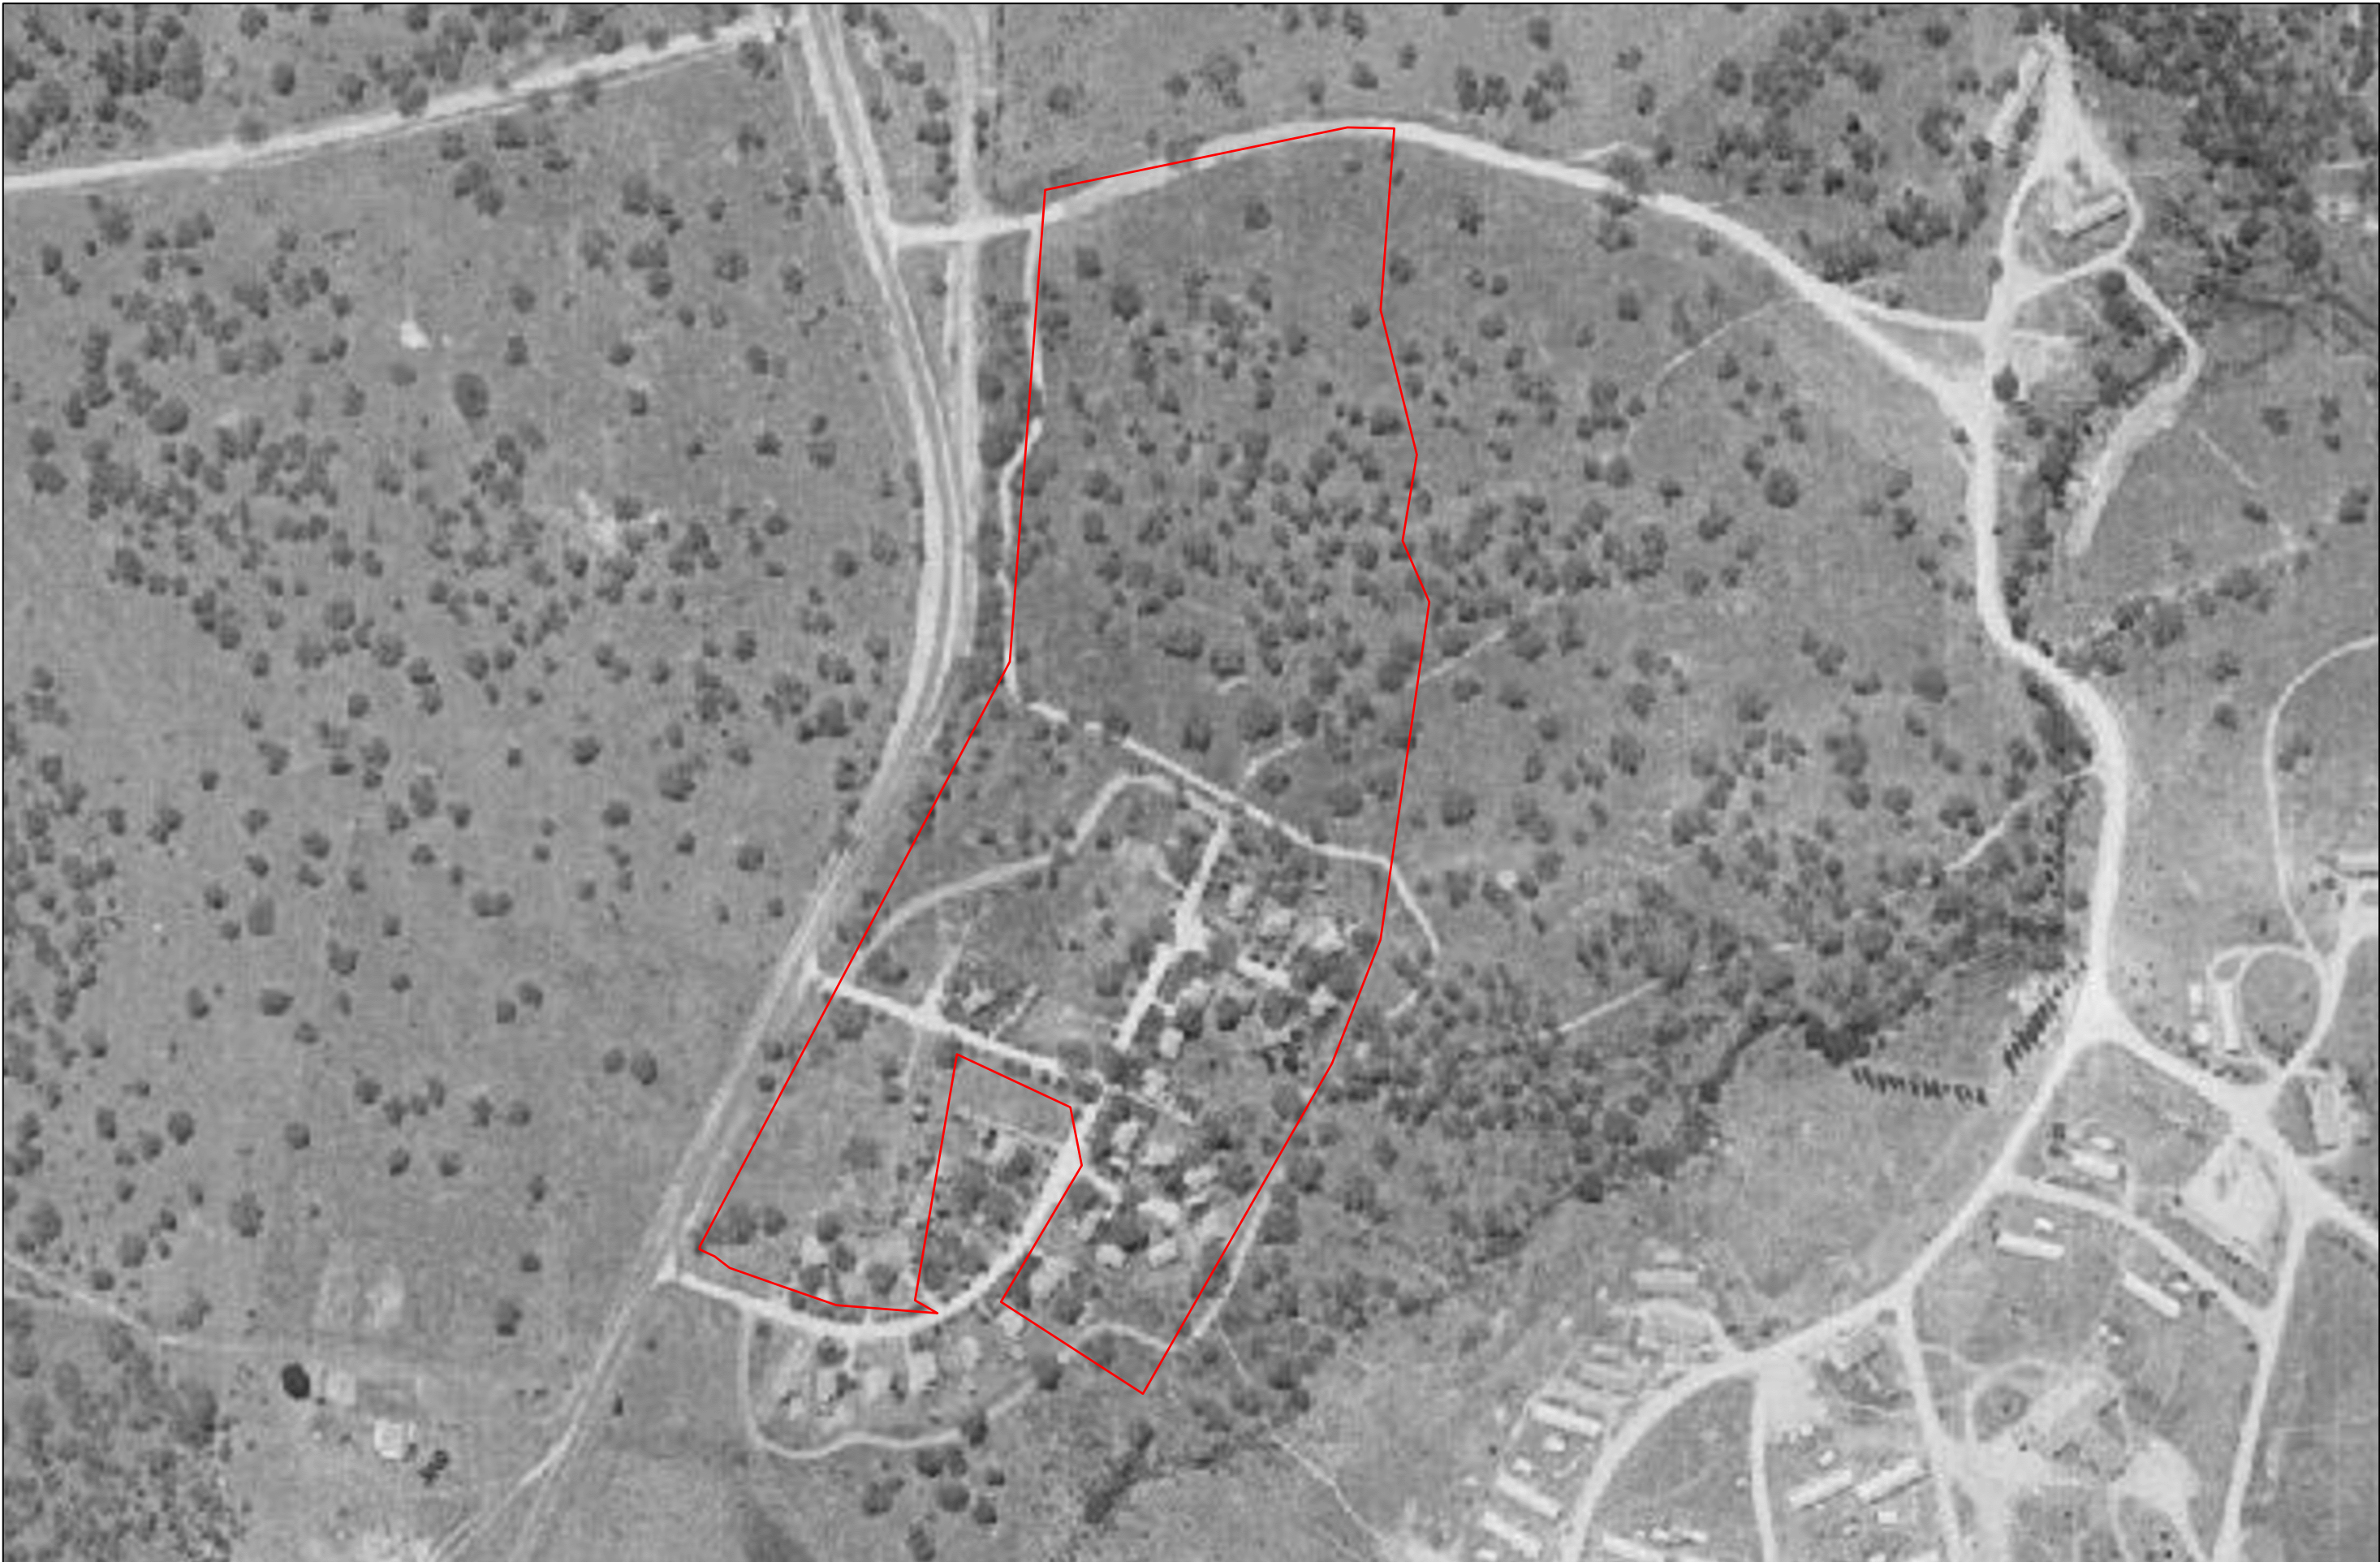
PROJECT No: 103109.03
	OFFICE: Canberra	DRAWN BY: SDG			PLATE No: D1
	SCALE: NTS	DATE: 29.11.2021			REVISION: 4

<b>Douglas Partners</b> <i>Geotechnics   Environment   Groundwater</i>	CLIENT: School Infrastructure NSW (SINSW)		TITLE: <b>Aerial Photograph 1962</b> <b>Proposed Jindabyne Central School</b> <b>Part Lot 101 DP1019527, Jindabyne</b>

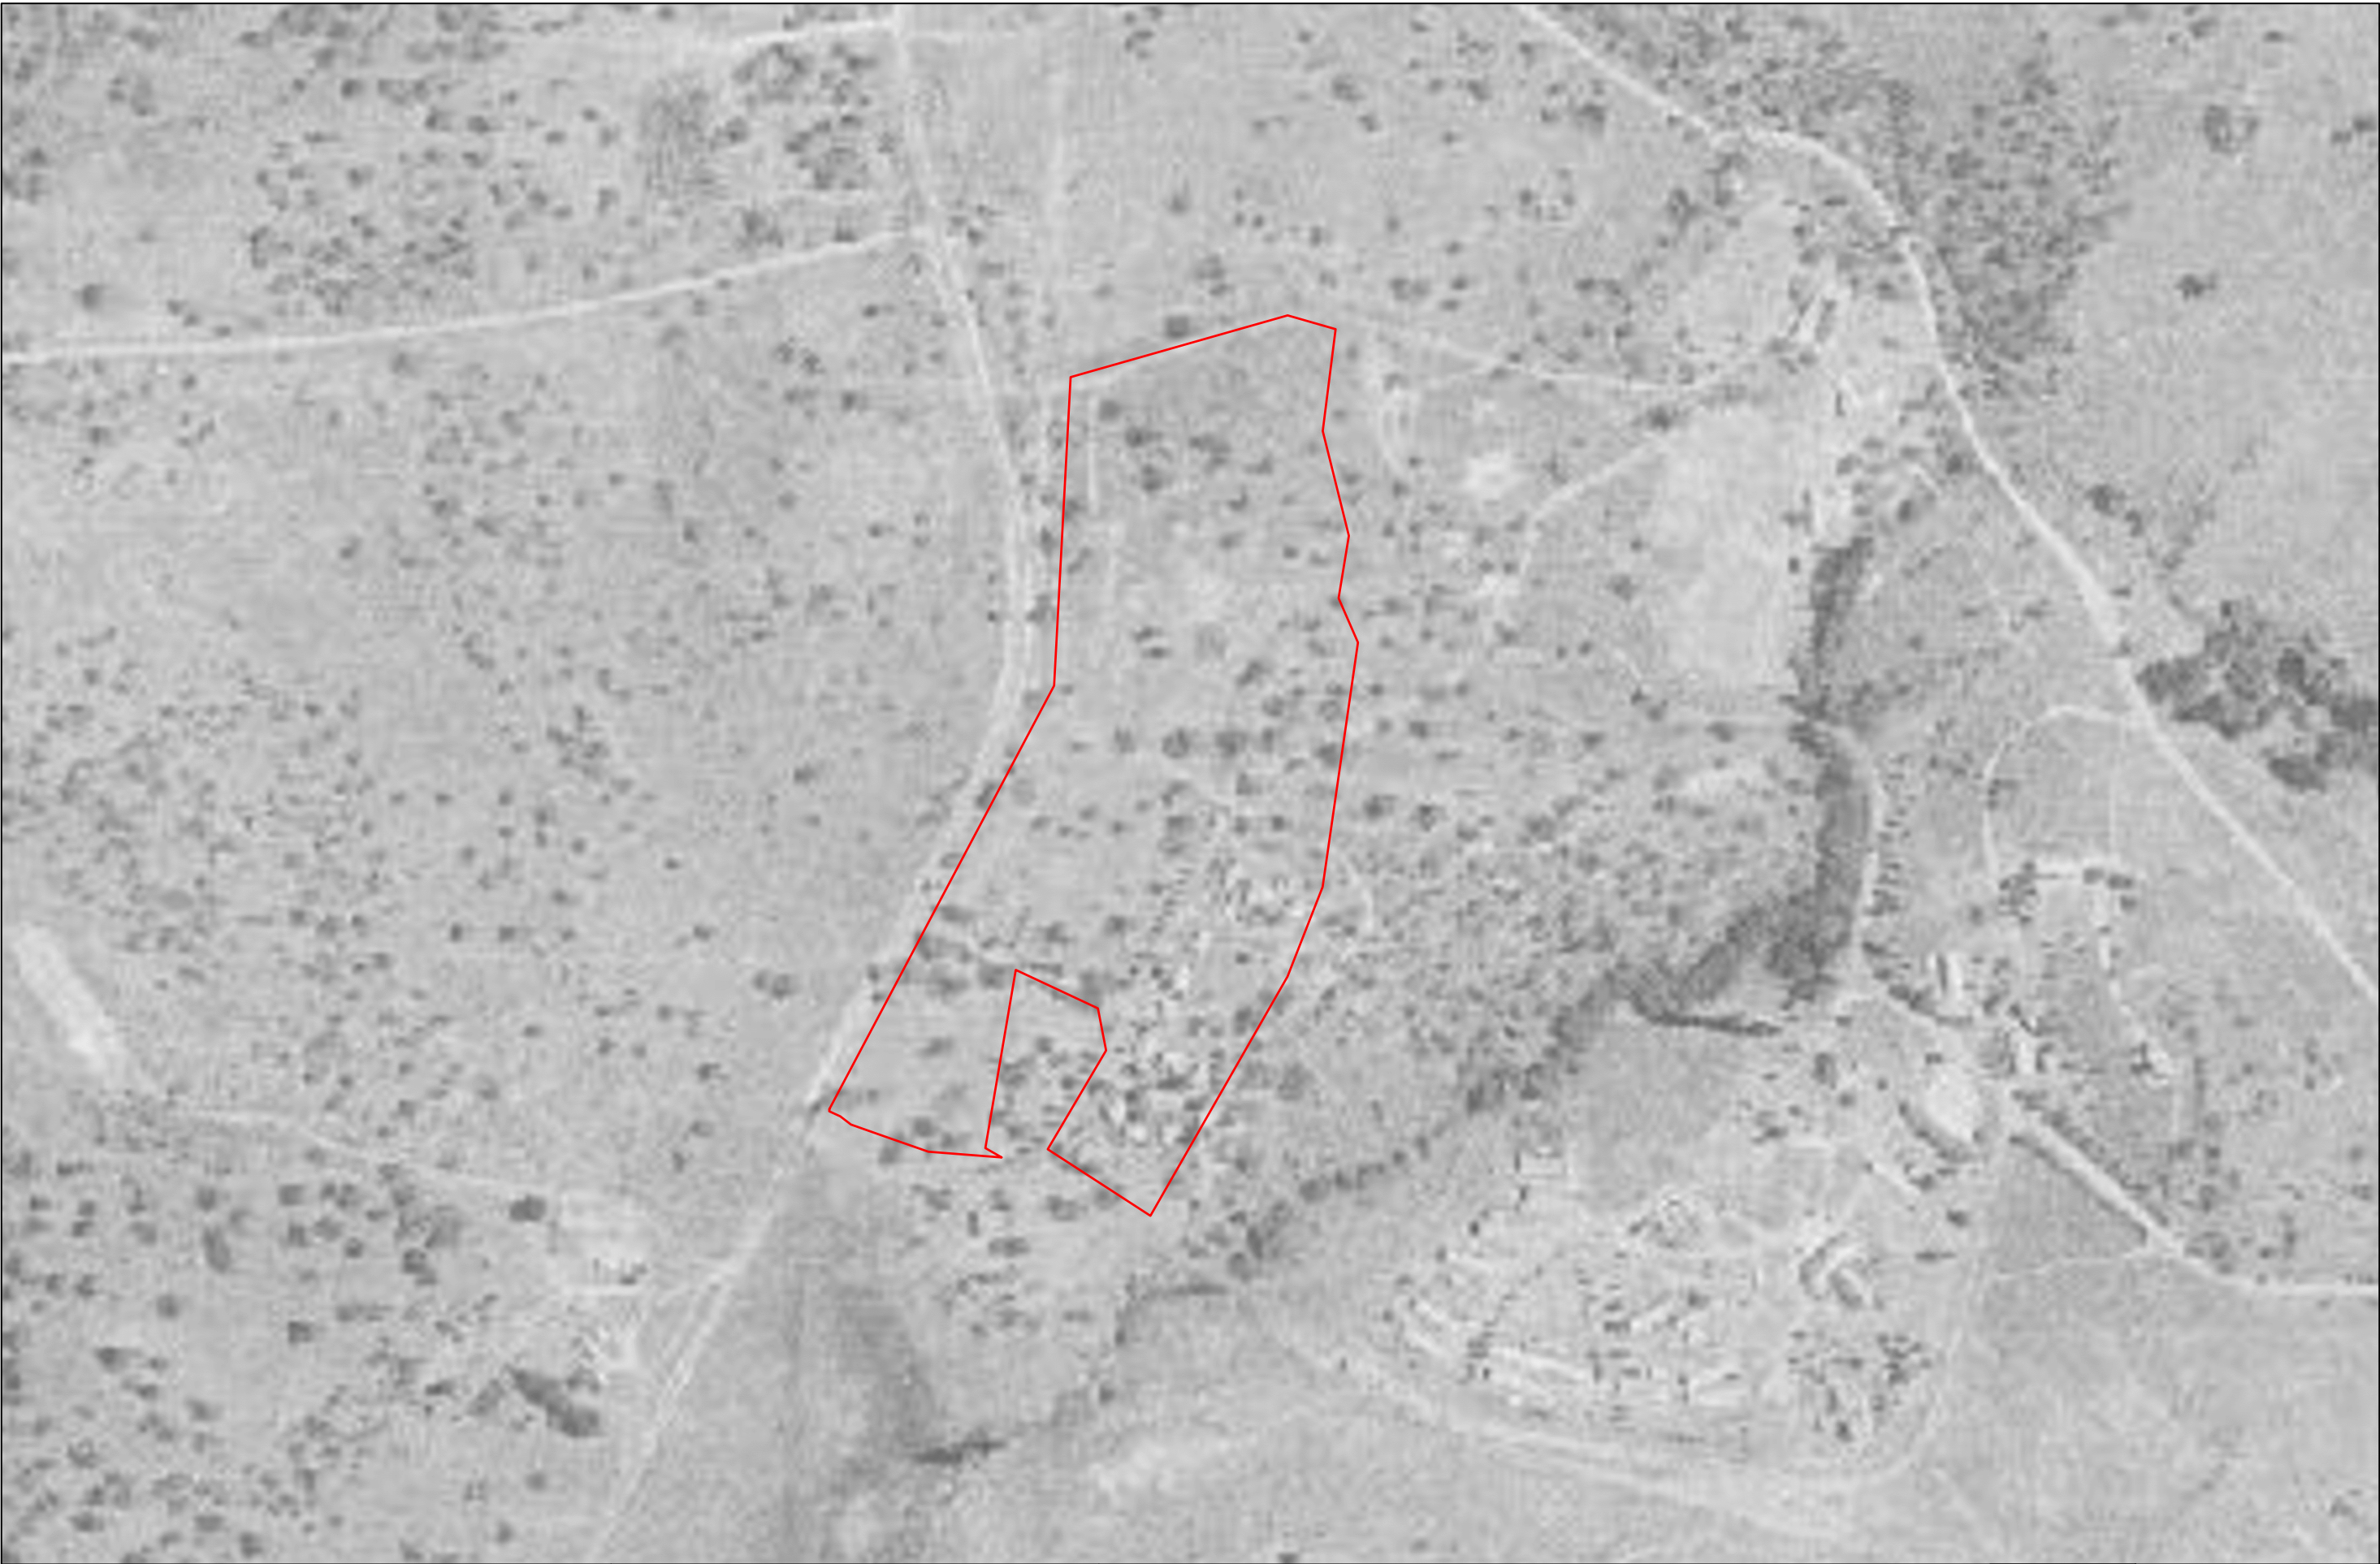
<b>Douglas Partners</b> <i>Geotechnics   Environment   Groundwater</i>	CLIENT: School Infrastructure NSW (SINSW)		TITLE: <b>Aerial Photograph 1979</b> <b>Proposed Jindabyne Central School</b> <b>Part Lot 101 DP1019527, Jindabyne</b>

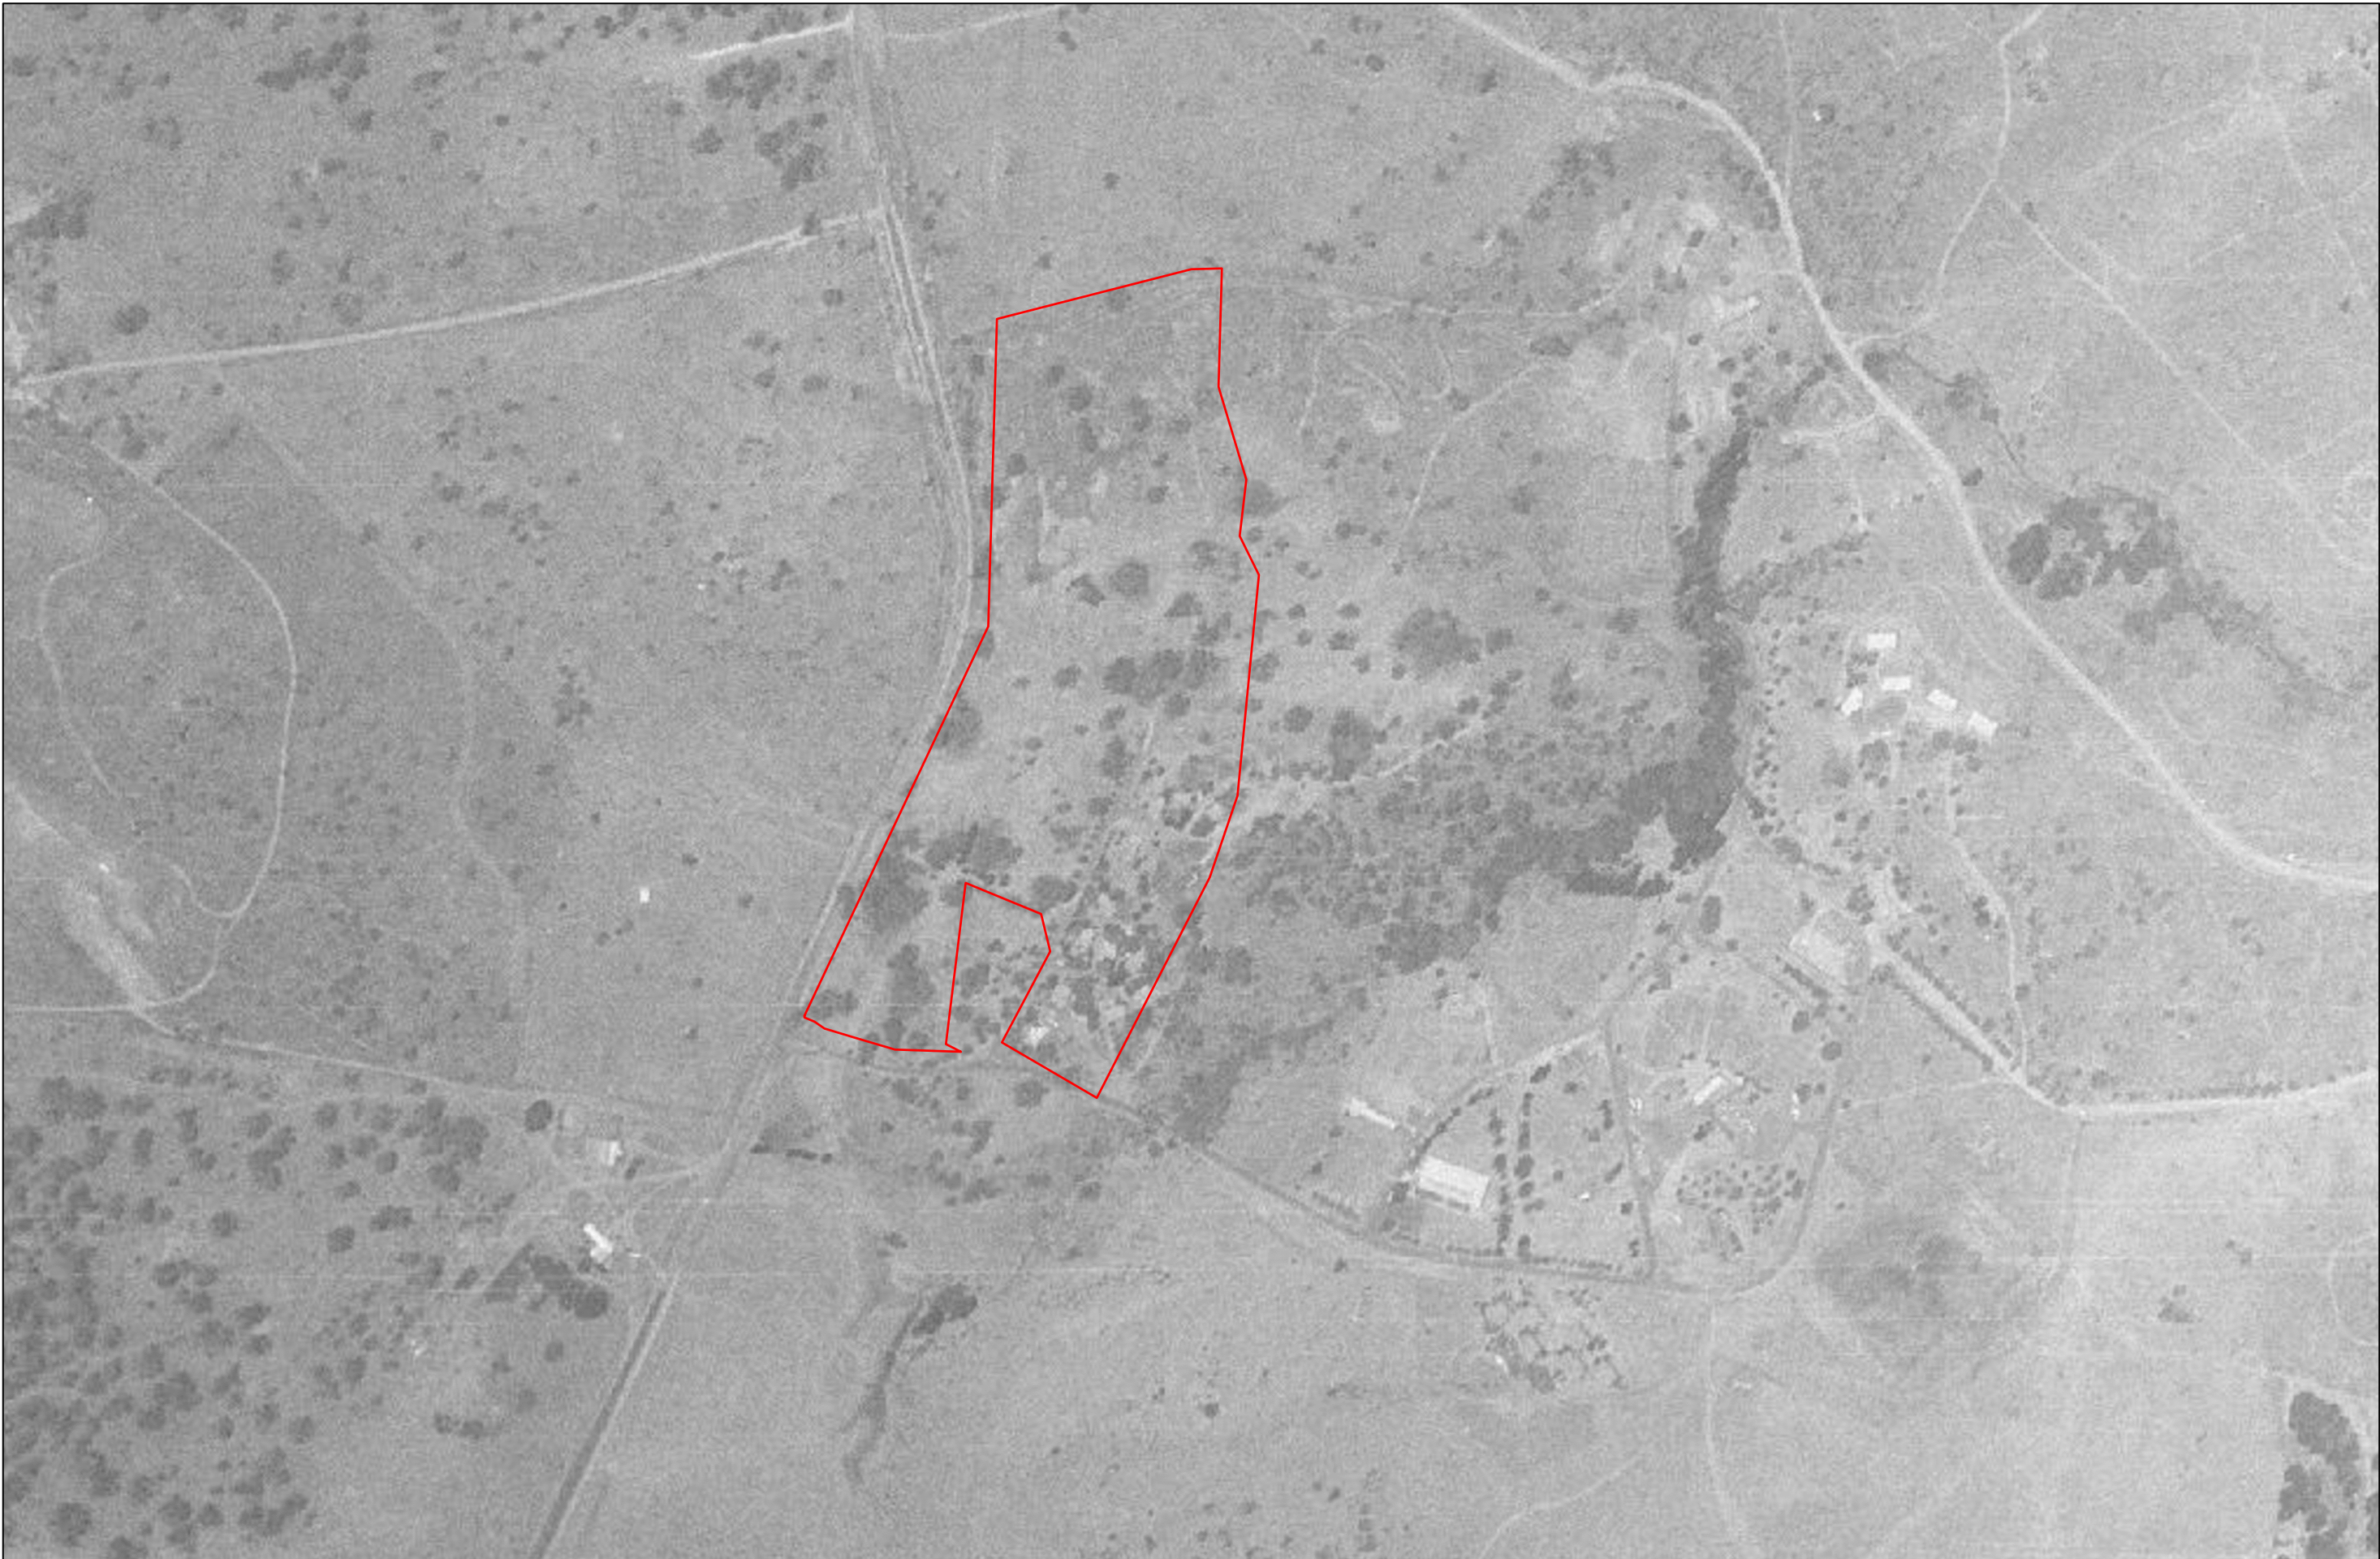
PROJECT No: 103109.03
	OFFICE: Canberra	DRAWN BY: SDG			PLATE No: D2
	SCALE: NTS	DATE: 29.11.2021			REVISION: 4

<b>Douglas Partners</b> <i>Geotechnics   Environment   Groundwater</i>	CLIENT: School Infrastructure NSW (SINSW)		TITLE: <b>Aerial Photograph 1988</b> <b>Proposed Jindabyne Central School</b> <b>Part Lot 101 DP1019527, Jindabyne</b>

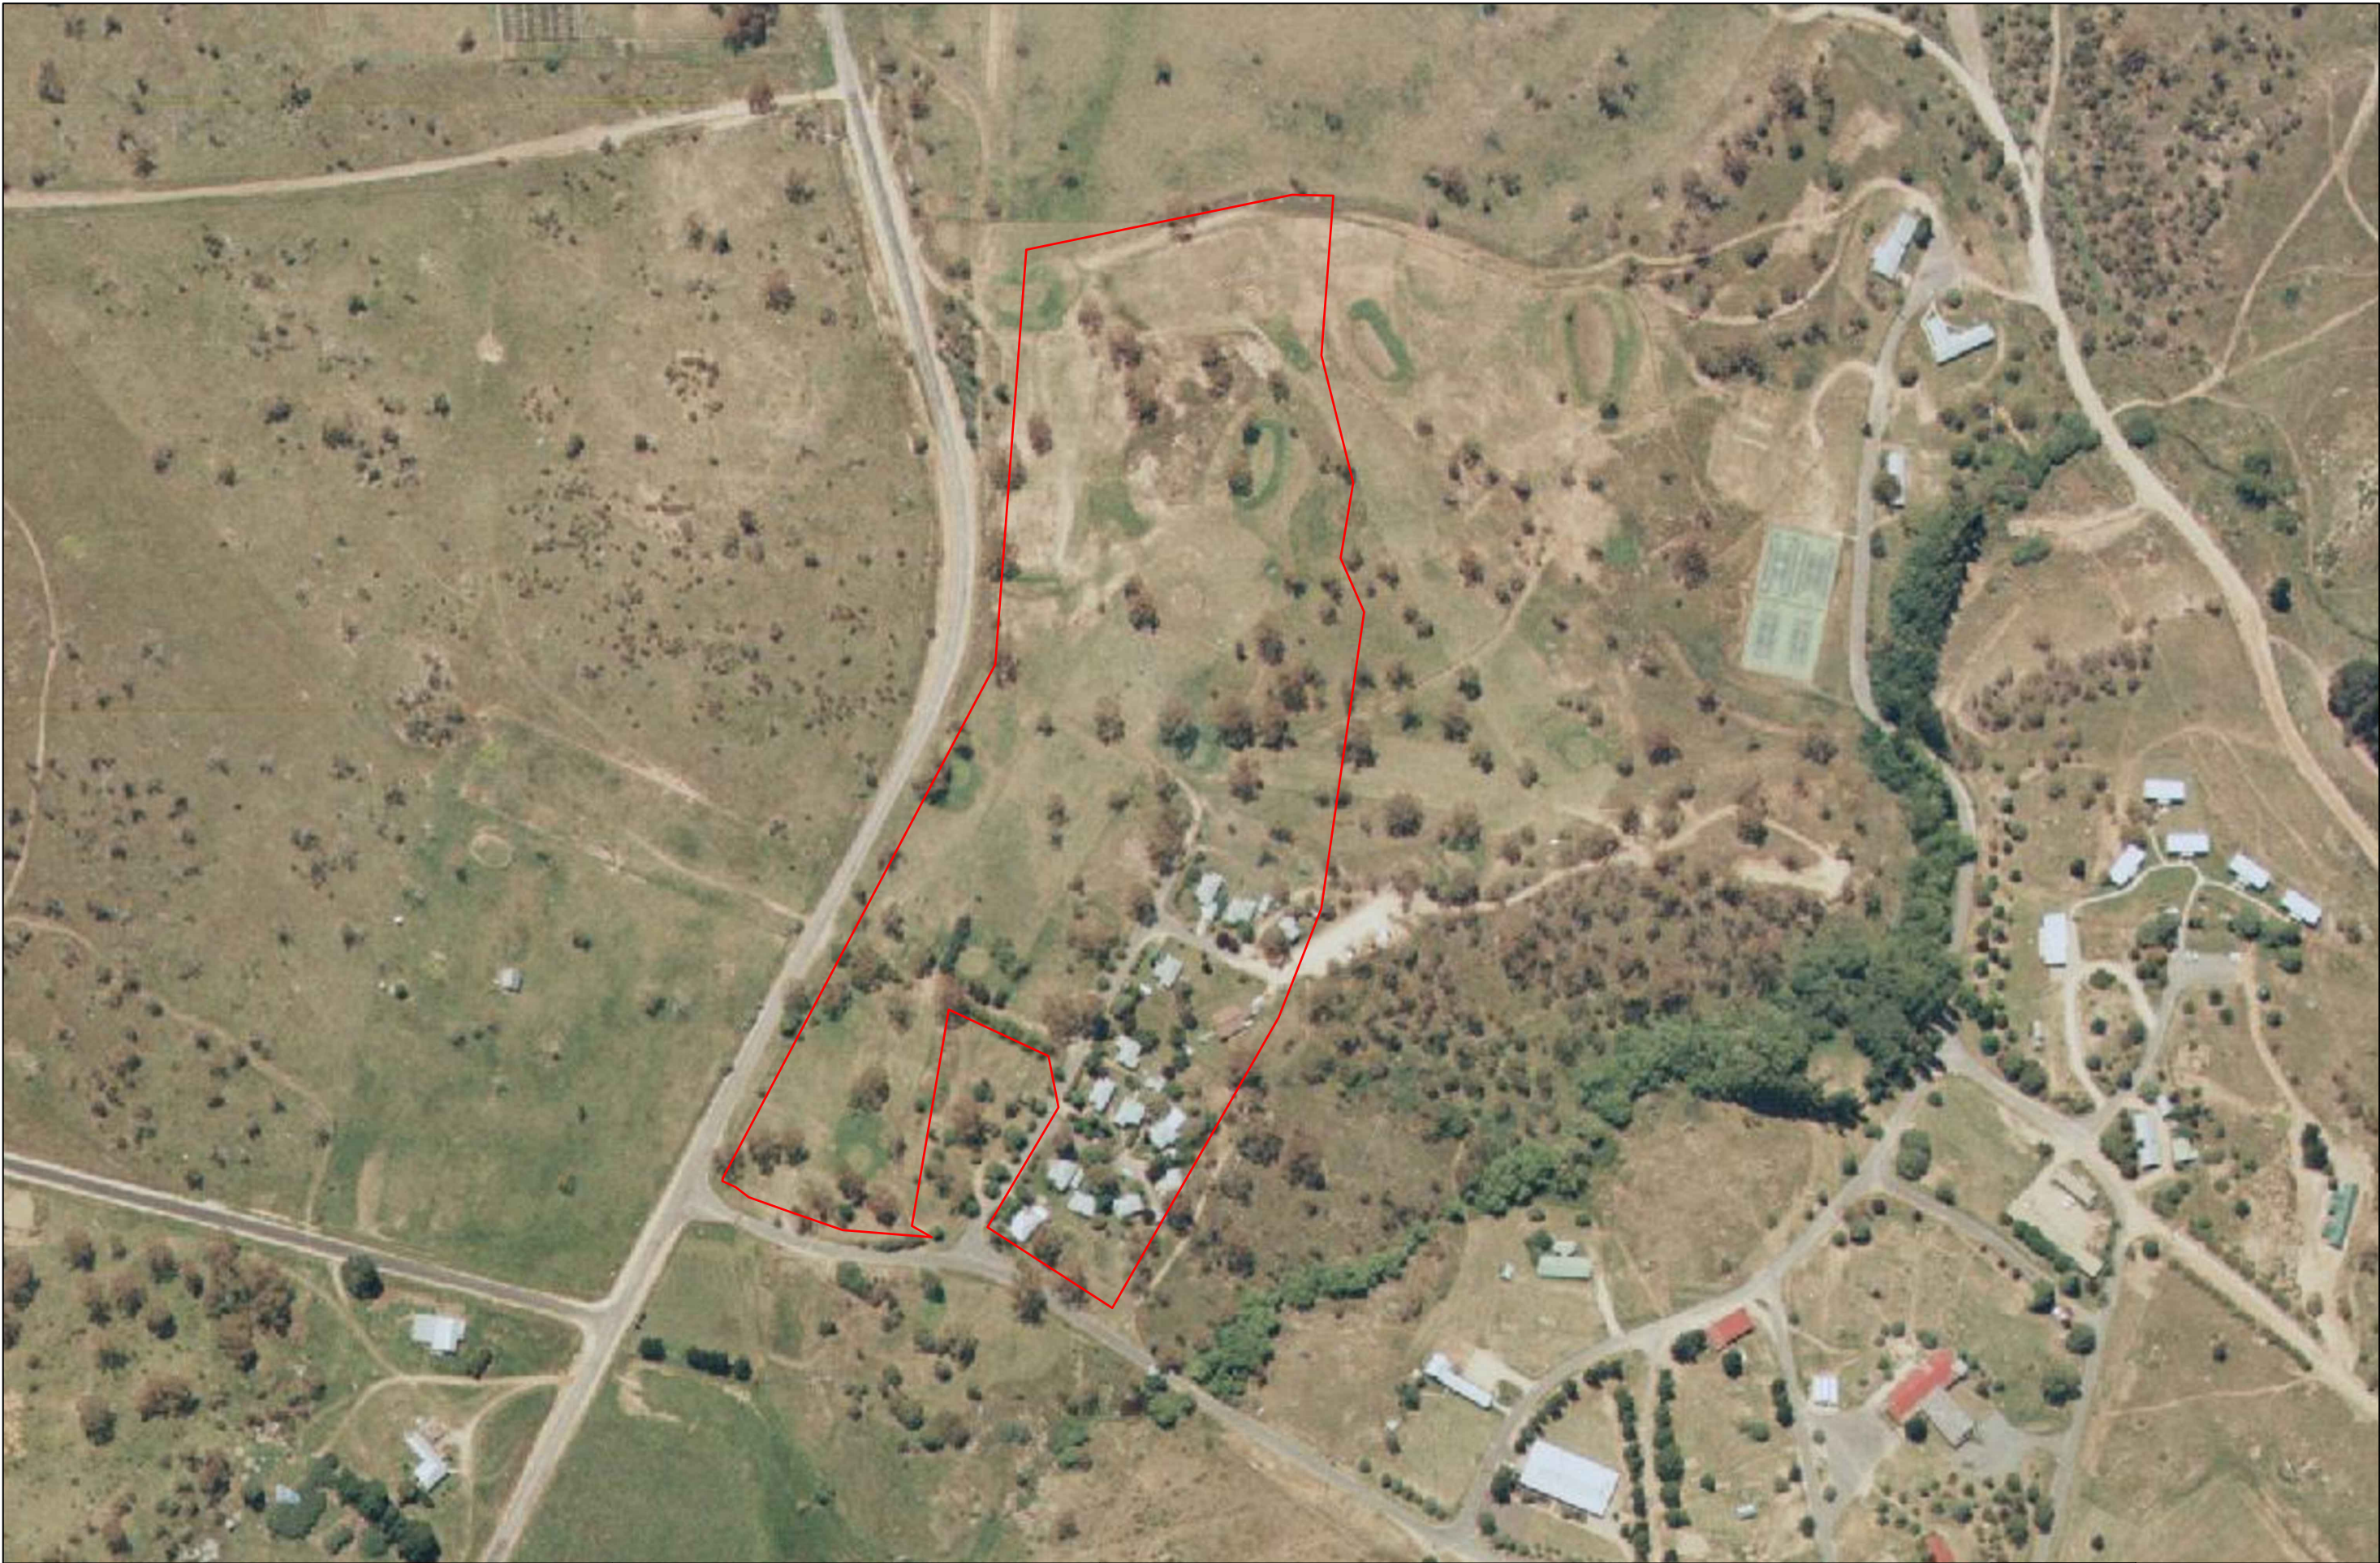
PROJECT No: 103109.03
	OFFICE: Canberra	DRAWN BY: SDG			PLATE No: D3
	SCALE: NTS	DATE: 29.11.2021			REVISION: 4

<b>Douglas Partners</b> Geotechnics   Environment   Groundwater	CLIENT: School Infrastructure NSW (SINSW)		TITLE: <b>Aerial Photograph 1992</b> <b>Proposed Jindabyne Central School</b> <b>Part Lot 101 DP1019527, Jindabyne</b>

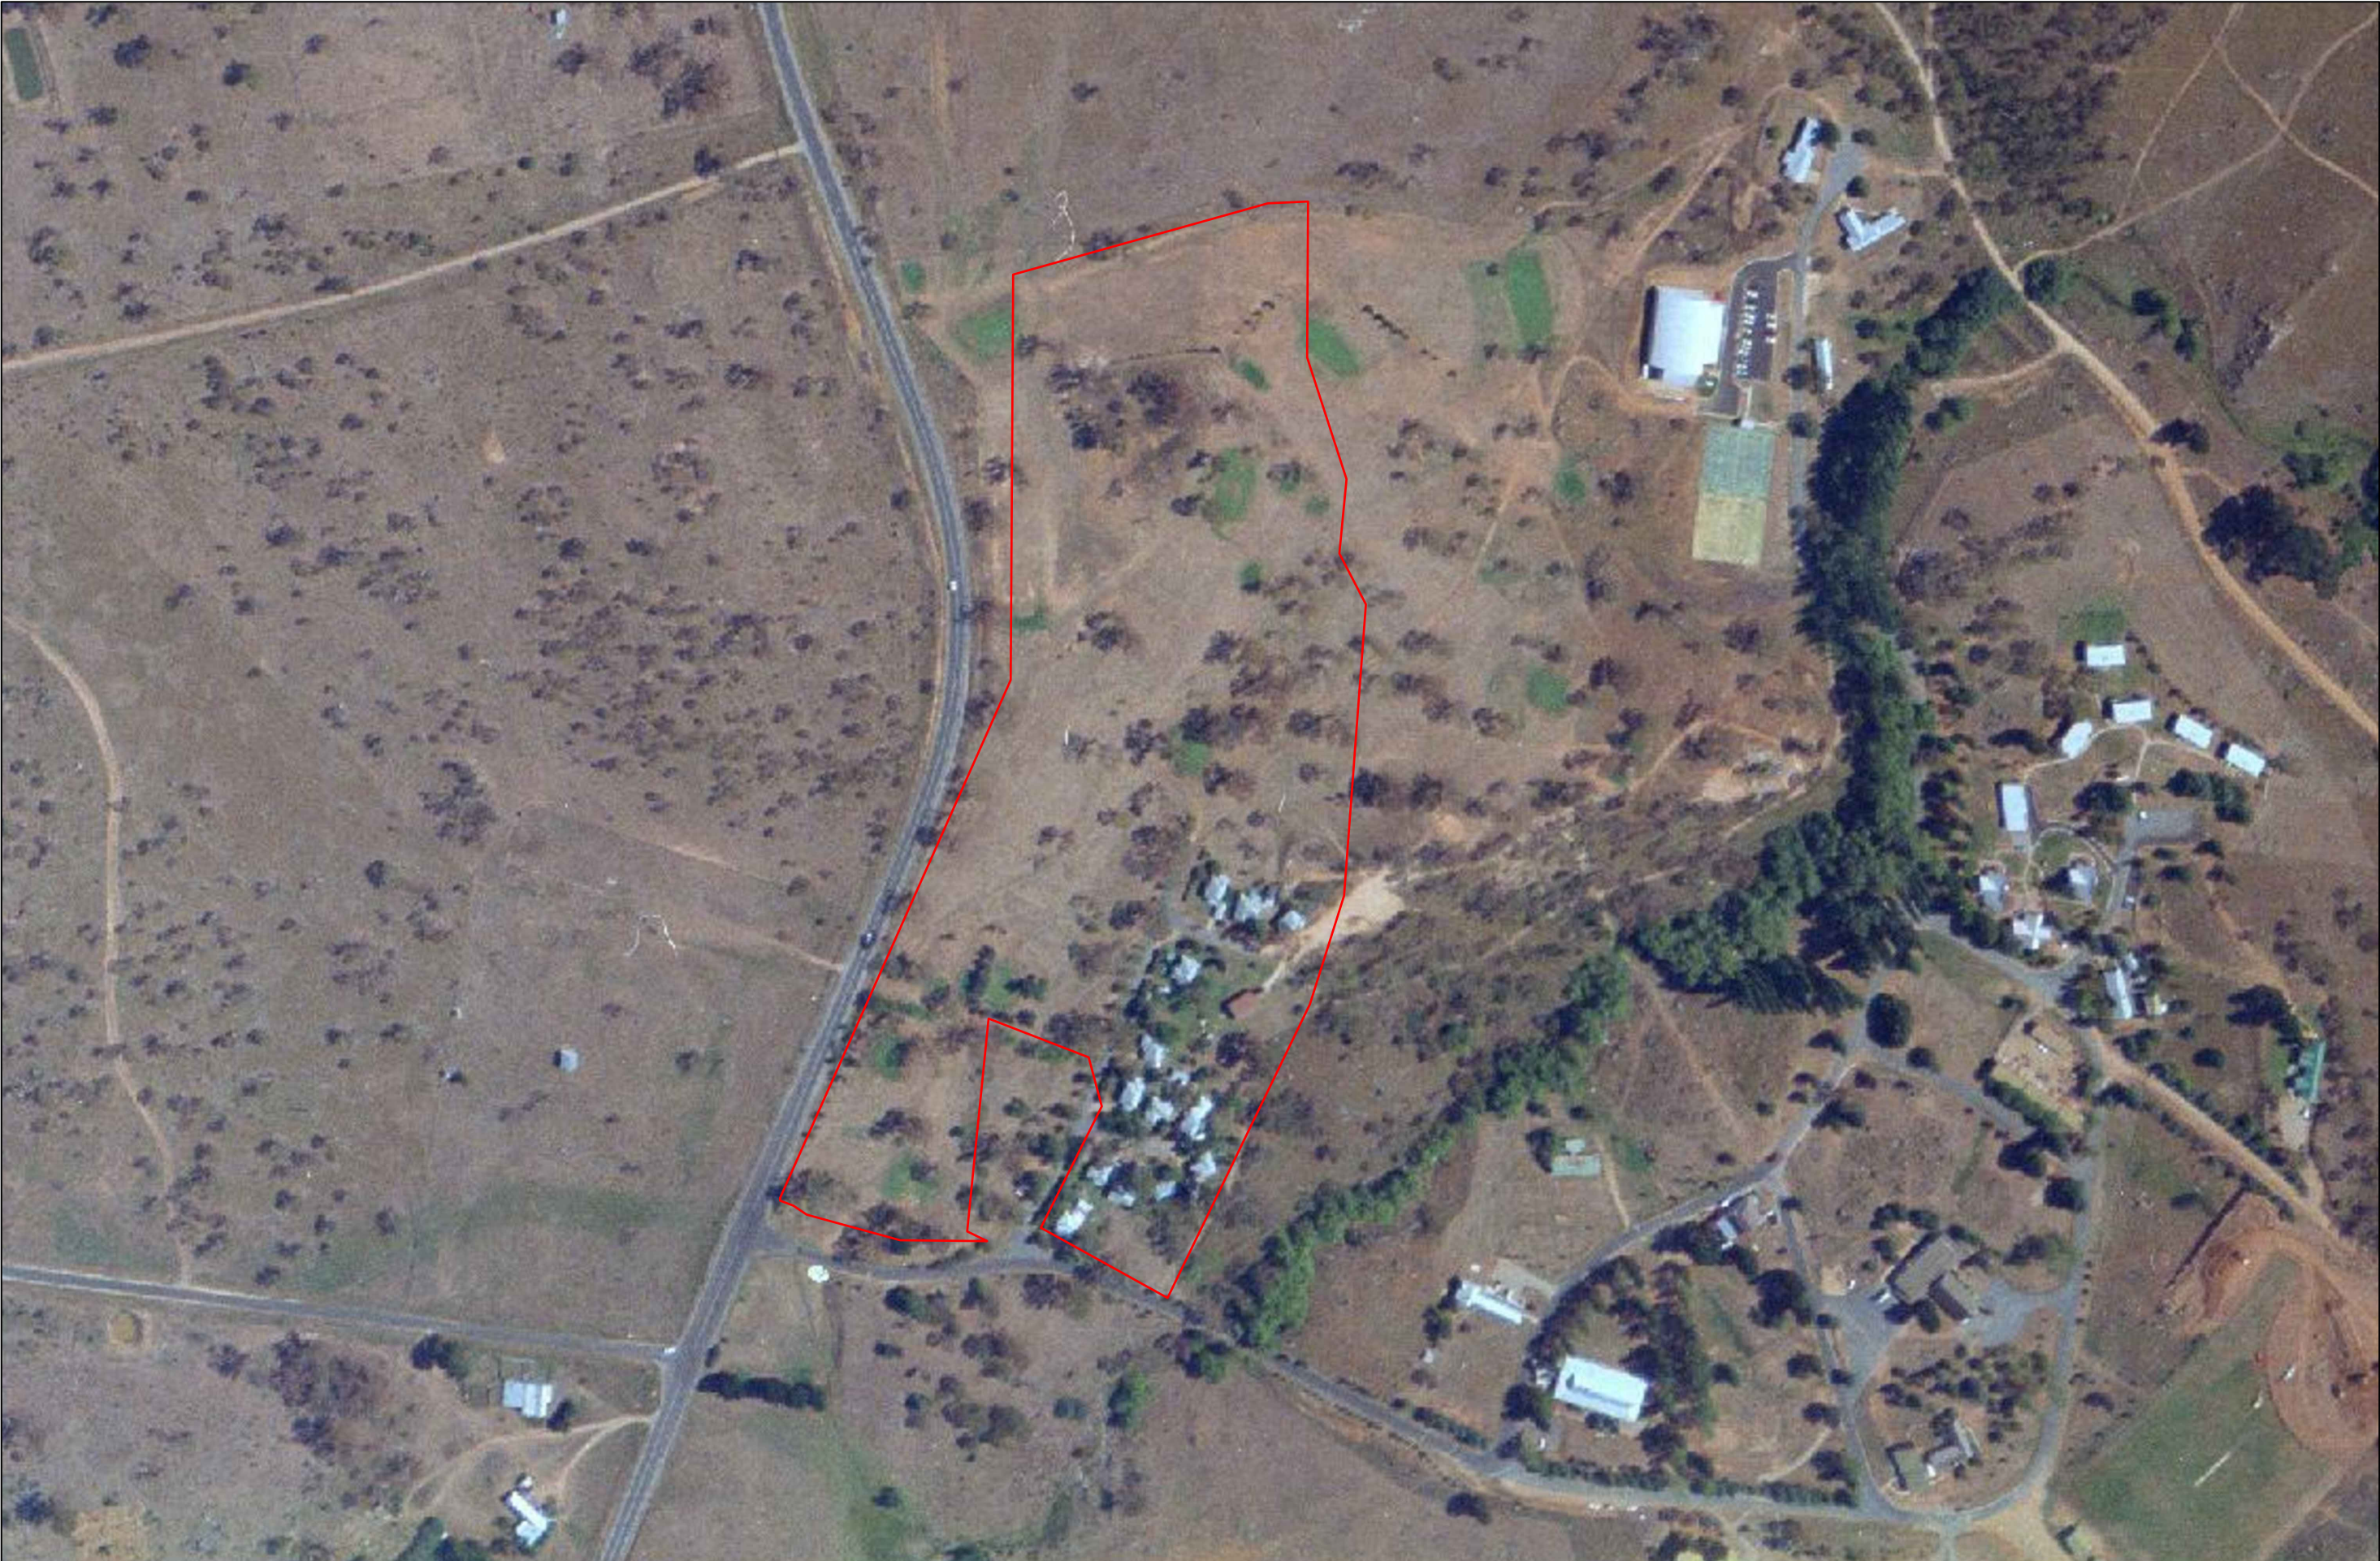
PROJECT No: 103109.03
	OFFICE: Canberra	DRAWN BY: SDG			PLATE No: D4
	SCALE: NTS	DATE: 29.11.2021			REVISION: 4

<b>Douglas Partners</b> Geotechnics   Environment   Groundwater	CLIENT: School Infrastructure NSW (SINSW)		TITLE: <b>Aerial Photograph 1998</b> <b>Proposed Jindabyne Central School</b> <b>Part Lot 101 DP1019527, Jindabyne</b>
