Report on  
Preliminary Site Investigation (Contamination) with  
Limited Sampling

Jindabyne Central School  
Part Lot 101, DP1019527, Jindabyne

Prepared for  
NSW Department of Education - School Infrastructure  
NSW

Project 103109.03  
December 2021

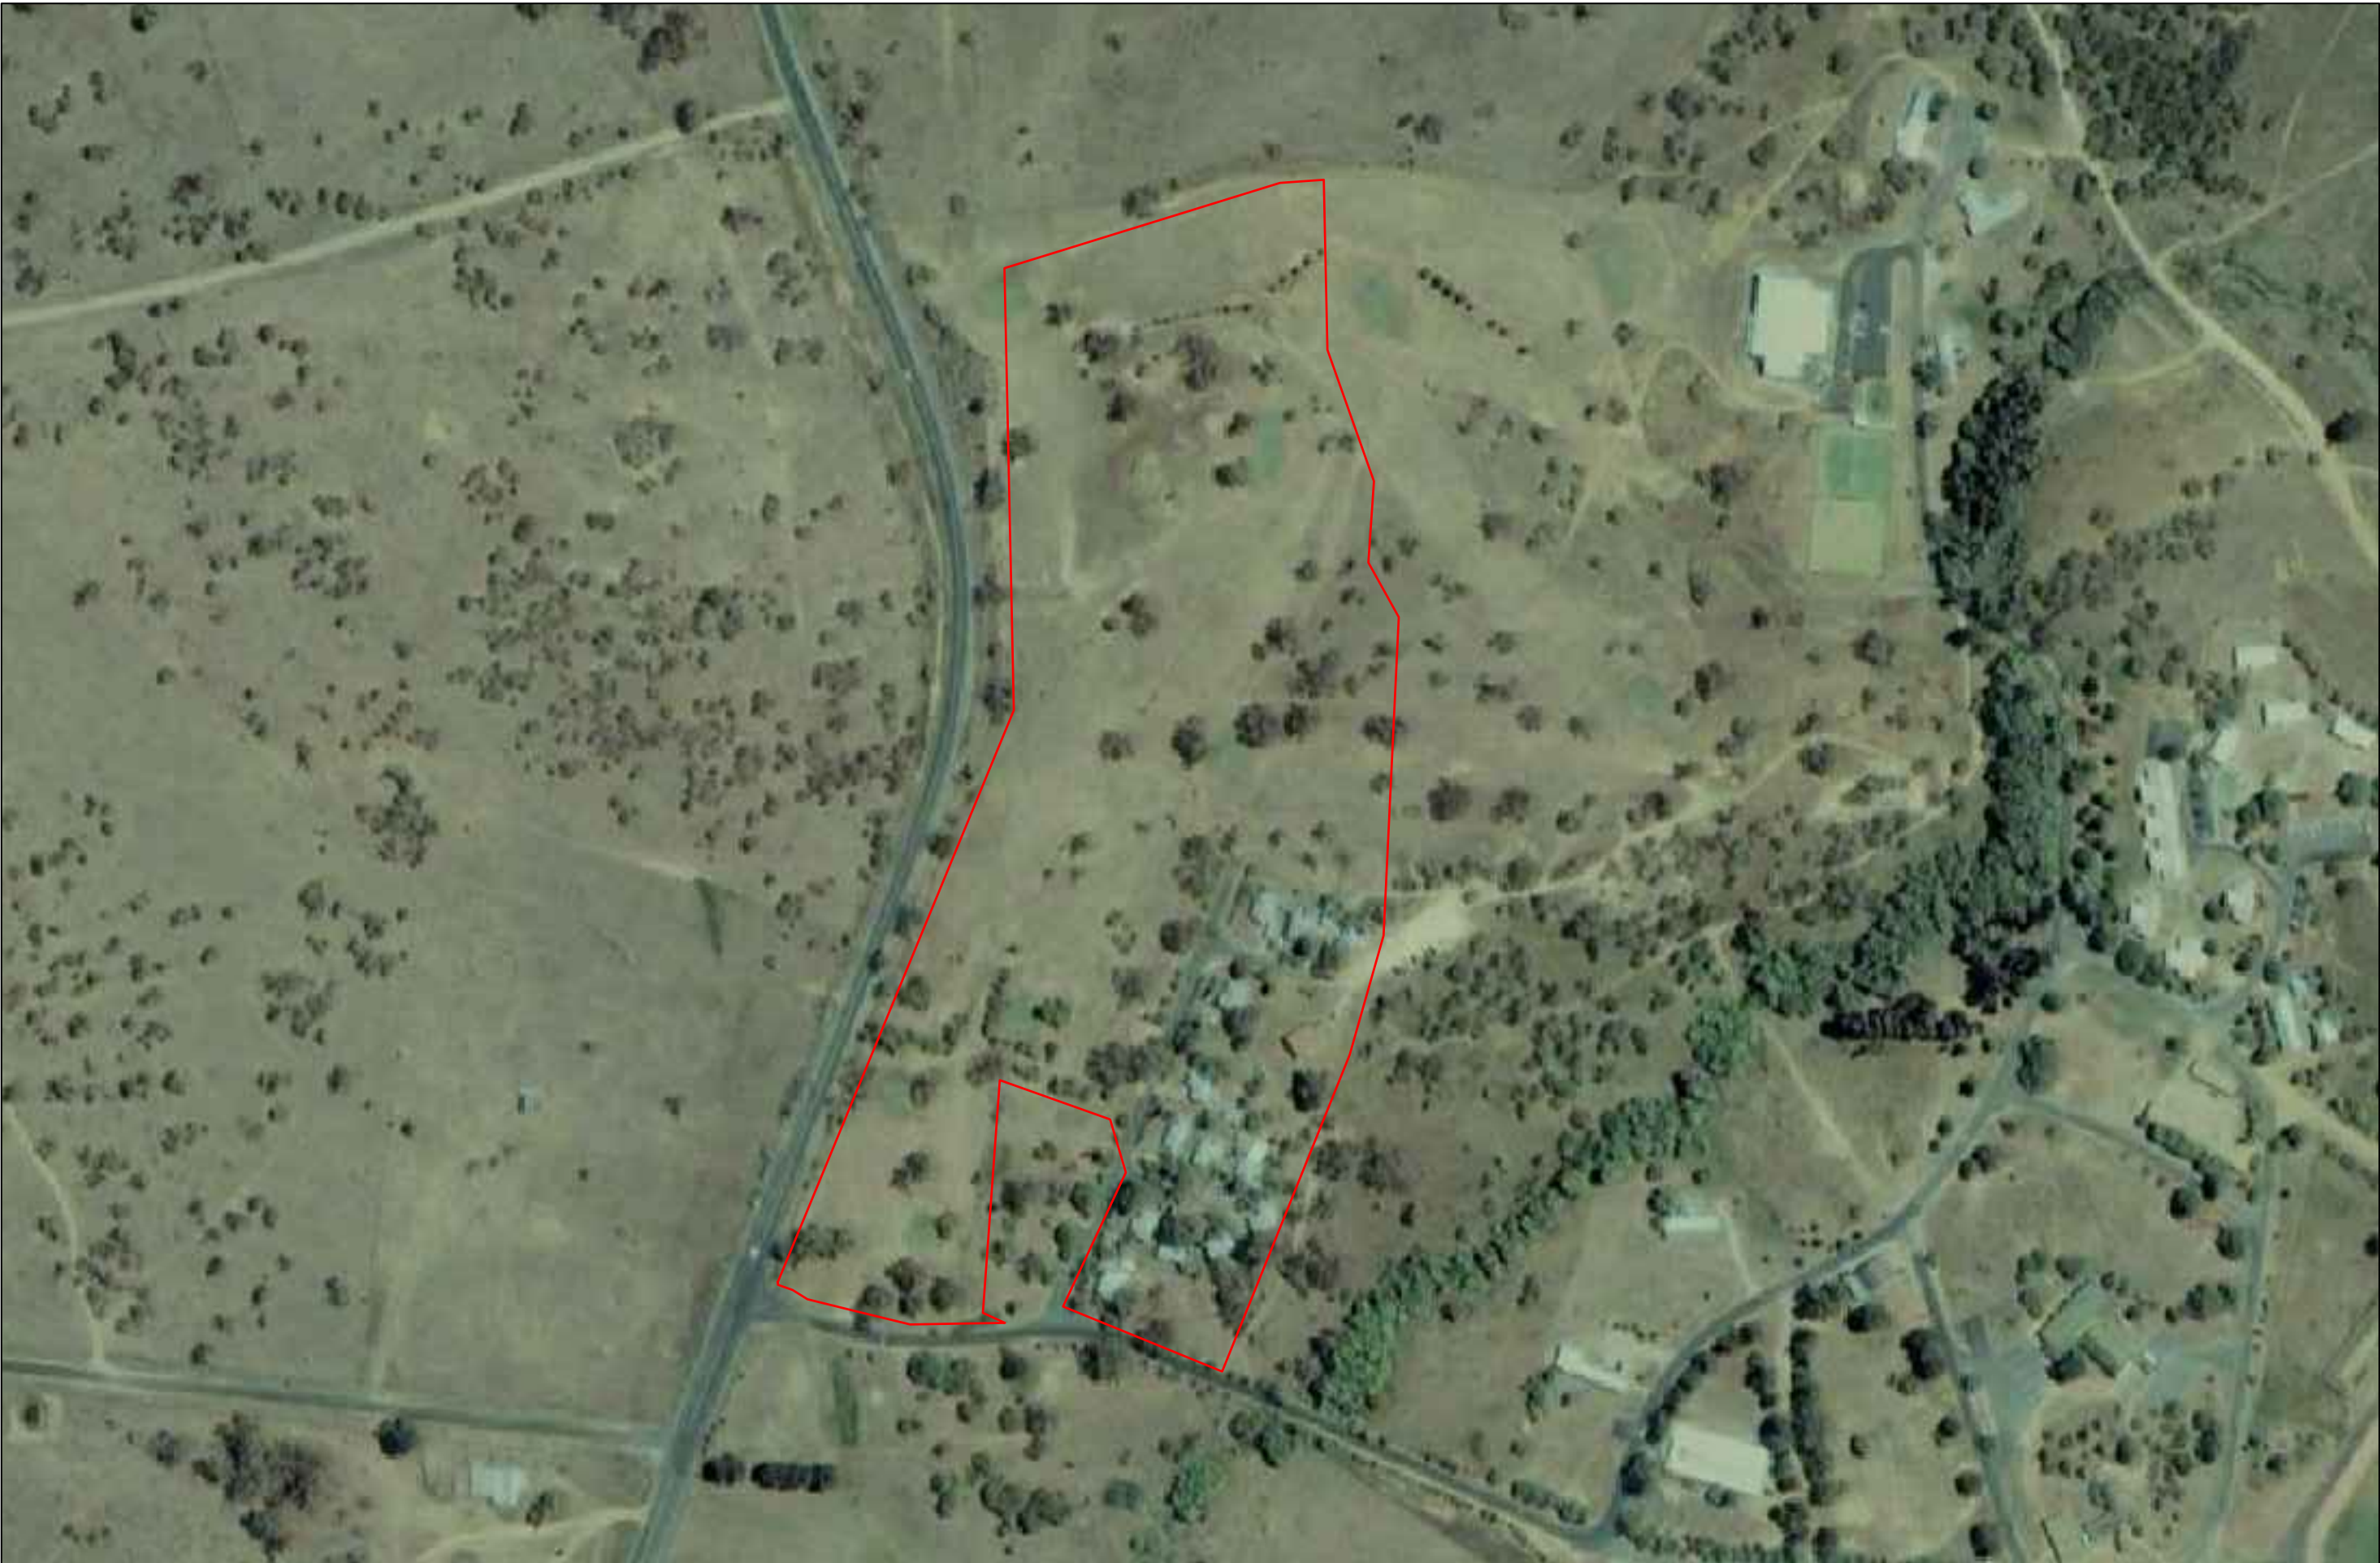
PROJECT No: 103109.03
	OFFICE: Canberra	DRAWN BY: SDG			PLATE No: D5
	SCALE: NTS	DATE: 29.11.2021			REVISION: 4

<b>Douglas Partners</b> <i>Geotechnics   Environment   Groundwater</i>	CLIENT: School Infrastructure NSW (SINSW)		TITLE: <b>Aerial Photograph 2003</b> <b>Proposed Jindabyne Central School</b> <b>Part Lot 101 DP1019527, Jindabyne</b>

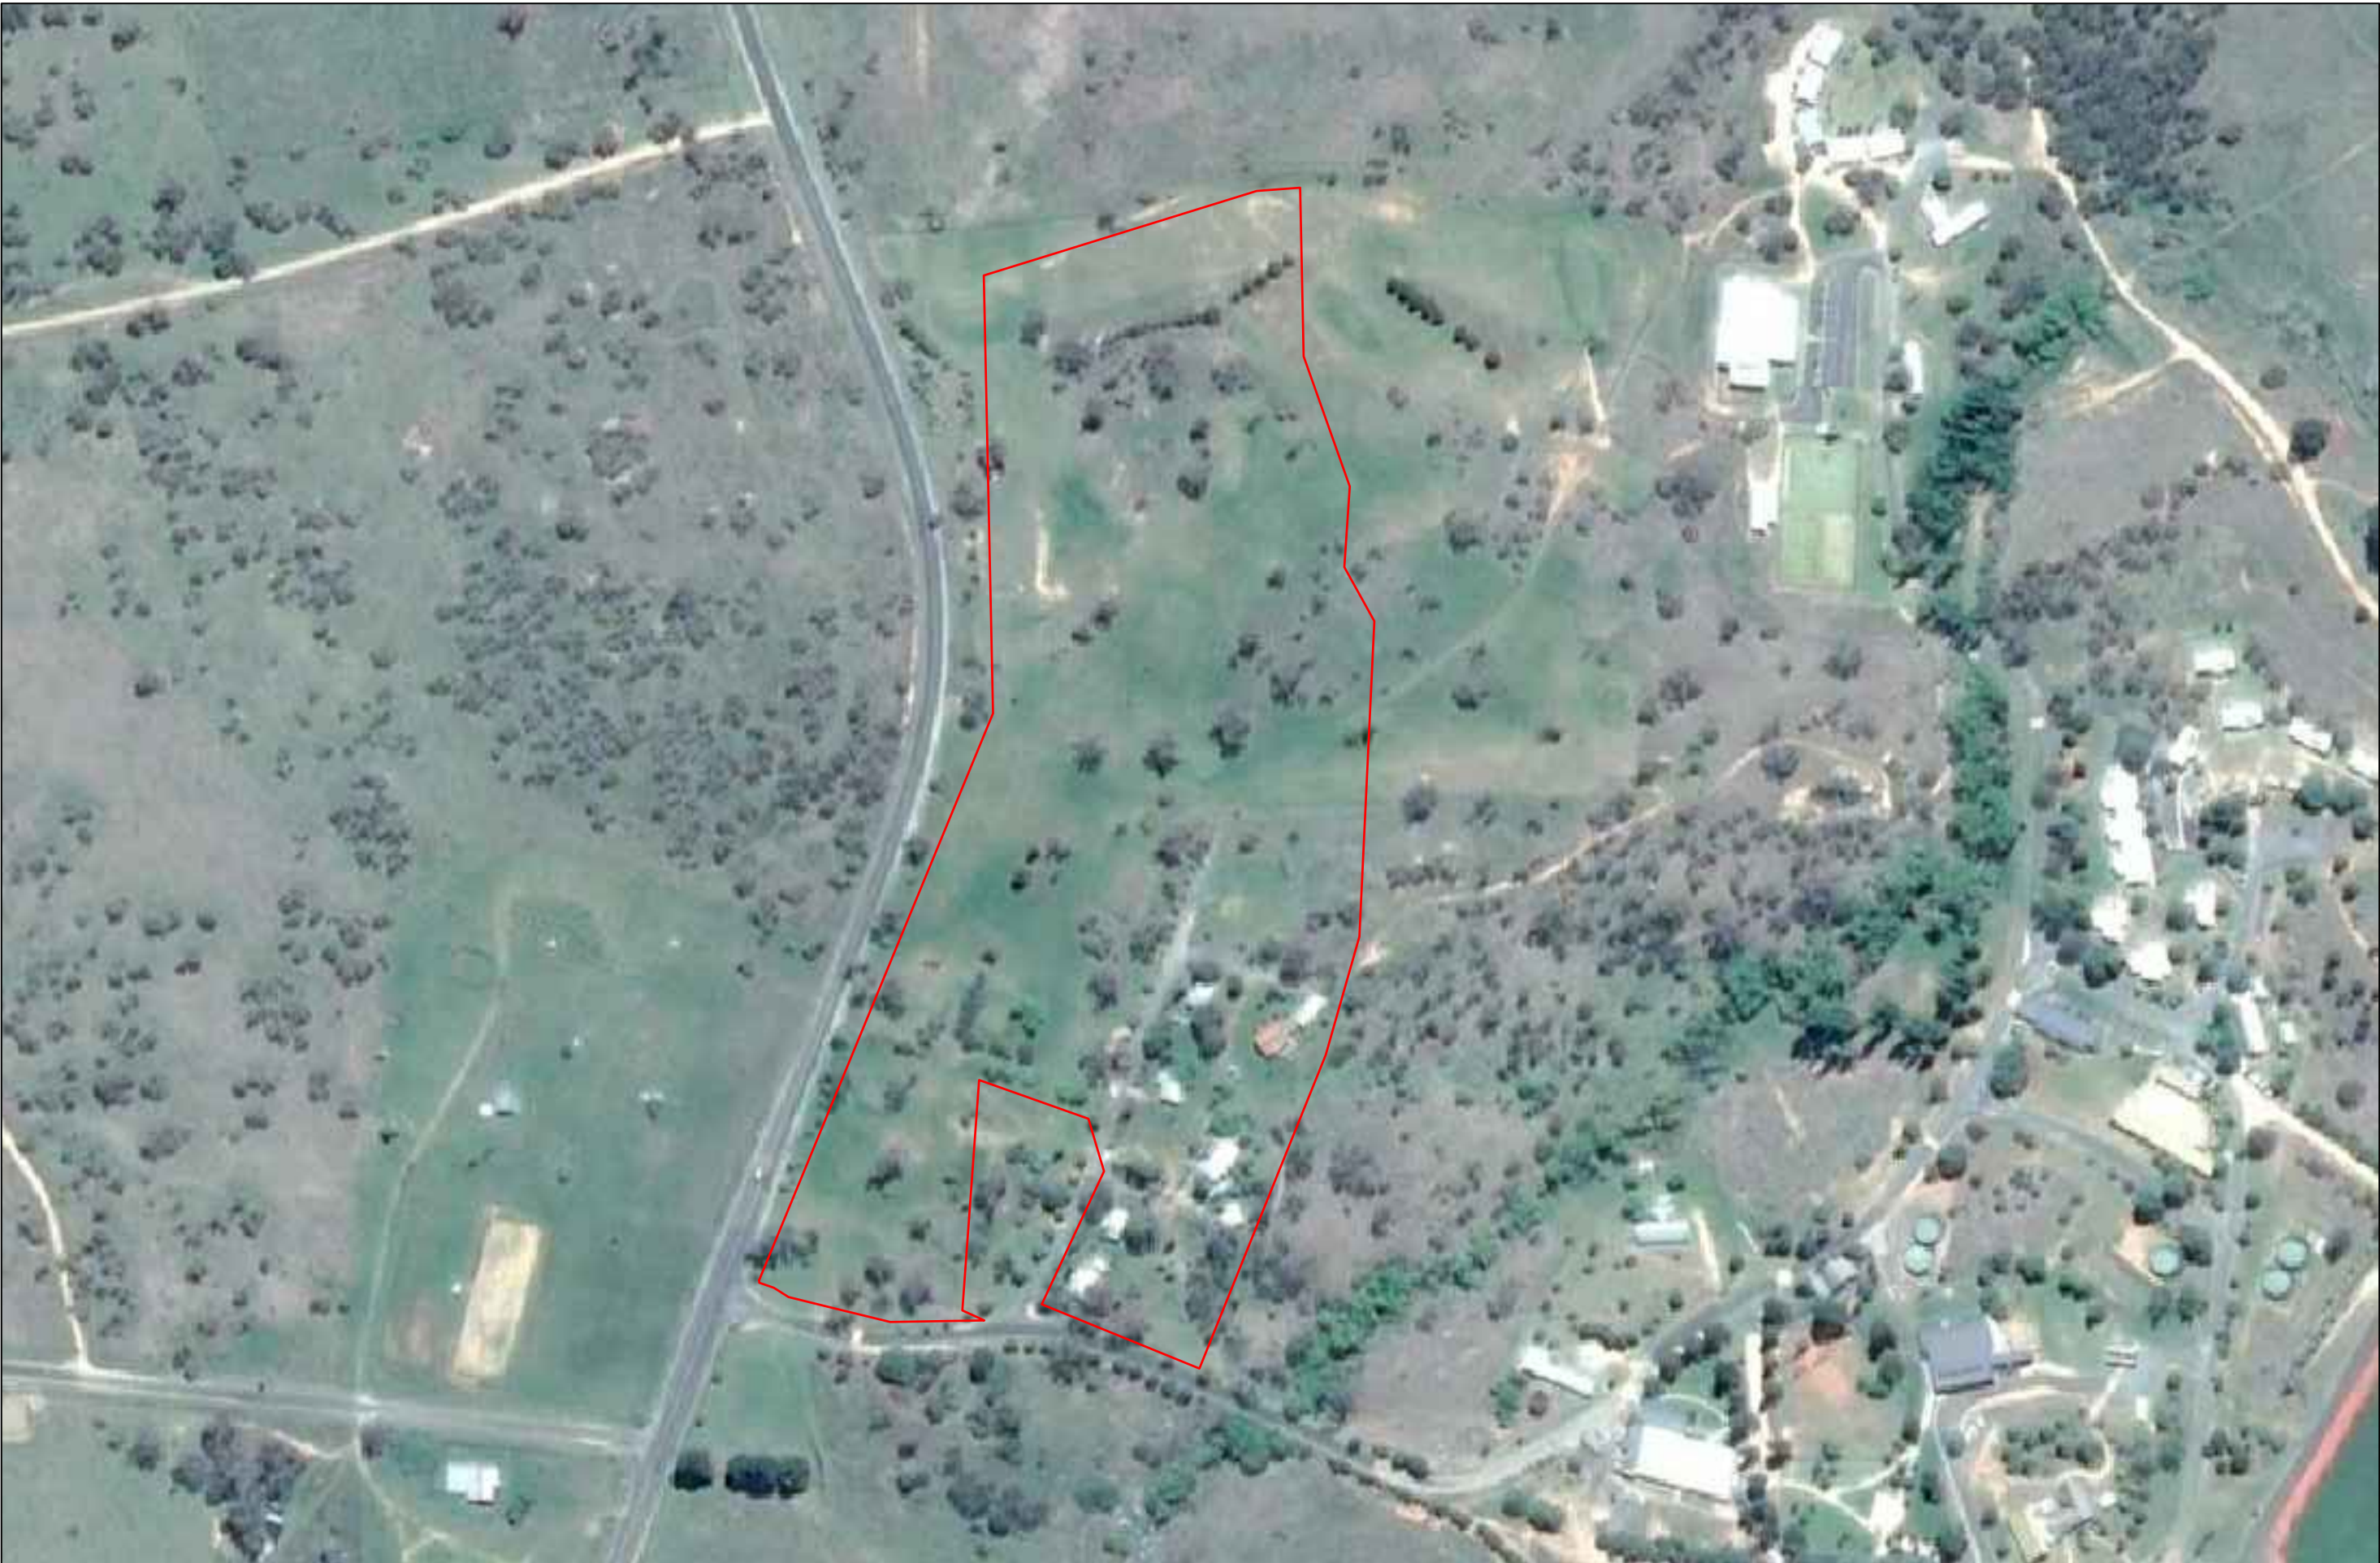
PROJECT No: 103109.03
	OFFICE: Canberra	DRAWN BY: SDG			PLATE No: D6
	SCALE: NTS	DATE: 29.11.2021			REVISION: 4

<b>Douglas Partners</b> Geotechnics   Environment   Groundwater	CLIENT: School Infrastructure NSW (SINSW)		TITLE: <b>Aerial Photograph 2013</b> <b>Proposed Jindabyne Central School</b> <b>Part Lot 101 DP1019527, Jindabyne</b>

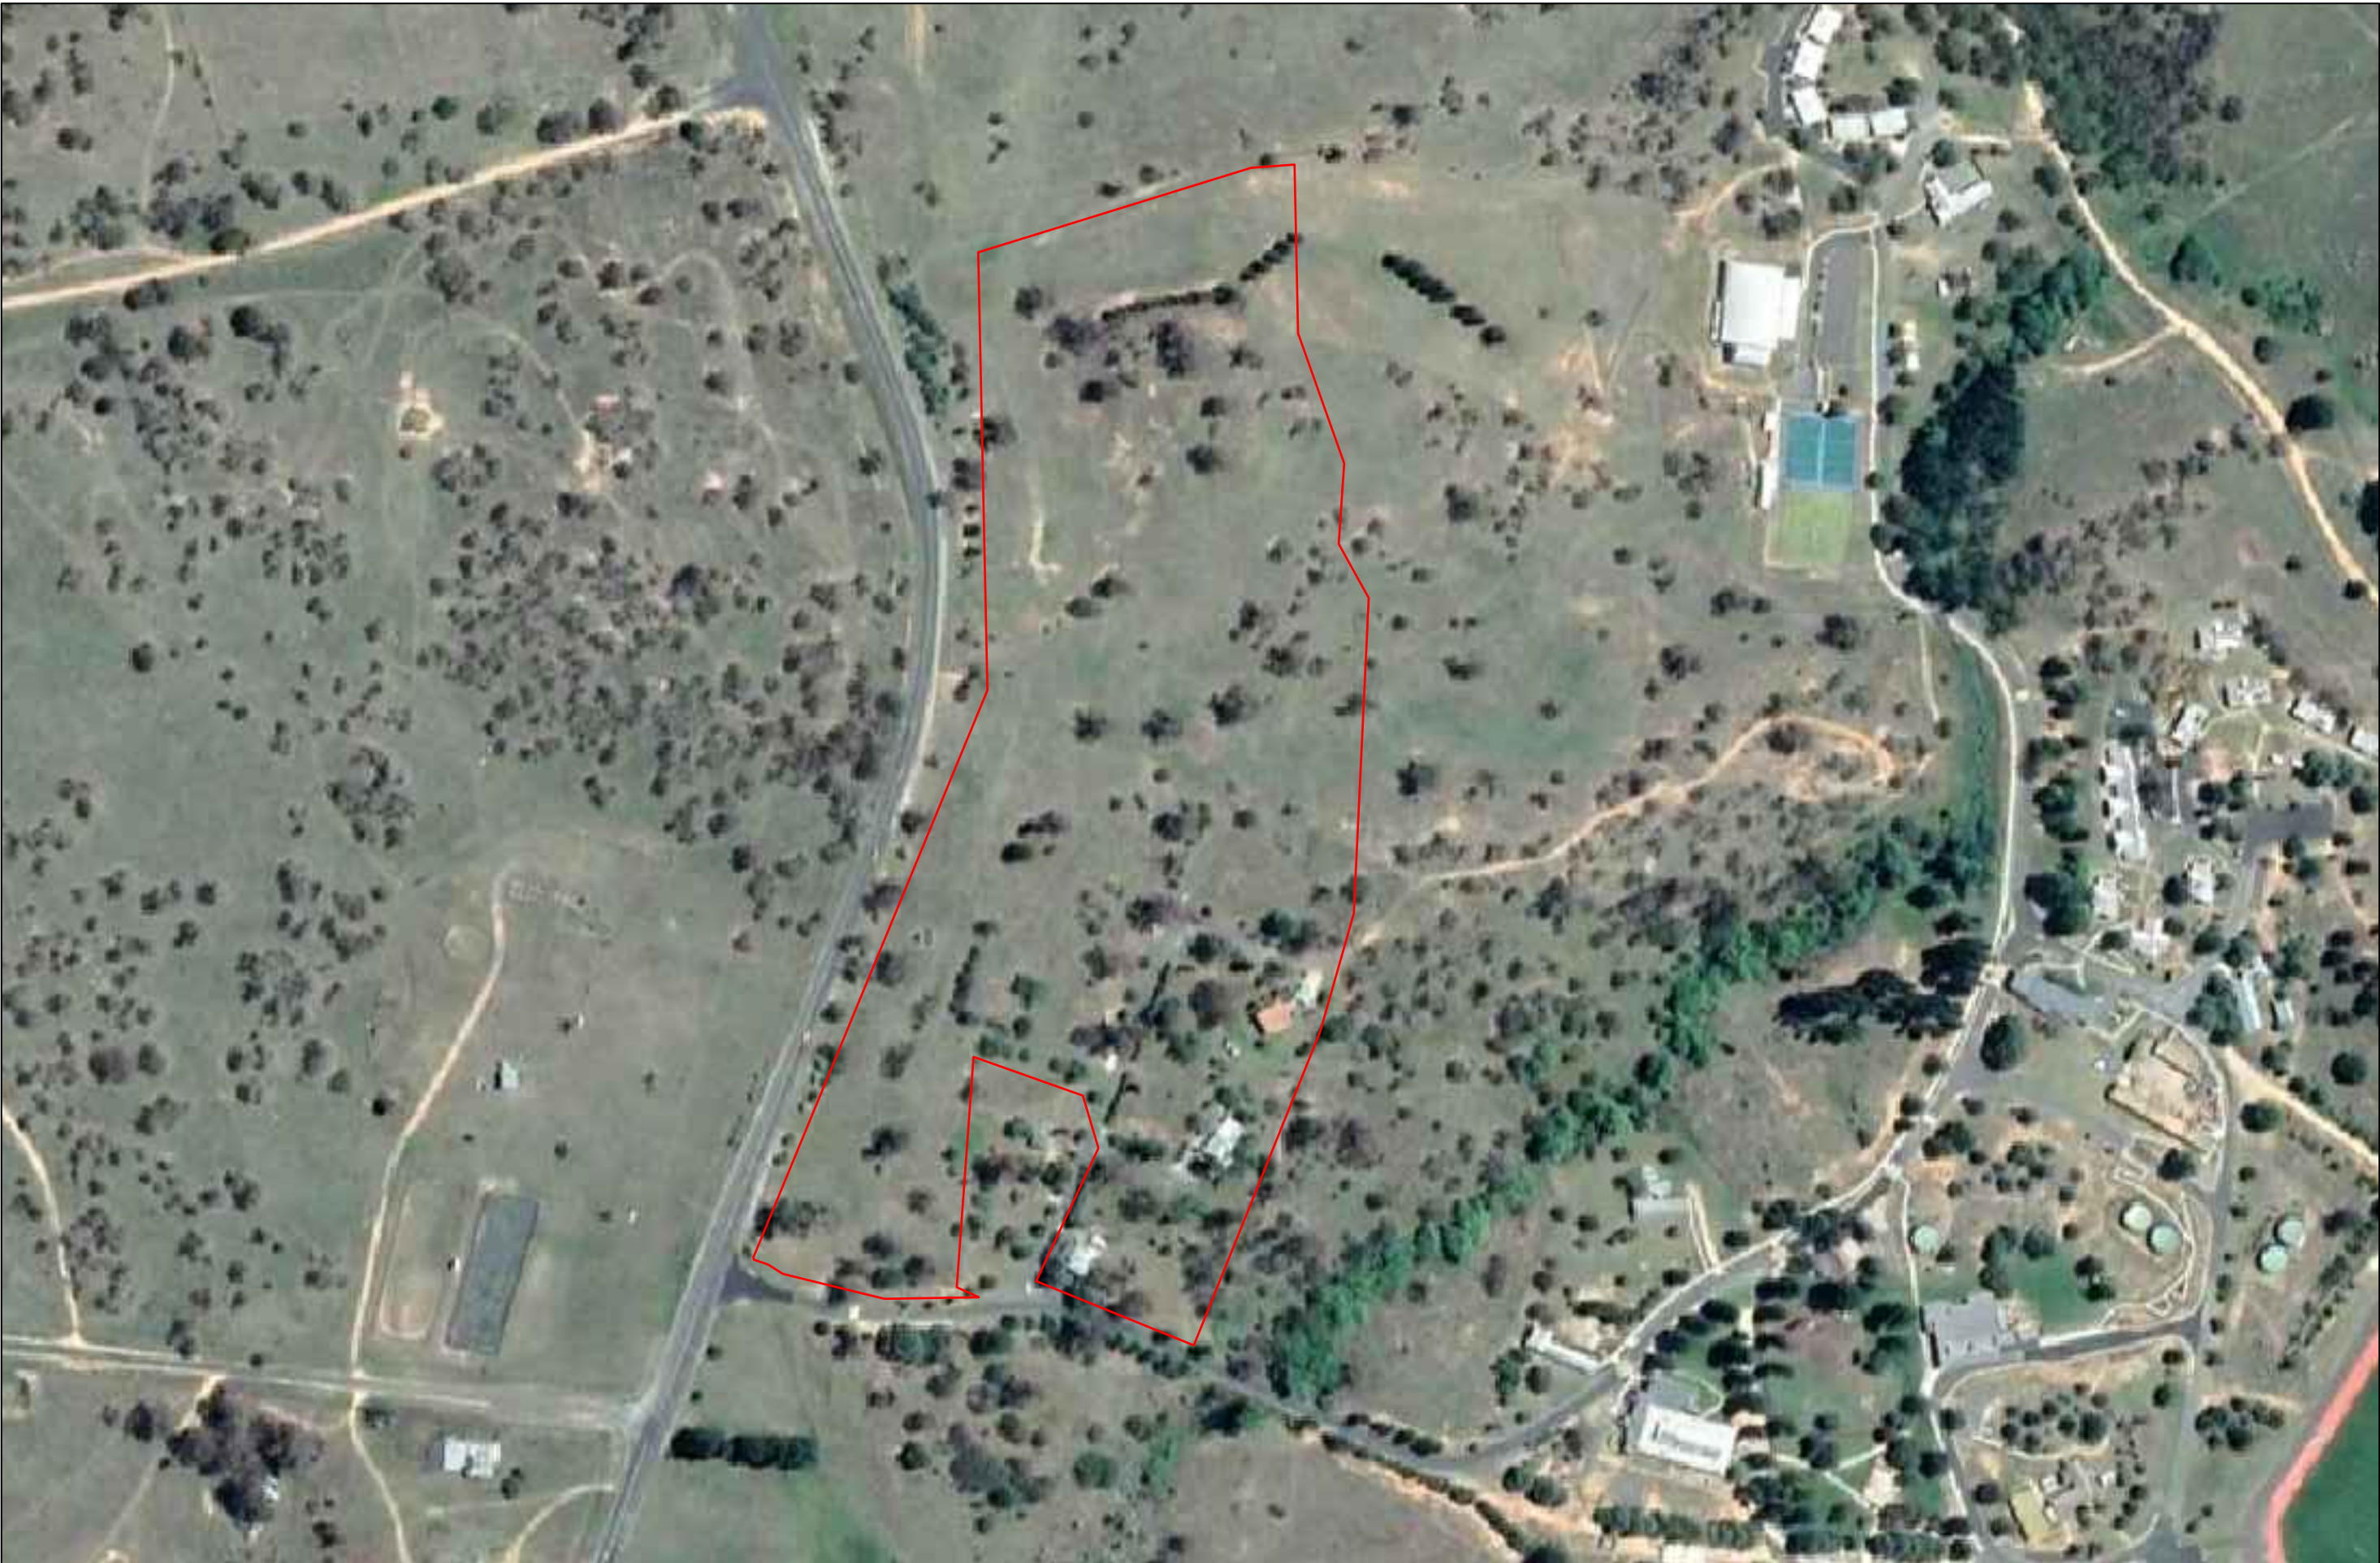
PROJECT No: 103109.03
	OFFICE: Canberra	DRAWN BY: SDG			PLATE No: D7
	SCALE: NTS	DATE: 29.11.2021			REVISION: 4

<b>Douglas Partners</b> Geotechnics   Environment   Groundwater	CLIENT: School Infrastructure NSW (SINSW)		TITLE: <b>Aerial Photograph 2018</b> <b>Proposed Jindabyne Central School</b> <b>Part Lot 101 DP1019527, Jindabyne</b>

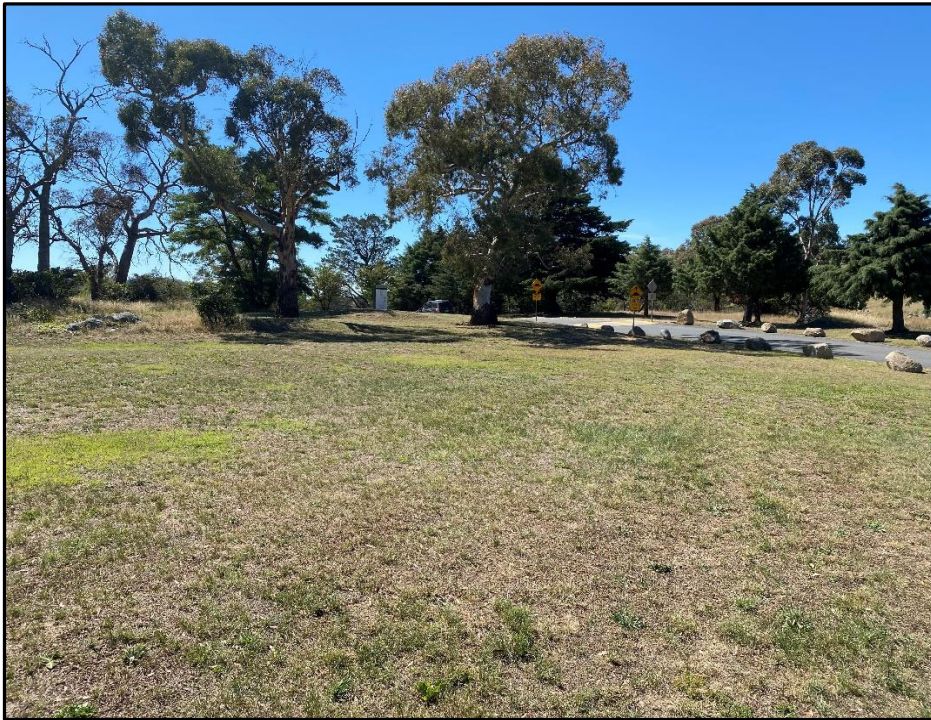
**Photo 1: General view of the southern portion of the site, looking east**

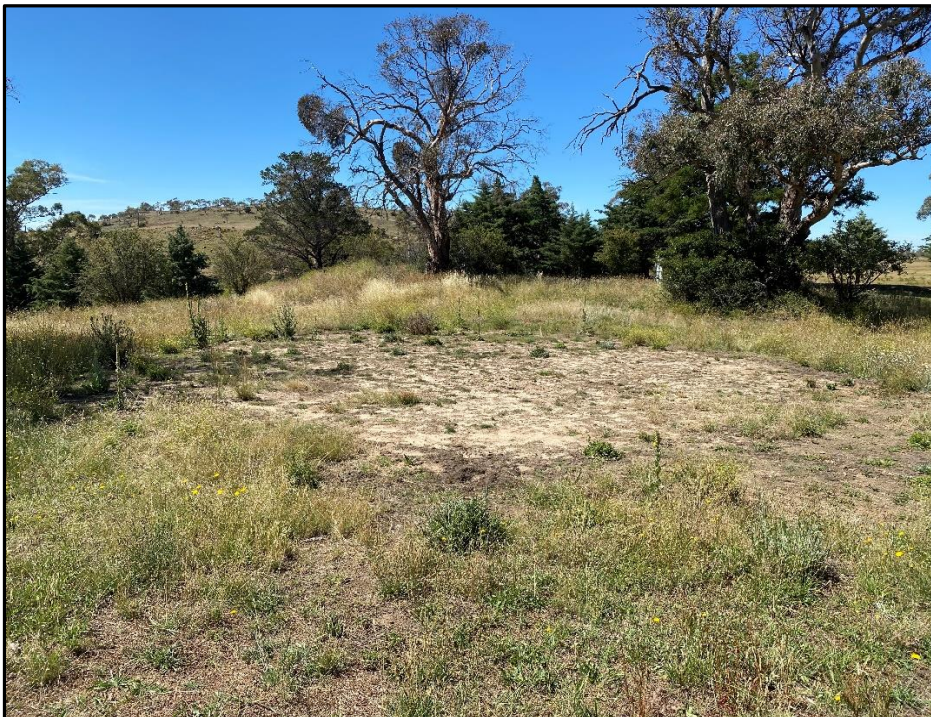
- Five small areas of sand and remnant topsoil were noted across the site. It is likely that they were once greens from the previous golf course;
- A potential fill pad or potential site cut was noted south of the storage shed, along the eastern portion of the site;

**Photo 2: View of a former golf green, looking west**

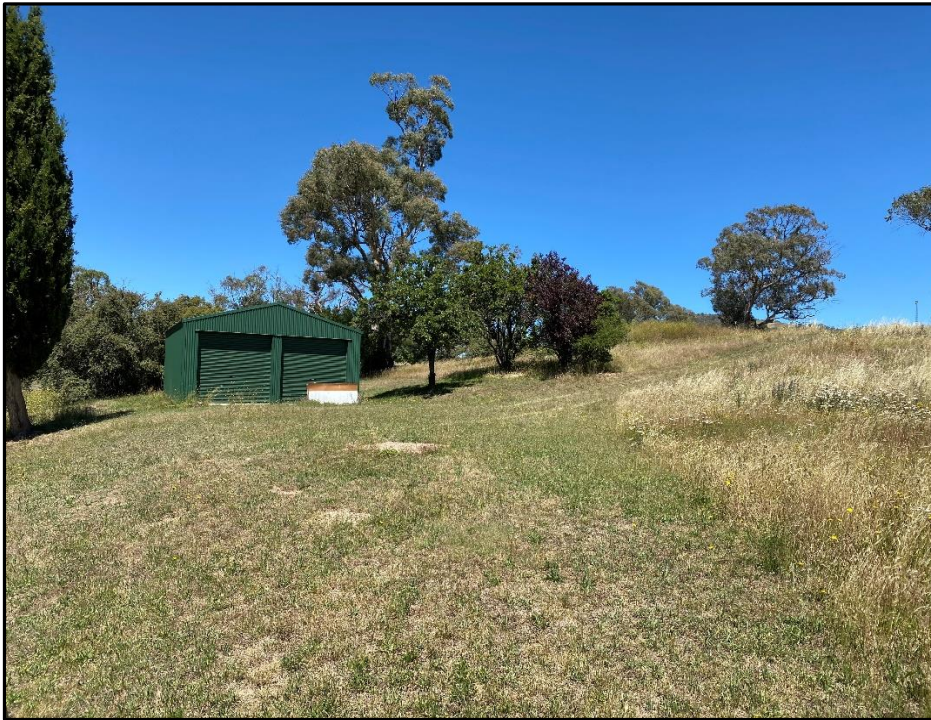
**Photo 3: View of the site's only structure and a potential fill pad, looking south**

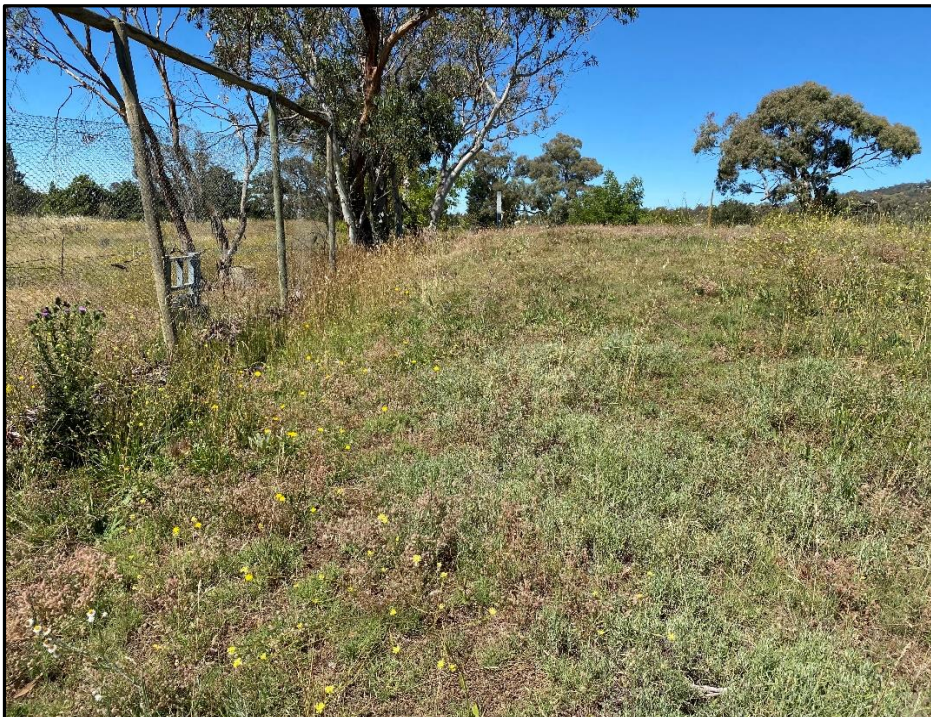
- Five fill pads were noted across the site. The fill pads appeared to be remnant tee-off points and greens from the former golf course;
- Potential surface fill was noted across the central eastern portion of the site;

**Photo 4: View of a former tee-off area/fill pad located at Pit 24**

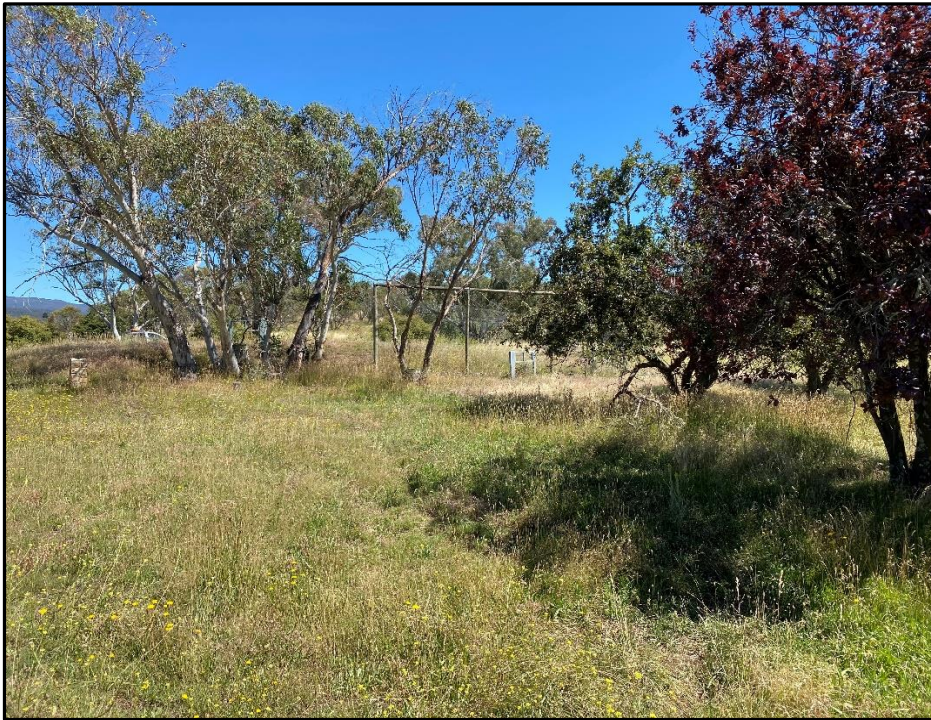
**Photo 5: View of the south central portion of the site and tee-off area, looking west**

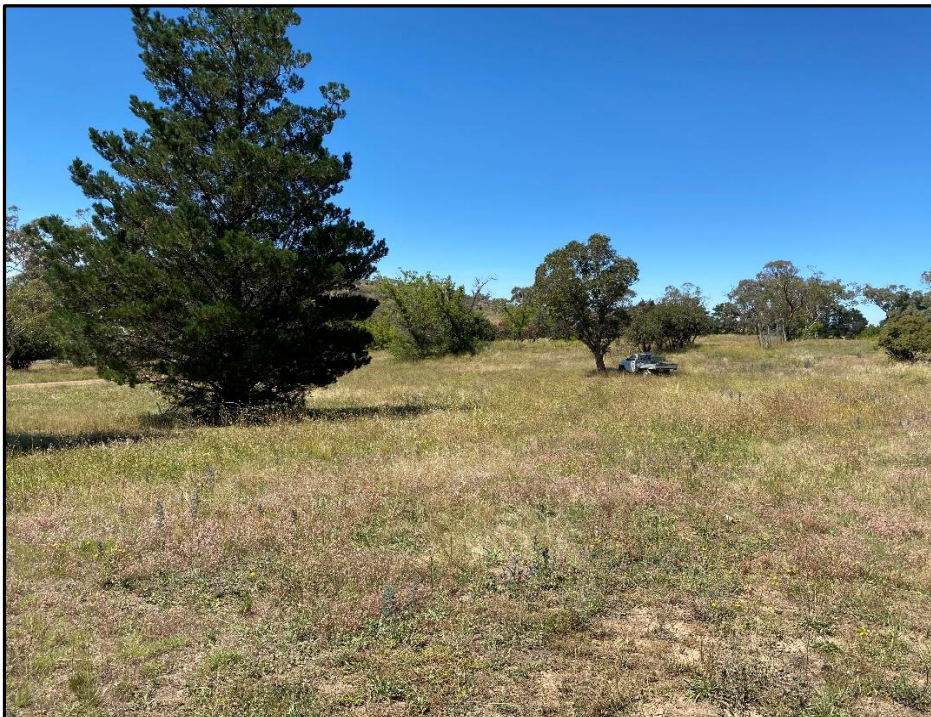
**Photo 6: General view of the central portion of the site, looking south-east**

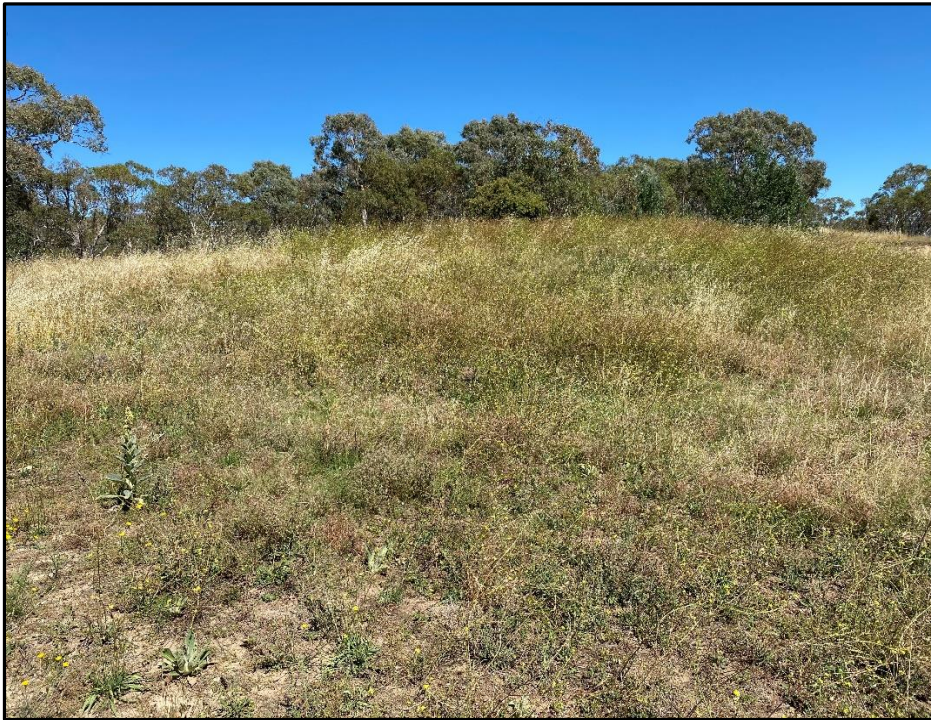
**Photo 7: View of an area of fill located along the central western boundary of the site**

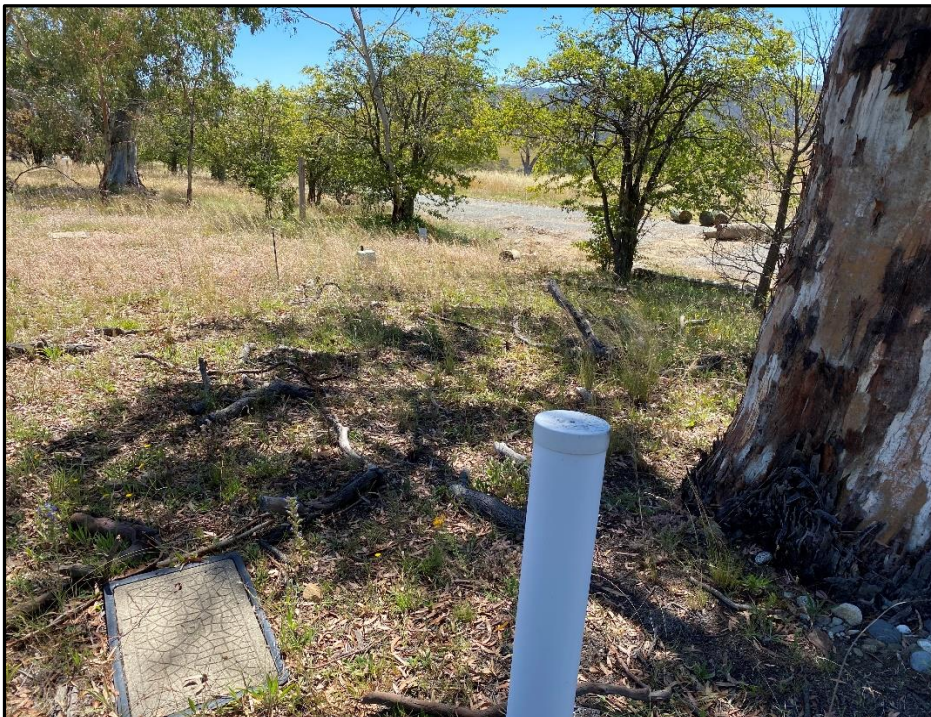
- Services were noted across the site including water and irrigation services and communication services. The service trenches have the potential to contain uncontrolled/undocumented fill;

**Photo 8: View of on-site services, possibly associated with former dwellings**

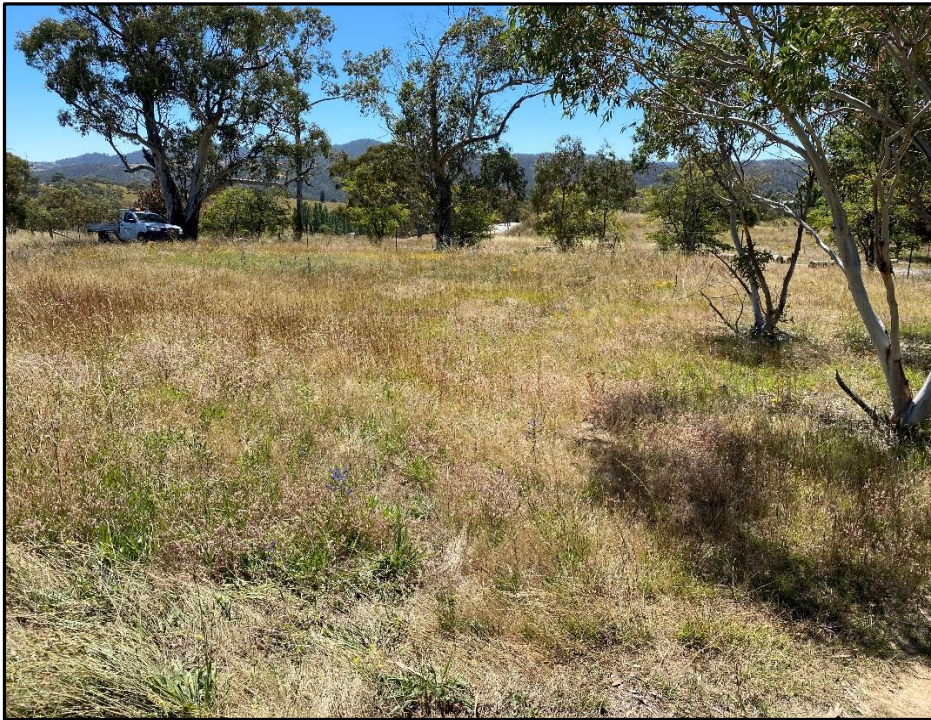
**Photo 9: General view of the eastern portion of the site, looking east**

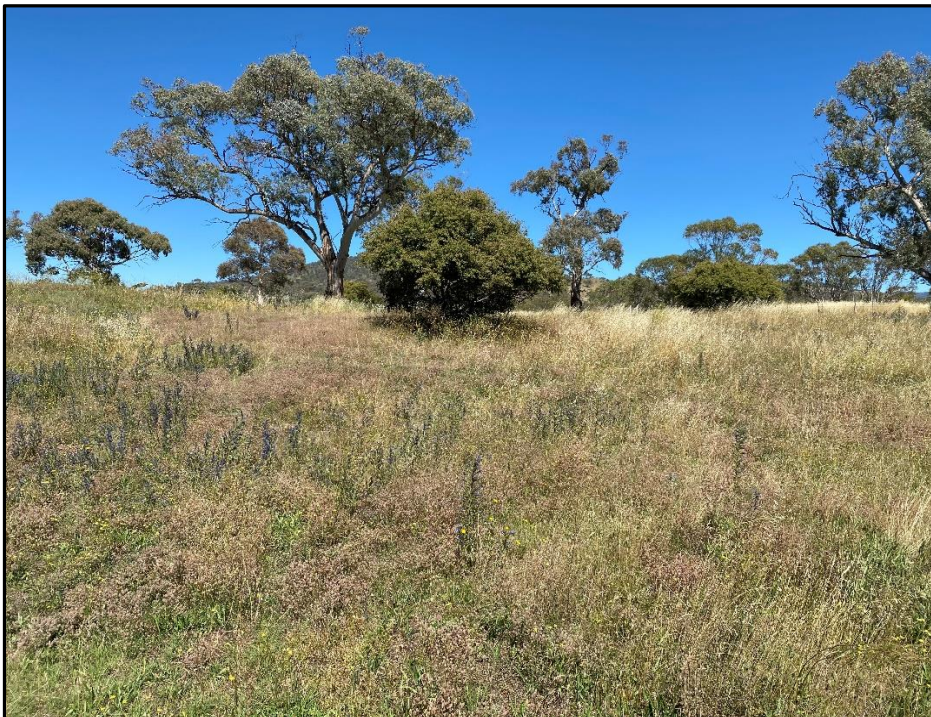
**Photo 10: General view of the central portion of the site, looking south-west**

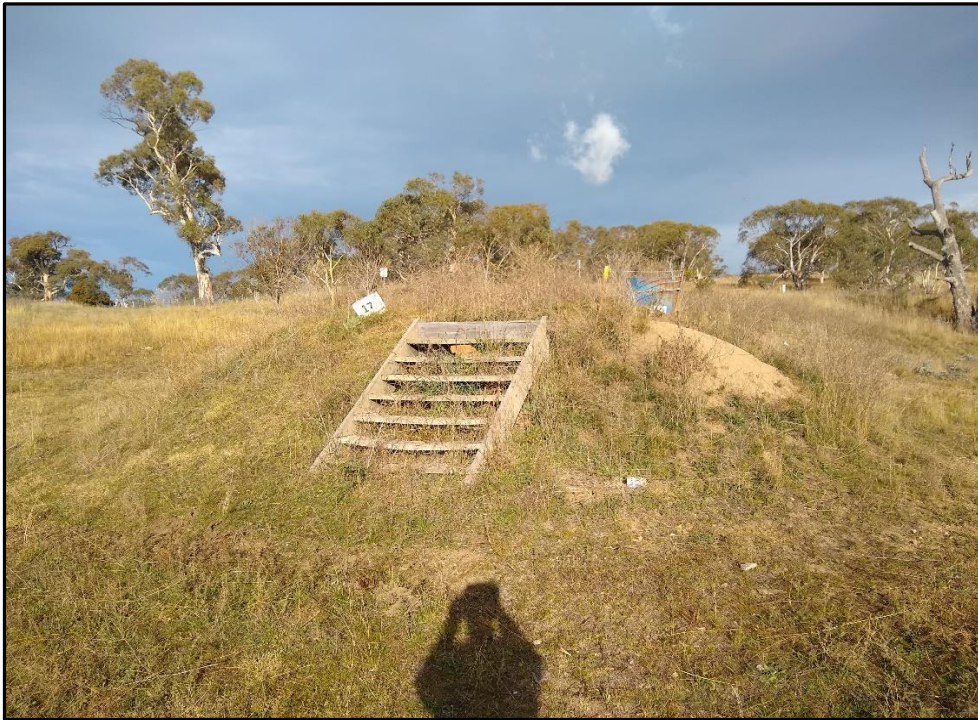
**Photo 11: View of a former tee-off area/fill pad located at Pit 16**

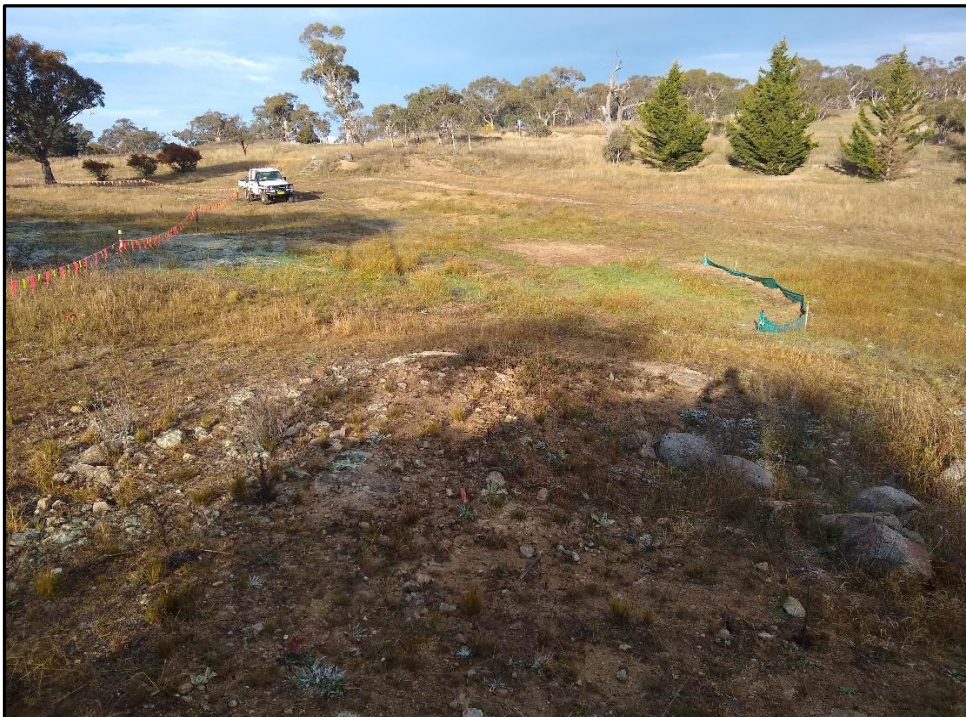
Perched groundwater was observed in Pit 20 at 2.2 m depth. No free groundwater was observed during the site investigation in all other test pits.

**Photo 12: View of fill area, located to the left of the silt fence and Pit 20**

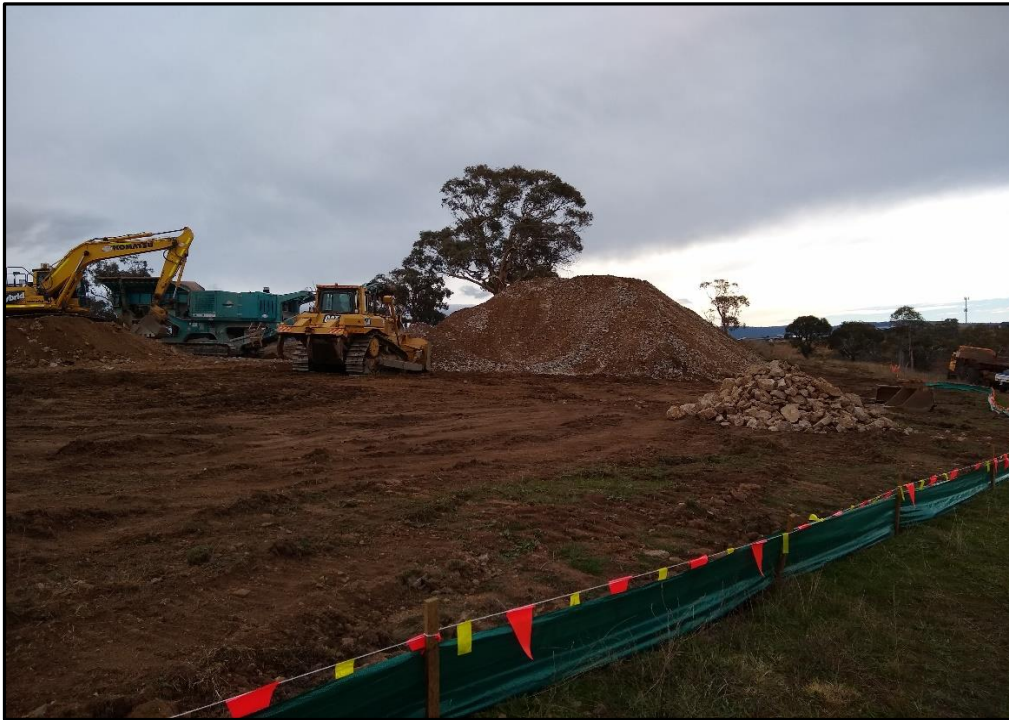
**Photo 13: View of the ski-jump construction site**

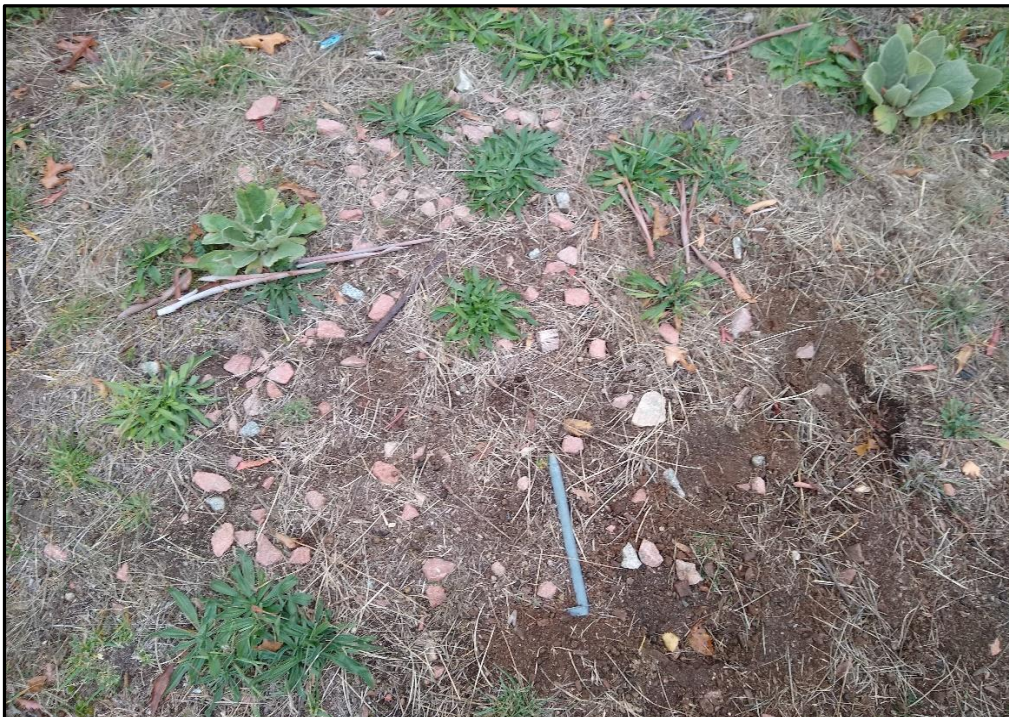
- Two potential asbestos containing material (PACM) fragments were noted during the site walkover within the south-eastern portion of the site. It is noted that DP's scope did not include a hazardous building materials assessment.

**Photo 14: View of brick fragments and PACM within the south-east portion of the site**

Potential asbestos containing materials were observed in fill at Pits 25 (collected as M1) and 26 (collected as M4) and on the surface in the south-eastern portion of the site (collected as M2 and M3). These locations are shown on Drawing 1, Appendix A. The material samples were submitted to the analytical laboratory for asbestos identification in materials in order to confirm the presence or absence of asbestos.

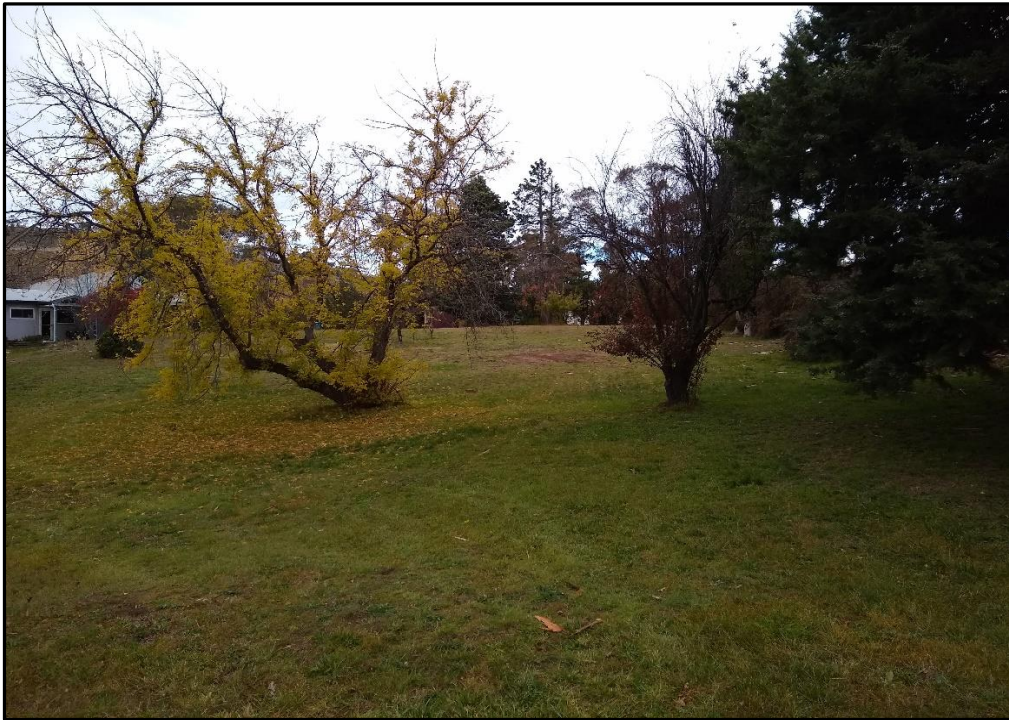
**Photo 15: View of the south-east portion of the site, looking south**

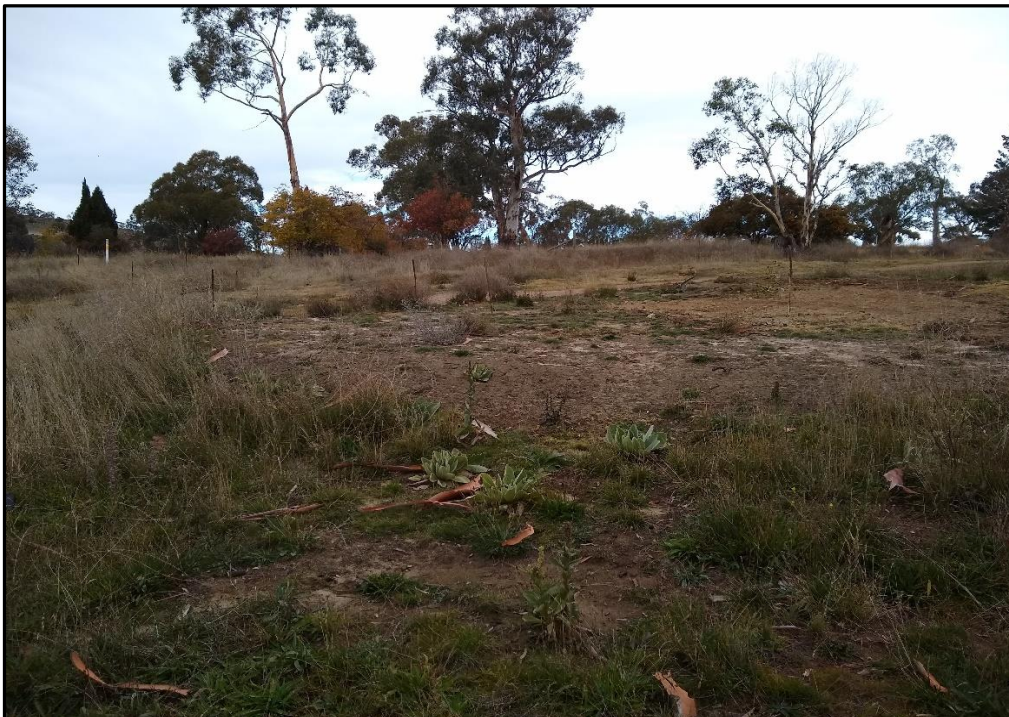
**Photo 16: View of a previous golf green, located at Pit 12**
