Report on
Targeted Detailed Site Investigation (Contamination)

Proposed Jindabyne Central School
Part of Lot 101 DP 1019725, Jindabyne

Project 103109.04
December 2021

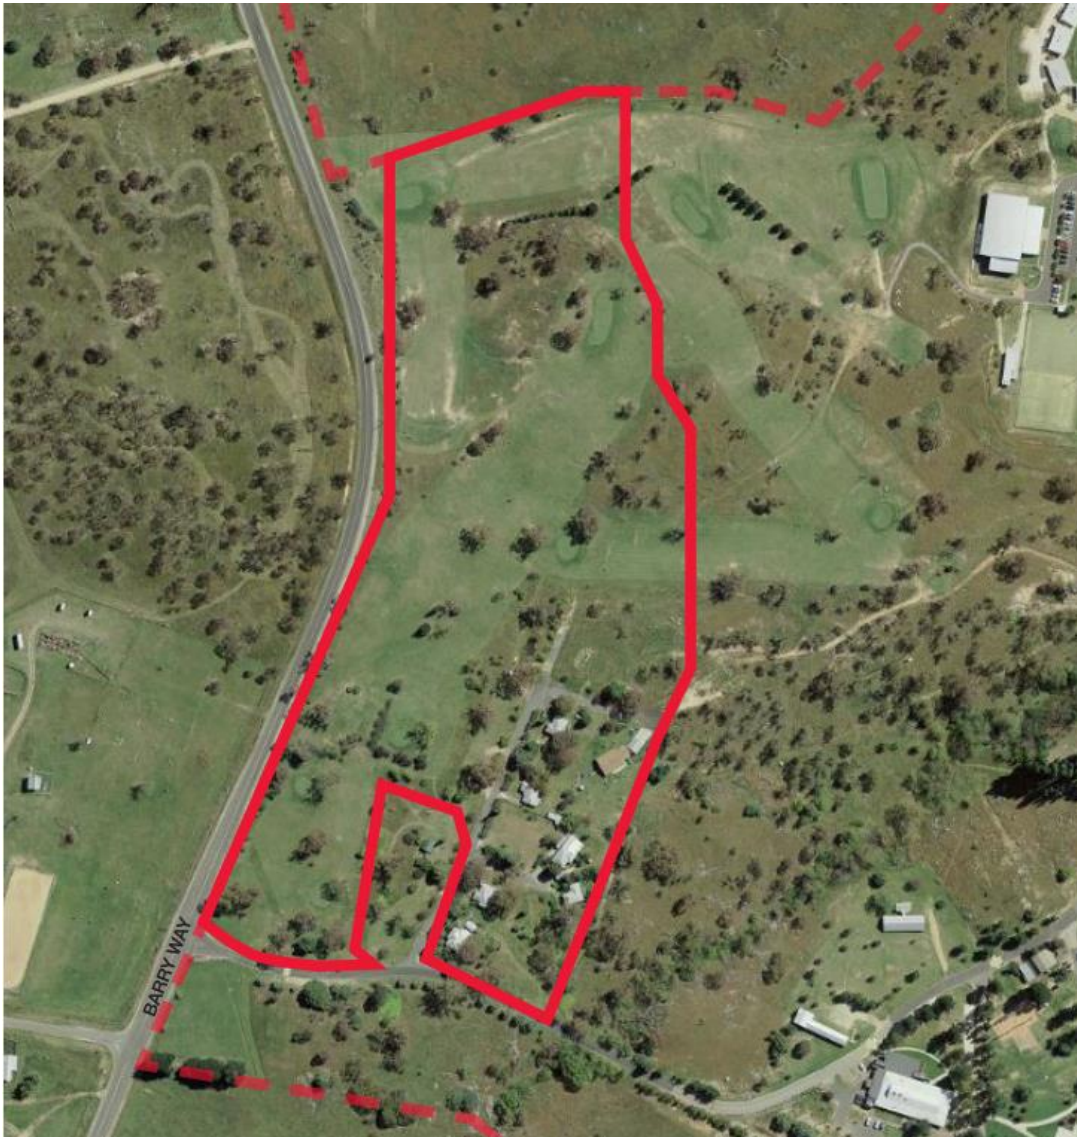
Figure 2: Site aerial – new education campus within the Jindabyne Sport and Recreation Centre.
Source: DJRD
