Report on
Remedial Action Plan

Jindabyne Central School
Part Lot 101 DP1019527, Jindabyne

Prepared for
NSW Department of Education - School Infrastructure
NSW

Project 103109.05
December 2021

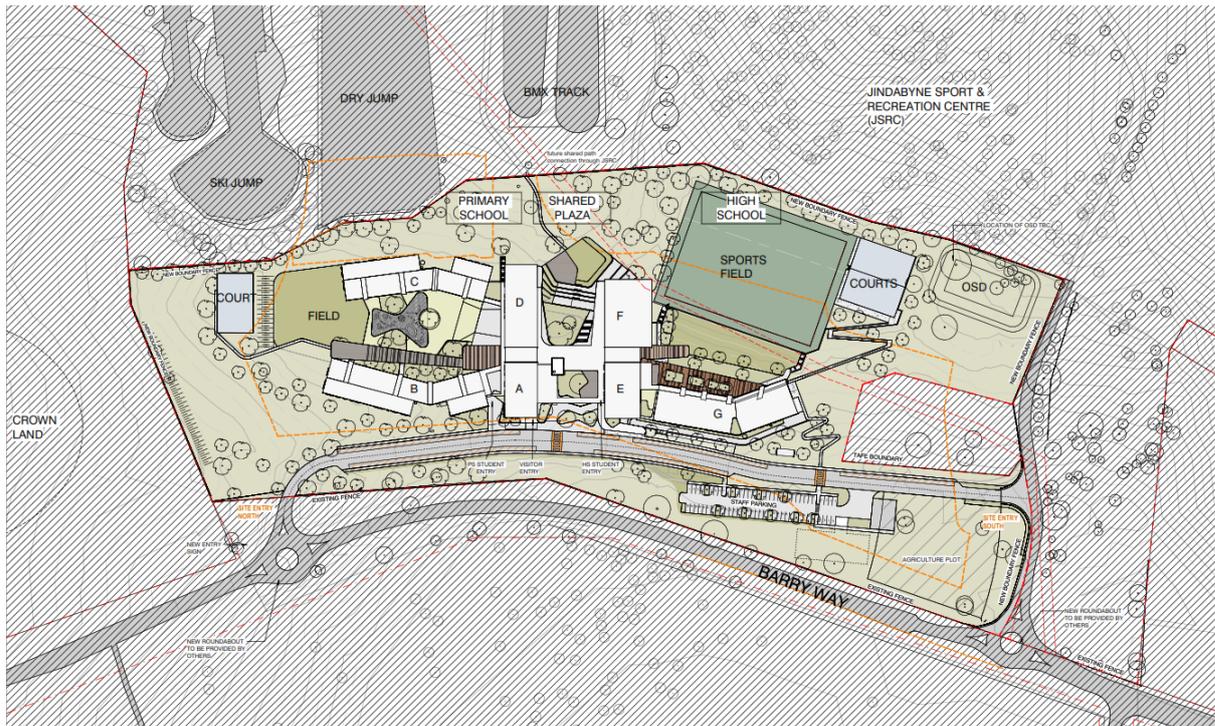
Figure 1 Proposed Site Plan
Source: DJRD

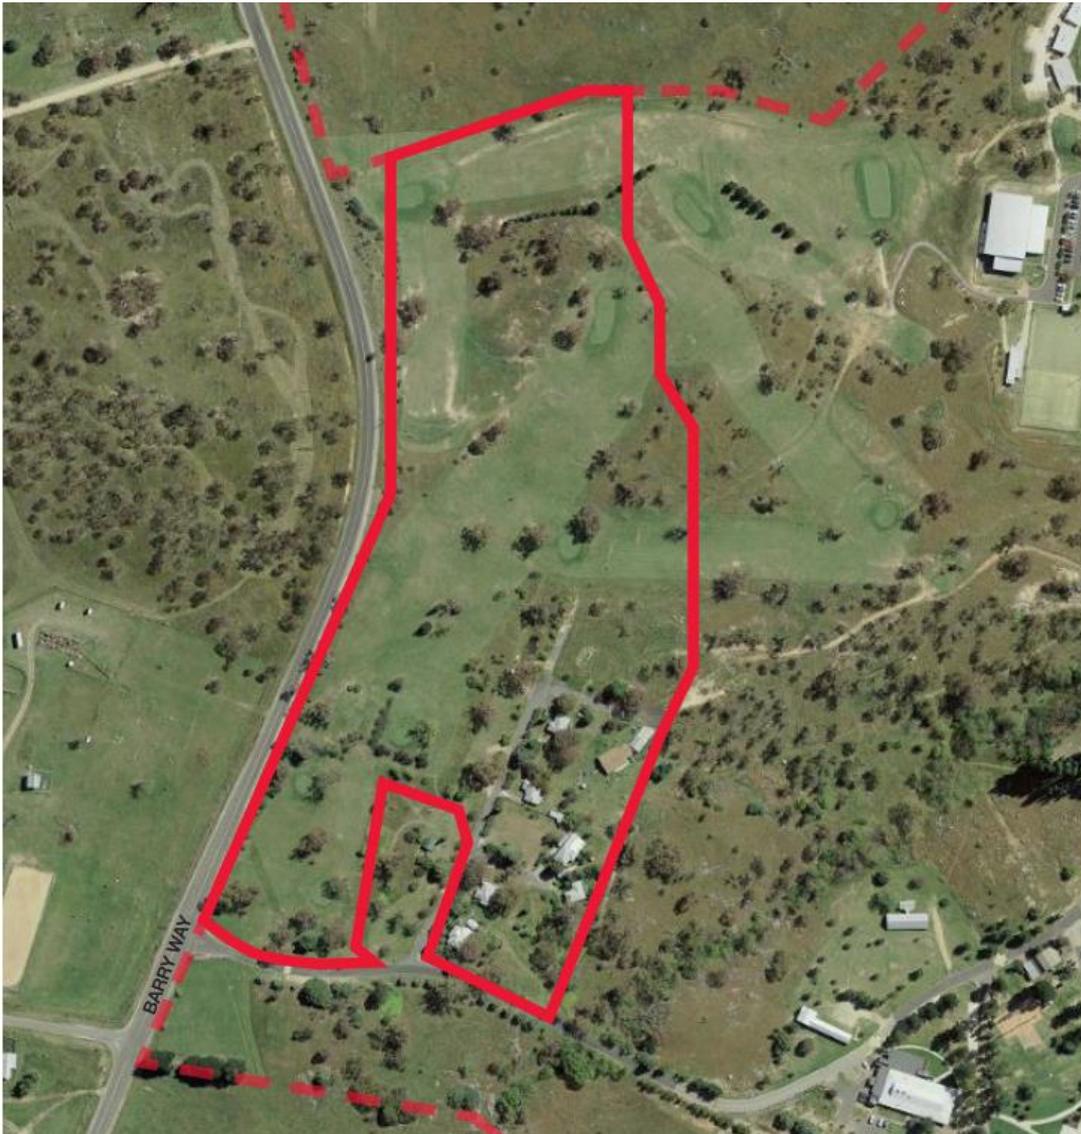
Figure 2: Site aerial - new education campus within the Jindabyne Sport and Recreation Centre.
Source: DJRD

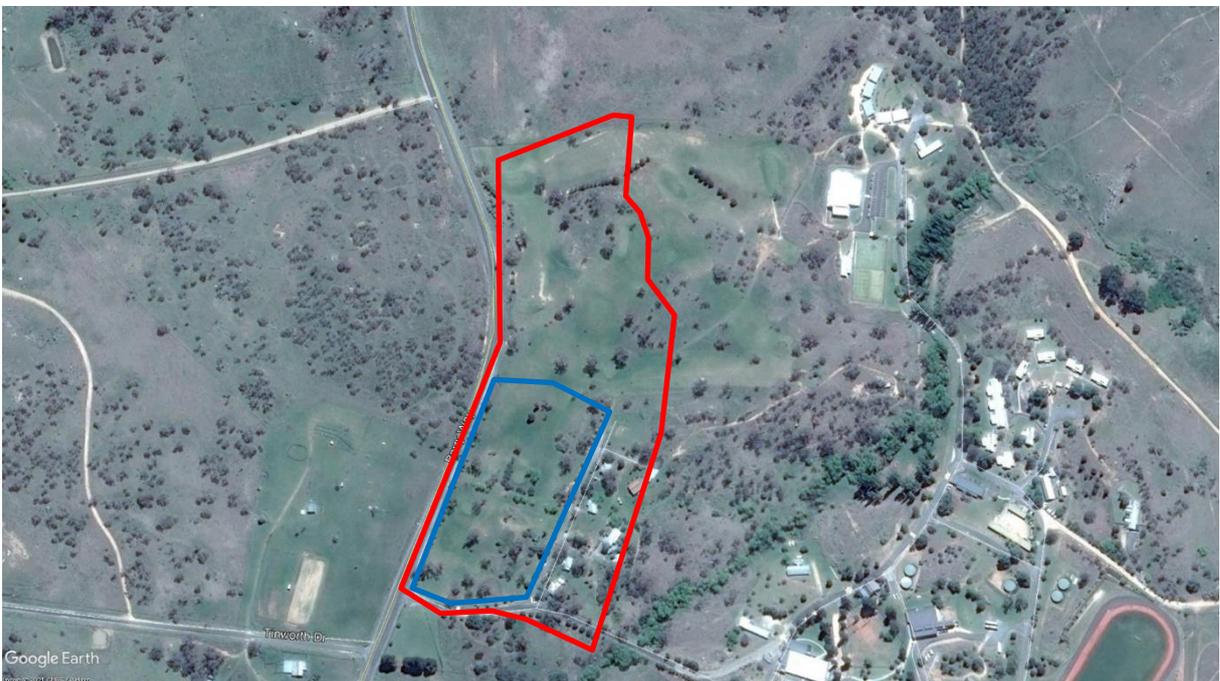
Figure 3: Previous site layouts from the desktop PSI (highlighted blue) and Limited Contamination assessment and T-DSI (highlighted red).

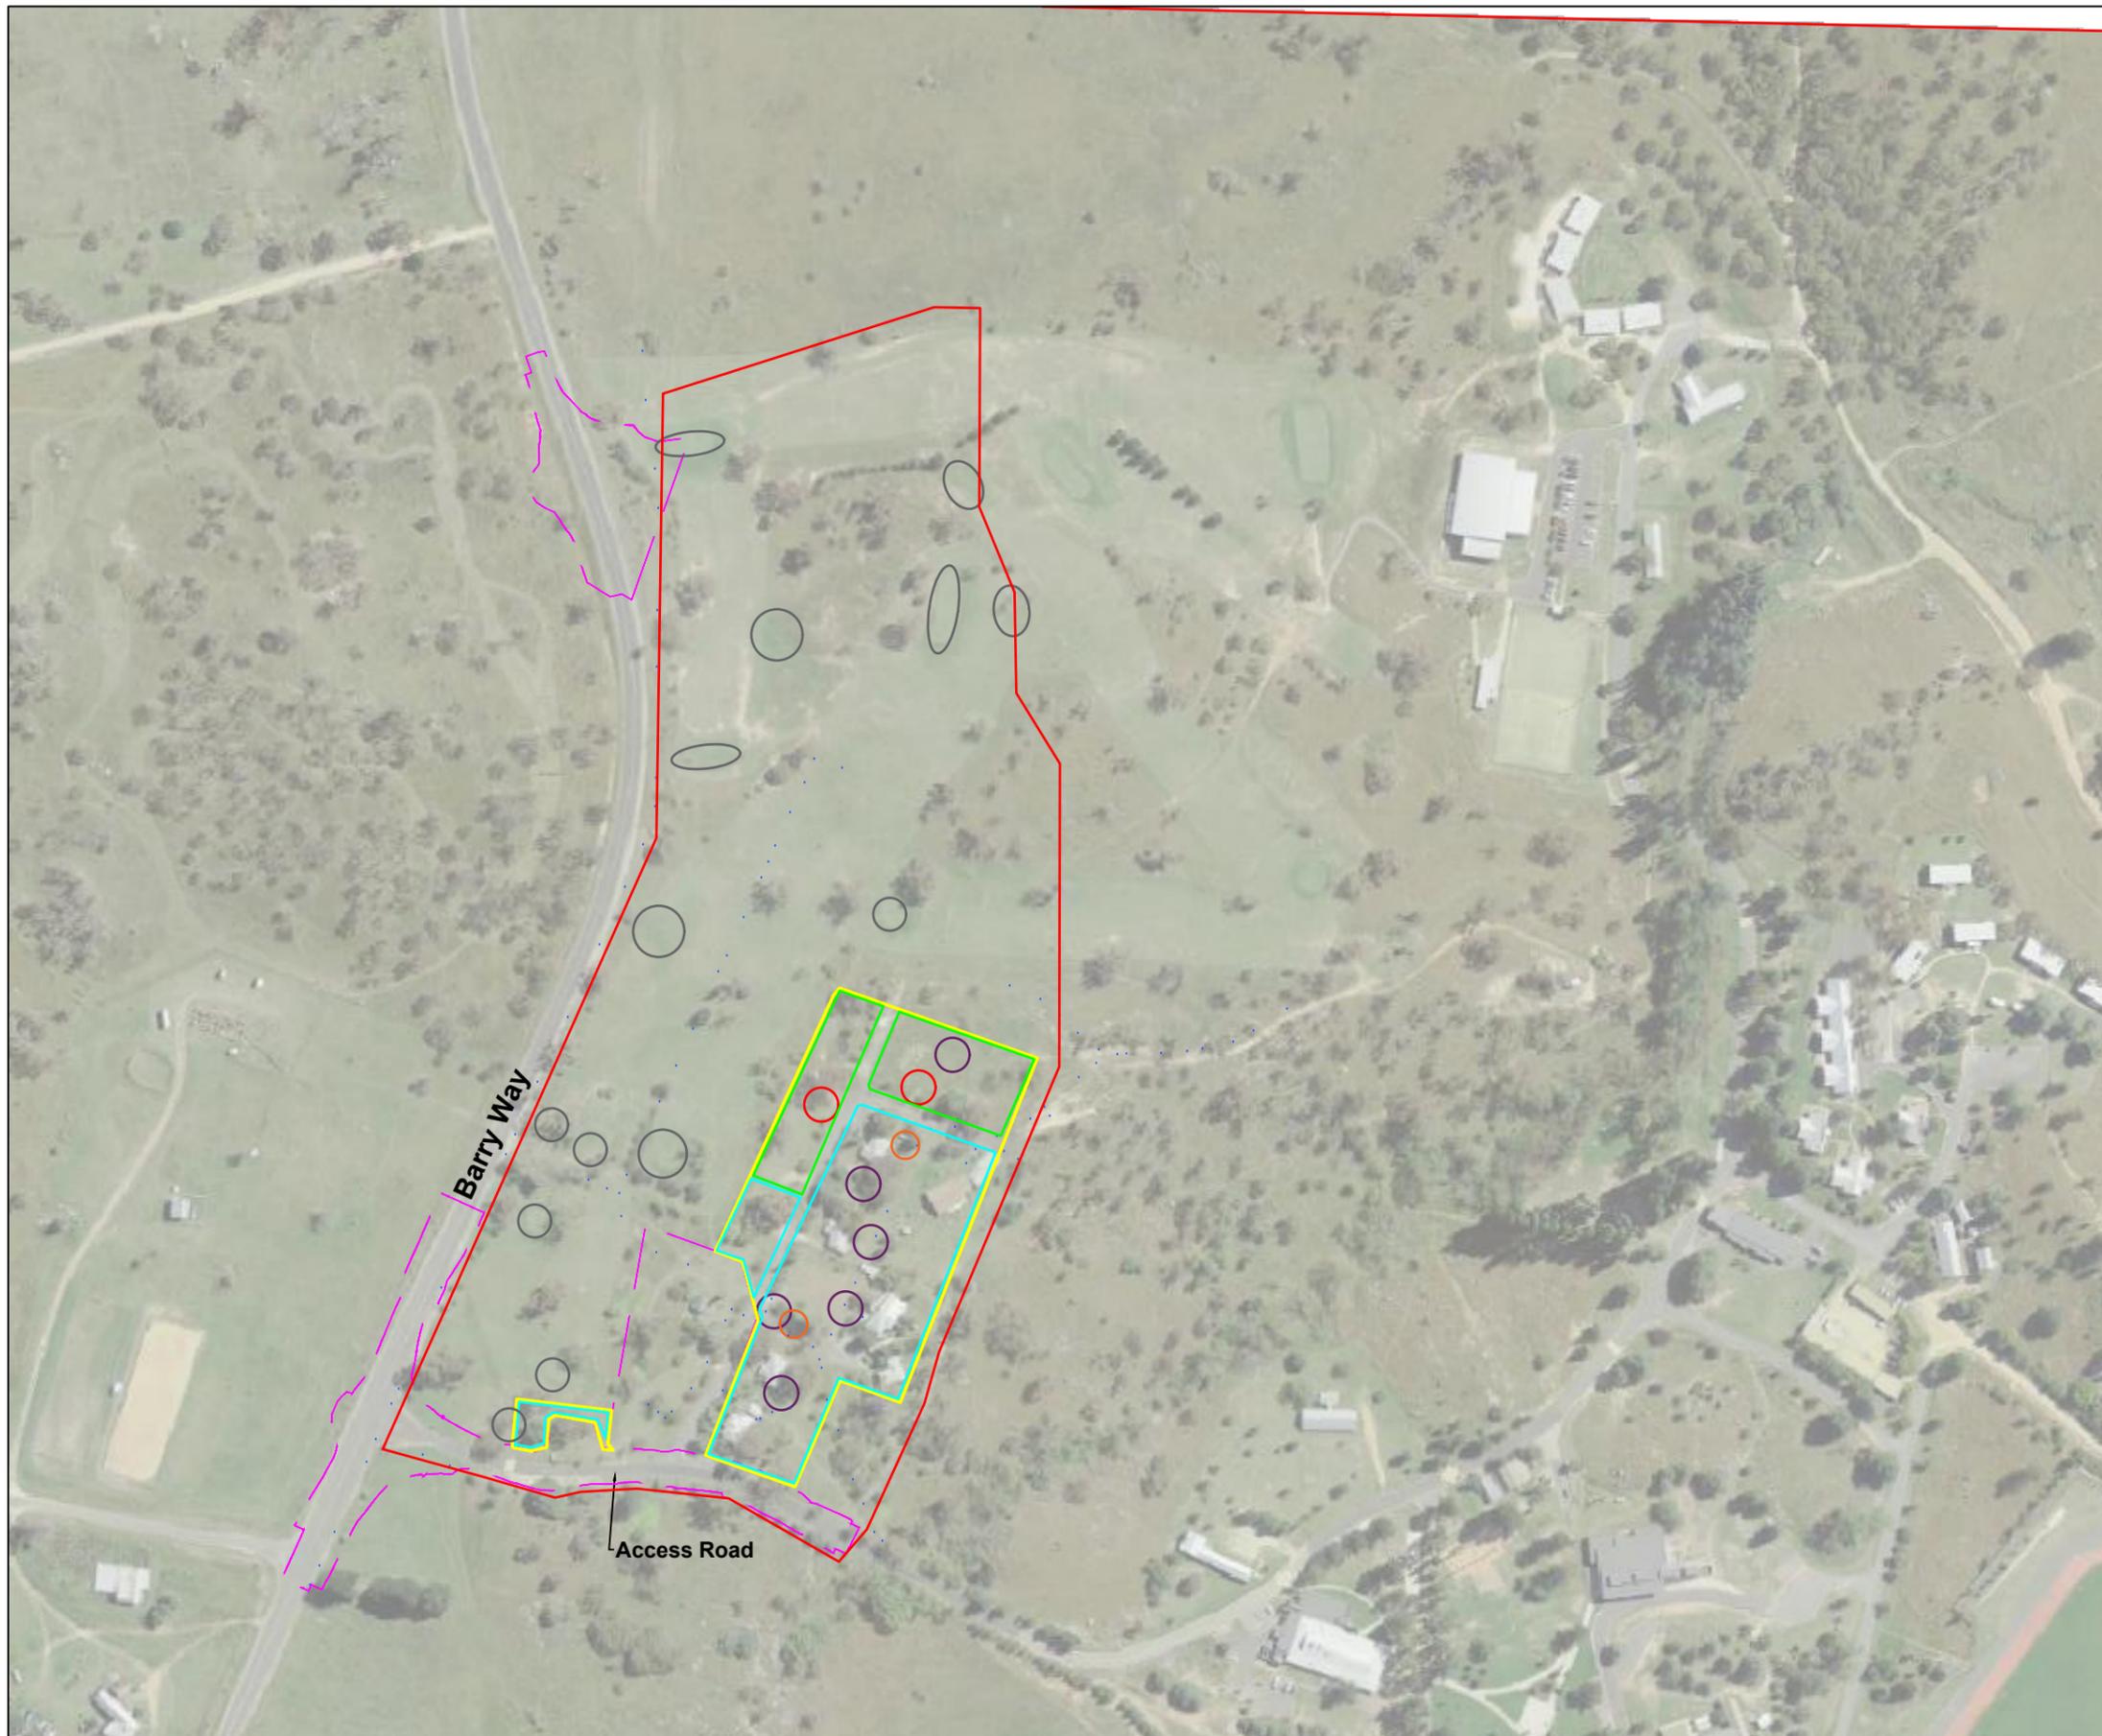
PROJECT No: 103109.05
 DRAWING No: 3
 REVISION: 1

fill to reduce the risk of ACM being left on site or being disposed of incorrectly. The likely extent of the identified impacts is shown on Drawing 3, Appendix B, the areas have been identified as Area 1 (where ACM was observed to exceed the adopted SAC of HIL-A) and Area 2 (where ACM was not observed or observed to be below the adopted SAC of HIL-A).

The likely extent of the identified impacts is shown on Drawing 3, Appendix B. As previously noted, once current residential dwellings are removed, some additional ACM is likely to be encountered and may require similar treatment.

Option 2 is the preferred asbestos treatment scope for Area 2 as highlighted on Drawing 3, where either ACM was observed to be below the SAC or not observed during investigation works. As a mixture of surface and buried asbestos fragments were noted across the site, it is recommended that an asbestos treatment area (ATA) should be established at the site for treatment of ACM-impacted soils. The ATA should be covered with geotextiles and/or black plastic to minimise the possibility of moving ACM from one area of the site to another. The treatment of asbestos on-site, methods from the WA DoH (2009) Guidelines or the Assessment and Management of Asbestos Contaminated Sites must be followed.

Option 4 is the preferred asbestos treatment scope for Area 1 as highlighted on Drawing 3, where ACM was observed to be above the SAC. The following remediation methodology is proposed for the ACM impacted topsoil fill within the south-east portion of the site (with responsibilities shown in brackets):

1. Undertake air monitoring during the works (Environmental Consultant/Licensed Asbestos Assessor).
2. Excavation of fill within the identified Area 1 shown on Drawing 3, Appendix B (Asbestos Contractor) under full time monitoring of the Environmental Consultant. Excavation should progress to chase out all fill observed within the side walls of the excavations, if present.

DP recommends that Option 4 is utilised for the remediation of OCP impacted soils as shown on Drawing 3, Appendix B. It is envisaged that the remedial works will comprise the following scope:
