Interim Report on  
Geotechnical Investigation

Proposed Murwillumbah Education Campus  
Murwillumbah High School, 86 Riverview Street,  
Murwillumbah

Prepared for  
Built (NSW) Pty Ltd

Project 203033.02  
October 2021

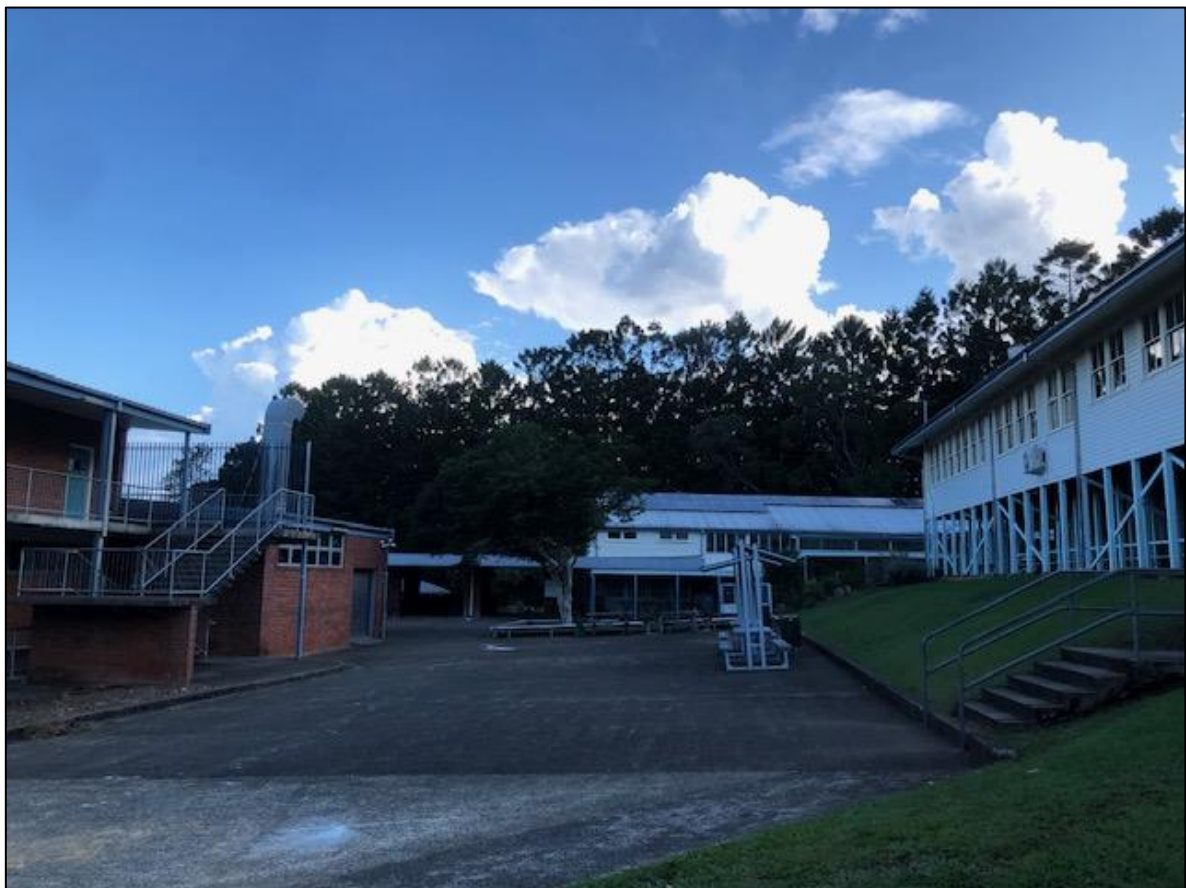
**Figure 1: Typical site conditions during investigation facing south near Bore 105.**

Figures 1 to 3 indicate typical site conditions encountered at the time of investigation.

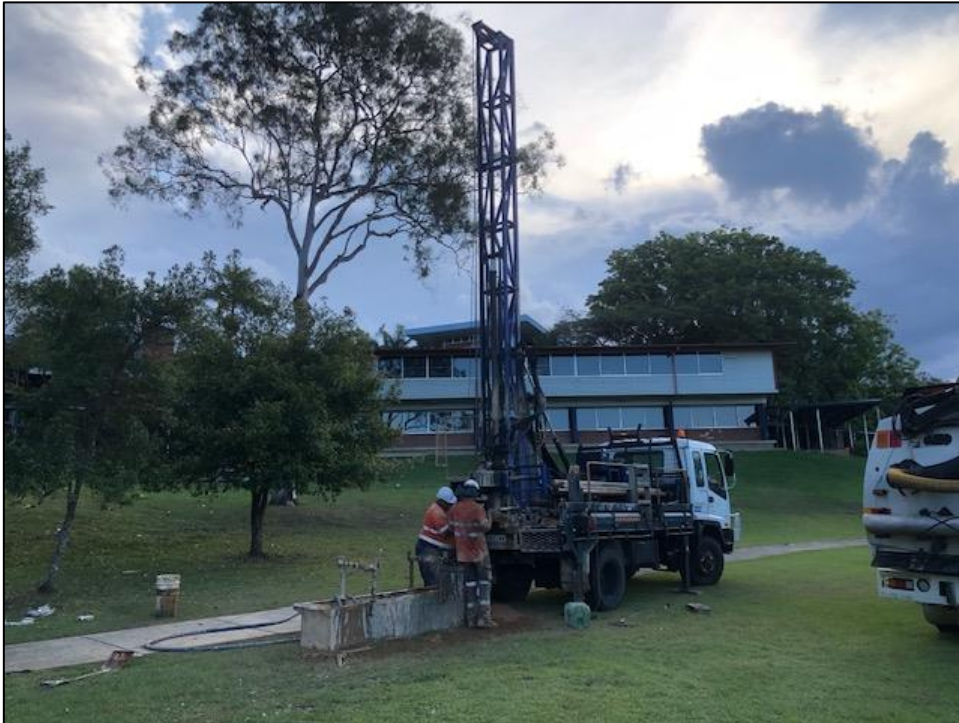
**Figure 2: Typical site conditions during investigation looking west at drill rig set up at Bore 103.**

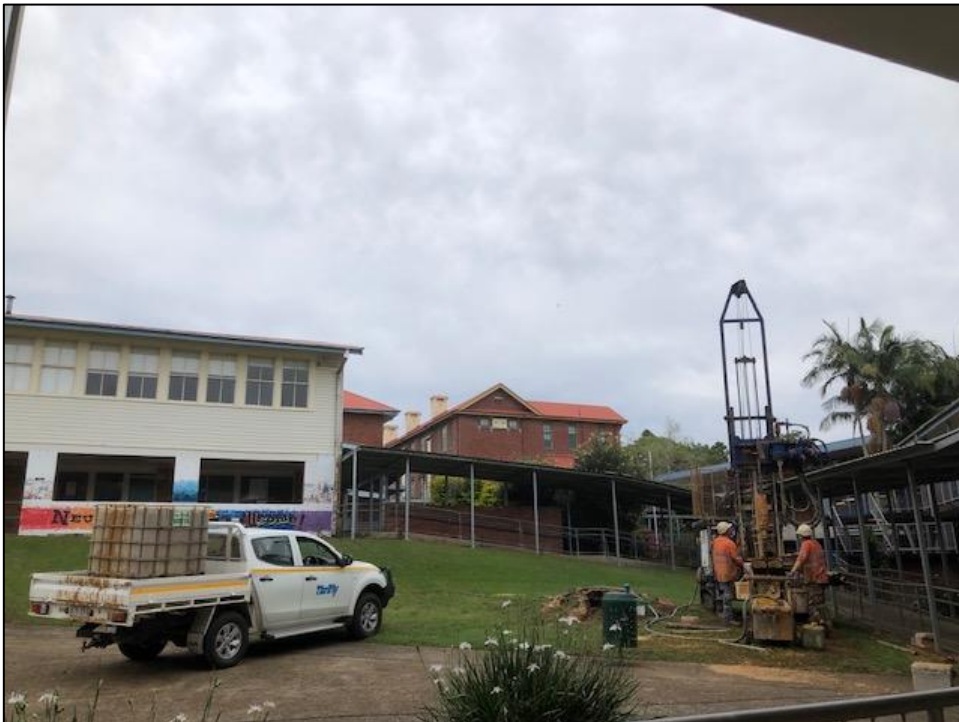
**Figure 3: Typical site conditions during investigation looking west at drill rig set up at Bore 105.**

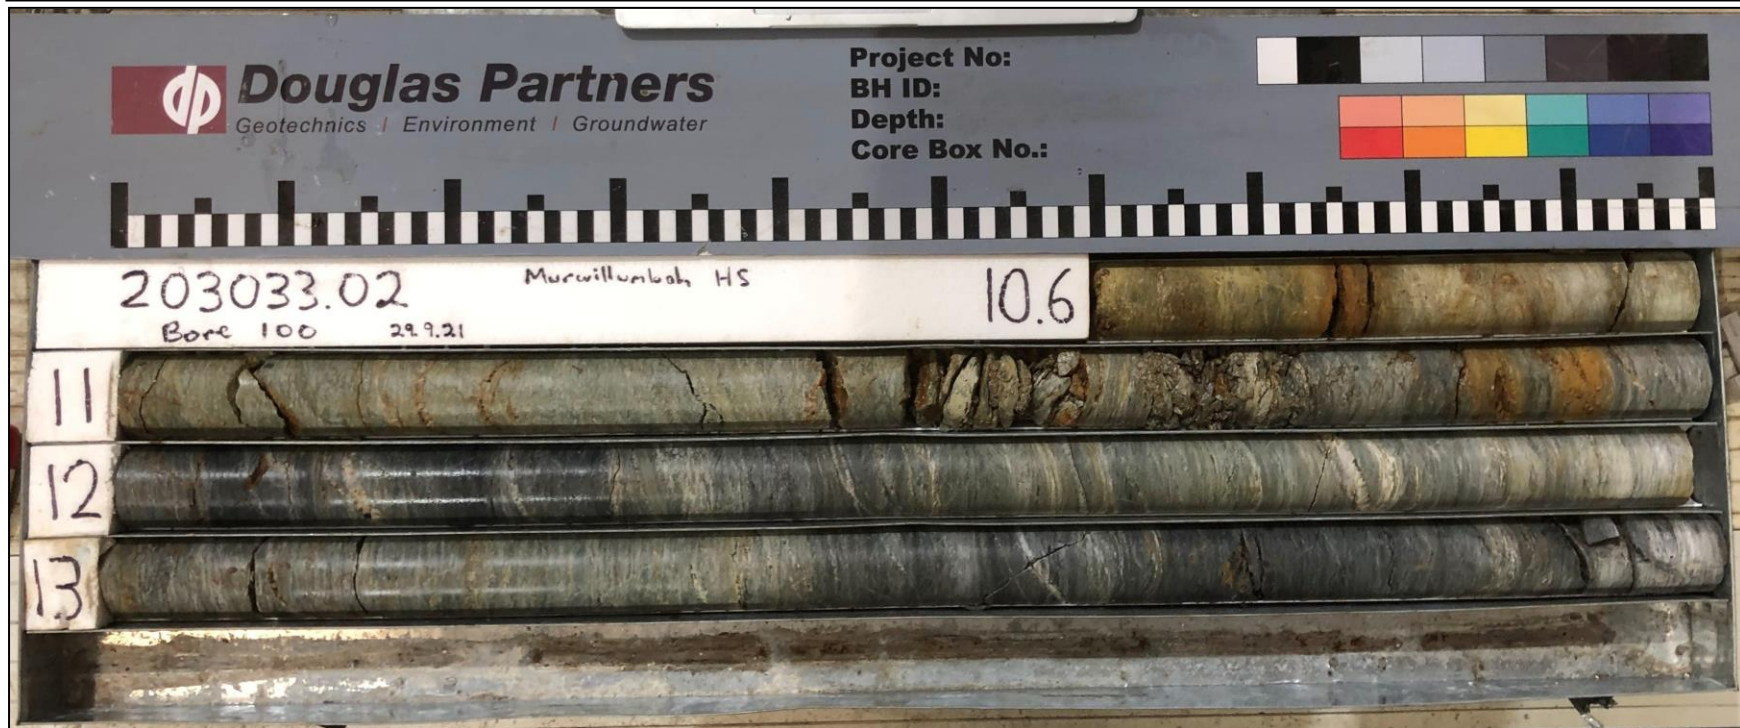
**Core Photograph – Bore 100**  
**Proposed Murwillumbah Education Campus**  
**86 Riverview Street, Murwillumbah**

Bore: 100  
 Box: 1 of 1  
 Depth: 10.6 m to 14.0 m

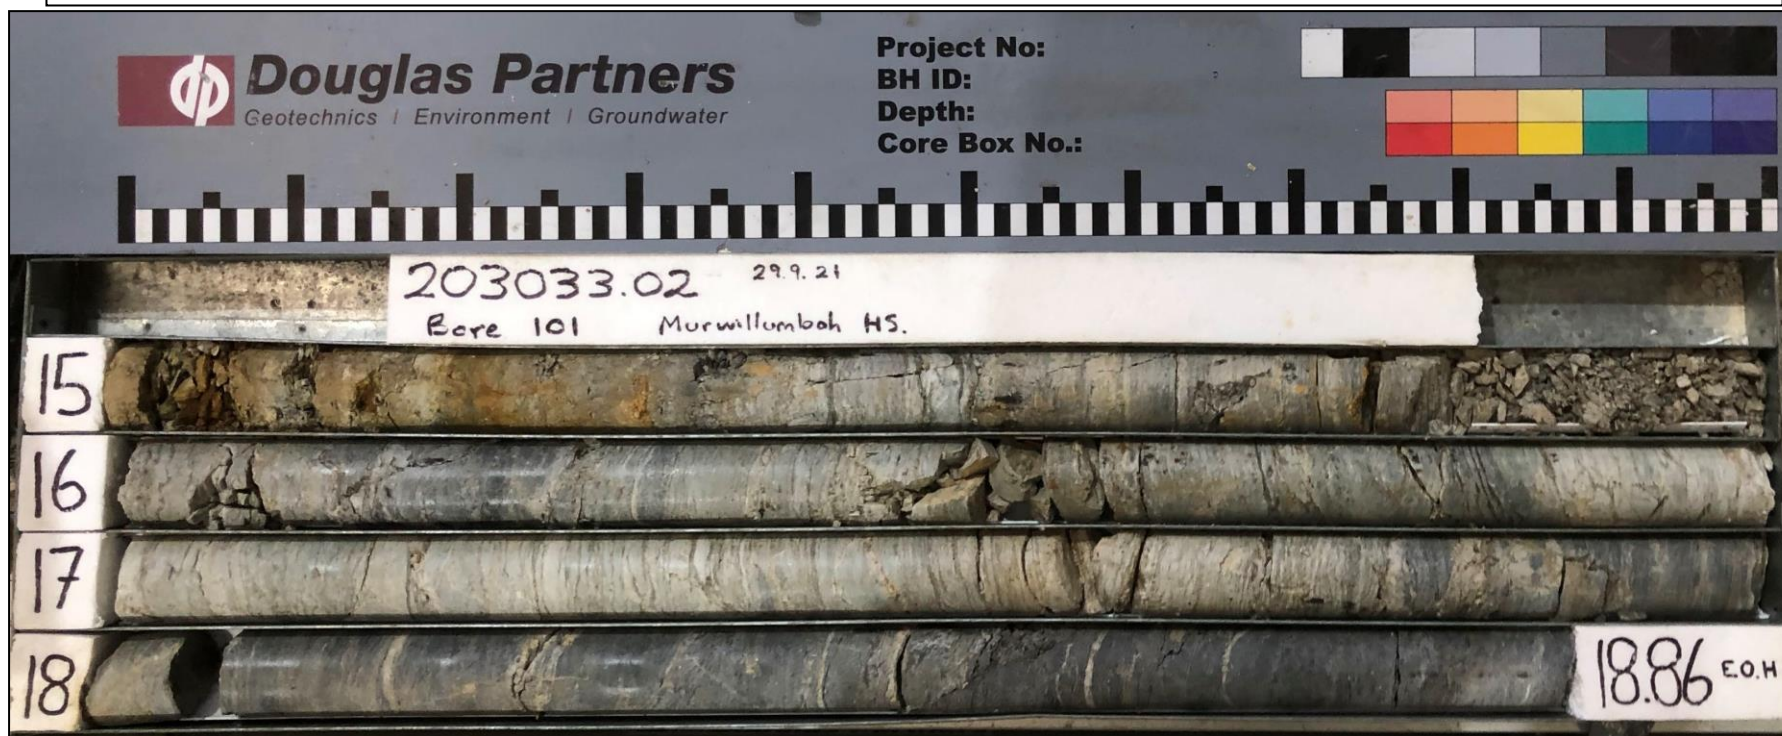
**Core Photograph – Bore 101**  
**Proposed Murwillumbah Education Campus**  
**86 Riverview Street, Murwillumbah**

Bore: 101  
 Box: 1 of 1  
 Depth: 15.0 m to 18.86 m

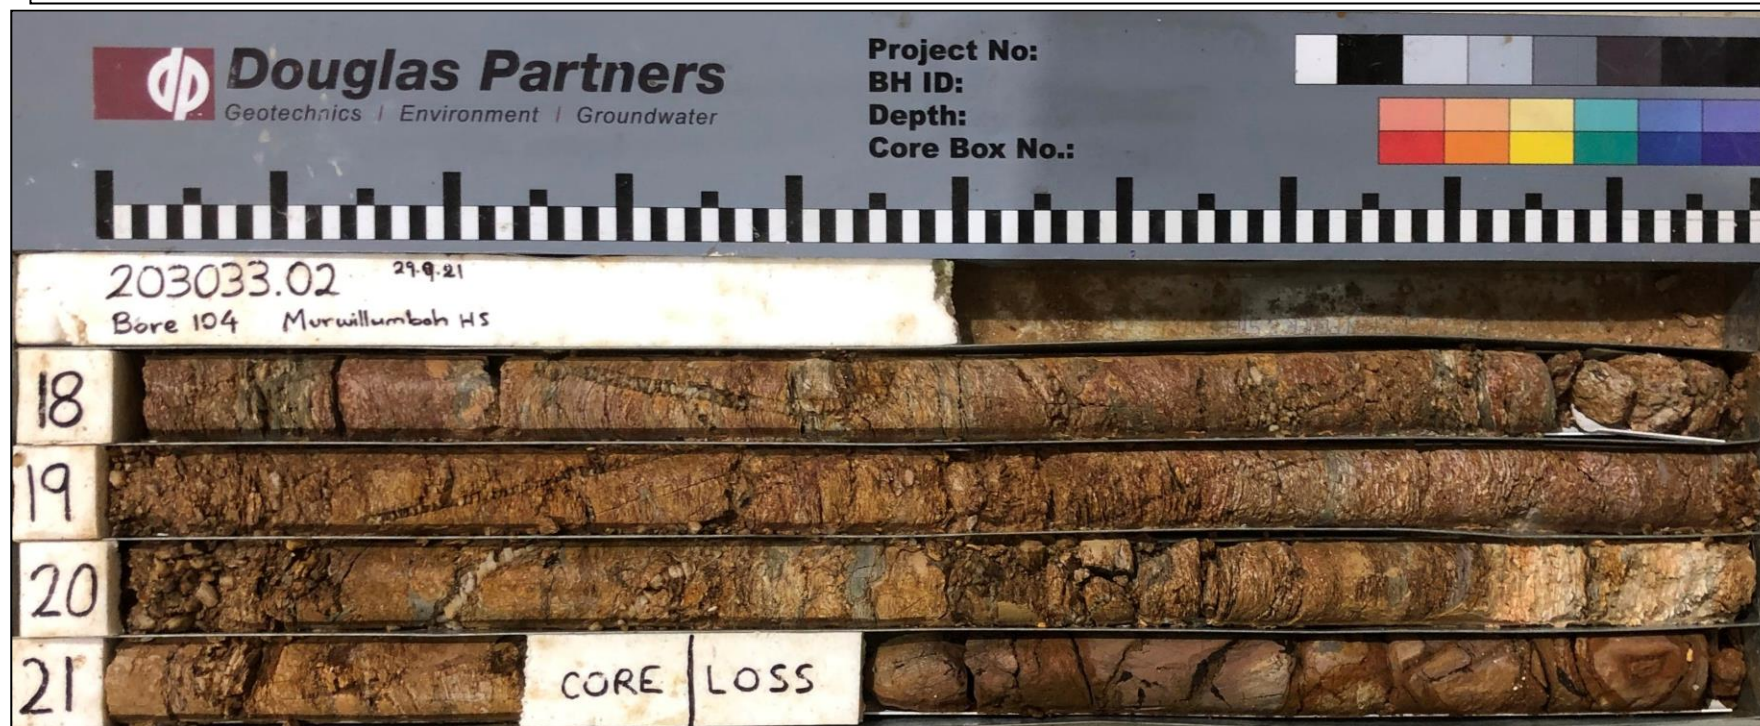
**Core Photograph – Bore 104**  
**Proposed Murwillumbah Education Campus**  
**86 Riverview Street, Murwillumbah**

Bore: 104  
 Box: 1 of 2  
 Depth: 18.0 m to 22.0 m

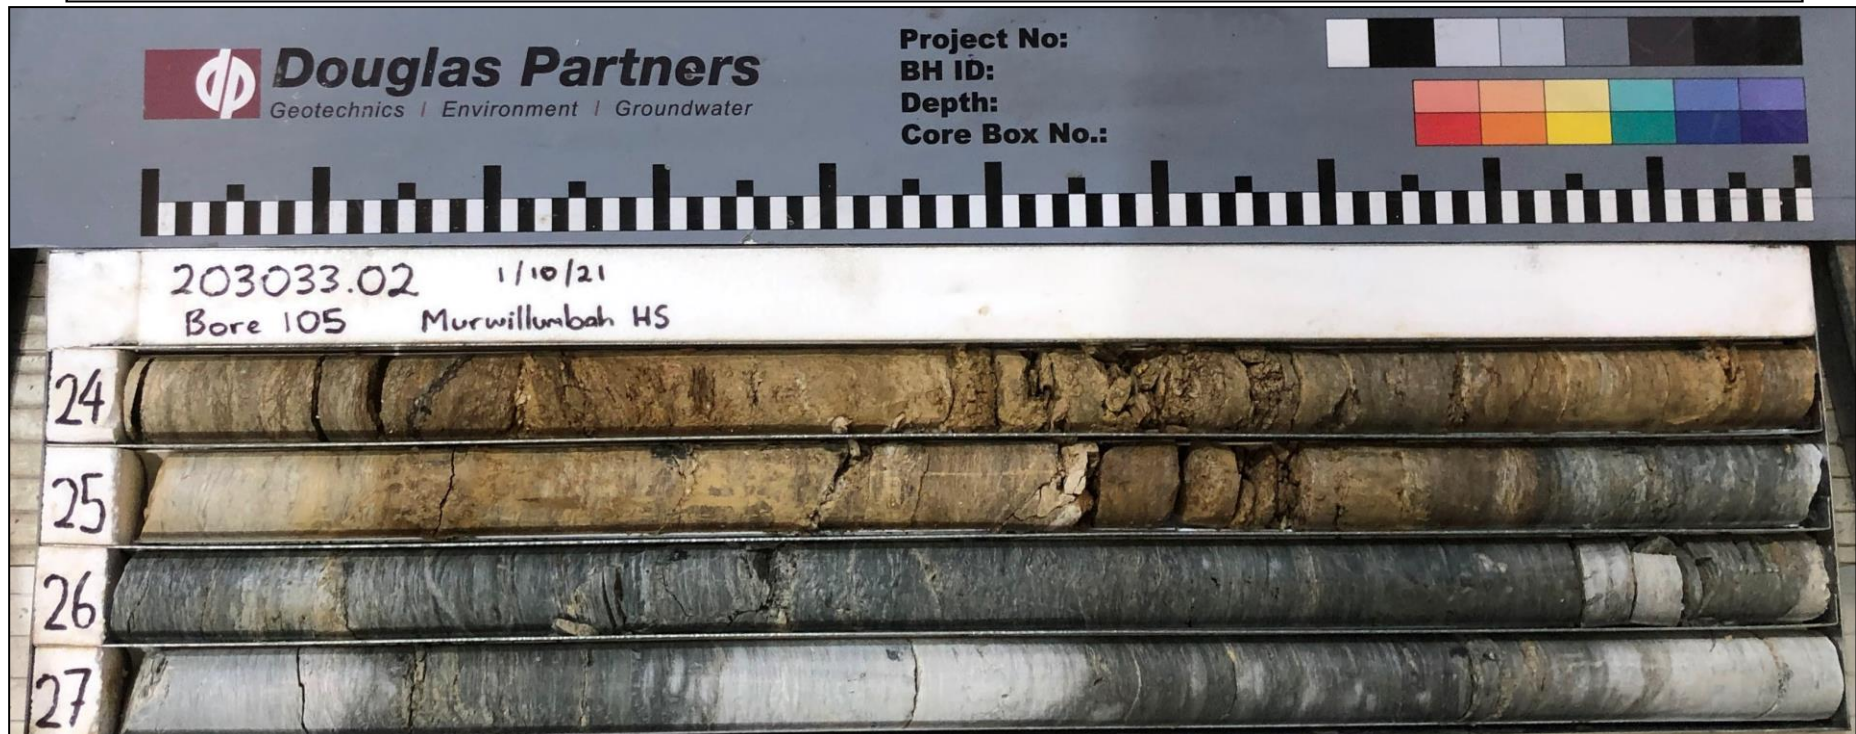
#### Core Photograph – Bore 105

Bore: 105  
 Box: 1 of 1  
 Depth: 24.0 m to 28.0 m

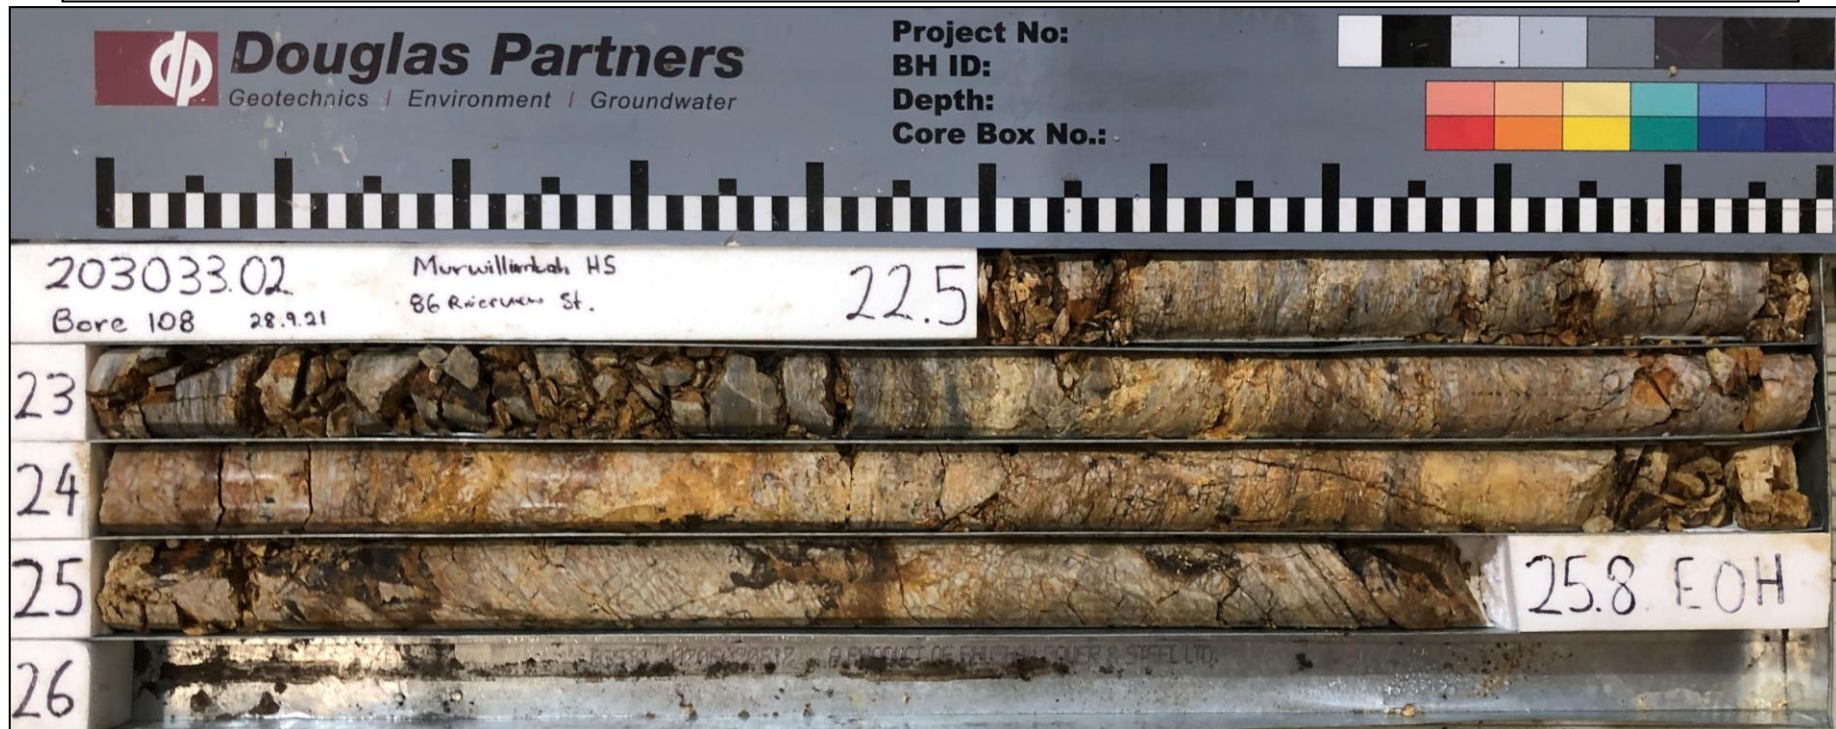
Core Photograph – Bore 108  
 Proposed Murwillumbah Education Campus  
 86 Riverview Street, Murwillumbah

Bore: 108  
 Box: 1 of 1  
 Depth: 23.0 m to 25.8 m

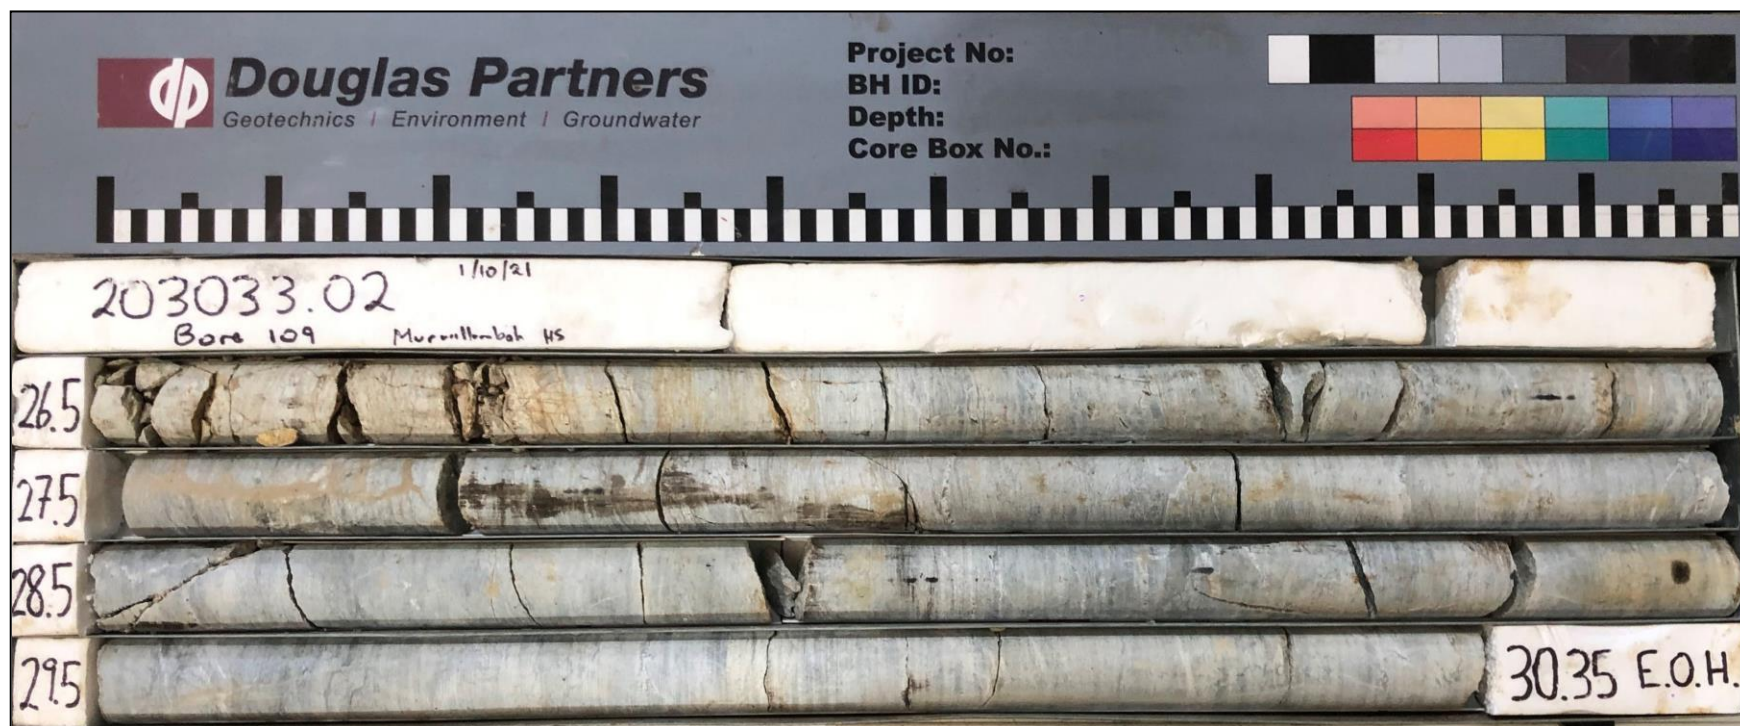
**Core Photograph – Bore 109**  
**Proposed Murwillumbah Education Campus**  
**86 Riverview Street, Murwillumbah**

Bore: 109  
 Box: 1 of 1  
 Depth: 26.5 m to 30.35 m
