RE: INTERIM AUDIT ADVICE LETTER NO. 1 - REMEDIATION ACTION PLAN, PROPOSED SCHOOL, MAITLAND STREET, MUSWELLBROOK

Ref 318000858

Audit No. RS 113

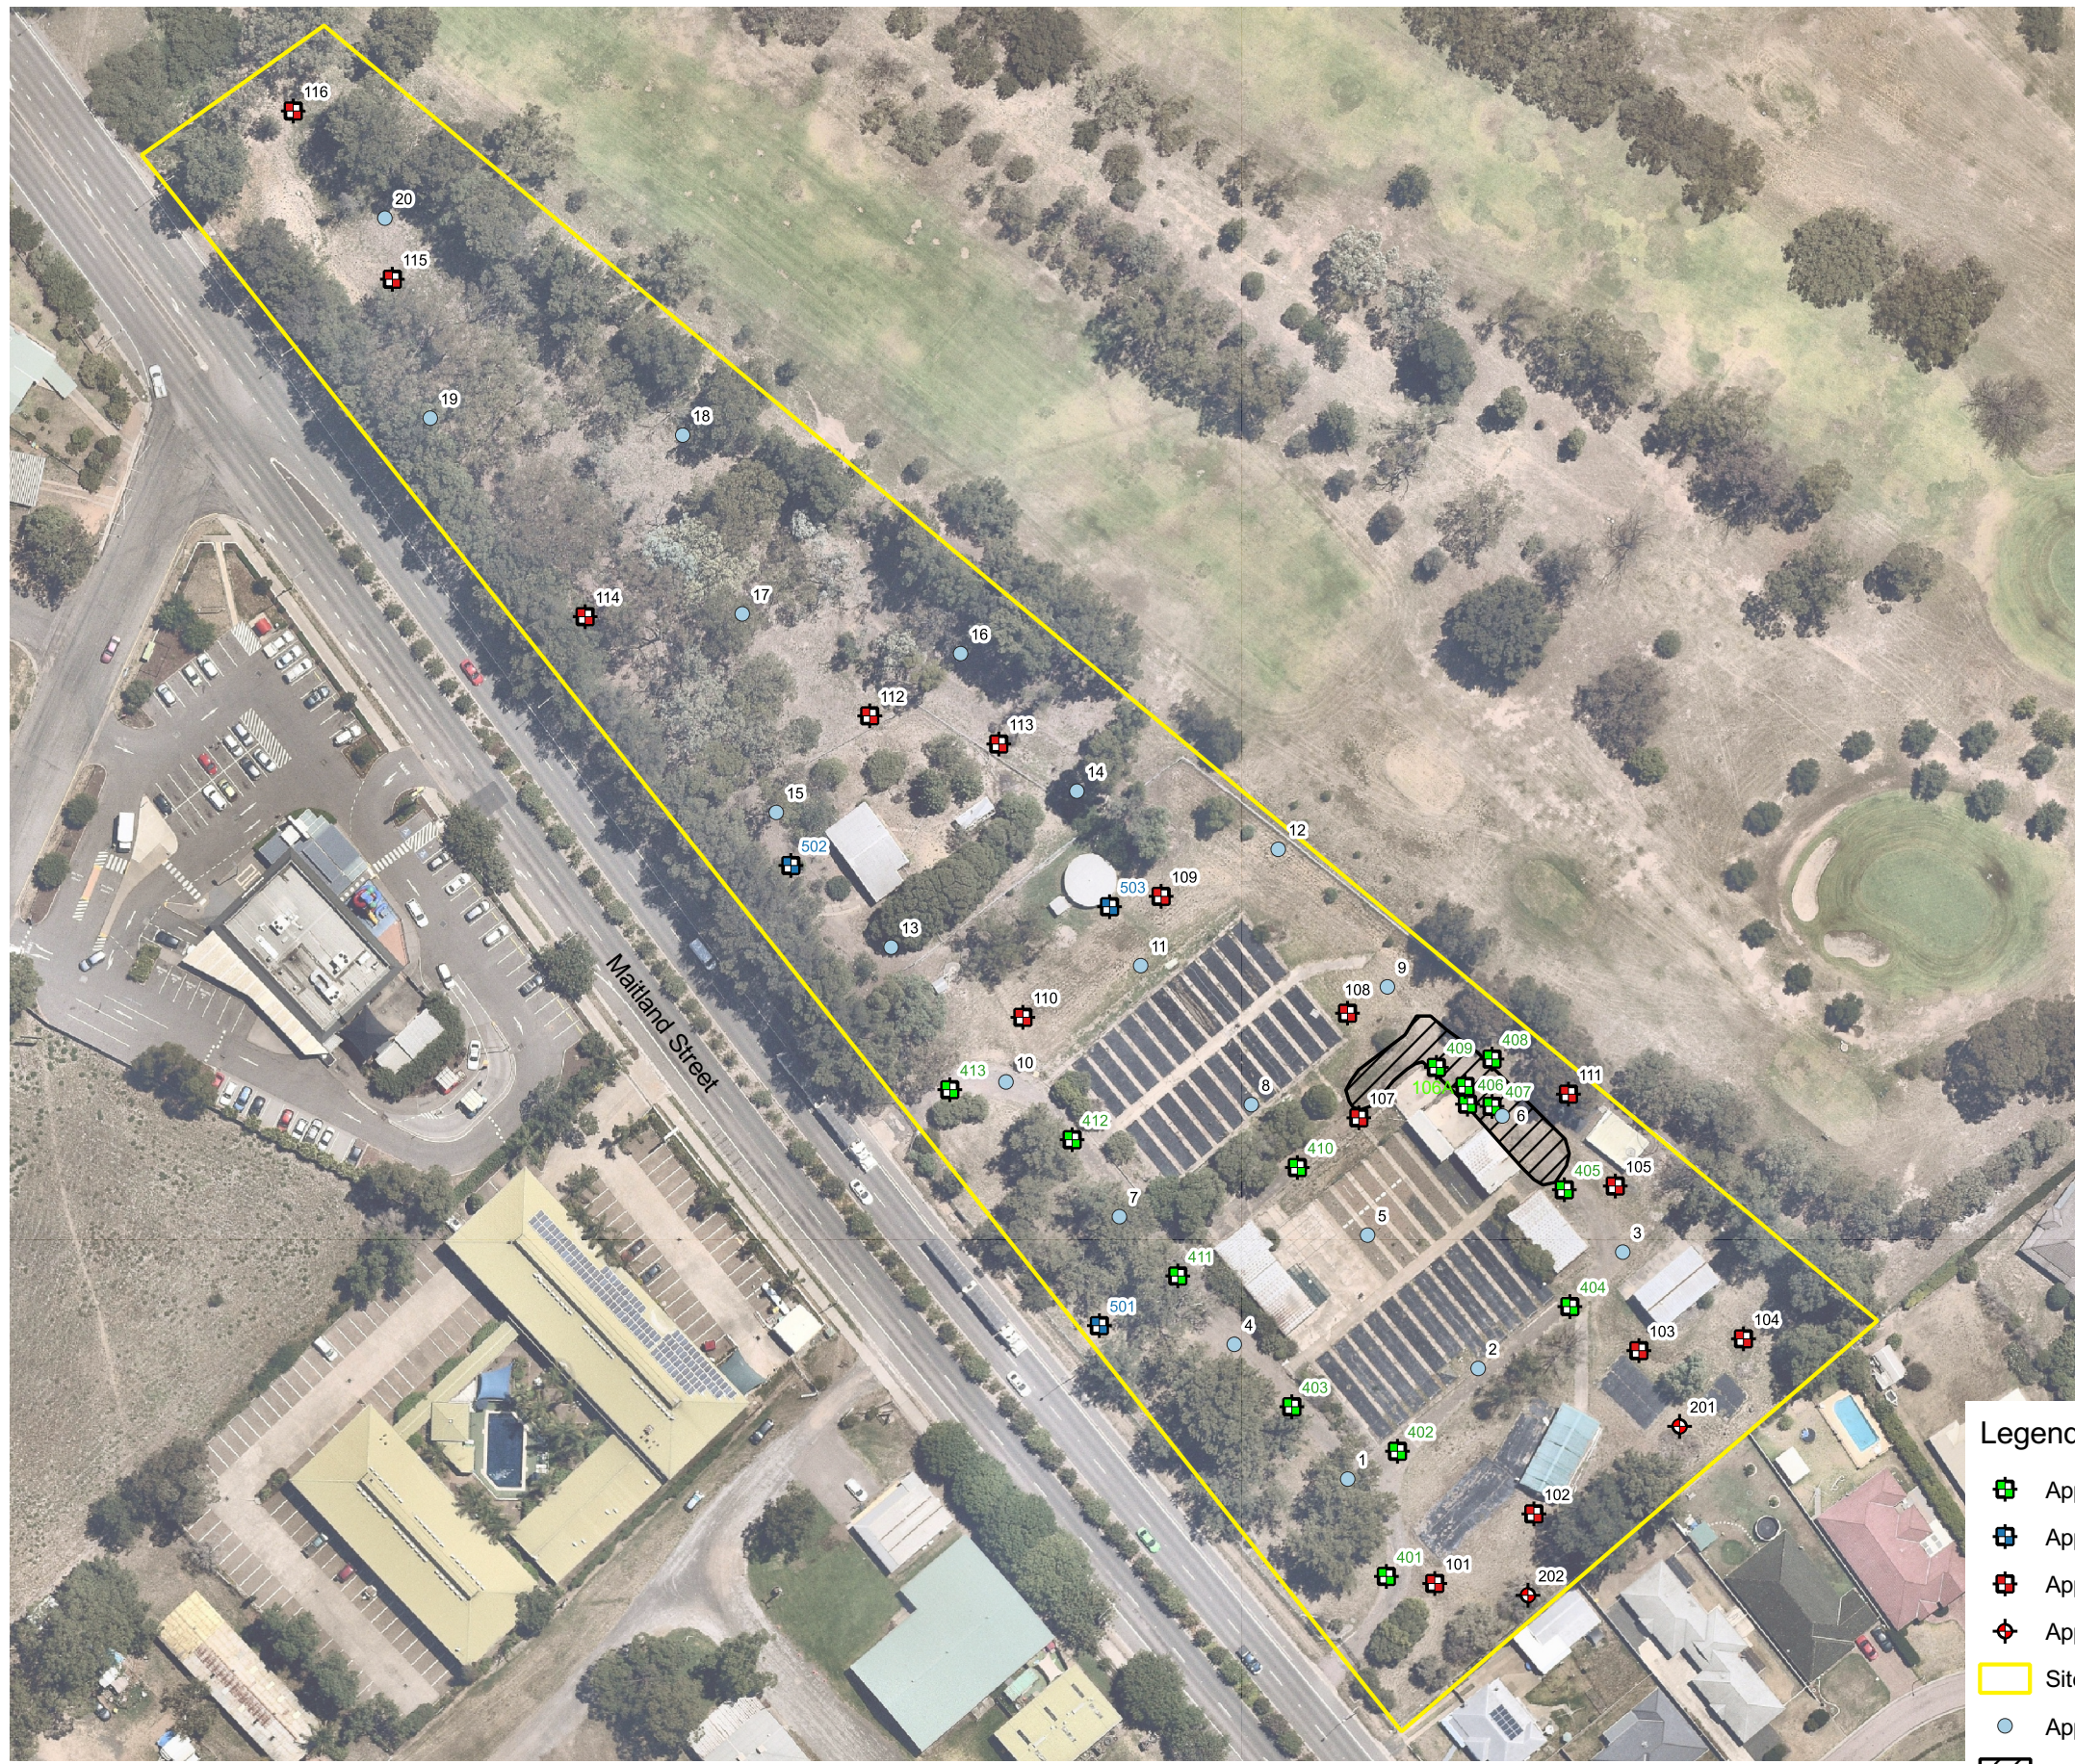
<p>Douglas Partners Geotechnics Environment Groundwater</p>	CLIENT: Pacific Brook Christian School	Site Locations Lot 62 Maitland Street Muswellbrook NSW	PROJECT No: 91601.01
	OFFICE: Sydney		DWG No: 1
	DATE: 28 Jun 2019		REVISION: 0

The site is currently vacant and occupied by several buildings associated with previous site use as a plant nursery, gravel and asphalt paths, gravel garden beds and grass covering as shown in Attachments 1 and 2. DP summarise the site conditions encountered during site works in April 2020 in the RAP and note the following:

A HBM Survey was completed on the buildings and structures currently located on the site. The buildings with associated ID numbers are shown in Attachment 2. Non-friable asbestos (bonded ACM) was identified in four of the 10 buildings (buildings 1, 5, 6 and 8). Lead paint was identified on buildings 1, 5, 8 and 9 and lead dust in building 1. Synthetic mineral fibres (SMF) were identified in buildings 1, 2, 5, 6, 7, 8 and 9 and PCBs in buildings 5, 6, 8 and 9.

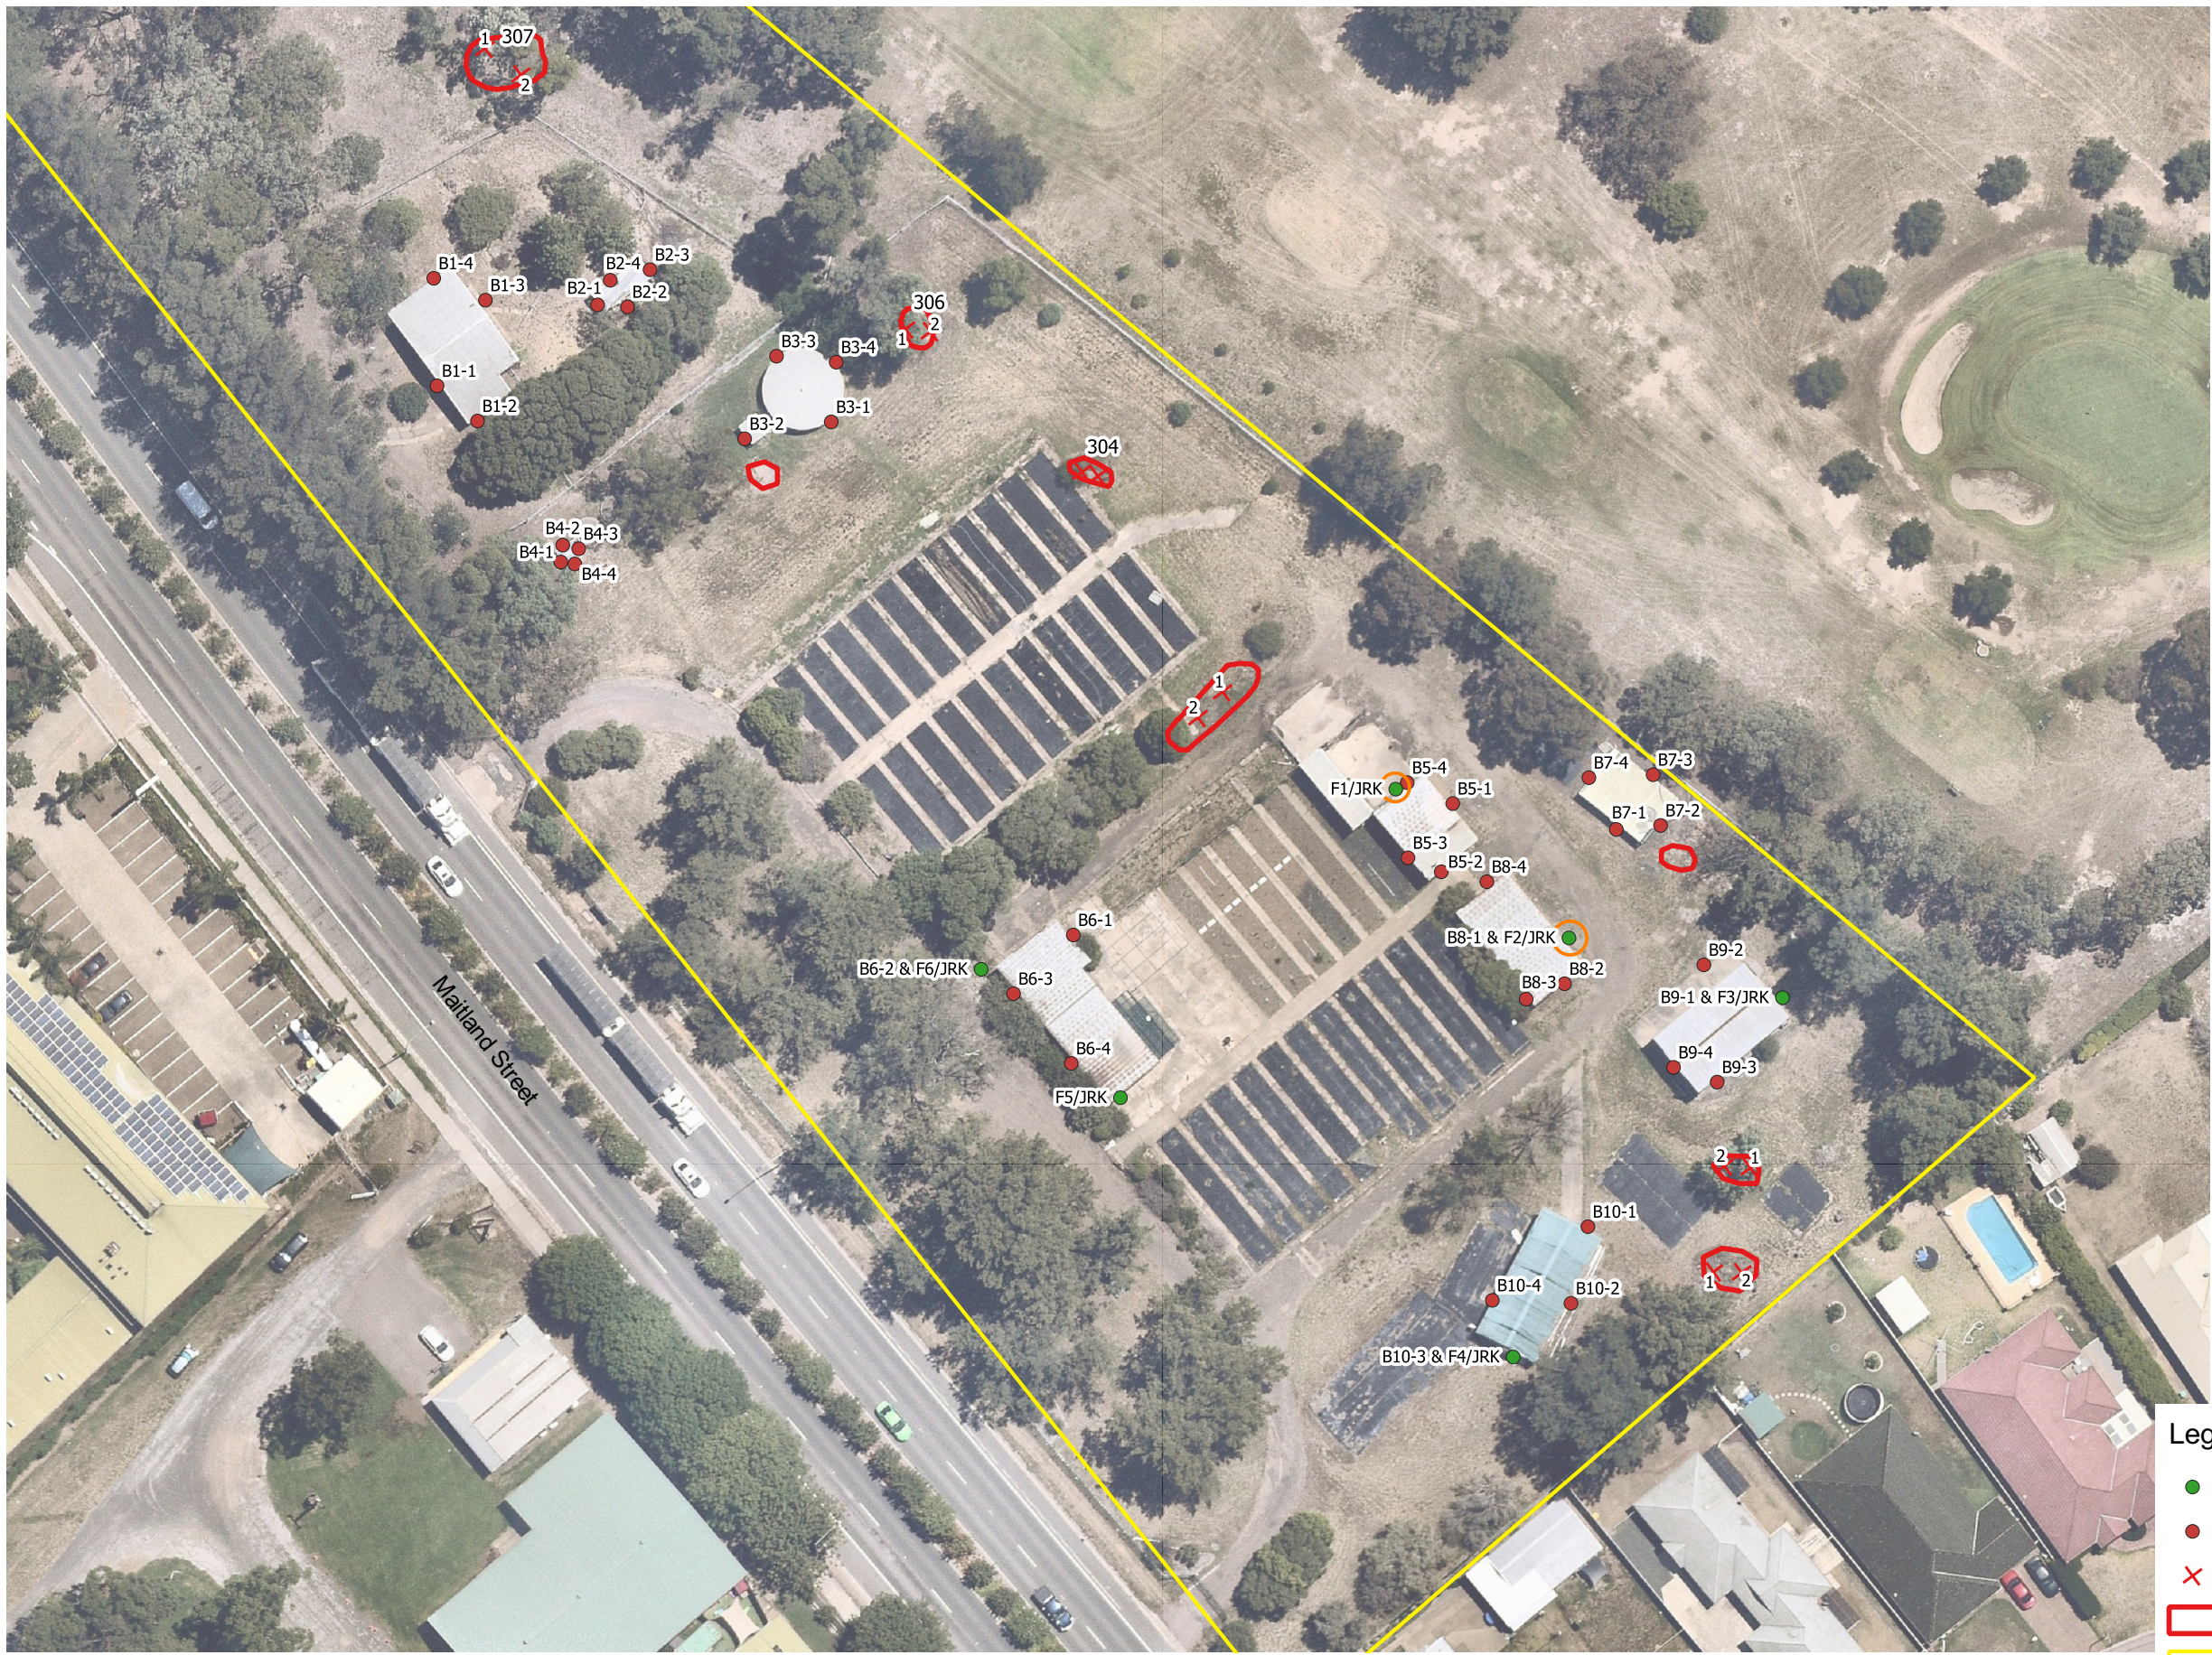
PROJECT No: 91601.04
 DRAWING No: 2
 REVISION: 0

- Legend**
- Approx. Location of Fibro Samples
 - Approx. Location of Surface Samples (B1-B10)
 - ✗ Approximate Stockpile Sampling Locations
 - Approx. Stockpile Locations (301-307)
 - Site Boundary
 - Approx Location of Confirmed ACM on Surface

During the Supplementary DSI, DP observed FCF at the surface adjacent to Buildings 5, 6, 8, 9 and 10. Analysis was completed on six FCF (F1/JRK-F6/JRK) and asbestos comprising chrysotile, amosite and crocidolite was detected in two of the fragments collected near buildings 5 and 8. DP noted that testing of surface soils in these areas for AF/FA did not detect asbestos.

ACM is still present at the site surface around some existing buildings (vicinity of building 5 and 8). The buildings currently remain on the site but are to be demolished during development. As noted in Section 2.4, several buildings contain HBM including asbestos. Confirmation of removal of all HBM and further assessment of soil conditions in the footprint of the buildings is required following demolition. The requirements for validation of surface soils following building demolition have been documented in a RAP discussed in Section 11 of this Interim Audit Advice. The Auditor is satisfied that no further investigations are needed prior to development works commencing.
