**REPORT TO
HEALTH INFRASTRUCTURE**

**ON
GEOTECHNICAL INVESTIGATION**

**FOR
PROPOSED STAGE 2 REDEVELOPMENT**

**AT
NEPEAN HOSPITAL, DERBY STREET, KINGSWOOD,
NSW**

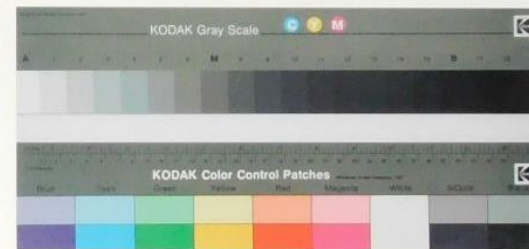
Job No: 33570LT
Borehole No: BH501
Depth: 9.2 m - 18 m

33570LT BH501 START CORING AT 9.20m

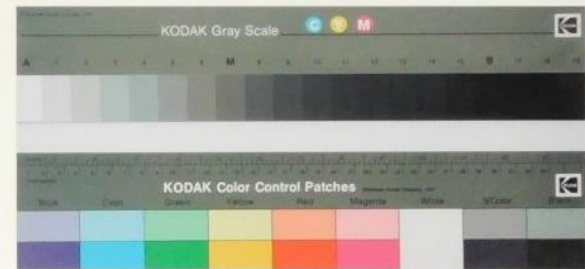
Job No: 33570LT
Borehole No: BH502
Depth: 6.20m - 15.00m

33570LTBH502 START CORING AT 6.20m

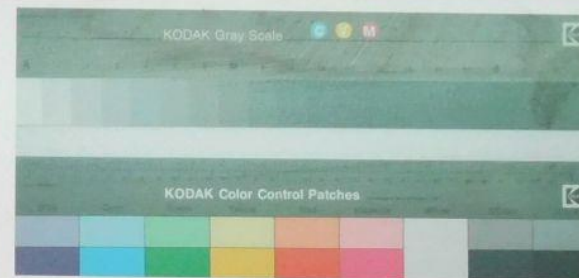
Job No: 33570LT
Borehole No: 504
Depth: 5.75m - 14.0m

JOB No. 33570LT, BH 504, CORING STARTS AT 5.75m

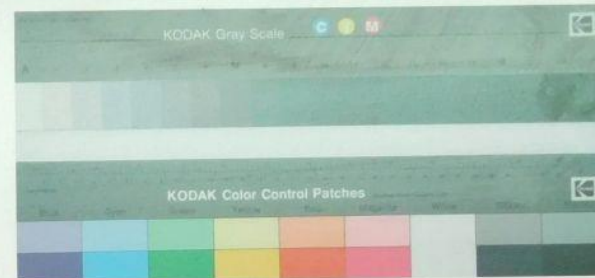
Job No: 33570LT
Borehole No: 505
Depth: 4.6m - 13.0m

33570LT BH505 START CORING AT 4.60m

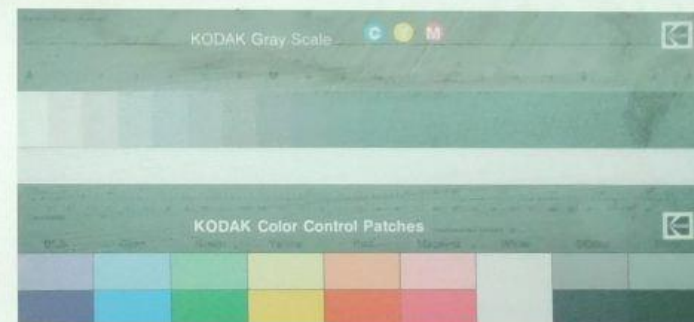
Job No: 33570LT
Borehole No: 505
Depth: 13.0m - 19.9m

END OF BOREHOLE AT 19.90m
