REPORT TO
PYMBLE LADIES COLLEGE

ON
PRELIMINARY (DESKTOP) SITE INVESTIGATION

FOR
**PROPOSED GREY HOUSE PRECINCT
DEVELOPMENT**

AT
**PYMBLE LADIES COLLEGE, AVON ROAD, PYMBLE,
NSW**

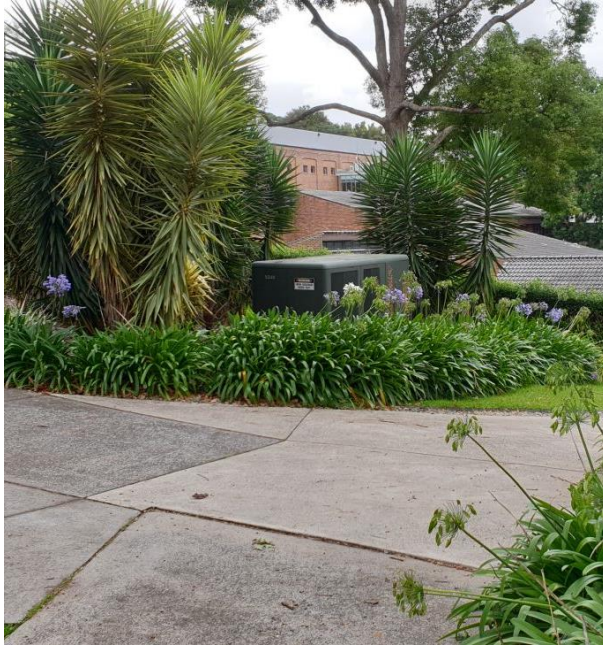
Photograph 1: Taken showing the north-east corner of the site, facing east. Note the electrical substation kiosk within the landscaped garden.

to be of new age construction. There was no staining on the sides of the kiosk slab and this features was not considered to be a potential source of contamination.

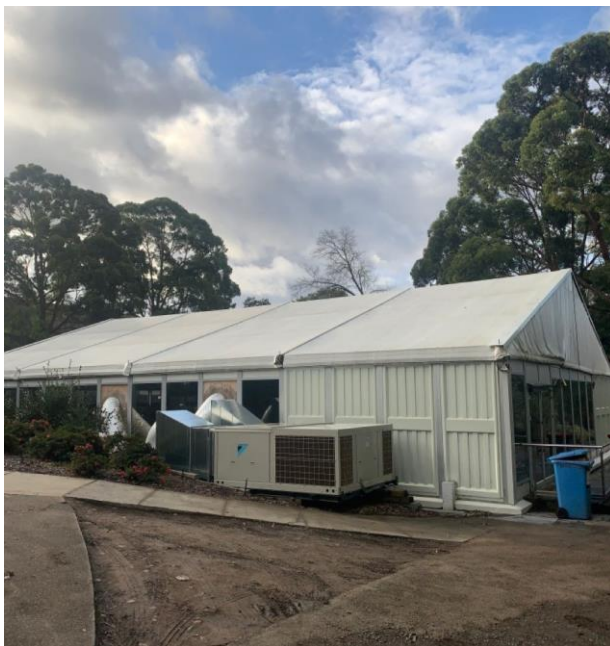
Photograph 2: Taken showing the temporary marquee in the western portion of the site, facing north-east.

At the time of the inspection, a temporary marquee type structure constructed on a concrete pad with plastic panel walls was located in the south-west portion (known as 'The Pavilion'). Demountable buildings were located immediately north-east of The Pavilion and appeared to have been assembled on a former concrete tennis court.

The erection of the marquee structure in the western portion of the site was approved in 2014 with the Complying Development Certificate signed and dated 6 November 2014. The certificate noted that the marquee was a pre-fabricated structure and no waste was to be produced through the development itself. Only minor waste management strategies were required (i.e. disposal of rubbish).

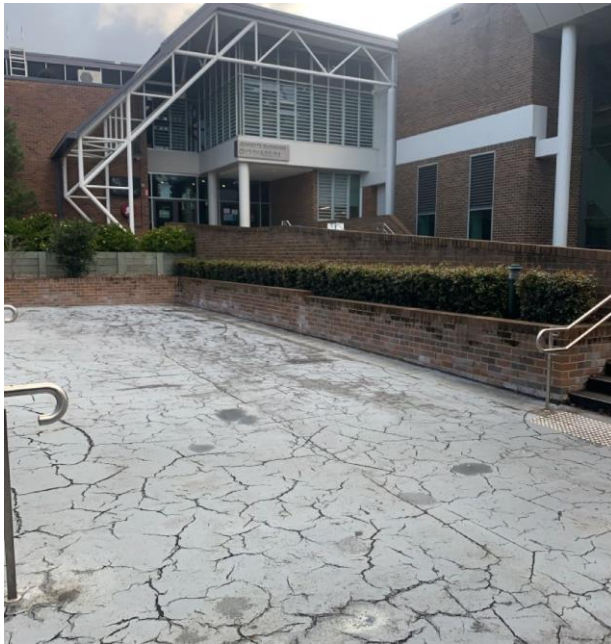
Photograph 3: Taken showing the northern retaining wall, facing west.

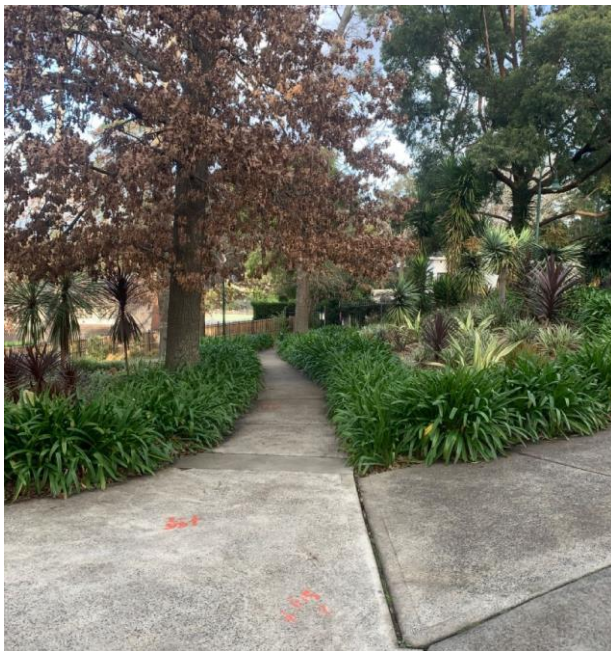
Photograph 4: Taken showing the landscaped garden beds and footpaths in the central and eastern portion of the site.

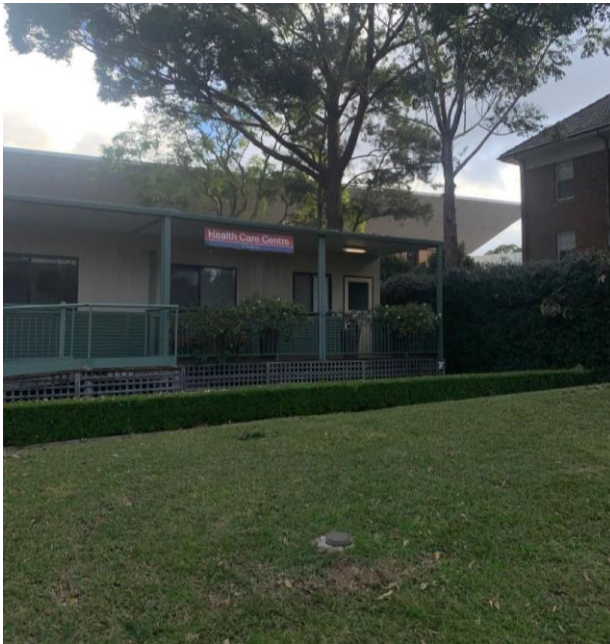
Photograph 5: Taken showing the demountable buildings at the site. Note the grassed lawn and landscaping.

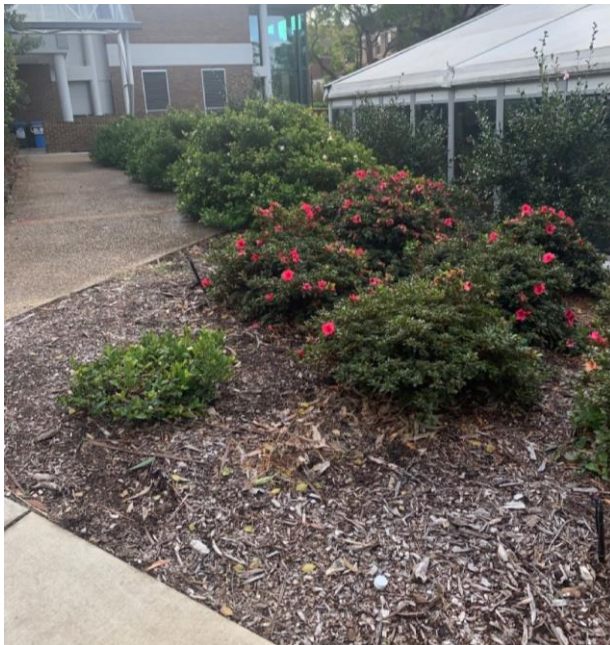
Photograph 6: Taken showing an example of the landscaped garden beds across the site, facing north. Note the garden mulch covering the soil surface.
