## 9.0 CONCLUSIONS

The main purpose of this Visual Impact Assessment (VIA), is to support a State Significant Development application for the redevelopment of the Greys House Precinct located within Pymble Ladies College. This report relies on desktop study, on-site analysis, drone photography, photomontages and CGI of the proposal. In particular potential visual impacts have been assessed for a number of locations along Pymble Ave and within the conservation area C11. These are in closest proximity to the development and therefore the most sensitive.

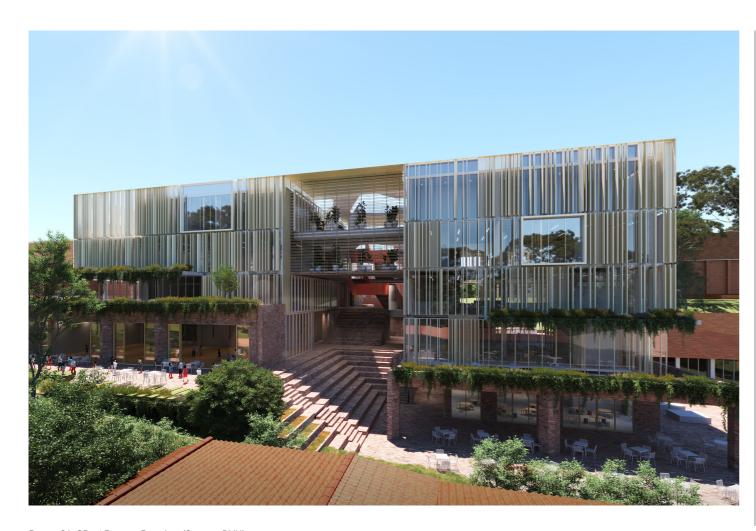
Figure 21: 3D of Eastern Facade - (Source: BVN)

Shown in above in Figure 21 is a visualisation by BVN architects of the eastern facade of the proposed new facility. This depicts a buildings which is sympathetic to the heritage brick which is found abundantly on other campus buildings. Higher levels above the colonnade have an open appearance with glass and a light supporting structure. Overall is it clear the building will be of extremely high architectural quality.

The development proposals indicate a high quality new facility which has been designed to be sympathetic to the most sensitive visual receivers along Pymble Avenue. This includes the use of brick, glass and a light open structure to be blend a modern design into the federation and inter-war architecture that is prevalent within the Campus.

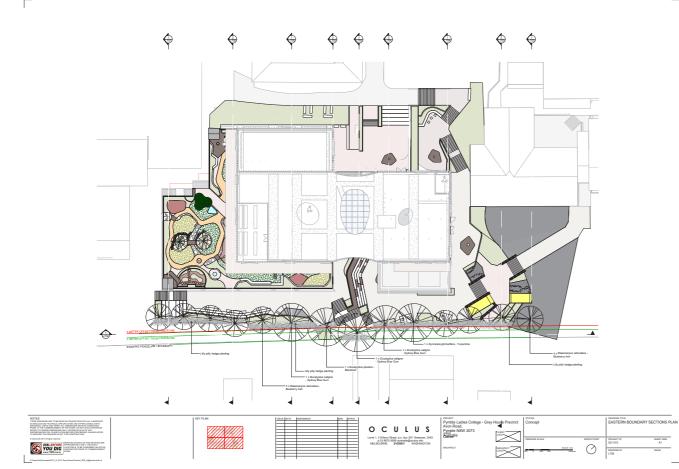
Figure 23: Concept Landscape Plan (Source: Oculus)

To reduce visual impacts for sensitive residential visual receivers in close proximity to the development along Pymble Avenue landscape mitigation has been introduced, this is in the form of a mix of endemic semi-mature large canopy, dense evergreen trees and hedging. These will be placed close to the southern boundary and will filter views of the built form. Refer to Year 10 photomontages within Section 8.0.

Landscape screen planting along the southern boundary adjacent to properties 59B, 57A and 53, will play a crucial role in providing visual mitigation

and privacy for the adjoining properties. Following review of the proposed landscaping plans, it is concluded that landscape mitigation can be successfully achieved and this will help to filter and screen views of the development.

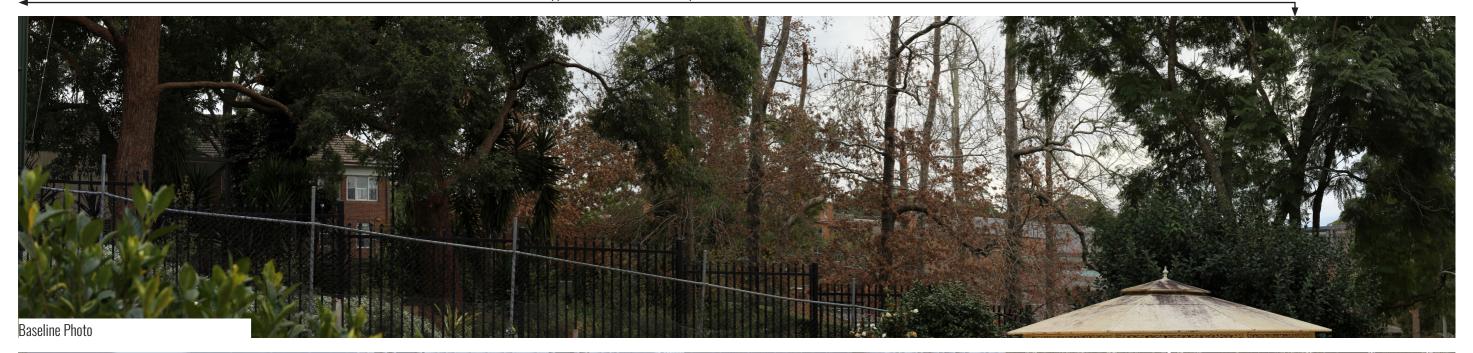
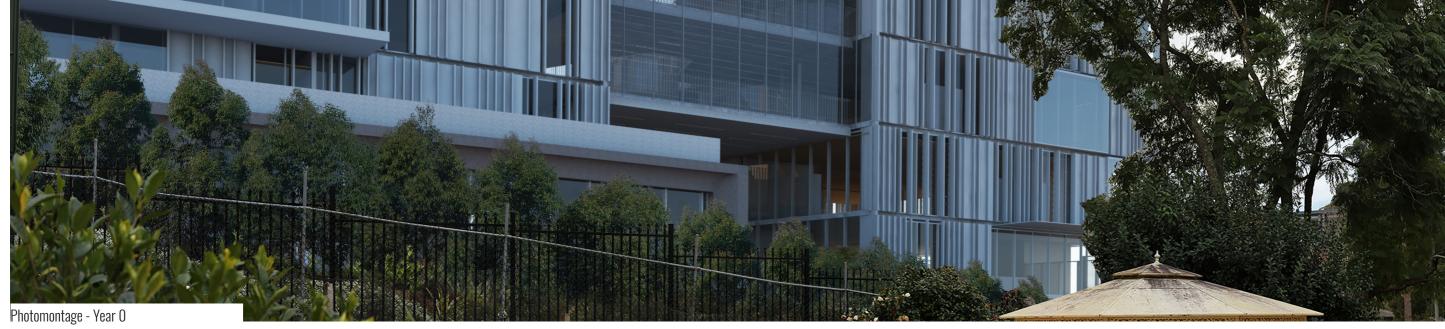
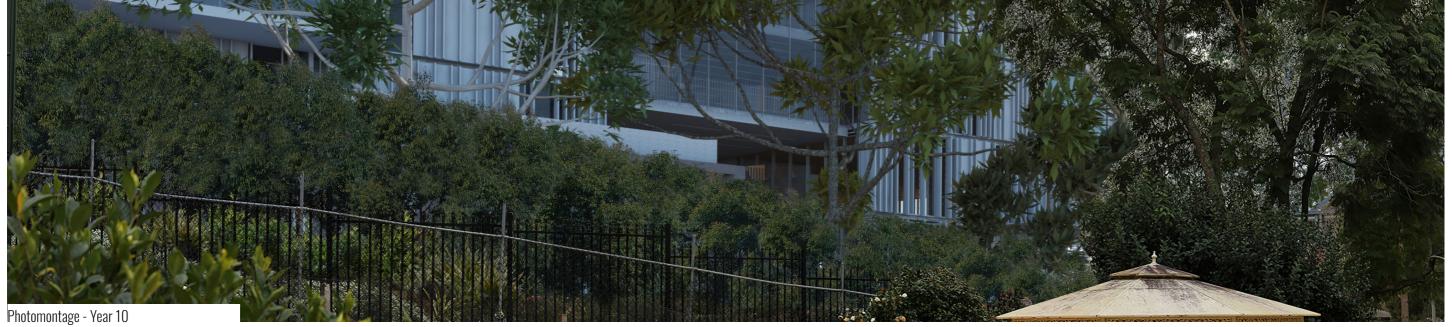
Figure 24: Viewpoint 1 - No. 59B Pymble Ave, Pymble - Looking North (Photomontage)

Viewing Location	No. 59B Pymble Ave, Pymble - Looking North
GPS	33°44'55"S, 151°8'11"E
Elevation (Eye-level)	117.53m
Date and Time of Photograph	8th June 2021 - 11.24am
Existing View & Photomontage Figures	Figure 24 and 24a (Photomontage Extended Angle of View - Refer to separate viewpoint sheet)
Visual Description	
Approx. Viewing Distance from Proposed Development	30m
View description & prominence of the development	This view was taken from the rear garden at ground level from No. 59B. This property is not located inside of the designated C11 conservation area.
	In the foreground the garden contains a swimming pool, pergola, paving and landscaping. The fence line to the college can be seen as a black palisade to the rear of the garden, to the right of the image is the fence line which adjoins the Grey House Walk access way from Pymble Avenue.
	The development will be in close proximity to this residential receiver.

Visual Receptor Sensitivity	The present view of the College campus is well screened by existing trees within the development area. Views will be possible from living spaces outside and inside of the property, although the property is not within the conservation area, residential receptors are often more critical of their view. Therefore, the sensitivity has been judged to be <b>high.</b>
Magnitude of Change	At Year O, planting will help to soften the visual impact, following maturity of landscaping at year 10 the building will be further screened and provide more privacy for the dwelling. The new development will be readily apparent in the view with a noticeable horizontal and vertical extent affected. Therefore, it is judged that the residual magnitude of change is <b>high.</b>
Significance of Visual Impact	The significance of the visual impact at this location is judged to be <b>high/moderate</b> .

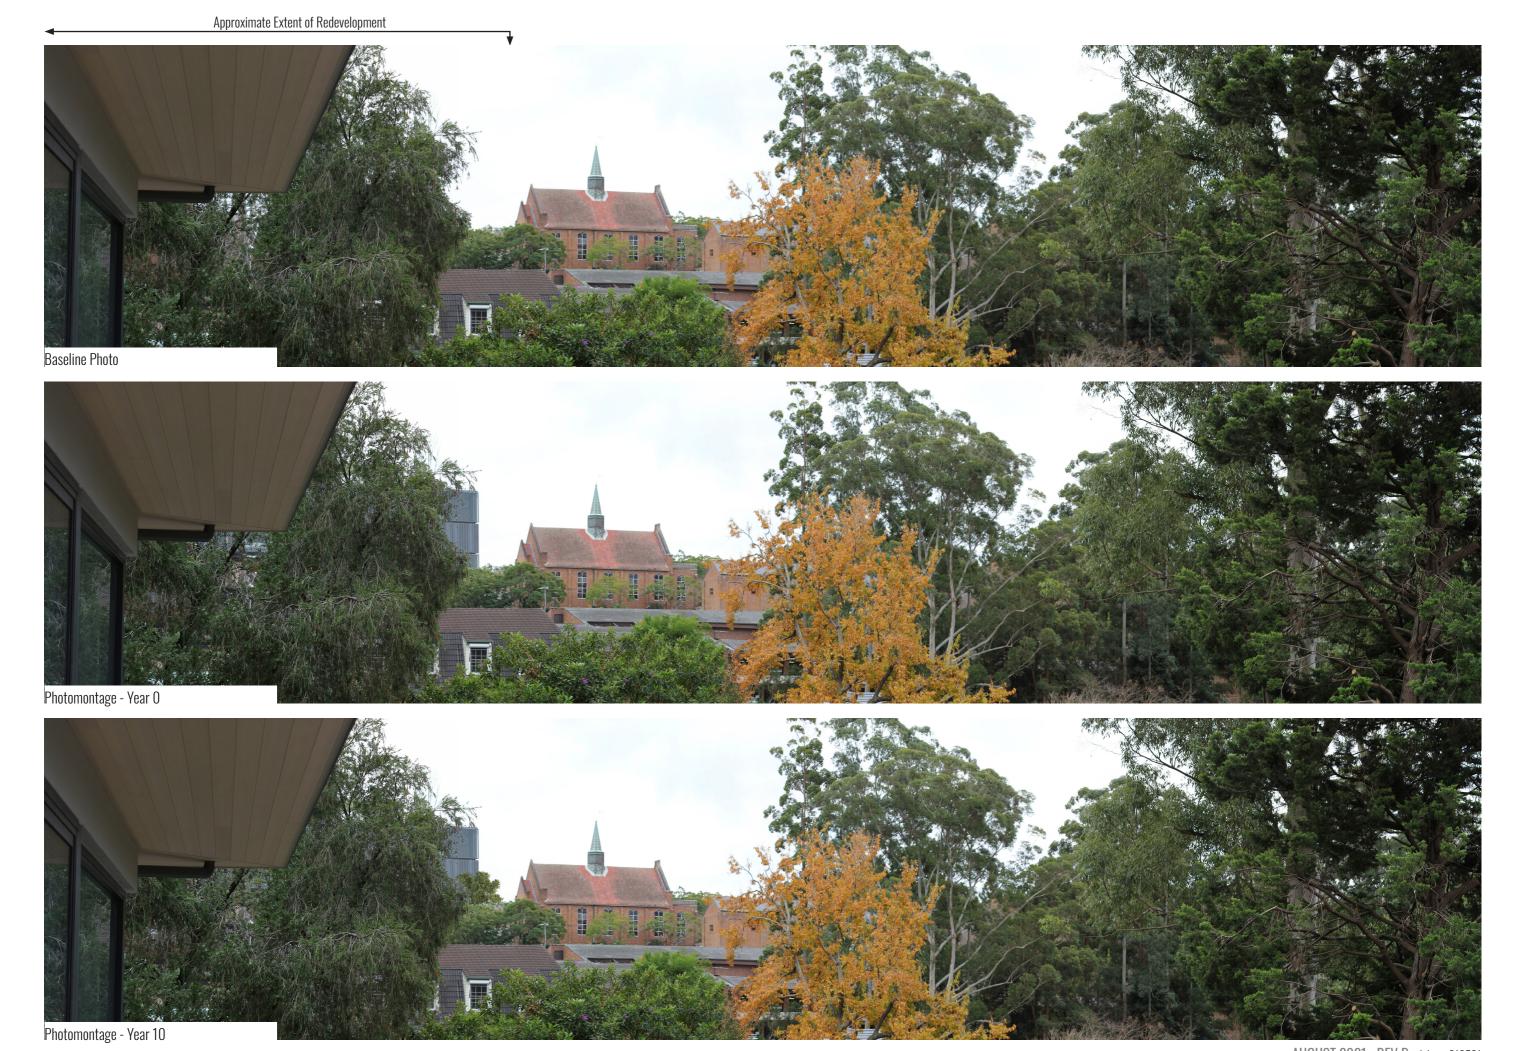
The property is listed as being within conservation area C11 and the view was taken from the first floor balcony. Buildings from the College campus are visible with the Chapel being highly prominent, vegetation to the property boundary and to the surrounding area does screen property 57A and some lower lying Campus buildings. The proposed development is located to the left of the photograph.

The view is currently one that has a leafy outlook with views towards the Chapel, the property is within conservation area C11 and primary and secondary living spaces are likely to affected by the resultant view.

Therefore, the visual sensitivity has been judged to be **high**.

Magnitude of Change The proposed development will form a new element within the view that will be recognisible to the receptor. However, the combination of existing vegetation coupled with the presence of other residential dwellings

between the receptor and the development, lessens the visual impact. Ground level views are also judged to experience a similar resultant visual impact. Therefore, it is judged that the residual magnitude of change is

low.

The significance of the visual impact at this location is judged to be **moderate/minor**.

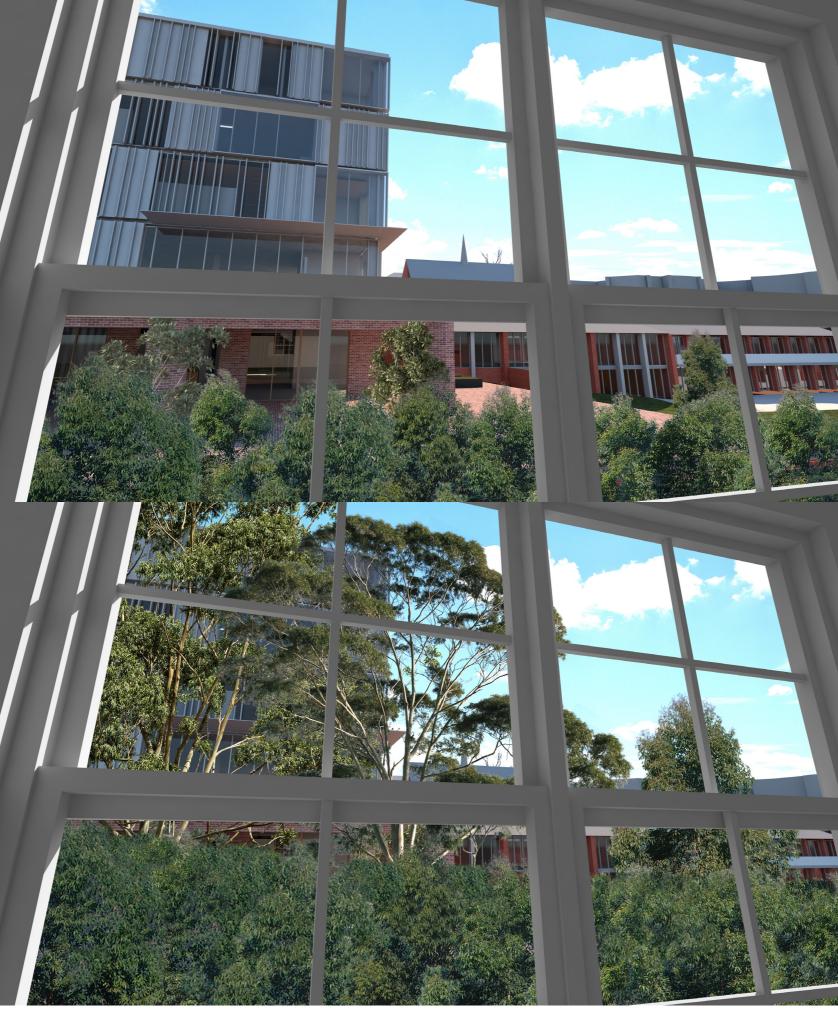
CGI - Year O

A photograph from within the property was not possible on the day of the site visit. Therefore the images presented are fully computer generated and accurately represent the height of the north facing windows of the

This residential property is the closest to the development of those located along Pymble Ave, however it is not within conservation area C11. Due to the proximity the visual sensitivity has been judged to be high.

Magnitude of Change Proposed landscape planting is expected to soften the built form, however due to the close proximity of the receptor, the development is likely to create a new focal element affecting a large extent of the horizontal

and vertical view corridor. It is judged that the residual magnitude of change is **high**.

The significance of the visual impact of the proposed scheme at this location is judged to be high/moderate.

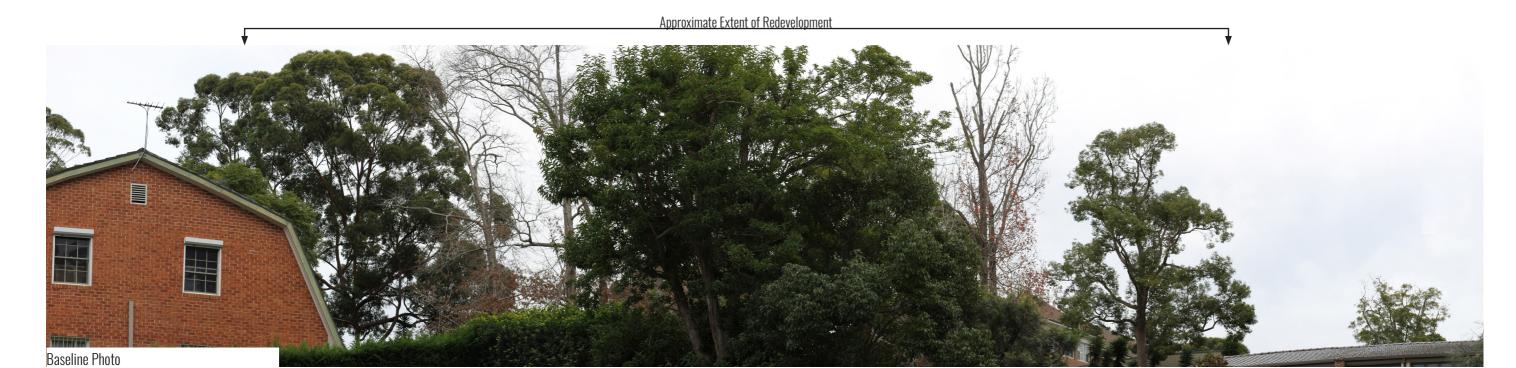
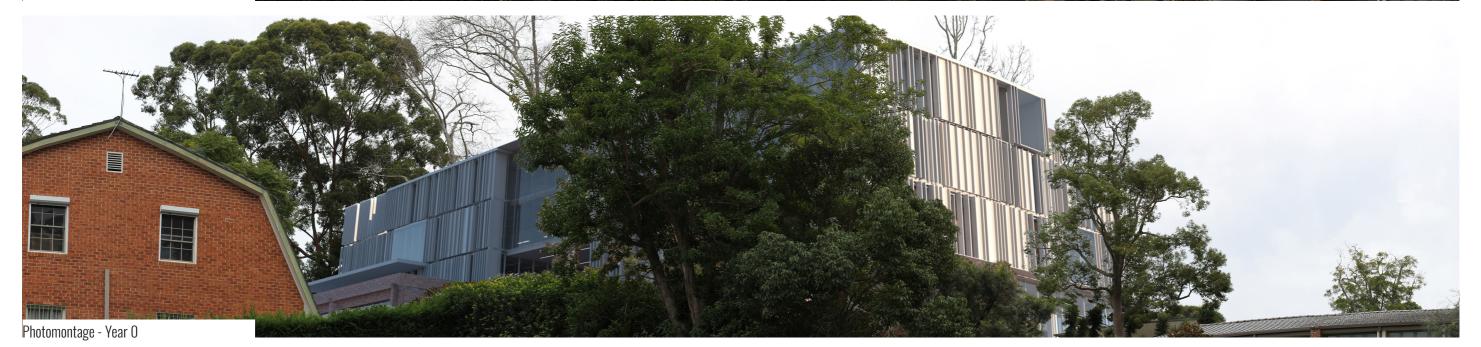
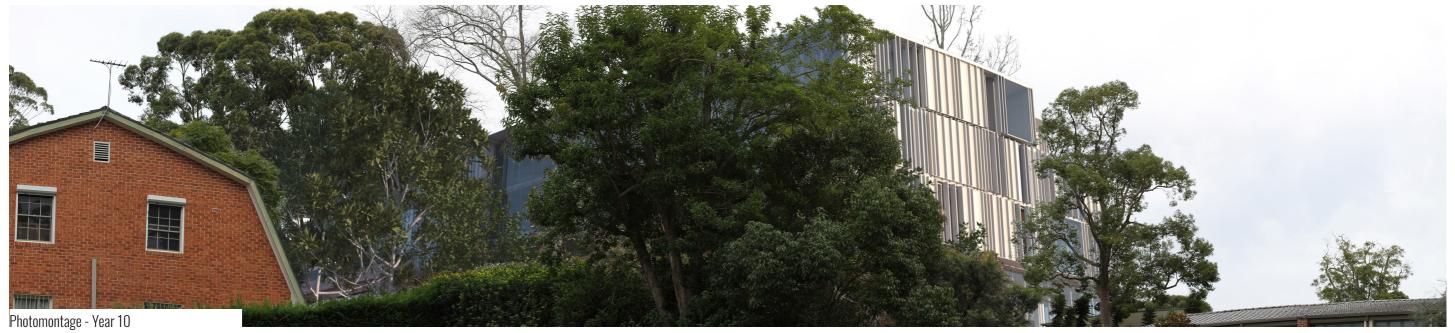
Figure 27: Viewpoint 4 - No. 53 Pymble Ave, Pymble - Looking West (Photomontage)

This view was taken from the rear garden adjacent to the pool of a presently under construction property. The rear garden terraces up towards the boundary of the college campus and this can be seen marked by the black palisade fencing. The junior school is visible above the fence line and Goodlet House is visible through the tree line. There is a dense hedge along the western boundary and No 57A is to the left of the image.

Generally views of the College Campus are presently well screened by existing trees within the development area. Views will be possible from living spaces outside and inside of the property, although the property is

not within the conservation area, residential receptors are often more critical of their view. Therefore, the sensitivity has been judged to be **high.**

Magnitude of Change The new development will be apparent in the view with a noticeable horizontal and vertical extent affected. Existing vegetation combined with the maturity of landscaping planting at year 10, will help to soften the

visual impact and provide more privacy for the dwelling. Therefore, it is judged that the residual magnitude of change is **medium.**

Significance of Visual Impact The significance of the visual impact at this location is judged to be **moderate.**

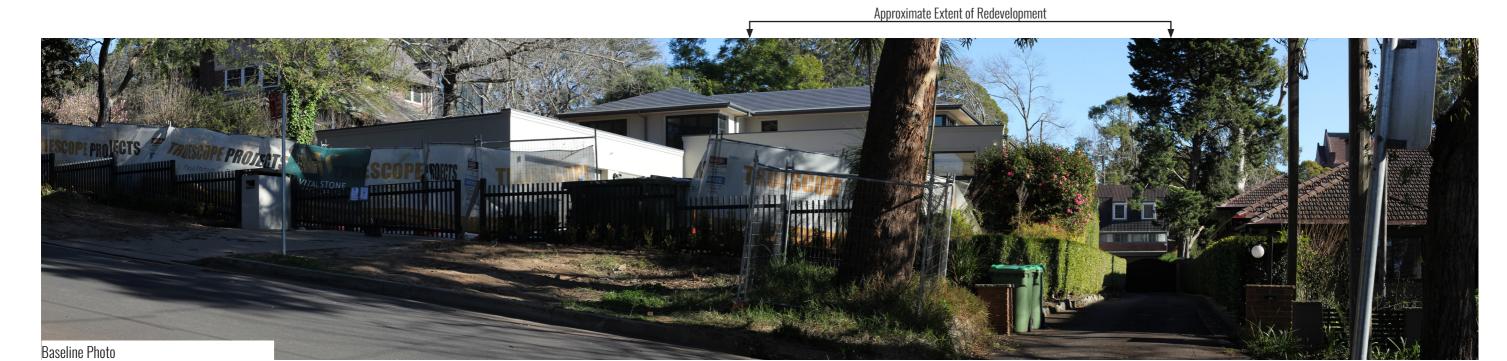
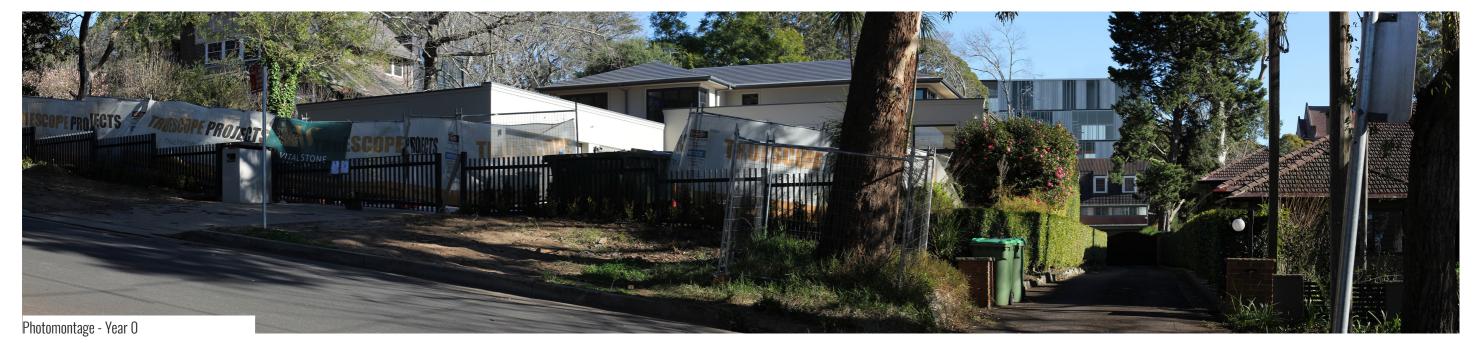
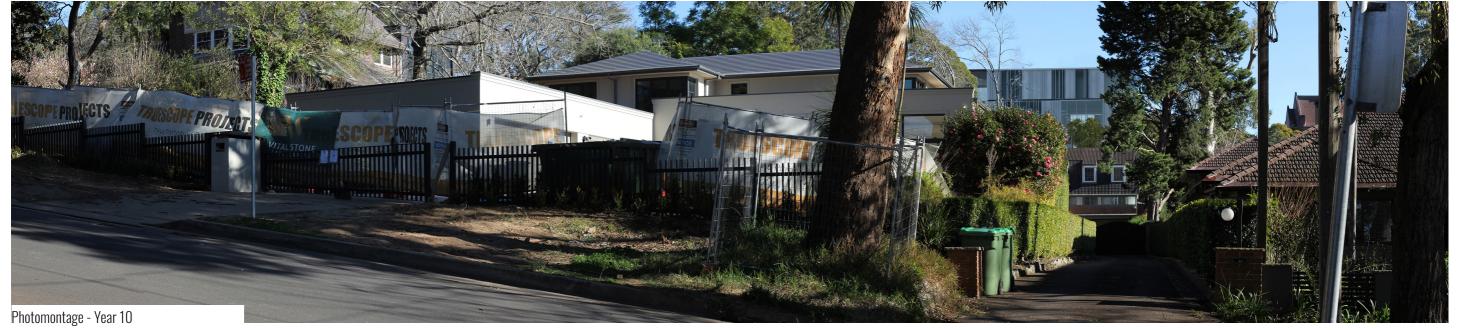
Figure 28: Viewpoint 5 - Pymble Avenue, opposite No.57, Pymble - Looking Northwest (Photomontage)

This view was taken along Pymble Avenue from a location identified during the drone photography, existing dwellings or existing vegetation, Pymble Avenue is generally well screened from

potential views of the development, however a few small view corridors will still exist.

The baseline photograph was taken just on the edge of the conservation C11 area, the C11 designation of the road itself extends southeast from this location. Residents would experience this view most likely when

walking along Pymble Aveune. In the foreground are residential properties with the development site situated behind. Due to the proximity to the C11 area and the DCP controls relating to views upon heritage areas,

the sensitivity has been judged to be **high.**

Magnitude of Change The proposed development will form a minor constituent of the view being partially visible and at sufficient distance to be a small component. A small horizontal and vertical extent of the view is only likely to be

affected. Therefore, it is judged that the residual magnitude of change is **low.**

The significance of the visual impact at this location is judged to be **moderate/minor**.
