Report on
Preliminary Site Investigation (Contamination) with
Limited Sampling

Taronga Reptile and Amphibian Conservation Centre
Taronga Zoo

Prepared for
Taronga Conservation Society Australia

Project 99931.00
July 2021

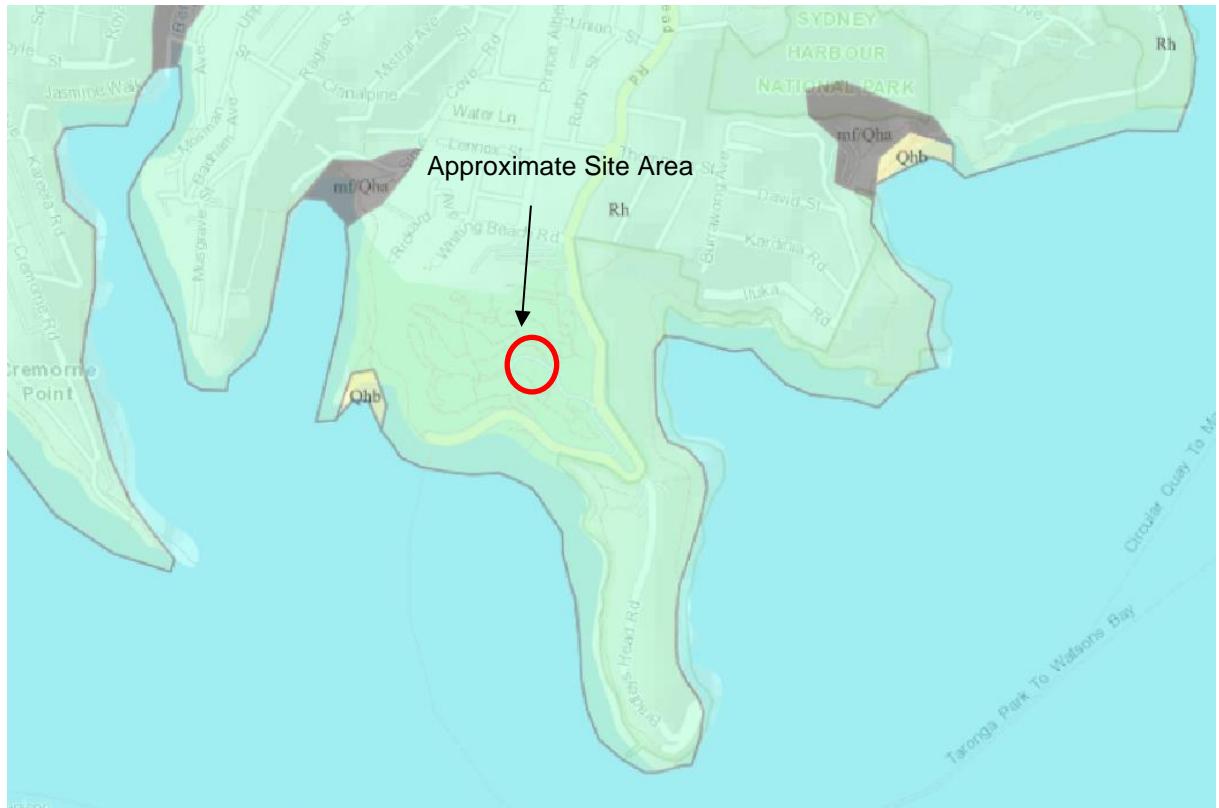
Figure 1: Extract from geological map

The *Sydney 1:100 000 Geological Series Sheet* shows that the site is underlain by Hawkesbury Sandstone which typically comprises medium to coarse-grained quartz sandstone with minor shale and laminitic lenses. An extract from the geological map is shown in Figure 1.
