Report on
Geotechnical Investigation

Taronga Reptile and Amphibian Conservation Centre
Taronga Zoo

Project 99931.00
July 2021

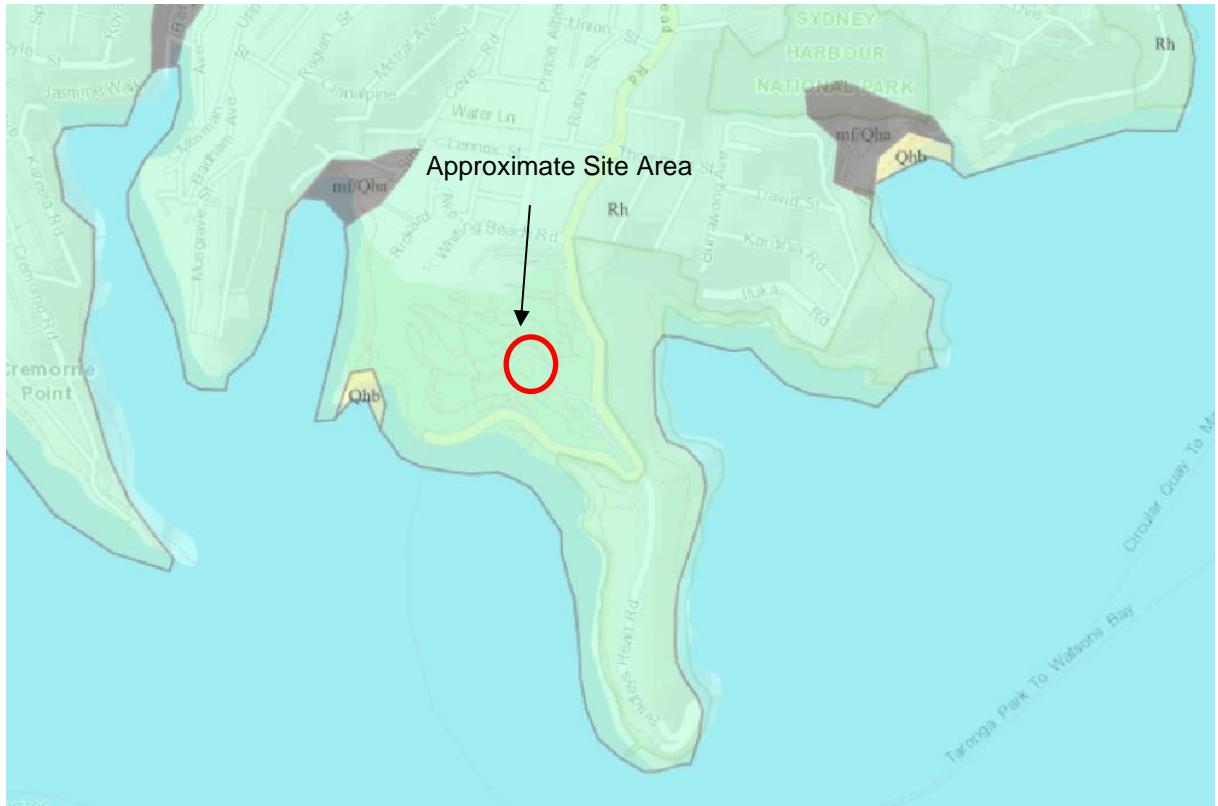
Figure 1: Extract from geological map

The Sydney 1:100 000 Geological Series Sheet shows that the site is underlain by Hawkesbury Sandstone which typically comprises medium to coarse-grained quartz sandstone with minor shale and laminitic lenses. An extract from the geological map is shown in Figure 1.

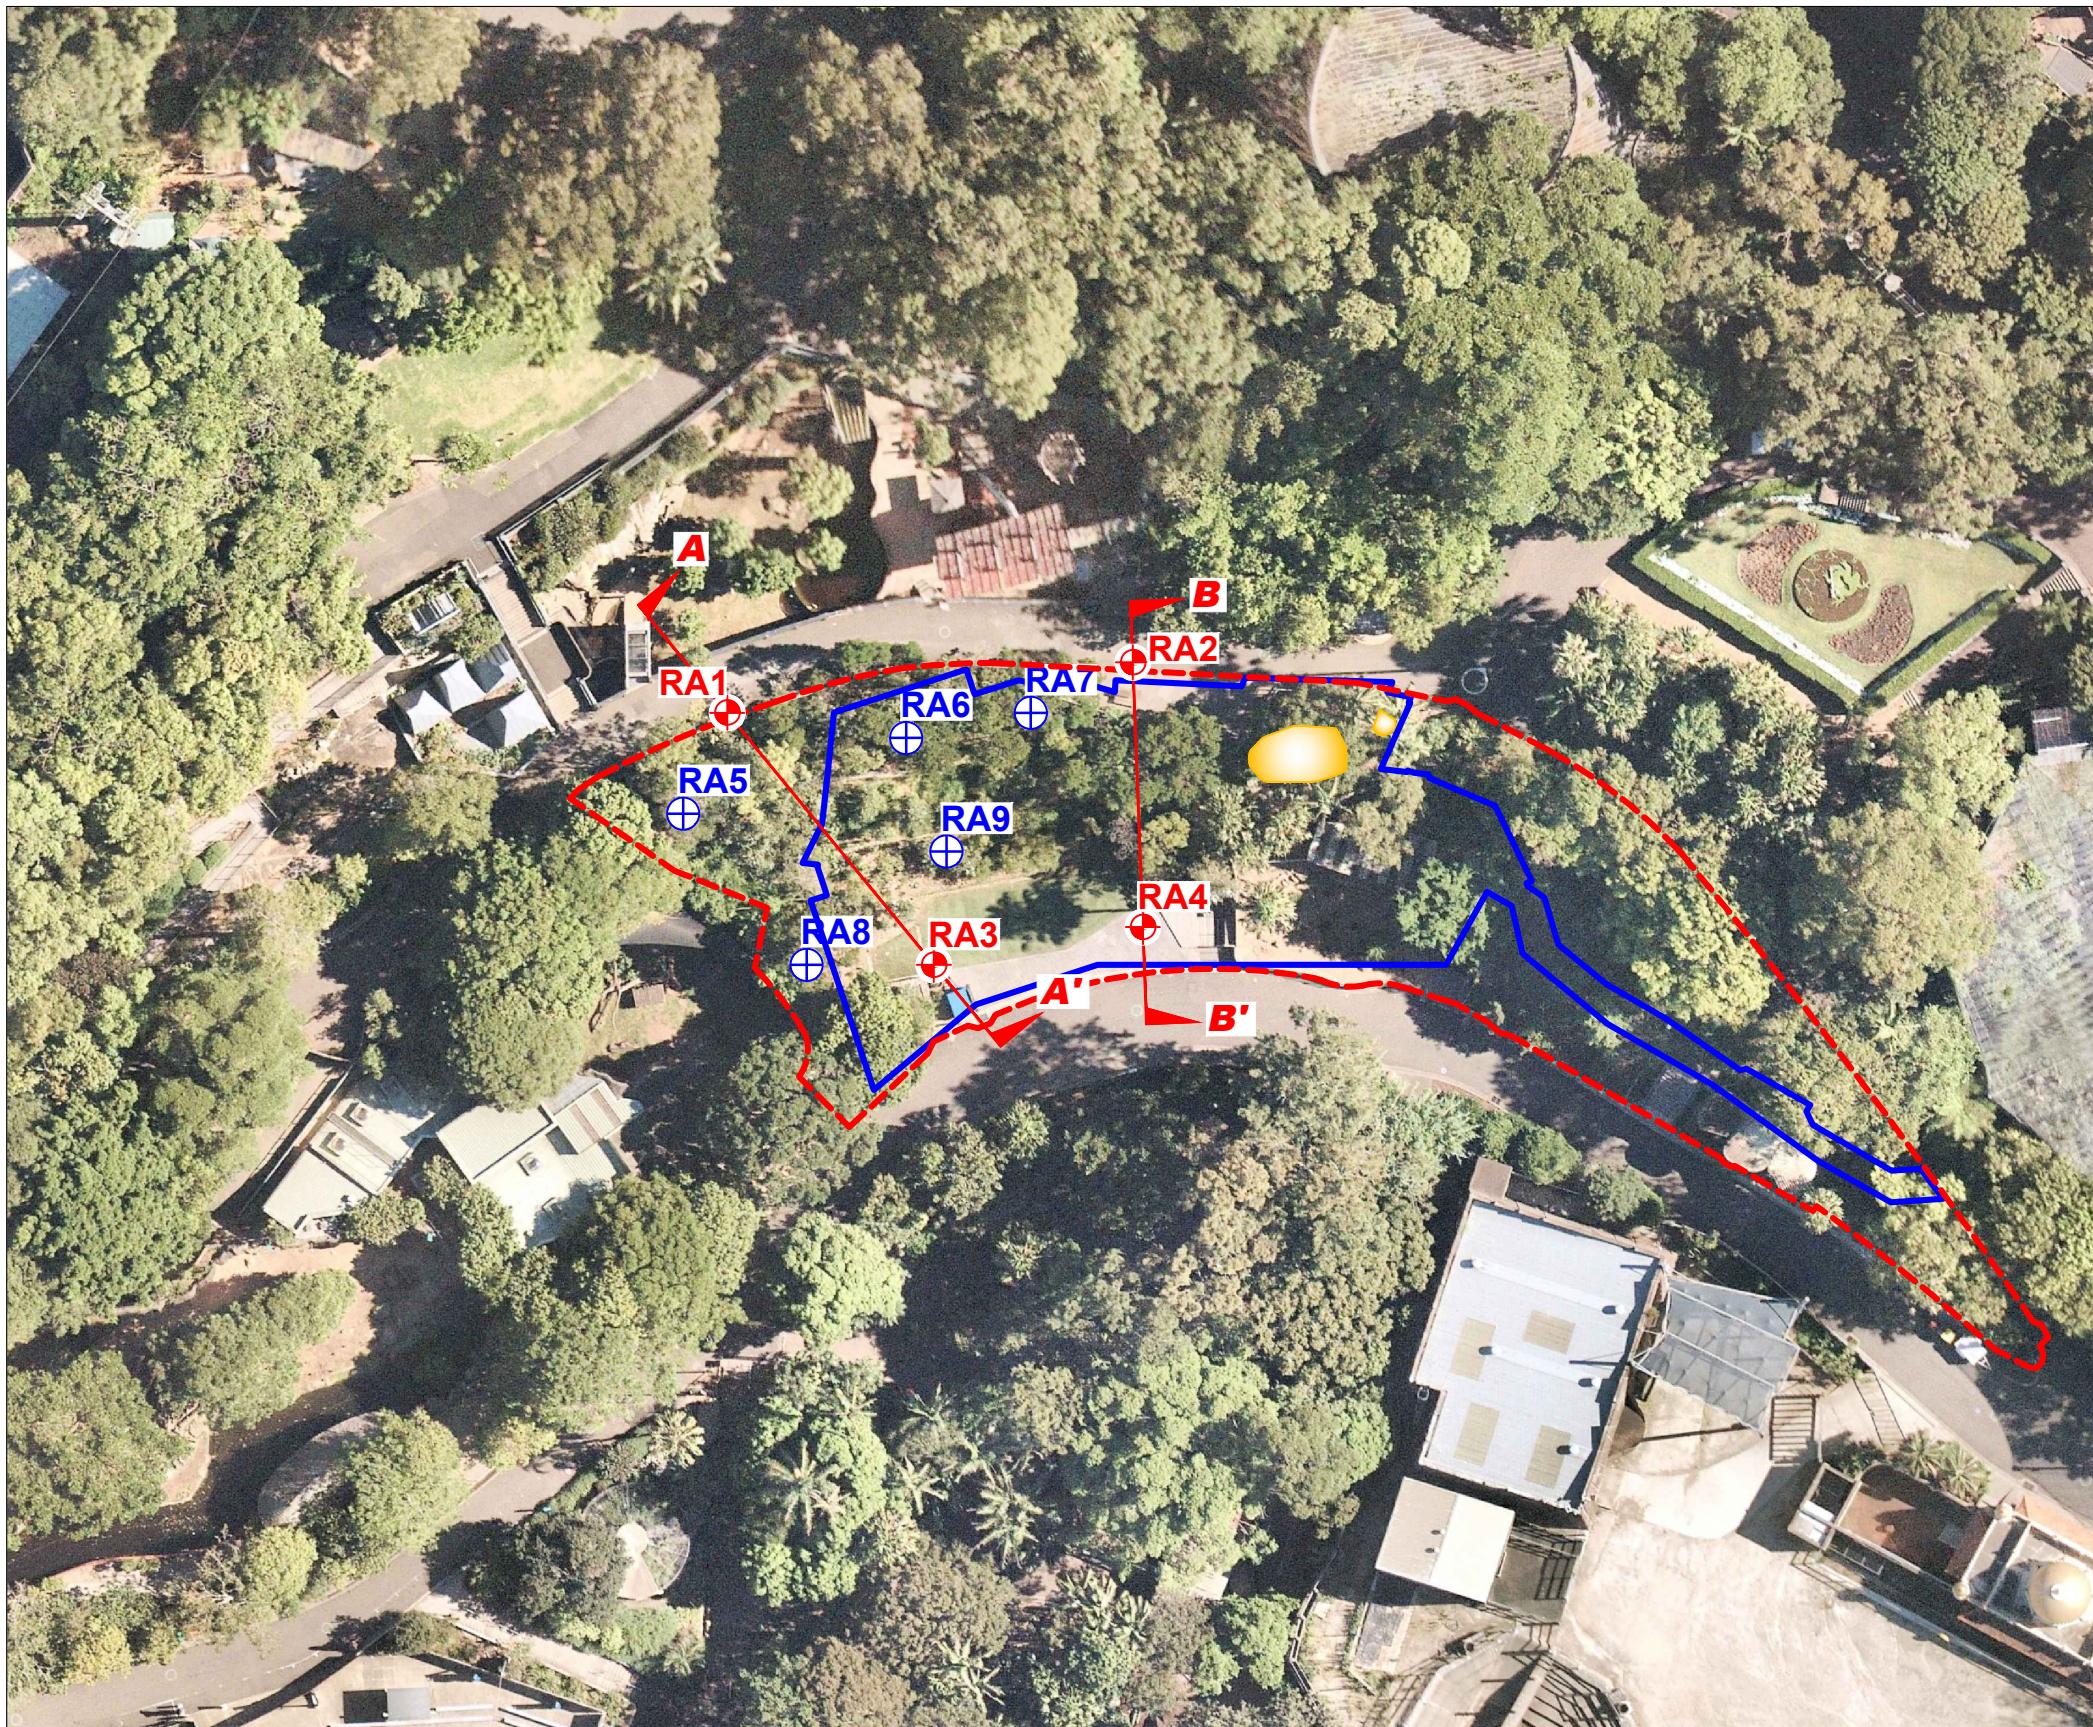
CLIENT: Taronga Conservation Society Australia
OFFICE: Sydney **DRAWN BY:** CJ/MG
SCALE: 1:600 @ A3 **DATE:** 06.07.2021
TITLE: **Test Location Plan**
Taronga Reptile and Amphibian Conservation Centre
Taronga Zoo, Mosman

Coordinates and levels for all test locations apart from RA5 to RA7 were determined using a differential GPS (dGPS) receiver. Due to heavy vegetation and interference from buildings the dGPS could not be used for RA5 to RA7 so levels at these test locations were estimated from the Details and Levels Plan (By: Hammond Smeallie & Co Pty Ltd, DWG No: TZ Master Survey with Infrastructure_MGA, Revision B, Dated 8/8/2017) provided by Taronga Conservation Society Australia. The test locations are shown on Drawing R1 in Appendix B.

Whilst undertaking the field work, mapping of outcropping rock and areas of obvious fill was completed. Observable rock outcrops are shown in Drawing R1 in Appendix B. Areas of deeper fill were

The portion of the site proposed for redevelopment is shown on Drawing R1 in Appendix B.

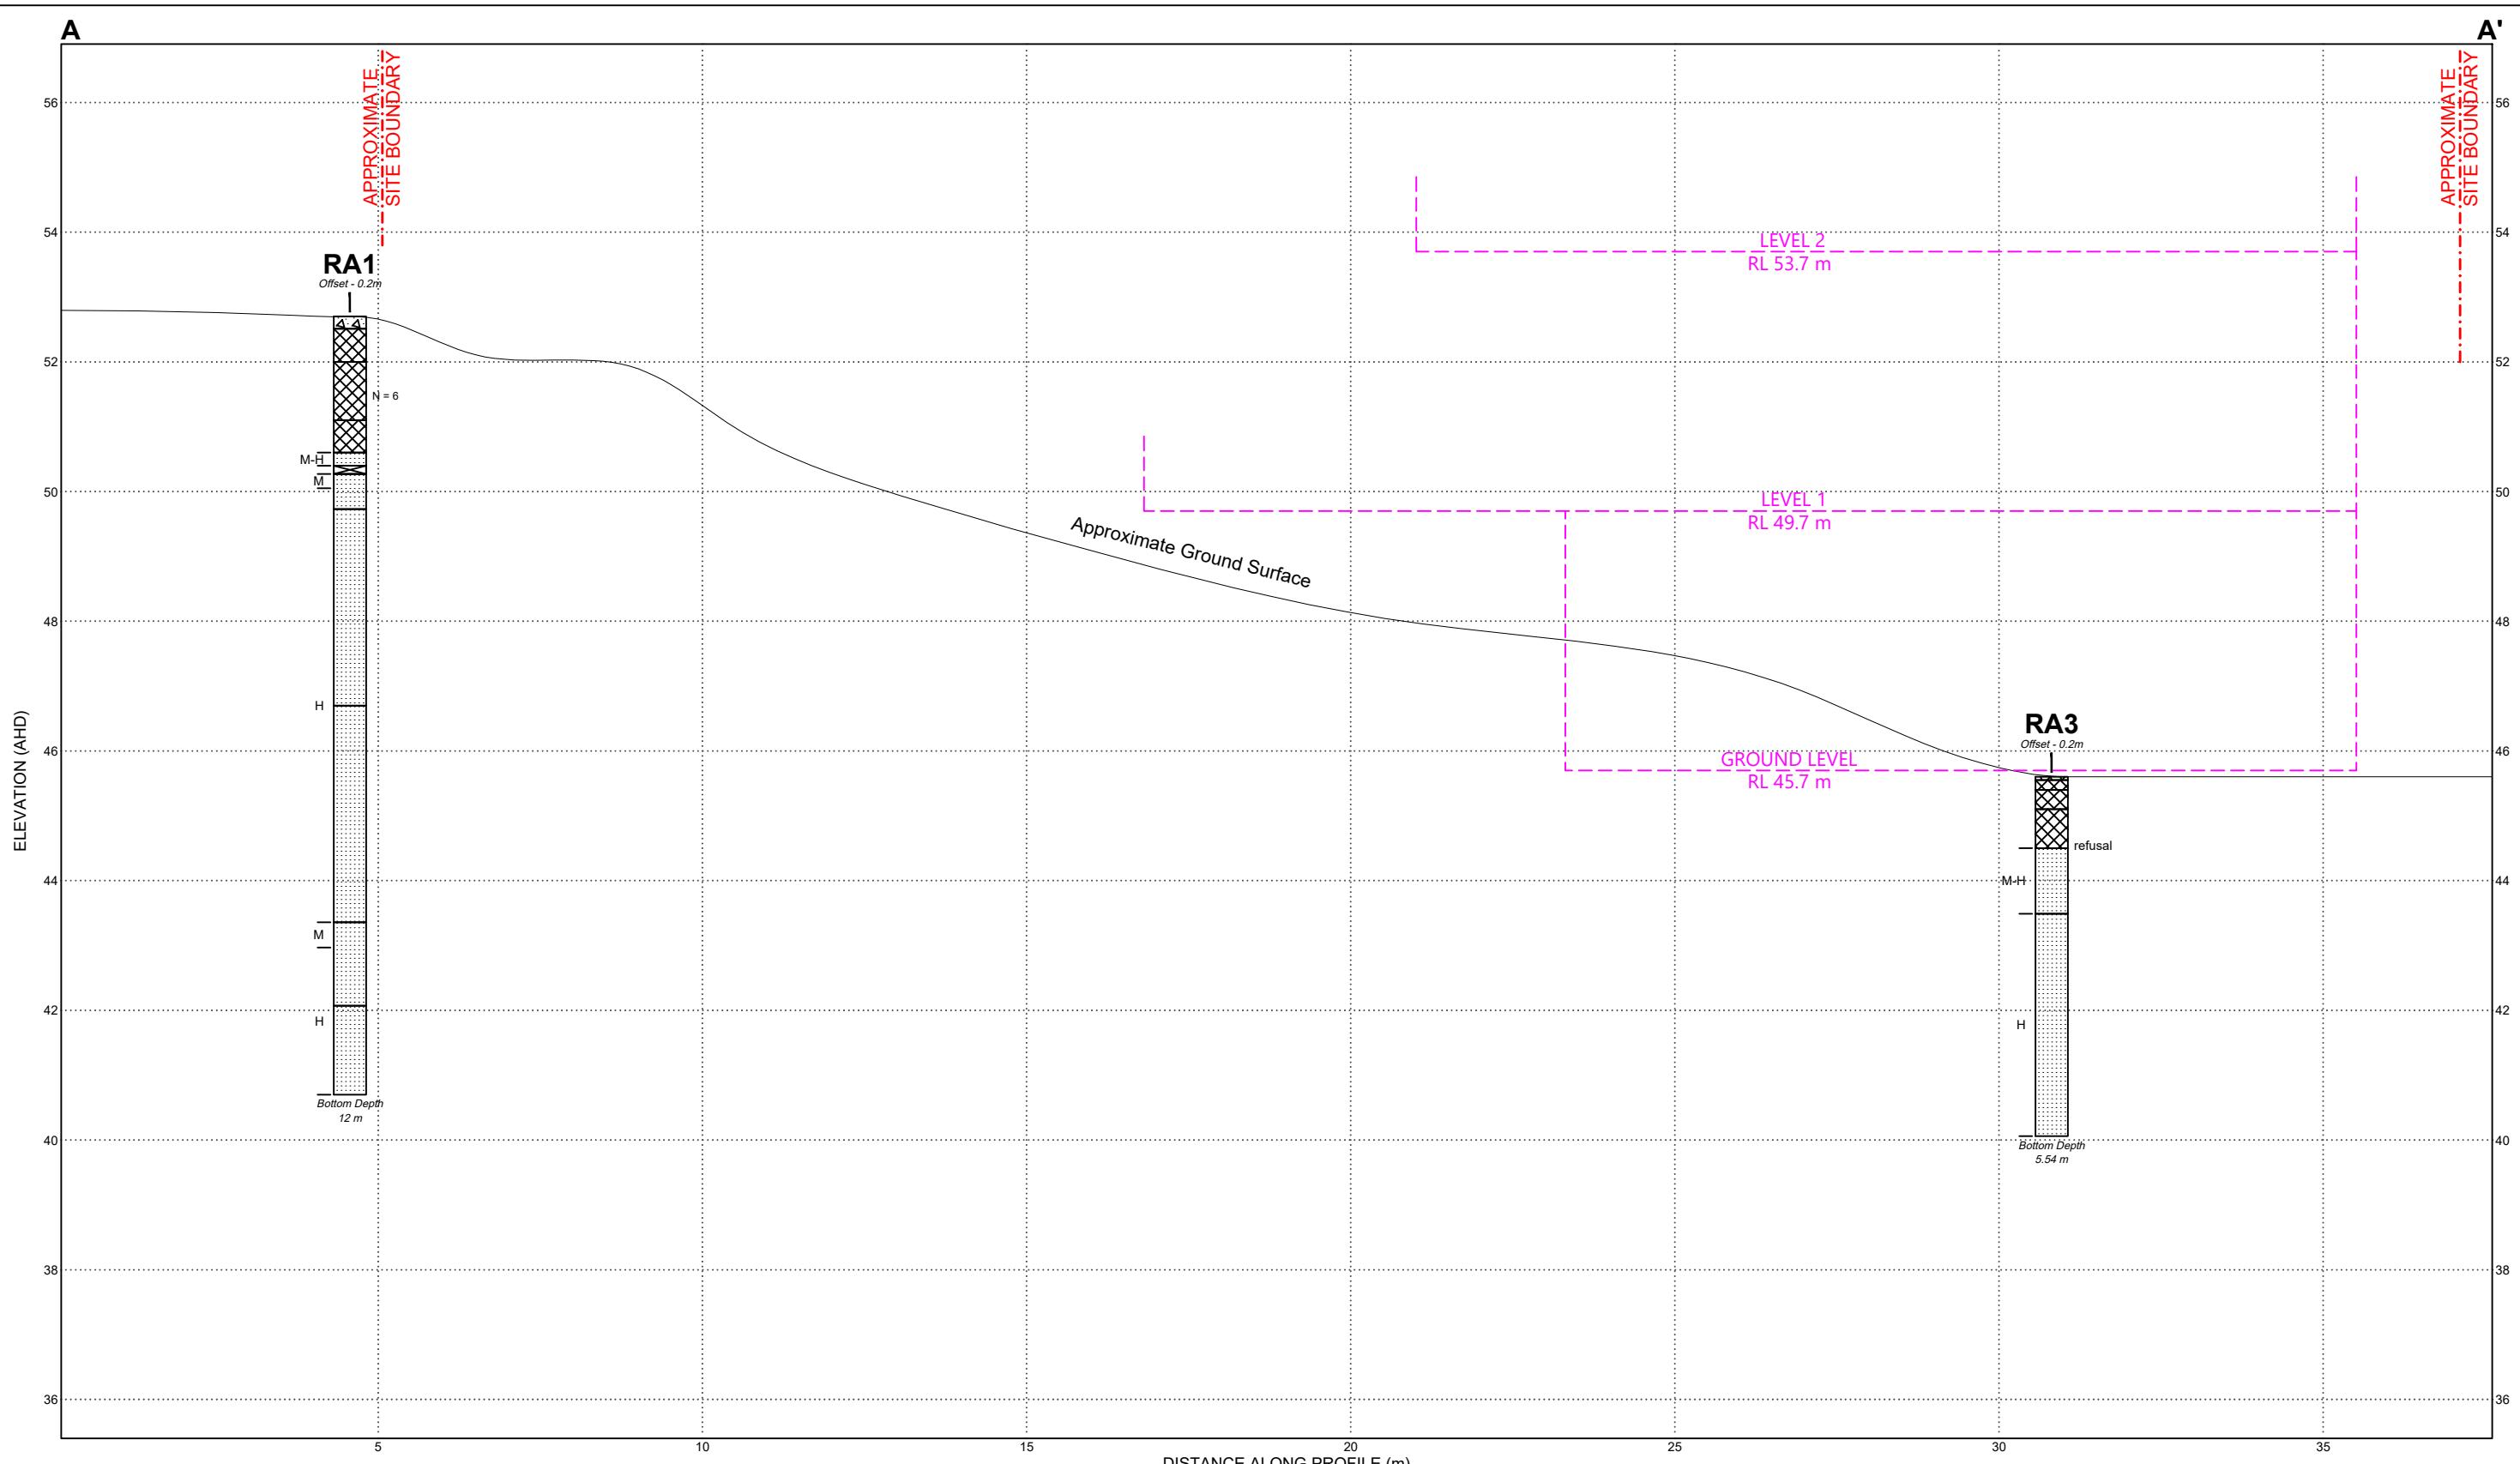
DRAWING No. R2

Geotechnical cross-sections are provided in Drawings R2 and R3 in Appendix B.

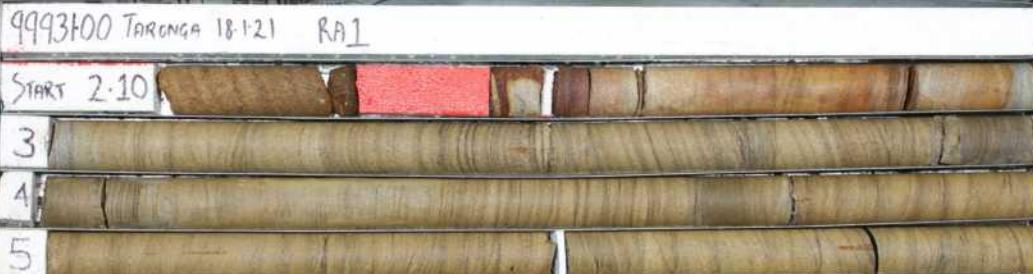
Project No: 99931.00
BH ID: RA1
Depth: 2.1 - 6 m
Core Box No.: 1/3

2.10 - 6.00m

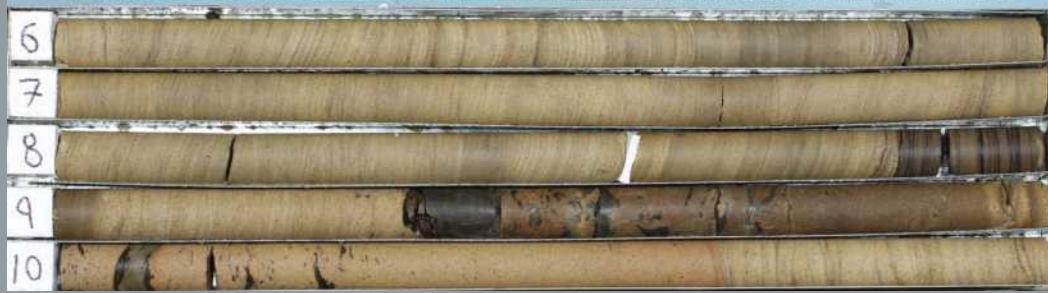
Project No: 99931.00
BH ID: RA1
Depth: 6-11 m
Core Box No.: 2/3

6.00 - 11.00m

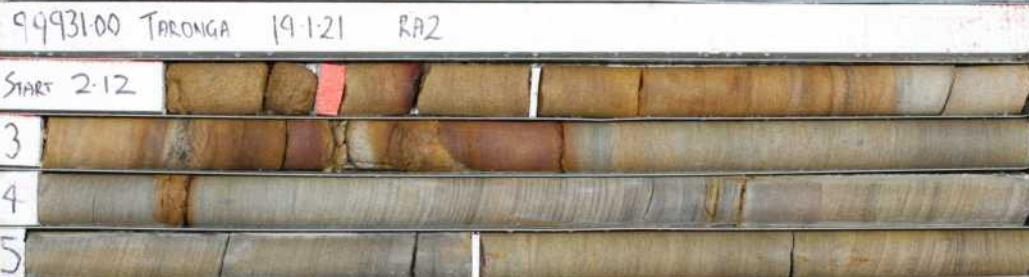
Depth: 2.12 - 6 m

2.12 - 6. 00m

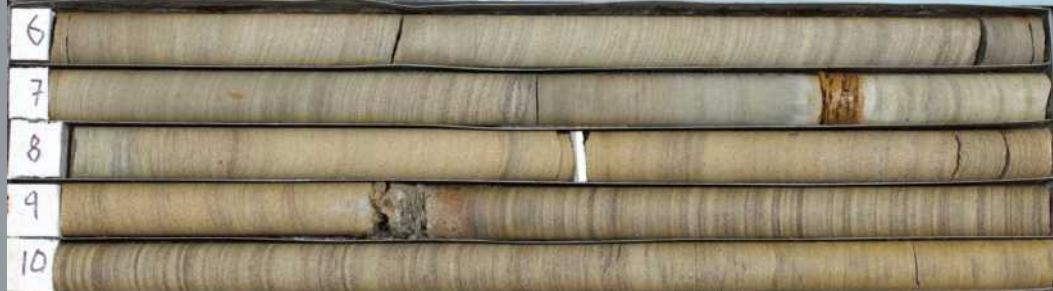
Depth: 6-11 m

6.00 - 11.00m
