# **HISTORICAL ARCHAEOLOGICAL ASSESSMENT**

**Reptile & Amphibian Conservation  
Centre, Taronga Zoo**  
Bradleys Head Road  
Mosman, NSW

Prepared for  
**TARONGA CONSERVATION SOCIETY AUSTRALIA**  
13 July 2021

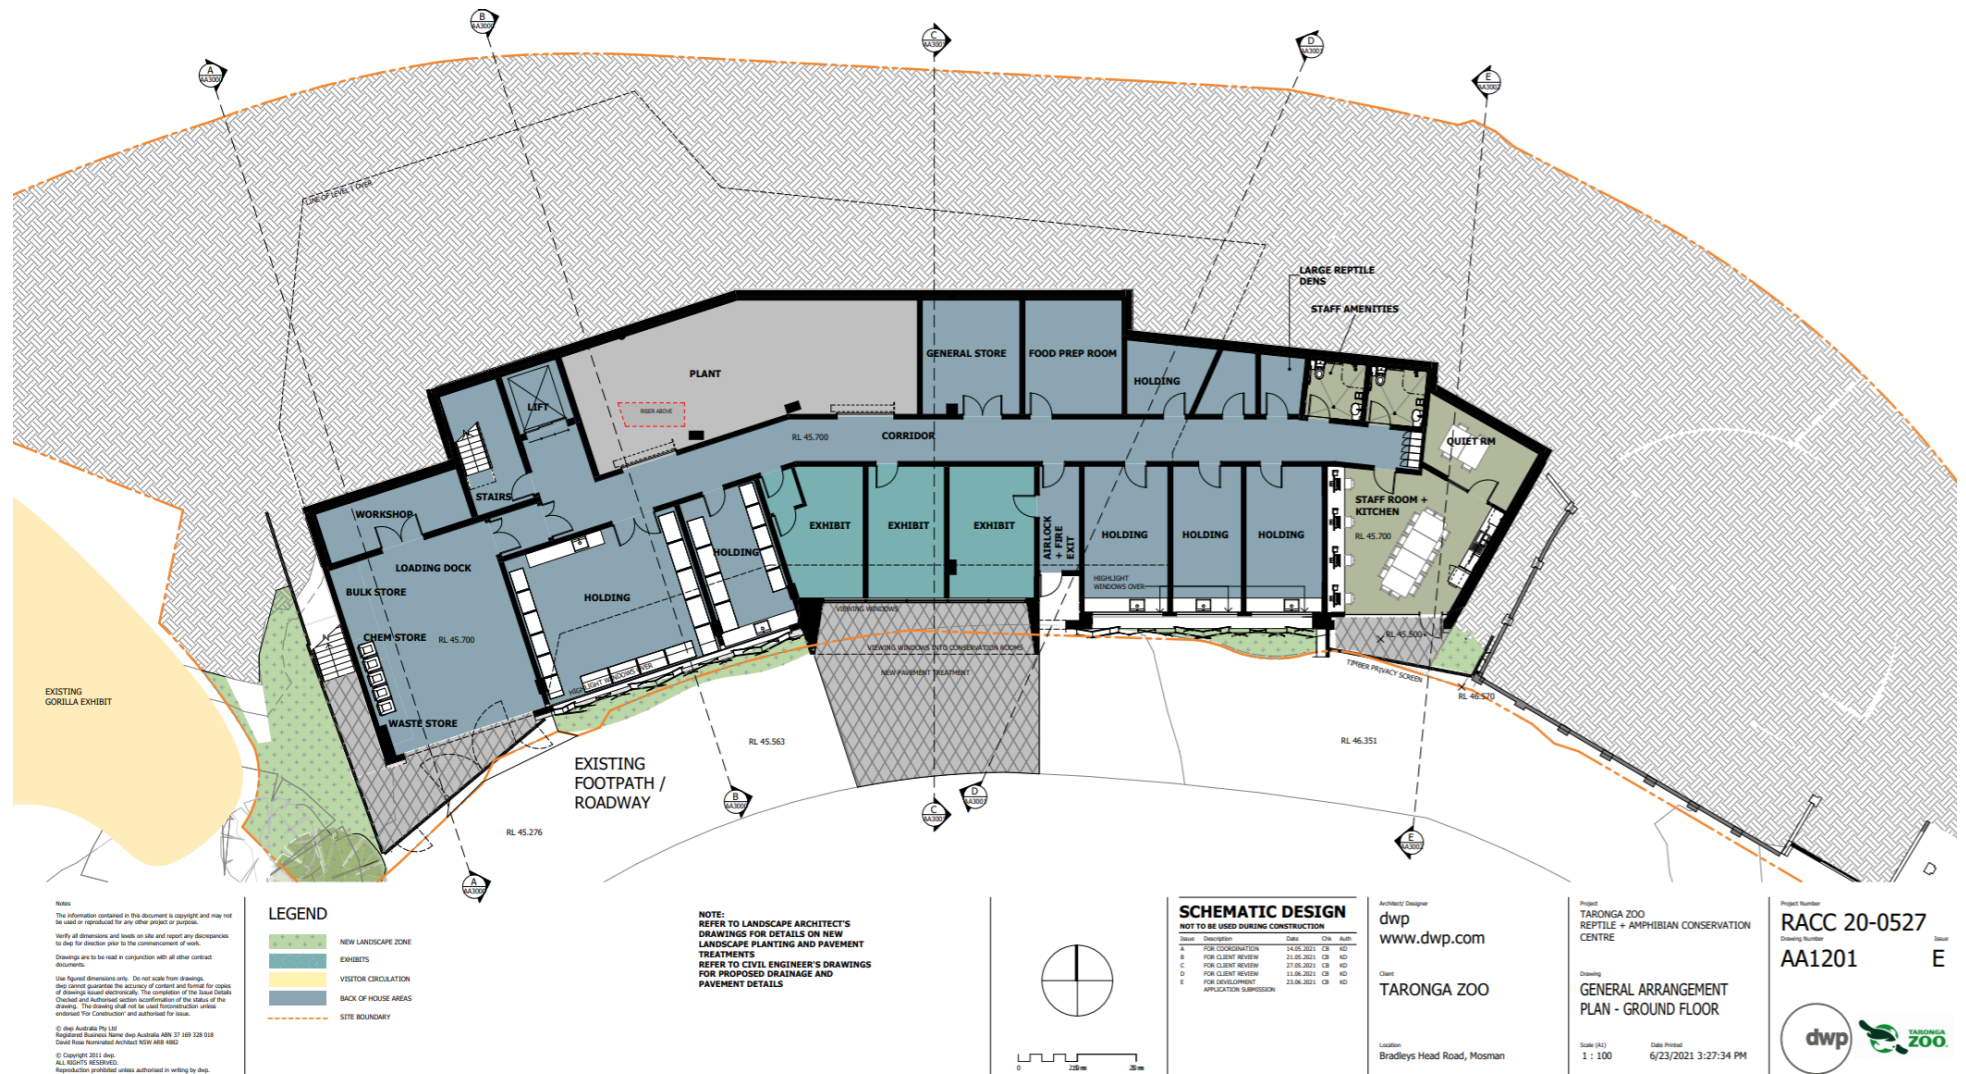
Figure 4 – General Arrangement Plan – Ground Floor  
 Source: DWP, 23/06/2021, Drawing no. AA1201, Issue E

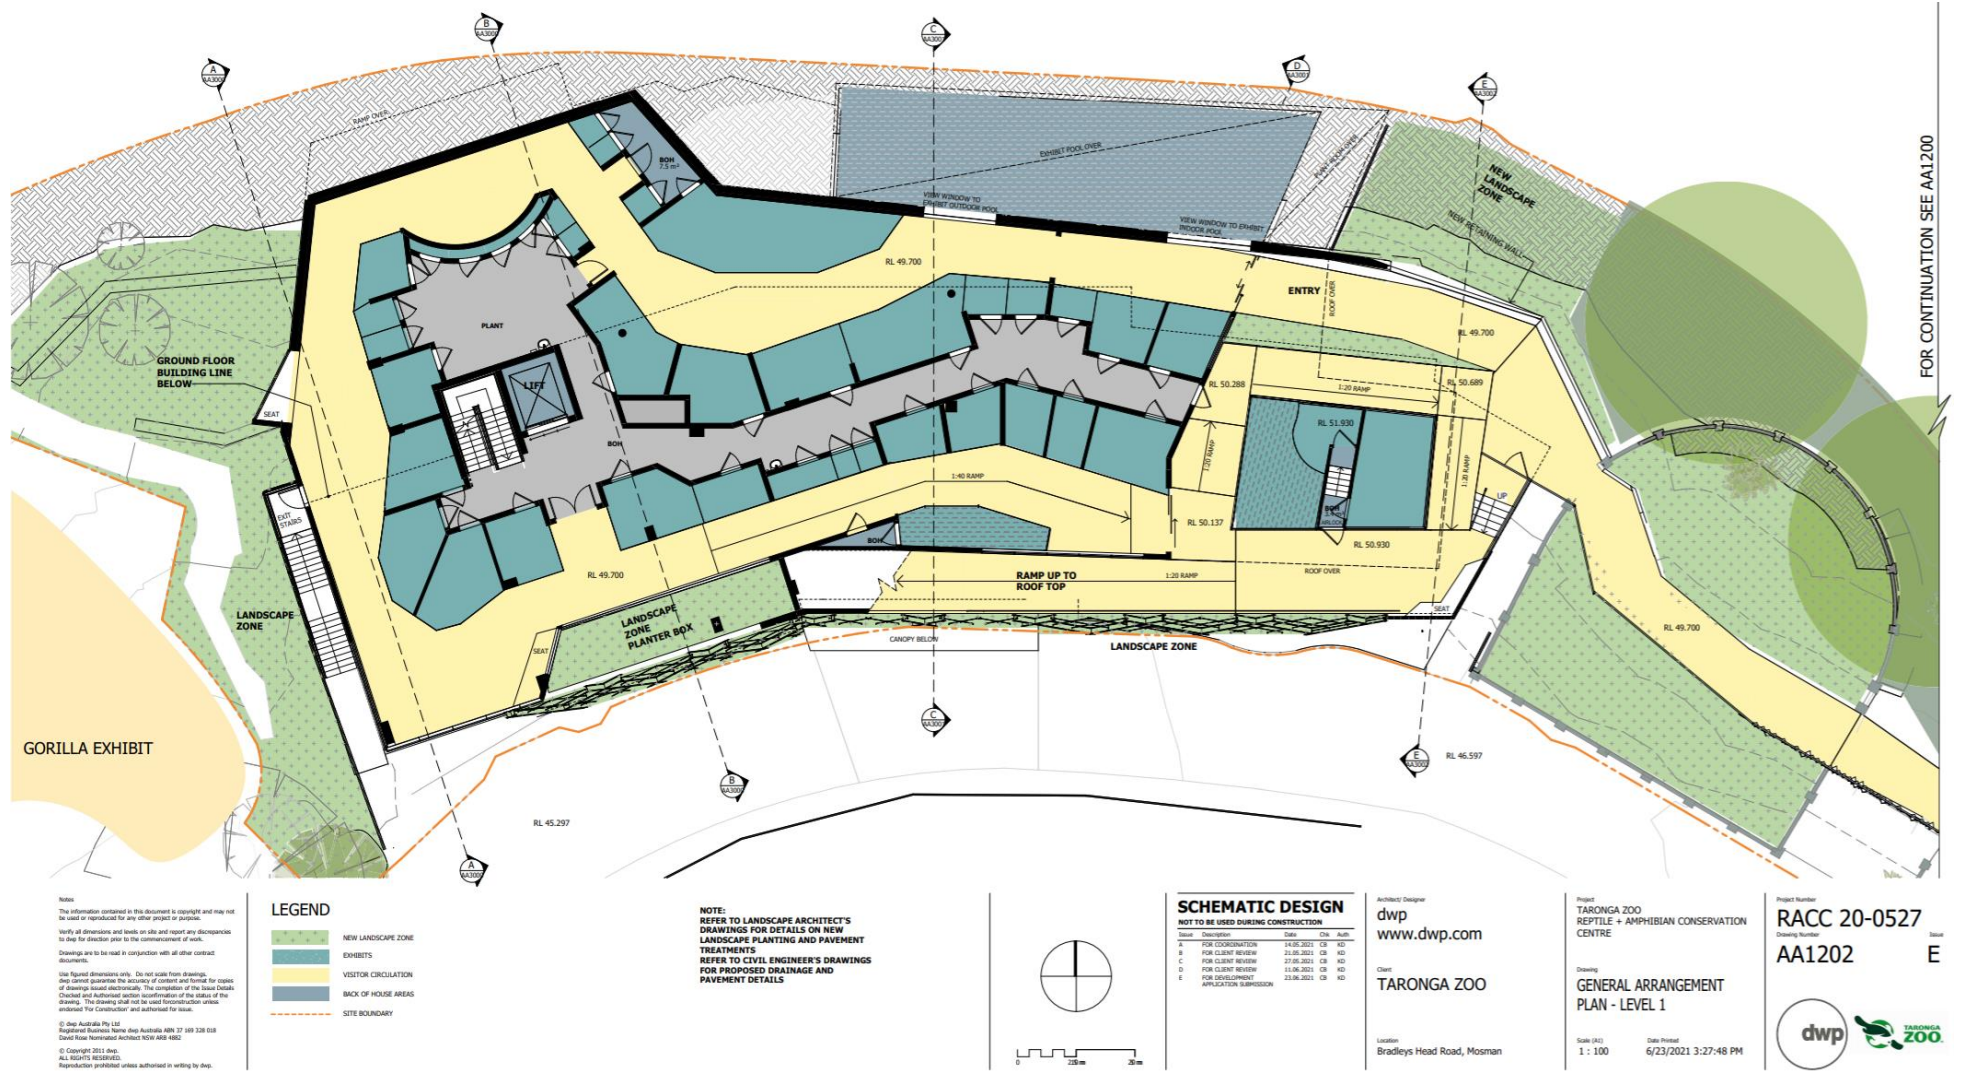
Figure 5 – General Arrangement Plan – Level 1

Source: DWP, 23/06/2021, Drawing no. AA1202, Issue E

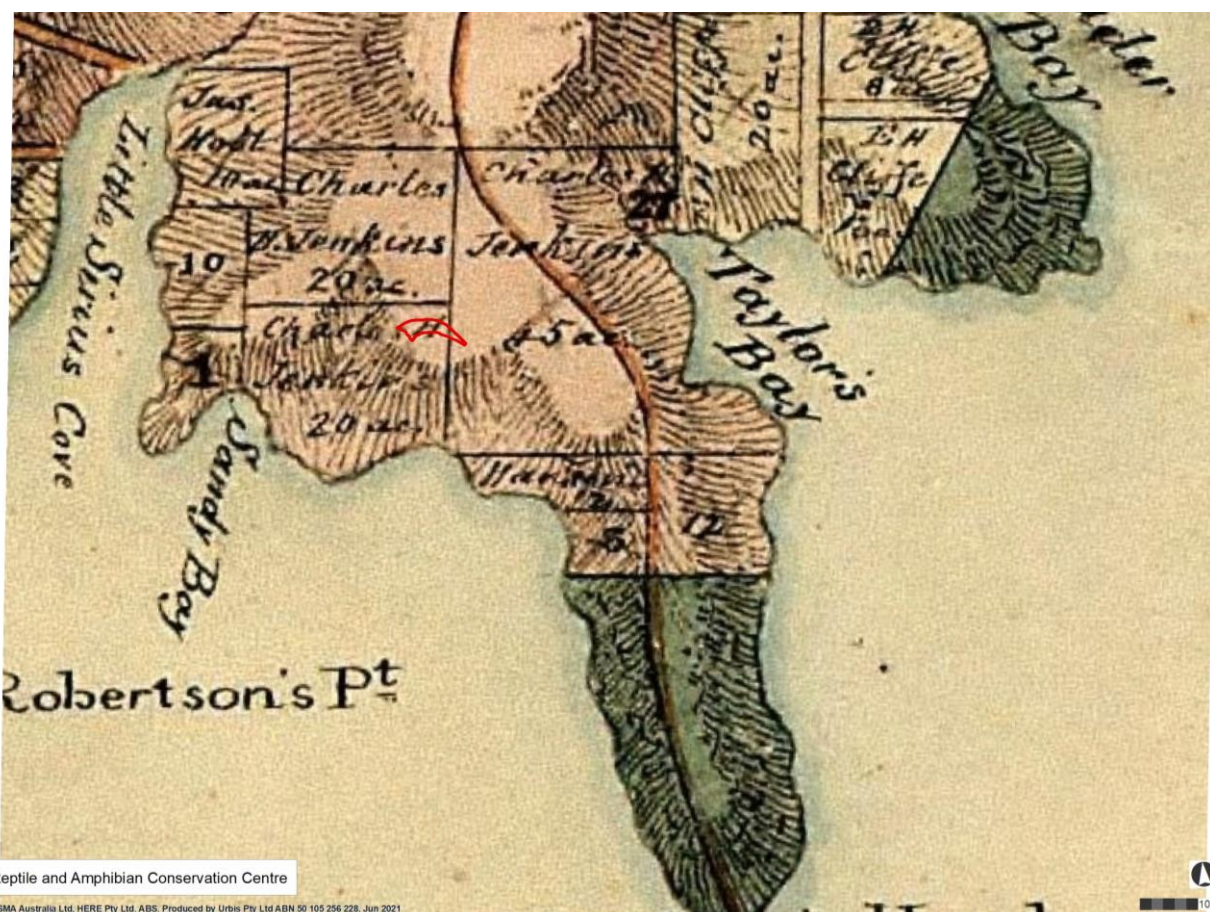
Figure 13 – Historic parish map of Willoughby, c. 1850s. Approximate location of the subject area indicated in red outline.

Taronga Zoo is located within the County of Cumberland, Parish of Willoughby. In 1837 a stone house known as 'Athol' was erected to the south of the subject area. This was later developed as a leisure destination with a hotel and pleasure garden. A Parish Map dating to c.1850s show that the subject area had by this time been incorporated within a land parcel granted in four allotments to Charles Jenkins and J. Holt (see Figure 13). There is no evidence of structures being erected within the subject area in association with this period.

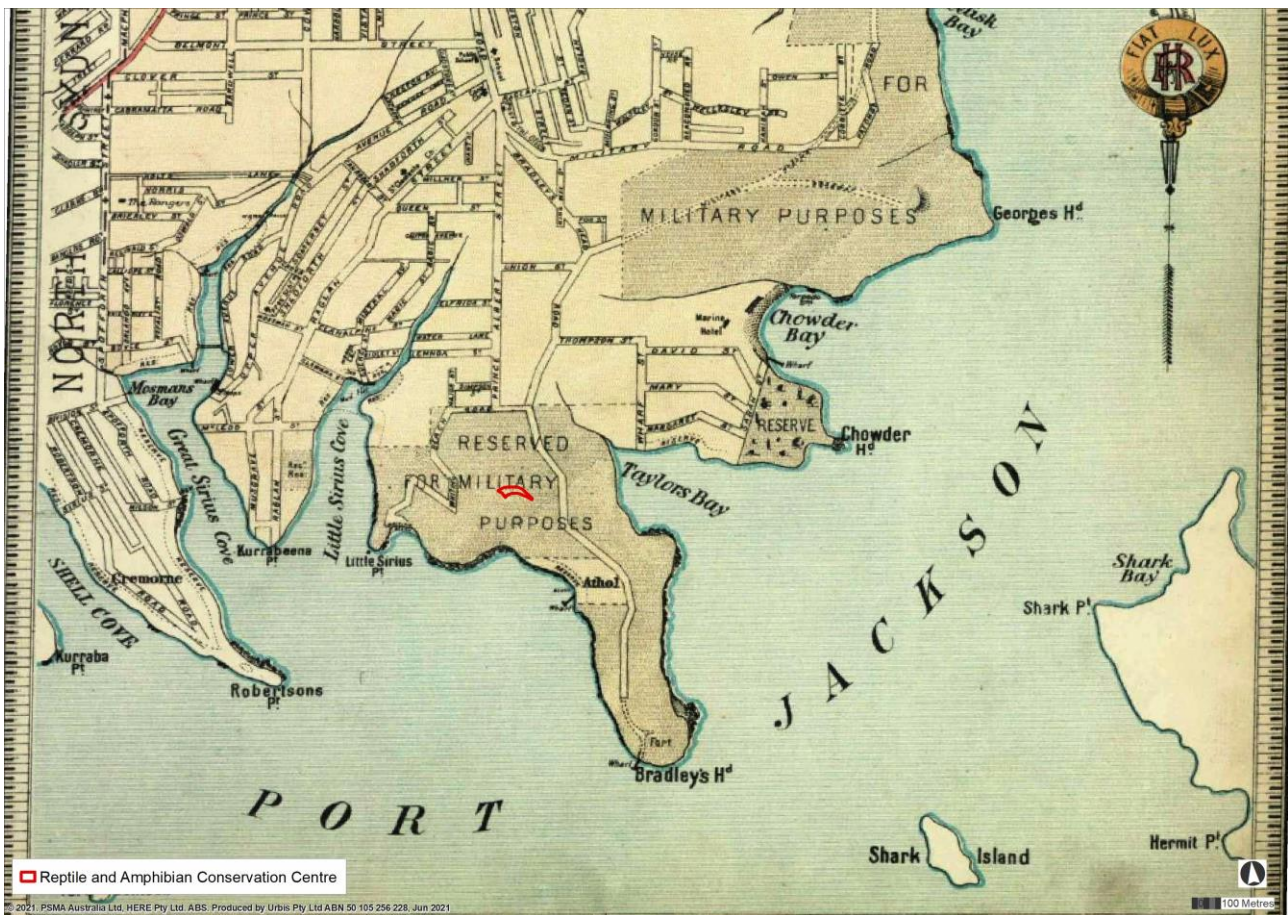
Figure 14 – 1893-94 Parish Map indicating resumption of land for military purposes. Approximate location of the subject area indicated in red outline.

In the 1890s, large portions of the land surrounding Sydney Harbour were resumed for Military Purposes (Figure 14), including Bradley's Head and the animal quarantine facilities which operated upon it. There is no evidence which suggests that any structures were established within the subject area in association with this period. Following federation in 1901, the Military Reserves were given to the Commonwealth. In 1908, Ashton Park, comprising 142 acres of public park land, was gazetted (Figure 15).

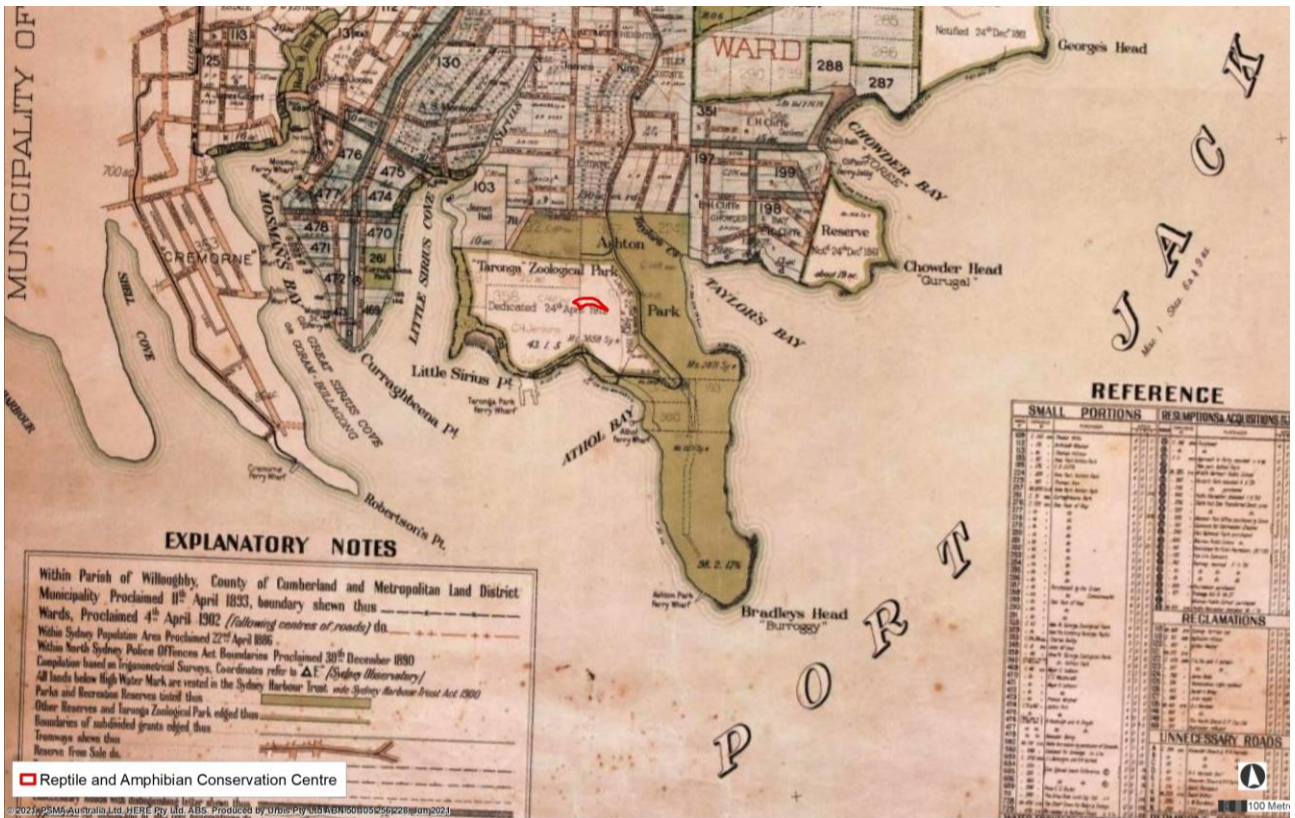
Figure 15 – 1917 Parish Map showing Crown Land, previously part of Ashton Park, which had been rededicated as a zoological park. Approximate location of the subject area indicated in red outline.

In April 1912 17 hectares of Crown Land within the north-western component of Ashton Park was rededicated as a zoological garden (Figure 15). Ground was broken on the site in October 1912 and continued until 1916. Prior to this much of the zoo lands was covered in natural Australian bushland. The Zoo officially opened on Saturday October 7<sup>th</sup> 1916 (The Sun, 1916).

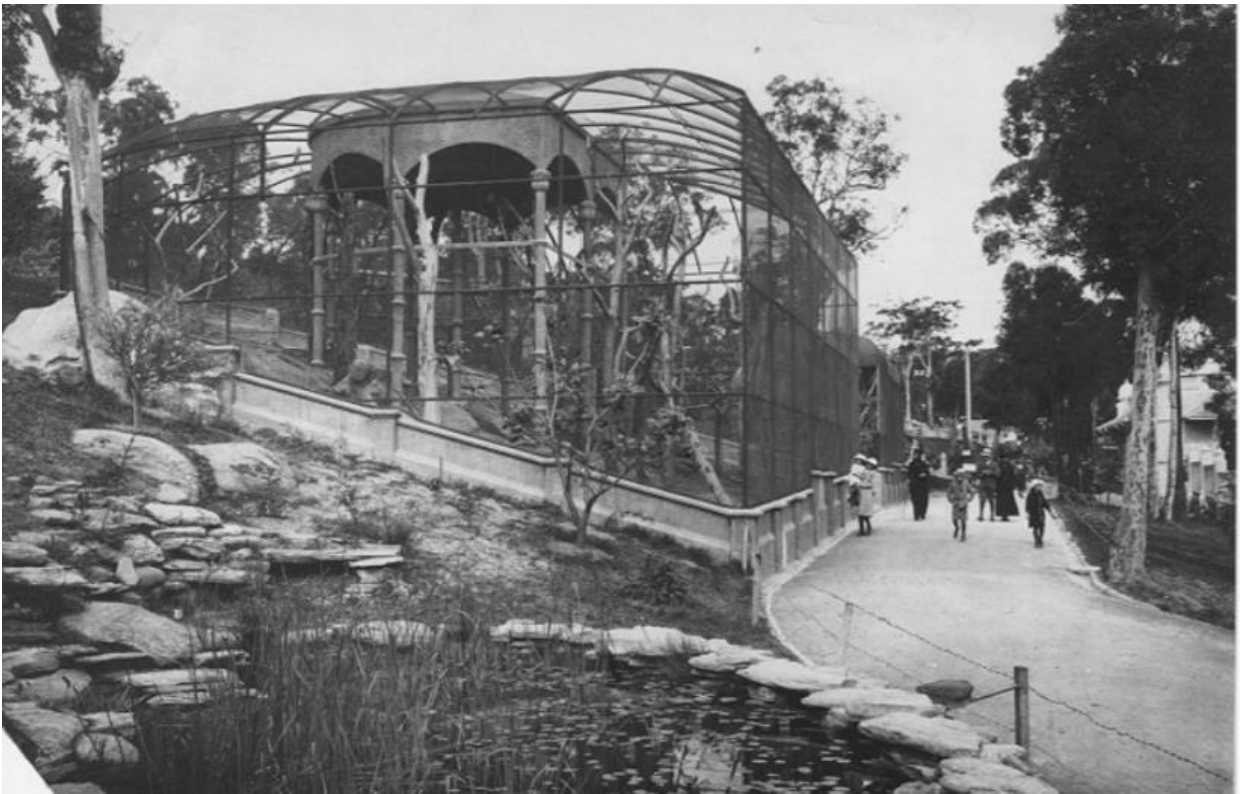
Figure 17 – Location of the two aviaries located along the southern boundary road, with the larger in the foreground.

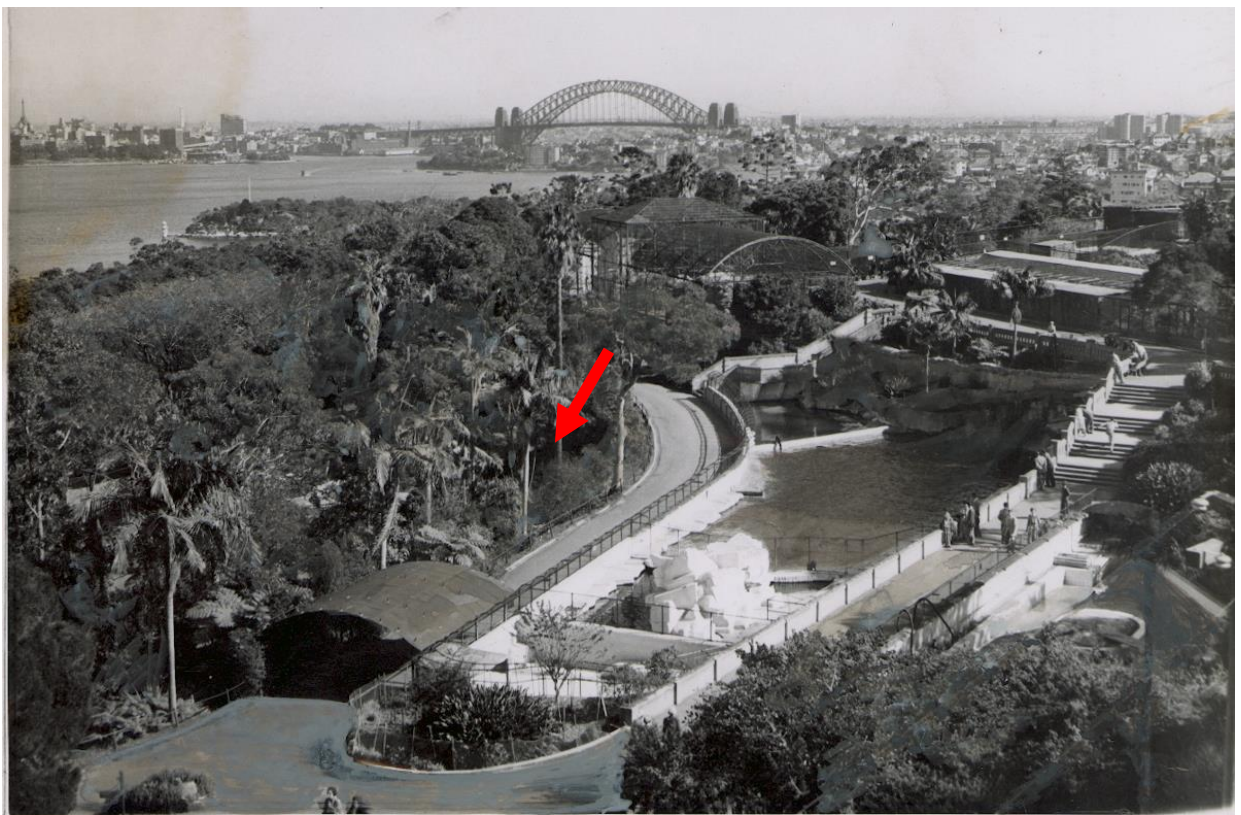
Figure 18 – c.1933 photograph showing the steep topography and dense vegetation which characterised the subject area (indicated with arrow) at this time.

A c.1933 photograph of the subject area (Figure 18) shows the steep topography and densely vegetated character of the site at this time. The land immediately to the north of the subject area had been excavated and levelled in preparation for the seal ponds.

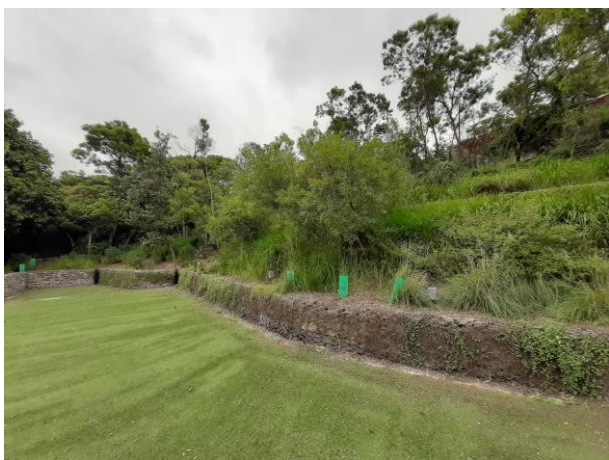
Figure 24 – The north-western portion of the subject area consists of steeply terraced gardens contained behind gabion walls.

The north-western component of the subject area consists of steeply terraced gardens contained by gabion walls (Figure 24). The terraced topography evidences the former presence of the Seal show theatre at this location. The area to the south of the terracing is grassed. A timber staircase is located along the south-western boundary of the site (Figure 25).

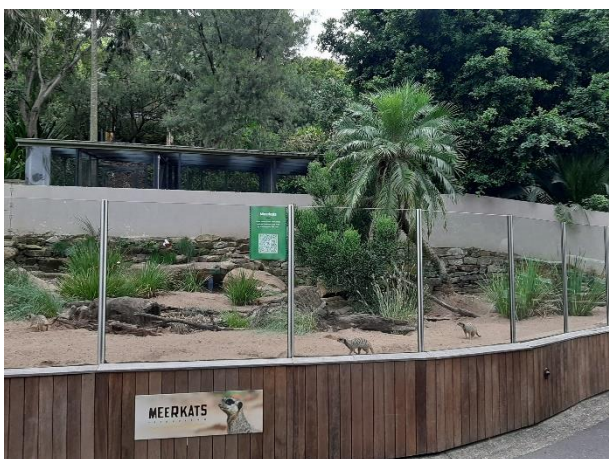
Figure 26 – The eastern component of the subject area contains a Meerkat enclosure.

The eastern component of the subject area is occupied by a Meerkat enclosure (Figure 26). The southern perimeter of the enclosure is defined by a timber and glass panel wall. The artificial slope of the enclosure has been created through the importation of fill and introduction of various landscape elements.

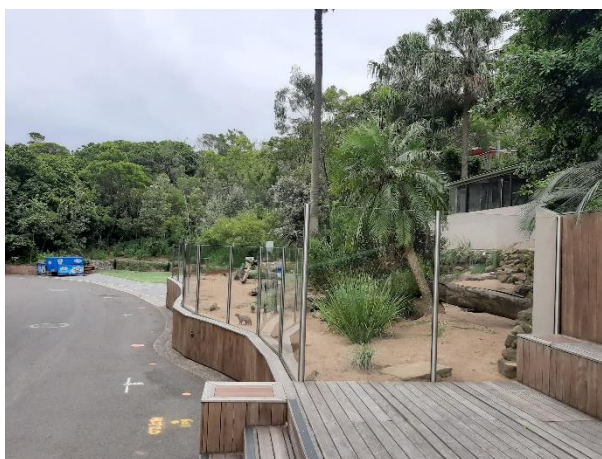
Figure 27 – The subject area is bounded to the south and north by bitumen roads which follow the original early 20<sup>th</sup> century road alignment.

The subject area is bounded to the north and south by bitumen roads, which follow the original early 20<sup>th</sup> century road alignment (Figure 27). The section of road to the north of the site has been extended southwards so that it now cantilevers over the site.
