Proposed Reptile & Amphibian Conservation Centre Heritage Impact Assessment

FINAL REPORT
July 2021

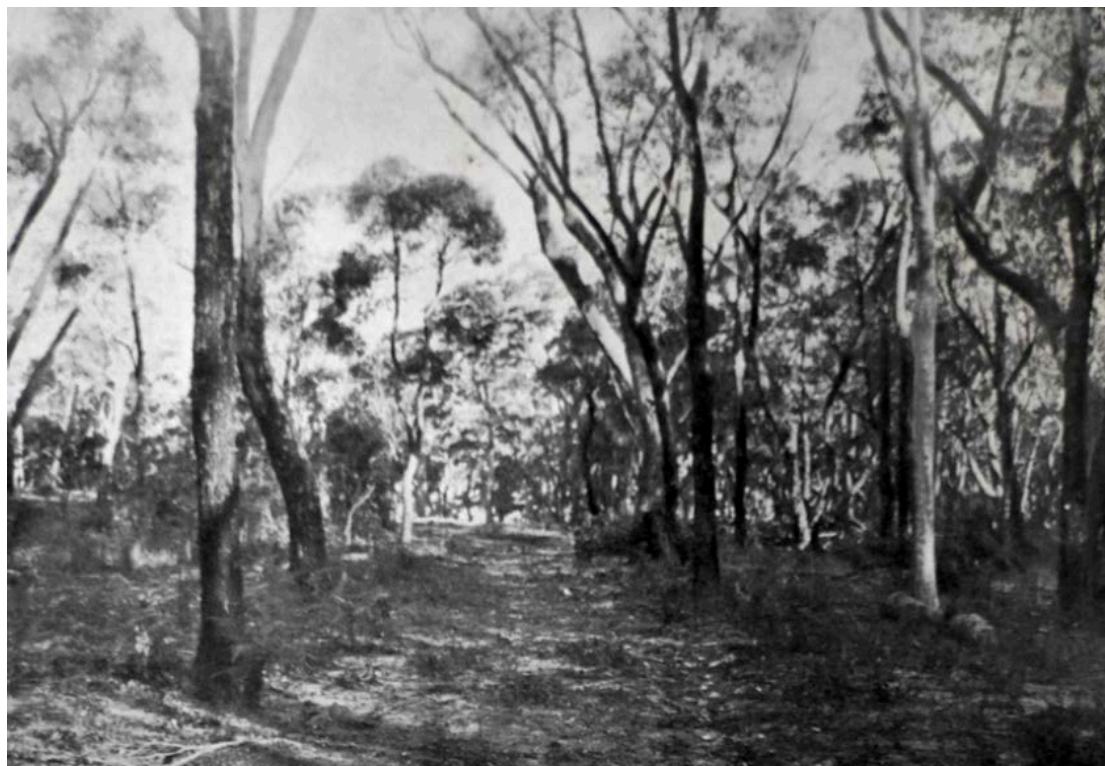
Figure 6 A photograph taken to record the natural state of the Zoo site prior to implementation of the works program. (Source: *Taronga Zoological Park Trust, Report for 1916, p. 9*)

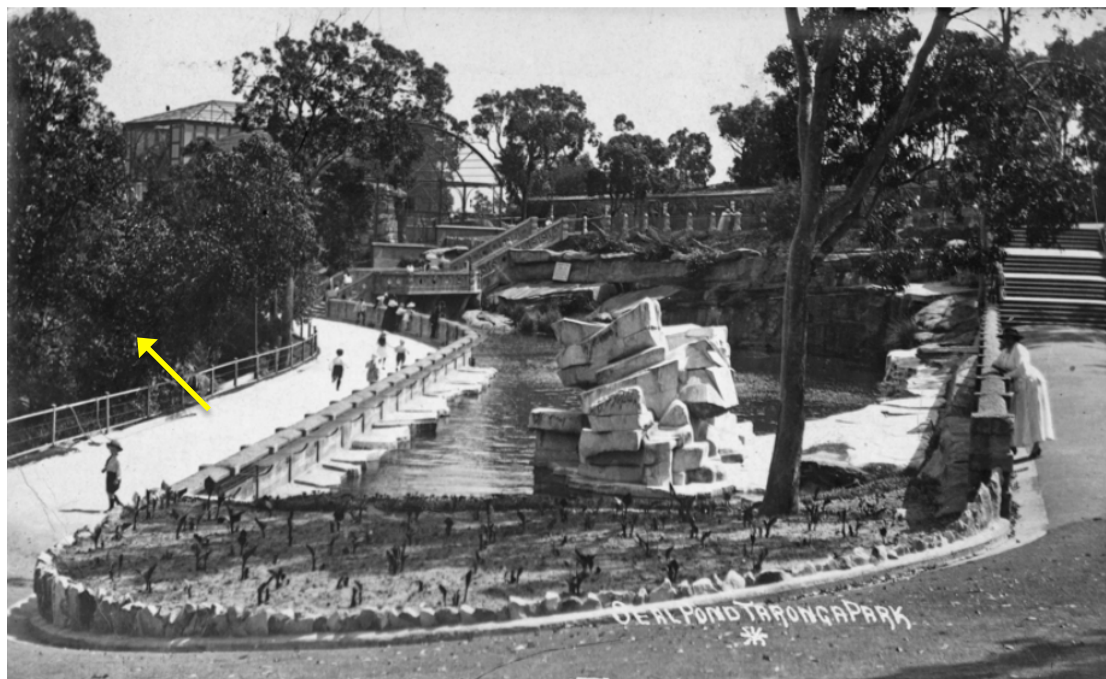
Figure 8 Undated, ca. 1920, photograph of the main Seal Pond. The original Birds of Prey Aviary is shown in the background while the present study site is to the left beyond the access road. In the image the present study site (arrowed) still appears to be remnant woodland vegetation. (Source: *Mosman Local Studies Collection (TarongaZoo.55)*)

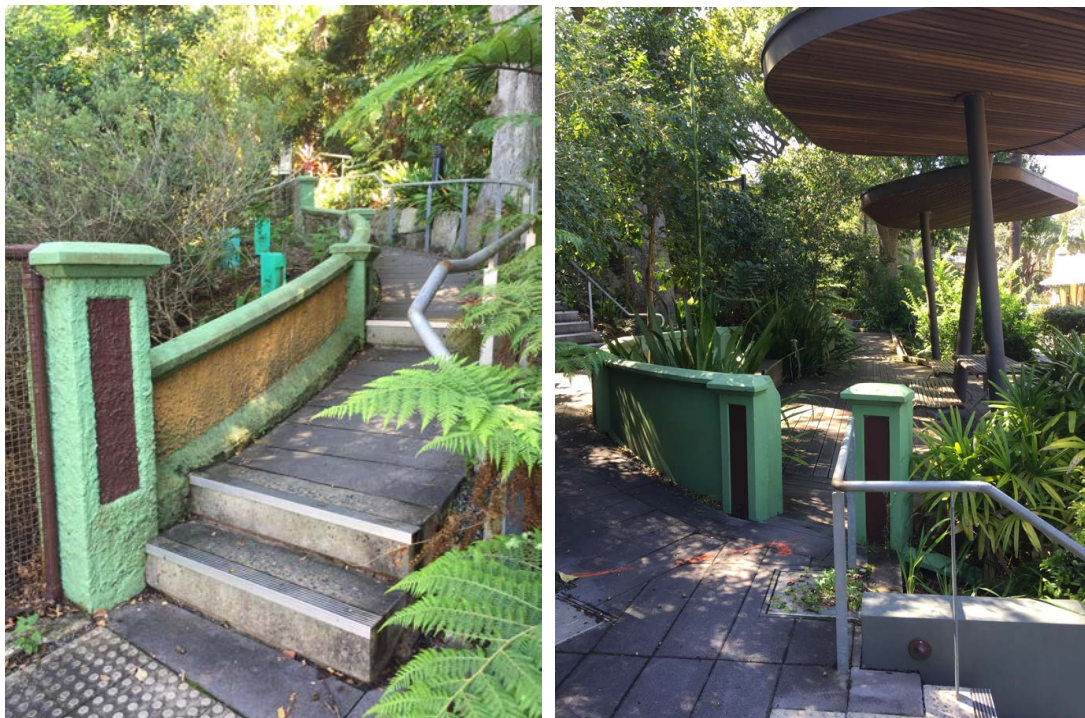
Figures 13 LEFT and **14** RIGHT show the present access arrangement that was introduced from the mid- 20th century between, and partly around, the remnant 'D-shaped' aviaries.

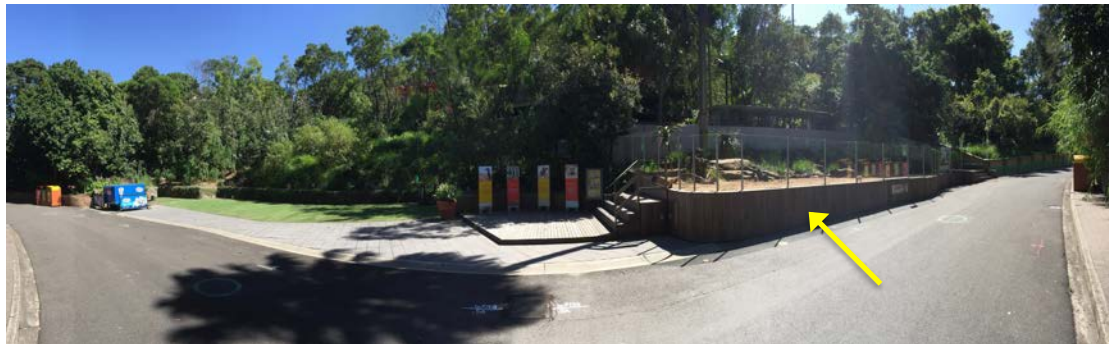
Figure 19 View across the front of the study site with the current temporary Meerkat enclosure noted with an arrow - the same structure being previously used as a pond and enclosure for penguins. The picnic lawn to the left was previously the site of the late 1970s Seal Show building with its former amphitheatre where there is currently dense vegetation.

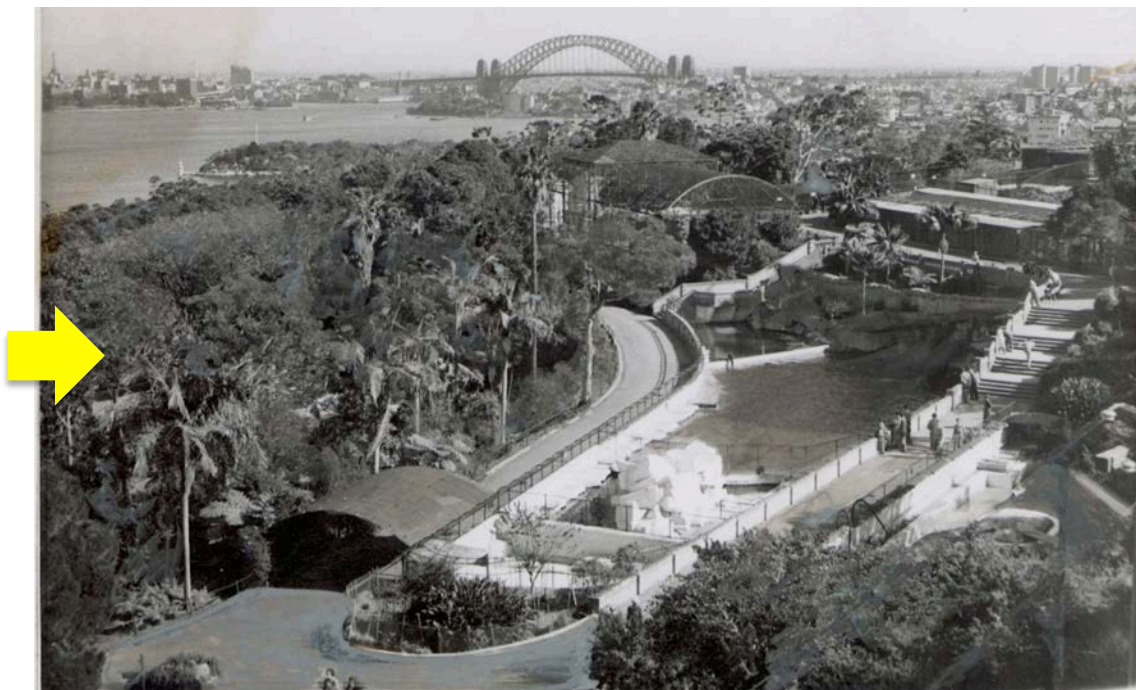
Figure 20 An oblique aerial view from 1933 across the main seal pond showing the study site to the left with mostly remnant woodland and introduced palm plantings along the upper road. The arched canopy structure over the road was built by the early 1930s but removed by 1970. (Source: TCSA Archives)

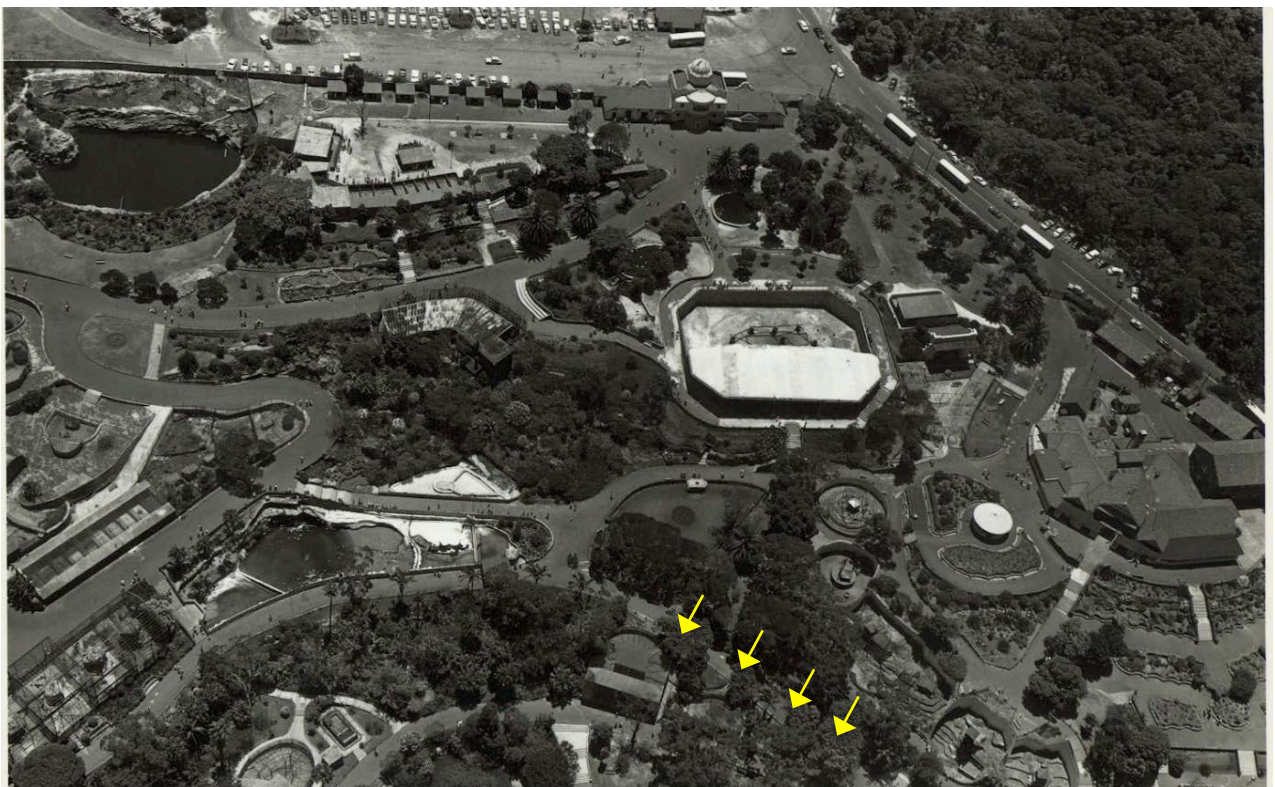
Figure 21 An oblique aerial photograph from about 1962 by the studio of Douglass Baglin showing the study site along the lower part of the image. The maturing canopies of the *Waterhousea floribunda* comprising the early avenue are indicated by the yellow arrows. (Source: TCSA Archives)

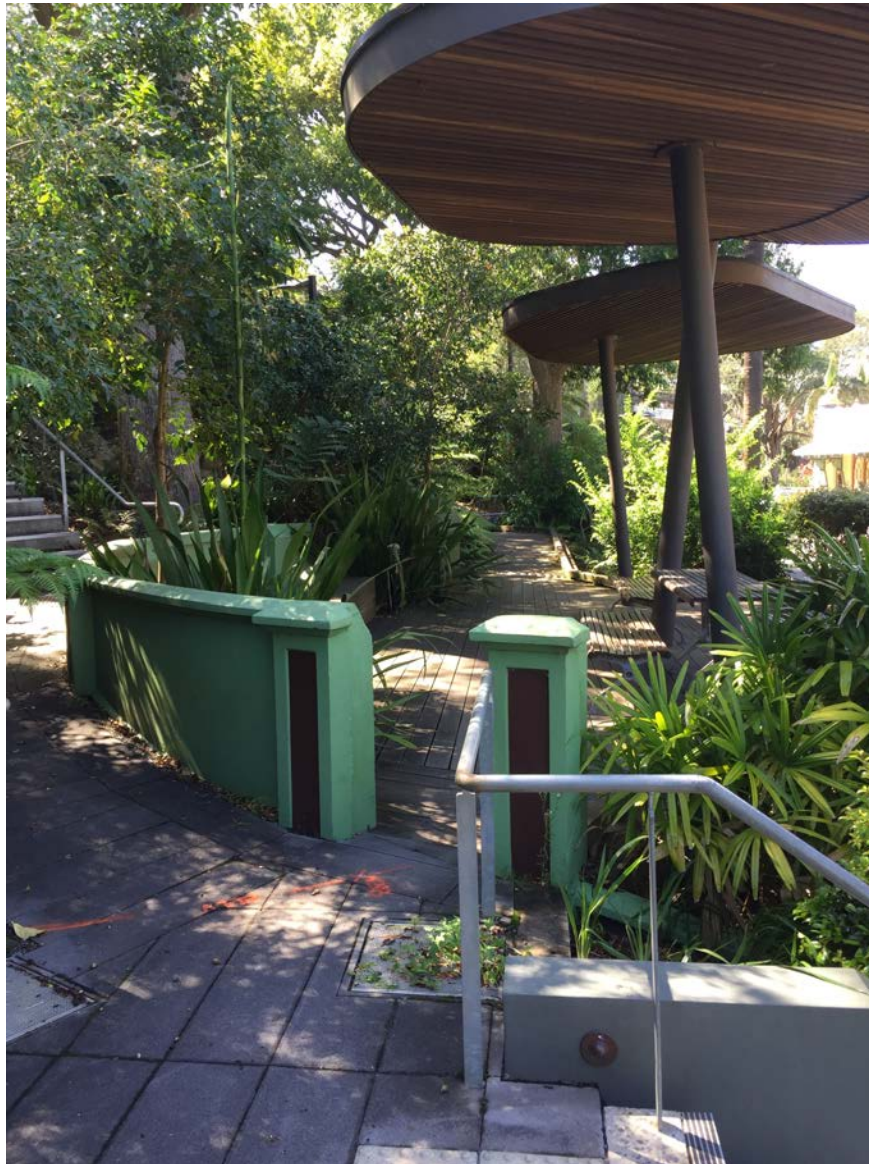
Most of the site vegetation has appeared since 2009 following a master plan proposal for the study site by Spackman & Mossop. This has included the revegetation of the former Seal Show area along with further plantings throughout the aviary precinct. An exception is the relocation of a large collection of *Camellia* cultivars (s170 Item 258L) in the 1990s. All of these were planted under the shade of the *Waterhousea* avenue. Further recent (later 2010s?) introductions of note are the unusual fig trees (*Ficus craterostoma*) west of the larger aviary walling.

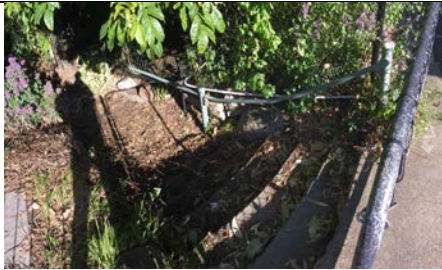
<p>While the emphasis appears to be on the balustrading, the actual path is itself an early access link between the stairs above (Item 56L) and below (Item 25L) this area</p>
<p>151L Rustic stone garden walls Local/Moderate</p>	<p>c. 1920s- 1940s</p>

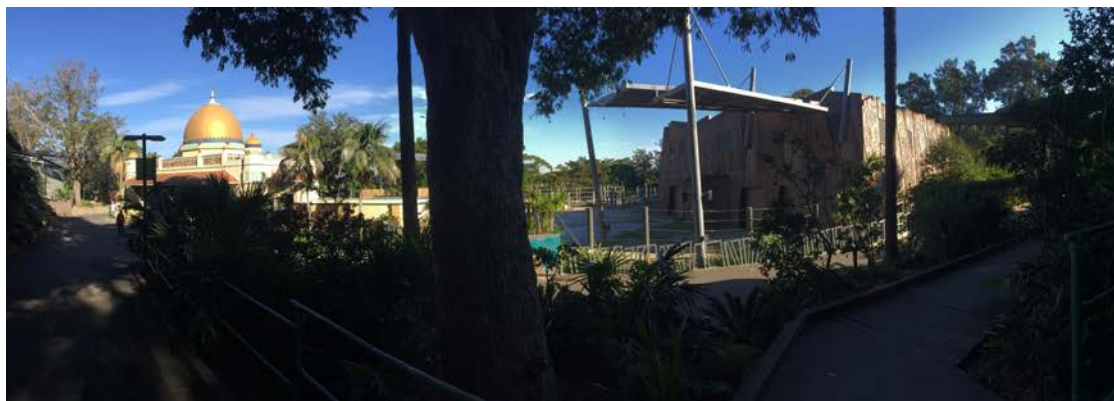
Zone	Archaeological Management	Archaeological Potential	
3	Areas of original bushland and rock surfaces	High	If subsurface disturbance proposed obtain "preliminary research permit", test trench, MLALC to monitor. If relic found AHIP required.
4	Areas heavily modified by European development	Medium to Low	Brief contractors if subsurface disturbance proposed and if relics exposed cease work and report to MLALC and NPWS and act as for Zone 3.
5	Areas previously excavated down to bedrock or culturally sterile profile	None	No further Aboriginal archaeological input required. Act as for Zone 3 if any relic is found (unlikely).

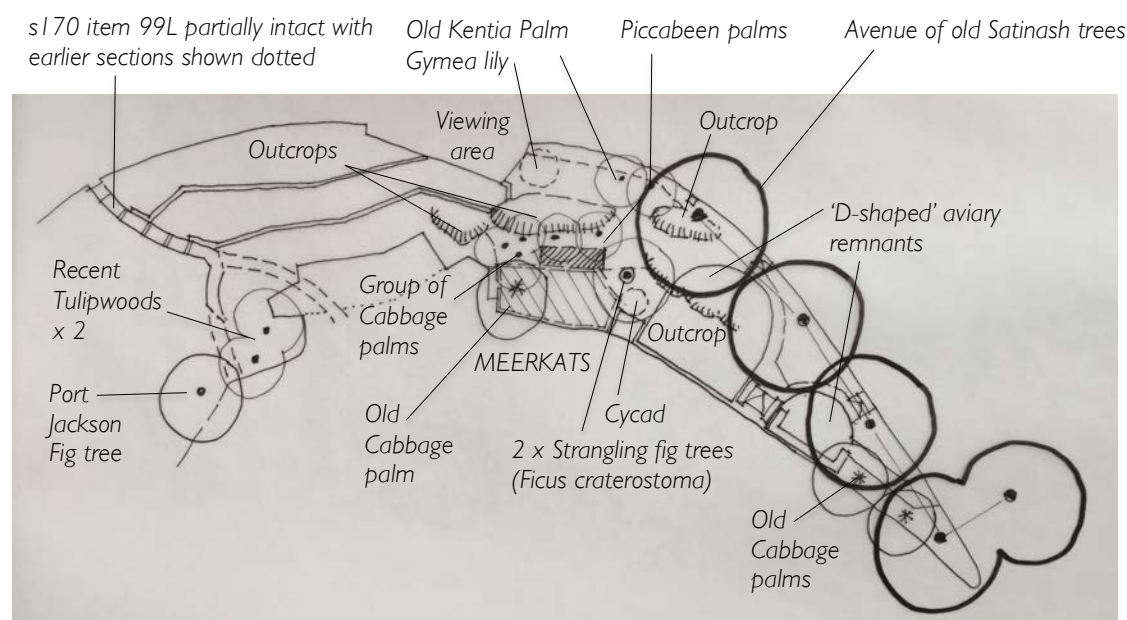
Figure 38 Site plan indicating additional elements of value within the study area. (Not to scale and s170 register site plan used as a base)

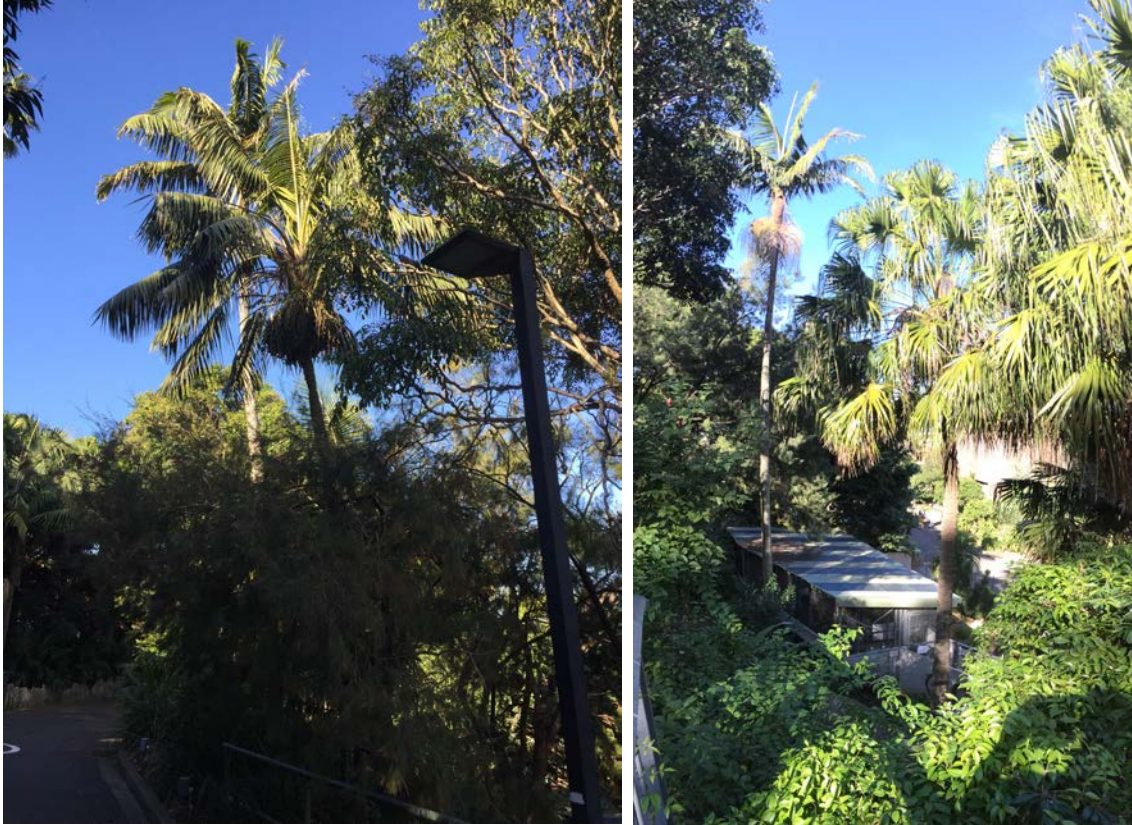
Figure 39 ABOVE LEFT Kentia Palm (*Howea forsteriana*) and Piccabeen palm (*Archontophoenix cunninghamiana*) behind along the upper access road. **Figure 40** ABOVE RIGHT Piccabeen palm (*Archontophoenix cunninghamiana*) left next to Meerkat back-of-house structure with a group of Cabbage palms (*Livistona australis*) to the right. **Figure 41** BELOW View of the current temporary Meerkat enclosure showing various smaller plantings that reinforce the intended thematic African environment. These include *Aloe ferox* and *Yucca* (left next to the Cabbage palm trunk) and *Euphorbia tirucalli* and *Phoenix* (right background) possibly relocated from the former African Savannah enclosures. To the left of the *Phoenix* sp., and behind the enclosure wall, are two representatives of an unusual and uncommon fig tree species (*Ficus craterostoma*)(see **Figure 42**).

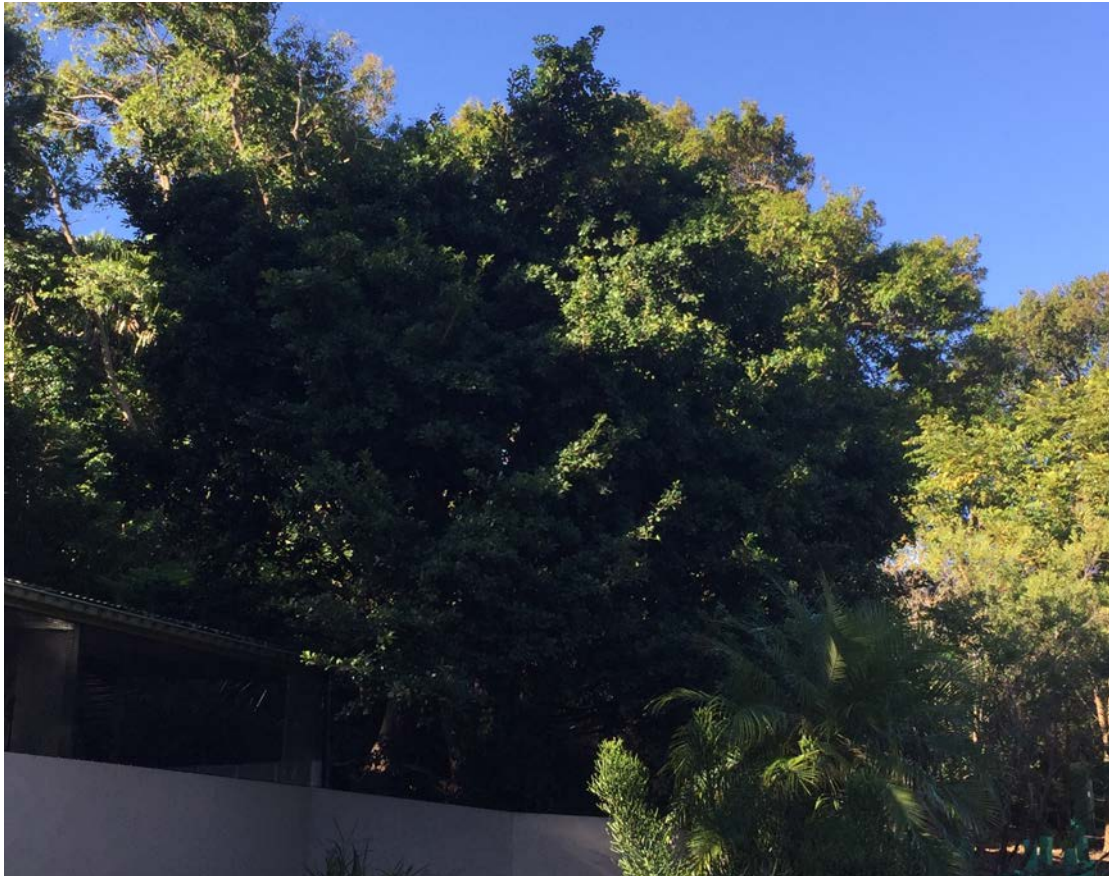
Figure 42 ABOVE African strangling fig trees (*Ficus craterostoma*) between the Meerkat enclosure and the larger aviary walling.

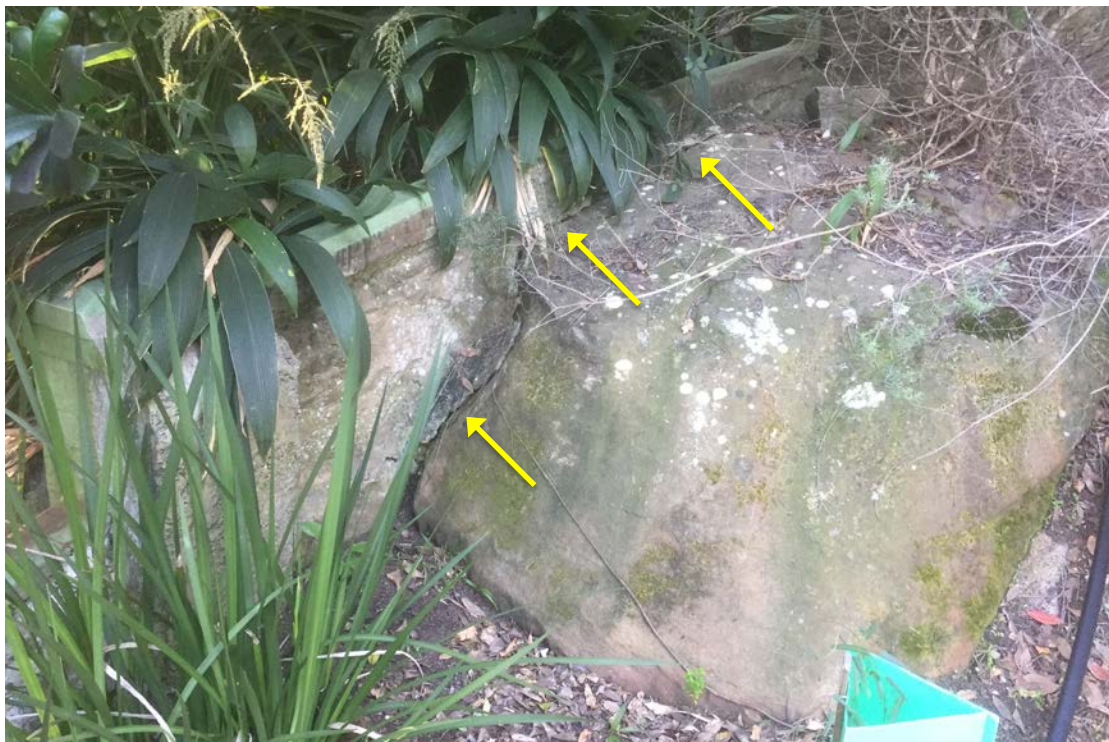
Figure 43 BELOW Detailed view of the western wall of the larger aviary showing its construction over and across (arrows) one of the natural rock outcrops in this area.

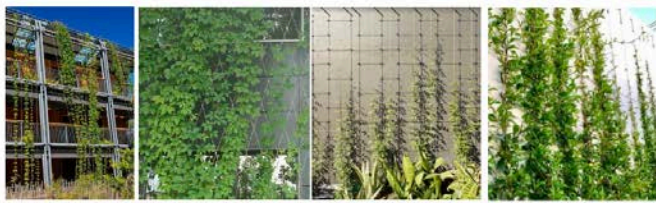
01 STAINLESS STEEL CABLE WIRE GREEN SCREEN
 (Supports steel wire to support landscape vines on southern side of building)
