Our Ref: PSM3589-003L

**RE: 167-201 ALDINGTON ROAD, KEMPS CREEK  
RESULTS OF DUE DILIGENCE GEOTECHNICAL INVESTIGATIONS**

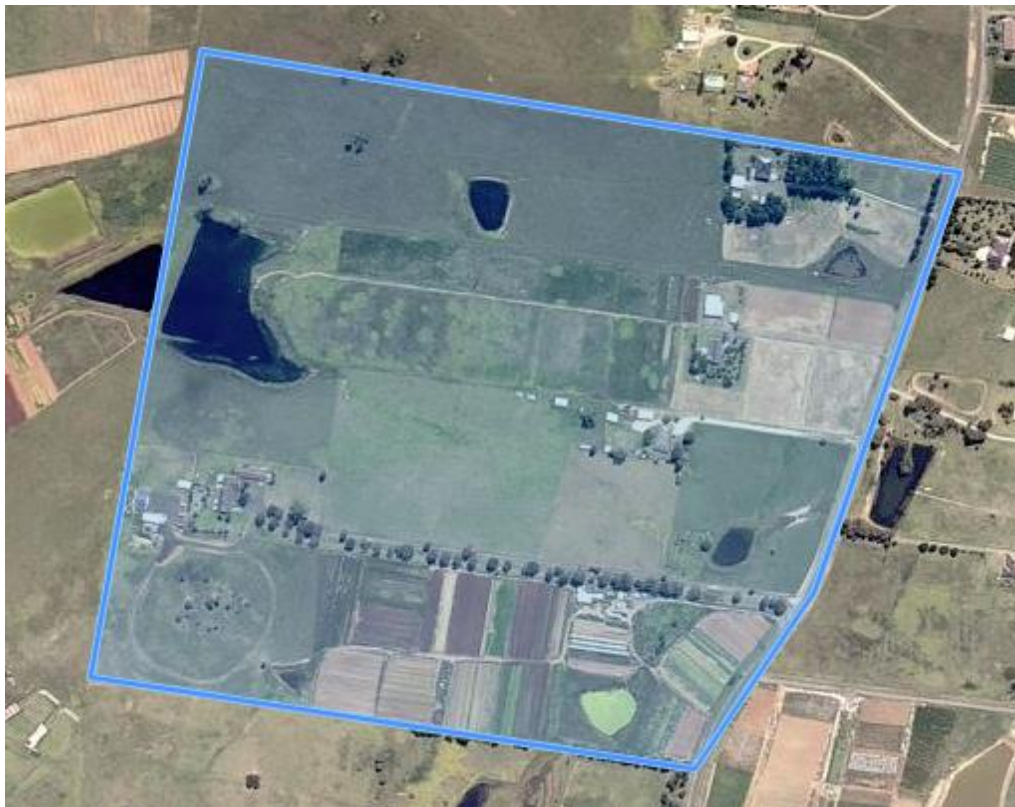
**Inset 1: Nearmap Aerial Image in 2010, Showing Surface Conditions**

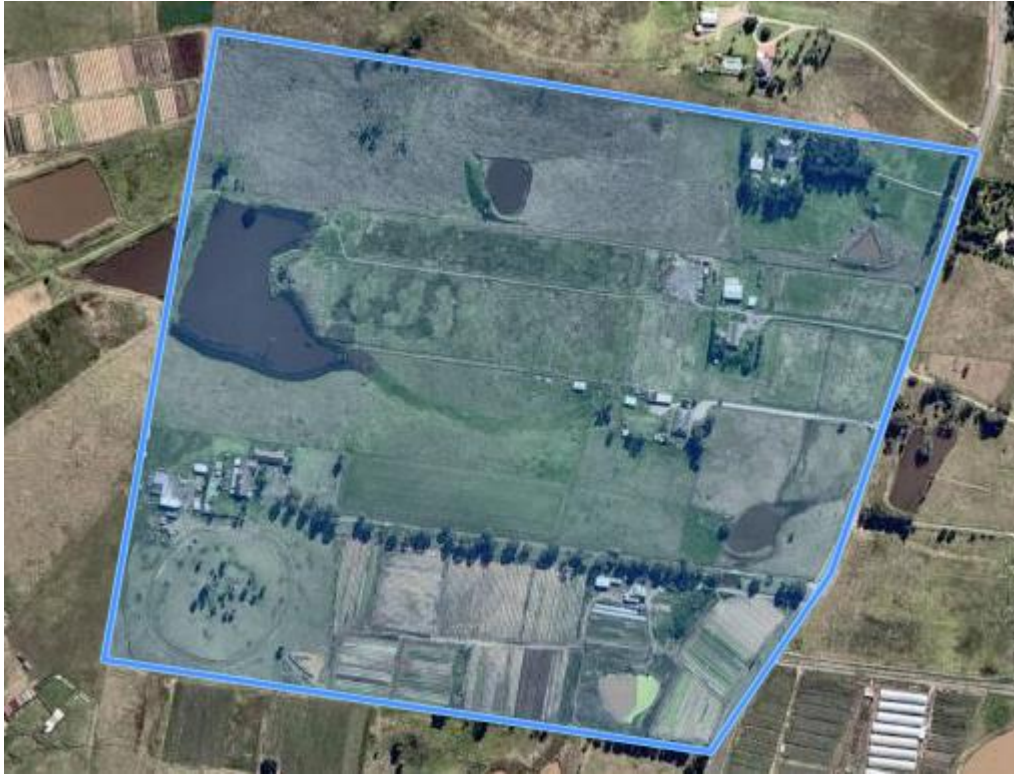
**Inset 2: Nearmap Aerial Image in 2015, Showing Surface Conditions**

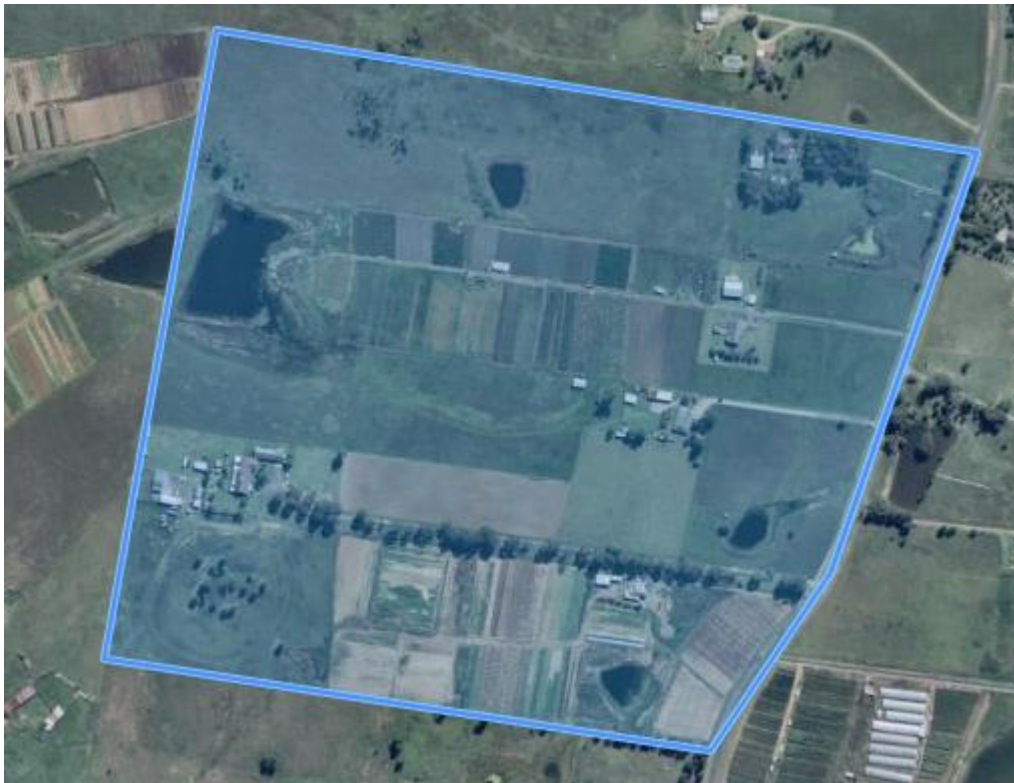
**Inset 3: Nearmap Aerial Image in 2019, Showing Surface Conditions**

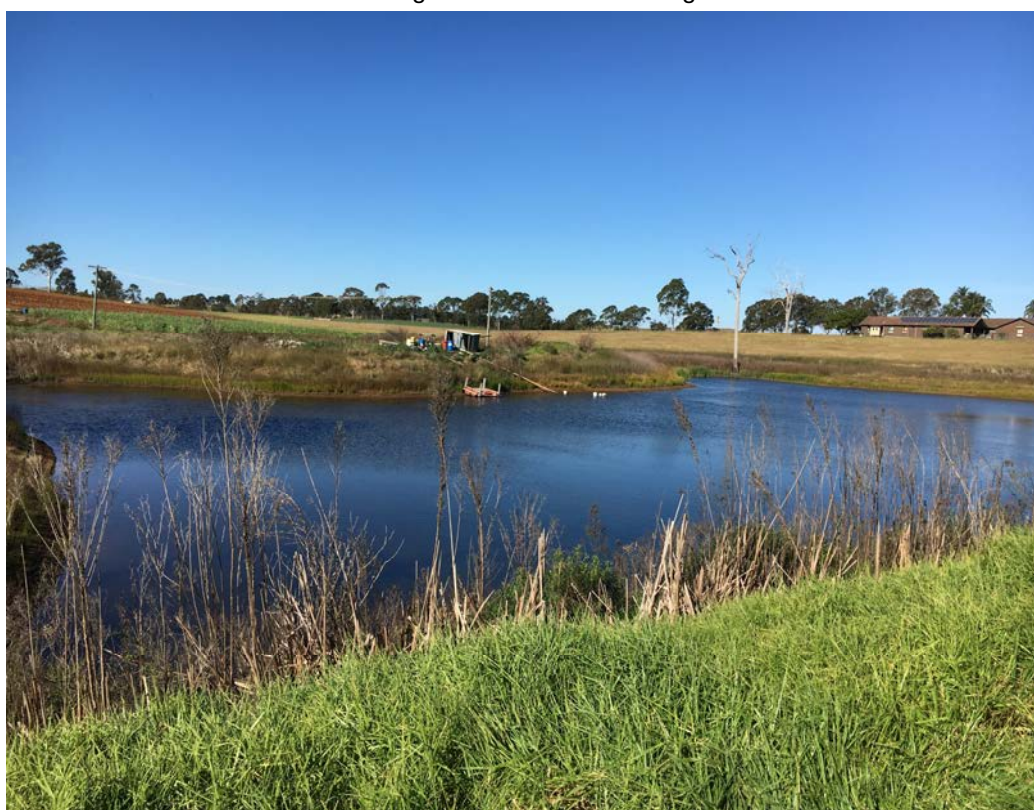
Photo 5 - Existing Dam at 169 Aldington Road

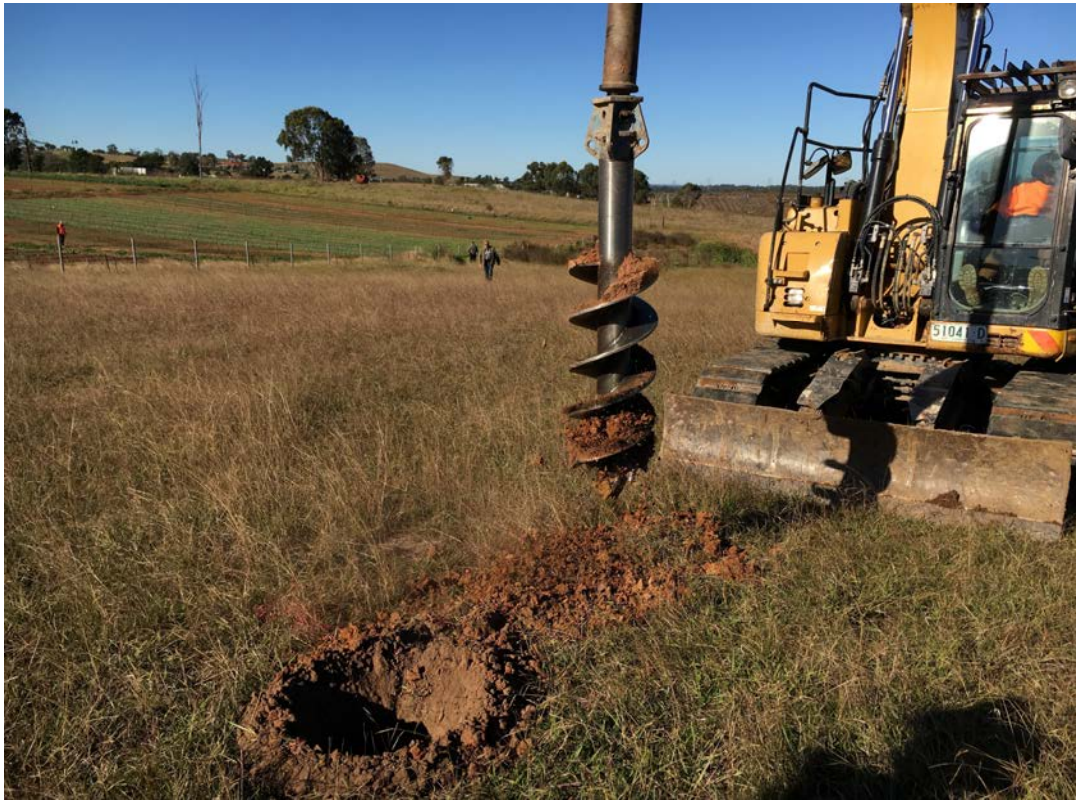
Photo 7 - 15 T Excavator with the 300 mm Auger

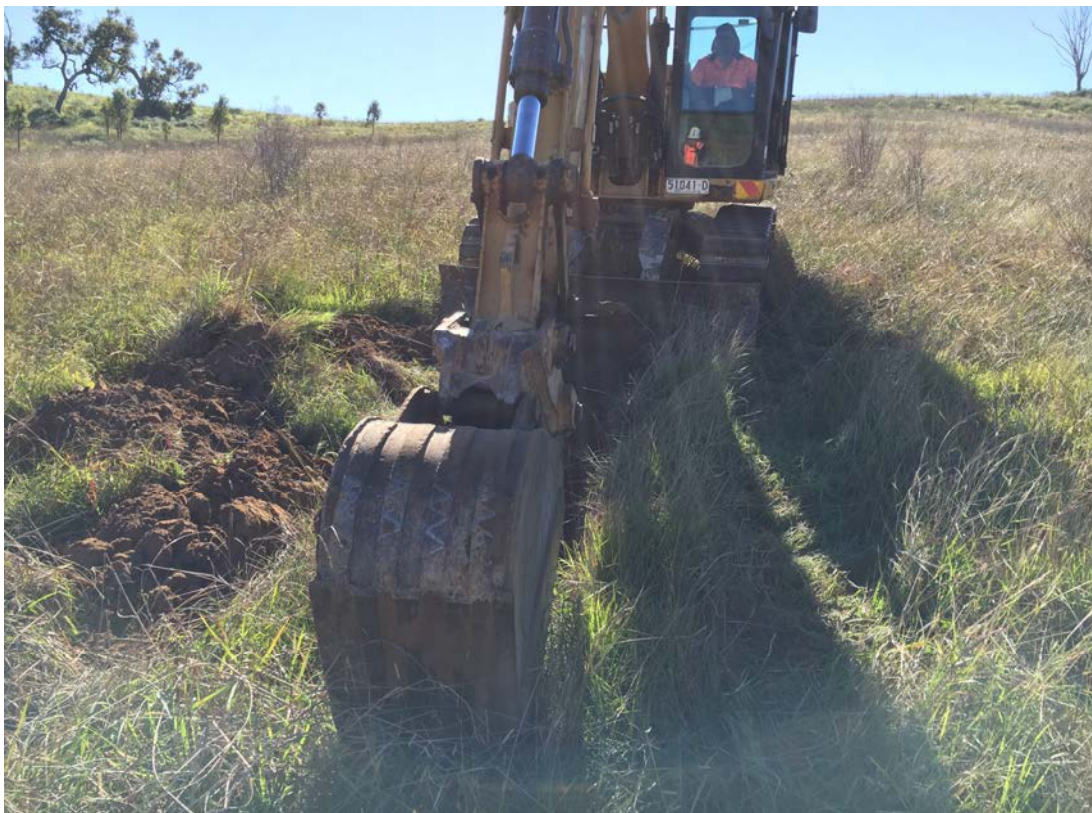
Photo 8 - 15T Excavator with the 500 mm Bucket

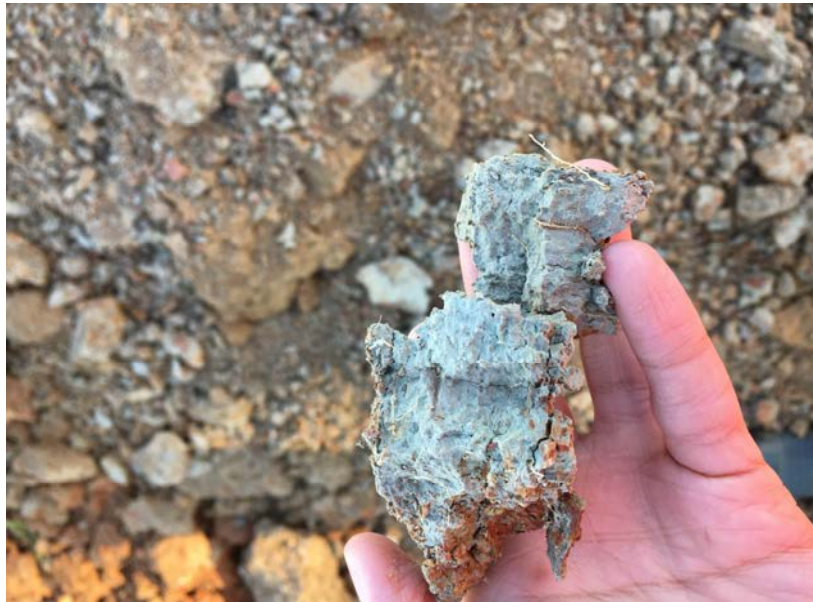
Photo 9 - Typical CLAY Unit excavated on Site

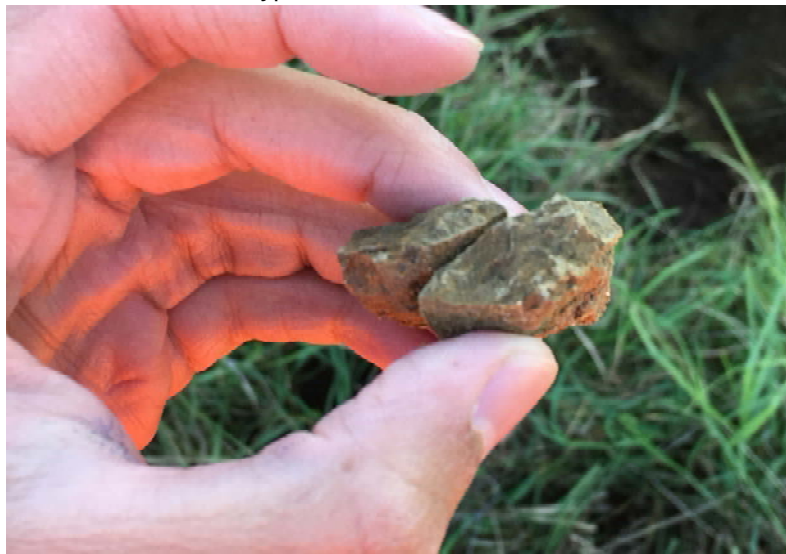
Photo 10 - Typical SILTSTONE Unit excavated on Site

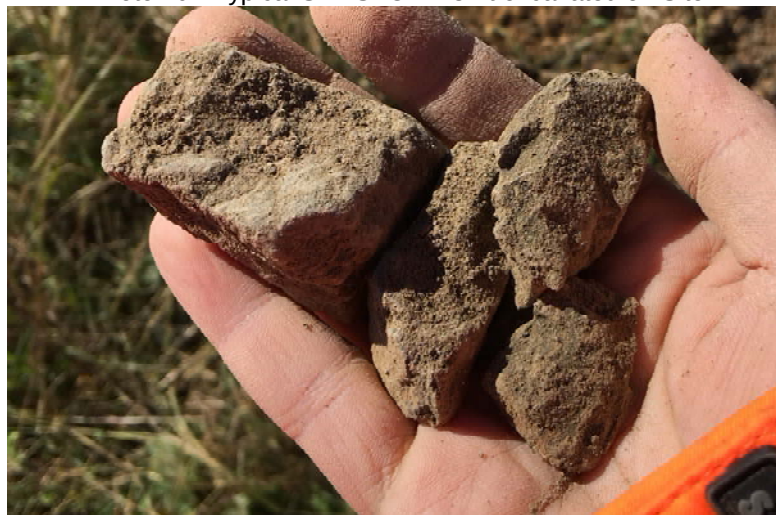
Photo 11 - Typical SANDSTONE Unit excavated on Site

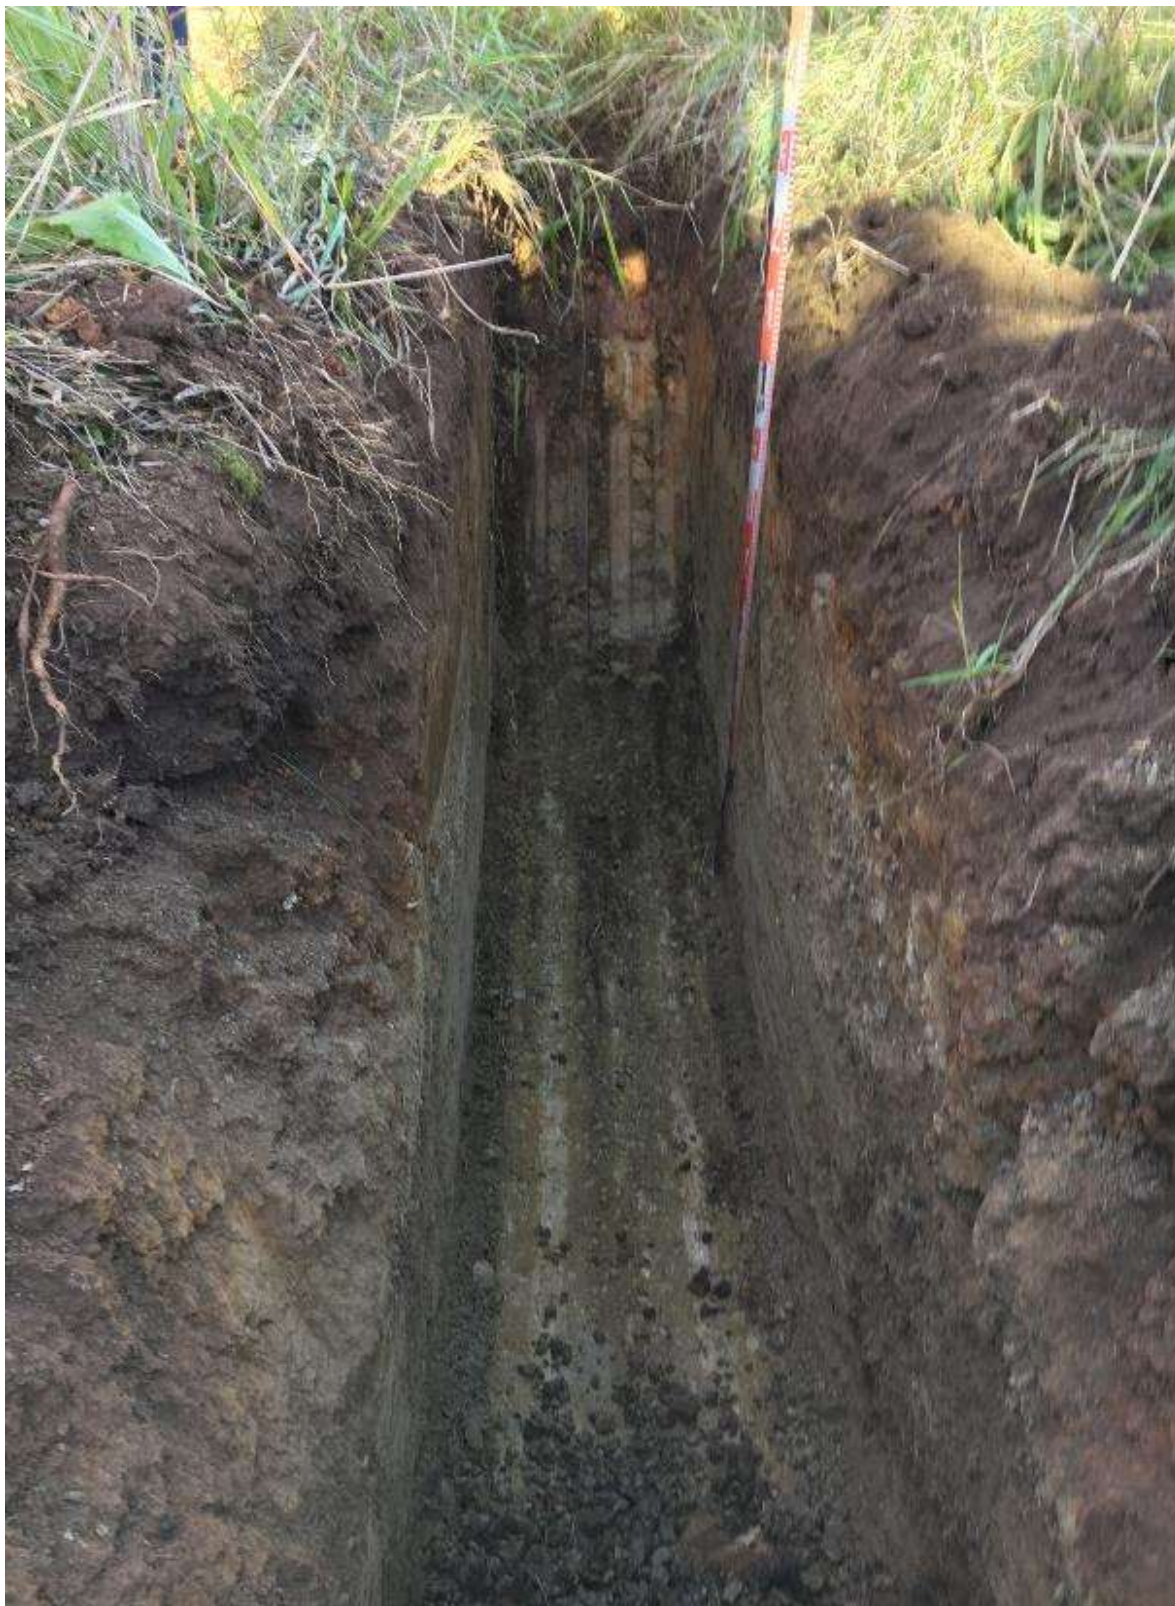
Test Pit TP03

| Test Pit ID | Depth (m) | Material Encountered |
|---|---|---|
| TP-03 | 0 – 0.2 m | TOPSOIL; silty CLAY with gravel; low plasticity, dark brown and grey, firm consistency, sub-angular gravel size up to 5 mm, dry to moist, rootlets and barks down to 0.2 m. |

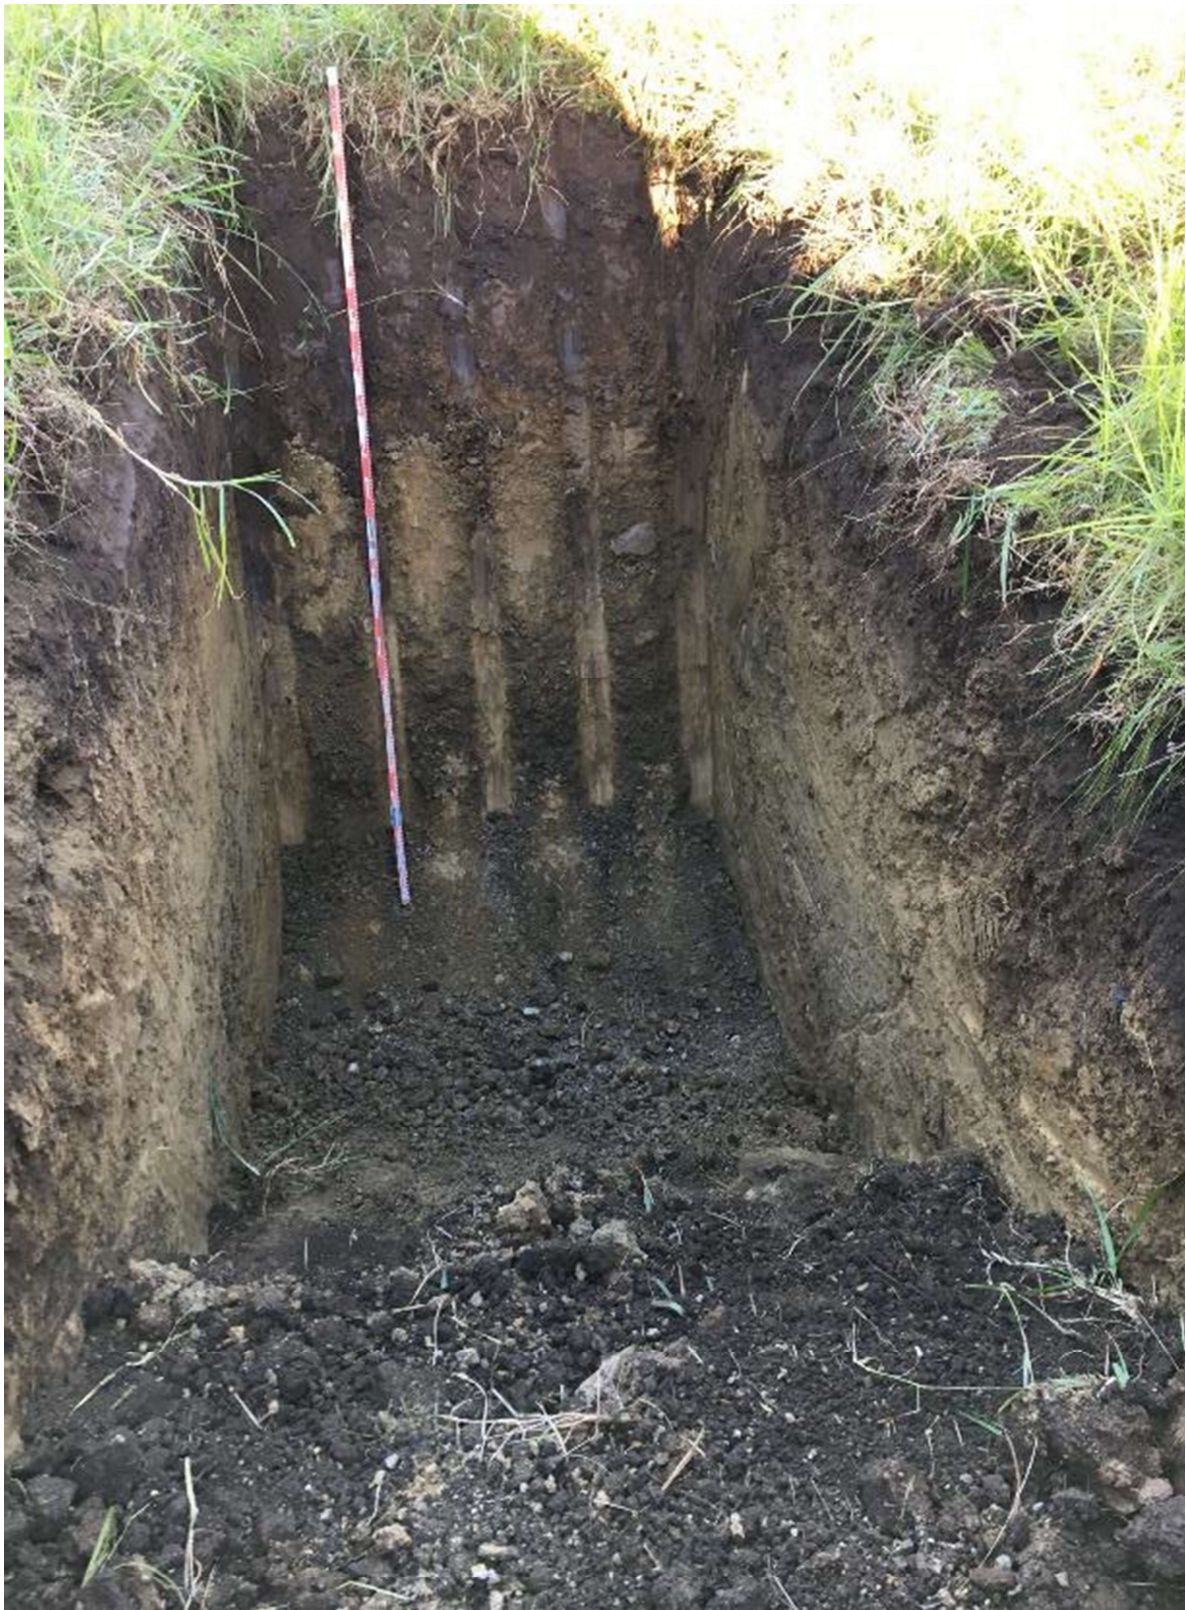
Test Pit TP05

| Test Pit ID | Depth (m) | Material Encountered |
|---|---|---|
| TP05 | 0 – 0.1 m | TOPSOIL; silty CLAY with gravel; low plasticity, dark brown, soft to firm consistency, sub-angular gravel size up to 5 mm, dry to moist, rootlets and barks down to 0.1 m. |
| | 0.1 – 0.4 m | CLAY; low to medium plasticity, dark brown and grey, stiff to very stiff consistency, dry to moist, trace of rootlets. |
| | 0.4 – 1.2 m | CLAY; high plasticity, pale brown and yellow, stiff to very stiff consistency, dry to moist.<br><br>Becomes hard consistency from 0.9 m. |

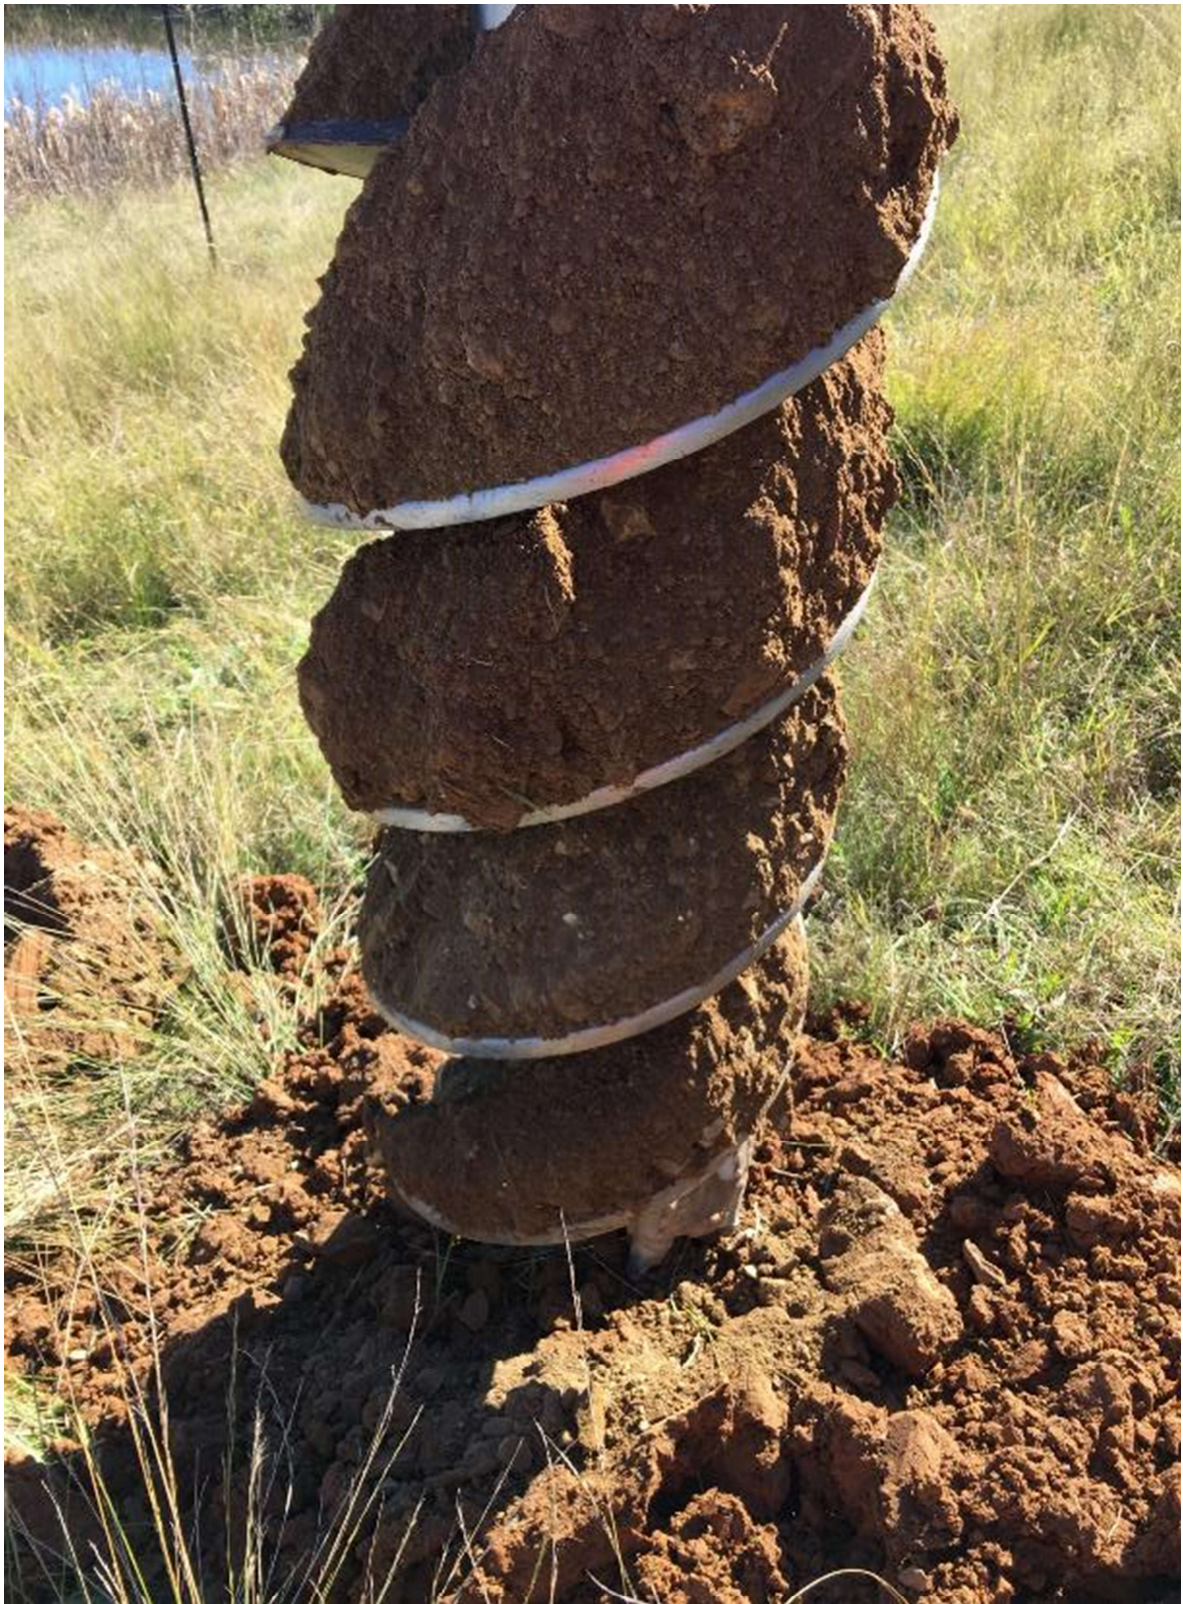
Test Pit TP10 (Auger)

| Test Pit ID | Depth (m) | Material Encountered |
|---|---|---|
| TP10<br>(Auger) | 0 – 0.2 m | TOPSOIL; silty CLAY; medium plasticity, dark brown and red, firm consistency, dry to moist, rootlets and barks down to 0.2 m. |
| | 0.2 – 1.0 m | CLAY; high plasticity, brown, yellow and red, very stiff consistency, dry to moist.<br><br>Becomes hard consistency from 0.9 m. |

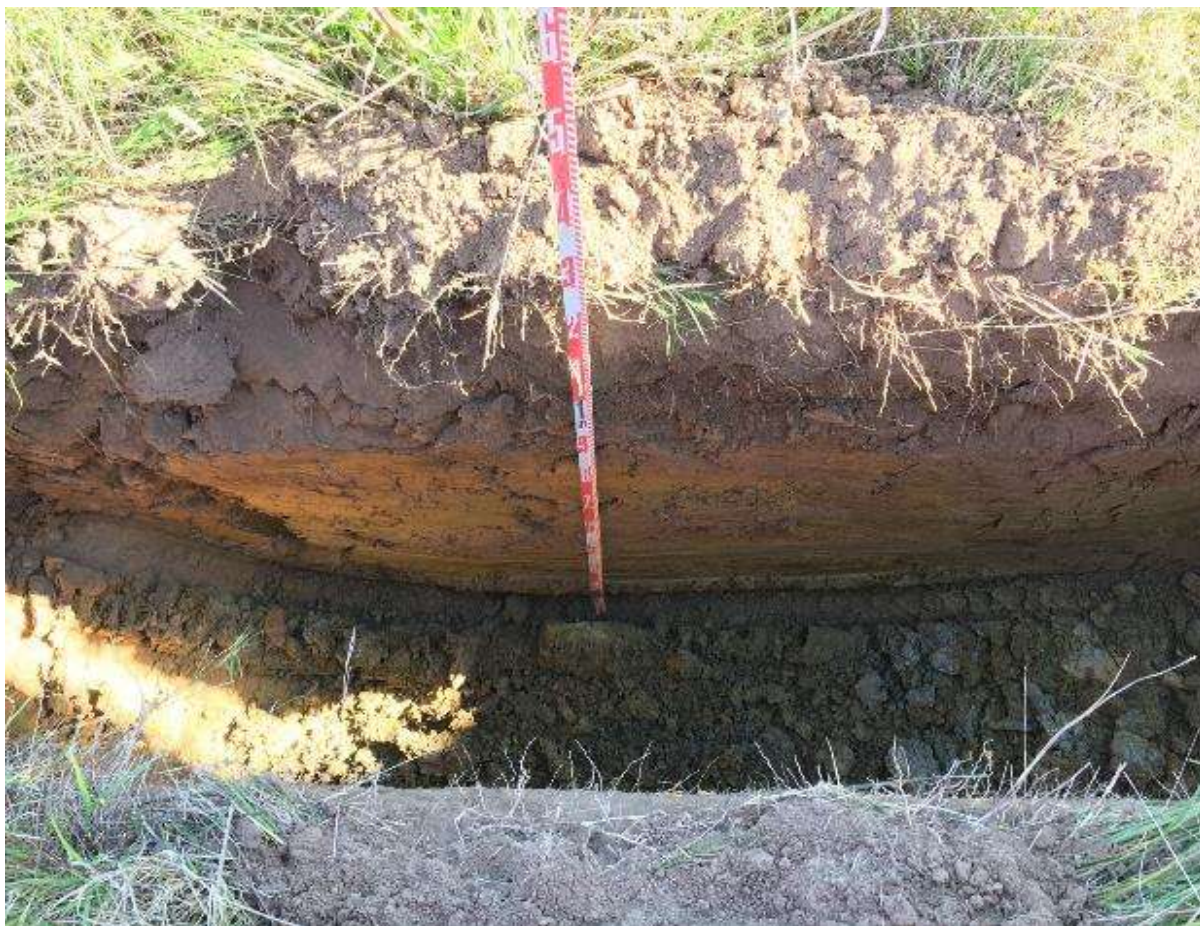
Test Pit TP11

| Test Pit ID | Depth (m) | Material Encountered |
|---|---|---|
| TP11 | 0 – 0.3 m | TOPSOIL; sandy silty CLAY; low plasticity, pale grey and brown, firm consistency, fine sand, dry to moist, rootlets and barks down to 0.3 m. |
| | 0.3 – 1.5 m | CLAY; medium to high plasticity, pale grey and yellow, very stiff consistency, dry to moist.<br><br>Becomes hard consistency from 1.1 m. |

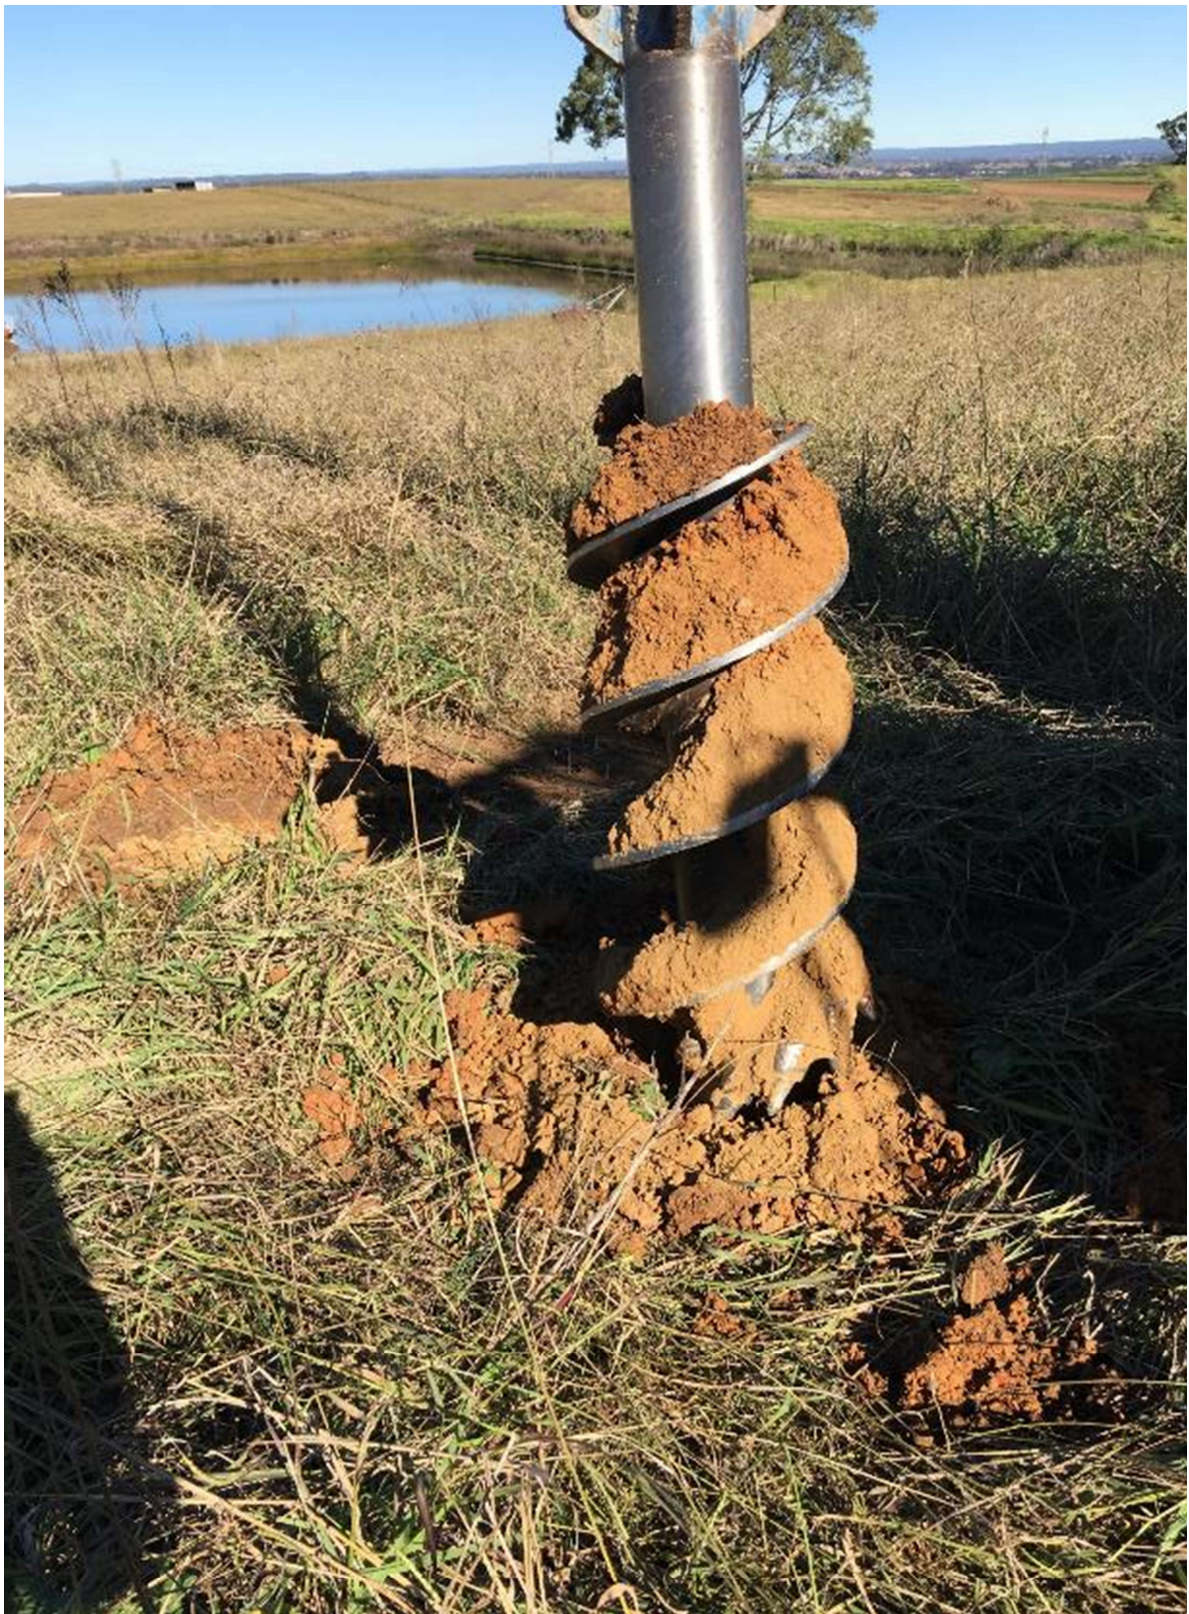
Test Pit TP12 (Auger)

| Test Pit ID | Depth (m) | Material Encountered |
|---|---|---|
| TP12<br>(Auger) | 0 – 0.3 m | TOPSOIL; silty CLAY; low to medium plasticity, dark brown and orange, firm consistency, moist, rootlets and barks down to 0.3 m. |
| | 0.3 – 0.5 m | CLAY; medium plasticity, pale grey, brown and yellow, very stiff consistency, moist. |
| | 0.5 – 0.7 m | CLAY; medium to high plasticity, pale brown and yellow, very stiff consistency, dry to moist. |

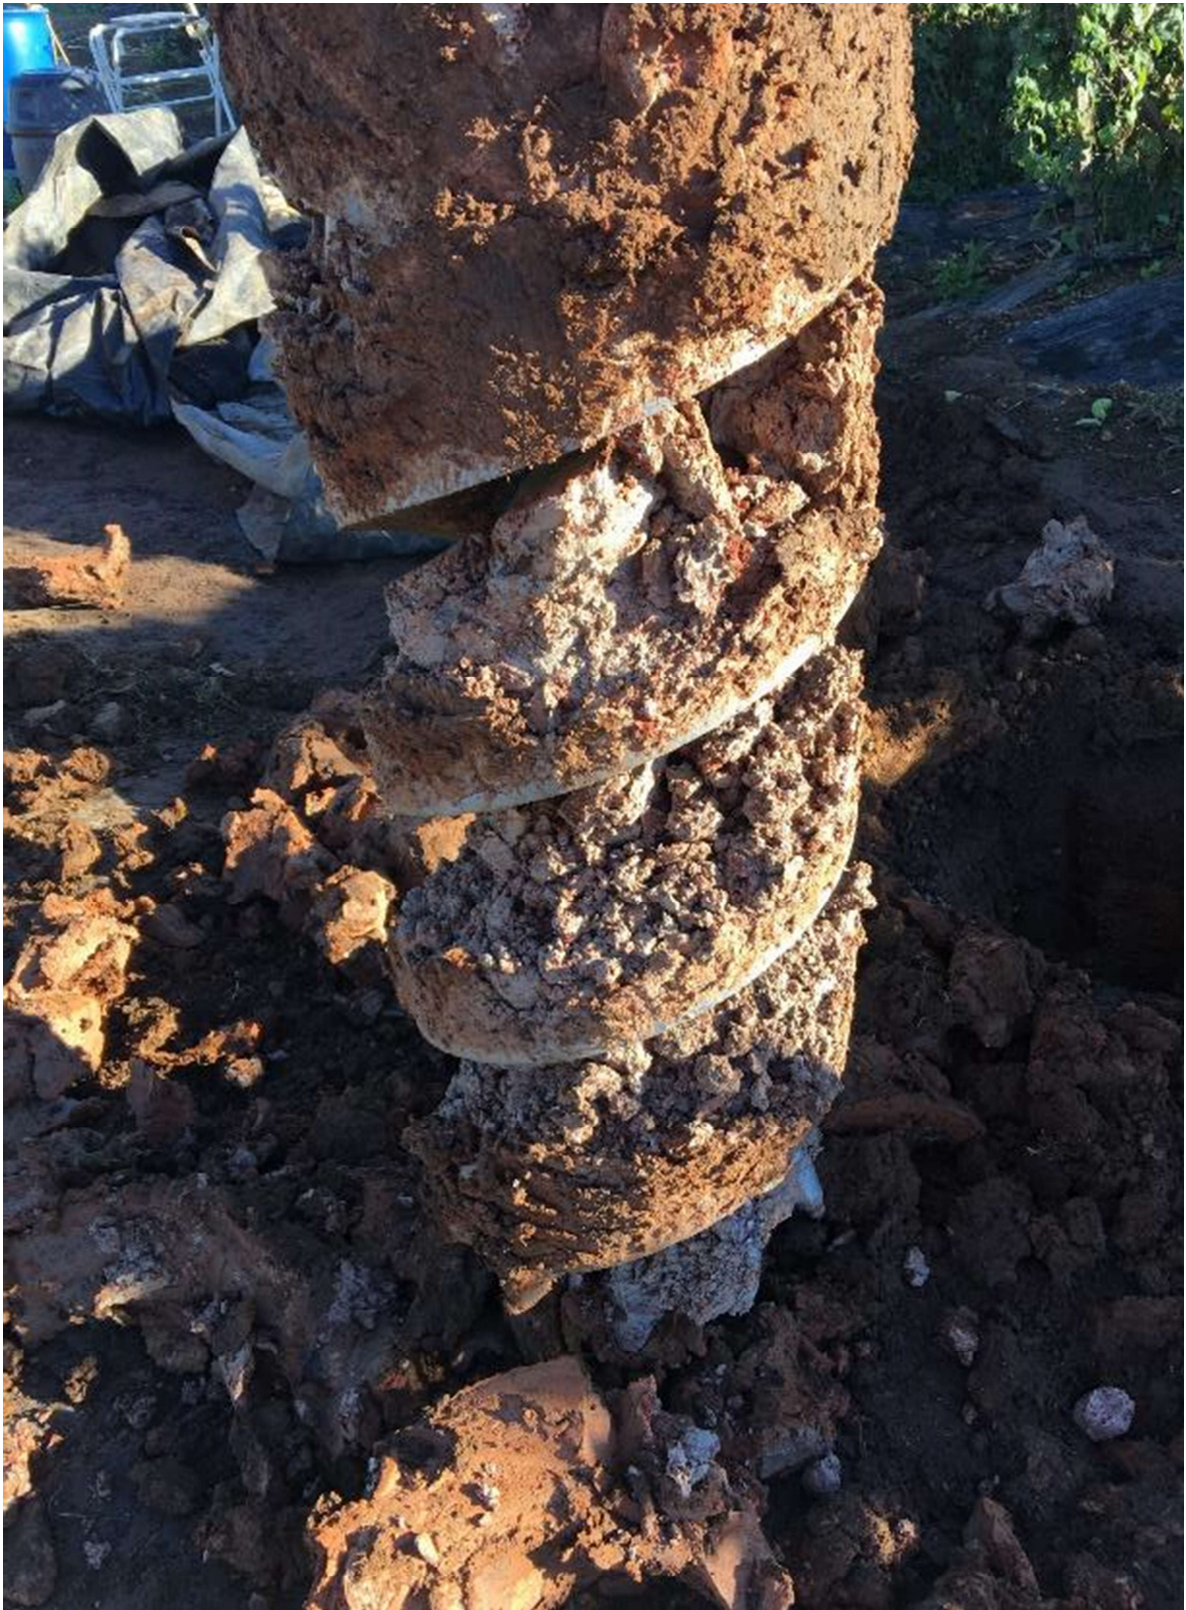
Test Pit TP16 (Auger)

| Test Pit ID | Depth (m) | Material Encountered |
|---|---|---|
| TP16<br>(Auger) | 0 – 0.2 m | TOPSOIL; silty CLAY; medium plasticity, dark brown and black, firm consistency, moist, rootlets and barks down to 0.2 m. |
| | 0.2 – 1.3 m | CLAY; medium to high plasticity, orange and pale grey, stiff to very stiff consistency, moist. |
| | 1.3 – 1.7 m | CLAY; high plasticity, pale grey and red, stiff to very stiff consistency, moist.<br><br>Becomes hard consistency from 1.6 m. |

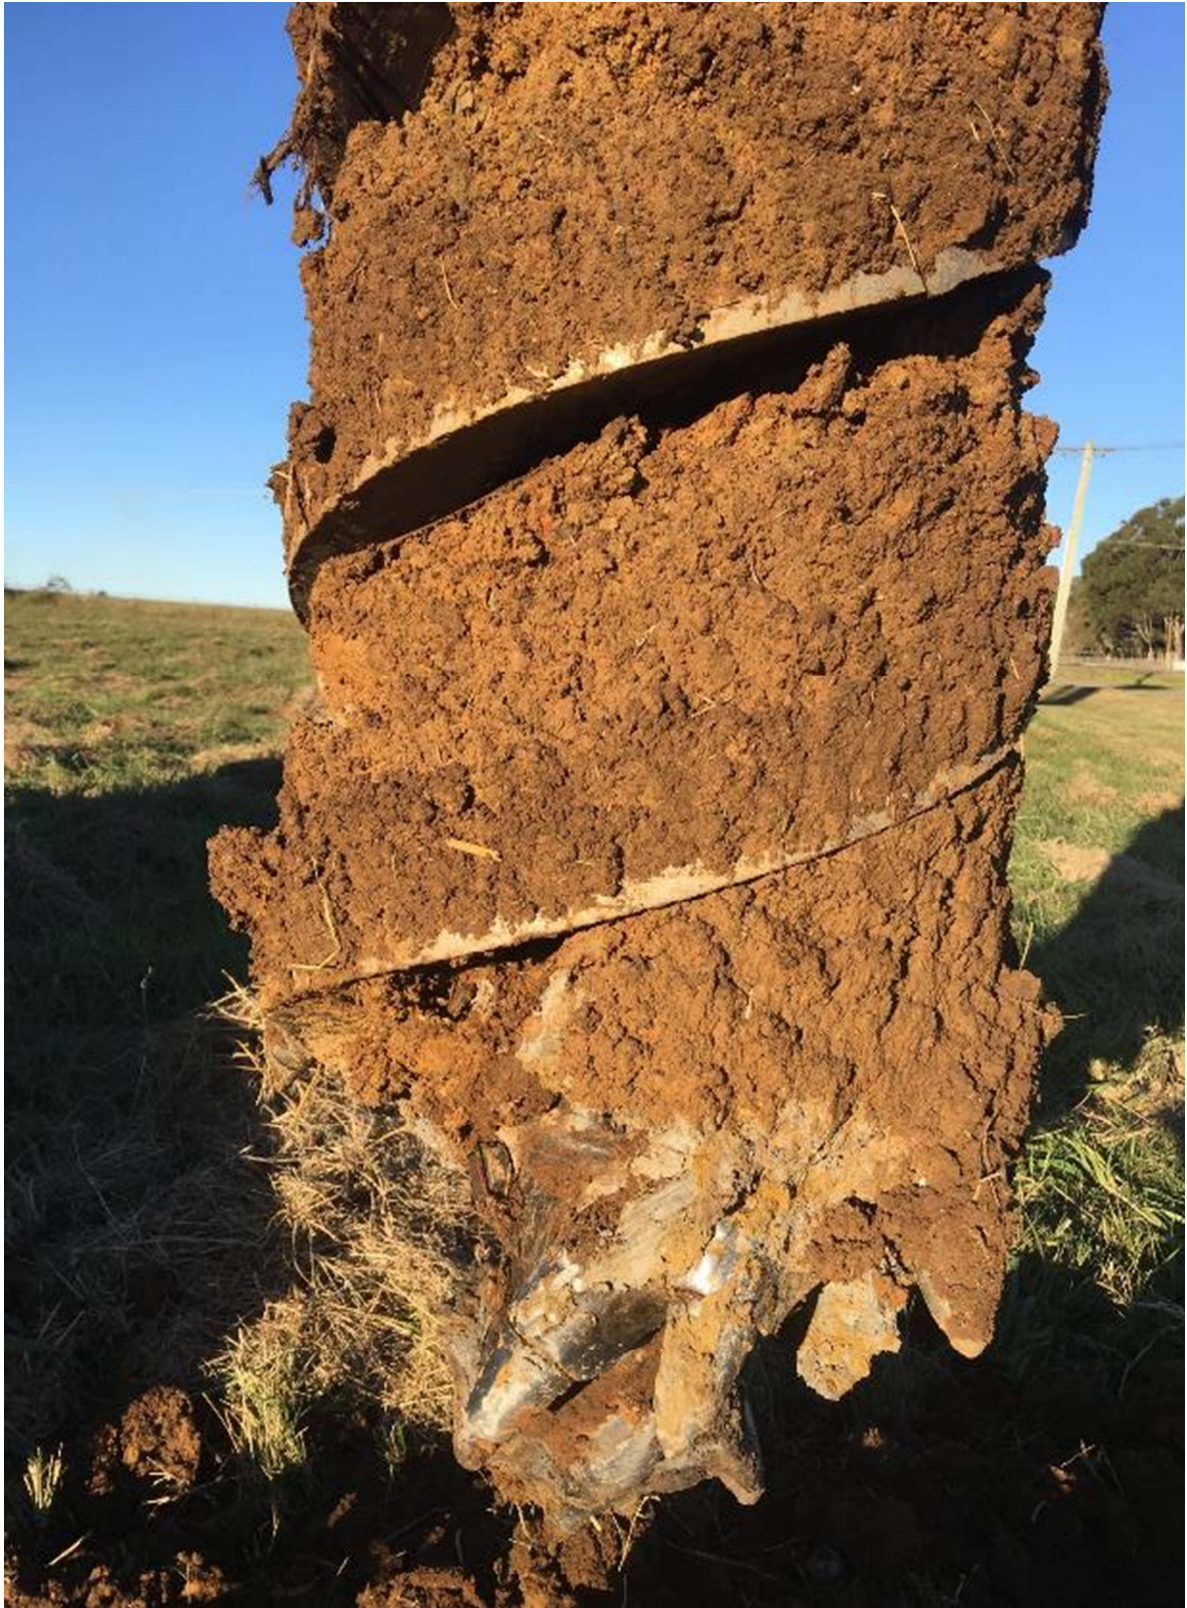
Test Pit TP18 (Auger)

| Test Pit ID | Depth (m) | Material Encountered |
|---|---|---|
| TP18<br>(Auger) | 0 – 0.3 m | TOPSOIL; silty CLAY; medium plasticity, dark brown and black, soft to firm consistency, moist to wet, rootlets and barks down to 0.3 m. |
| | 0.3 – 1.0 m | Silty CLAY; medium plasticity, dark brown, stiff consistency, moist to wet. |
| | 1.0 – 2.6 m | CLAY; medium to high plasticity, pale brown and yellow, very stiff consistency, moist to wet, trace of rootlets.<br><br>Becomes hard consistency from 2.5 m. |
| | 2.6 – 3.0 m | SILTSTONE; pale grey and red, highly weathered to moderately weathered, iron stained, low to medium strength.<br><br>Ironstone encountered from 2.6 m with medium strength. |

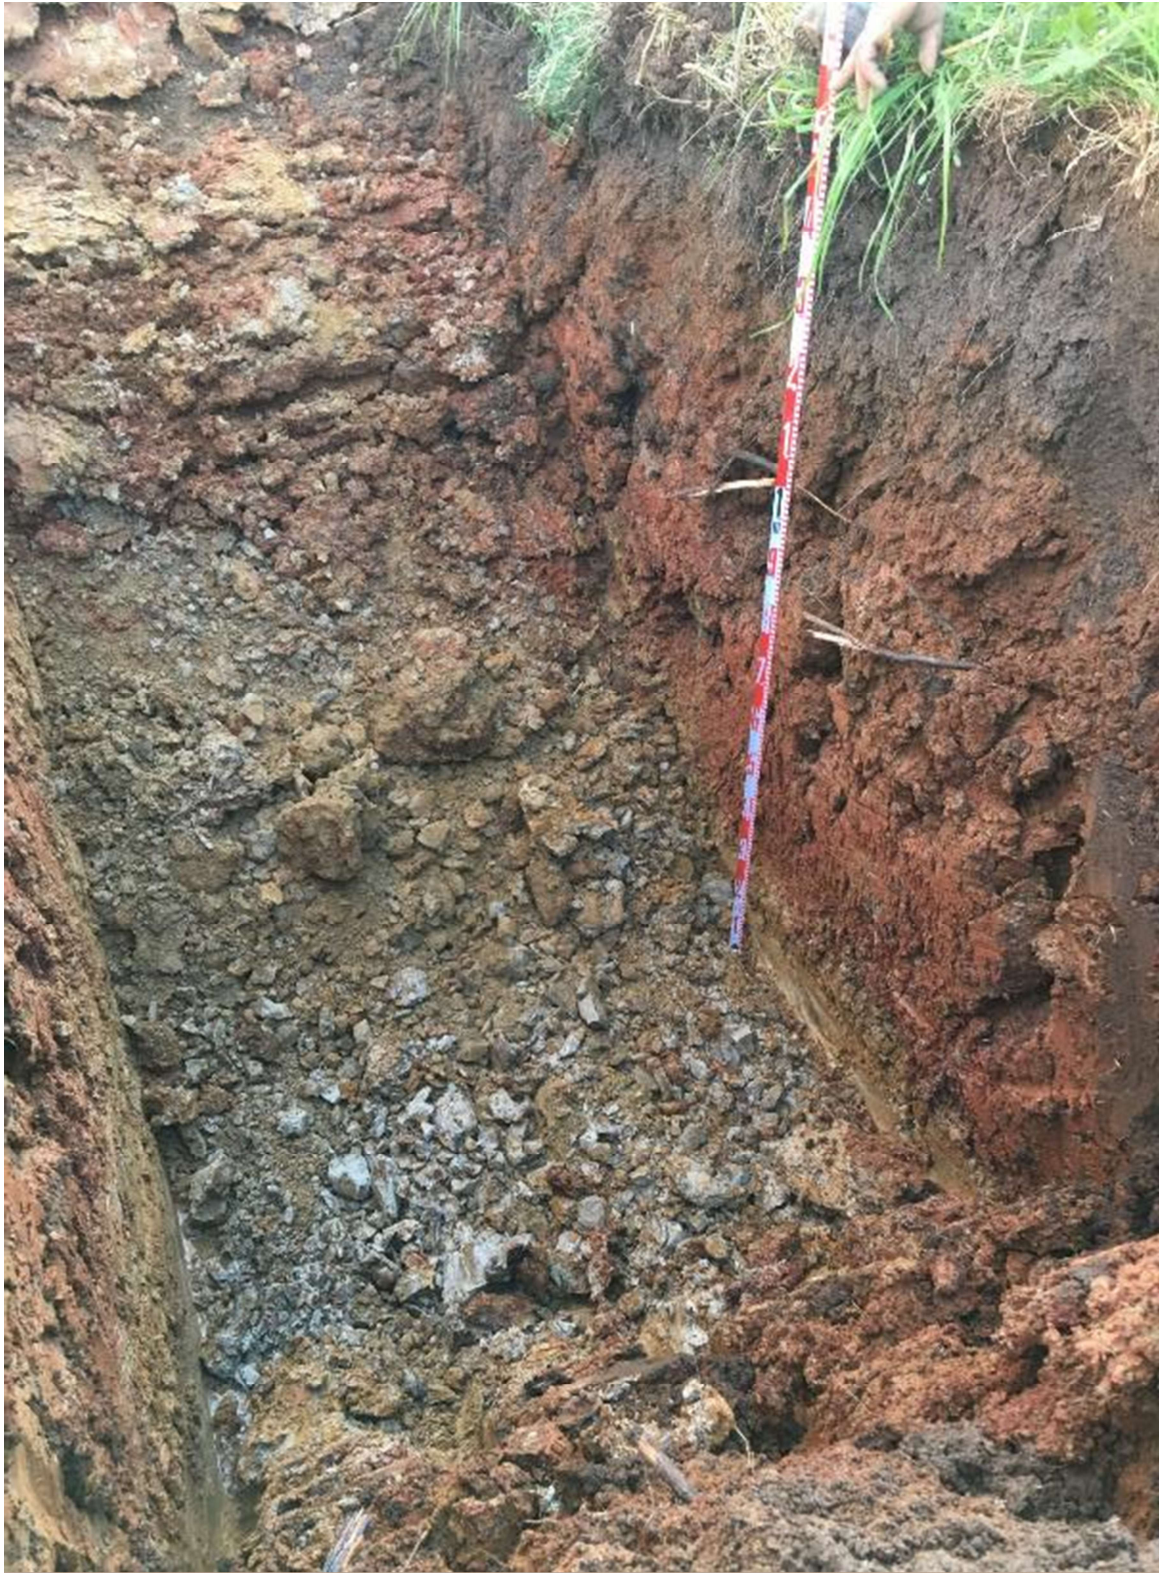
Test Pit TP21

| Test Pit ID | Depth (m) | Material Encountered |
|---|---|---|
| TP21 | 0 – 0.3 m | TOPSOIL; silty CLAY; low plasticity, dark brown and black, soft consistency, moist, rootlets and barks down to 0.3 m. |
| | 0.3 – 1.4 m | CLAY; medium to high plasticity, red, pale grey and brown, stiff consistency, moist.<br><br>Becomes very stiff to hard consistency from 1.2 m. |
| | 1.4 – 1.6 m | SILTSTONE; pale grey and brown, highly weathered, iron stained, low strength.<br><br>Ironstone encountered from 1.45 m with medium strength. |
