Our Ref: PSM3589-003L

**RE: 167-201 ALDINGTON ROAD, KEMPS CREEK  
RESULTS OF DUE DILIGENCE GEOTECHNICAL INVESTIGATIONS**

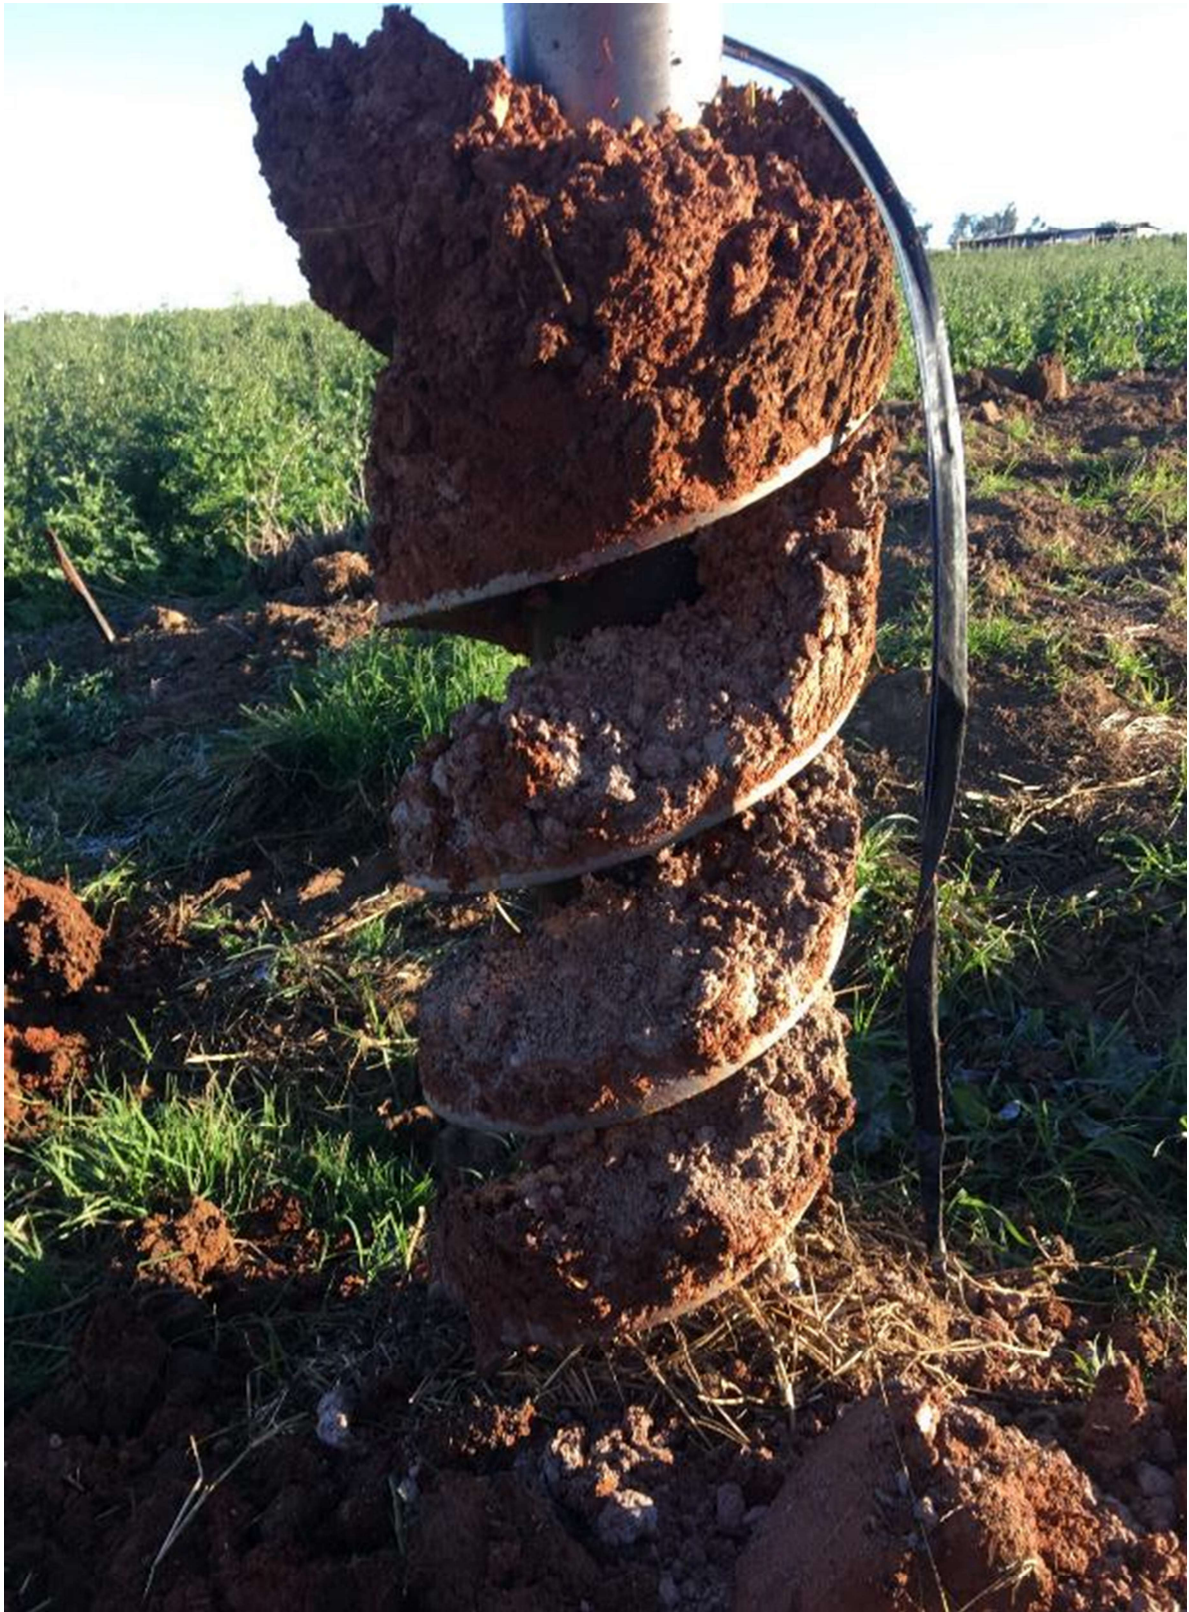
Test Pit TP22 (Auger)

| Test Pit ID | Depth (m) | Material Encountered |
|---|---|---|
| TP22<br>(Auger) | 0 – 0.3 m | TOPSOIL; silty CLAY with trace of gravel; low plasticity, dark brown, firm consistency, sub-angular gravel size up to 5 mm, moist, rootlets and barks down to 0.3 m. |
| | 0.3 – 0.8 m | CLAY; medium plasticity, dark brown and black, stiff to very stiff consistency, moist, trace of rootlets. |
| | 0.8 – 2.0 m | CLAY; medium plasticity, red, orange and pale grey, very stiff consistency, moist, trace of rootlets.<br><br>Becomes hard consistency from 1.9 m.<br><br>Ironstone encountered from 1.9 m with medium strength. |

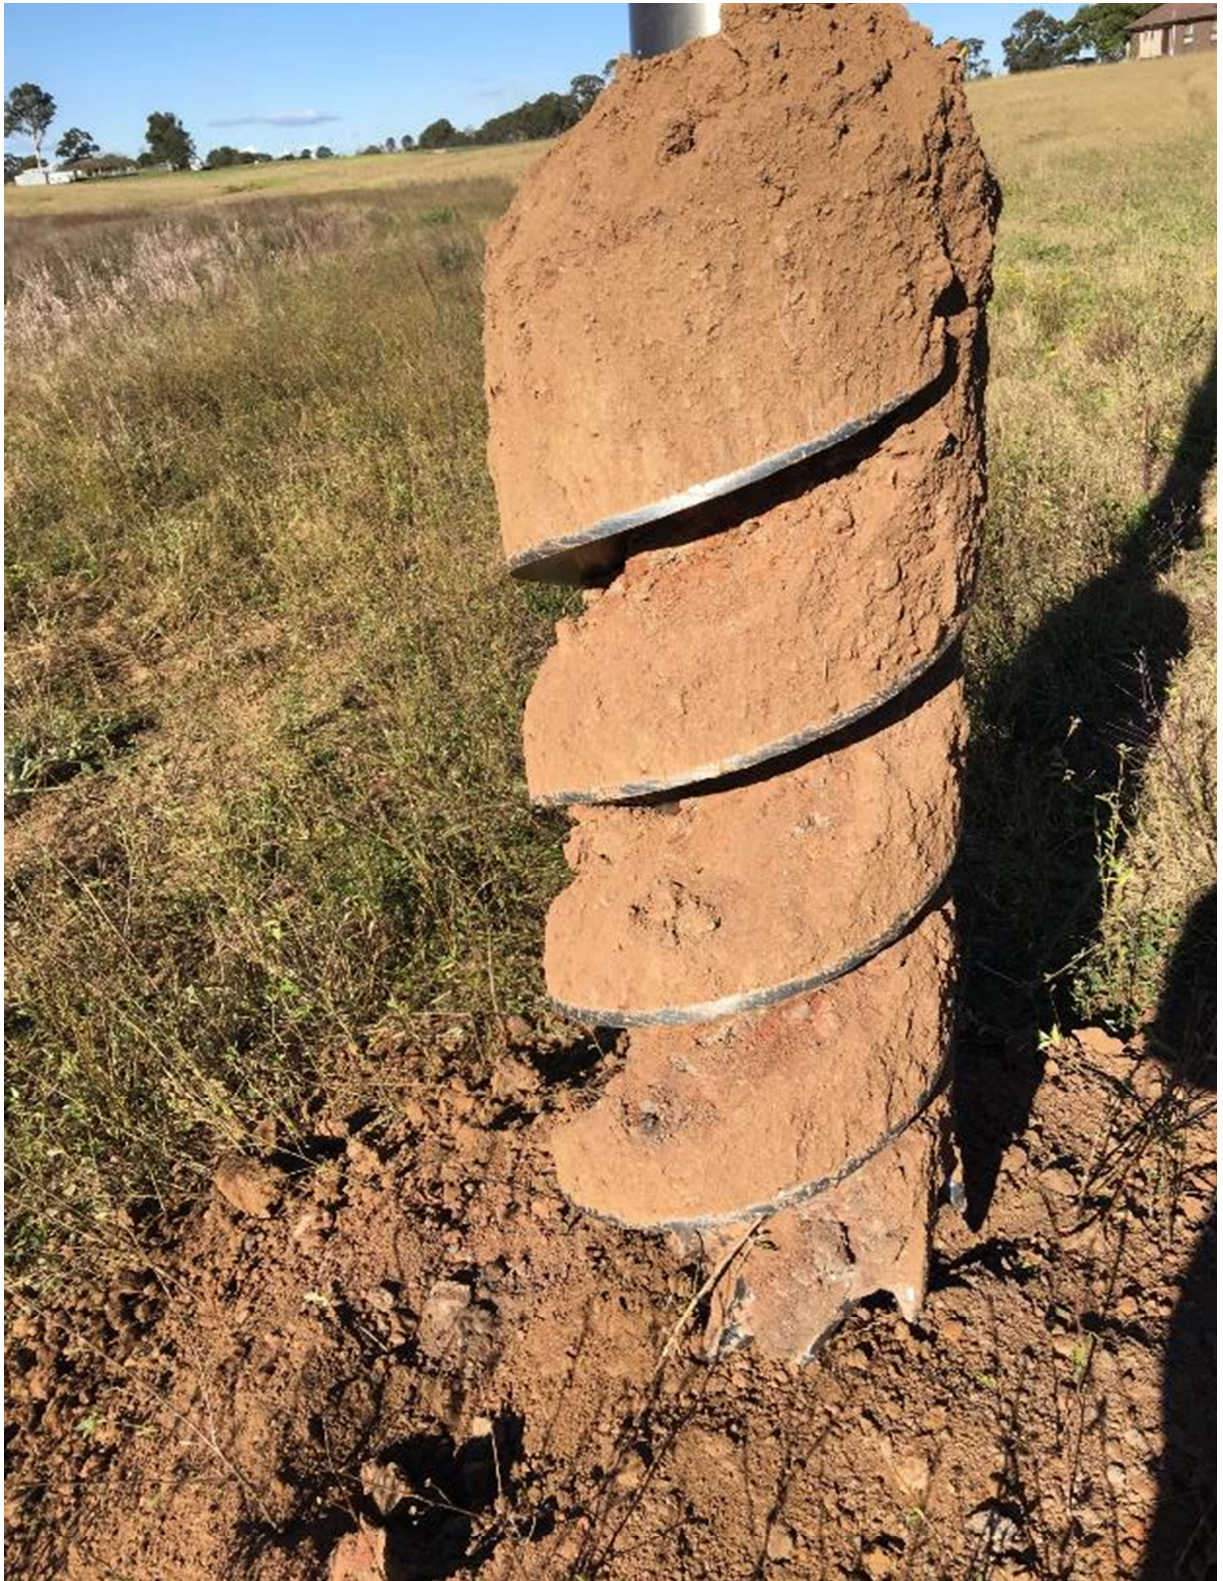
Test Pit TP25 (Auger)

| Test Pit ID | Depth (m) | Material Encountered |
|---|---|---|
| TP25<br>(Auger) | 0 – 0.1 m | TOPSOIL; silty CLAY; medium plasticity, dark brown, firm consistency, moist, rootlets and barks down to 0.1 m. |
| | 0.1 – 1.5 m | CLAY; medium to high plasticity, pale grey and red, stiff to very stiff consistency, moist.<br><br>Becomes hard consistency from 1.4 m |
| | 1.5 – 2.5 m | SILTSTONE; pale grey and orange, highly weathered, iron stained, low strength.<br><br>Ironstone encountered from 1.5 m with medium strength. |
| | 2.5 – 2.6 m | SILTSTONE; pale grey and red, moderately weathered, iron stained, medium strength. |

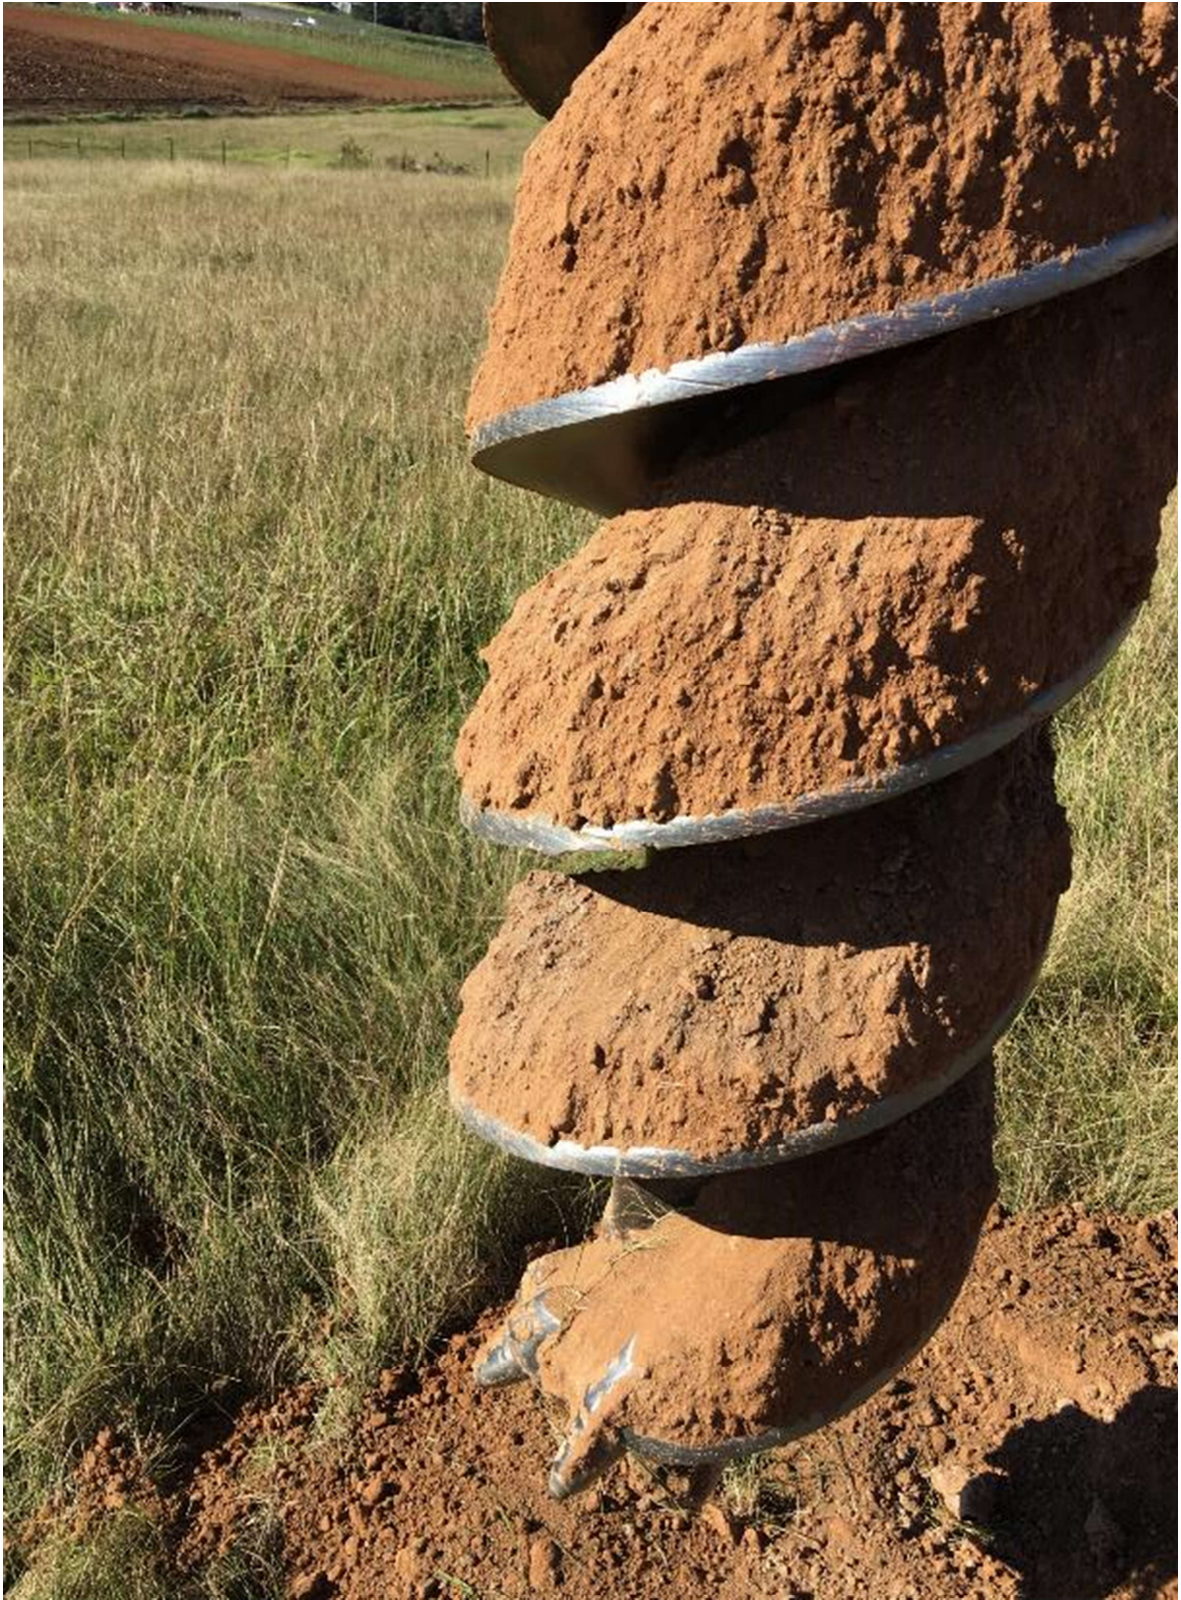
Test Pit TP26 (Auger)

| Test Pit ID | Depth (m) | Material Encountered |
|---|---|---|
| TP26<br>(Auger) | 0 – 0.3 m | TOPSOIL; silty CLAY, low plasticity, dark brown and grey, firm consistency, dry to moist. rootlets and barks down to 0.3 m. |
| | 0.3 – 1.0 m | CLAY; medium plasticity, dark brown, very stiff consistency, dry to moist.<br>Becomes hard consistency from 0.9 m. |

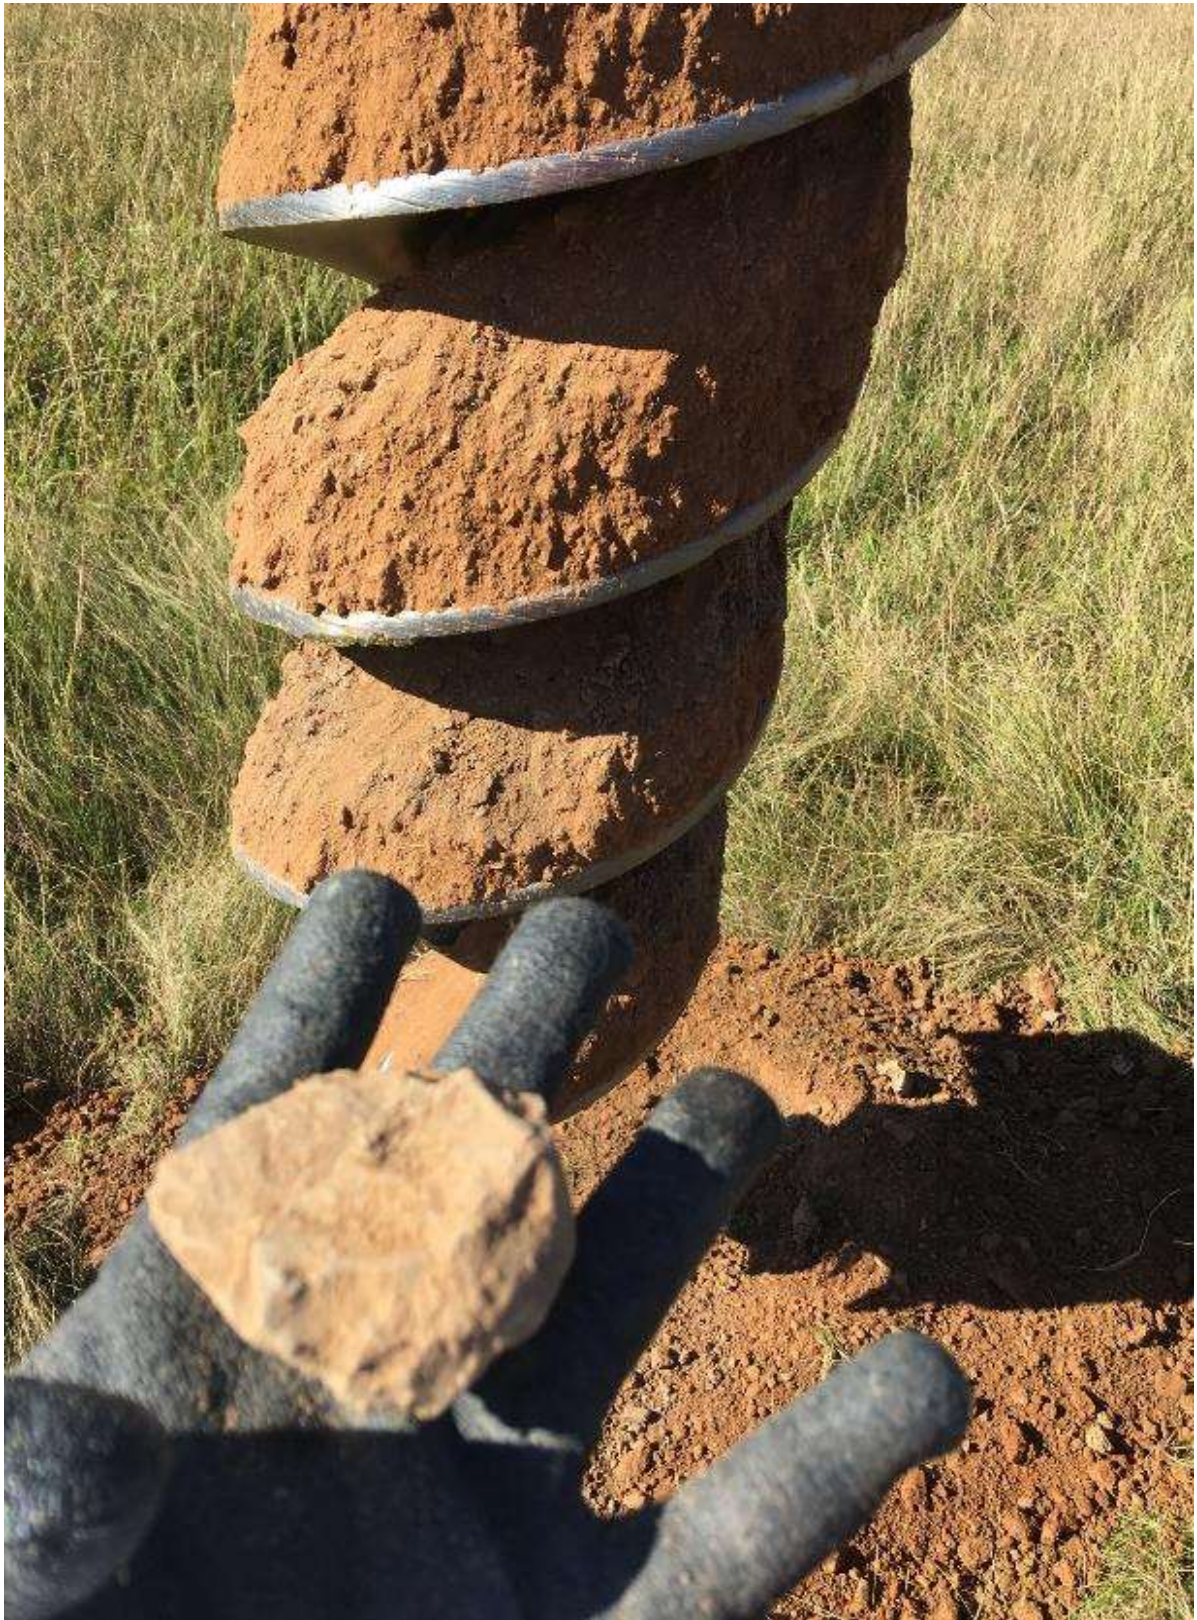
Test Pit TP28 (Auger)

| Test Pit ID | Depth (m) | Material Encountered |
|---|---|---|
| TP28<br>(Auger) | 0 – 0.2 m | TOPSOIL; silty CLAY with trace of gravel; low plasticity, dark brown, firm consistency, sub-angular gravel size up to 5 mm, moist, rootlets and barks down to 0.2 m. |
| | 0.2 – 1.7 m | CLAY; medium to high plasticity, dark brown and red, stiff to very stiff consistency, moist, trace of rootlets.<br>Becomes hard consistency from 1.6 m. |

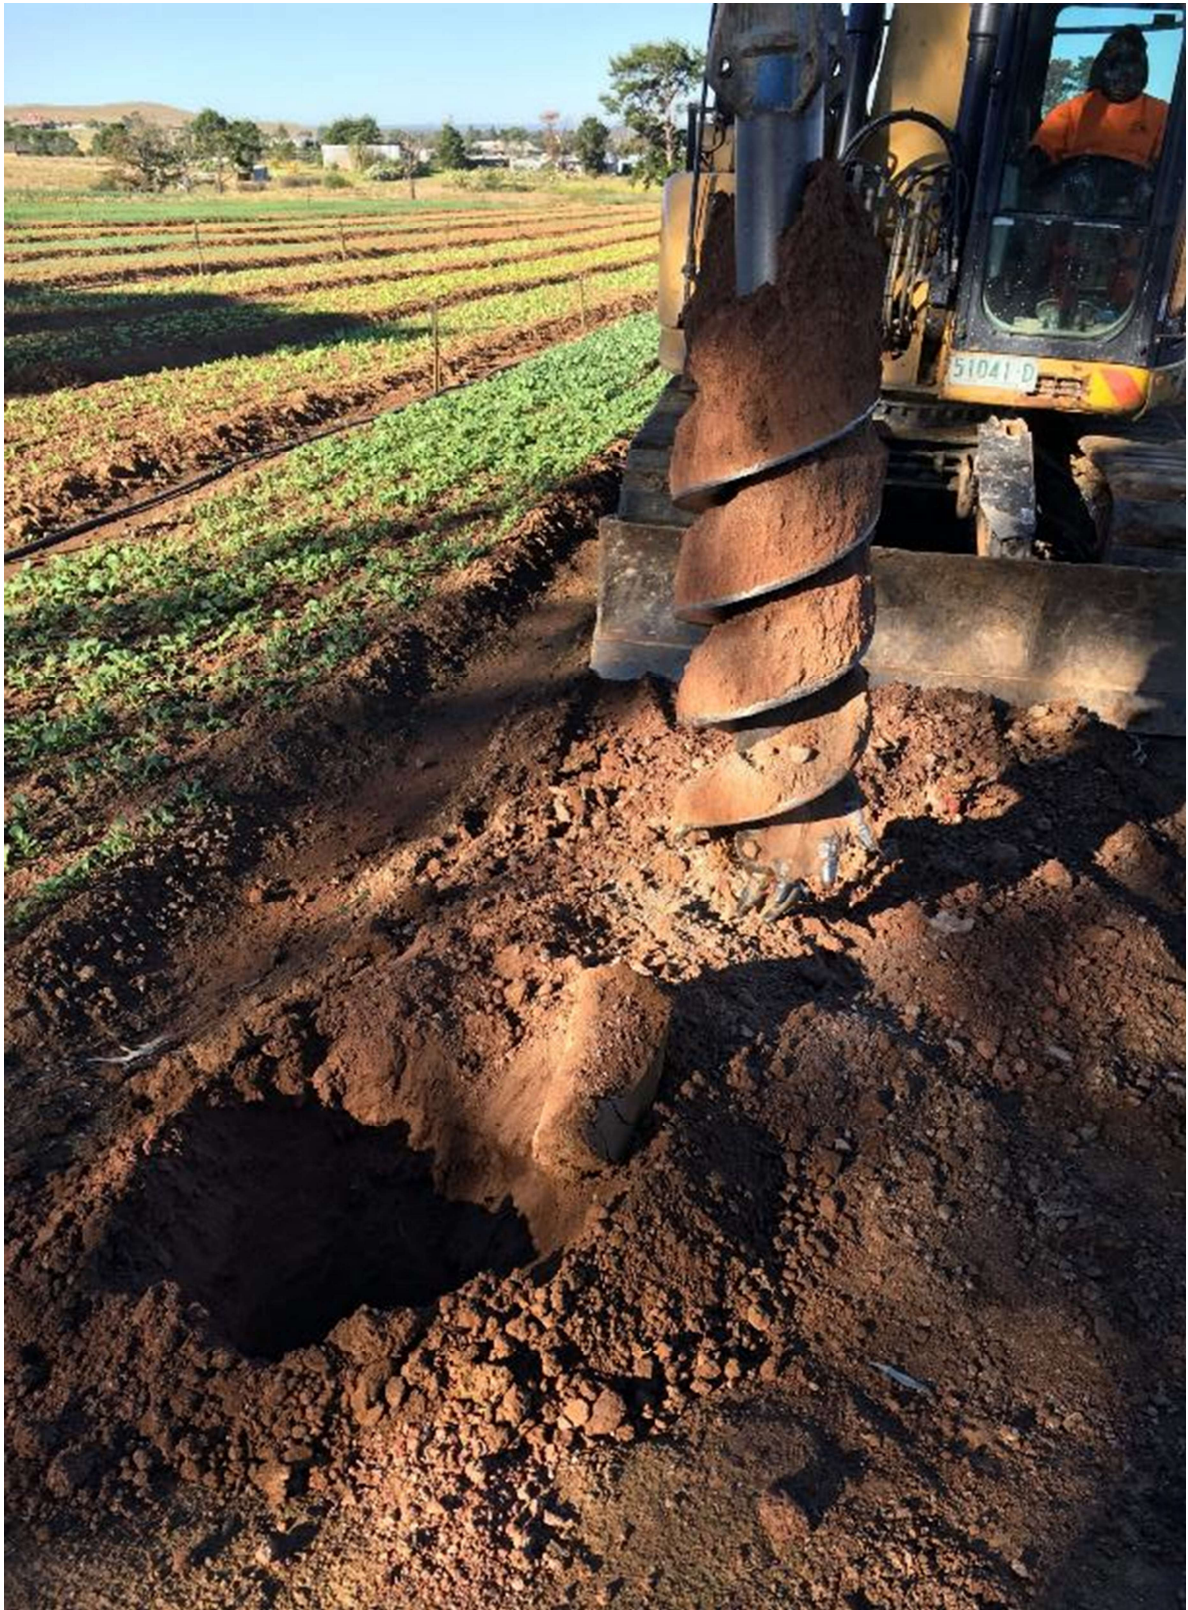
Test Pit TP38 (Auger)

| Test Pit ID | Depth (m) | Material Encountered |
|---|---|---|
| TP38<br>(Auger) | 0 – 0.15 m | TOPSOIL; silty CLAY; low to medium plasticity, dark brown and red, firm consistency, moist. |
| | 0.15 – 1.0 m | Silty CLAY; high plasticity, dark brown and red, stiff to very stiff consistency, moist.<br>Becomes hard consistency from 0.9 m. |
| | 1.0 – 1.7 m | SILTSTONE; pale grey and red, extremely weathered, iron stained, extremely low strength.<br>Ironstone encountered from 1.2 m with medium strength. |
| | 1.7 – 1.8 m | SILTSTONE; pale grey and red, highly weathered to moderately weathered, iron stained, low strength. |
