HISTORICAL ARCHAEOLOGICAL ASSESSMENT

**Taronga Wildlife Hospital - The
Nutrition Centre, Taronga Zoo**
Bradleys Head Road
Mosman, NSW

Prepared for
TARONGA CONSERVATION SOCIETY AUSTRALIA
22 December 2021

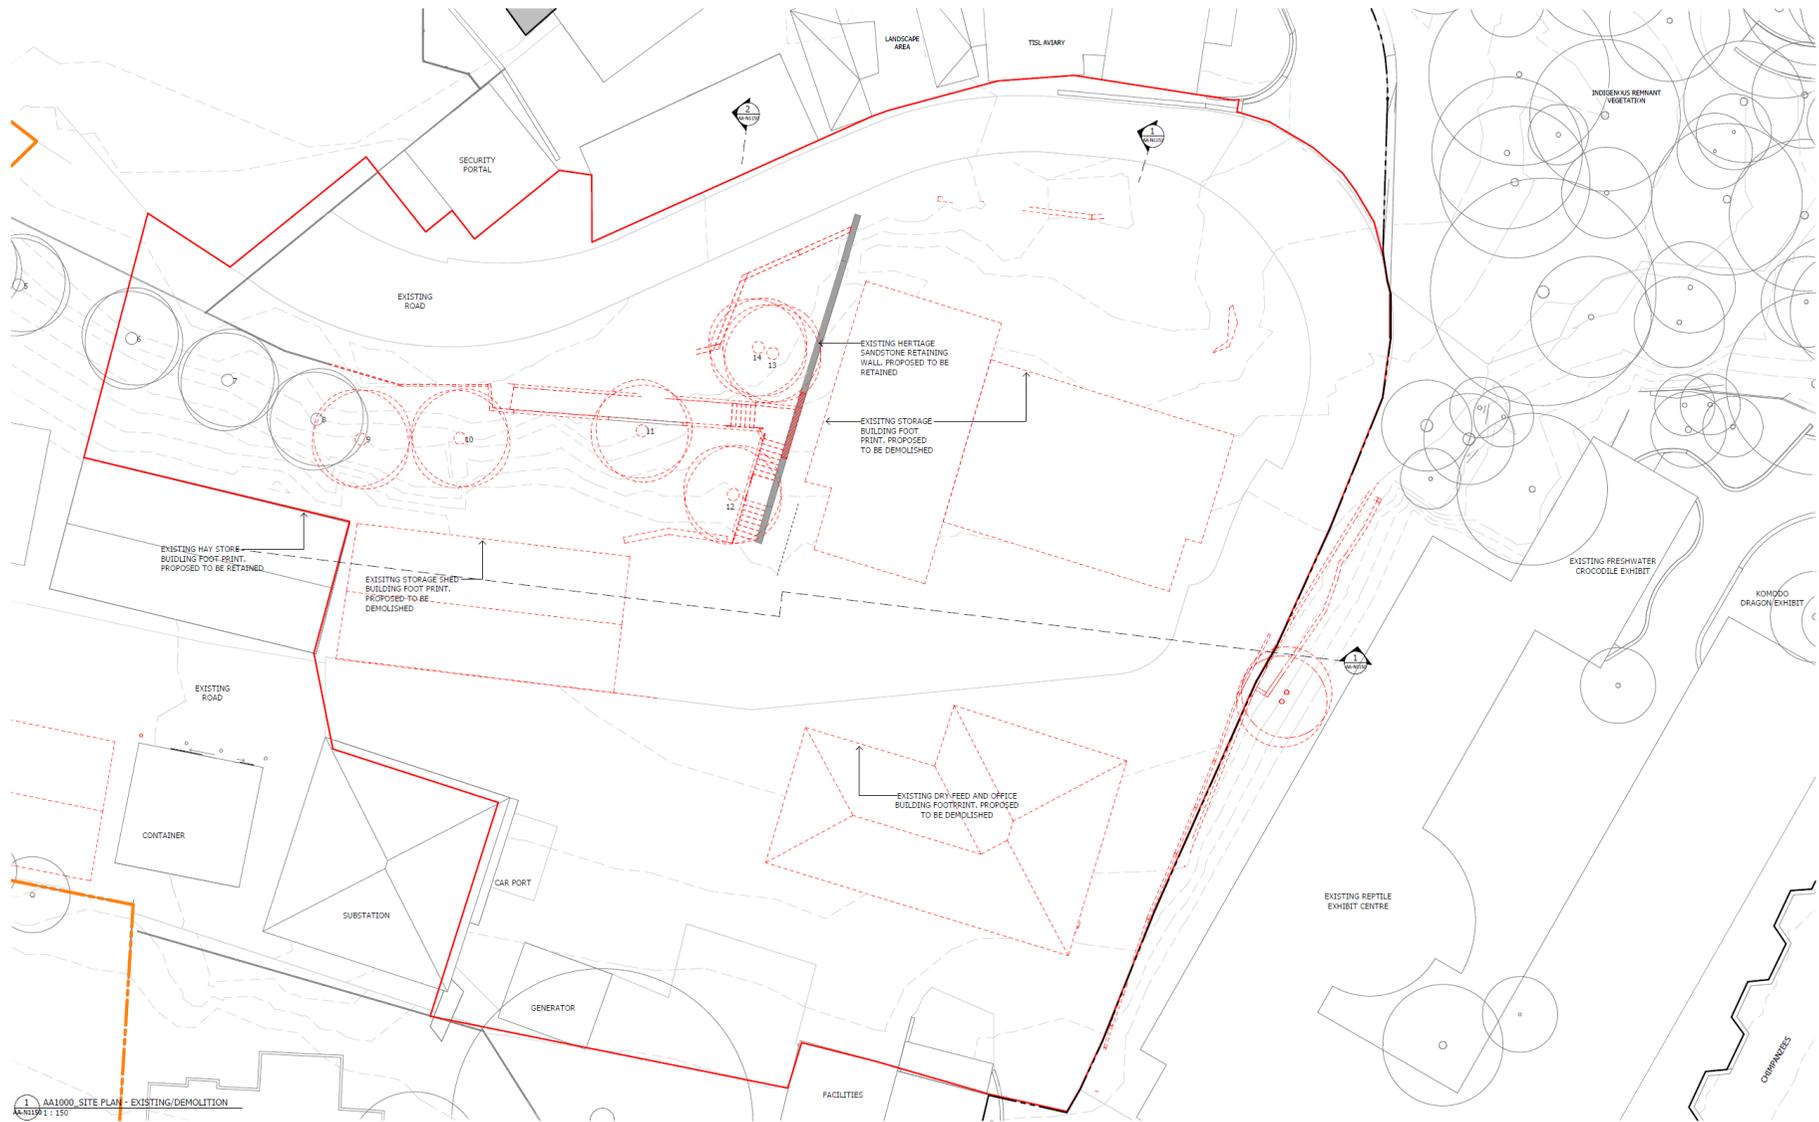
Figure 3 – Site Plan – Existing and Demolition

Source: DWP, 14/12/2021, Issue Q, Drawing no. AA-N1000

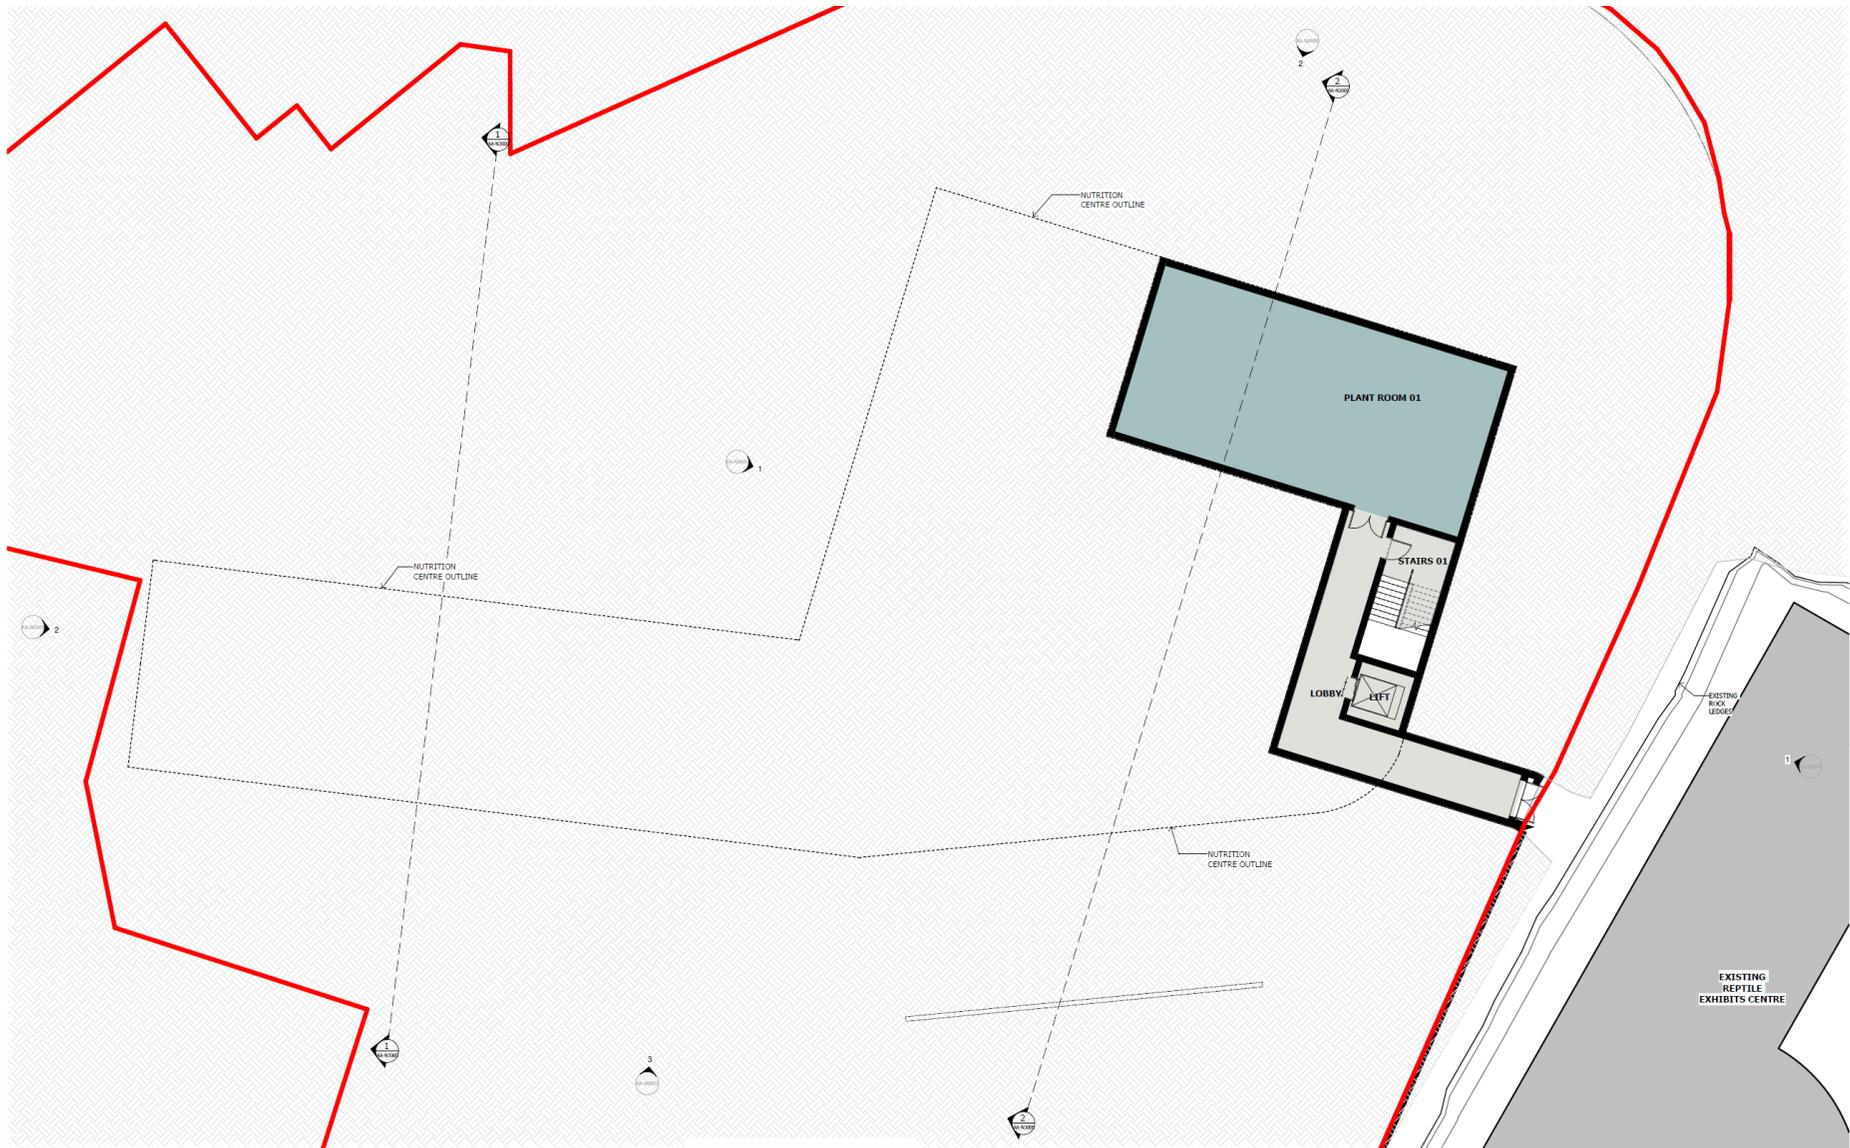
Figure 4 – General Arrangement Plan – Level 01

Source: DWP, 14/12/2021, Issue P, Drawing no. AA-N1200

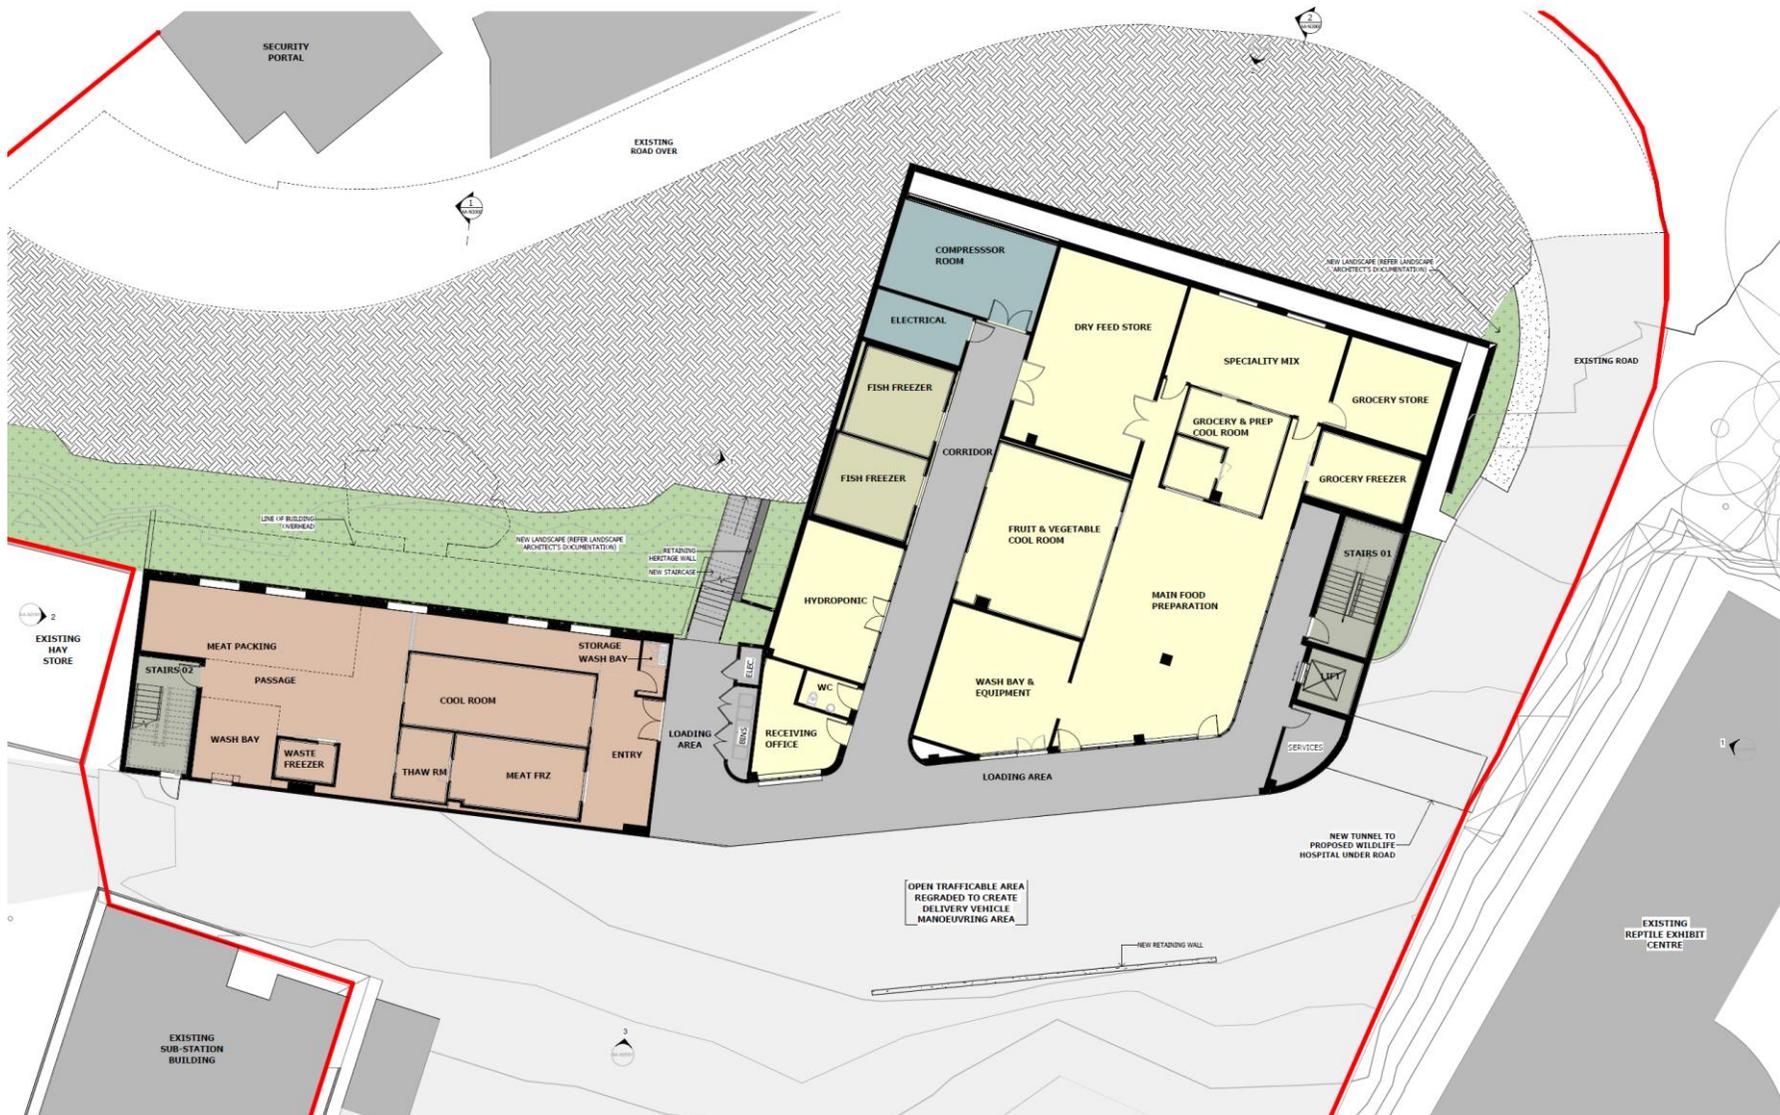
Figure 5 – General Arrangement Plan – Level 02

Source: DWP, 14/12/2021, Issue S, Drawing no. AA-N1201

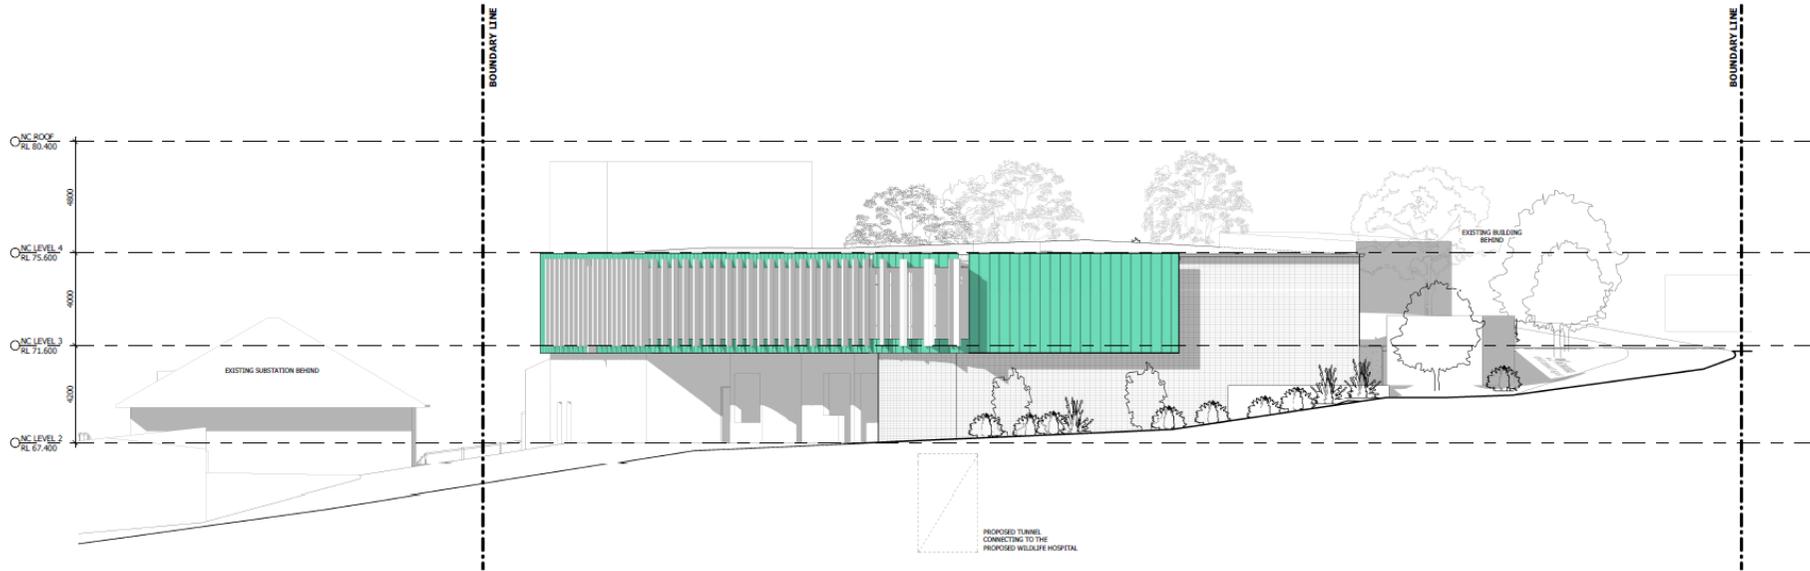
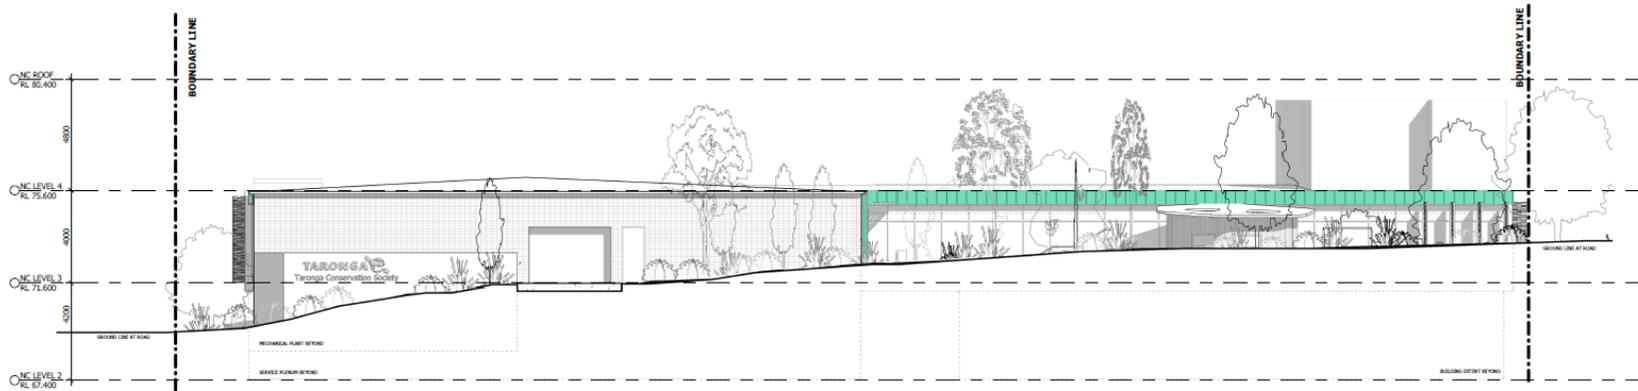
Figure 6 – Elevations

1 NUTRITION BUILDING - SOUTH ELEVATION
 A4:RDA 1:100

2 NUTRITION BUILDING - EAST ELEVATION
 A4:RDA 1:100

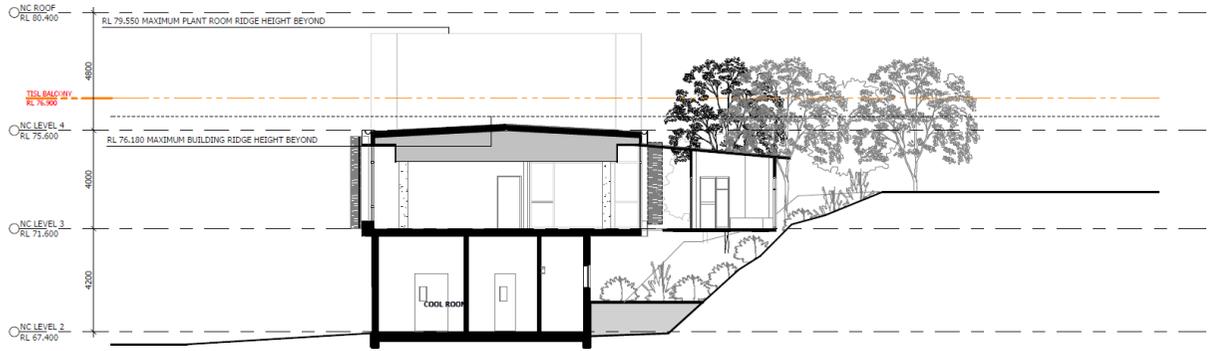
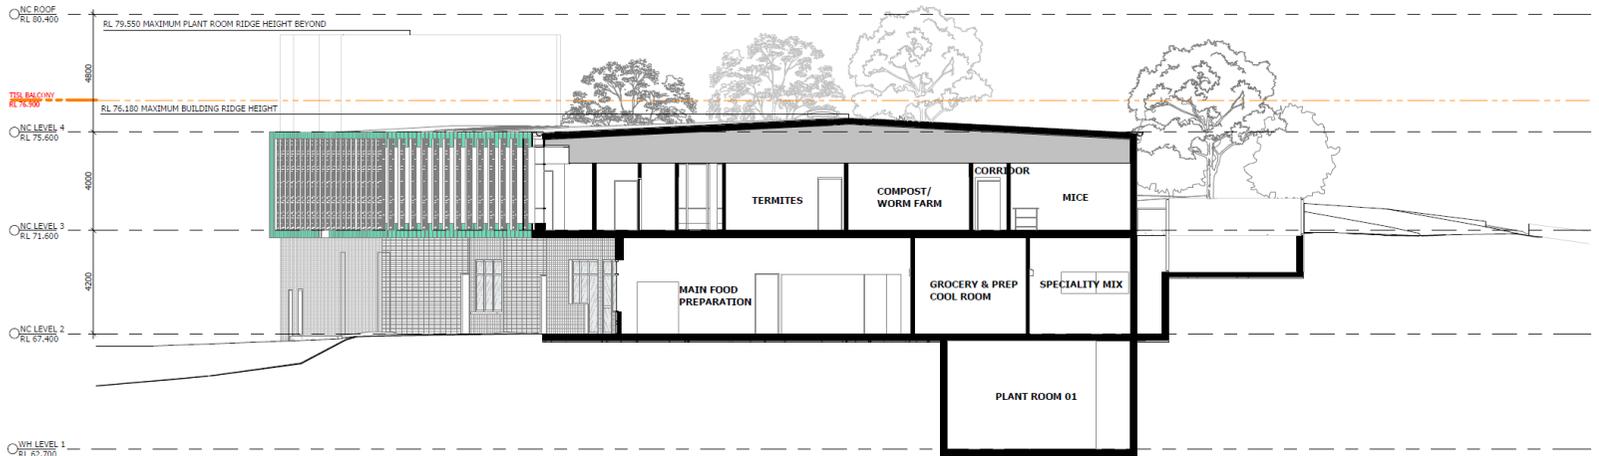
Figure 7 – Sections

1 NUTRITION BUILDING SECTION A
 1:100

2 NUTRITION BUILDING SECTION B
 1:100

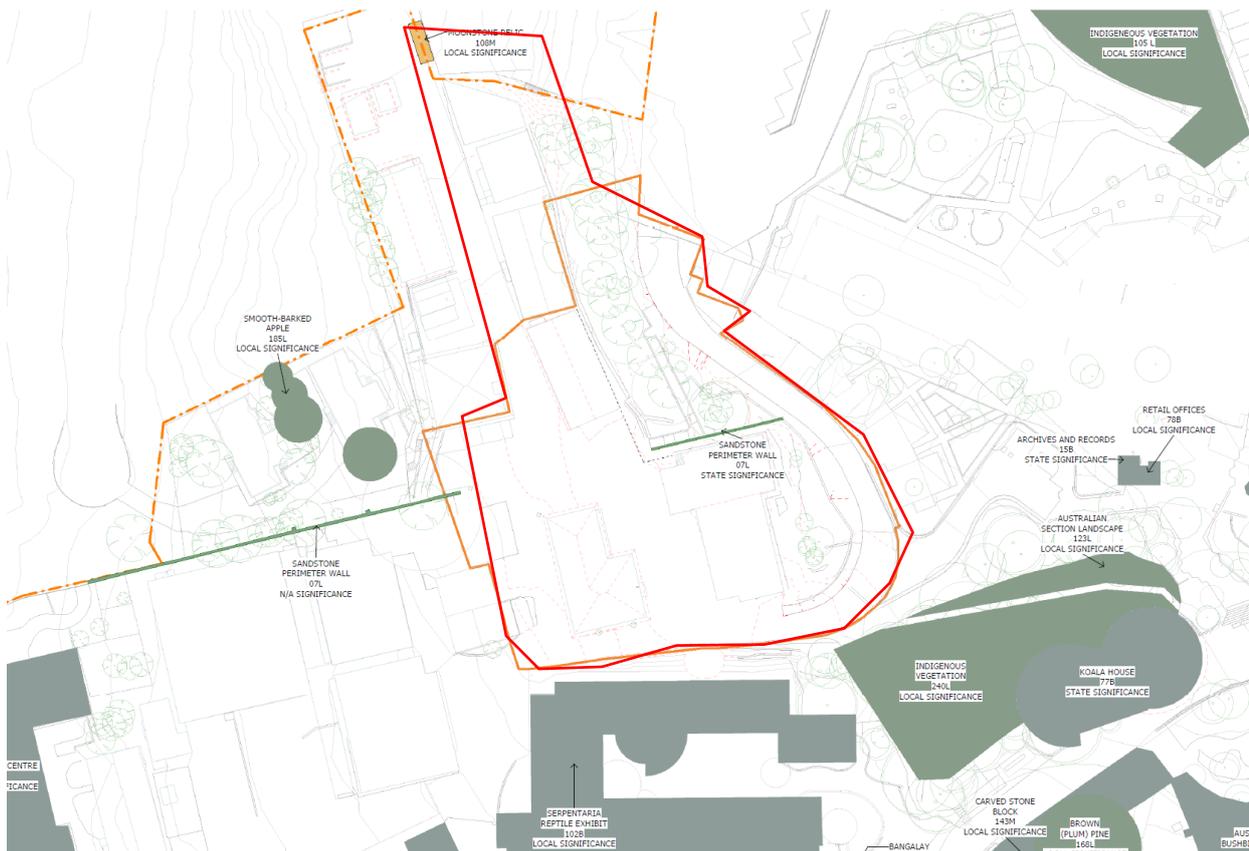
Figure 8 – Section 170 heritage items located within the subject area.

Table 3 - S.170 heritage items located within the subject area

Item Name	Listing	Significance
Sandstone Perimeter Wall	07L	State
Moonstone Relic	108L	Local

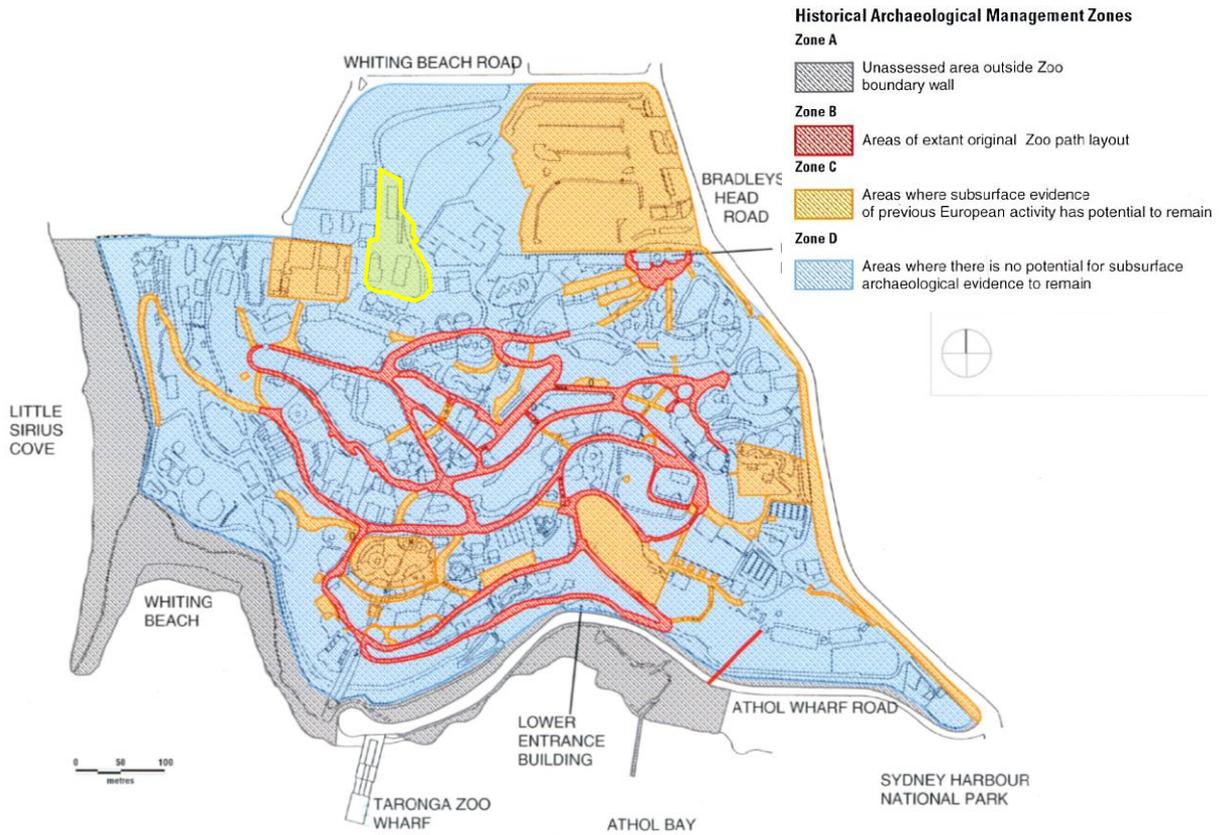
Figure 10 – Historical archaeological management zones. Approximate location of the subject area indicated in yellow outline.

This Historical Archaeological Management Zone encompasses the rest of the site, where excavations for the foundations of previous Zoo structures have reached down to bedrock or culturally sterile soil profiles, or where there has been little or insignificant historical development. Zone D is not expected to contain any historical material culture and is therefore assessed as having no archaeological sensitivity.

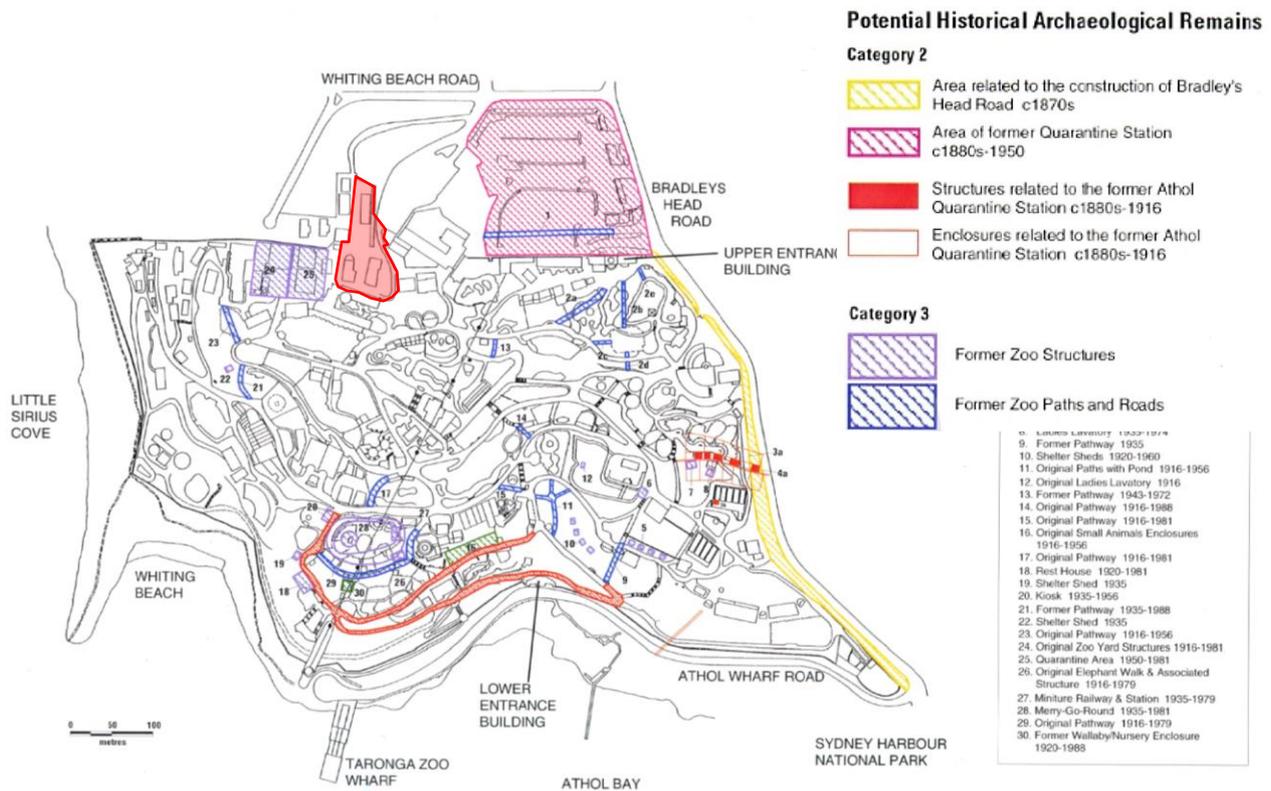
Figure 11 - Potential historical archaeological remains. Approximate location of the subject area indicated in red outline.

The Taronga Zoo AMP does not identify the potential for historical archaeological remains within the subject area (Figure 11):

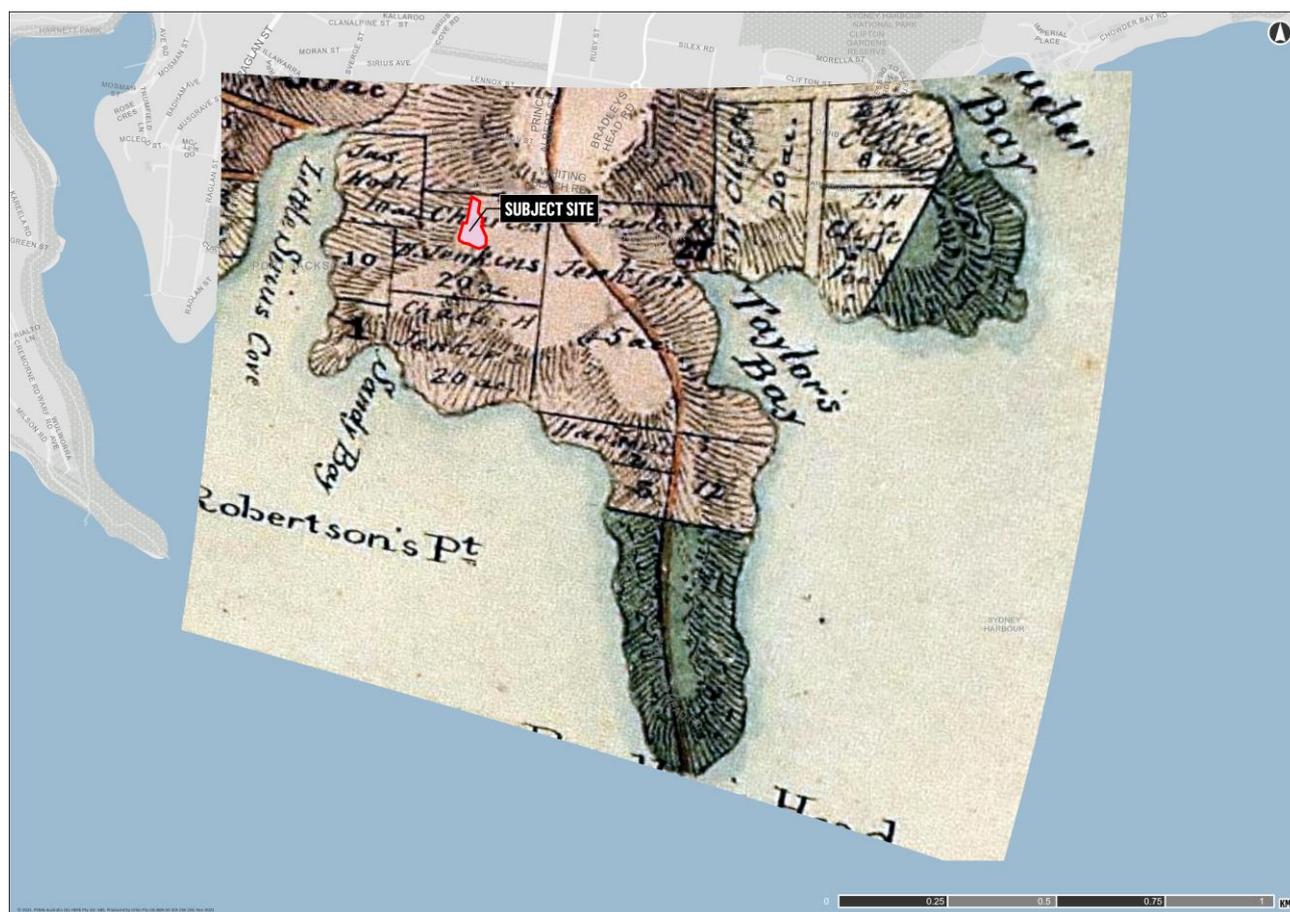
Figure 12 – Historic parish map of Willoughby, c. 1850s. Approximate location of the subject area indicated in blue outline.

Taronga Zoo is located within the County of Cumberland, Parish of Willoughby. In 1837 a stone house known as 'Athol' was erected to the south of the subject area. This was later developed as a leisure destination with a hotel and pleasure garden. A Parish Map dating to c.1850s show that the subject area had by this time been incorporated within a land parcel granted in four allotments to Charles Jenkins and J. Holt (see Figure 12). There is no evidence of structures being erected within the subject area in association with this period.

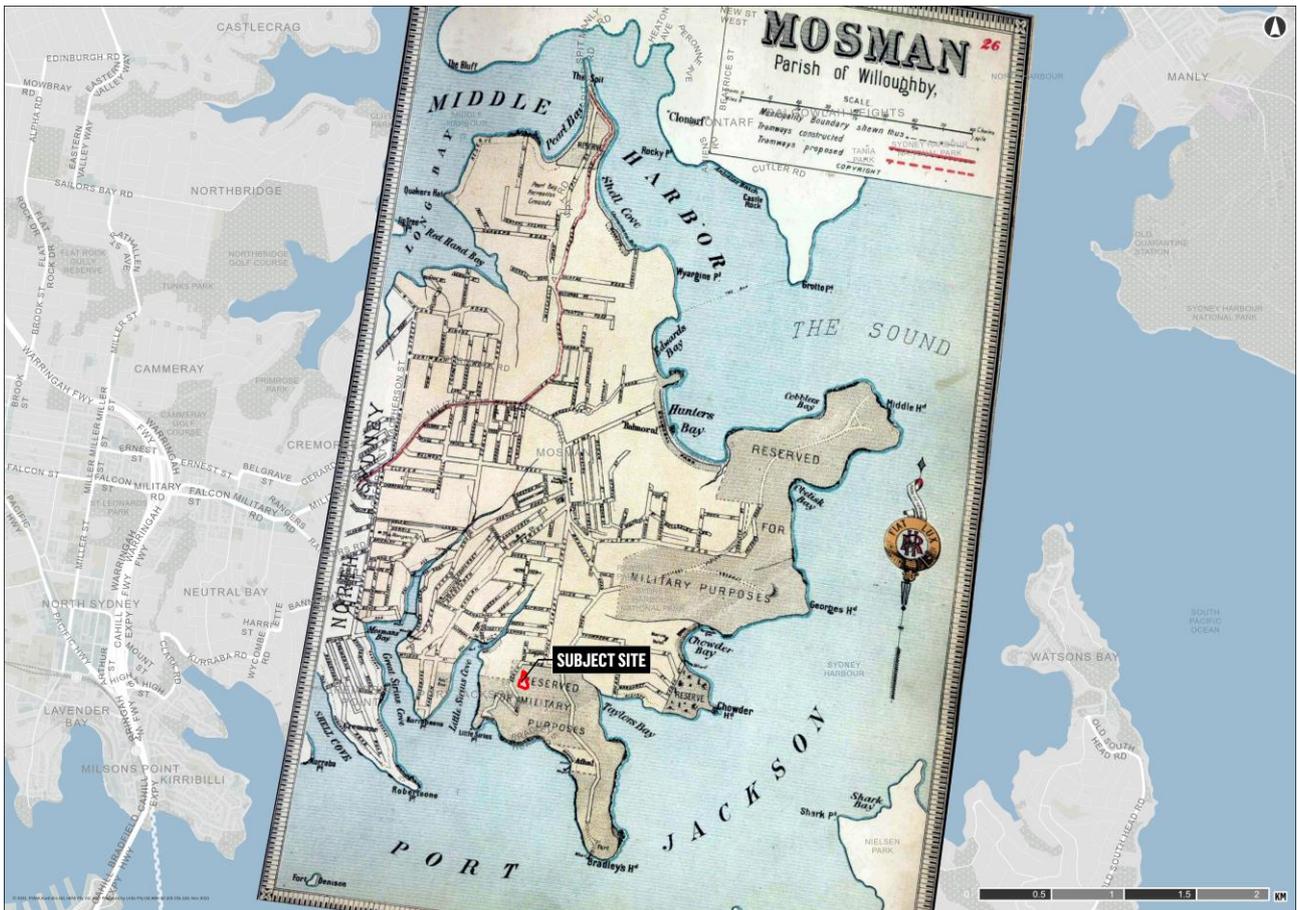
Figure 13 – 1893-94 Parish Map indicating resumption of land for military purposes. Approximate location of the subject area indicated in red outline.

In the 1890s, large portions of the land surrounding Sydney Harbour were resumed for Military Purposes (Figure 13), including Bradley's Head and the animal quarantine facilities which operated upon it. There is no evidence which suggests that any structures were established within the subject area in association with this period. Following federation in 1901, the Military Reserves were given to the Commonwealth. In 1908, Ashton Park, comprising 142 acres of public park land, was gazetted (Figure 14).

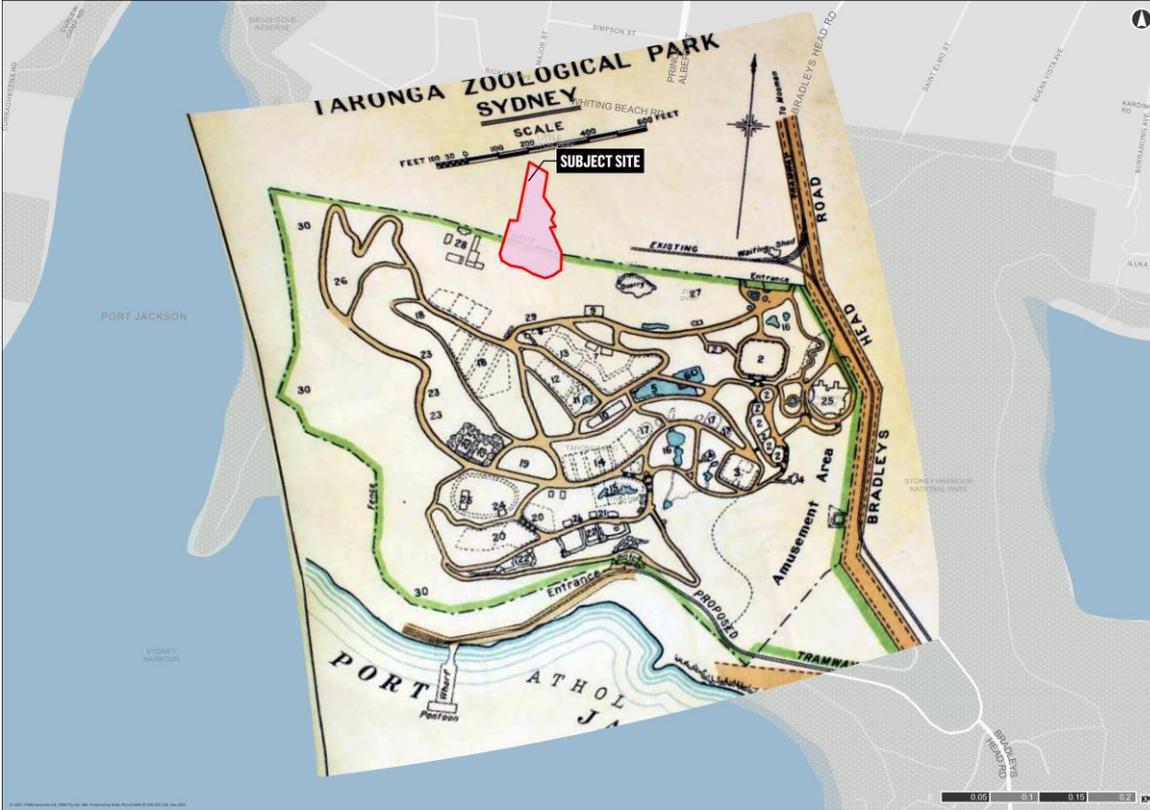
Figure 15 -1916 plan of Taronga Zoological Park, approximate location of the subject area is indicated in red outline. Note the location of the northern boundary wall in green which transected the Zoo site at this time.

Figure 15 demonstrates the Zoo in its original plan in 1916, with approximately 23 animal exhibits and the original path network. The subject area was undeveloped. The northern component of the subject area was located outside the northern boundary of the site at this time and was separated by a boundary wall which transected the site. The wall was constructed in the 1930s as an interwar Depression incentive. The wall was unlikely to have contained substantial footings on the grounds that it was of rudimentary construction.²

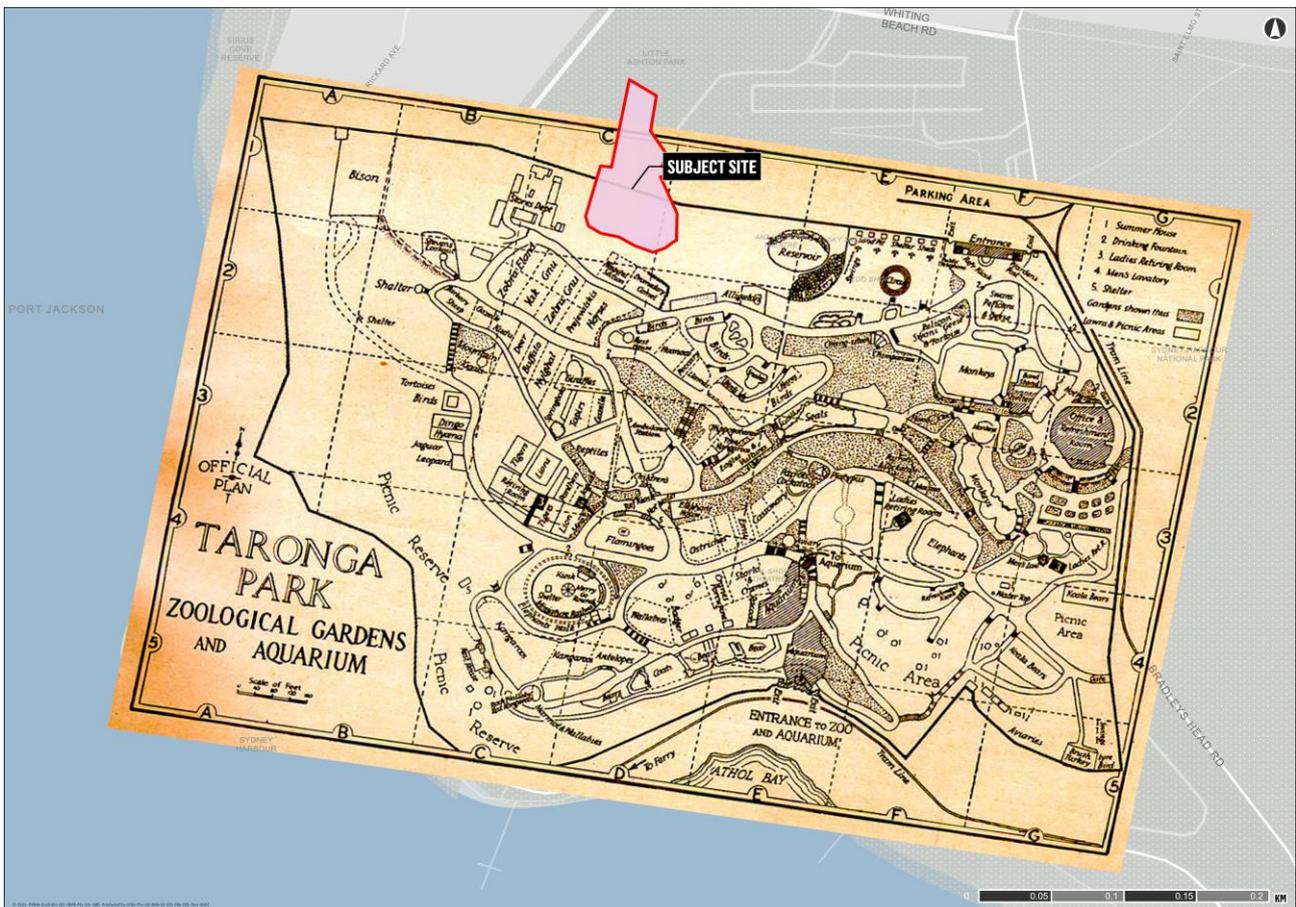
Figure 16 – 1940s plan of Taronga Zoo with location of subject area indicated in red. Note that the site remained undeveloped at this time, with a camel enclosure and hospital established to the south-east.

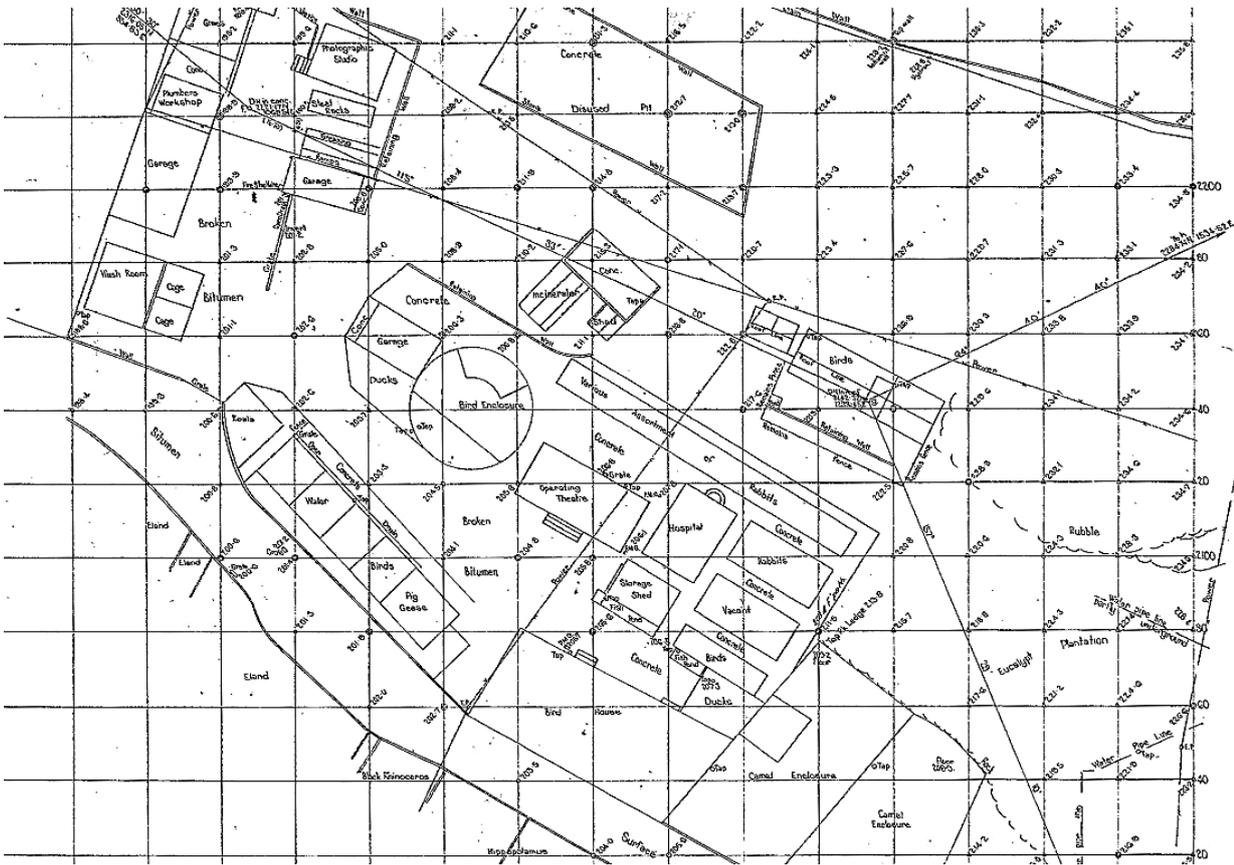
Figure 17 – 1969 survey indicating the location of structures within the subject area including the Camel enclosure, hospital, bird enclosure and incinerator. The eastern component of the subject area remained vegetated at this time.

A 1969 detail survey of the subject area indicates that the southern portion of the subject area had been developed by this date (Figure 17). A rectangular bird enclosure can be observed within the south-eastern portion of the site and a U-shaped shed was located to the west. A large disused concrete pit occupied the area to the north of these structures. A Camel enclosure and hospital buildings can be observed to the south-east of the subject area. A number of bird enclosures and ancillary structures occupied the area where the current Reptile facility is located.

The northern component of the subject area contained an incinerator, which had been constructed by the 1950s in the area north of the current Reptile facility, today occupied by an asphalt carpark. Figure 18 and Figure 19 indicate the form and sub-surface impacts associated with this feature.

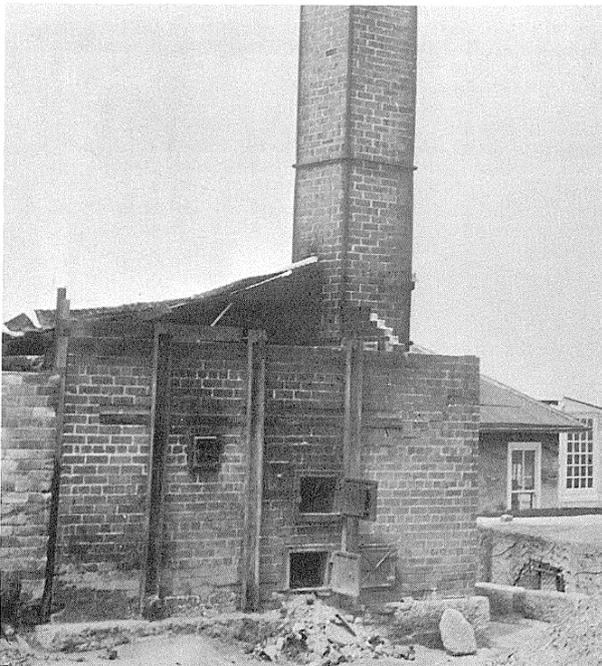
Figure 18 – 1966 photograph of Hediger incinerator

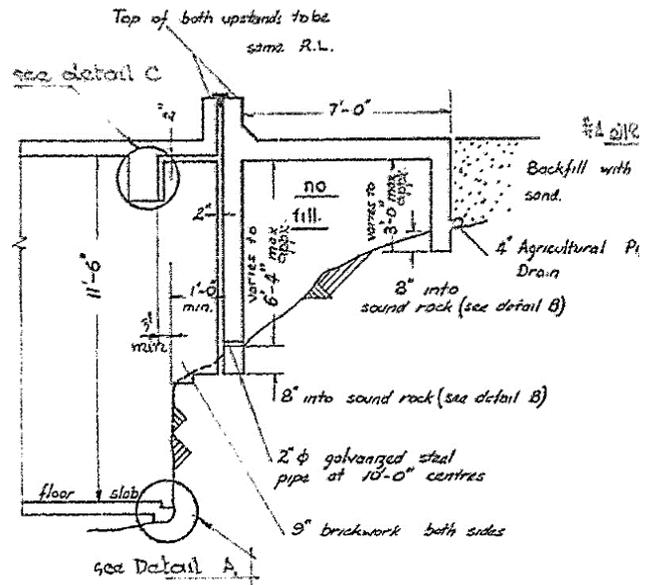
Figure 19 – Cross-section of incinerator showing depth of footings and floor slab and installation of fill

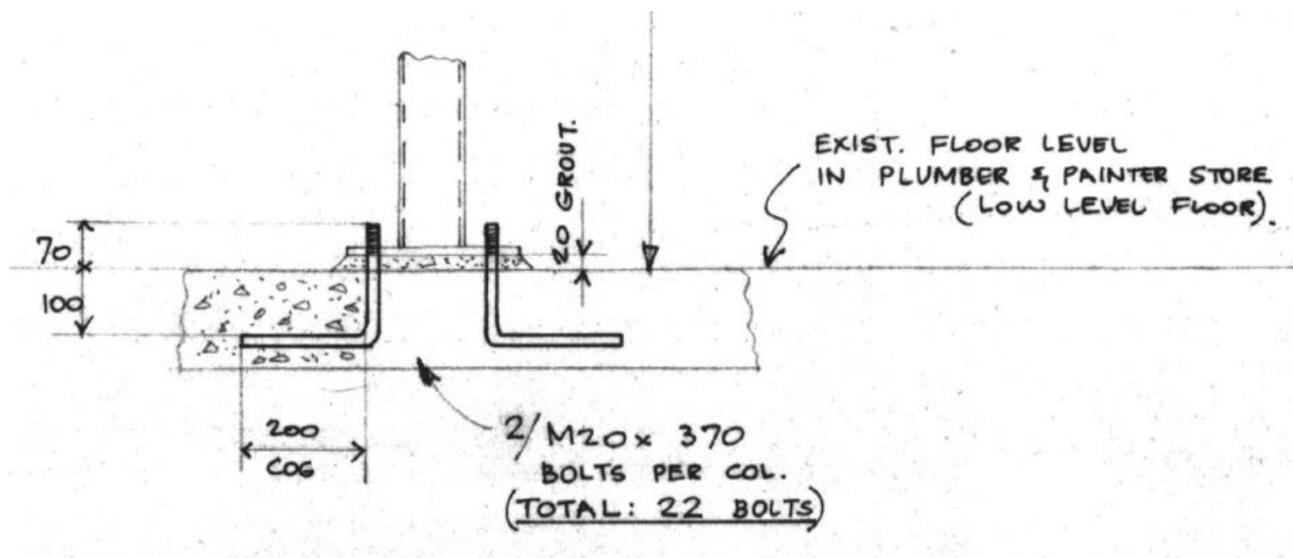
Figure 20 – Detail of footing for Carpenter's Workshop/ Store, 1986

By the 1970s the northern component of the subject area had been incorporated within the Zoo site and the boundary wall removed. The sloped and vegetated landscape had been levelled. Throughout the 1970s and 1980s a number of workshops and storage structures were constructed within the northern component of the subject area. Figure 21 demonstrates that the landscape was levelled, and concrete slabs installed in order to accommodate these structures. Figure 20 provides a detail

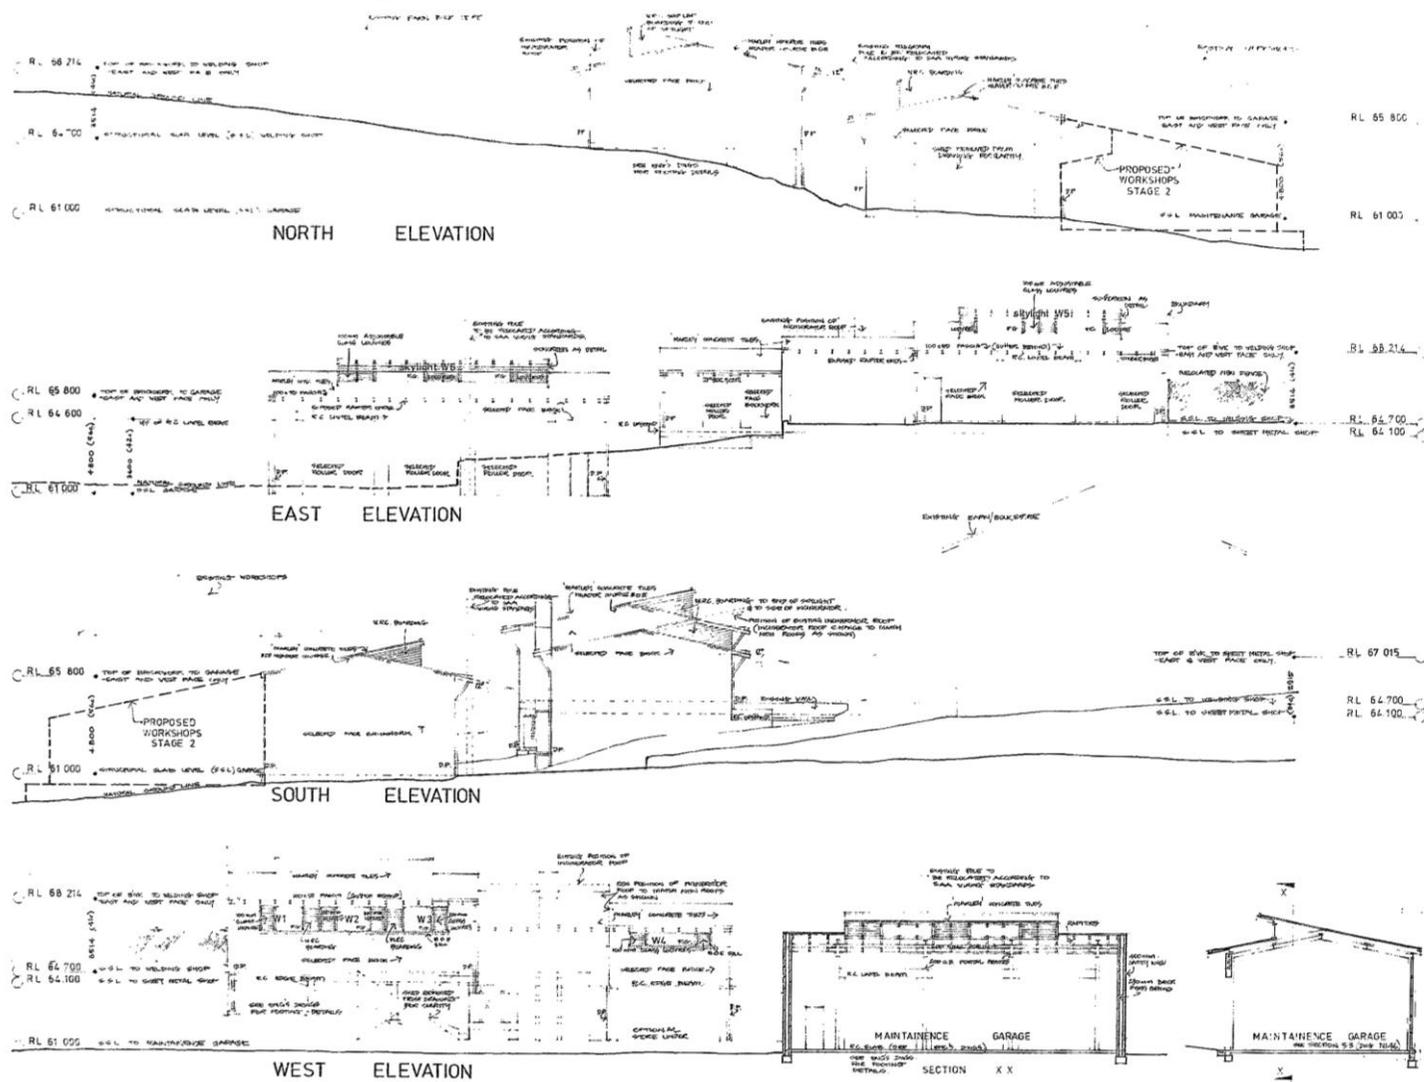
Figure 21 – Elevations of the 1985 workshops and garage

Phase	Potential Archaeological Resource	Integrity of archaeological resource	Potential
	Brick lined chamber and floor slab of former incinerator.	The northern component of the subject area contained an incinerator, which had been constructed by the 1950s in the area north of the current Reptile facility which is today occupied by an asphalt carpark. Foundations of this feature, including the concrete floor slab and brick-lined chamber walls, may be located beneath the existing asphalt surface.	Moderate-High
Strahan's Directorship (1967-1986)	Extant workshops and storage structures.	By the 1970s the northern component of the subject area had been incorporated within the Zoo. The northern boundary fence had been removed, vegetation cleared, and an asphalt road established. Throughout the 1970s and 1980s a number of workshops and storage structures were constructed within the northern component of the subject area. The landscape was levelled, and concrete slabs installed in order to accommodate these structures (Figure 21). These structures remain extant.	High
