HISTORICAL ARCHAEOLOGICAL ASSESSMENT

**Taronga Wildlife Hospital - The
Nutrition Centre, Taronga Zoo**
Bradleys Head Road
Mosman, NSW

Prepared for
TARONGA CONSERVATION SOCIETY AUSTRALIA
22 December 2021

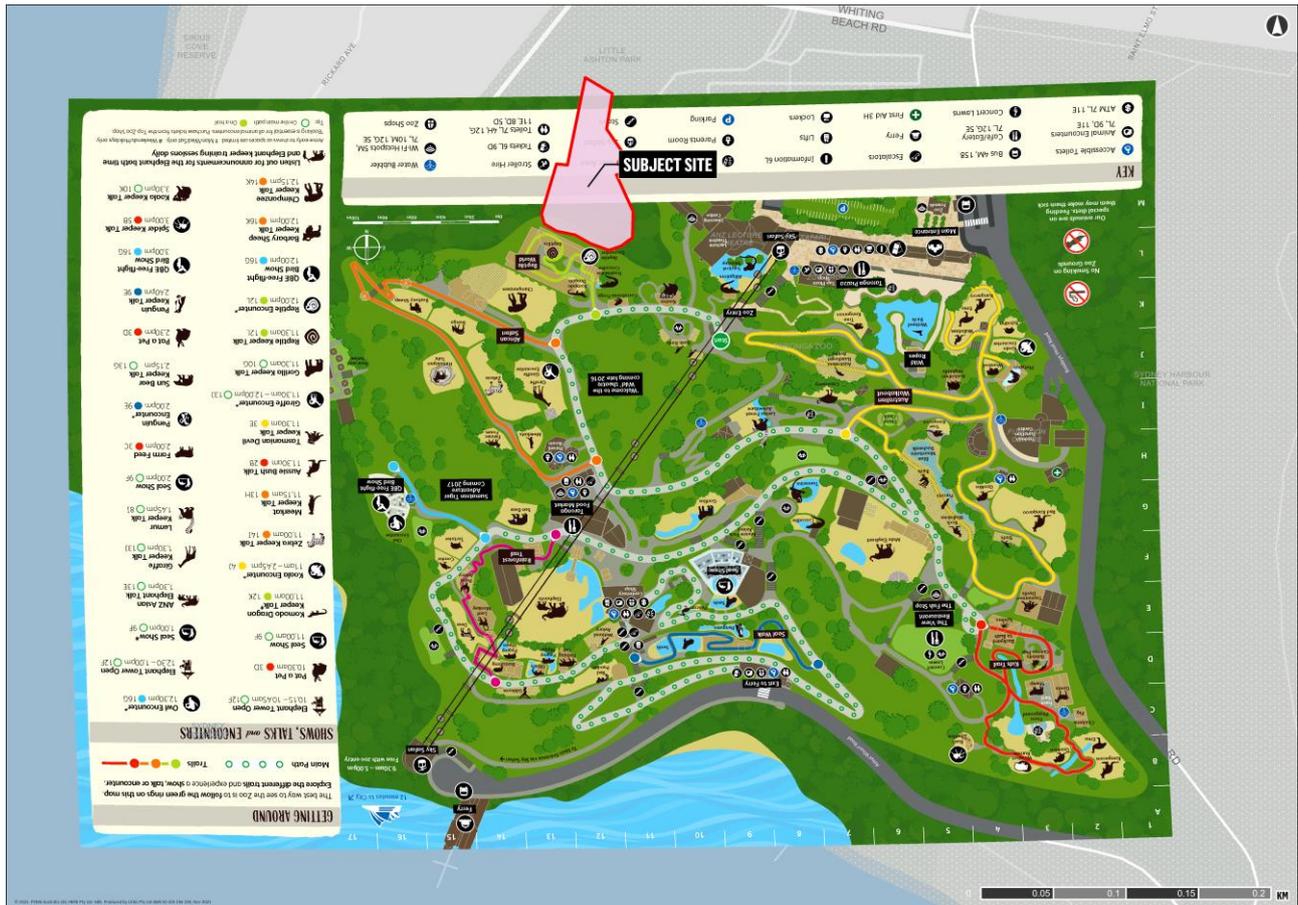
Figure 22 - 2016 Guidebook indicating that a large Serpentaria had been constructed within the subject area by this time. Approximate location of the subject area indicated in red outline.

By 2016 the Camel enclosure and associated structures to the south of the subject area had been removed and a large Serpentaria constructed (Figure 22). Figure 23 indicates the extent of excavation and importation of fill.

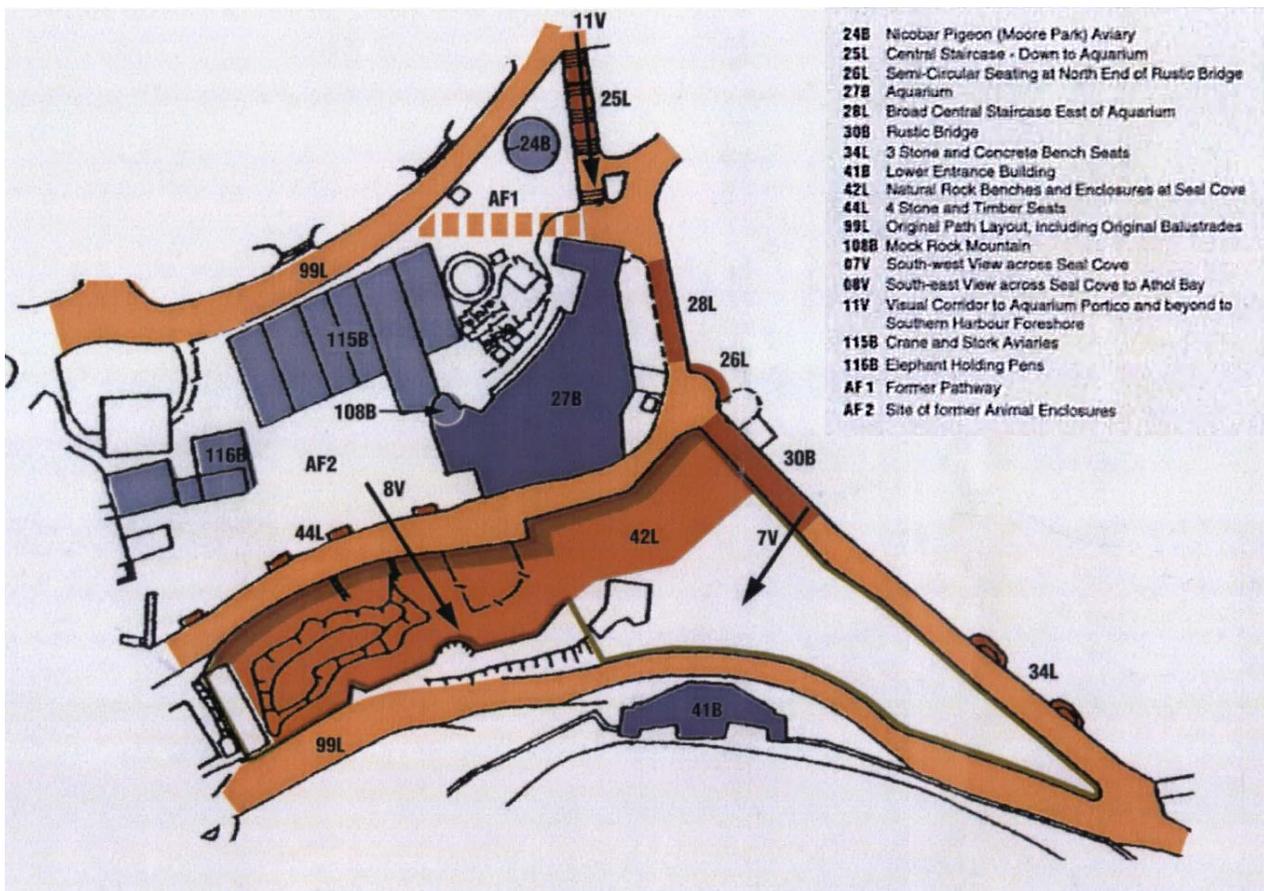
Figure 27 – Location of areas of archaeological potential in relation to the Australian Coastline Precinct

Location of this feature had been subject to some disturbance in association with the construction of the adjacent aquarium building. The location of this feature was characterised by fill, which had been installed after the removal of the former animal enclosure. No evidence of this feature was uncovered besides a few remnant concrete footings. No additional conservation or recordation was undertaken for this feature.

The monitoring works exposed an early concrete path with associated kerbing and guttering to the south of AF2. It was determined that this path reflects the original path layout of the Zoo (1912-1916), although it had been resurfaced with concrete at a later date. With the exception of this feature, the monitoring yielded results which were consistent with the available historical information for the site although and revealed that only fragmentary evidence of these features survives.

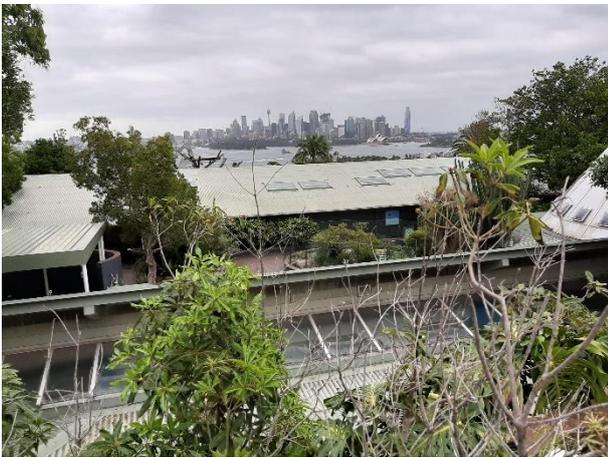
Figure 28 – The southern component of the site contains a ring road which terminates to the north of the reptile house.

The topography of the subject area slopes gradually to the south and west. The southern component of the site contains a ring road which terminates at a ledge located immediately to the north of the reptile house (Figure 28 & Figure 29). The topography here steps down dramatically to the south.

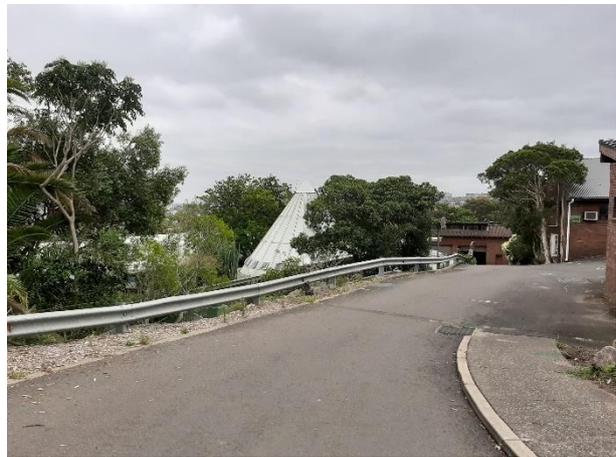
Figure 29 – Ring road within southern portion of subject area.

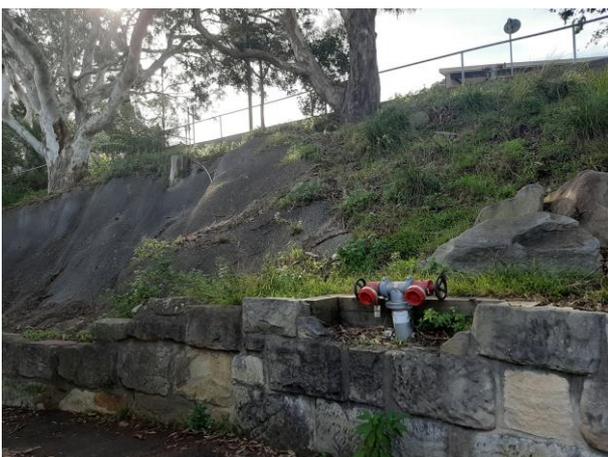
Figure 30 – State heritage item 'Sandstone Perimeter Wall' (item no. 07L) within the eastern portion of the subject area.

State heritage item 'Sandstone Perimeter Wall' (item no. 07L) is located within the eastern portion of the subject area. This is a sandstone block retaining wall with chisel marks.

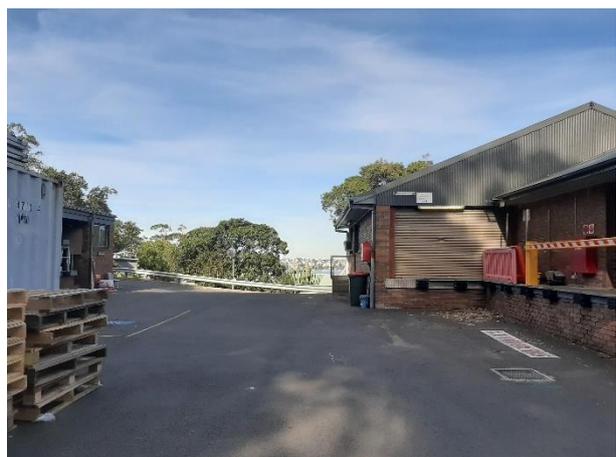
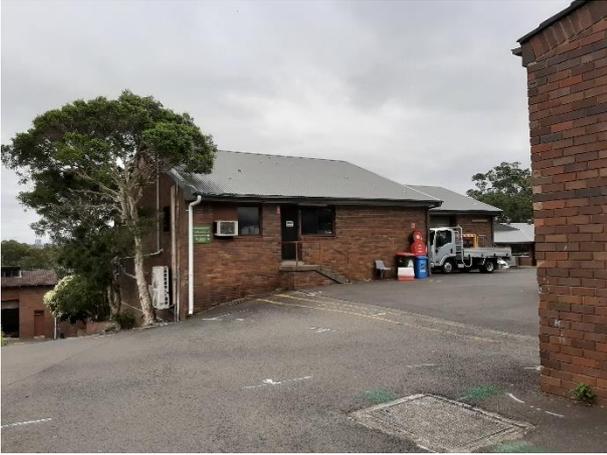
Figure 31 – Brick administration and storage buildings located within southern portion of subject area.

Figure 32 – Brick administration and storage buildings located within southern portion of subject area.

A series of brick administration buildings with pitched roofs are located within the southern portion of the subject area. Those located within the western section appear to have been built into the hill (Figure 30). A bitumen road leading north is lined by corrugated metal sheds (Figure 31). These are currently used for workshop and storage purposes. Comparison with a mid-19th century map (Figure 12) suggests that this area has been levelled. The road continues north and beyond the historical northern boundary of the Zoo.

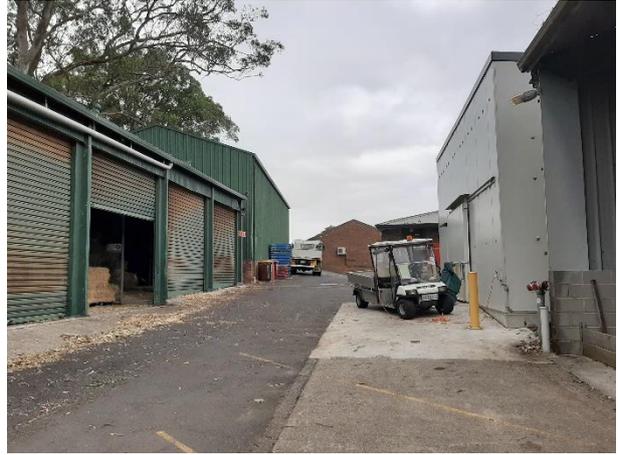
Figure 33 – A road to the north of the reptile house separates a series of corrugated metal sheds and brick structures which are currently used for storage purposes.

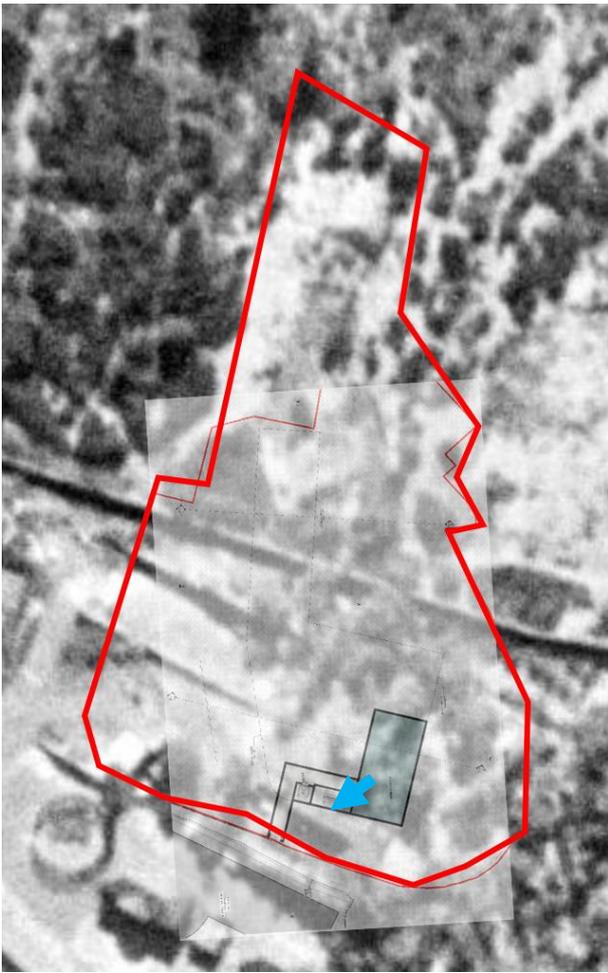
Figure 34 – Overlay of first floor plan on 1943 aerial photograph. Note the former bird enclosure (indicated with arrow) within the footprint of the proposed excavation works.

Based on the above observations, it is anticipated that there is low-moderate potential for the proposal to impact evidence of the former bird enclosure within the south-eastern portion of the site. In the unlikely event that high integrity, legible remains of this feature are exposed, these may meet the threshold for local significance.

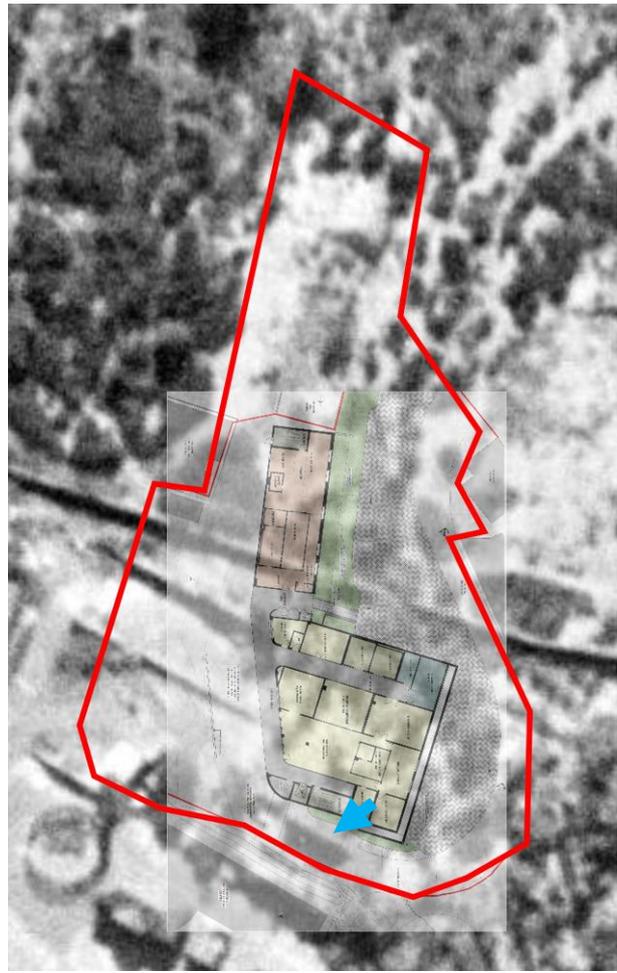
Figure 35 – Overlay of second floor plan on 1943 aerial photograph. Note the former bird enclosure (indicated with arrow) within the footprint of the proposed excavation works.

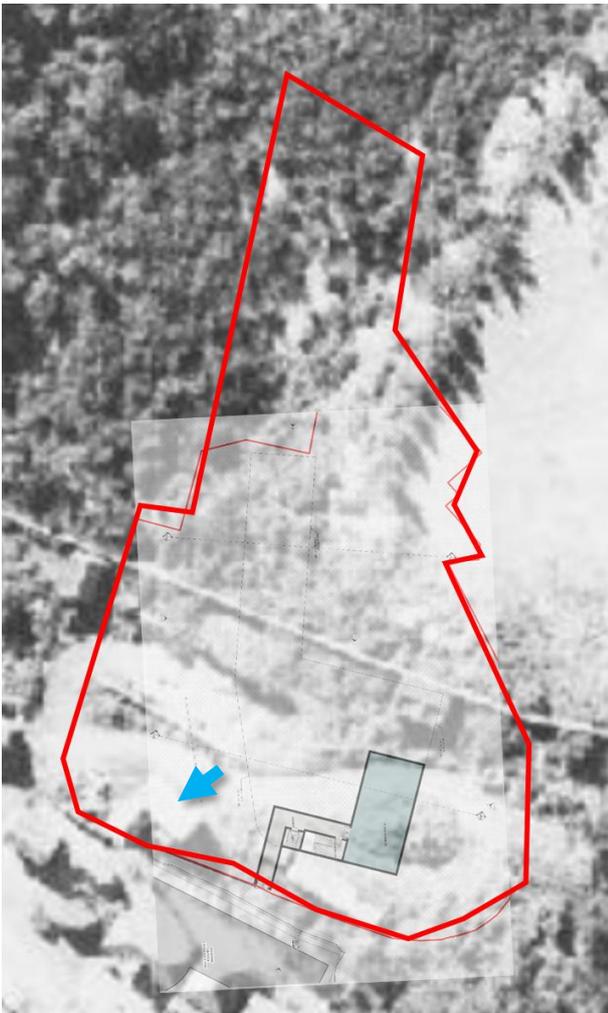
Figure 36 – Overlay of first floor plan on 1961 aerial photograph. Note the former incinerator (indicated with arrow) located to the west of the proposed excavation works.

An overlay of the first (Figure 36) and second (Figure 37) floor site plans on a 1961 aerial photograph reveal that the proposed excavation and grading works would be located to the south-east, and outside the footprint of, the former incinerator. Although there is moderate-high potential for the brick lined chamber and floor slab of the former incinerator in this location, it is likely that these features are located at some depth beneath the existing road base and brick administration building. There is nil potential for these potential archaeological features to be impacted by the proposed development.

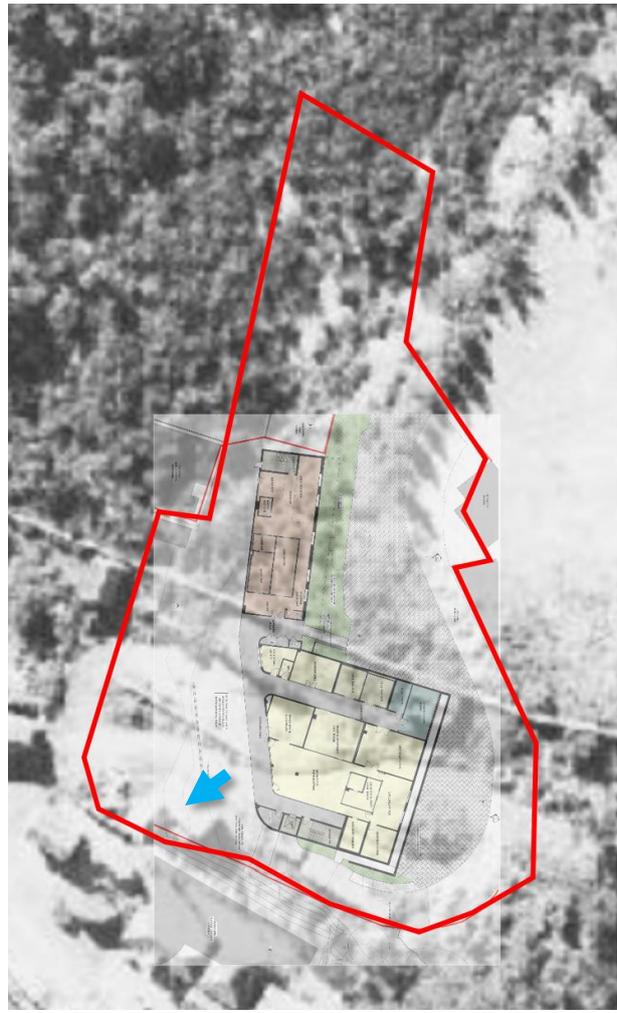
Figure 37 – Overlay of second floor plan on 1961 aerial photograph. Note the former incinerator (indicated with arrow) located to the west of the proposed excavation works.
