Proposed Taronga Wildlife Hospital, Sydney
Nutrition Centre
Heritage Impact Assessment

FINAL REPORT
November 2021

for the Taronga Conservation Society Australia

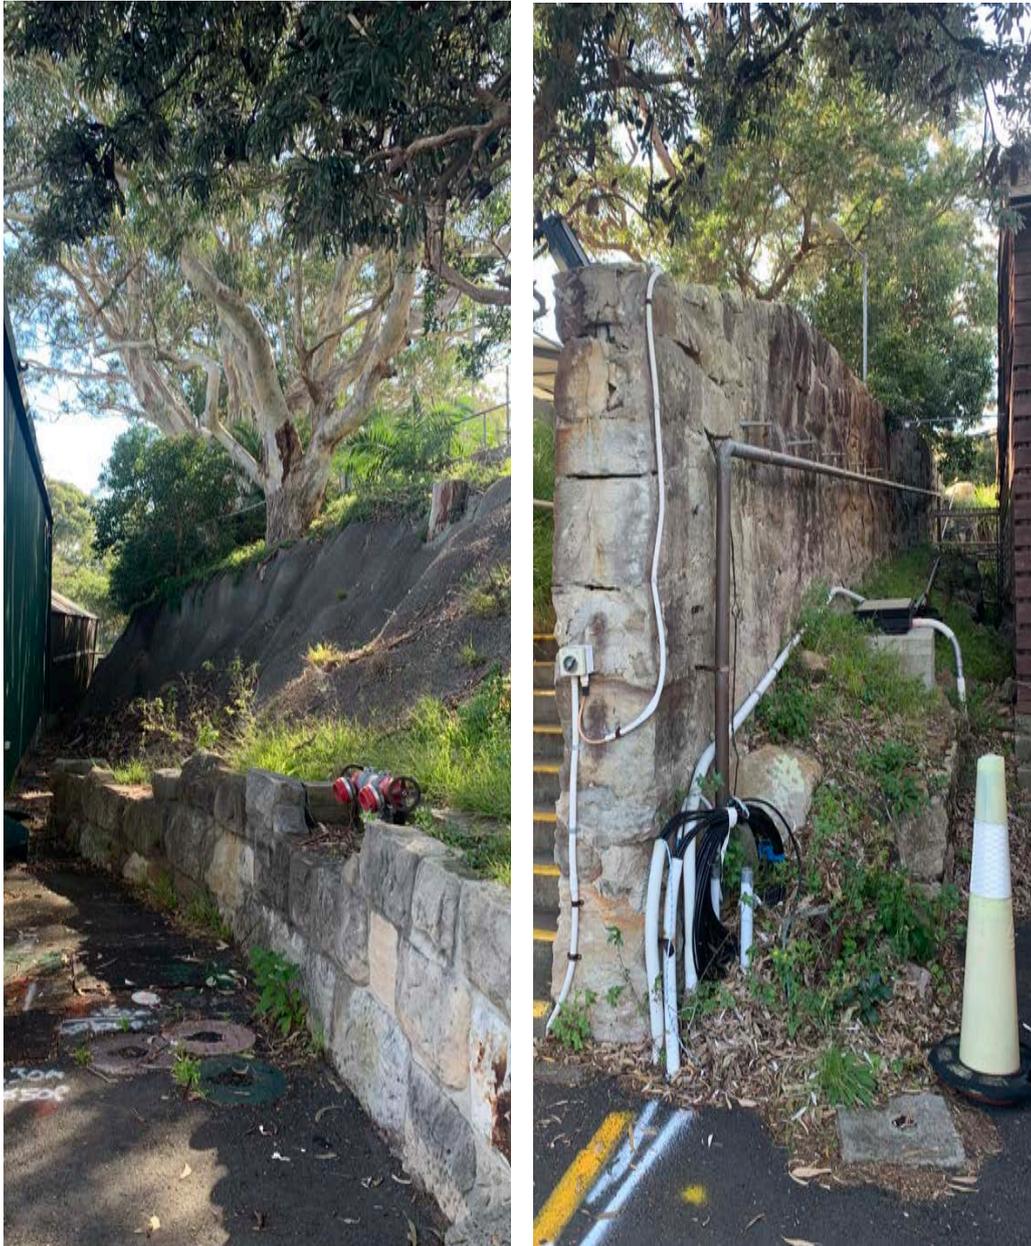
LEFT The area between the bulk storage sheds and the western car park featuring a line of *Eucalyptus globulus* subsp. *maidenii* from the 1960s. RIGHT A remnant section of the Interwar period stone wall indicating the original northern perimeter of the zoo site. Both features fall within an area that is the subject of this cultural heritage impact report.

wall remained intact for many decades before being finally breached for buildings in the 1970s to facilitate the zoo's functional expansion. Remaining sections of the wall are important to retain and should be conserved as a direct record of the original zoo site area (Figures 33 and 49 to 51). The boundary wall was added to the zoo's s170 Register in 1998. Remnant blocks from previous breaches of the wall are to be found at either end of the remaining section within the study site (see for instance cover photograph (left frame) and Figure 50).

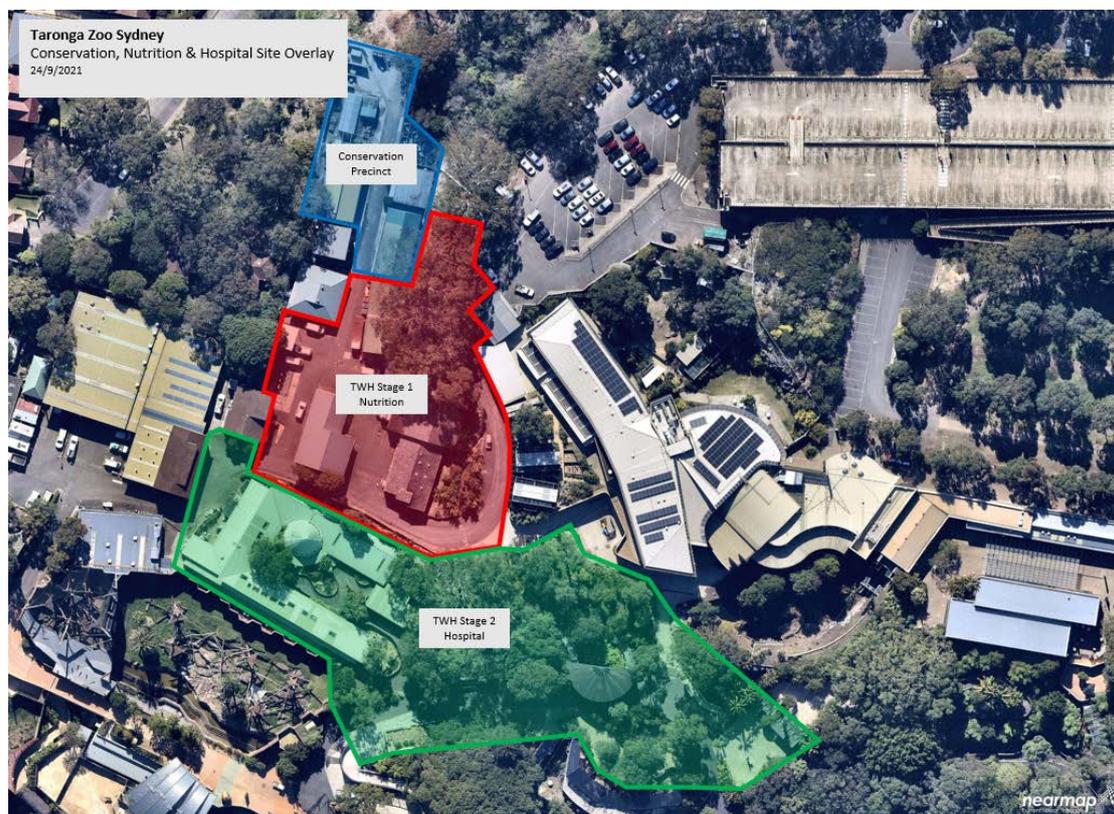
Figure 2 A project overview plan showing the area relevant to this heritage impact assessment report as the middle site identified in red (Stage 1 Nutrition). Refer to **Figure 3** for more detail of the listed heritage items included within this area. (Source: Taronga Conservation Society Australia)

The commission originally began as a combined Wildlife Hospital and Animal Nutrition Centre project with an additional Conservation Precinct appended to the general site area however, for various pragmatic reasons, the overall project was split into three separate stages with the Animal Nutrition building becoming Stage 1 (see **Figure 2**).

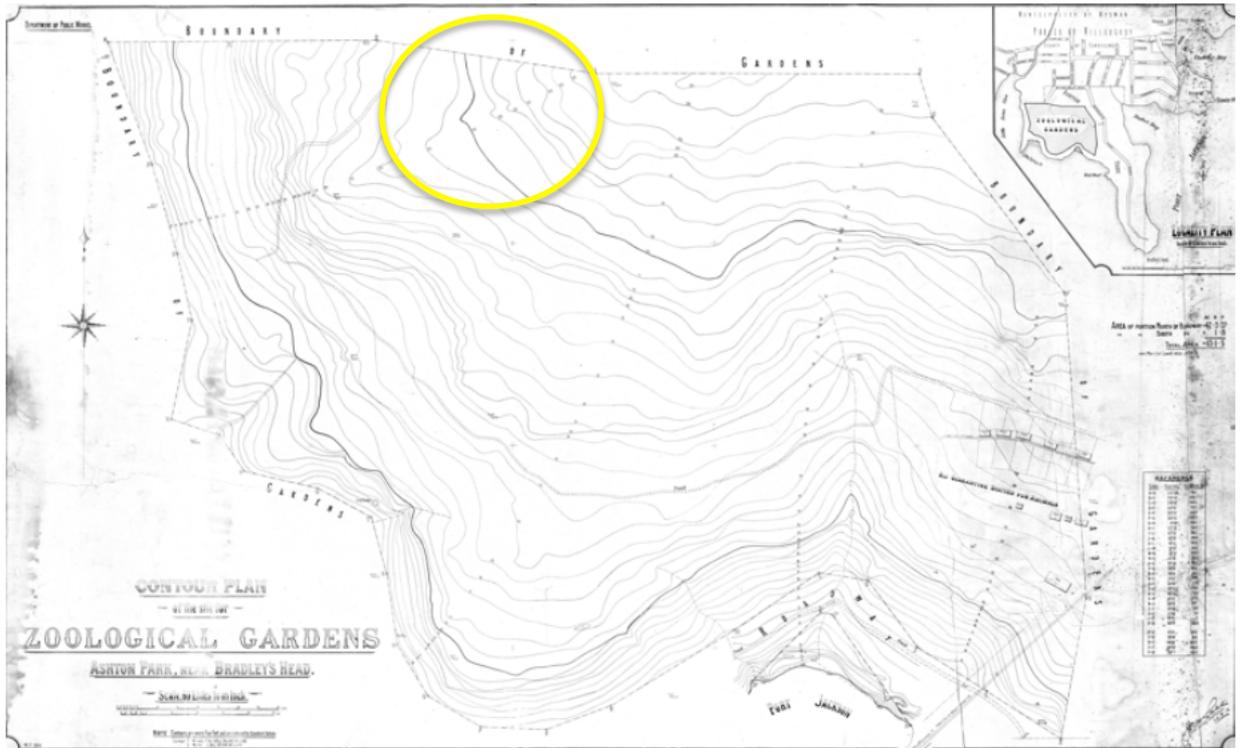
Figure 4 A detailed contour plan of the new zoo site by the Public Works Department (September 1912). The majority of the site remained as bushland, with the exception of the stock quarantine compound at the southeast corner. The approximate location of the present focus for this heritage impact review is shown circled. (Source: NSW Public Works - Plan Room)

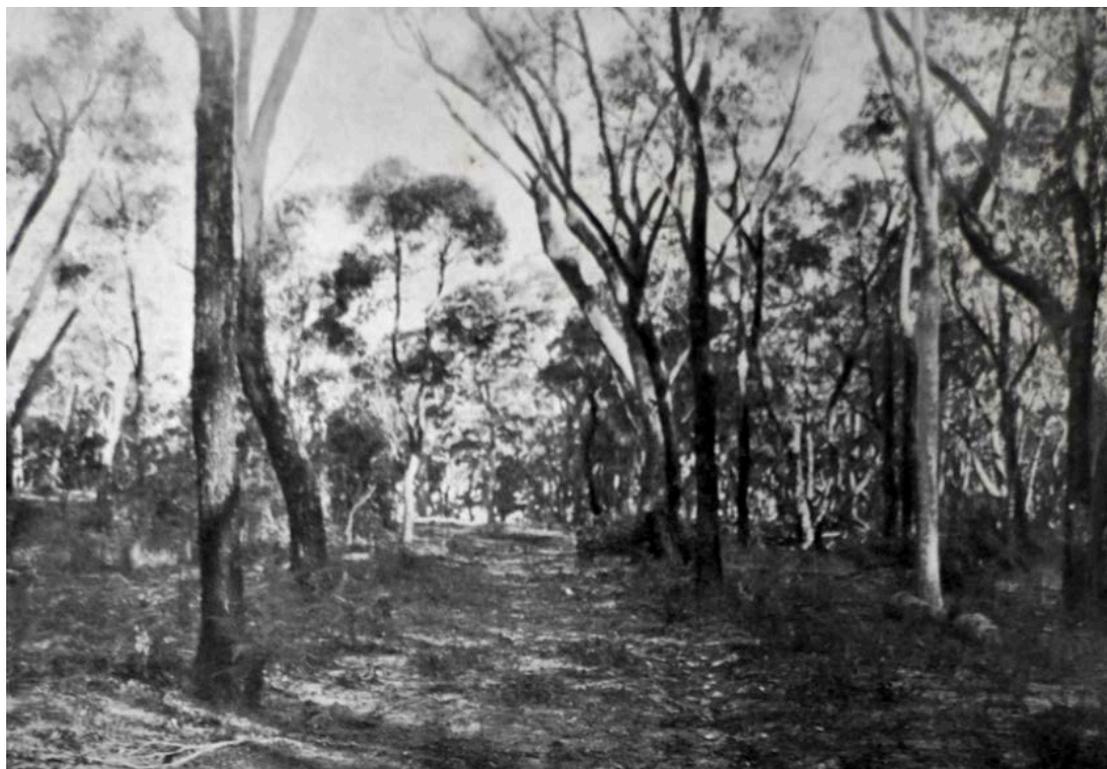
Figure 7 A photograph taken to record the natural state of the Zoo site prior to implementation of the works program. (Source: *Taronga Zoological Park Trust, Report for 1916, p. 9*)

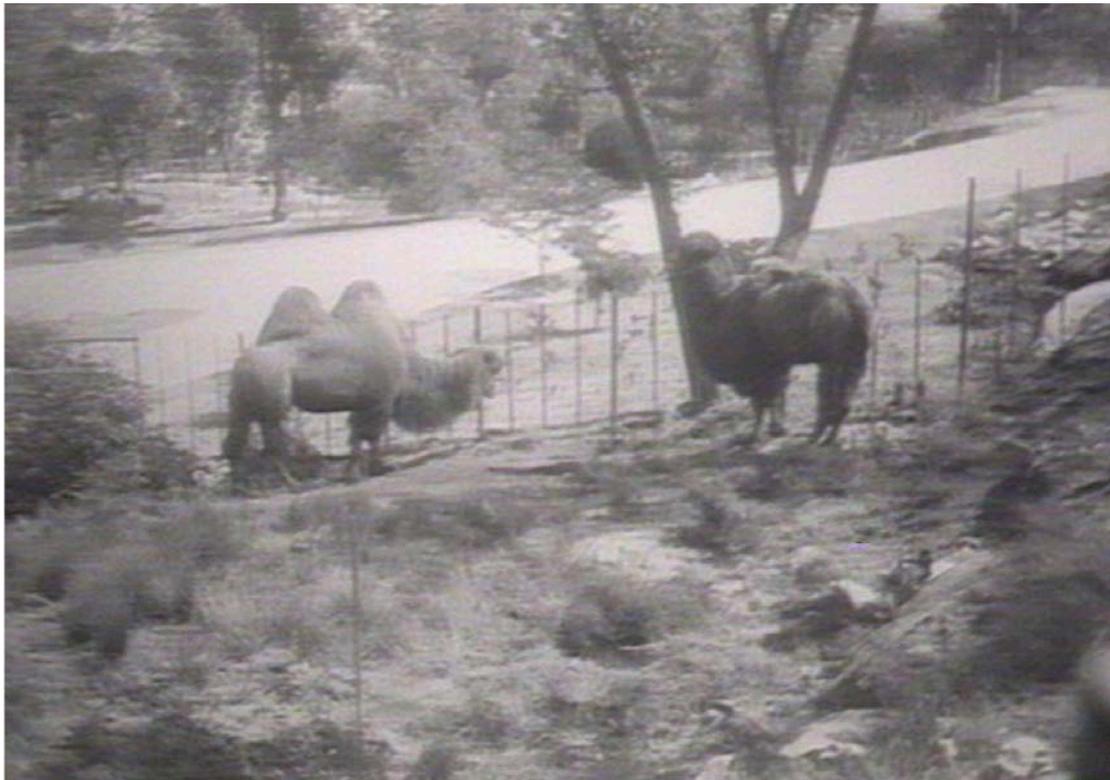
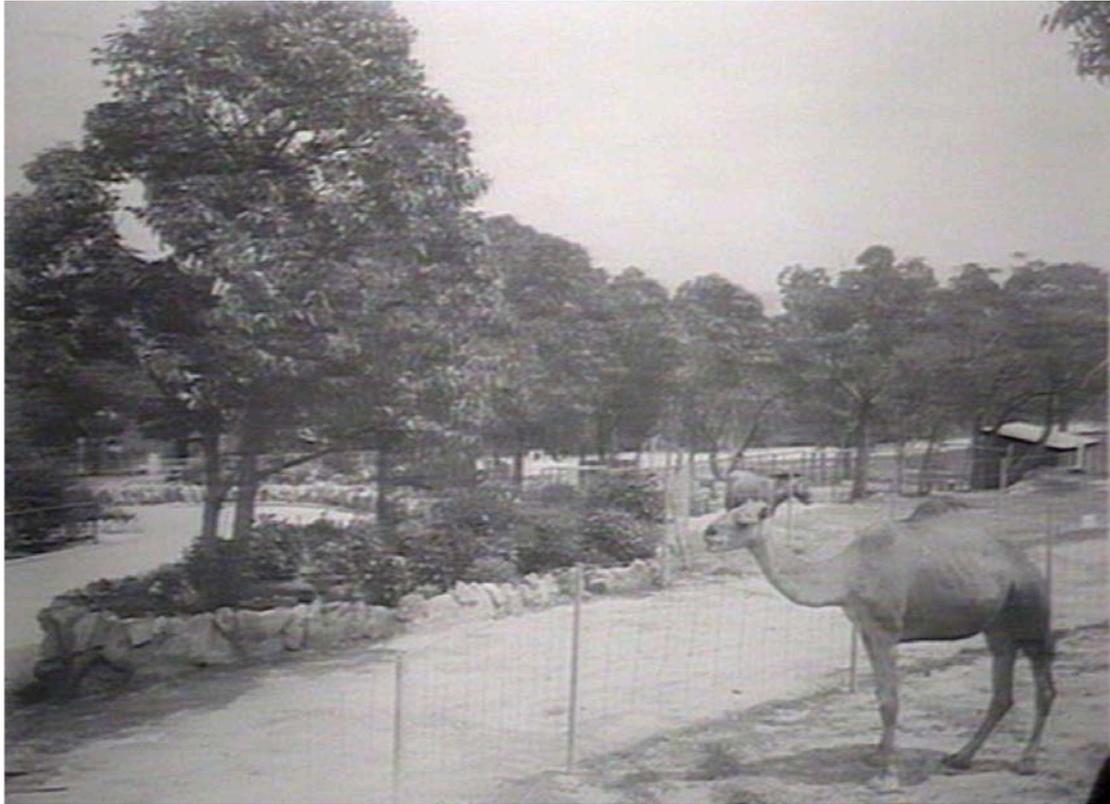
Figure 11 ABOVE The Camel yard in 1924 showing surviving woodland vegetation beyond with an edging garden to the western end of the large ungulates section (now Chimpanzee Park). The image suggests that the large surviving Bangalay may have been planted (or retained) within a decade earlier. (Source: Government Printing Office, 1 February 1924, GPO 1-19169 TCSA Archives) **Figure 12** BELOW Looking north into the Camel yard a year later showing some of the remnant *Angophora* woodland at the back of the enclosure. (Source: Government Printing Office, 1 June 1925, GPO 1-15945 TCSA Archives)

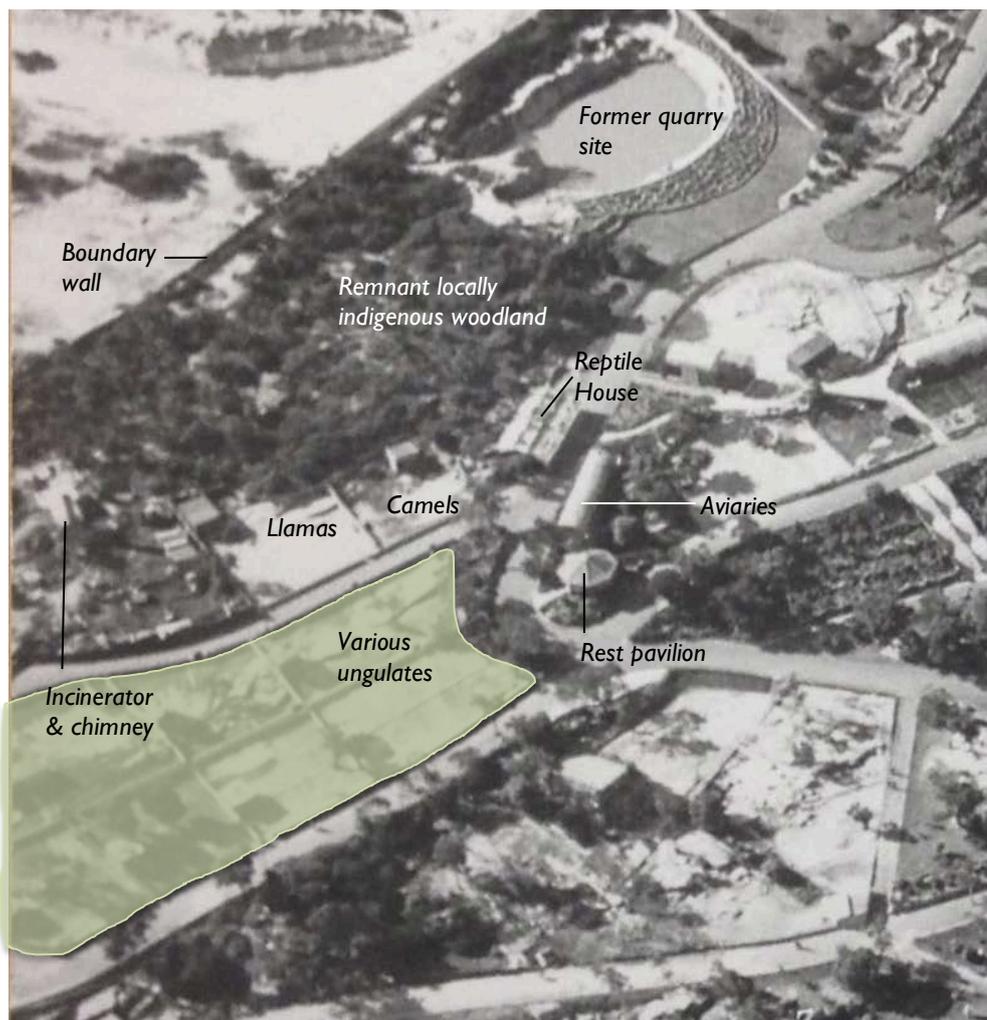
Figure 14 An annotated detail of a 1930 oblique aerial photograph showing part of the present study area either side of the site boundary wall. The view is looking approximately to the northeast. Note that the northern boundary stone wall is shown as complete at this date. (Source: TCSA Archives)

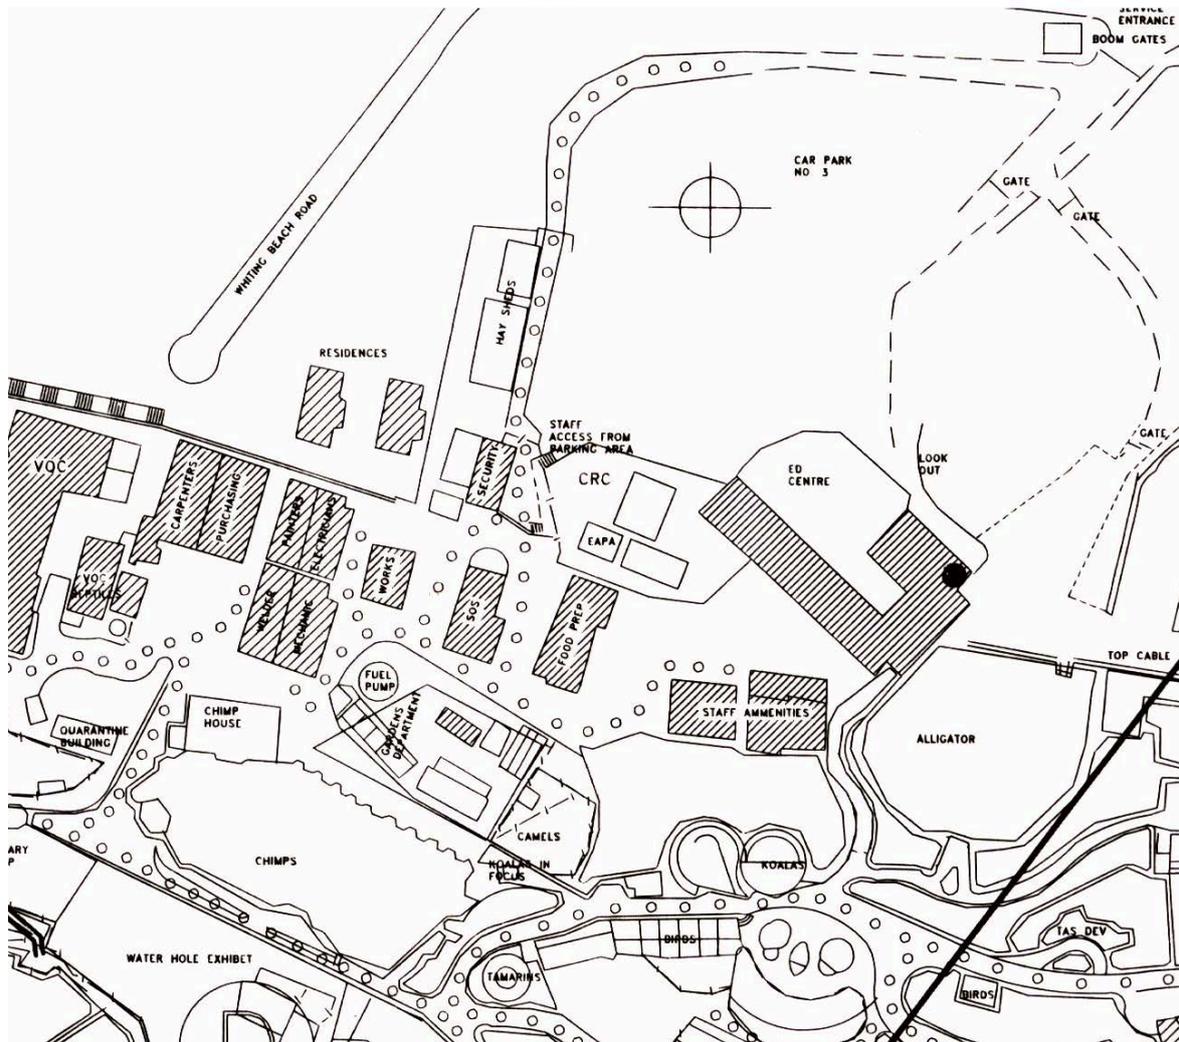
Figure 23 Part of a 1992 site plan showing the present study area immediately prior to the construction of the current reptile complex. Note the breach in the former northern boundary wall and the addition of food storage buildings (the present metal sheds) along the western side of the earlier *ad hoc* northern car park. (Source: TCSA Archives)

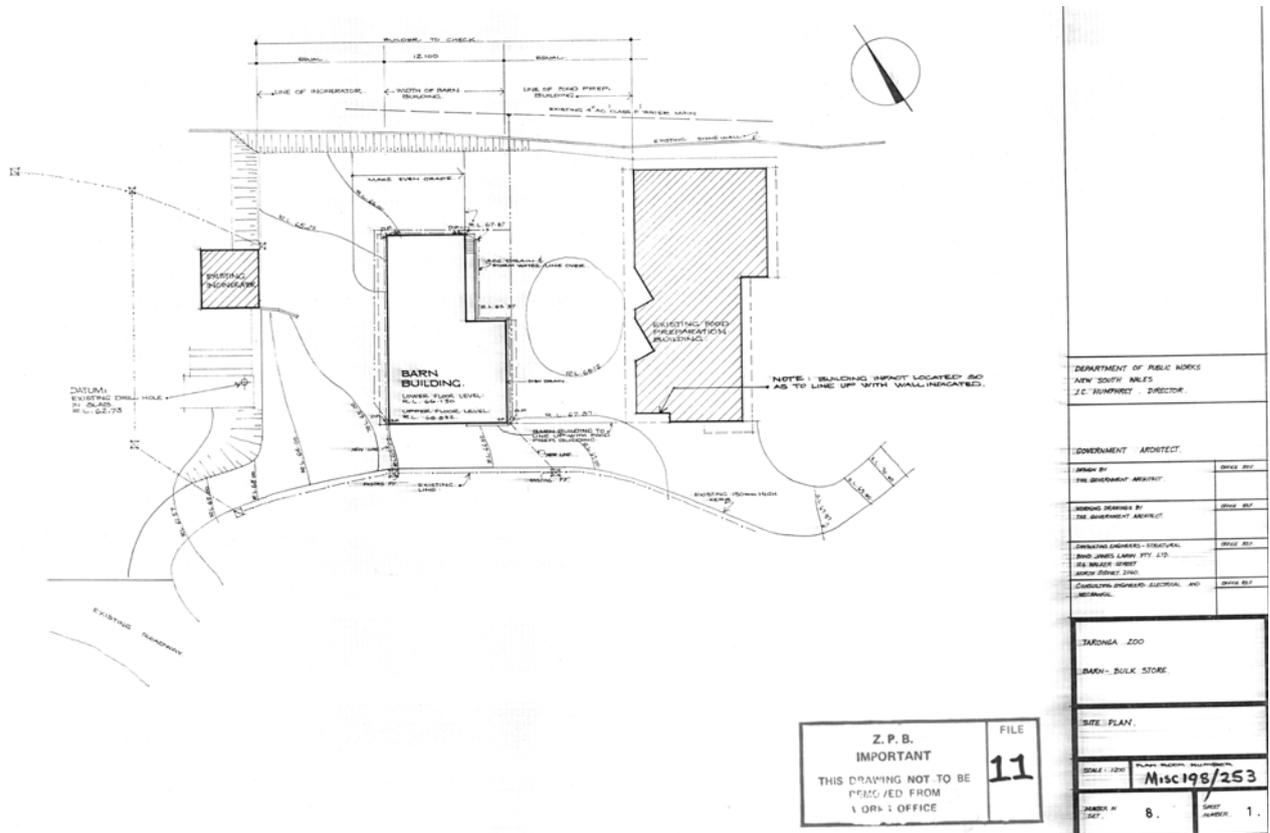
Figure 24 ABOVE An undated (probably 1970s) site plan showing the food preparation building (right) and the incinerator (left) with the 'barn building' in between. The latter structure was documented in two very different use options – as a split level storage building but also as a staff amenities building. (Source: TCSA Archives) **Figure 25** BELOW A view of the woodland remnant north of the Koala House and to the immediate south of the proposed Nutrition Centre development.

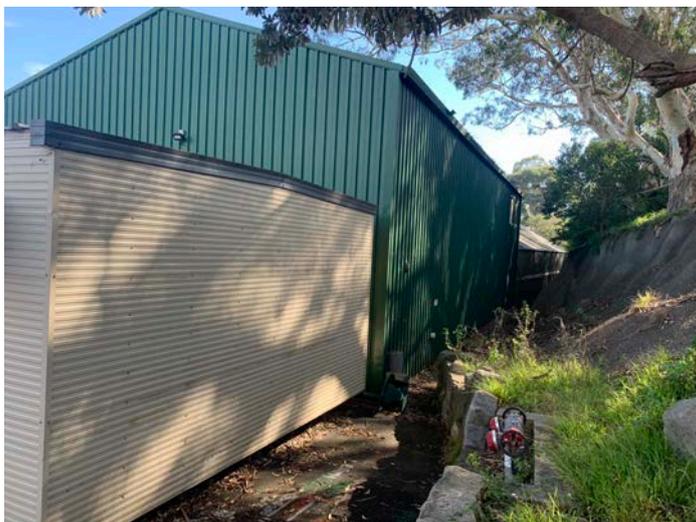
Figure 28 View behind the current metal warehouse and hay shed buildings of the concrete stabilised bank with the line of Maiden's Gums above (extreme right).

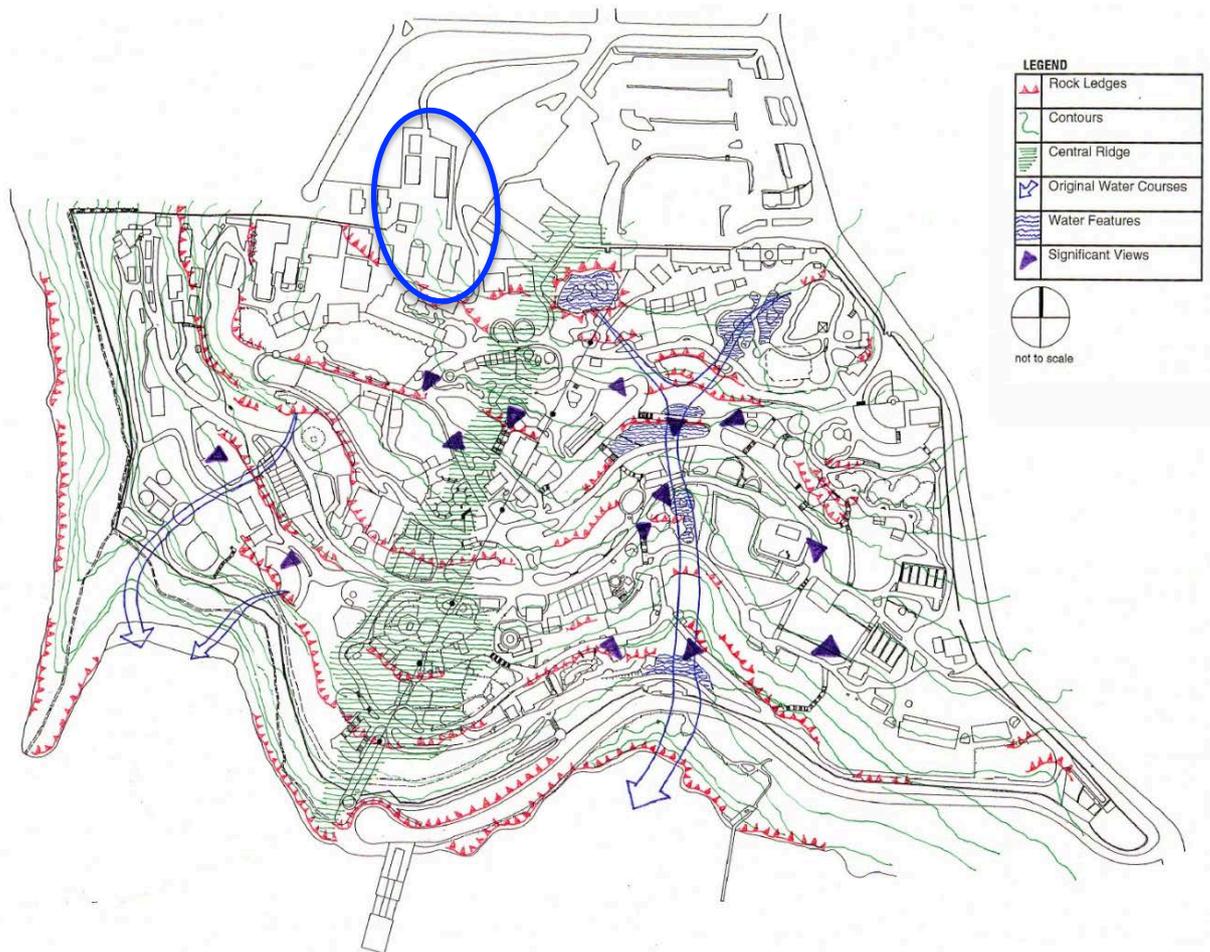
Figure 29 Overall site plan showing the zoo's basic landform. The hatched green area denotes the central ridgeline that defines the principal valleys either side while the red graphic indicates the main rock ledges though this is not meant to be exhaustive. (Base courtesy: GML Conservation Strategy, 2002)

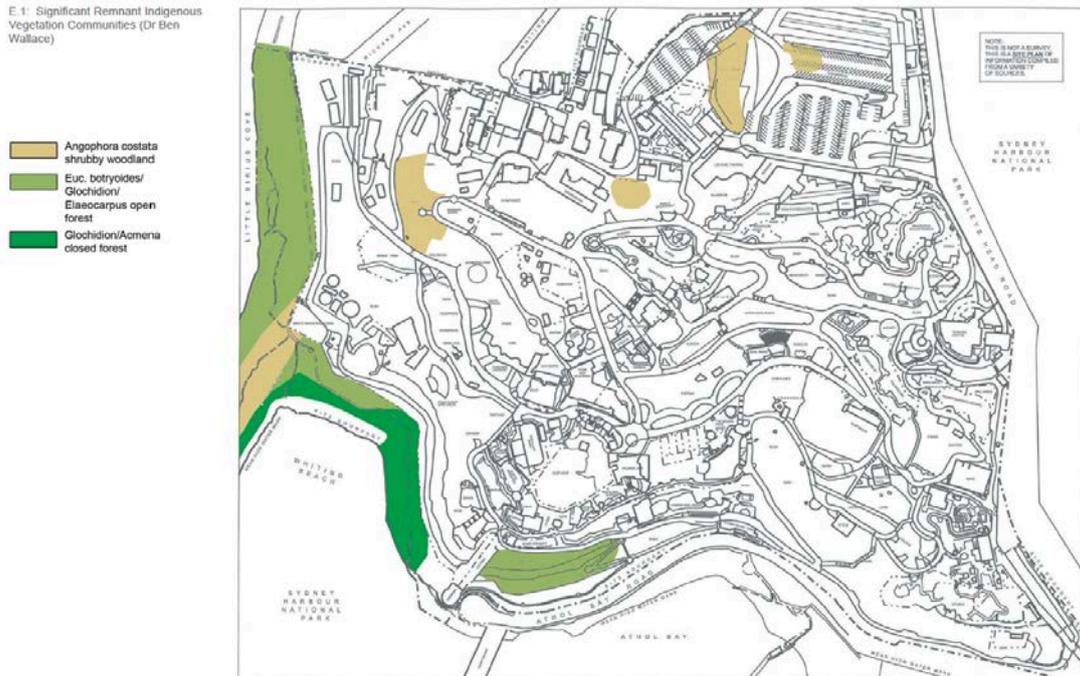
Figure 32 Approximate areas of significant remnant indigenous vegetation within the zoo. The area of *Angophora* woodland in proximity to the Koala House is probably more extensive than indicated on this plan originally drawn in 2006 from initial basic mapping by botanist Dr Ben Wallace. However the same woodland may be less well represented with key indicator species. Similar woodland shown to the north has been impacted (reduced) by the multi-storey car park development (Source: Design 5 et al LMP, 2007)

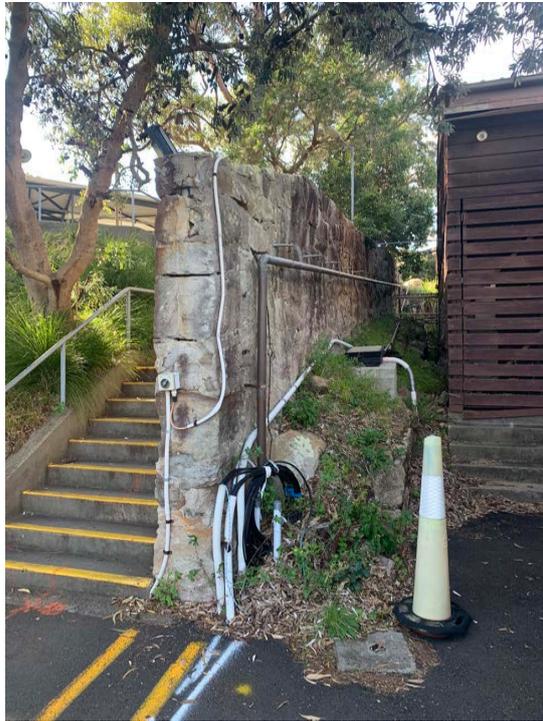
Figure 33 RIGHT A section of the former northern zoo site boundary wall from the Interwar period (probably 1920s) – the 1930 aerial view (Figure 14) shows it already complete at this date.

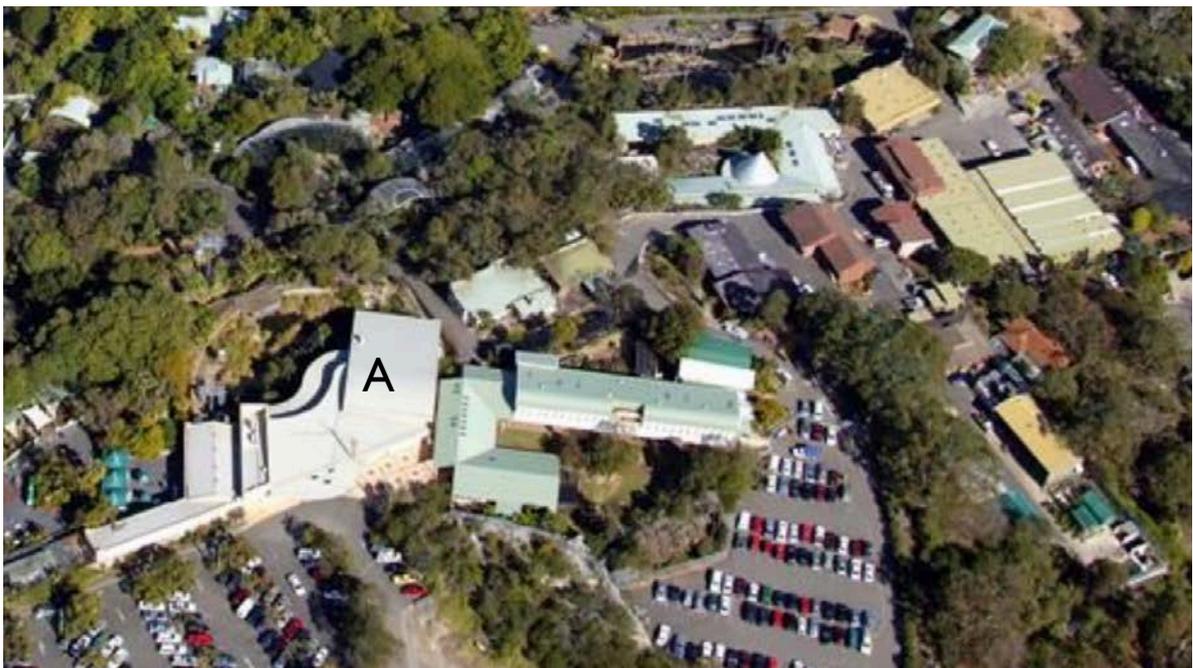
Figure 34 Detail from the 2004 oblique aerial photography showing the current Taronga Institute of Science & Learning Theatre (A) with the study site to the right of, and above, the adjacent car park.

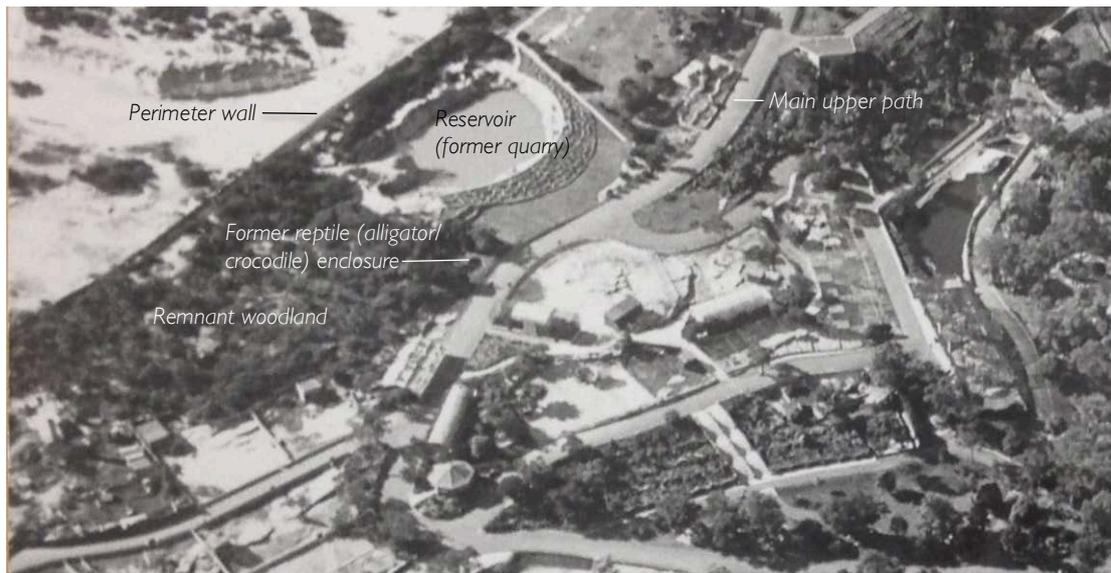
Figure 35 Detail of the 1930 oblique aerial photography with annotations. It clearly shows the former northern boundary wall intact by this date as well as considerable remnant woodland to the south but much clearing to the north. (Source: TCSA Archives)

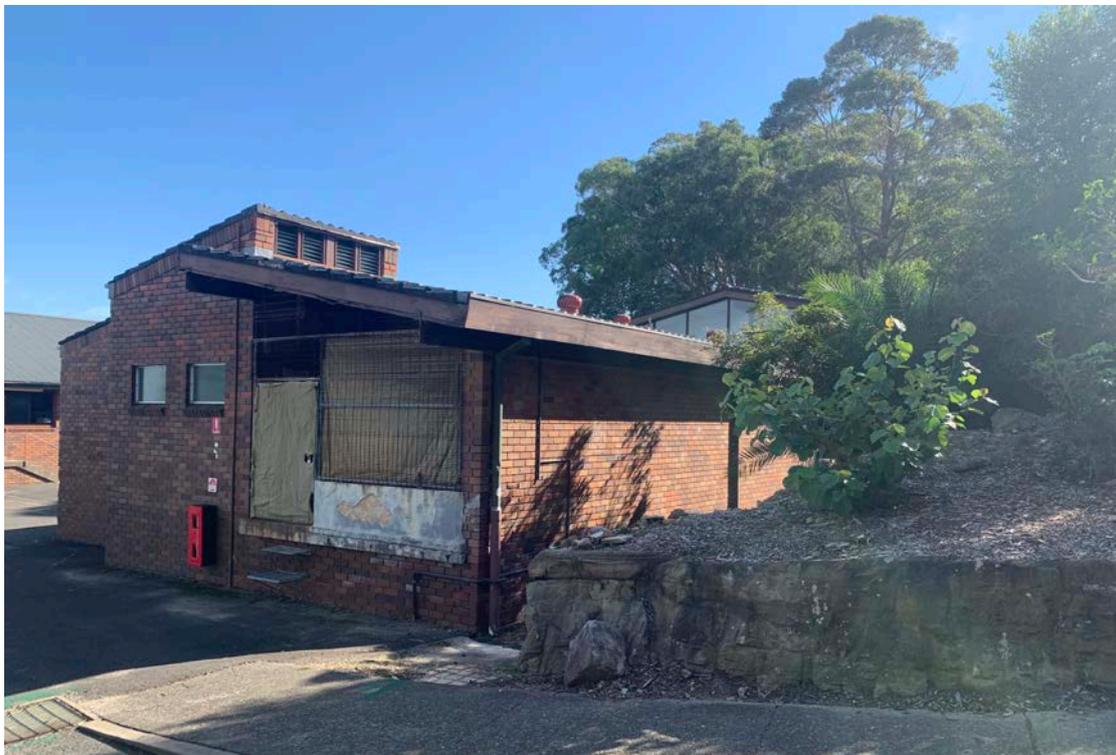
Figure 36 Southern elevation of the existing food preparation building. Note the remnant rock outcrop behind it to the east. This is part of the exposed bedrock across the upper sections of the Mosman site.

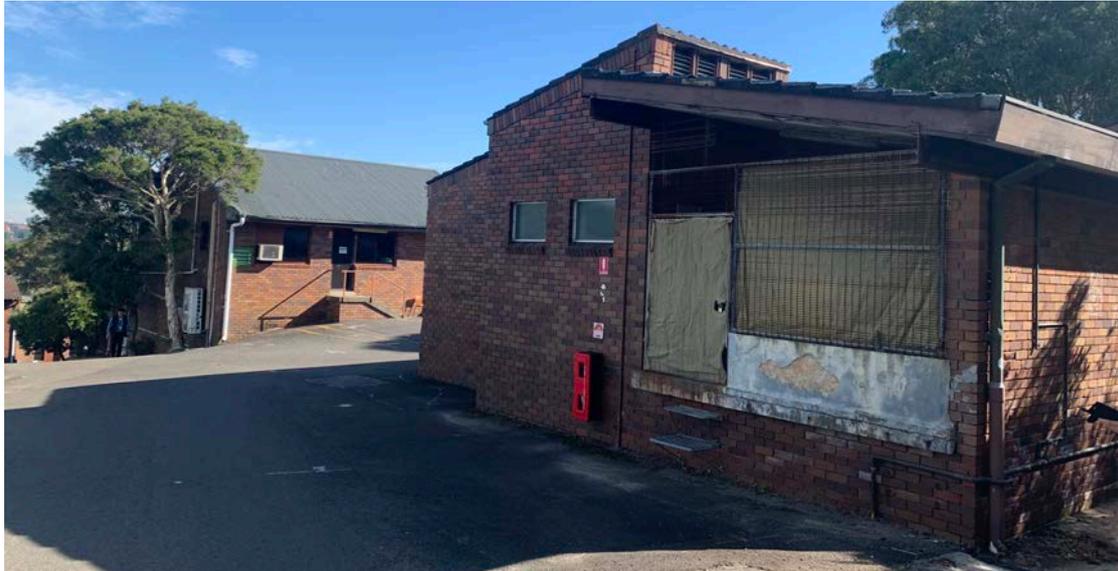
Figure 37 ABOVE The 1970s amenities building is shown to the left of the existing food preparation building (foreground and right). Note especially the steep change of level to the former building. **Figure 38** BELOW A panoramic view of the back-of-house area with the two-level 1970s amenities building (centre), the food preparation building to the left and the offices building to the right that subsumed the former incinerator. Beyond these is the low profile (light green) metal roof of the existing reptile building.

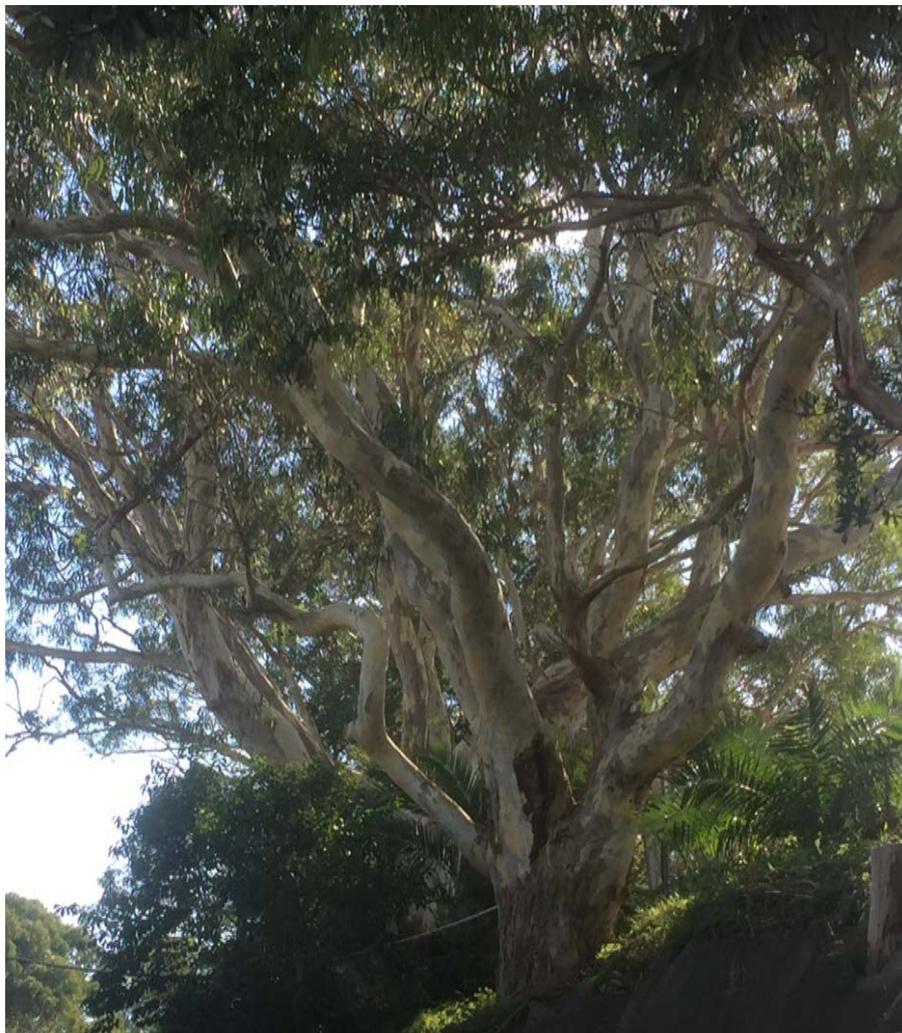
Figure 39 Detail of the Maiden's Gums behind the large hay shed with the upper car park at right.

On the basis of the 2021 arboricultural assessment by Sydney Arbor Trees, all eight of the gums appear to be in good health and vigour.²⁵ With one exception (Tree 10), all eight are also in good condition. Tree 10 is described as in a fair condition as a result of a fungal infection (*Phellinus robusta*?) caused by a substantial past abrasion (physical impact). However the report also notes that between the two recorded Picus Sonic Tomograph tests in 2013 and 2016 by Australian Tree Consultants, the area of decay appears to be reduced indicating that the tree's vigour has enabled it to successfully fight the pathogen. It is also noted that the last Picus test recommended another such assessment in 5 years time to gauge the further extent of recovery of the tree.

At the southern end of this line of gums is a lone mature Bangalay (*E. botryoides*) – a locally indigenous species - also of unknown age. The arboricultural report indicates that the location of the Bangalay in relation to the Maiden's Gums may be important as all of these trees are growing along one of the most exposed sites of the zoo in relation to southerly winds and the Bangalay appears to be sheltering the gums from excessive wind loading.

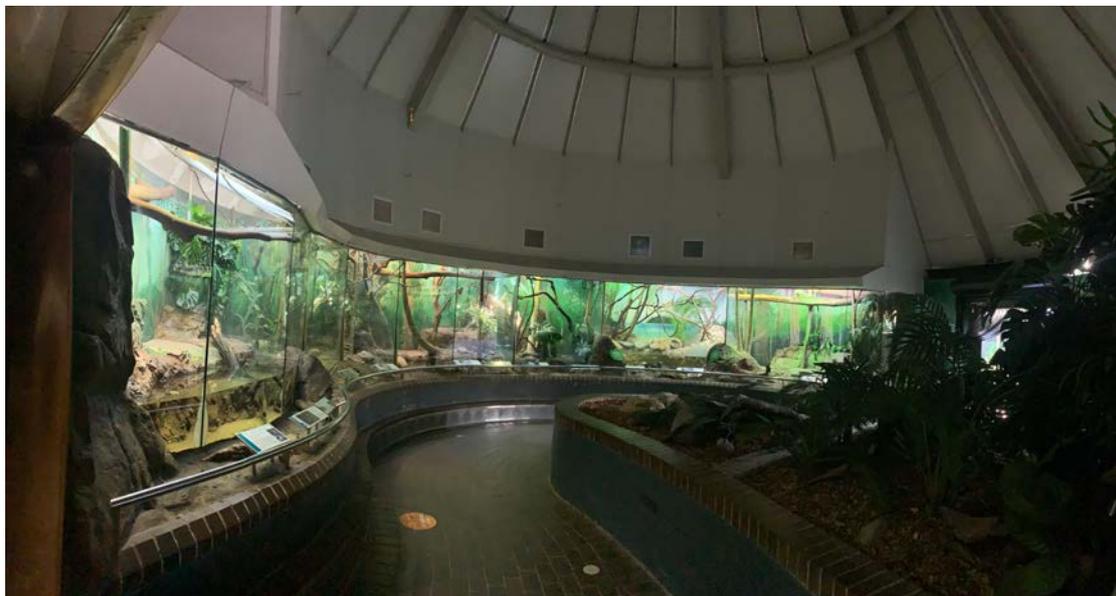
Figure 40 ABOVE View of the distinctive conical space of the existing reptile/amphibian complex with part of the circuitous, convoluted circulation system evident. The brick paving and brick and painted/bagged plinth and dwarf walling are used as unifying devices throughout the building. **Figure 41** LEFT A view of the small active display/animal handling area with the natural sandstone bedrock and some of its associated indigenous vegetation evident beyond. The compact 'U'-plan arrangement of the building was basically dictated by the site's spatial constraints wedged between the Chimpanzee Park, the rock outcrop and the large retaining wall to the north.

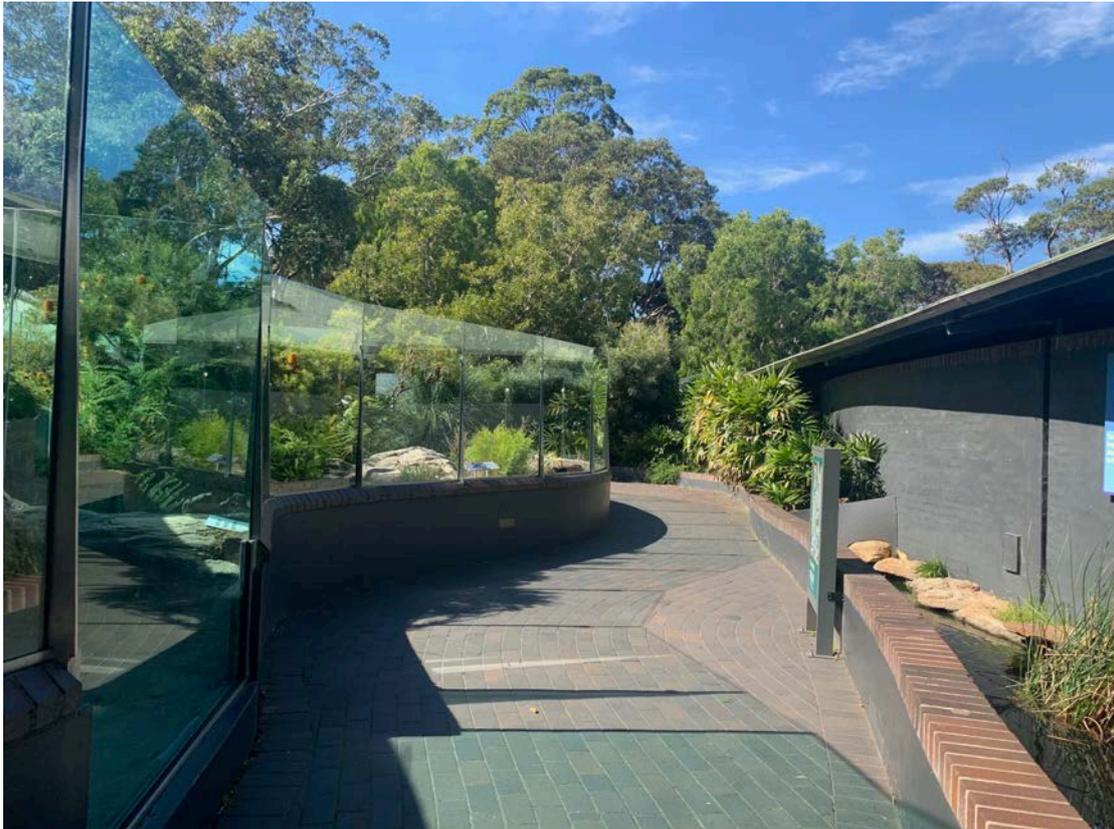
Figure 42 View of the courtyard area of the existing reptile/amphibian complex looking to the remnant woodland vegetation between this space and the Koala House beyond.

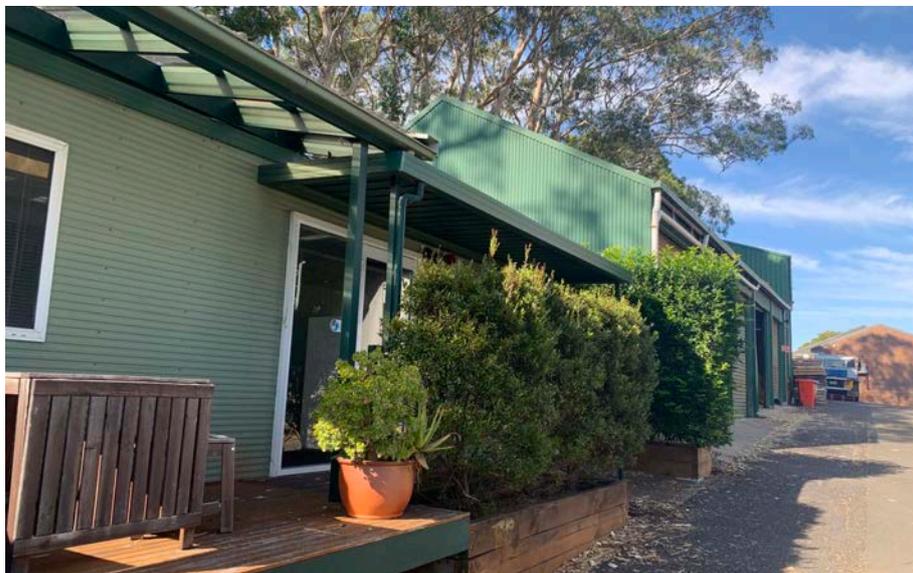
Figure 43 Various metal-clad 'industrial' buildings between the Maiden's Gums (background) and the existing horticulture shed (out of view to the right of the photograph).

By 2014 the existing large metal bulk food storage buildings to the west of the Maiden's Gums were added (**Figure 43**). None of these later structures are regarded as having any conservation value yet the 'shotcreted' embankment built to allow the buildings remains as a detracting element within the landscape (**Figure 28**) while it is remarkable that this excavation has not, as yet, deleteriously affected the viability of the significant trees beyond.

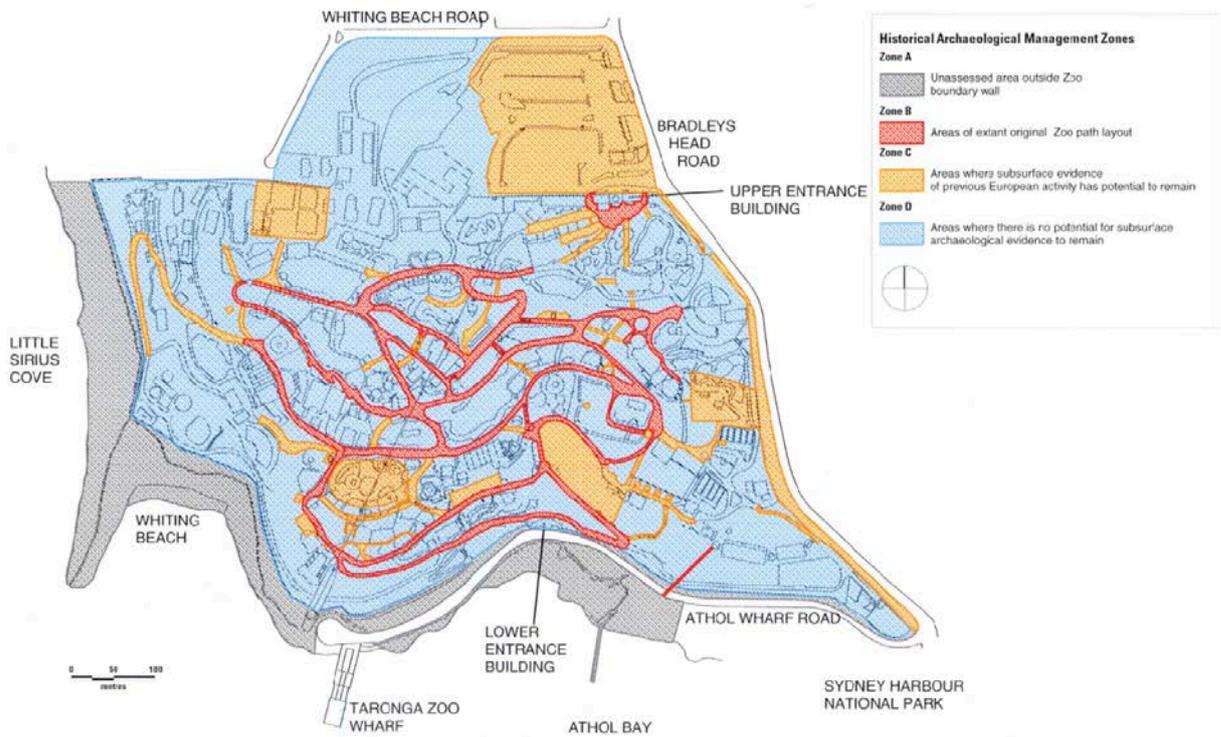
Figure 44 A plan from the 2004 *Archaeological Management Plan* of GML Heritage showing site zones with potential for European archaeology. (Extract courtesy of GML Heritage)

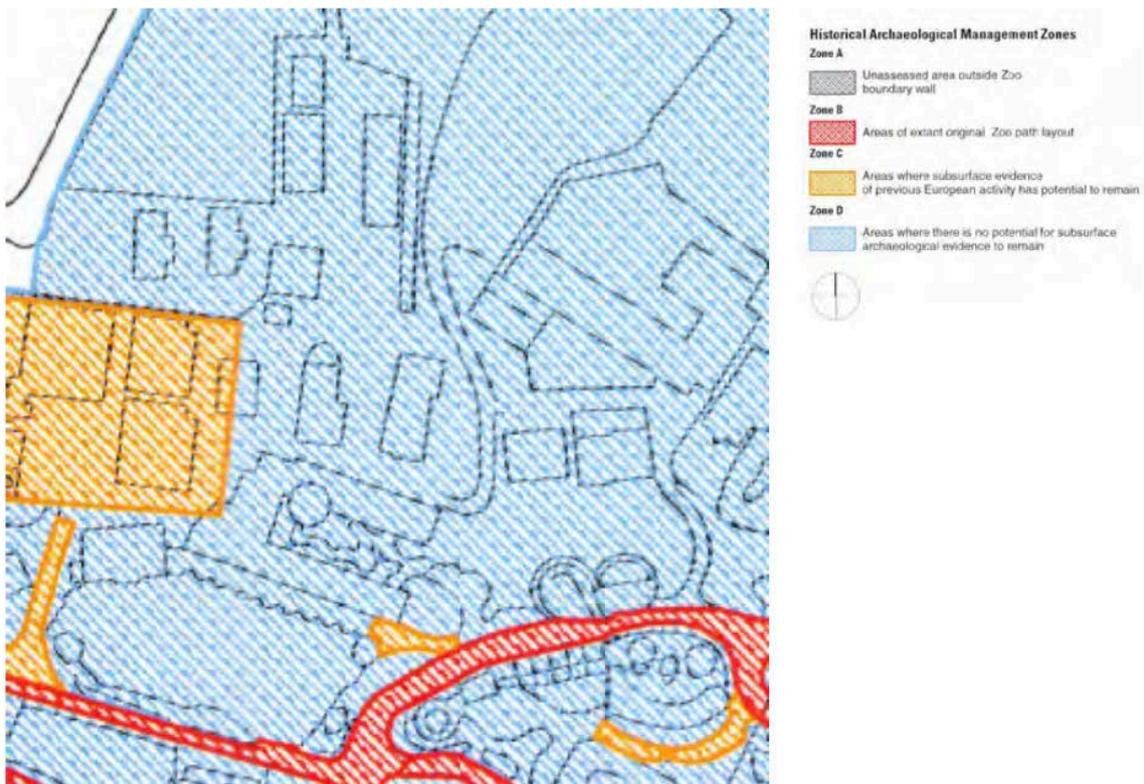
Figure 45 A detail from the plan above showing all of the study area indicated as Historical Archaeological Management Zone D (light blue) where it is considered that there is no potential for subsurface archaeology. Historical archaeology is also the subject of a current study for the site and reference is made to that report for more detailed advice. (Extract courtesy of GML Heritage with reformatting by Jean Rice)

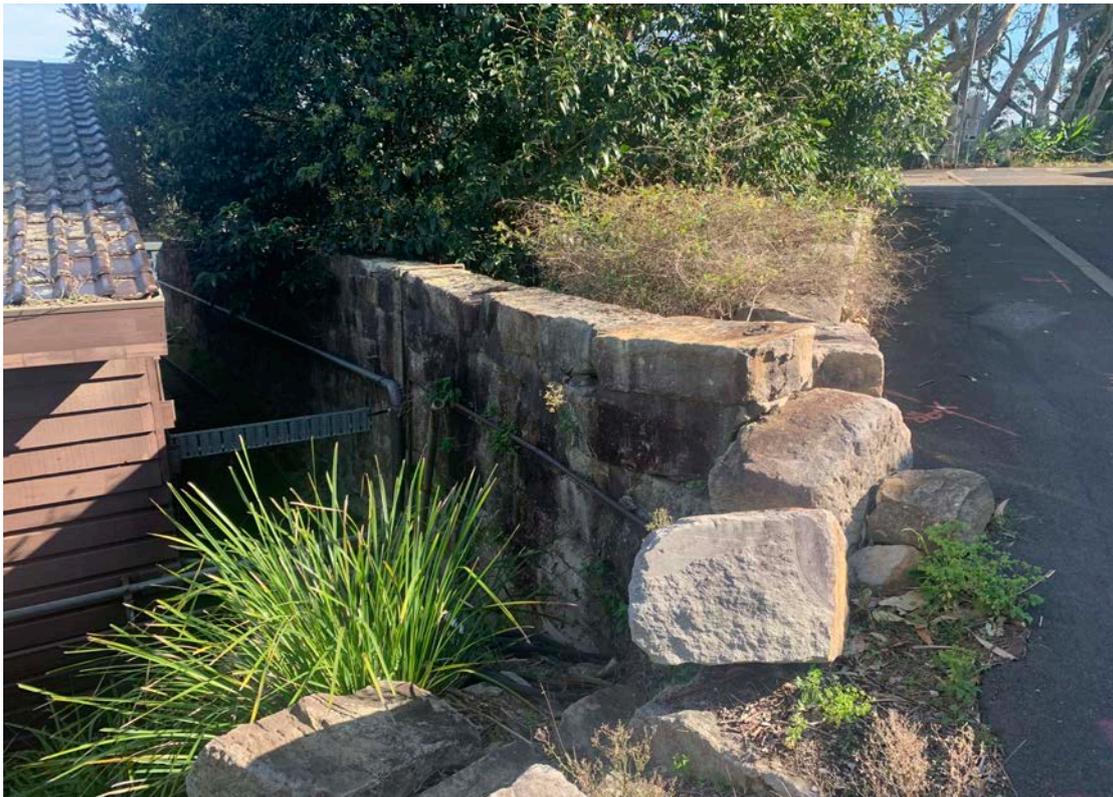
Figure 47 A section of the northern stone boundary wall with the northern end of the current food preparation building adjacent beyond.
